MITIGATION PLAN

Bug Headwaters Mitigation Site Wilkes County, NC NCDEQ Contract No. 7617 DMS ID No. 100084

Yadkin River Basin HUC 03040101

USACE Action ID No. SAW-2018-01788

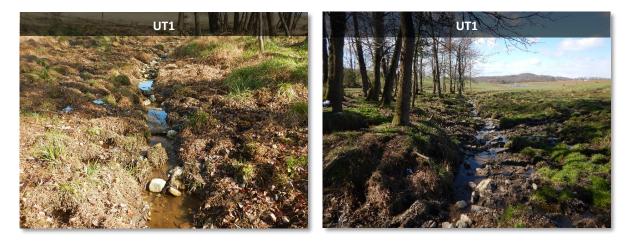
UT1 originates as a wetland seep within the project property limits near the head of Big Bugaboo Creek. The valley is similar to Big Bugaboo Creek Reach 1 in that it is narrow but less steep than other portions of the site. The stream flows through a small wooded area where cattle access the stream for water and shade and have trampled it causing severe degradation of the channel. The bed material is a mix of fine sediments, gravel, and cobble but the bed forms have been destroyed by cattle. There are multiple wallow areas in the adjacent wetland complex as well, and cattle access points to the stream have resulted in a network of groundwater seeps connected with the channel. The channel is incised in the areas were banks are intact, with bank height ratios up to 5.0.

Reach Summary Information – UT1				
Parameters	UT1			
Length of Reach (Linear Feet)	380			
Valley confinement (Confined, moderately confined, unconfined)	Confined			
Drainage area (acres)	7			
Perennial, Intermittent, Ephemeral	Intermittent			
NCDWR Water Quality Classification	С			
Stream Classification (Existing and Proposed)	B4/B4			
Evolutionary Trend				
FEMA zone Classification	Х			
NC Sam Rating	Low

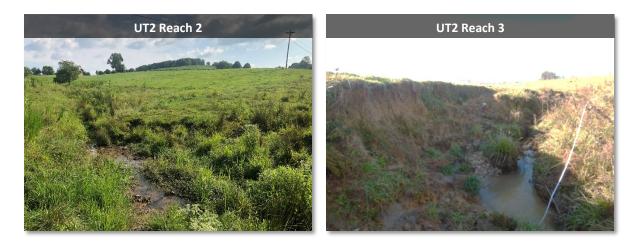
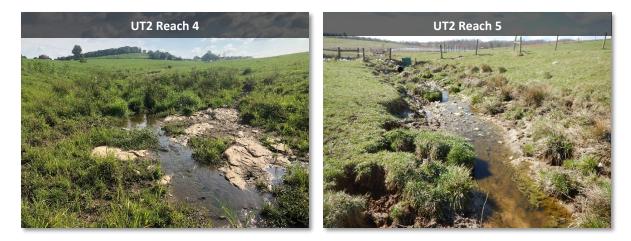
<u>UT2</u>

UT2 begins at the north end of the Wood property near King Billings Road and is contained entirely within the project property. A utility easement intersects UT2 Reach 2 and continues through UT2A. UT2 is generally entrenched in a tight valley (ER < 2.2) and flows through cattle pasture for its entire length. Cattle trampling is evident throughout but more severe on the downstream portion of the stream. The downstream portion is characterized by incision, bank erosion, and degradation of bed forms. Bed material is mostly a mix of fine sediments and gravel with some small cobble present farther downstream. Multiple patches of exposed bedrock provide grade control for Reach 4.

Reach Summary Information – UT2						
Parameters	Reach 1	Reach 2	Reach 3	Reach 4	Reach 5	
Length of Reach (Linear Feet)	506	124	450	314	778	
Valley confinement (Confined, moderately confined, unconfined)	Confined	Confined	Confined	Confined	Moderately Confined	
Drainage area (acres)	15	16	44	45	65	
Perennial, Intermittent, Ephemeral	Intermittent	Intermittent	Perennial	Perennial	Perennial	
NCDWR Water Quality Classification	C	С	С	С	C	
Stream Classification (Existing and Proposed)	B4a/B4a	A4/B4	B4/B4	B4/B4	F4b/C4b	
Evolutionary Trend	II	II	===		111	
FEMA zone Classification	Х	Х	Х	Х	Х	
NC SAM Rating	Medium	Medium	Low	Medium	Low

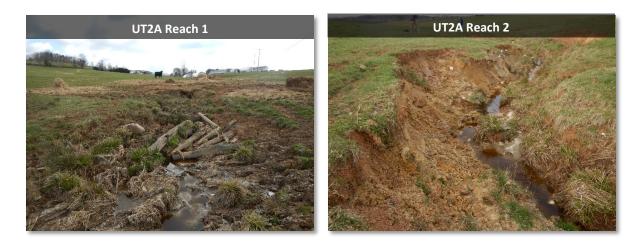
UT2A originates at the north edge of the Wood property near Austin Traphill Road and continues to the confluence with UT2. There is a large head cut at the upstream end before the stream flows underneath an overhead electric line through a relatively stable wetland complex. Downstream of the wetland complex, UT2A is similar to UT2 Reach 2 in that it is entrenched in a narrow valley, often bordered by small pocket wetlands, and buffered by open, active cattle pasture. It has a bank height ratio of 4.8 and the constant, reachwide cattle access has led to destruction of bed forms and severe erosion of the streambanks. The bed material is a mix of fine sediments and gravel.

Reach Summary Information – UT2A					
Parameters	Reach 1	Reach 2			
Length of Reach (Linear Feet)	211	450			
Valley confinement (Confined, moderately confined, unconfined)	Moderately Confined	Confined			
Drainage area (acres)	13	17			
Perennial, Intermittent, Ephemeral	Intermittent	Intermittent			
NCDWR Water Quality Classification	С	C			
Stream Classification (Existing and Proposed)	B4a/B4a	A4/B4a			
Evolutionary Trend	II	III			
FEMA zone Classification	Х	Х			
NC SAM Rating	Medium	Low

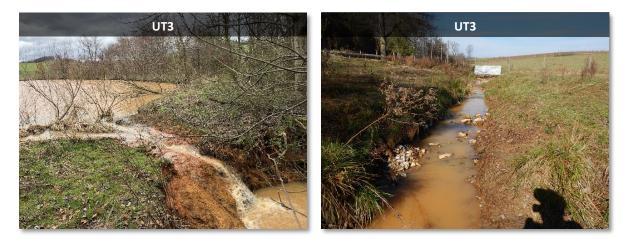
UT3 originates just upstream of the Swaim property near King Billings Road. It flows south onto the Swaim property and through a wooded area where the stream is stable and in good condition. After entering the project area, UT3 flows into an existing farm pond (Pond B) with a dam that is in poor condition. The original pond outlet structure has been destroyed and the earthen dam is now partially breached. All outflow now exits the pond through the breach and has created a head cut from UT3 to the dam. The dam is covered with trees, is seeping, and is in imminent danger of failing. Immediately downstream of the dam, the UT3 channel has been abandoned due to the breach and head cut. The outflow eventually flows back into the UT3 channel approximately 200 feet downstream of the dam. The stream then flows through a short section of forest and into open pasture, where it is incised (2.1 bank height ratio) and the banks have been heavily trampled by cattle. The stream appears to have been channelized through the cattle pasture; it is somewhat over-widened and has a sinuosity of approximately 1.0 despite the valley being only moderately confined.

Reach Summary Information – UT3				
Parameters	UT23			
Length of Reach (Linear Feet)	1,281			
Valley confinement (Confined, moderately confined, unconfined)	Moderately Confined			
Drainage area (acres)	96			
Perennial, Intermittent, Ephemeral	Perennial			
NCDWR Water Quality Classification	С			
Stream Classification (Existing and Proposed)	G4/C4			
Evolutionary Trend	=			
FEMA zone Classification	Х			
NC SAM Rating	Low

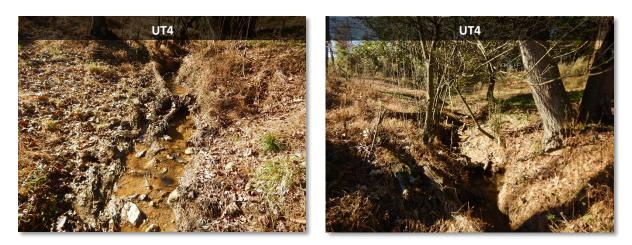
<u>UT4</u>

UT4 originates off the project property to the west and is impounded by a farm pond approximately 200 feet upstream of the project property. It flows through a fairly tight valley that becomes less confined as it reaches the floodplain of Big Bugaboo Creek Reach 4. Cattle have access to the entire length of UT4 within the project property. There are a few scattered trees within the UT4 buffer zone, which cattle use as shade, and some adjacent herbaceous vegetation, which is grazed. UT4 is generally vertically and laterally stable, although the upstream portion appears to be somewhat incised.

Reach Summary Information – UT4				
Parameters	UT24			
Length of Reach (Linear Feet)	128			
Valley confinement (Confined, moderately confined, unconfined)	Moderately Confined			
Drainage area (acres)	21			
Perennial, Intermittent, Ephemeral	Perennial			
NCDWR Water Quality Classification	С			
Stream Classification (Existing and Proposed)	B4/B4			
Evolutionary Trend	11			
FEMA zone Classification	Х			
NC SAM Rating	High
