MITIGATION PLAN

Burnetts Chapel Buffer Mitigation Site Guilford County, North Carolina DENR Contract 003996

Randleman Lake Watershed Cape Fear River Basin HUC 03030003

February 2012

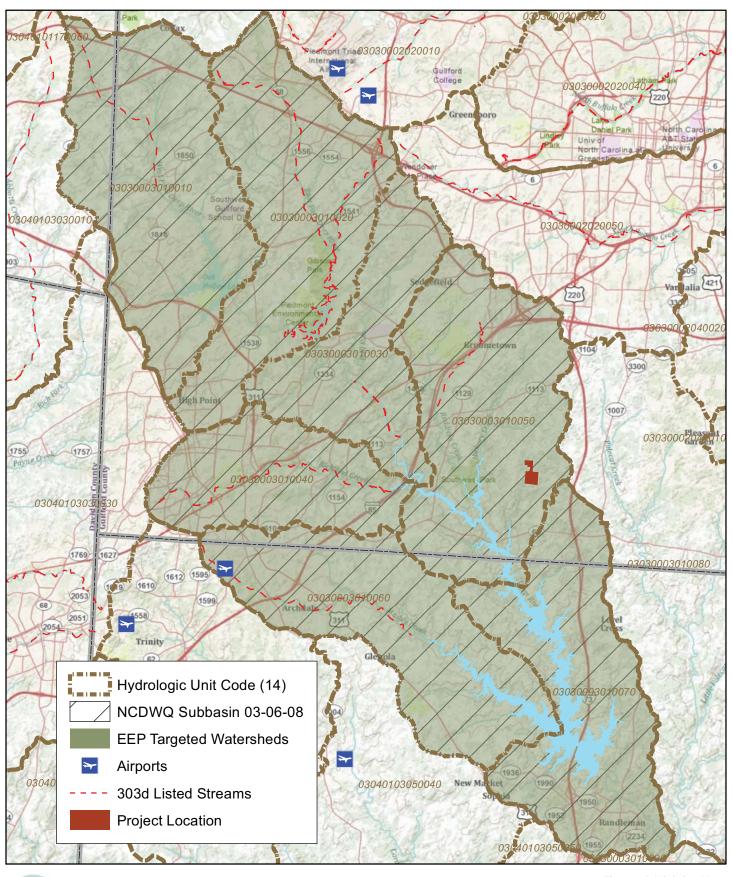
Figure 1 Vicinity Map Burnetts Chapel Buffer Mitigation Site Cape Fear Basin (03030003)

The project site is located within the Randleman Reservoir watershed (NCDWQ Subbasin 03-06-08) of the Cape Fear River Basin (USGS Hydrologic Unit Code 03030003010050) as shown in Figure 1. Onsite stream channels are unnamed tributaries to Deep River (Randleman Lake) (NCDWQ Index No. 17-(4)). The North Carolina Division of Water Quality (NCDWQ) assigns best usage classifications to State Waters that reflect water quality conditions and potential resource usage. Deep River is classified as Class WS-IV; Critical Area (CA) waters. Class WS-IV waters are used as sources of water supply for drinking or food processing purposes where a more restrictive WS-I, WS-II, or WS-III classification is not feasible. These waters are also protected for Class C uses such as secondary recreation, fishing, wildlife, fish and aquatic life propagation and survival, and agriculture. WS-IV waters are generally in moderately to highly-developed watersheds or Protected Areas. This portion of Deep River (Randleman Lake) is also located within the Critical Area or area within ½ mile of a water supply. See Figure 1 for the Vicinity Map of the Burnetts Chapel Buffer Mitigation Project.

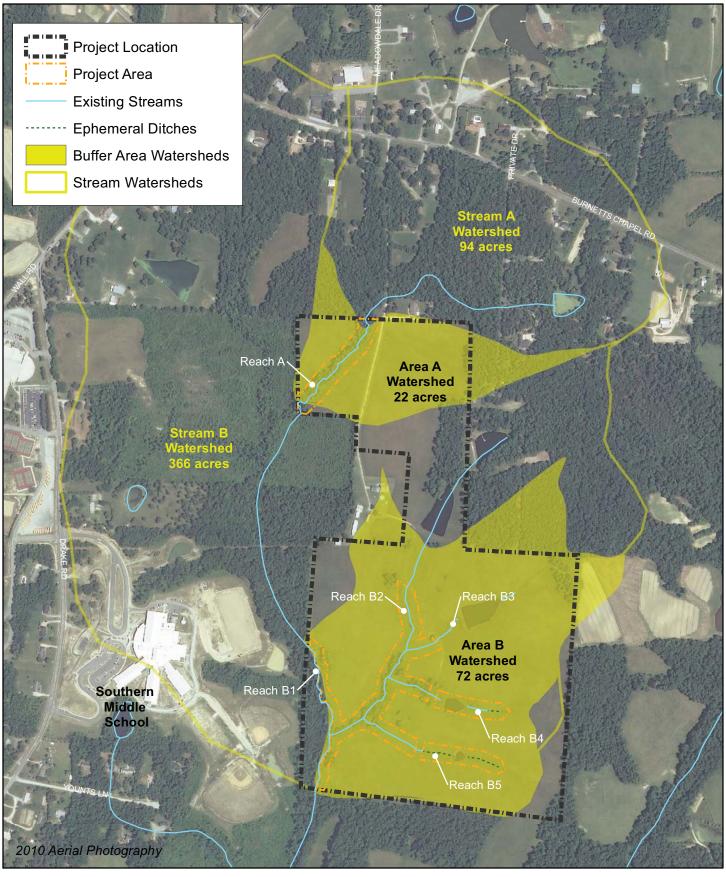
Figure 2 Watershed Map Burnetts Chapel Buffer Mitigation Site Cape Fear River Basin (03030003)

The Burnetts Chapel Buffer Mitigation Site is located within the Randleman Reservoir/ Hickory Creek watershed (NCDWQ Subbasin 03-06-08) of the Cape Fear River Basin (USGS Hydrologic Unit Code 03030003010050). Land use within the watershed is historically rural and is dominated by forestry, agriculture and livestock with approximately 52% of the watershed forested, 41% cultivated/ agriculture, and 7% institutional (Figure 2). While development is occurring in Guilford County along the Interstate 85 and Interstate 40 corridors within and around Greensboro, there is no evidence of increased development pressure in the project site's watershed which is located approximately four miles south of Greensboro.

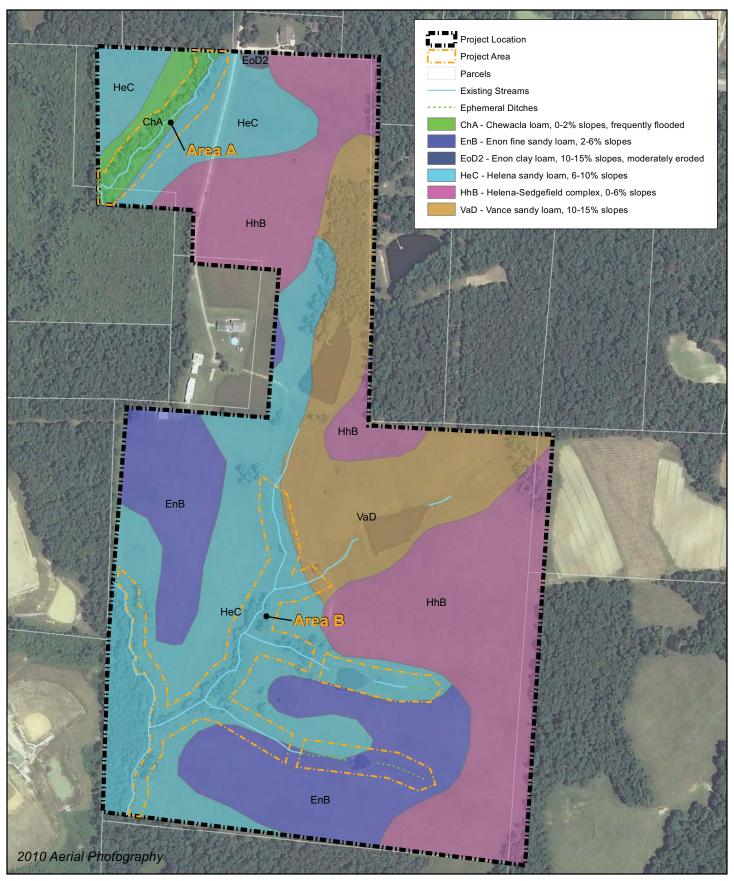
Figure 3 Soils Map Burnetts Chapel Buffer Mitigation Site Cape Fear River Basin (03030003)

Soil mapping units are based on the U.S. Department of Agriculture (USDA) Natural Resource Conservation Service (NRCS) Soil Survey for Guilford County. Soils along the Burnetts Chapel Buffer Mitigation project area are primarily mapped as Chewacla loam, Enon fine sandy loam, Helena sandy loam, and Vance sandy loam. These soils are described below in Table 2. A soils map is provided in Figure 3.

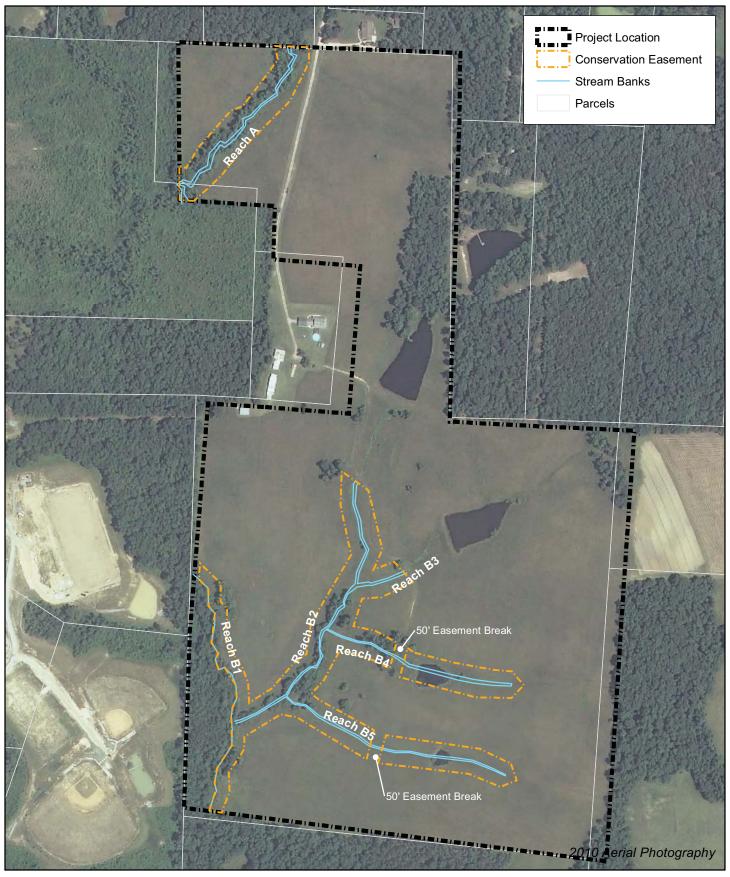
Figure 5 Site Protection Instrument Burnetts Chapel Buffer Mitigation Site Cape Fear River Basin (03030003)

See Figure 5 for the Site Protection Instrument Figure for the Burnetts Chapel Buffer Mitigation Project.

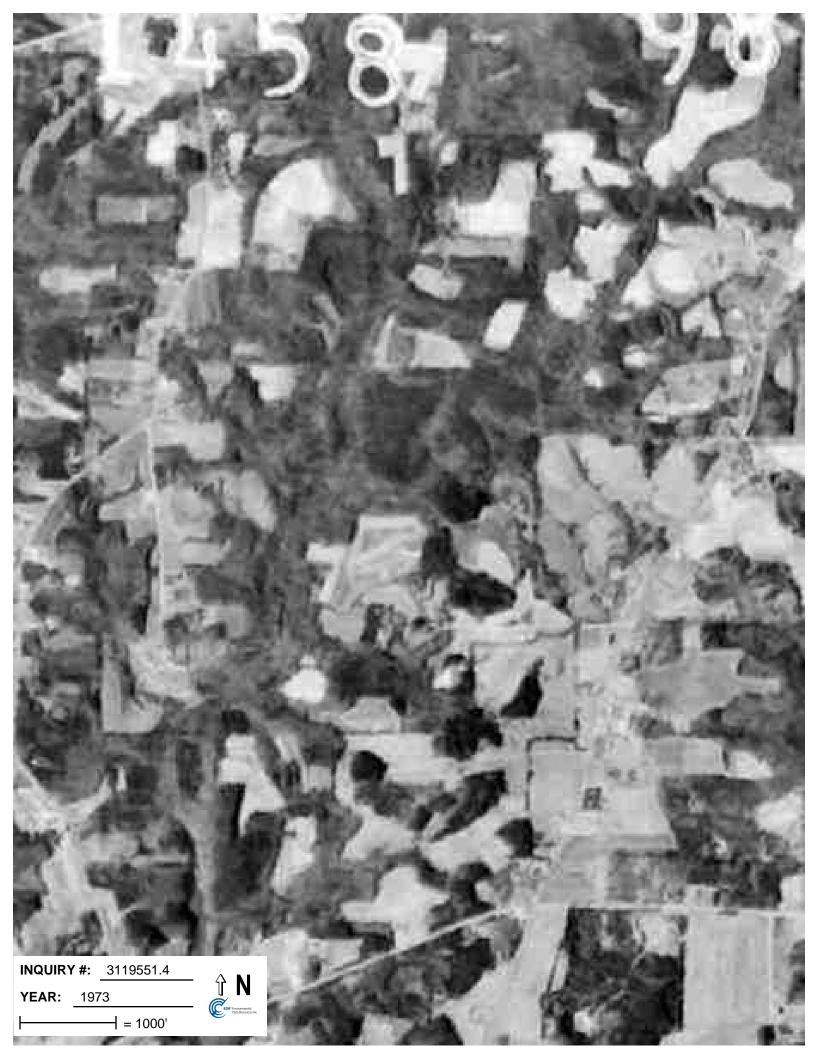
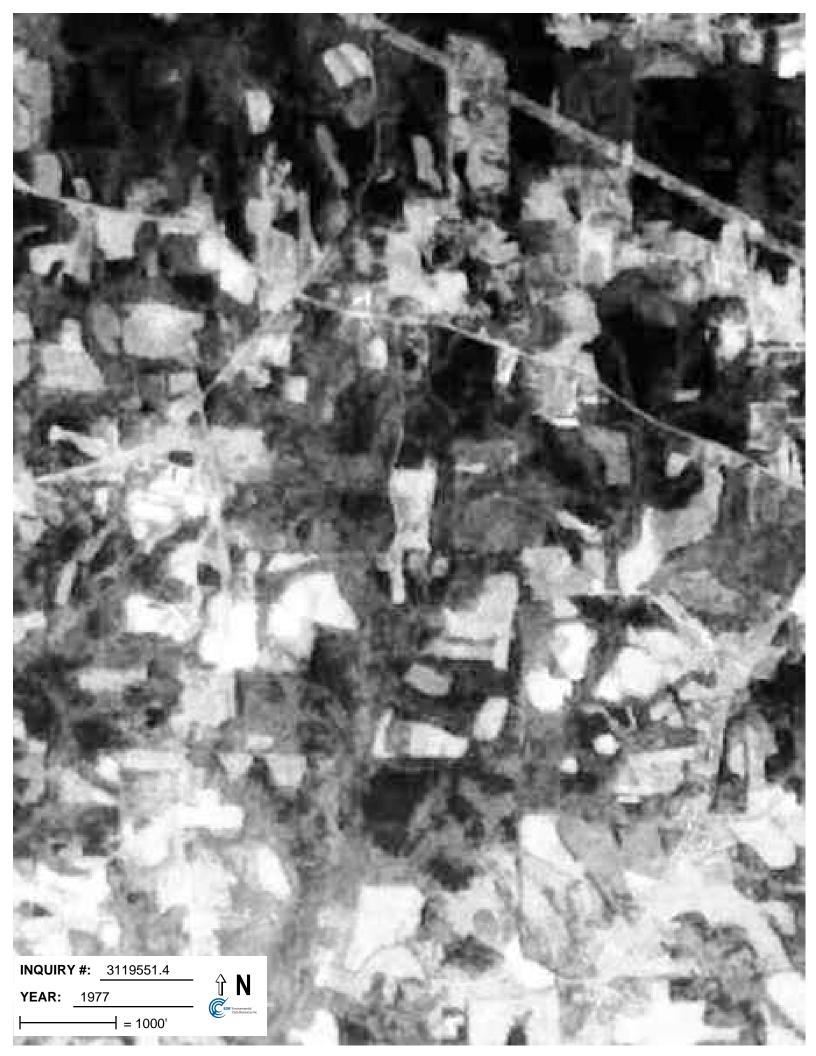
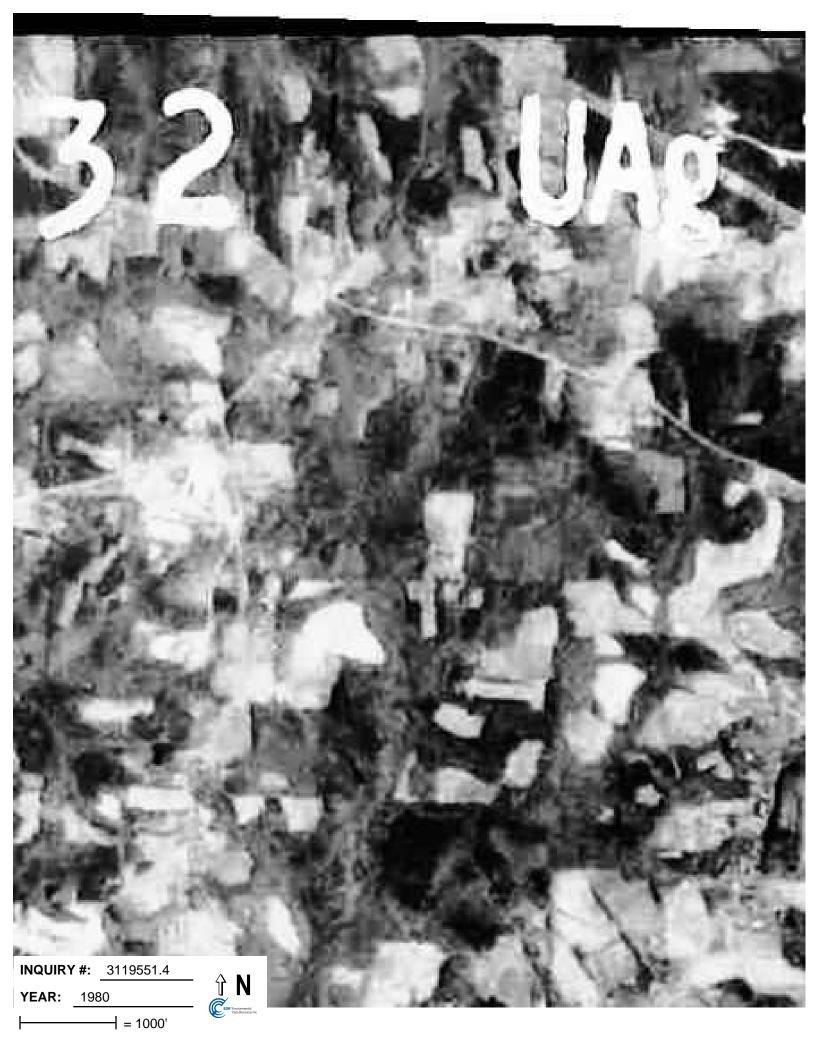
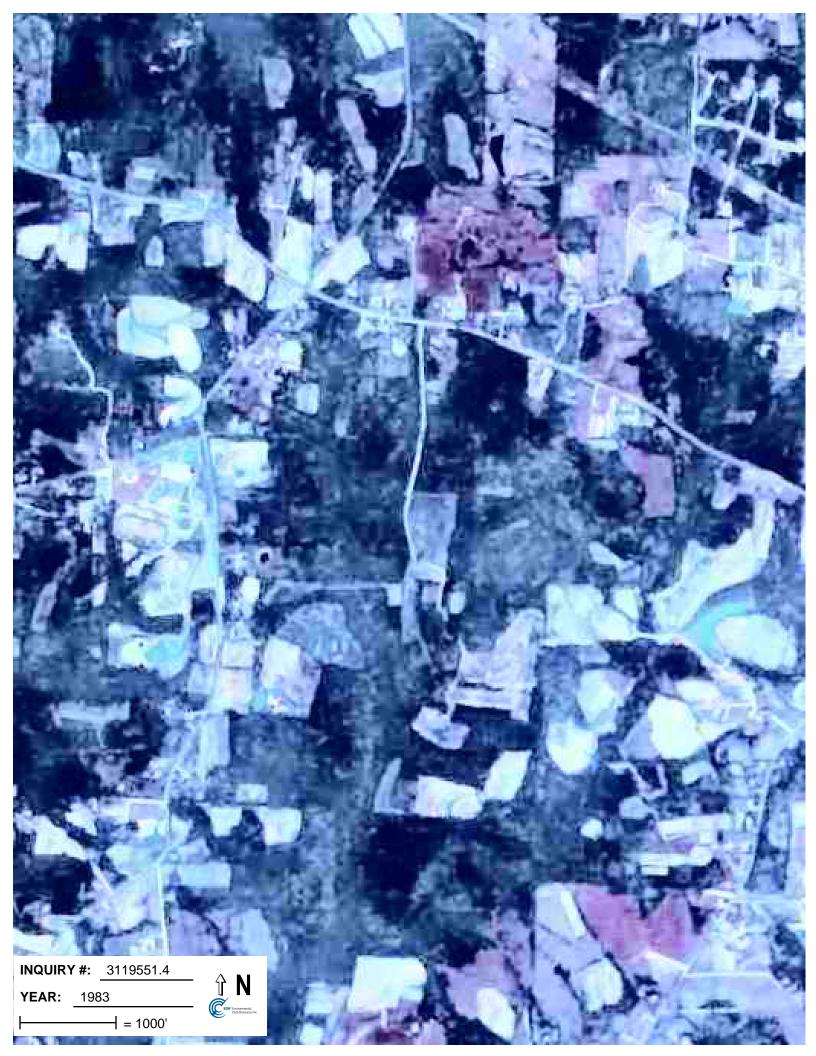
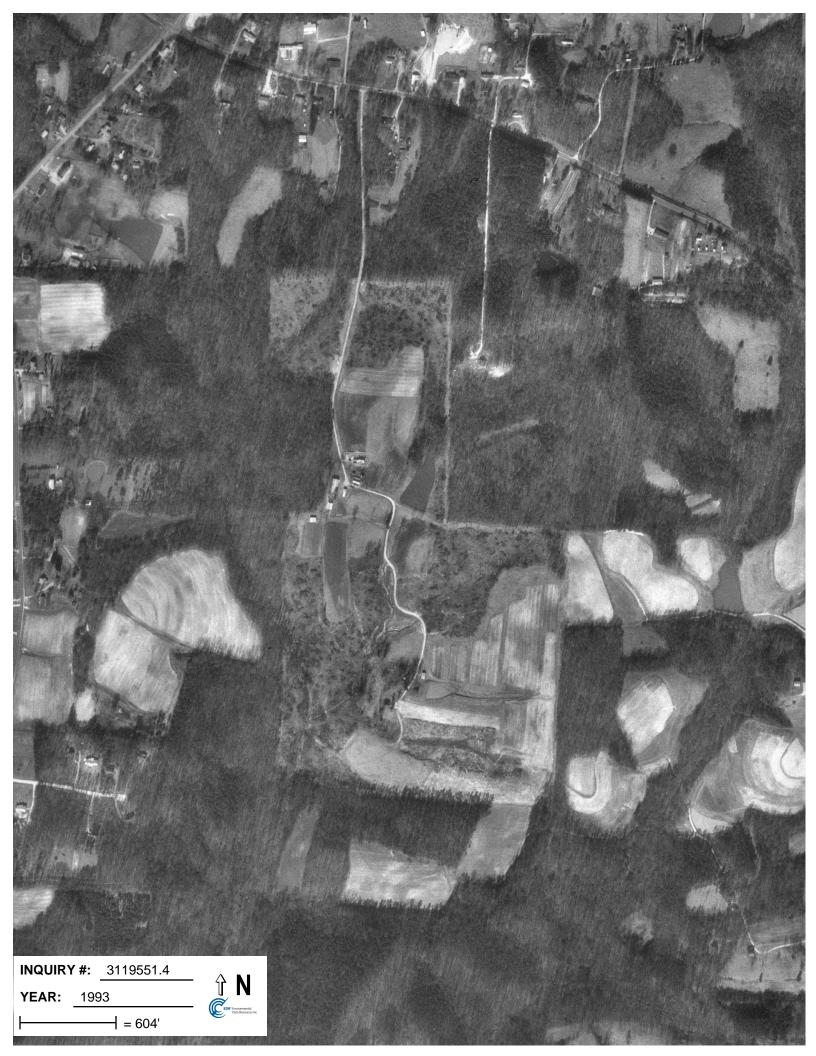
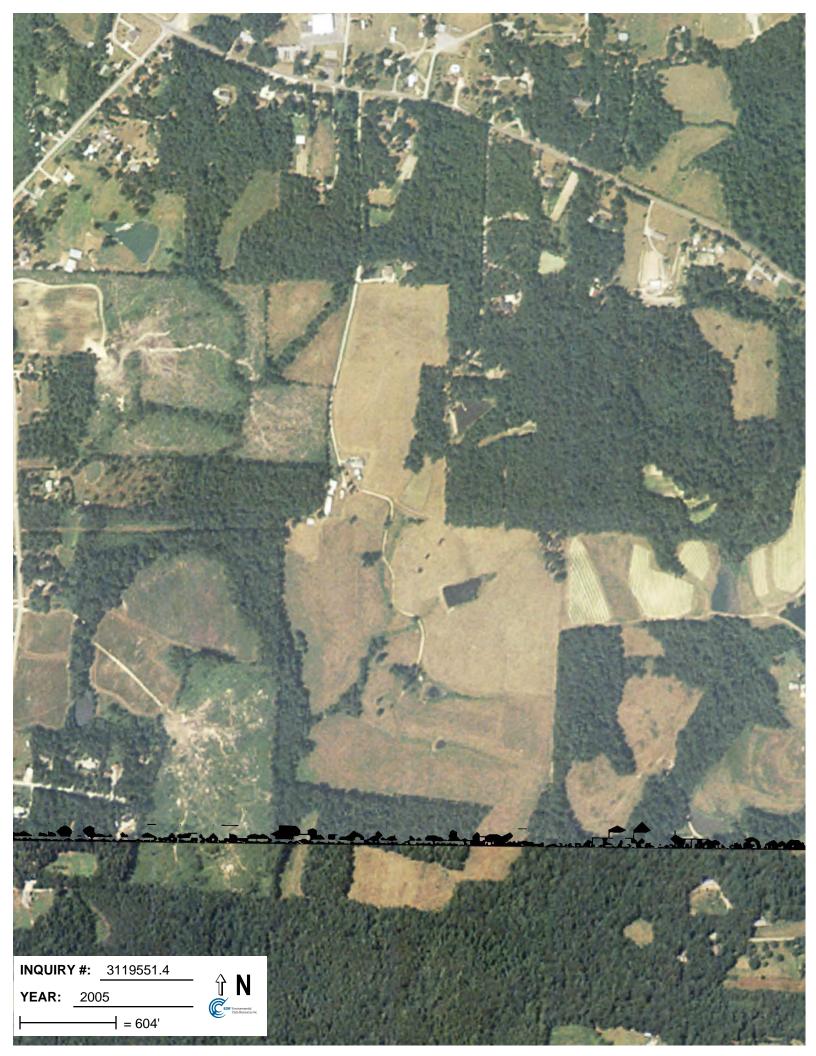
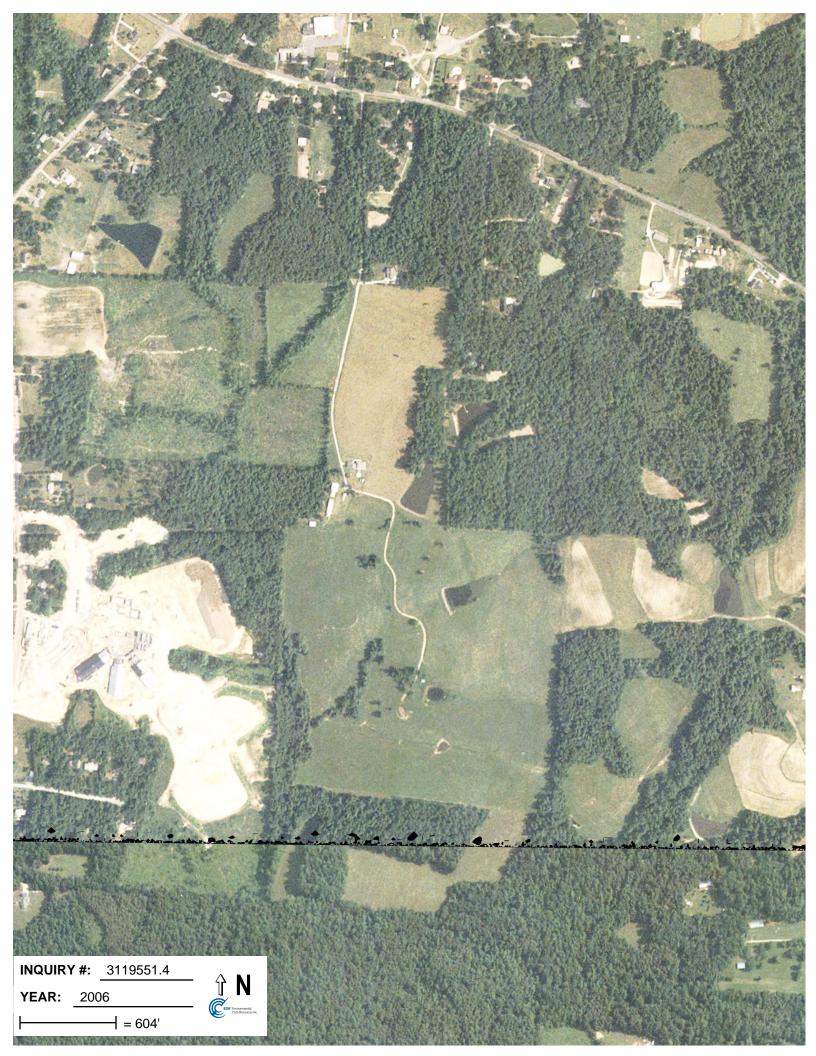
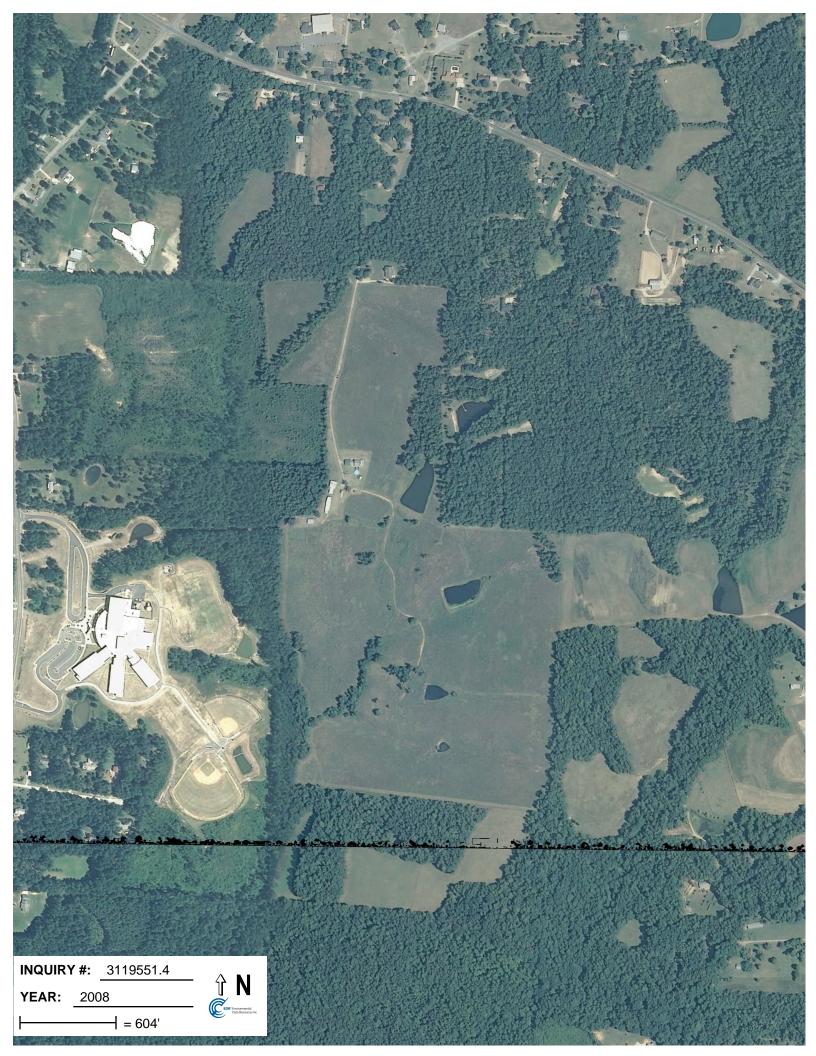
<u>Year</u>	<u>Scale</u>	<u>Details</u>	<u>Source</u>
1973	Aerial Photograph. Scale: 1"=1000'	Panel #: 35079-H7, Pleasant Garden, NC;/Flight Date: February 24, 1973	EDR
1977	Aerial Photograph. Scale: 1"=1000'	Panel #: 35079-H7, Pleasant Garden, NC;/Flight Date: March 01, 1977	EDR
1980	Aerial Photograph. Scale: 1"=1000'	Panel #: 35079-H7, Pleasant Garden, NC;/Flight Date: March 15, 1980	EDR
1983	Aerial Photograph. Scale: 1"=1000'	Panel #: 35079-H7, Pleasant Garden, NC;/Flight Date: April 21, 1983	EDR
1993	Aerial Photograph. Scale: 1"=604'	Panel #: 35079-H7, Pleasant Garden, NC;/Composite DOQQ -acquisition dates: February 02, 1993	EDR
2005	Aerial Photograph. Scale: 1"=604'	Panel #: 35079-H7, Pleasant Garden, NC;/Flight Year: 2005	EDR
2006	Aerial Photograph. Scale: 1"=604'	Panel #: 35079-H7, Pleasant Garden, NC;/Flight Year: 2006	EDR
2008	Aerial Photograph. Scale: 1"=604'	Panel #: 35079-H7, Pleasant Garden, NC;/Flight Year: 2008	EDR

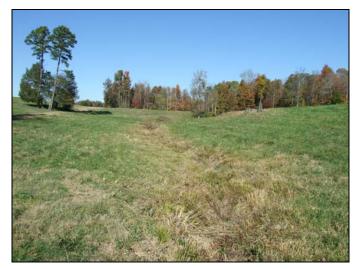
Photo 1- Intermittent Reach B2, facing upstream

Reach B2 is a perennial stream flowing south from a large off-site pond until its confluence with Reach B1. This channel exhibited stable geomorphic conditions with no active bed incision or bank erosion. Large portions of this channel are entirely lacking riparian buffer zones as a result of active pasture mowing and the buffer zones currently include low growing graminoid species. Small pockets of mature hardwood canopy forest exist along this reach with 5" diameter or greater tree densities of approximately 290 to 484 trees per acre (Table 5).

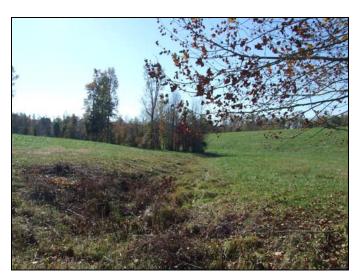
Photo 2- Intermittent Reach B3, facing downstream

Reaches B3, B4, and B5 are small intermittent channels with small upstream ephemeral channels located entirely within existing open pasture. These channels exhibit small cross-sectional areas with very minor flow pattern, silt and sand substrates, and relatively stable bank conditions. These three reaches entirely lack suitable woody riparian species and are dominated by various grass and sedge species.

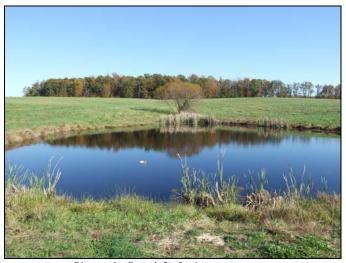
Photo 3- Pond C, facing upstream

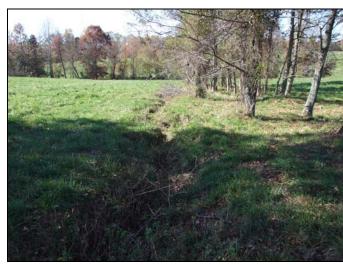
Photo 4- Intermittent Reach B4, downstream of Pond C

Reach B4 – No tree counts were requested on Reach B4. This reach will be riparian buffer restoration. The knickpoint identified at the second site visit was surveyed and used as the beginning of a true channel form along this reach. The upstream end of the easement area has been "bubbled" 50 feet per NCDWQ guidance. There is also one 50 foot easement break on this reach at an existing road crossing on the property. WEI is currently working with NCDWQ and USACE on the permits for the existing pond removal and channel restoration on the reach.

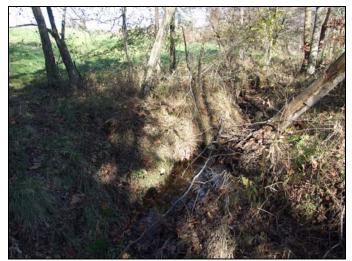
Photo 6- Perennial Reach B2, facing upstream

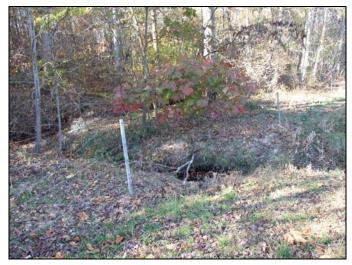
Photo 7- Reach B2 confluence with Reach B1

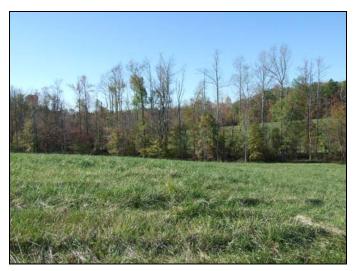
Photo 8- Existing buffer along Reach A

Areas of mixed hardwood bottomland forests are located throughout Reaches A, B1, and the middle portion of Reach B2. These forested areas exhibit mature canopy tree species with a moderate understory shrub and vine layer. These areas are in good condition and show no evidence of recent maintenance or vegetation disturbances. Canopy hardwood species include: American sycamore (*Platanus occidentalis*), red maple (*Acer rubrum*), sweet gum (*Liquidambar styraciflua*), shagbark hickory (*Carya ovata*), tulip poplar (*Liriodendron tulipifera*), southern red oak (*Quercus falcata*), box elder (*Acer negundo*), red elm (*Ulmus rubra*), and red cedar (*Juniperus virginiana*). Typical shrub species include common blackberry, small amounts of Chinese privet (*Ligustrum sinense*), and American holly (*Ilex opaca*) with interspersed vine species of catbriar (*Smilax rotundifolia*), poison ivy (*Toxicodendron radicans*), and Japanese honeysuckle.

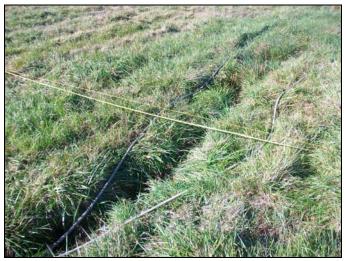
Photo 9- Ephemeral channel downstream of Pond D

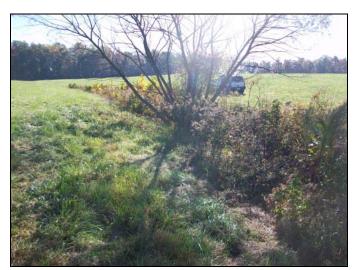
Photo 10- Intermittent Reach B4, upstream of Pond C

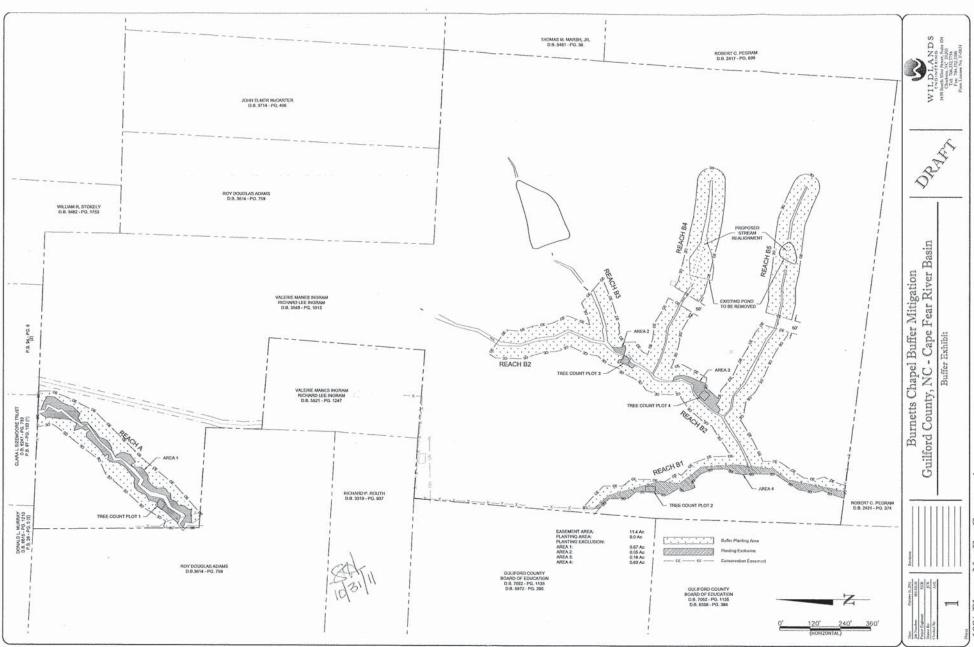
Attached is the updated map showing the proposed planting area for the Burnetts Chapel Buffer Mitigation Site. The conservation easement boundary is 50 feet from the surveyed top of bank. There are two existing ponds located within the conservation easement area (Reaches B4 and B5) that will be removed and the channels restored as part of the proposed project. In those areas the proposed restored stream channel location was used to create the easement boundary.
