MITIGATION PLAN

CANDY CREEK MITIGATION SITE

Guilford County, NC
DEQ Contract No. 5794
DMS ID No. 96315

Wildlands Engineering, Inc.

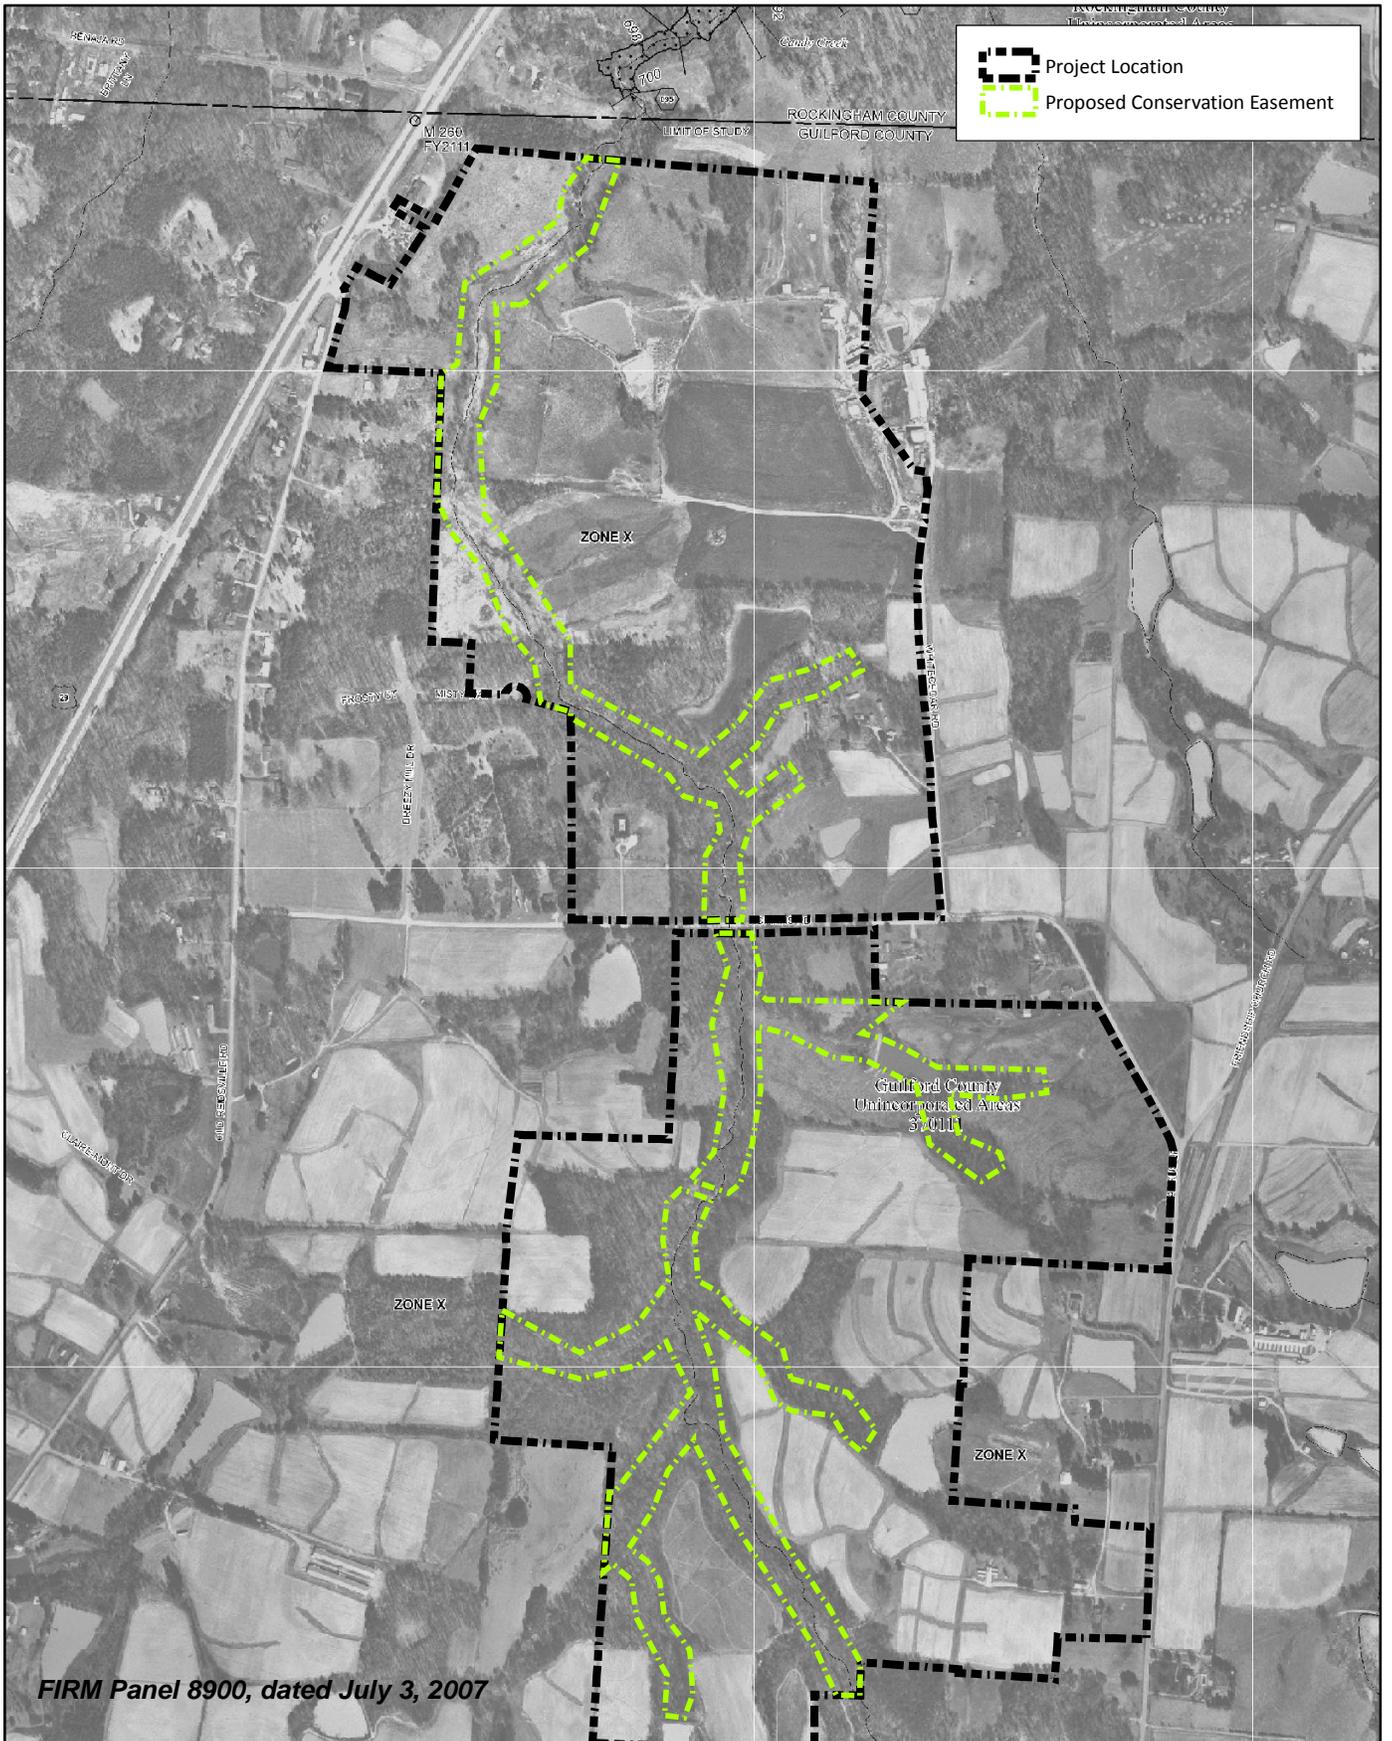
Figure 7 FEMA Map
 Candy Creek Mitigation Site
 Cape Fear River Basin (0303002)

Candy Creek is not within a Special Flood Hazard Area (SFHA). The nearest mapped FEMA floodplain is approximately 500 LF downstream of the project limits (Figure 7).

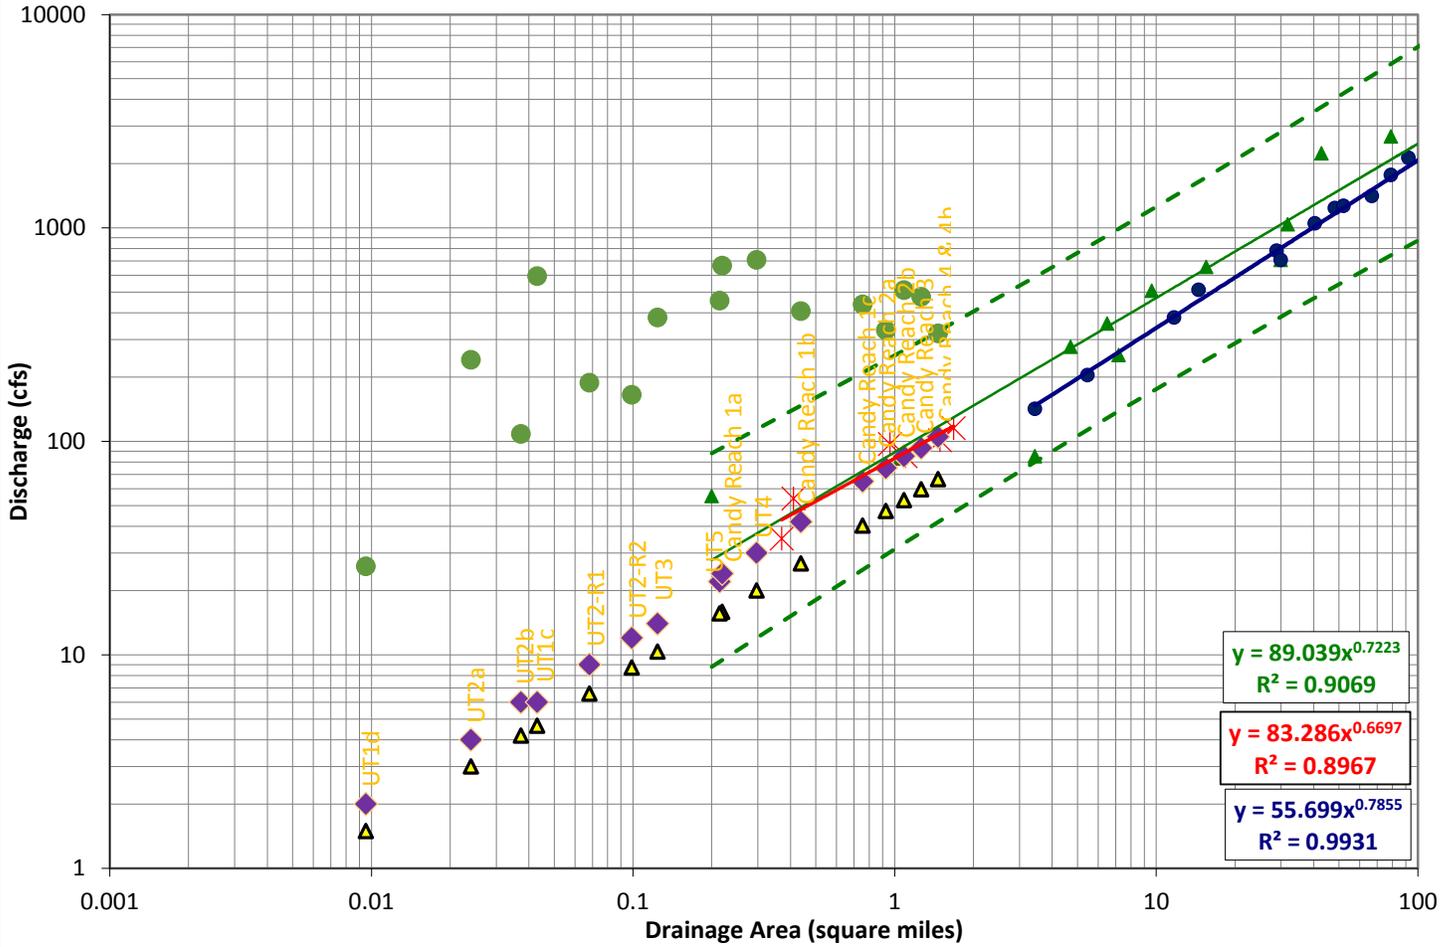
Figure 9 NC Piedmont Regional Curves with Project Data Overlay
Candy Creek Mitigation Site
Cape Fear River Basin (03030002)

Candy Creek Design Discharge Plot

- ▲ Rural Data
- Rural Lower 95% Limit
- Qmax - Existing Site Streams
- ✖ Reference Reach Curve
- Alan Walker Curve
- Power (Rural Data)
- Power (Reference Reach Curve)
- Rural Upper 95% Limit
- ◆ Reference Reaches
- ▲ USGS Rural Piedmont 1.2-yr Predictions
- ◆ Design Discharges
- Power (Alan Walker Curve)

The streams exist in an unnatural condition due to historic and ongoing manipulation, maintenance, and agricultural activities; therefore, reliable bankfull features were difficult to identify. The design bankfull discharge was estimated using methods outlined Section 9.2. This design bankfull discharge was routed through the surveyed cross sections to quantify existing condition bankfull dimensions for descriptive purposes. Existing geomorphic conditions for each reach included in the project are summarized above in Table 6 and the reaches are mapped on Figures 6a and 6b.

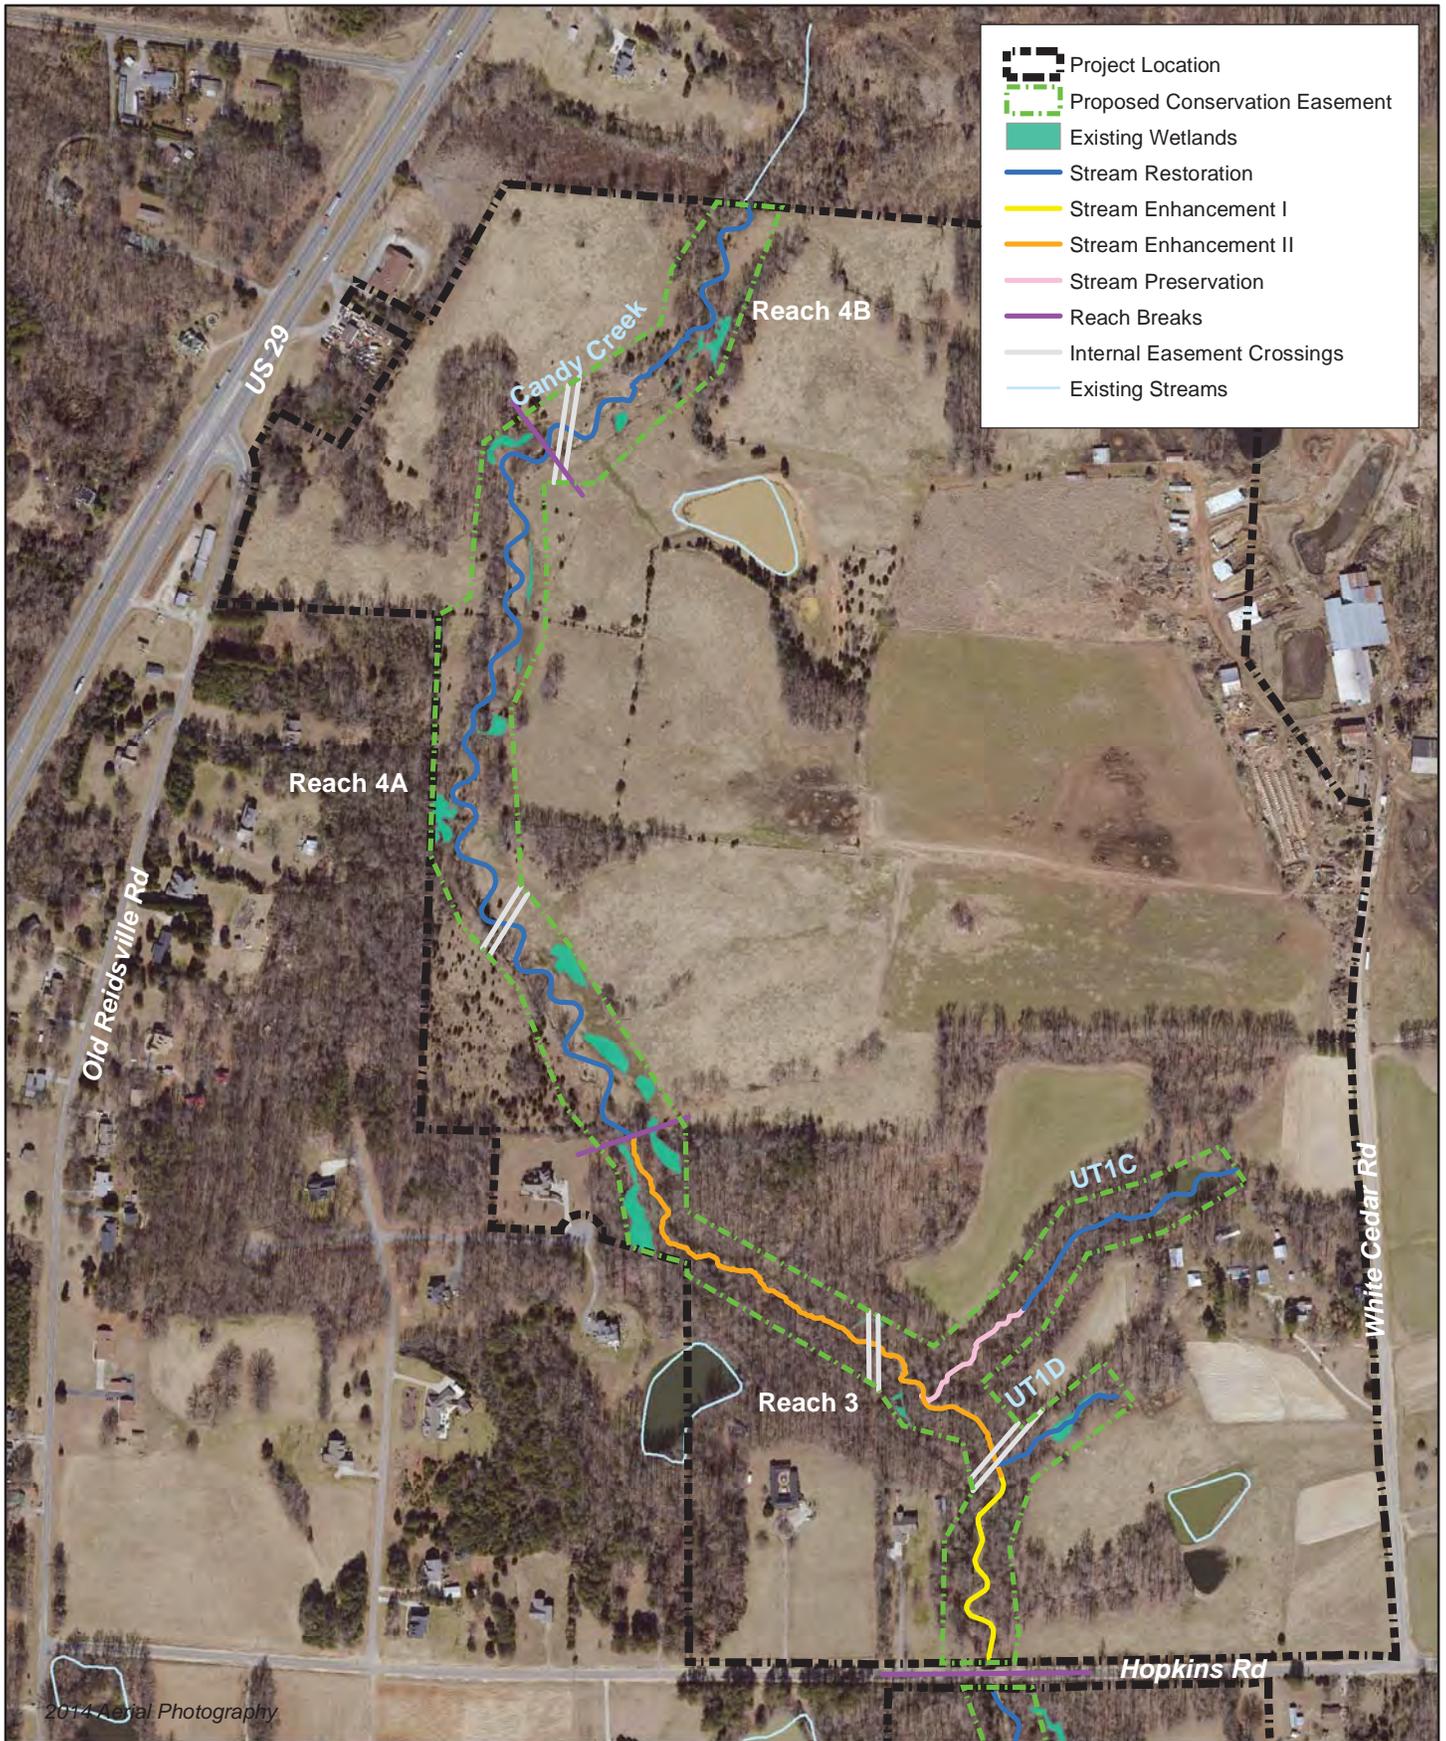
Figure 10a Concept Design Map (North)
 Candy Creek Mitigation Site
 Cape Fear River Basin (03030002)

- Project Location
- Proposed Conservation Easement
- Existing Wetlands
- Stream Restoration
- Stream Enhancement I
- Stream Enhancement II
- Stream Preservation
- Reach Breaks
- Internal Easement Crossings
- Existing Streams

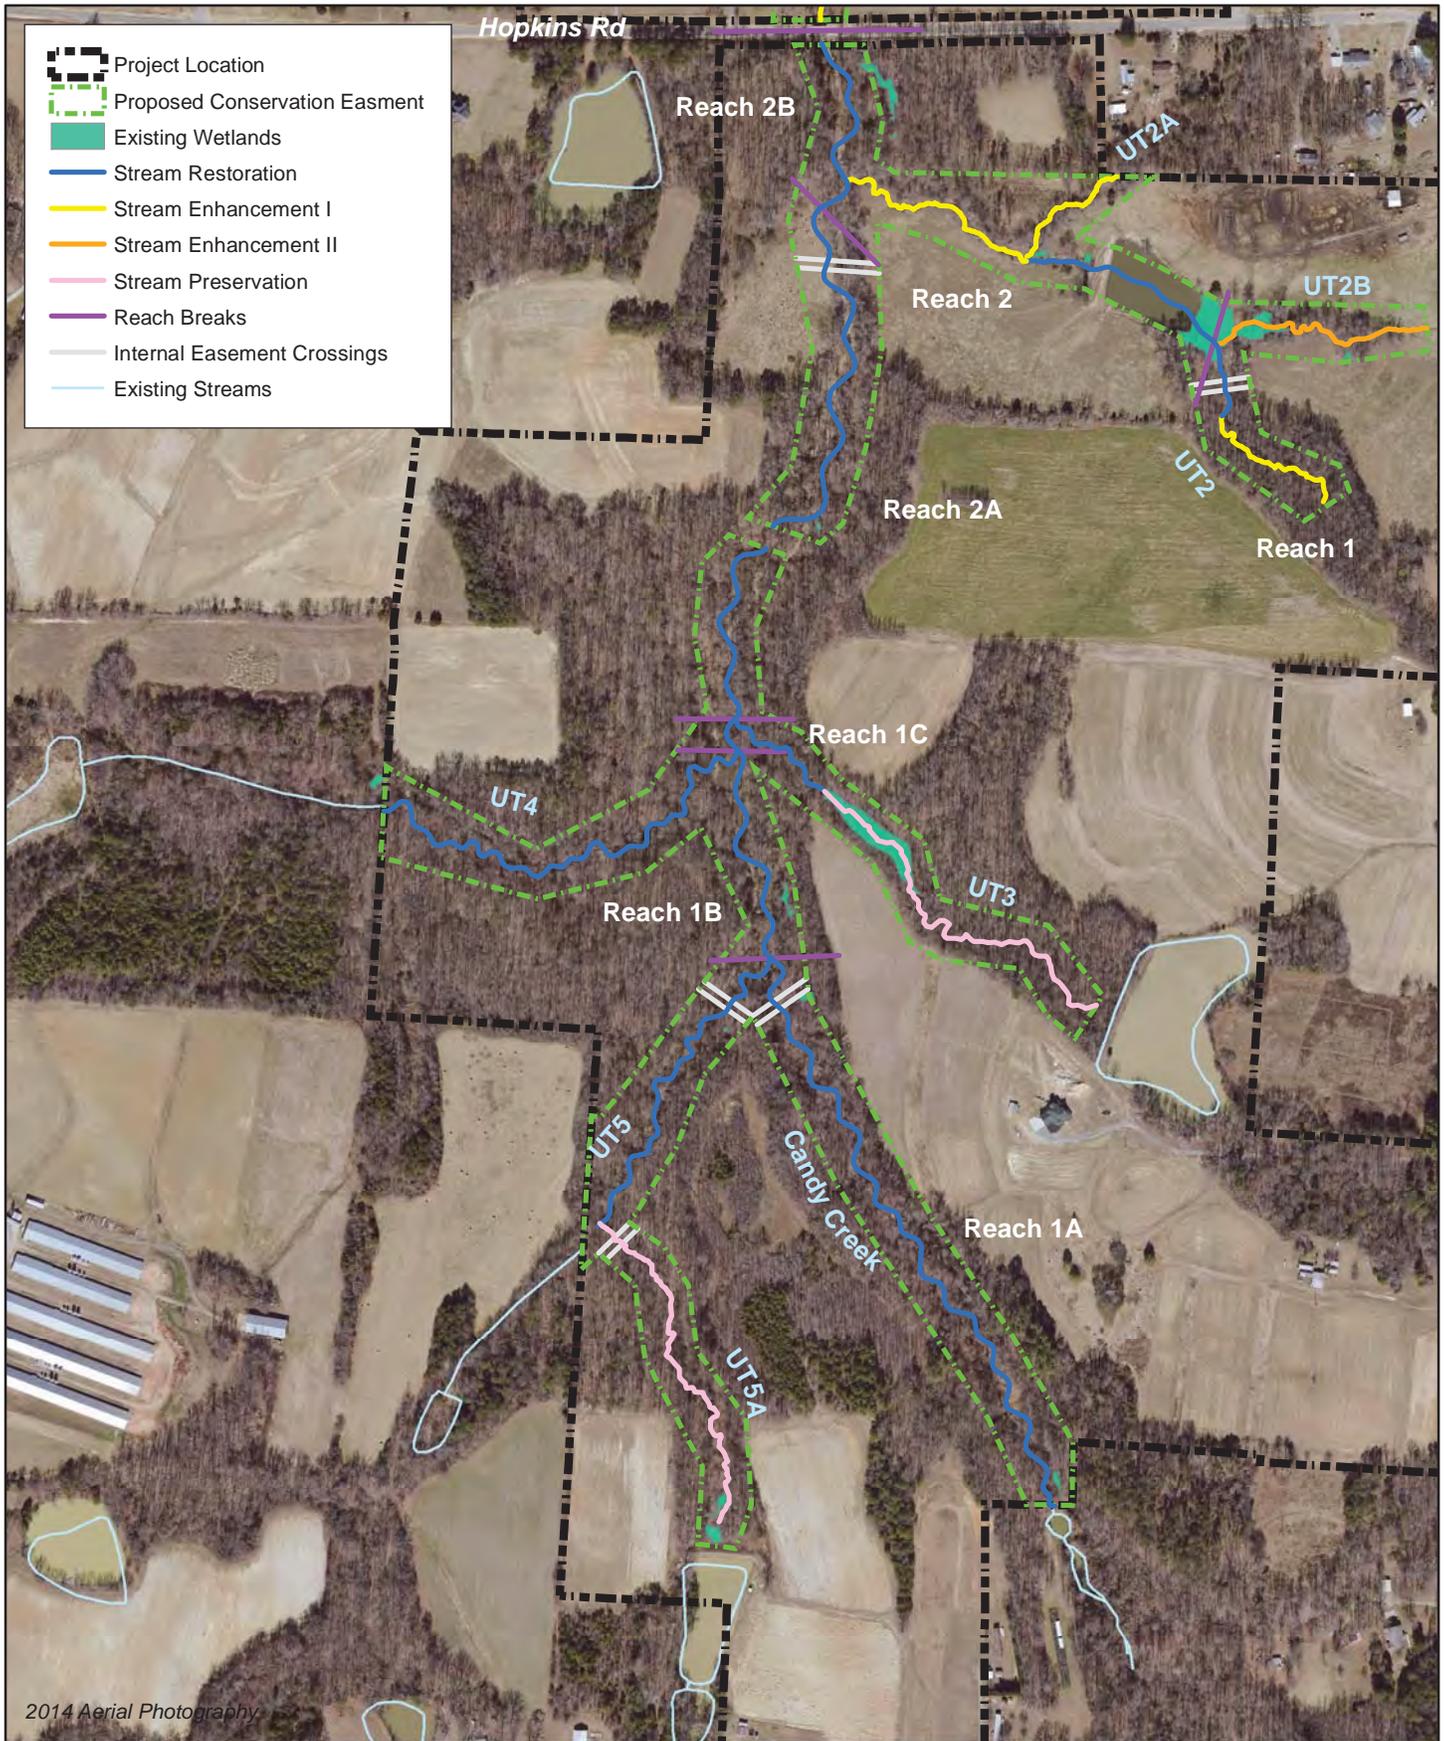
Figure 10b Concept Design Map (South)
Candy Creek Mitigation Site
Cape Fear River Basin (03030002)

- Project Location
- Proposed Conservation Easement
- Stream Restoration
- Stream Enhancement I
- Stream Enhancement II
- Stream Preservation
- Reach Breaks
- Existing Streams
- Proposed Cross-Sections
- Proposed Vegetation Plots

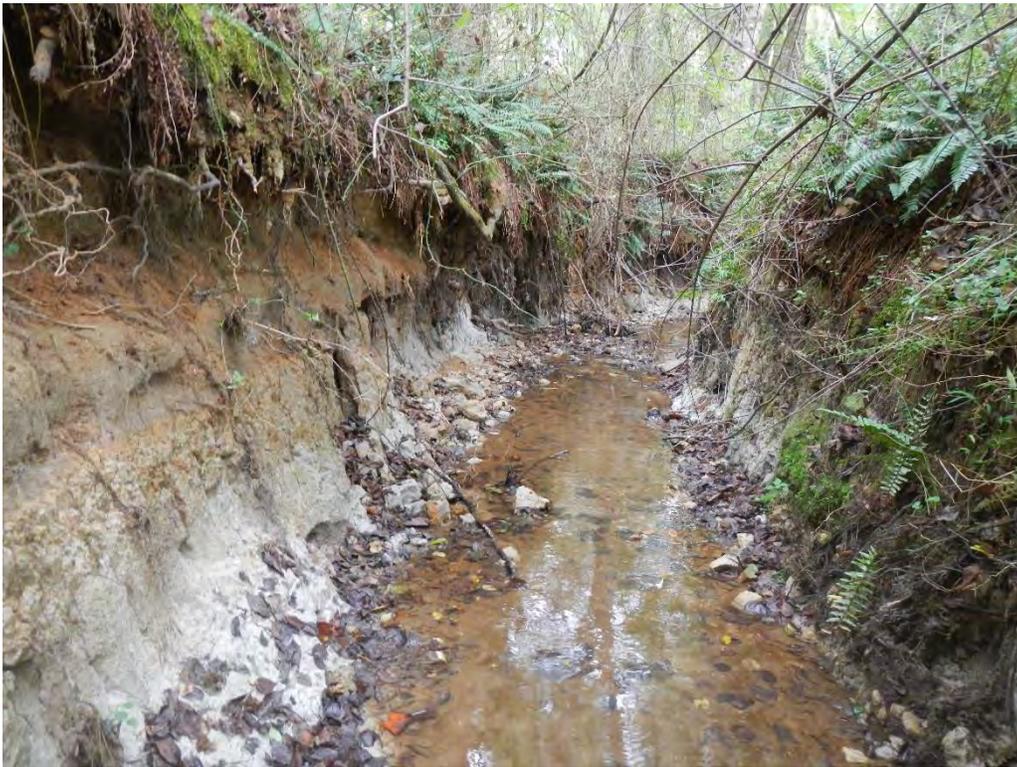
Photo 1: Candy Creek Reach 1 restoration reach

Candy Creek Reach 1 enters the Site at the southern property boundary next to a small pond and flows north through a wooded valley. Reach 1 is severely incised for its entire length with mass wasting occurring on approximately 75% of its banks. The reach has moderate sinuosity with sandy bed conditions from active bank erosion occurring along the reach. The result is that Reach 1 has impaired in-stream habitat from siltation and a lack of floodplain connectivity due to the severity of channel degradation. As Candy Creek Reach 1 continues downstream, the dimension widens and the incised condition continues. Remnants of a historic, breached dam exist on the left and right floodplain approximately 430 LF from the upstream project limits. The floodplain is not engaged until the predicted 25-year return interval discharge.

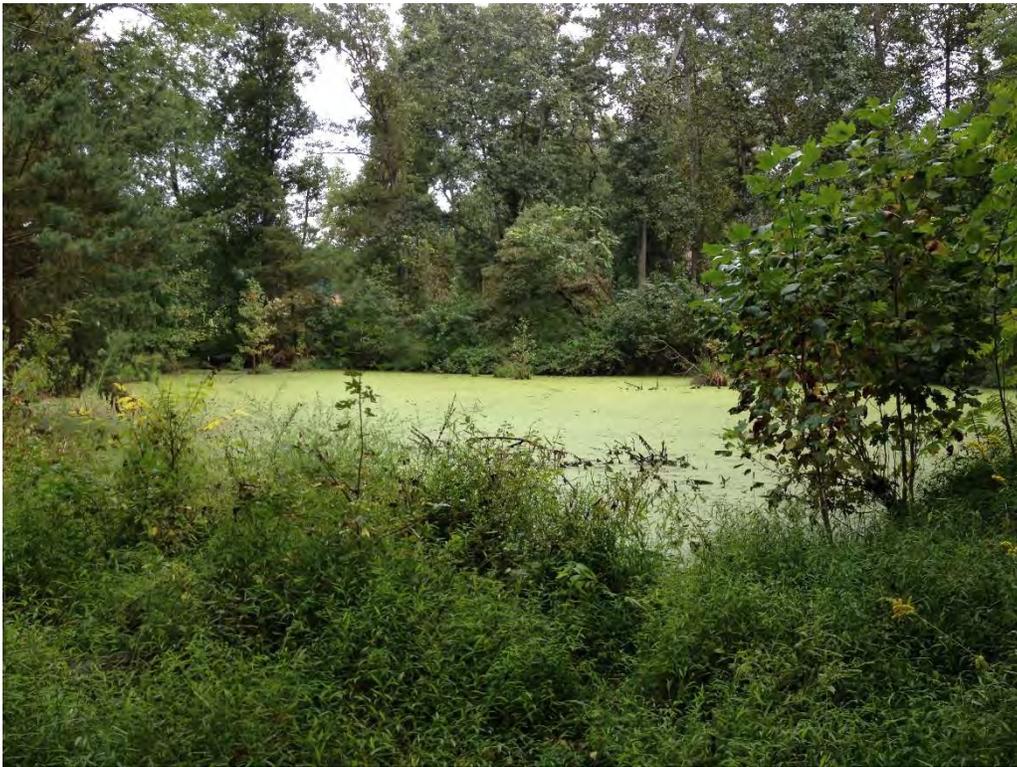
Photo 5: Pond to be removed on UT1c

U1C originates at an on-site farm pond and flows southwest through a wooded valley before draining into Candy Creek Reach 3. Storm drainage feeding the pond originates from a 12 inch reinforced concrete pipe and an agricultural ditch that connects to the pond. An ephemeral drainage enters from the right side of the valley just below the pond embankment. This drainage combined with outlet drainage from the pond and falls down a massive headcut which is and will continue to threaten the pond embankment stability until it ultimately fails. On the opposite side of the embankment, at the downstream base of the slope, there is a small seep wetland likely the result of pond seepage. Downstream of the pond, the banks are deeply incised with up to 20-foot high vertical eroding banks, and little potential for self-correction due to the steep valley side slopes and extreme incision. The incision peters out near a relic impoundment that has been breached. Downstream of this, the banks are fairly stable and well vegetated within the downstream half of the stream, which will be preserved.

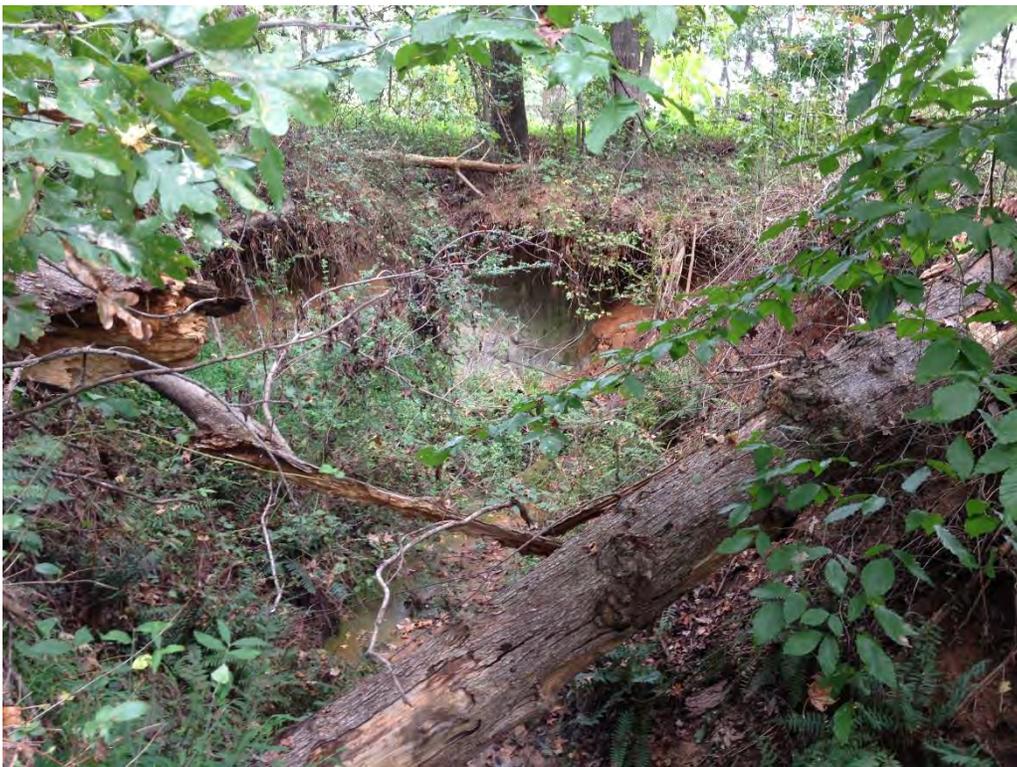
Photo 6: UT1c restoration reach

The non-impounded section of UT1C, downstream of the existing dam, flows through a steep, narrow, wooded valley. It appears that further bed degradation is possible since there are no signs of bedrock and due to the steeper stream slope. While the banks are vertical and eroding, it does not seem like the widening process has commenced. This reach is in Stage III of the evolutionary process.

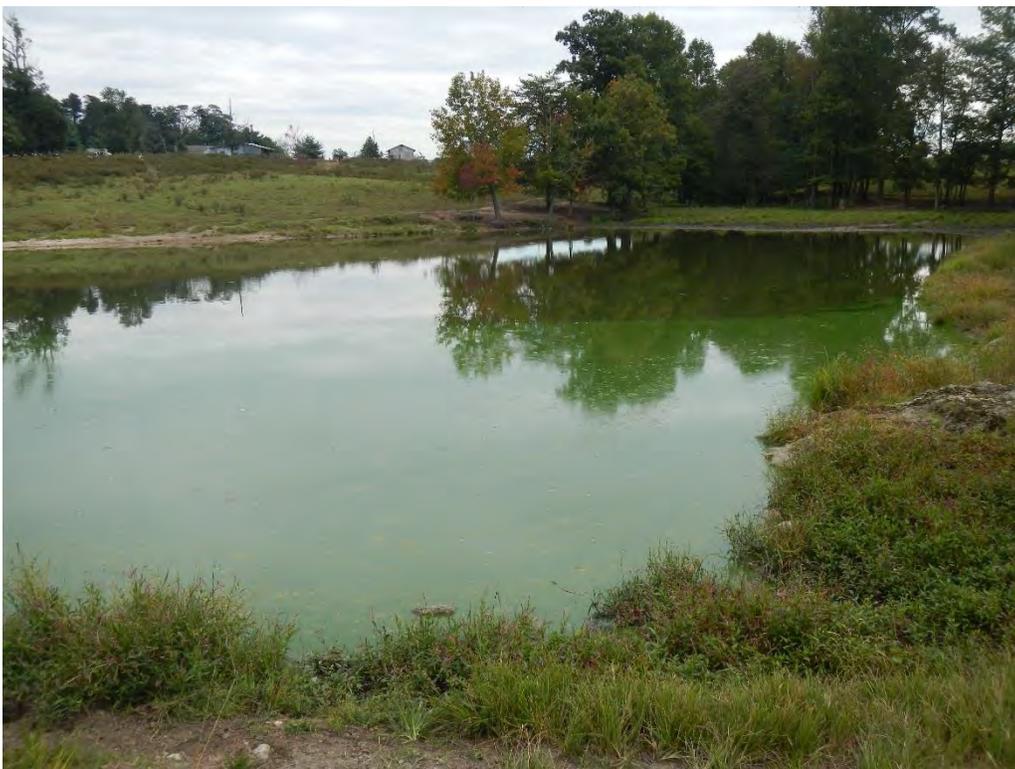
Photo 8: Pond to be removed on UT2

UT2 Reach 2 begins in the wetland just upstream of the existing cattle pond and terminates at Candy Creek. The wetland lies at the upstream edge of the existing cattle pond and most likely formed because of the pond. Cattle have free range in the wetland and it is highly impacted. The stream channel bank height decreases through the wetland before disappearing into the pond. The pond is used as a water source for cattle and was observed to be overtaken with algae on multiple site visits. Pond banks have been degraded by cattle and, with the exception of a single tree, has no woody vegetation. The 14-ft high earthen dam appears to be in fair, stable condition with no visible signs of failure or seeps. UT2A flows into UT2 approximately 180 LF downstream of the dam. Downstream of the confluence, the stream flows between a cow pasture in the left floodplain and woods in the right floodplain. The channel is incised but has fairly stable, vegetated banks. This section also has moderate pattern and the formation of floodplain benches.

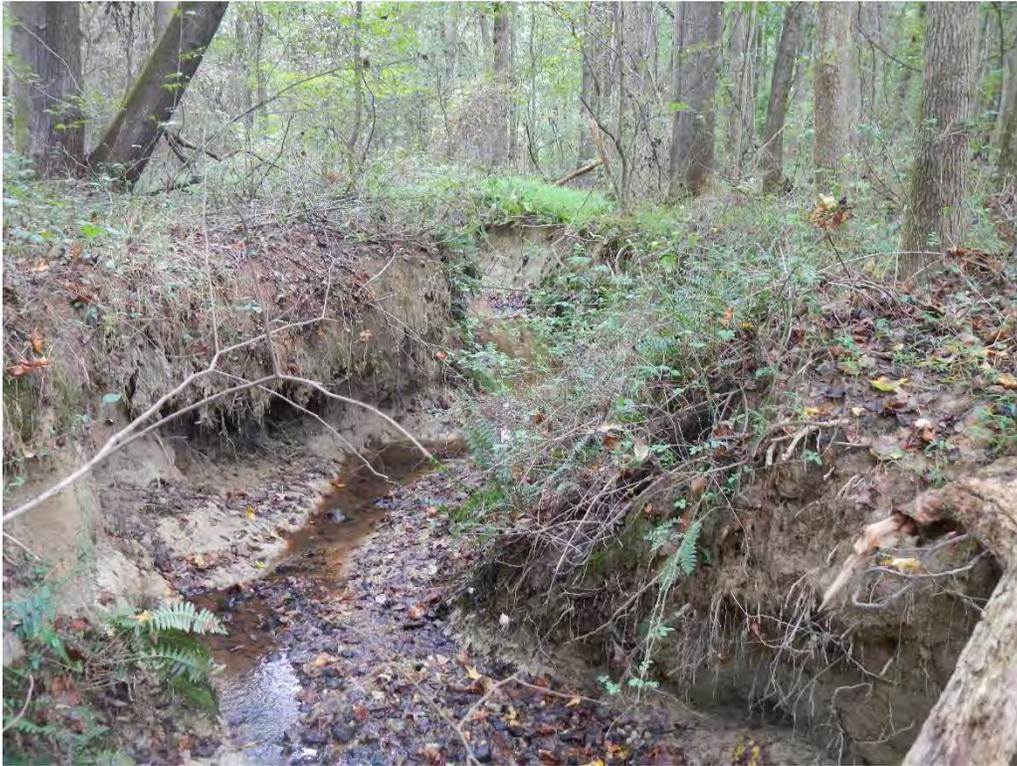
Photo 11: UT3

UT3 originates from a farm pond at the southeast end of the project. An outlet could not be located at the downstream end of the pond and the majority of flow exits the pond through seep flow out of the existing embankment. UT3 flows from southeast to northwest in a stable condition for approximately 1,365 LF. The stable portion of UT3 has low bank heights, good connection to the floodplain, and flows through an existing jurisdictional wetland. Downstream of this area, UT3 makes an immediate turn south to circumvent a previously abandoned farm road crossing. The stream flow is split between an embedded 6-inch PVC pipe and the channel that goes around the embankment. Beyond the embankment UT3 turns north and flows toward the main stem of Candy Creek for approximately 700 LF. This section of UT3 appears to have been previously straightened and realigned to the existing toe of the valley wall. The stream is deeply incised, actively eroding, straightened, and isolated from the existing mature wooded floodplain. On average, the floodplain in UT3 is not engaged until the predicted 100-year return interval discharge. Woody vegetation species along UT3 is very similar to the species listed under Candy Creek Reach 1.

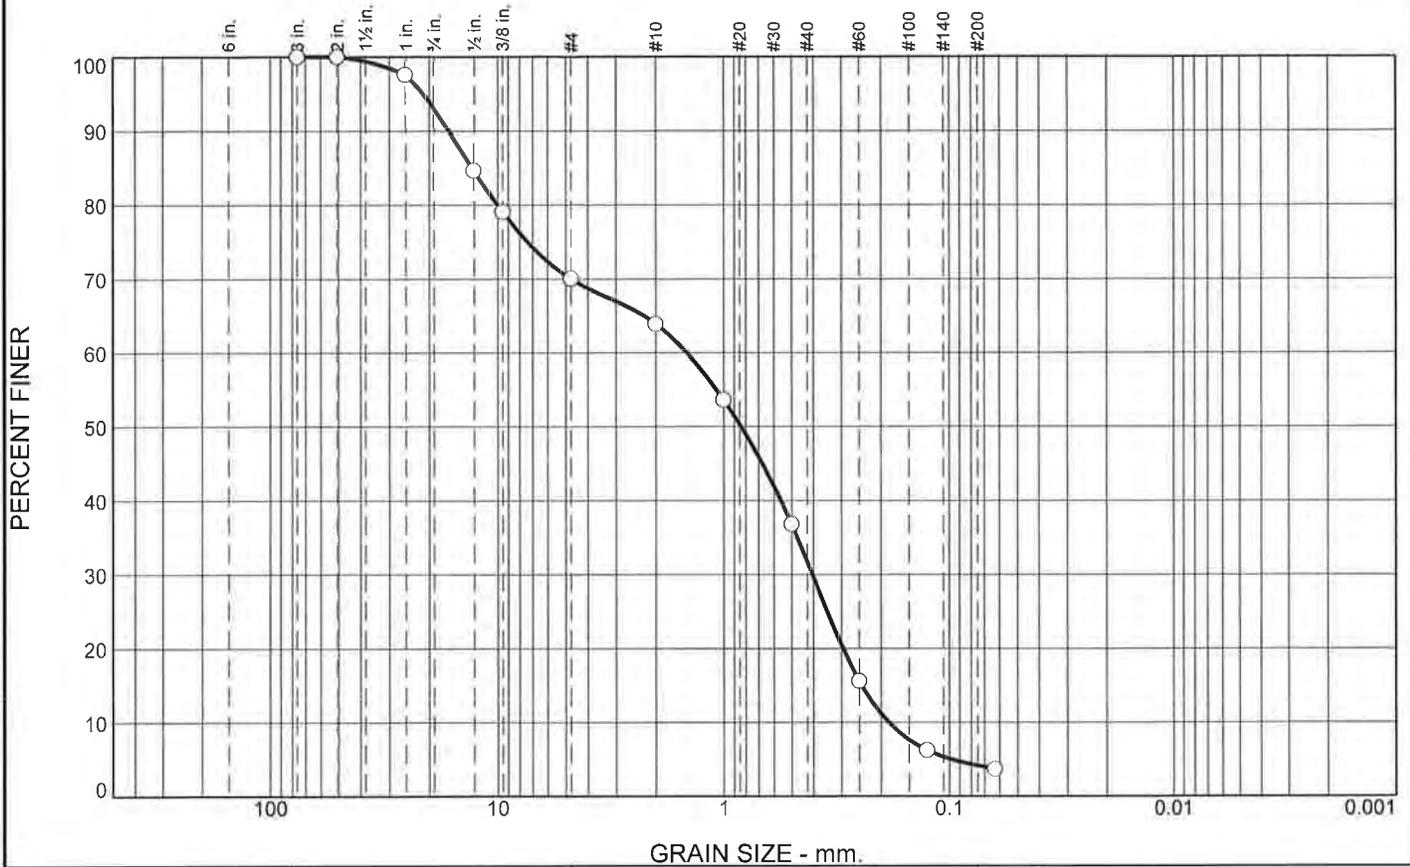
Particle Size Distribution Report

% +3"	% Gravel		% Sand			% Fines	
	Coarse	Fine	Coarse	Medium	Fine	Silt	Clay
0.0	6.9	23.1	6.1	32.2	27.6	4.1

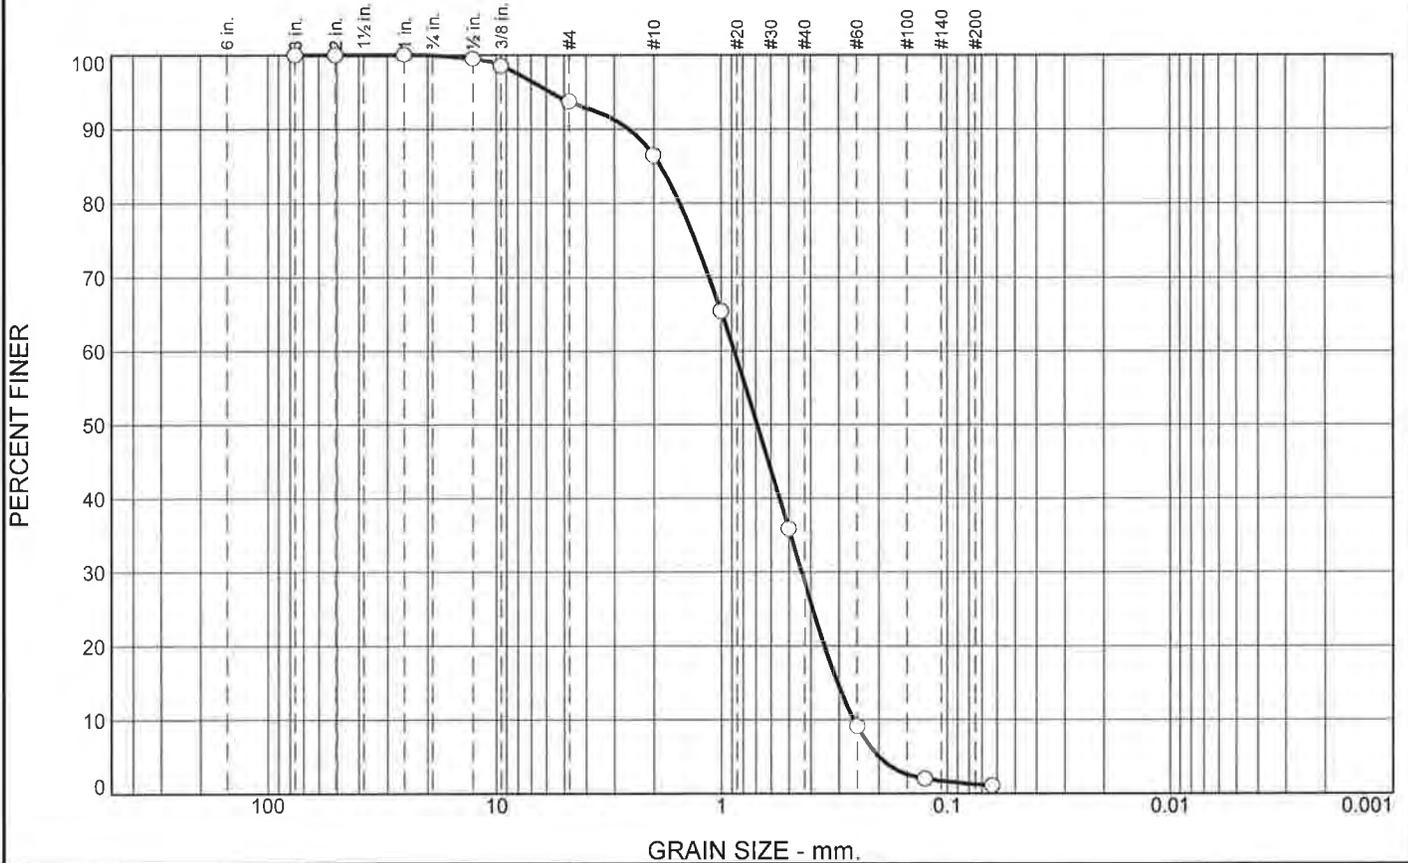
Particle Size Distribution Report

% +3"	% Gravel		% Sand			% Fines	
	Coarse	Fine	Coarse	Medium	Fine	Silt	Clay
0.0	0.1	6.2	7.3	57.9	27.2	1.3
