CARBONTON DAM – DEEP RIVER WATERSHED RESTORATION SITE 2006 Annual Monitoring Report (Year 1)

> Chatham, Lee and Moore Counties, NC EEP Project No. D-04012A Design Firm: Milone and MacBroom, Inc.

October 2006

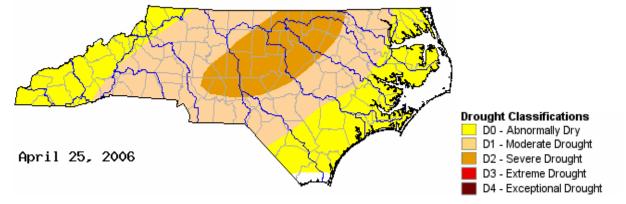
Diagram 1. N.C. Drought Conditions in April 2006 (from N.C. Drought Management Advisory Council)

The summary data in Table 9 shows that following dam removal the mean number of organisms and mean number of taxa decreased at both impounded and reference stations. Mean EPT richness and mean biotic index increased following dam removal in impounded stations. The summary data for both the impounded and reference stations shifted similarly following dam removal. The fluctuating response in reference benthic data can be attributed to a temporary response to the dam removal, or more likely the severe drought conditions that affected the Deep River watershed during the entire benthic sampling period. The following Diagram 1 (using data from N.C. Drought Advisory Council, 2006) shows the drought conditions on April 25, 2006 for North Carolina. The Deep River watershed and former Site Impoundment lie within the Severe Drought classification.

Drought conditions within the Deep River watershed continued into mid June 2006, throughout the benthic monitoring period. Rivers in the Triassic basin experience low flow conditions during summer months and flows are even further diminished when drought conditions are introduced. Drought conditions play a major role in altering the composition of the benthic community and have contributed to a decline in benthic sampling results. Continued benthic monitoring is recommended until success criteria are achieved.

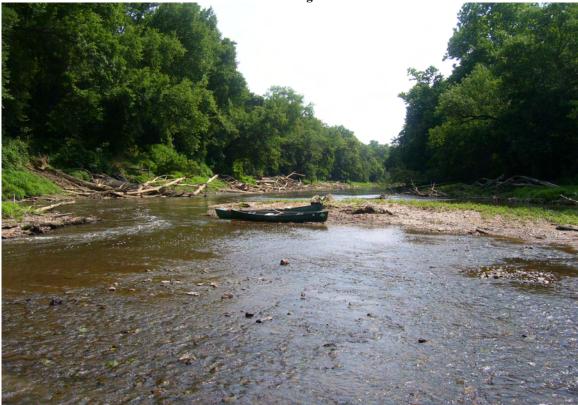
Picture 1. Station 55 established in Year-1 Monitoring

In general, bankfull channel parameters were largely unchanged from baseline conditions during the first monitoring year. Scouring and transportation of bank and bed material was detected at some monitoring cross- sections. Others showed signs of an influx of bed material as sediment was redeposited. Station 55 was established following dam removal and therefore no baseline (2005) bankfull channel geometry data is available for this station. At Stations 7, 15, and 17, only one of the original benchmark pins was recovered and a new pin was established. Hence, the discrepancies in cross-sectional dimensions and bankfull channel geometry between the baseline and Year-1 monitoring data at these locations.

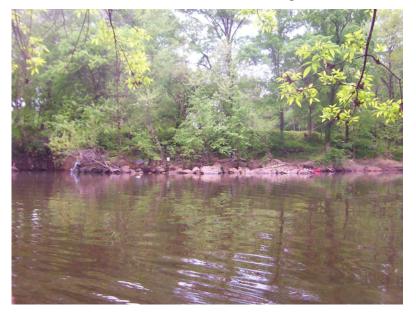
Picture 2: Station 8 in 2005 Baseline Monitoring

As discussed in the project's Mitigation Plan (Restoration Systems 2006), photography and/or videography were conducted during baseline and Year-1 monitoring data collection to assess qualitative changes in channel cross-sections and in-stream habitat. The following pictures (Pictures 2-5) of monitoring stations 8 and 52 were taken during baseline and Year-1 Monitoring. The pictures characterize the restoration of the Deep River following dam removal. Both station 8 and 52 display lotic flow conditions with increased stream habitat and bank vegetation. Monitoring pictures and/or videos for all stations have been included on 2 data compact discs in Appendix H.

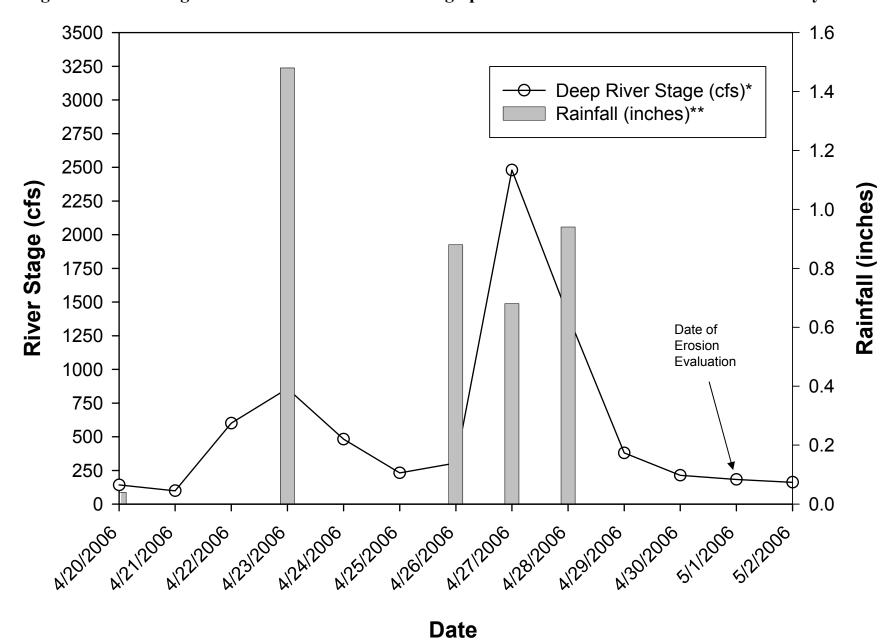
Figure 1. River Stage vs. Rainfall Conditions Leading up to the 5-1-2006 Erosion Evaluation Survey

\* River Stage Data collected from USGS Station #02100500 located on the Deep River at Ramseur, NC.

\*\* Rainfall Data collected from NC Climate Retrieval and Observations Network of the Southeast Database Station #317924 located at Siler City, NC.

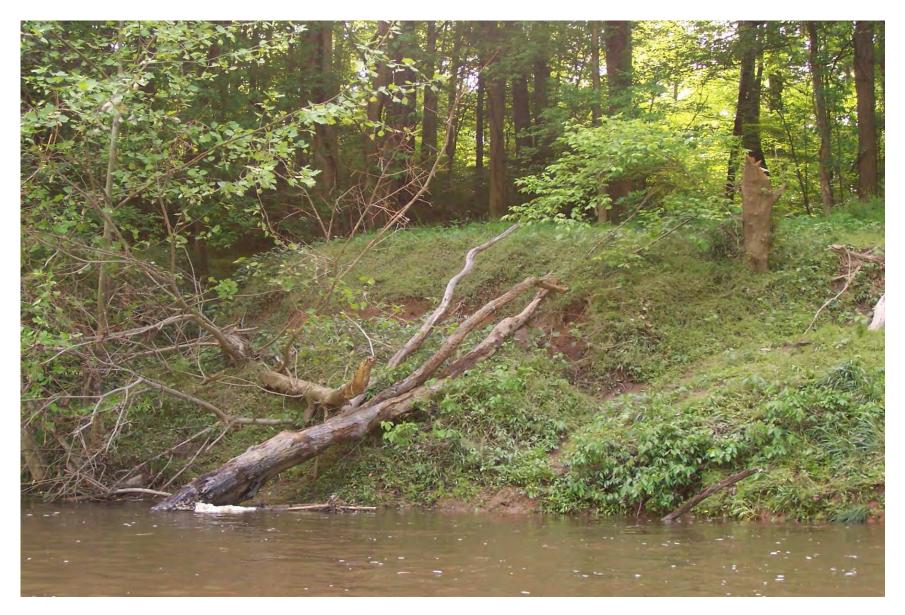
# **Photo 1. River Observation Point 1**

Location:Deep River downstream of Glendon Carthage Road crossingDescription:Erosion of bank material into the Deep River

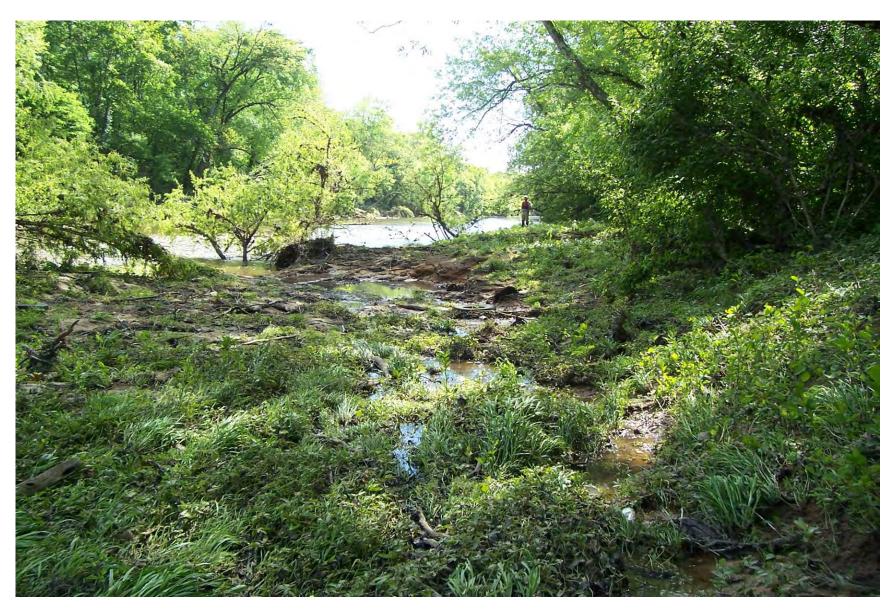
# Photo 2. River Observation Point 2

Location: Deep River near Monitoring Station 12

Description: Scouring along the banks due to overland storm flow

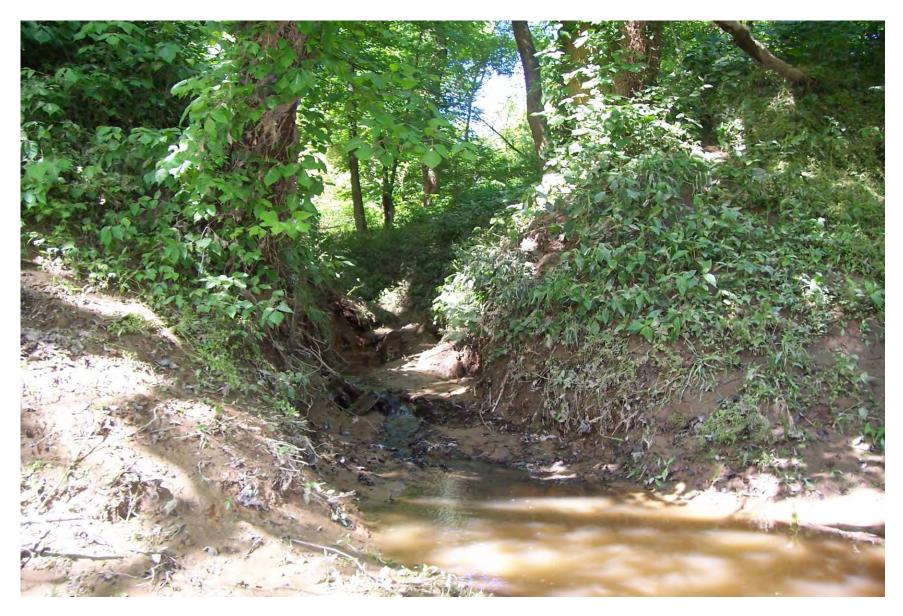
# Photo 3. River Observation Point 3

Location: Confluence of the Deep River and an unnamed tributary near Monitoring Station 11

Description: Minor bank erosion and headcutting

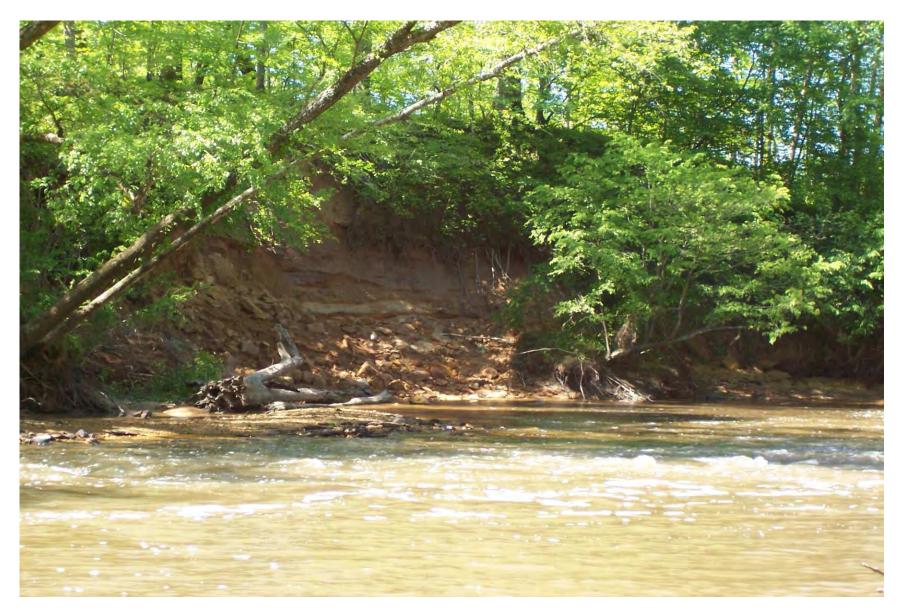
# Photo 4. River Observation Point 4

Location: Deep River downstream of the Norfolk-Southern rail bridge

Description: Bank failure and erosion into the Deep River.

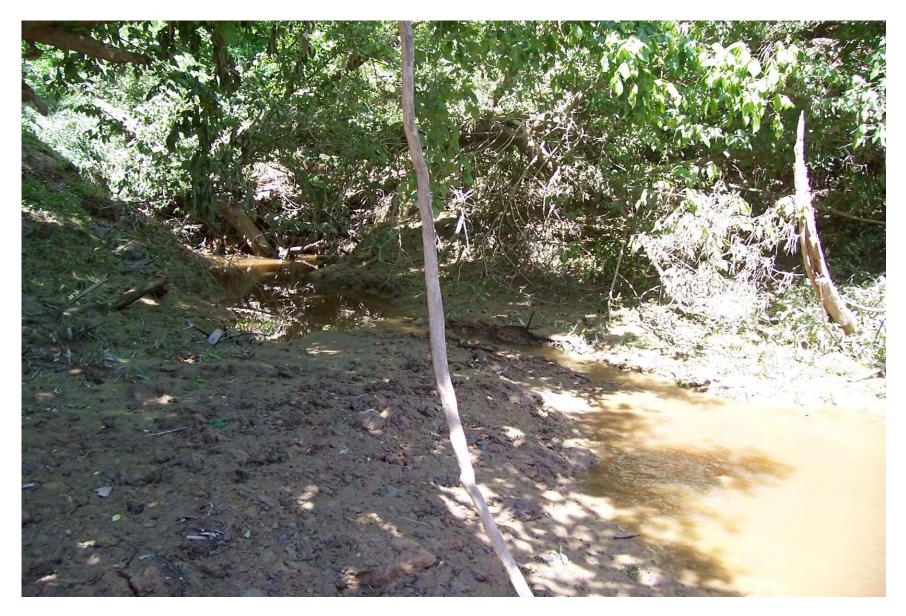
# Photo 5. River Observation Point 5

Location: Confluence of the Deep River and Lick Creek

Description: Coarsening of stream substrate through sediment transport

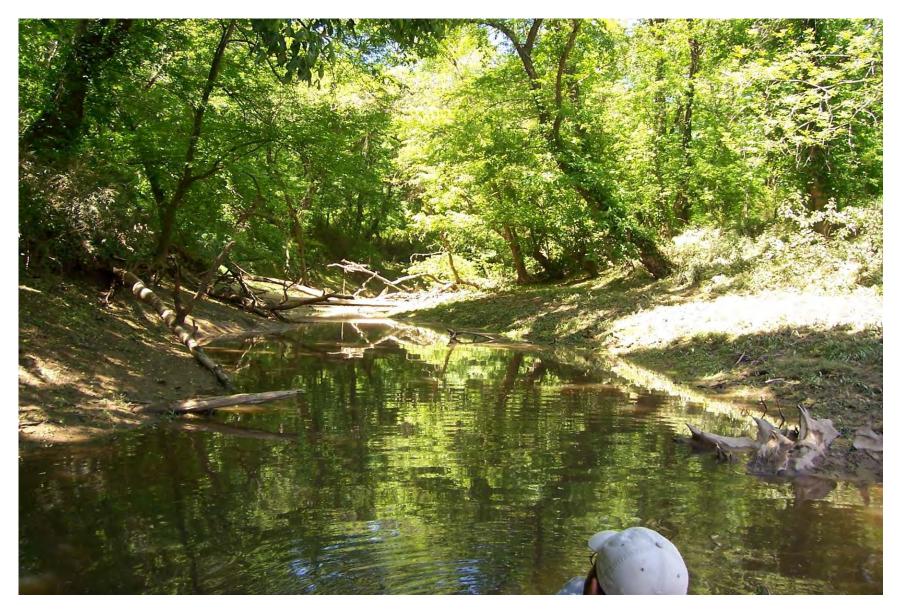
# Photo 6. River Observation Point 6

Location: Confluence of the Deep River and McClendon's Creek

Description: Stable banks without signs of erosion

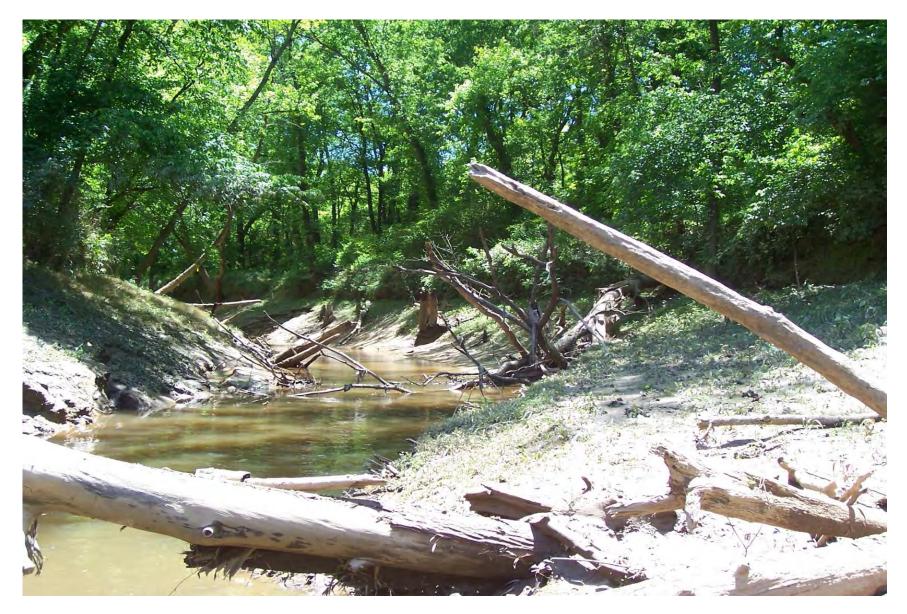
# **Photo 7. River Observation Point 7**

Location: Confluence of the Deep River and Big Governors Creek.

Description: Stable banks with only minor erosion

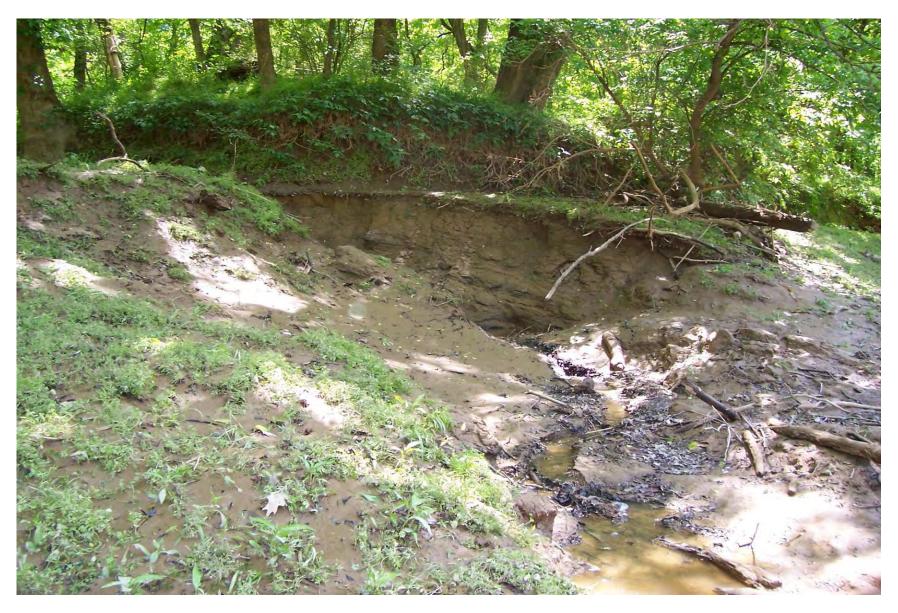
# Photo 10. River Observation Point 10

Location: Confluence of the Deep River and an unnamed tributary

Description: Sloughing of bank material

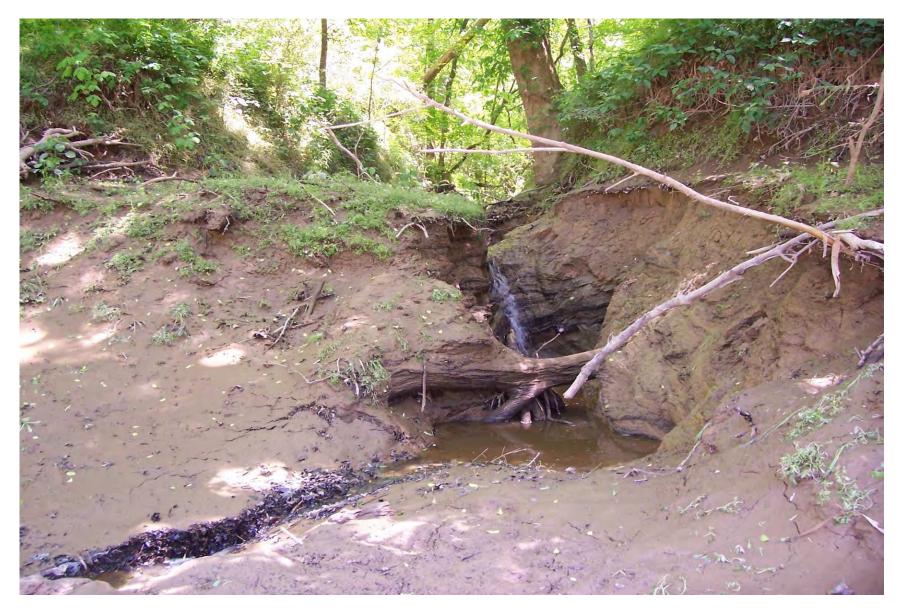
# Photo 11. River Observation Point 10

Location: Confluence of the Deep River and an unnamed tributary

Description: Large headcut and eroded banks

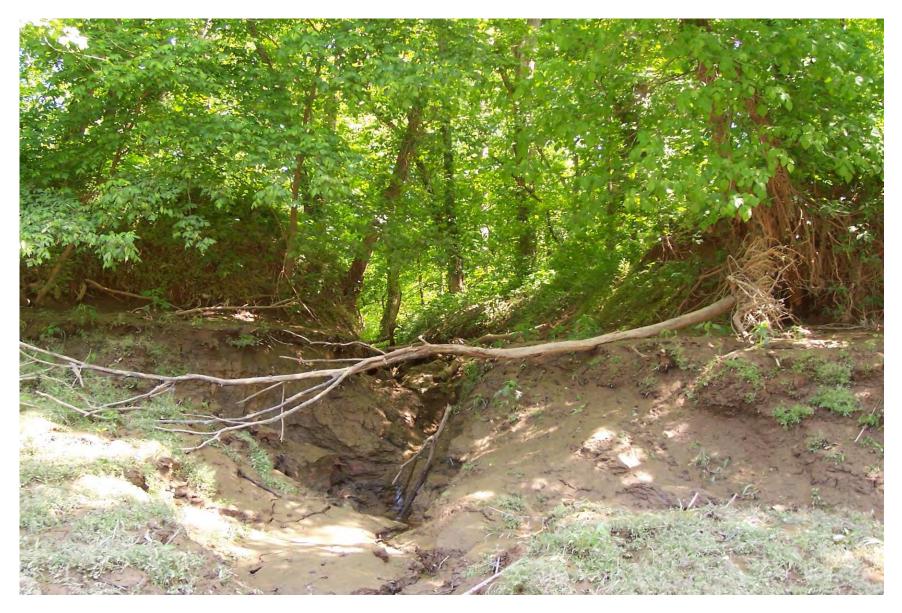
# Photo 14. River Observation Point 12

Location: Confluence of the Deep River and an unnamed tributary

Description: Headcut and erosion of bank material

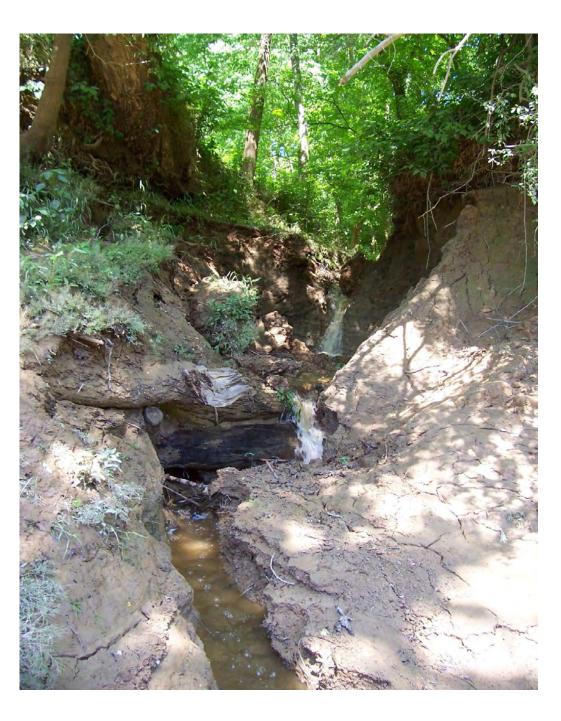
Photo 15. River Observation Point 13

- Location: Confluence of the Deep River and an unnamed tributary near Monitoring Station 2
- Description: Severe headcutting and erosion of bank material

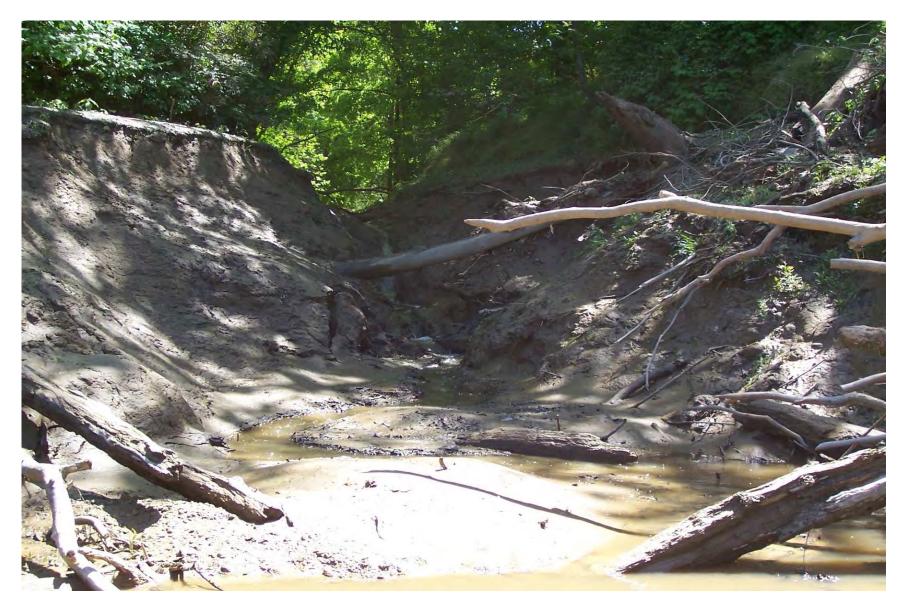
# Photo 16. River Observation Point 14

Location:Confluence of the Deep River and an unnamed tributary near Monitoring Station 23Description:Severe headcutting and erosion of bank material

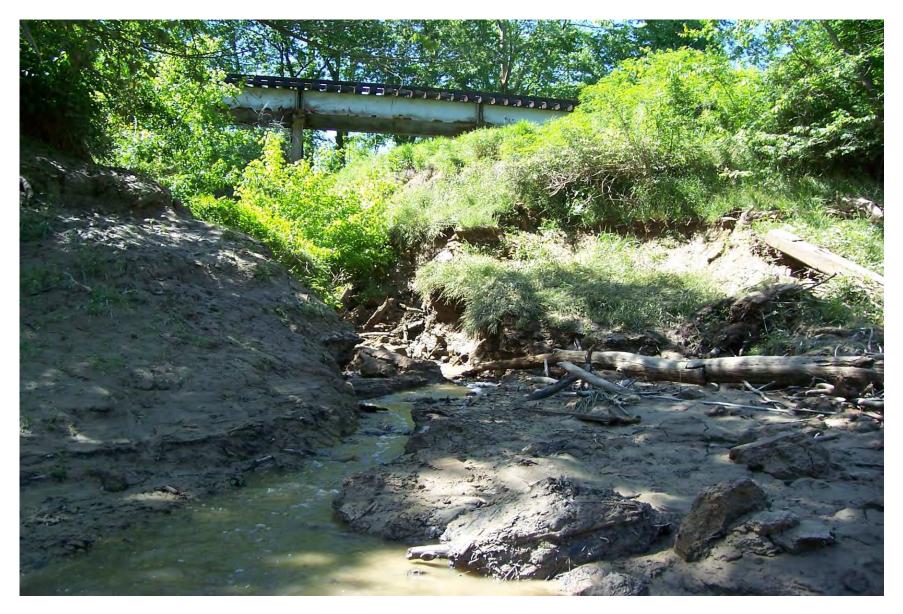
# Photo 17. River Observation Point 15

Location: Confluence of the Deep River and Line Creek

Description: Large separation of bank material

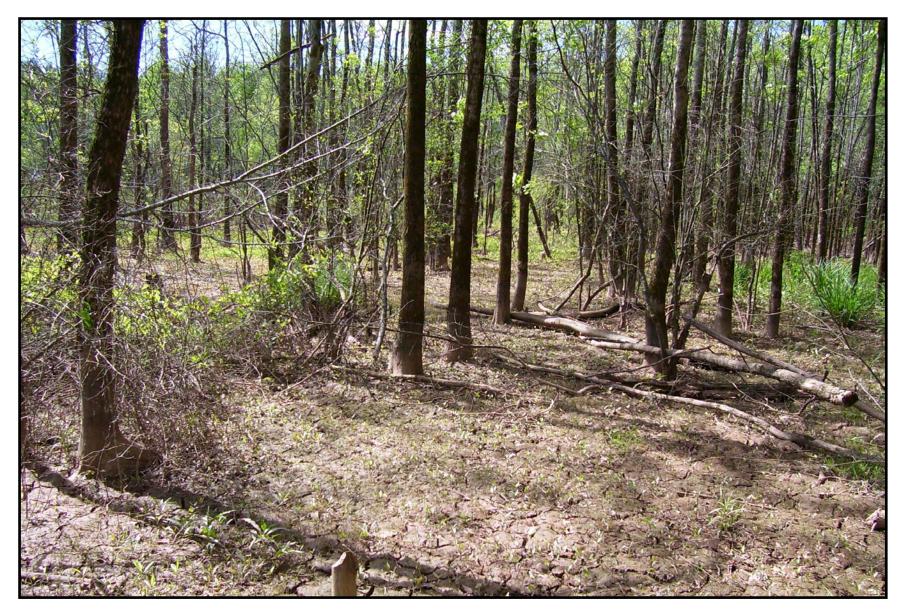
# Photo 18. Land Observation Point 1

Location: Downstream of the Carbonton Road and Line Creek crossing

Description: Thin layer of deposition at ground surface within the floodplain

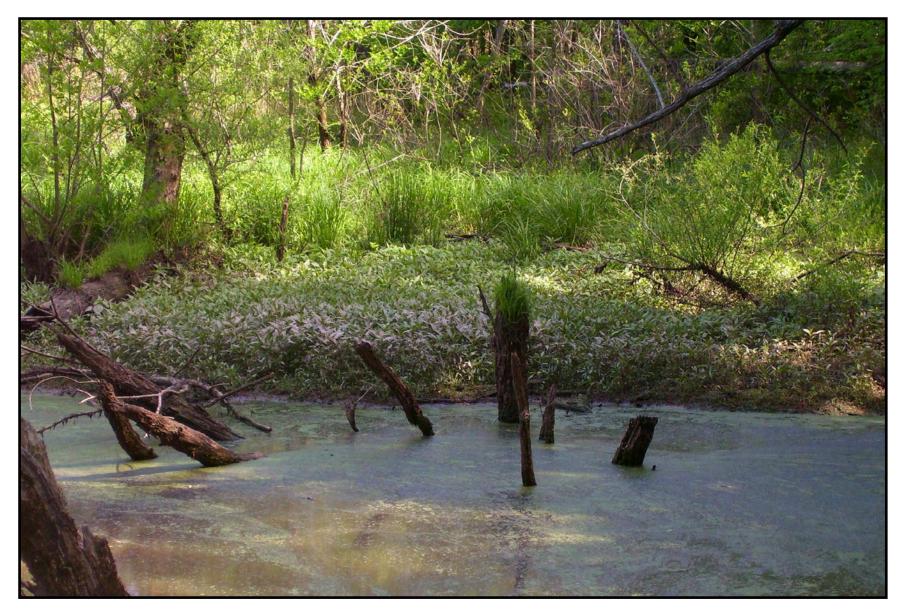
# Photo 19. Land Observation Point 1

Location:Upstream of the Carbonton Road and Line Creek crossingDescription:Thin layer of deposition on stream bank vegetation

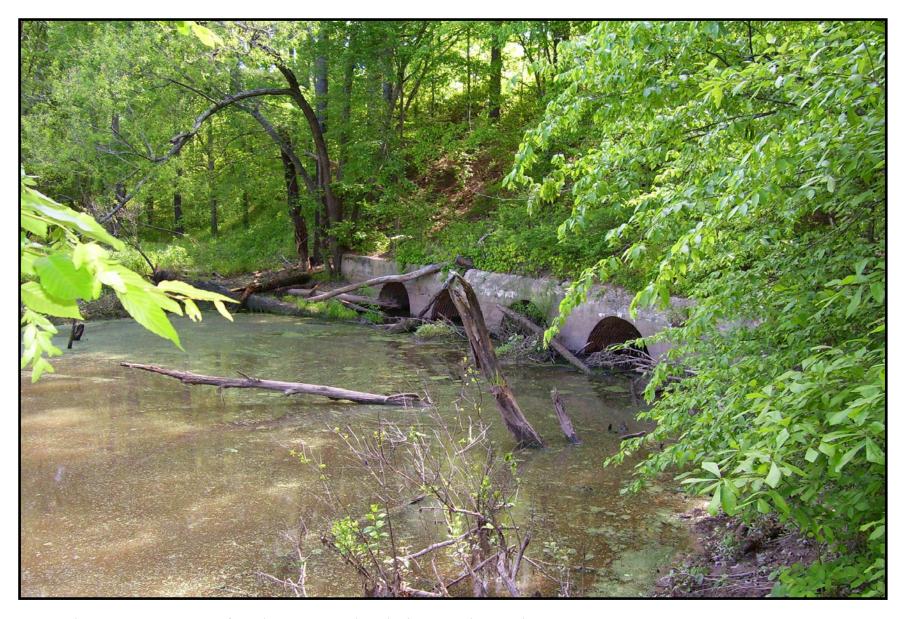
# Photo 20. Land Observation Point 1

Location:Upstream of Carbonton Road and Line Creek crossingDescription:Coarse woody debris at culvert intake leading under Carbonton Road

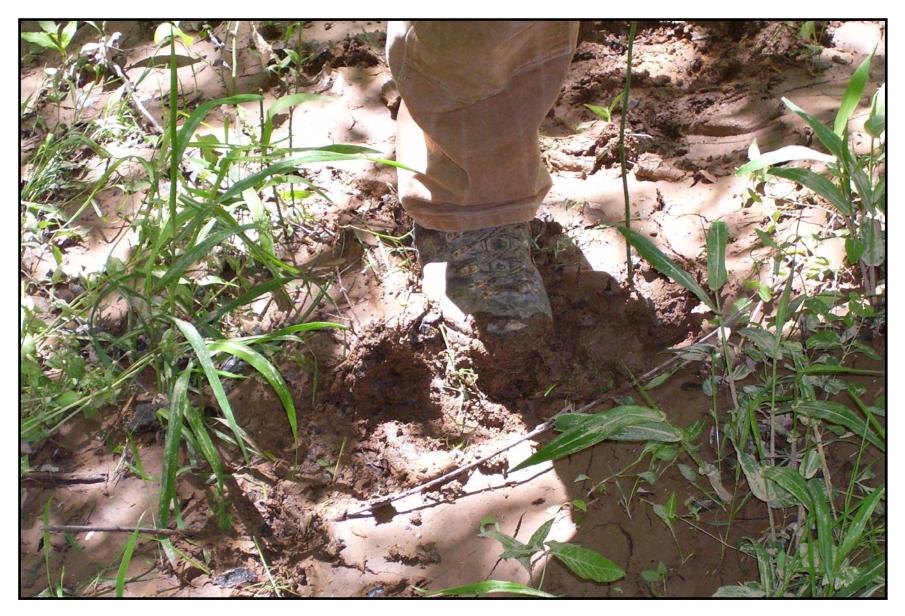
Photo 21. Land Observation Point 2

Location: McClendons Creek left bank at Monitoring Station 45

Description: Moderate layer of fine sediment deposited on stream bank

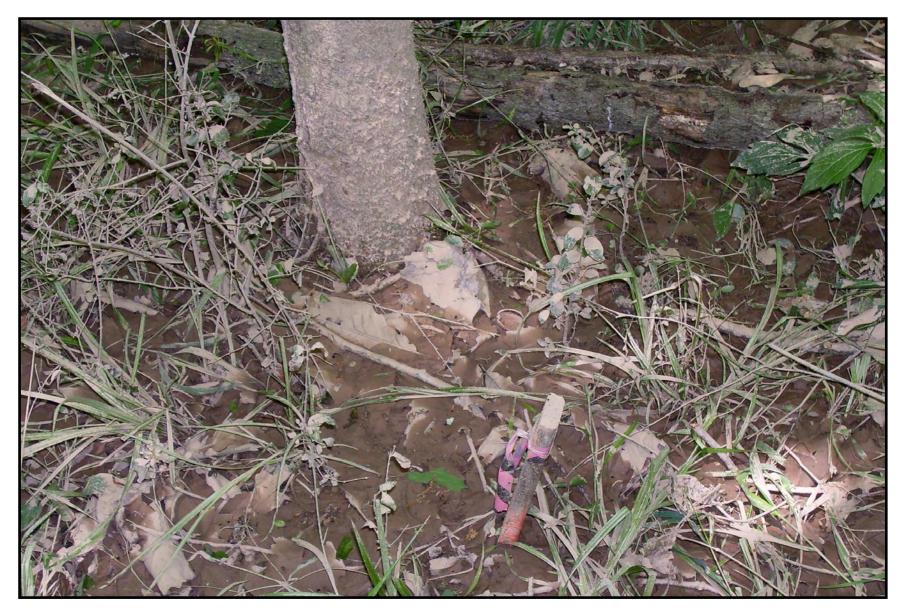
Location: McClendons Creek left bank at Monitoring Station 47

Description: Moderate layer of fine sediment deposited on stream bank and vegetation

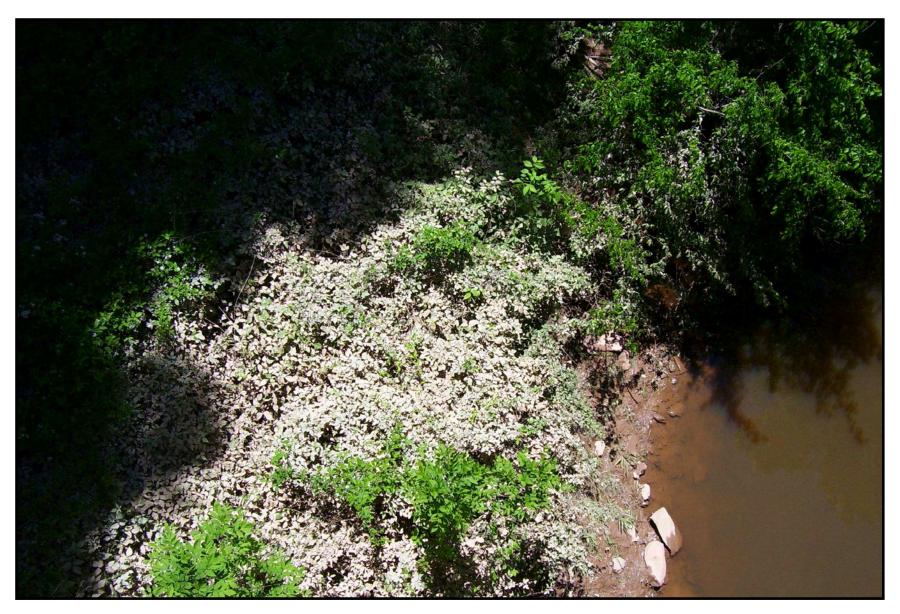
Photo 23. Land Observation Point 4

Location: Little Governers Creek right bank immediately upstream of Steel Bridge Road crossing (picture taken from the bridge looking down at the bank and floodplain)

Description: Sedimentation on leaves approximately 1.5 feet above bankfull

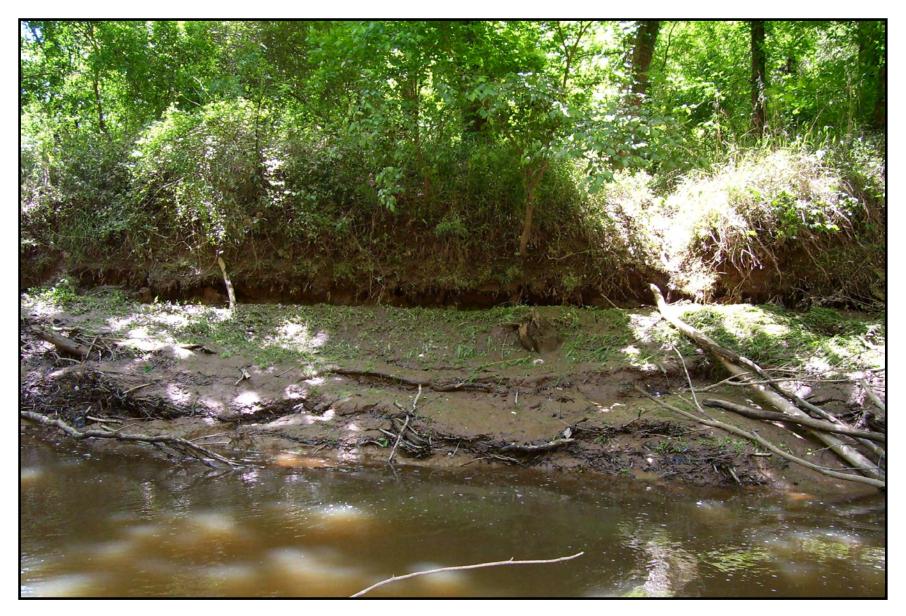
# Photo 24. Land Observation Point 4

Location:Little Governers Creek left bank upstream of Monitoring Station 40Description:Some exposed sections of the stream bank following the dewatering of the impoundment have<br/>begun to slough toward the current lotic water level

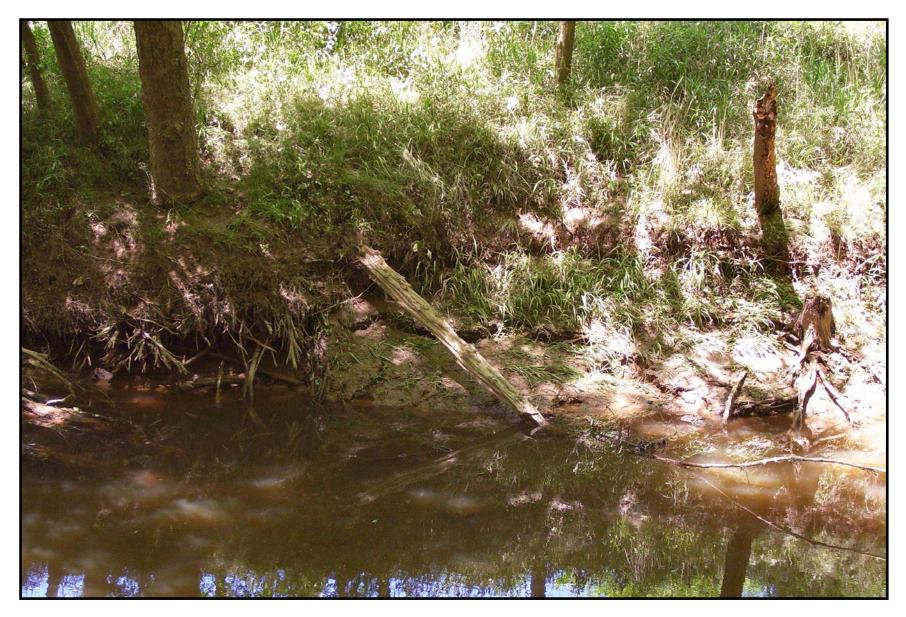
### Photo 25. Land Observation Point 4

Location: Little Governers Creek left bank upstream of Monitoring Station 40
 Description: Some exposed sections of the stream bank following the dewatering of the impoundment have begun to slough toward the current lotic water level

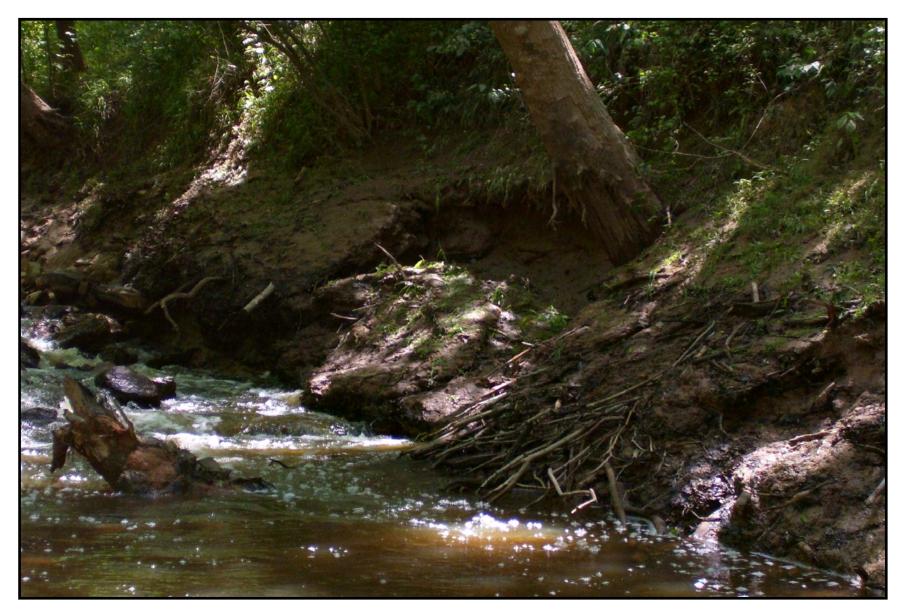
Photo 26. Land Observation Point 4

Location: Little Governers Creek left bank downstream of Steel Bridge Road crossingDescription: Stream bank slough occurring immediately downstream of a riffle in the outside bend of the creek

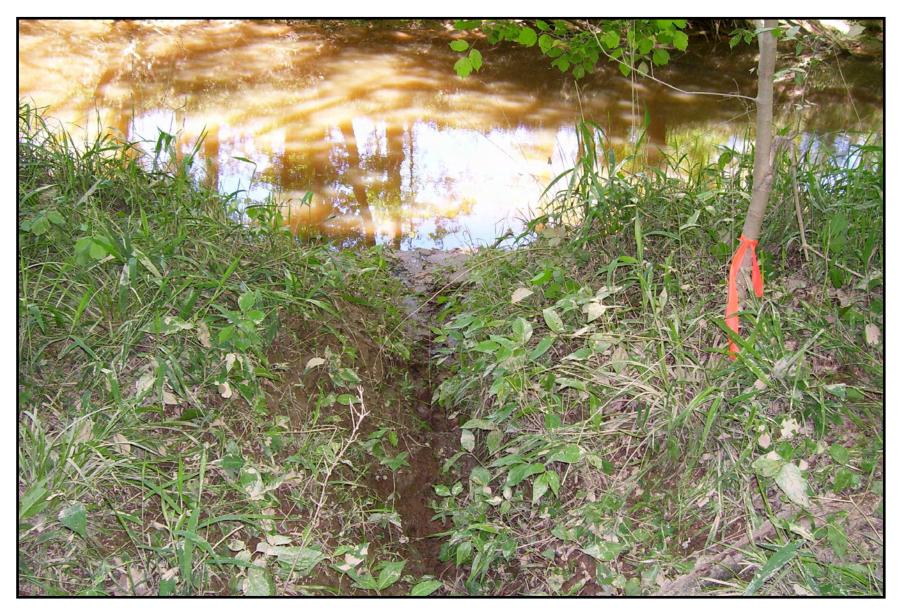
Photo 27. Land Observation Point 4

Location:Little Governers Creek right bank upstream of Monitoring Station 40Description:Developing slight headcut on small ephemeral-intermittent tributary

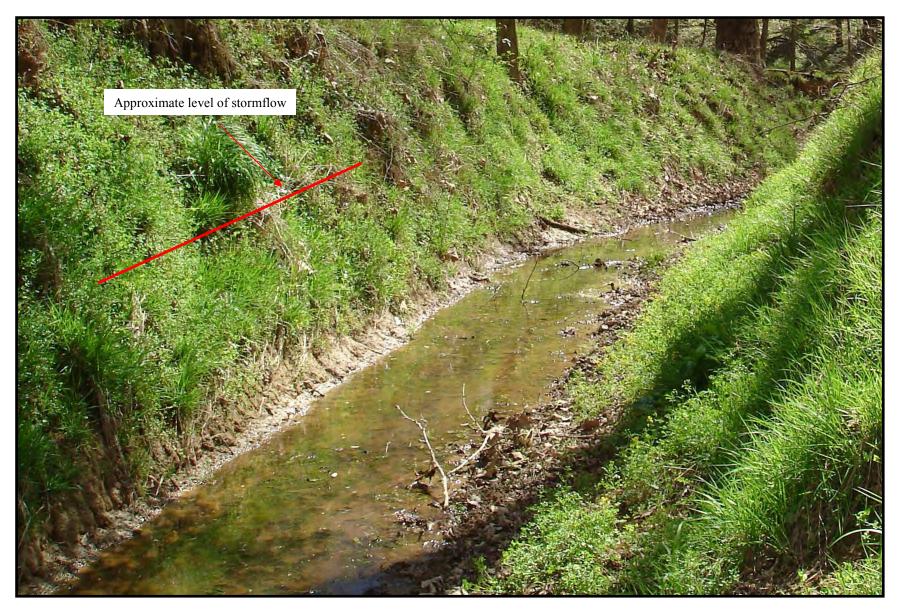
### Photo 28. Land Observation Point 5

Location: UT to Deep River at Monitoring Station 29

Description: Approximate level of stormflow and resultant sediment stained vegetation\*

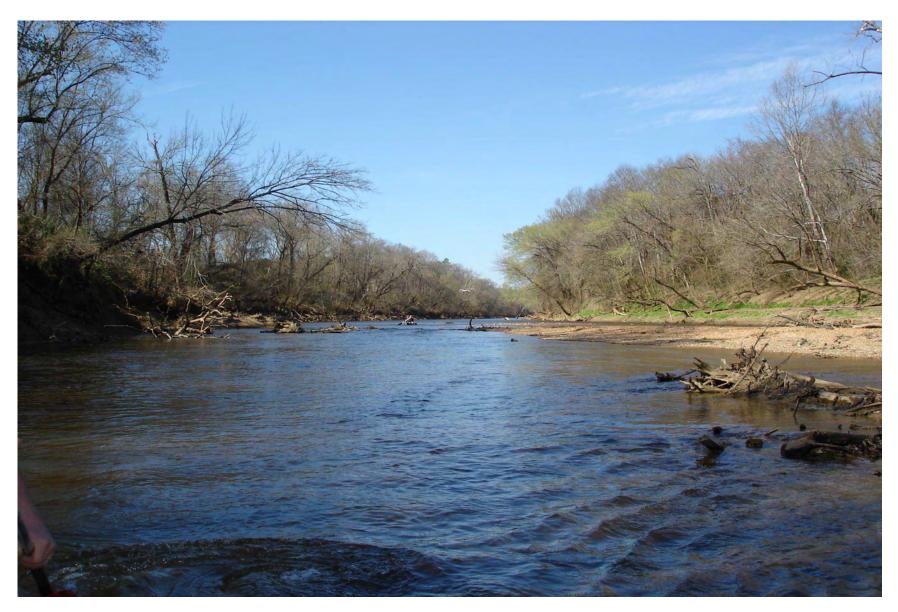
### Photo 1. New Riffle 1

Location: Deep River downstream of the confluence with Lick Creek, at Monitoring Station 9.

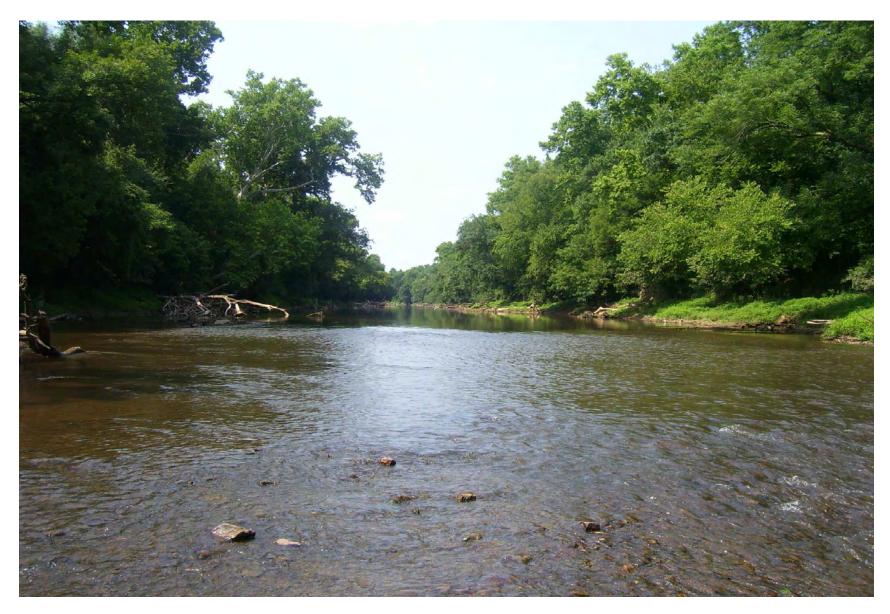
# Photo 2. New Riffle 4

Location: Deep River upstream of the confluence with an unnamed tributary, at Monitoring Station 55.

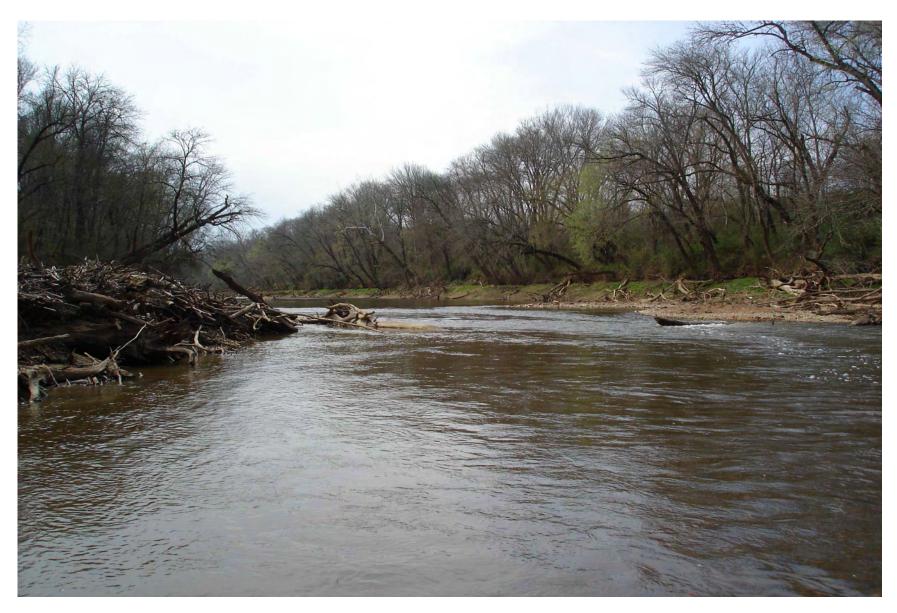
# Photo 3. New Riffle 5

Location: Deep River at the confluence with Big Governors Creek.

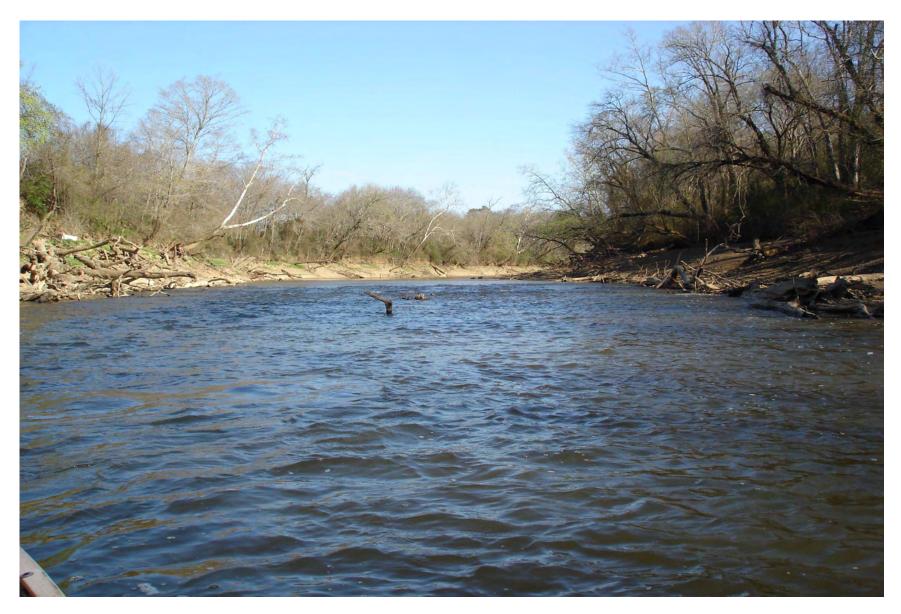
### Photo 4. New Riffle 6

Location: Deep River at the confluence with an unnamed tributary at Monitoring Station 5.

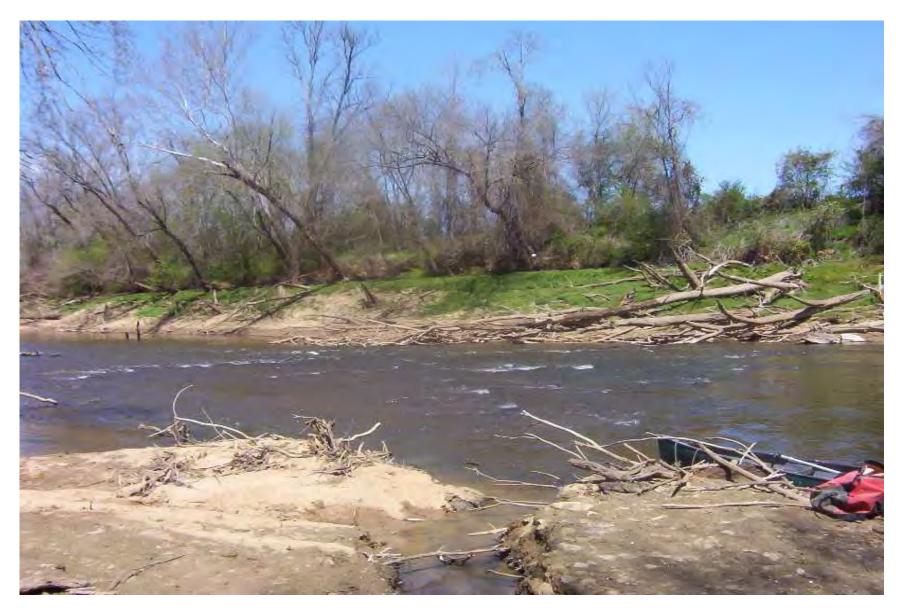
### Photo 5. New Riffle 7

Location: Deep River at the confluence with an unnamed tributary at Monitoring Station 23.

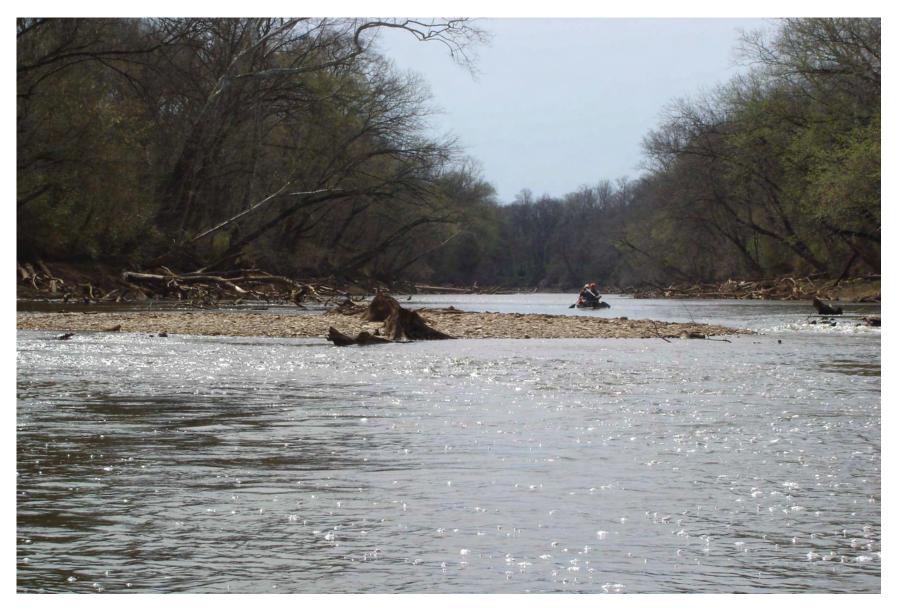
# Photo 6. New Riffle 8

Location: Deep River at the confluence with Line Creek.

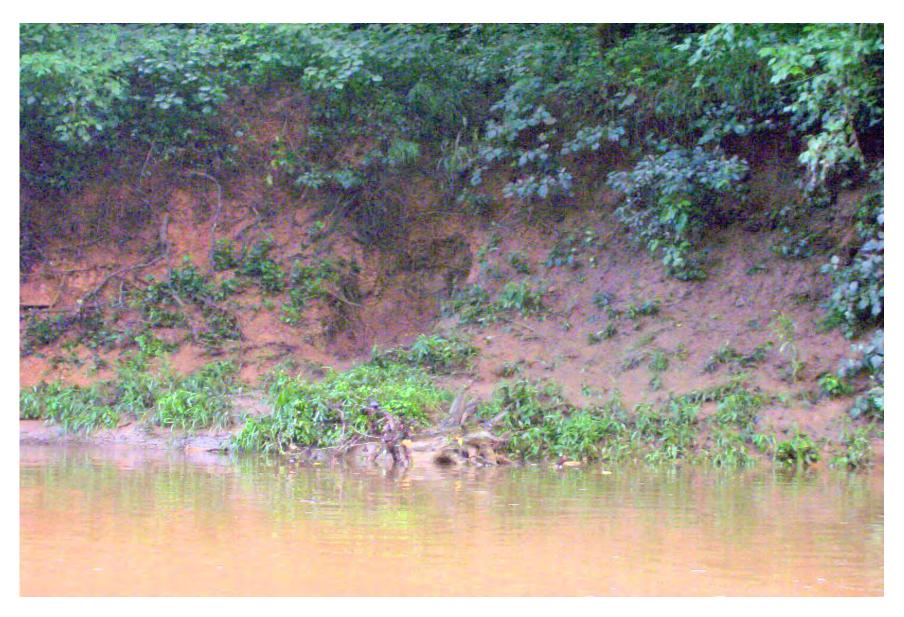
### Photo 1. River Observation Point 1

Location:Deep River downstream of Glendon Carthage Road crossingDescription:Erosion of bank material into the Deep River

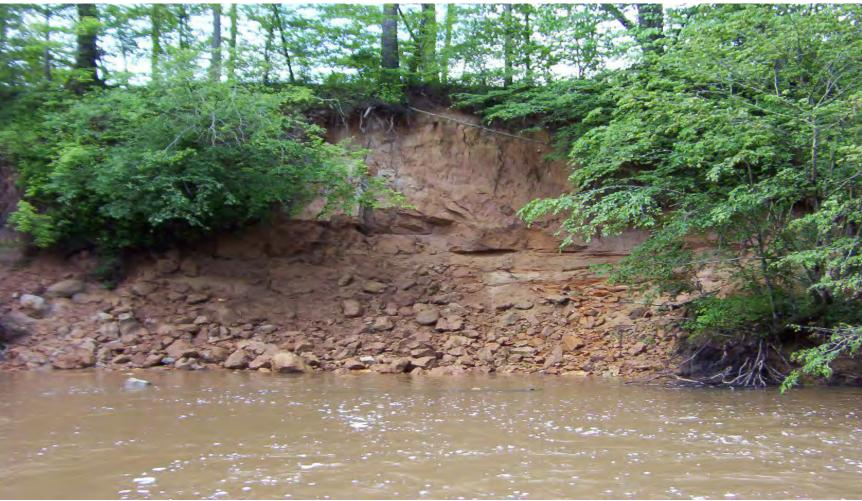
Photo 2. River Observation Point 2

Location: Deep River downstream of the Norfolk-Southern rail bridge Description: Bank failure and continued erosion into the Deep River.

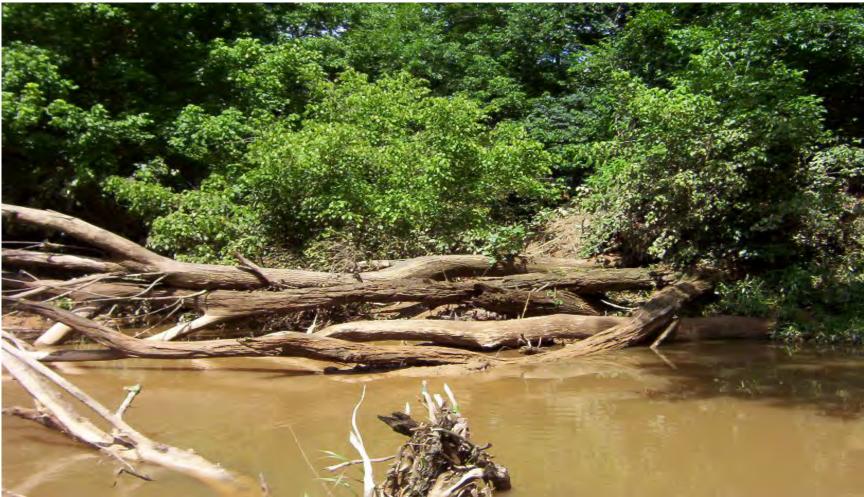
# Photo 3. River Observation Point 3

River Observation Point 3 (previously evaluated on May 1, 2006) is located on the Deep River at the confluence with Lick Creek (Figure 2). Bank erosion was not an issue at the confluence and there was no evidence of the formation of a head-cut. A large logjam has formed within the Deep River at the confluence from an accumulation of woody debris that has been trapped behind a recent tree fall (Photo 3).

Location: Confluence of the Deep River and Lick Creek Description: Tree fall and log jam formation at the confluence

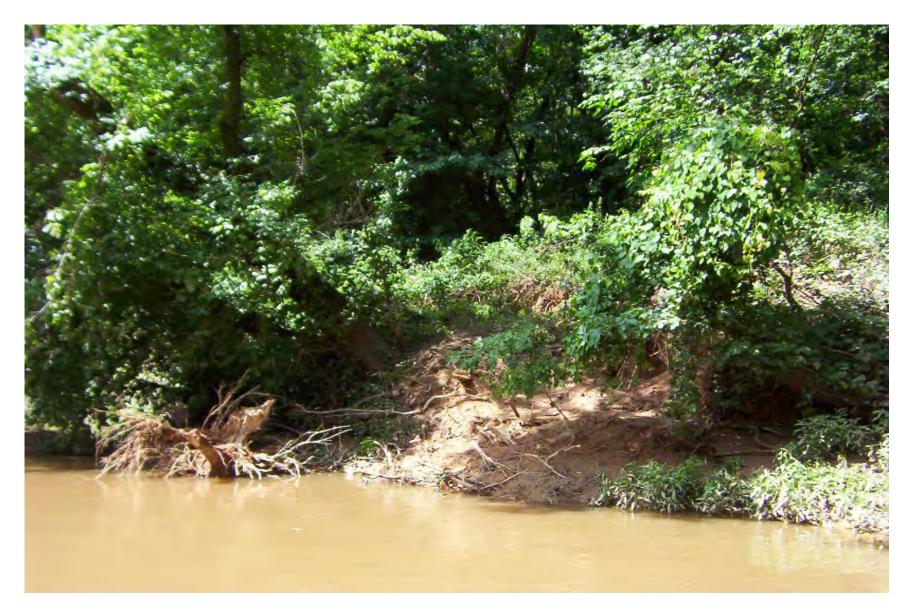
### Photo 4. River Observation Point 4

Location: Deep River downstream of Monitoring Cross-section 9.

Description: Bank failure and erosion into the Deep River.

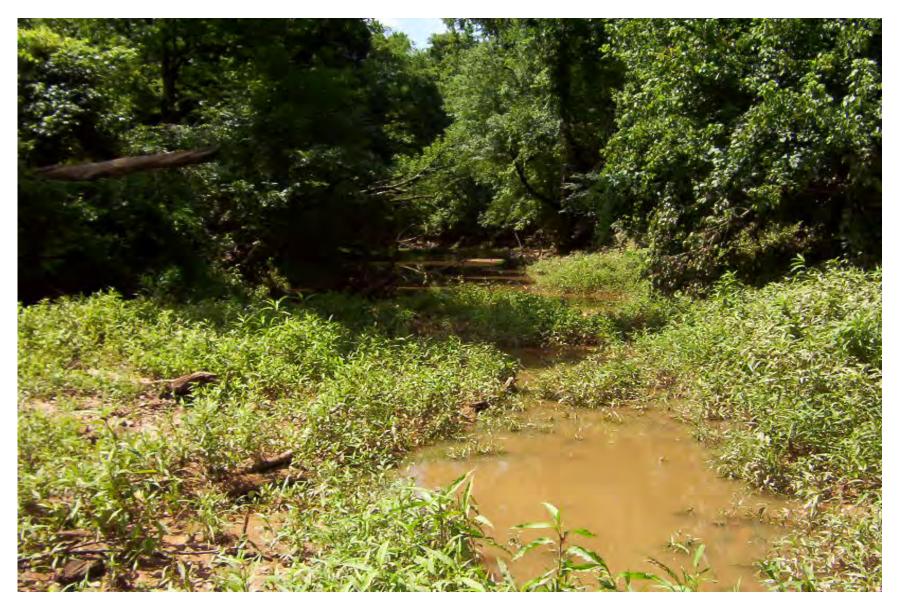
### Photo 5. River Observation Point 5

Location: Confluence of the upstream end of an oxbow channel and the Deep River Description: Overland flow and sediment transport resulting from storm surge.
