CARBONTON DAM – DEEP RIVER WATERSHED RESTORATION SITE 2006 Annual Monitoring Report (Year 1)

> Chatham, Lee and Moore Counties, NC EEP Project No. D-04012A Design Firm: Milone and MacBroom, Inc.

October 2006

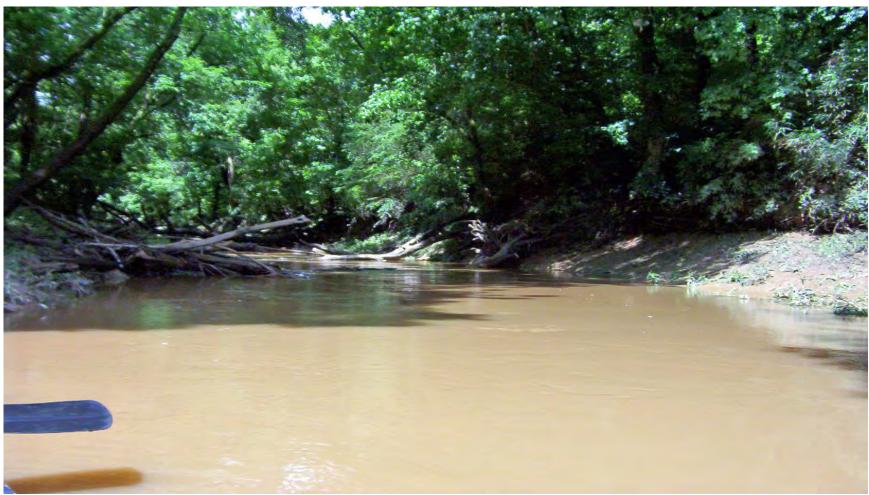
# Photo 6. River Observation Point 6

River Observation Point 6 (previously evaluated on May 1, 2006) is located on the Deep River at the confluence with McClendon's Creek (Figure 2). No erosion or bank failures could be seen from the confluence and the majority of the banks remained well vegetated following the rise in storm flow (Photo 6).

Location:Confluence of the Deep River and McClendon's CreekDescription:Stable banks without signs of erosion

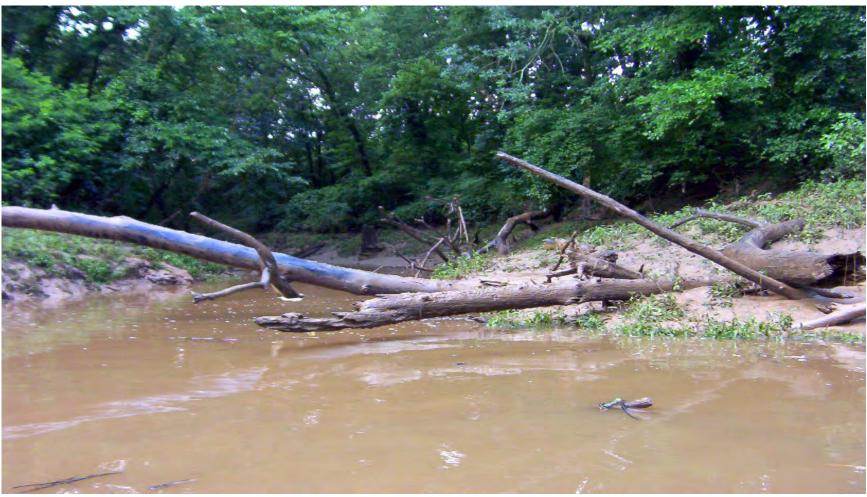
# Photo 7. River Observation Point 7

River Observation Point 7 (previously evaluated on May 1, 2006) is located on the Deep River at the confluence with Big Governors Creek (Figure 2). Minor erosion and bank failures could be seen from the confluence and the majority of the banks remained well vegetated following the rise in storm flow. A few areas at waters edge showed continued scouring but the majority of the bank material appeared stable and still intact. A large accumulation of woody debris has collected at the confluence (Photo 7).

Location: Confluence of the Deep River and Big Govenor's Creek. Description: Stable banks with only minor erosion. Woody debris deposition.

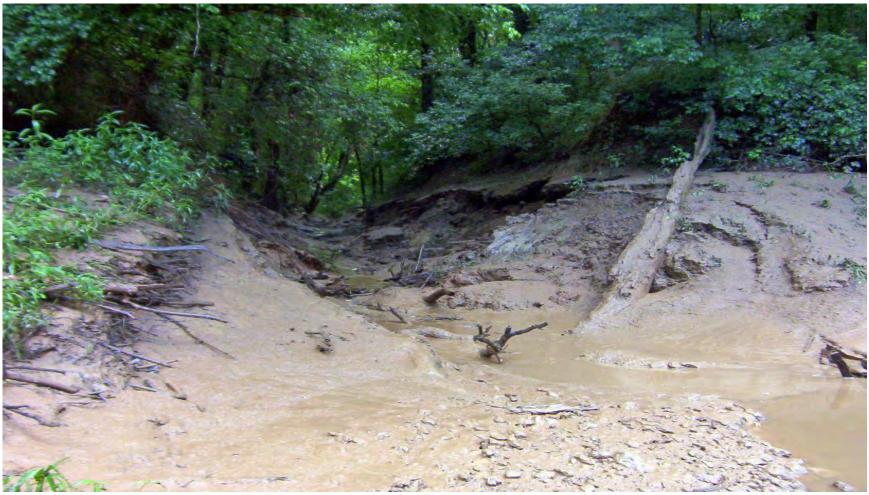
# Photo 8. River Observation Point 8

River Observation Point 8 (previously evaluated on May 1, 2006) is located near Monitoring Station 5 at the confluence of the Deep River and an unnamed tributary (Figure 2). The previously observed head-cut has continued to transport sediment from the tributary and the banks show continued signs of erosion. Large amounts of bank material have sloughed into the tributary channel and deposition has accumulated at the confluence with the Deep River. The nearly closed canopy over the tributary has greatly limited the establishment of herbaceous vegetation which would provide additional bank stability (Photo 8).

Location: Confluence of the Deep River and an unnamed tributary Description: Continued sloughing of bank material.

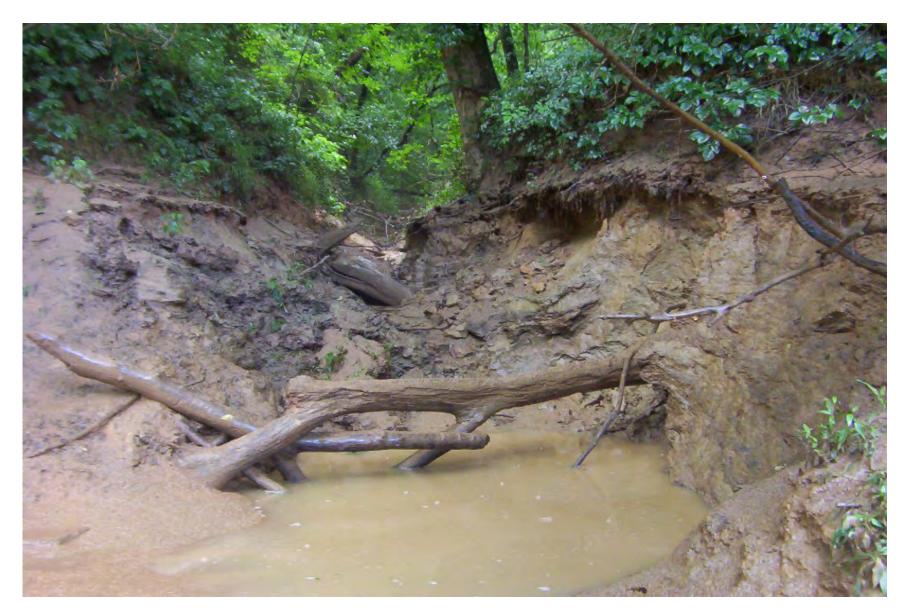
### Photo 9. River Observation Point 9

Location:Confluence of the Deep River and an unnamed tributaryDescription:Continued headcutting and erosion of bank material

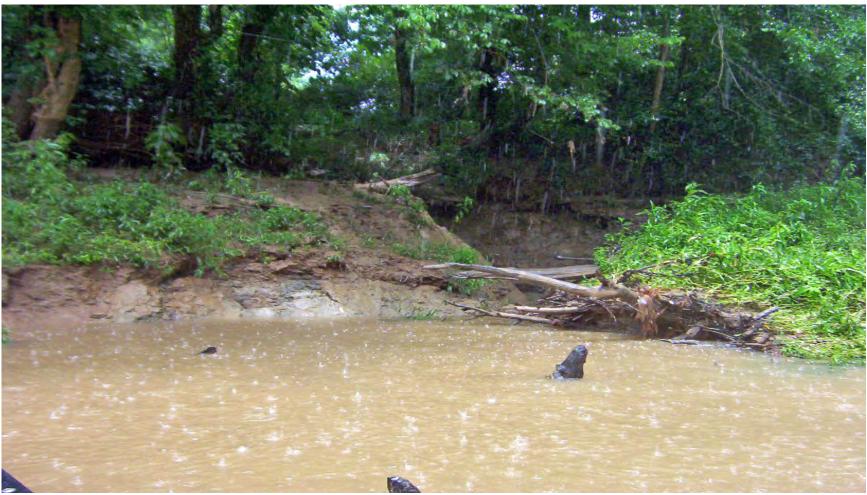
# Photo 10. River Observation Point 10

River Observation Point 10 (previously evaluated on May 1, 2006) is located on the Deep River at the confluence with an unnamed tributary (Figure 2) near Monitoring Station 27. A head-cut has continues to transport sediment from the tributary and has eroded further upstream. In some areas the banks are steep and incised. A large tree has fallen from the banks at the confluence and has accumulated additional woody debris from the Deep River (Photo 10).

Location: Confluence of the Deep River and an unnamed tributary near Monitoring Station 27 Description: Continued headcutting and erosion of bank material

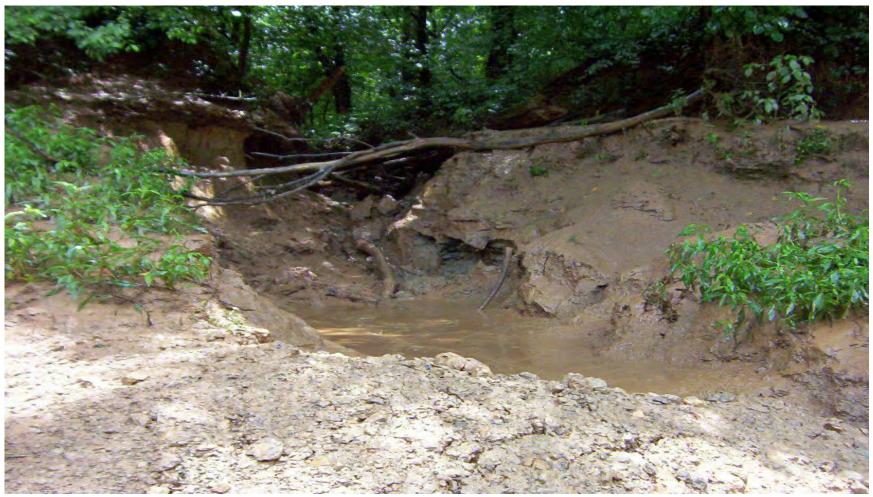
Photo 11. River Observation Point 11

Location: Confluence of the Deep River and an unnamed tributary Description: Continued headcutting and erosion of bank material

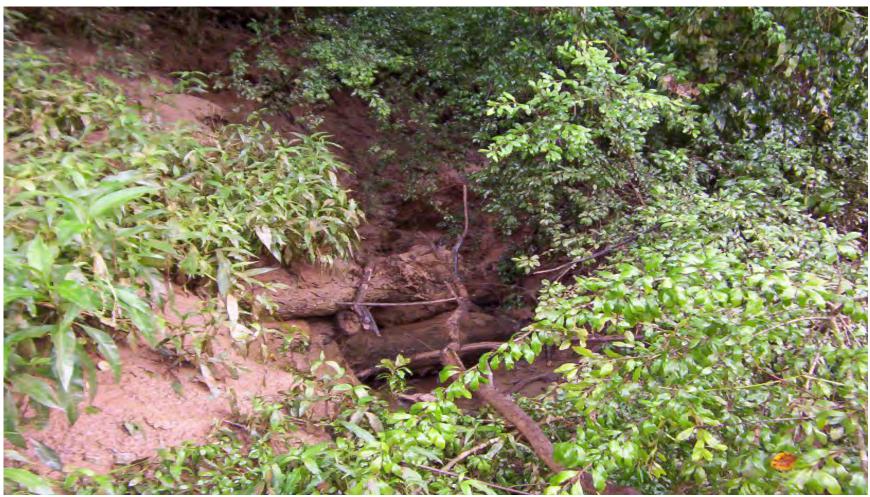
## Photo 12. River Observation Point 12

Location: Confluence of the Deep River and an unnamed tributary near Monitoring Station 2 Description: Continued headcutting behind a log jam created by tree fall

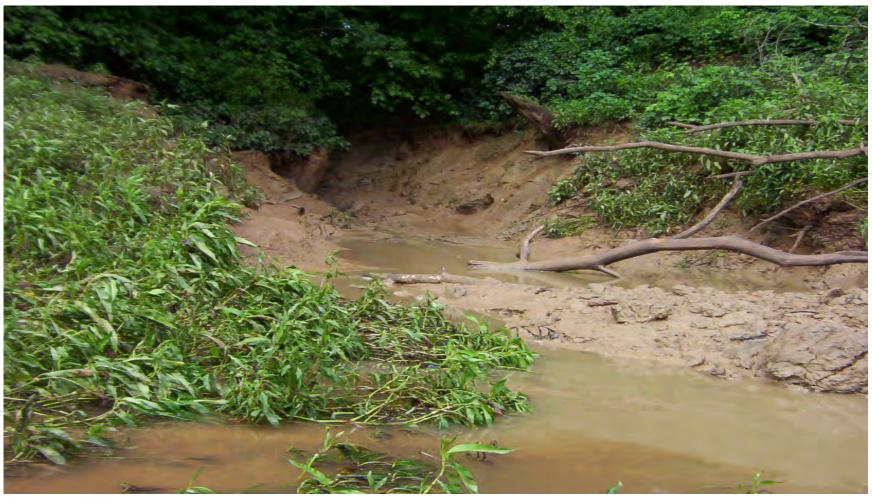
## Photo 13. River Observation Point 13

Location: Confluence of the Deep River and an unnamed tributary near Monitoring Station 23 Description: Continued headcutting and erosion of bank material

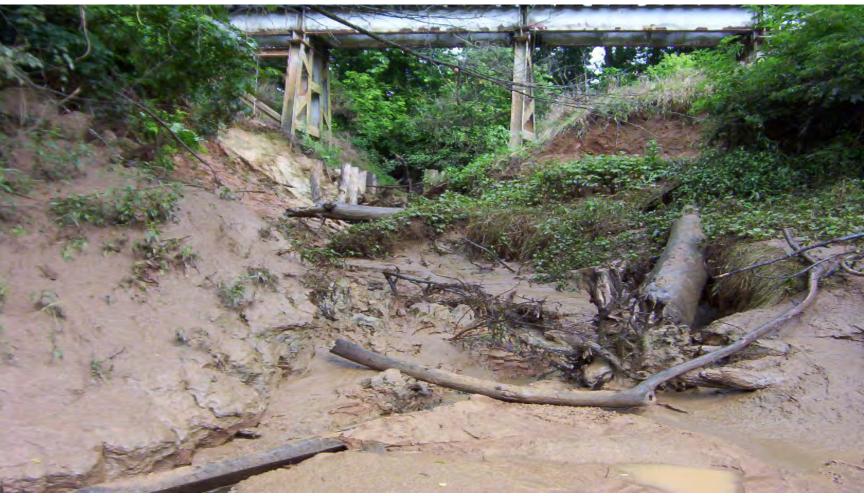
Photo 14. River Observation Point 14

Location: Confluence of the Deep River and Line Creek Description: Continued erosion of bank material and woody debris

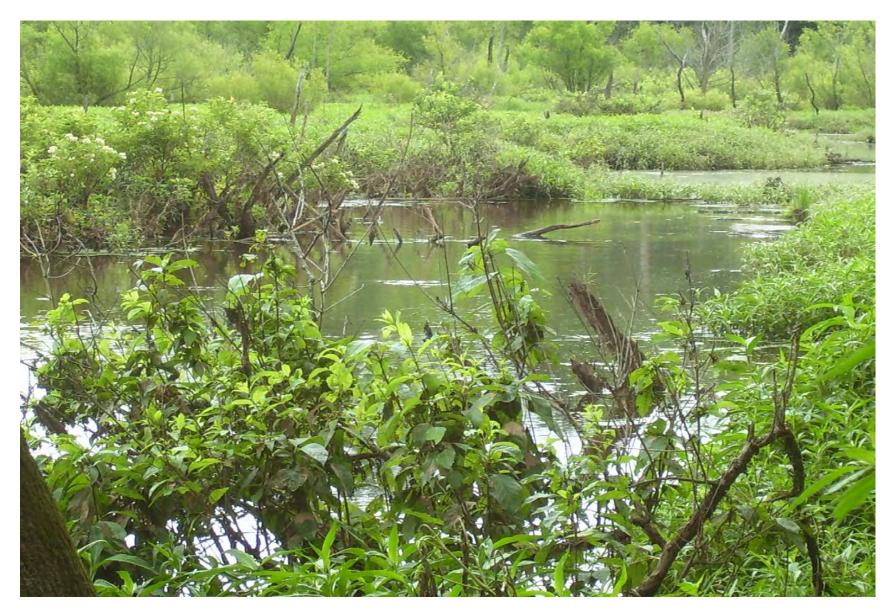
## Photo 15. Land Observation Point 1

Location: Line Creek

Description: Stable banks and well established herbaceous vegetation

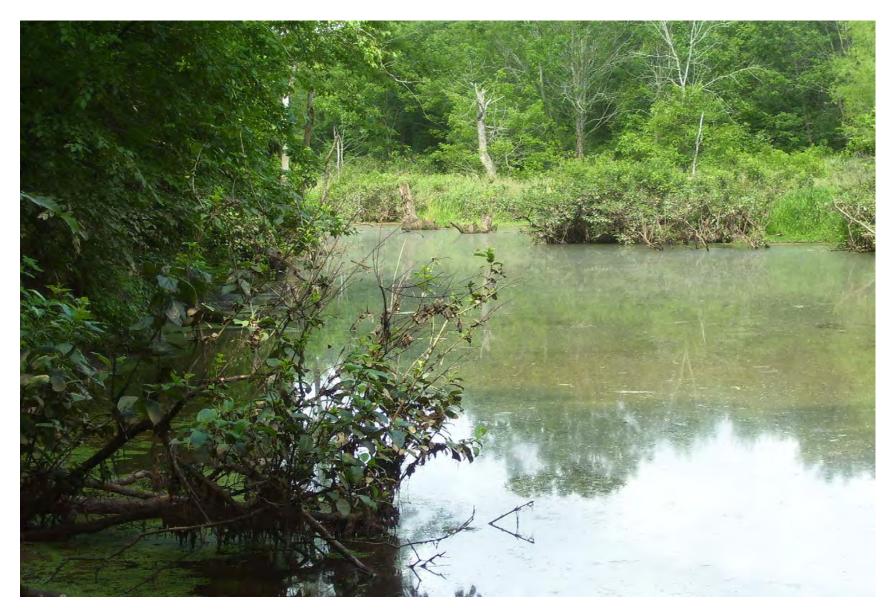
# Photo 16. Land Observation Point 1

Location:Line CreekDescription:High water level remaining from storm surge

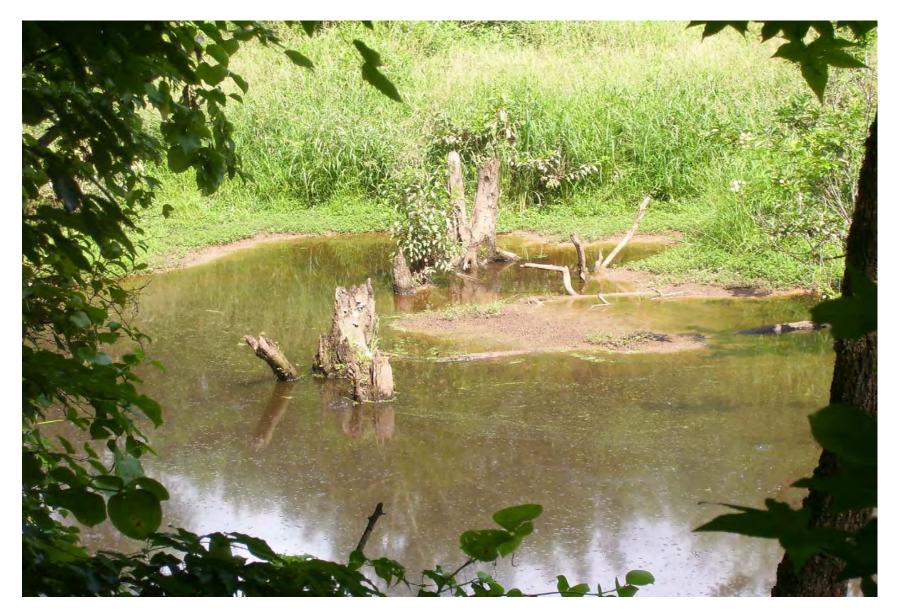
# Photo 17. Land Observation Point 1

Location: Line Creek Description: Sediment deposition

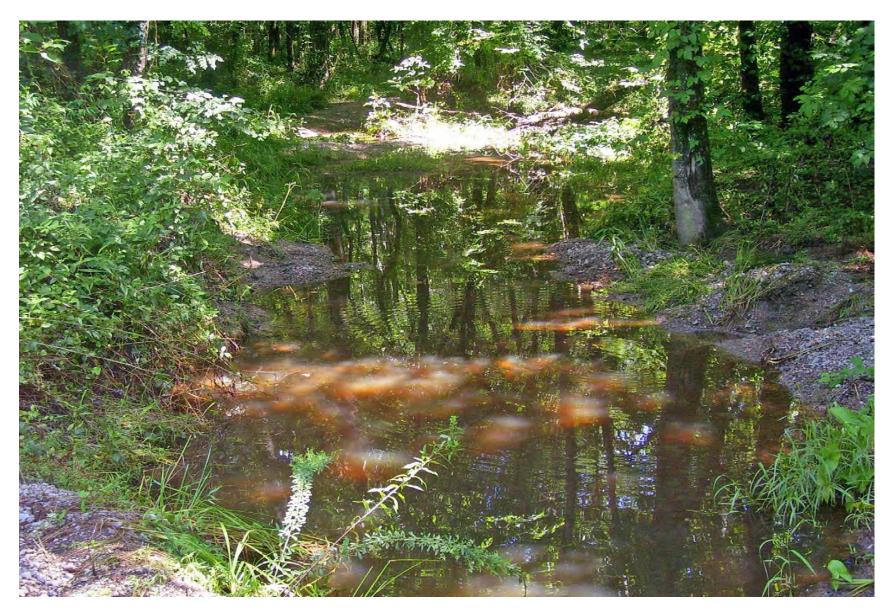
## Photo 18. Land Observation Point 2

Location: McClendon's Creek near Monitoring Station 45

Description: Gravel deposition on stream banks

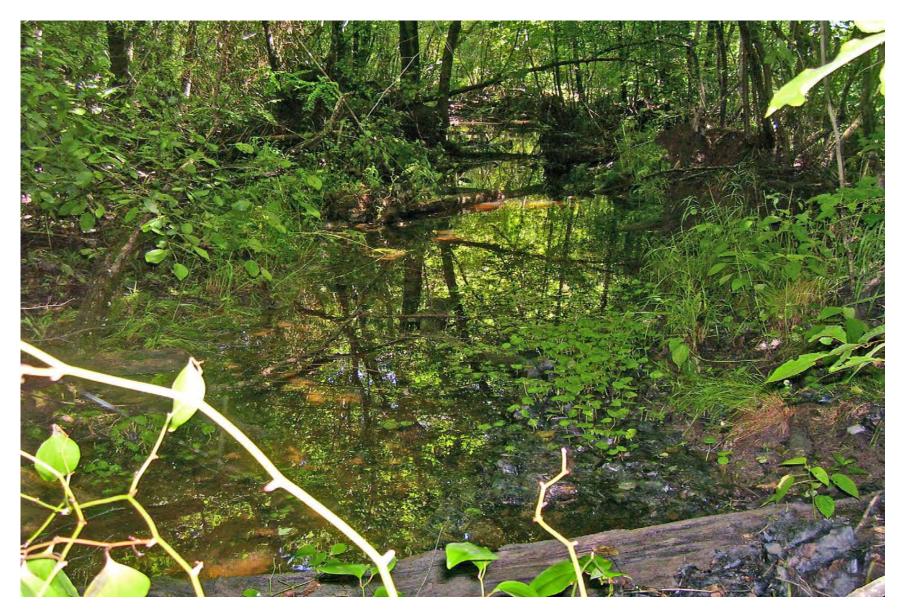
#### Photo 19. Land Observation Point 2

Location:McClendon's Creek near Monitoring Station 45Description:Stable banks and well established herbaceous vegetation

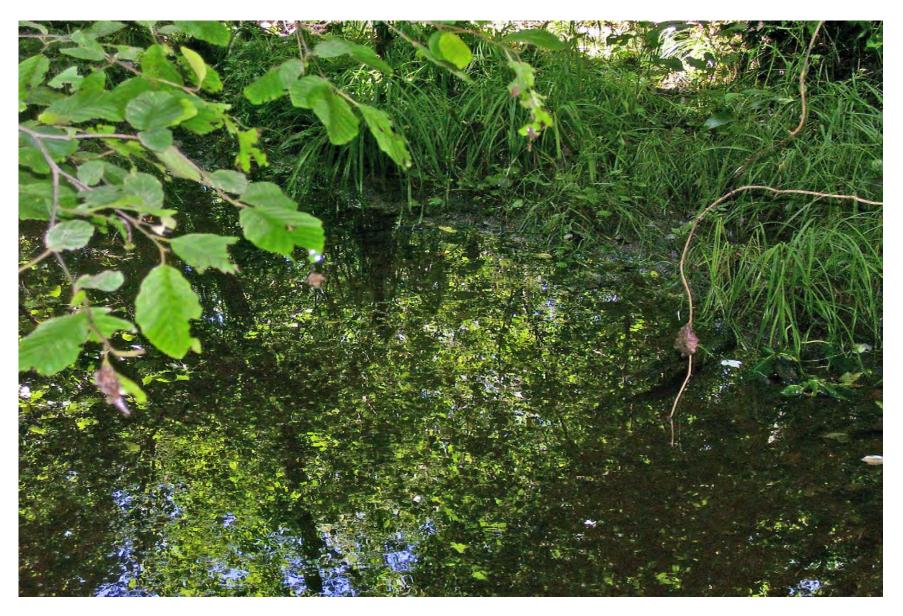
#### Photo 20. Land Observation Point 2

Location:McClendon's Creek near Monitoring Station 45Description:Pool of standing water within floodplain

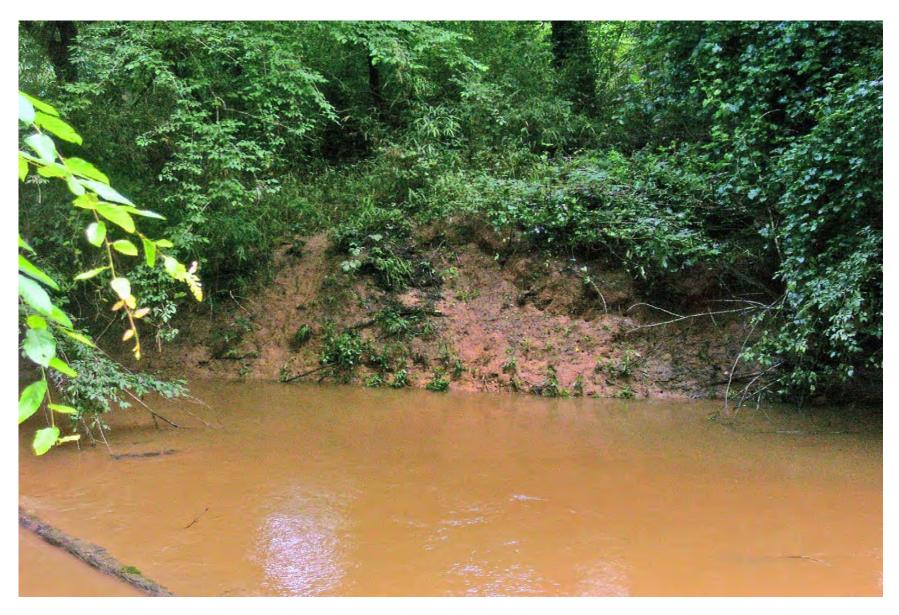
## Photo 21. Land Observation Point 3

Location: McClendon's Creek near Monitoring Station 47 Description: Bank erosion

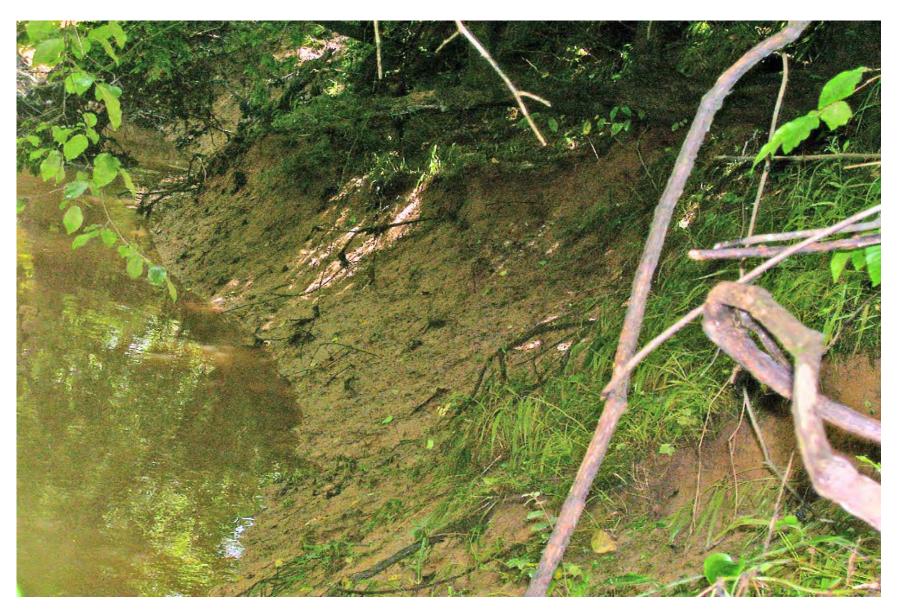
### Photo 22. Land Observation Point 3

Location: McClendon's Creek near Monitoring Station 47

Description: Bank erosion

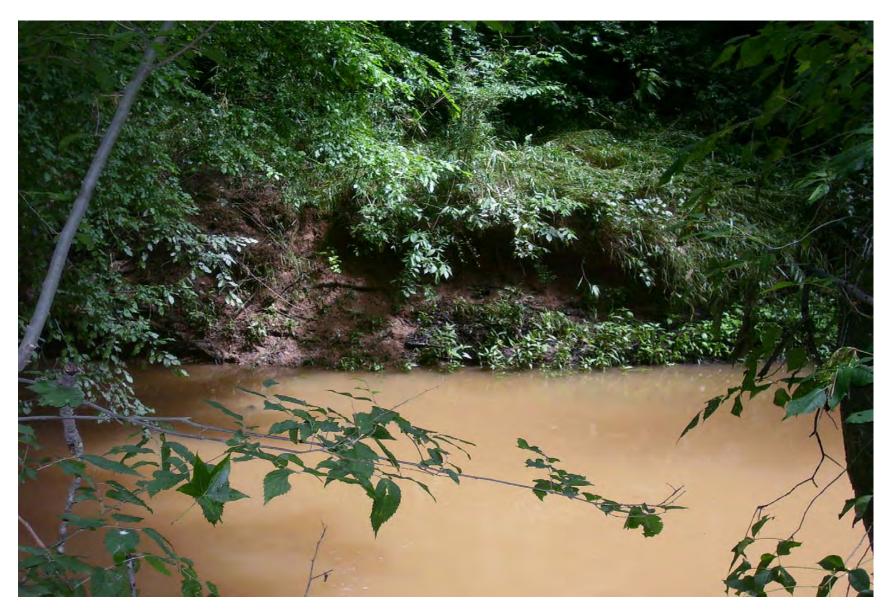
Photo 23. Land Observation Point 3

Location: McClendon's Creek near Monitoring Station 47

Description: Undercut bank

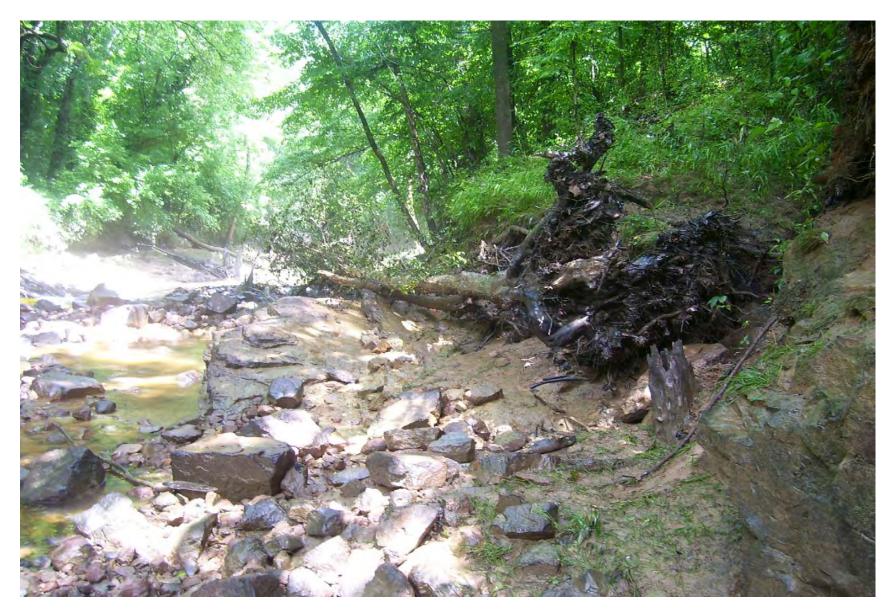
#### Photo 24. Land Observation Point 4

Location:Governor's Creek near Monitoring Station 40Description:Undercut tree fallen into the channel

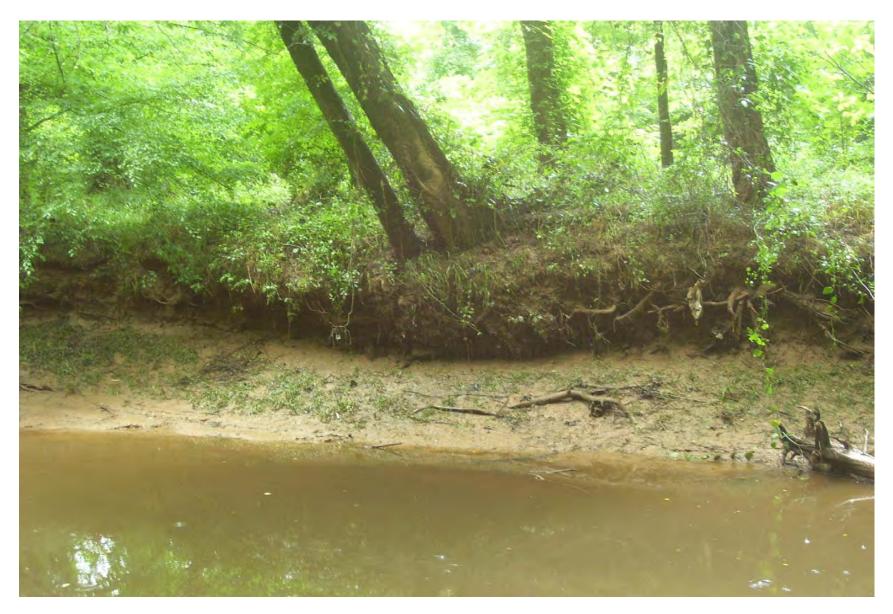
## Photo 25. Land Observation Point 4

Location: Governor's Creek near Monitoring Station 40

Description: Stream bank undercutting

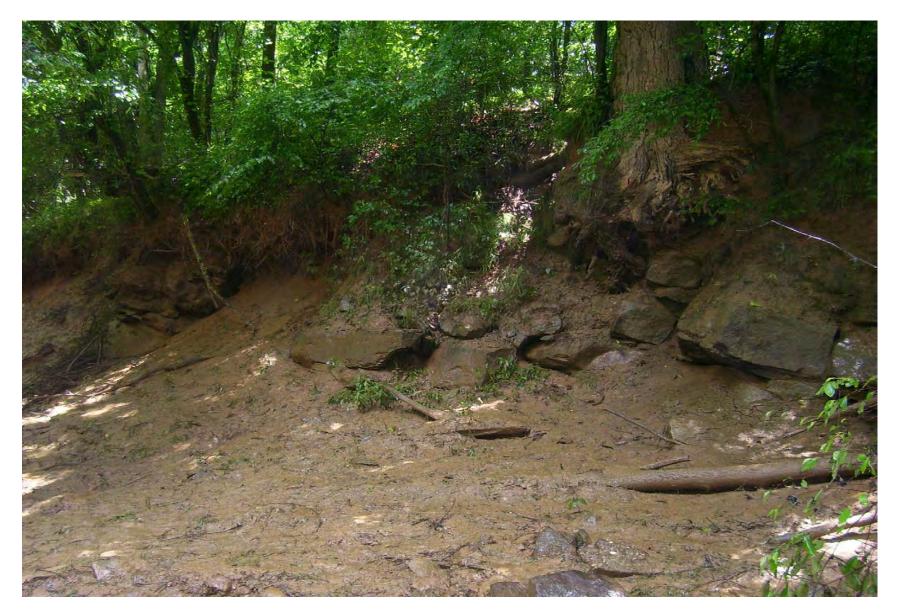
#### Photo 26. Land Observation Point 4

Location:Governor's Creek near Monitoring Station 40Description:Undercut banks with sediment deposition
