FINAL MITIGATION PLAN

Catbird Site Davie County, North Carolina

Yadkin River Basin HUC 03040101

DMS Project #: 100022 Contract #: 7186 USACE Action ID: SAW-2017-01506 DWR Project #20171039 RFP: 16-006993

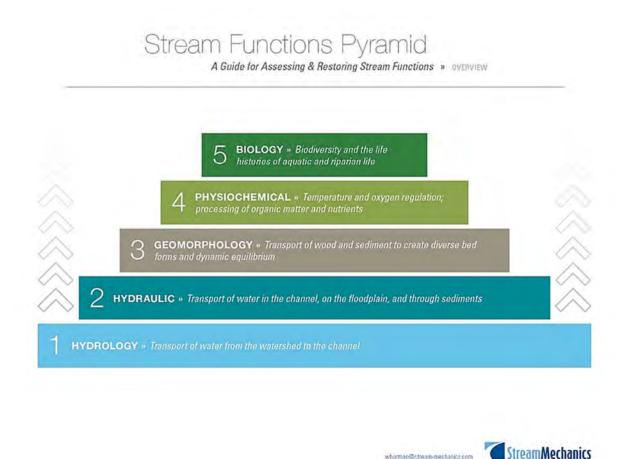
Chart 1. Stream Functions Framework

The Stream Functions Pyramid Framework (Harman et. al. 2012) uses stream functions to describe project objectives, existing condition assessments and monitoring, performance metrics, and design criteria. The Framework separates stream functions into five categories, ordered into a hierarchy, which communicate the interrelations among functions and illustrate the dependence of higher level functions (biology, physicochemical and geomorphology) on lower level functions (hydrology and hydraulics). Functions that affect the greatest number of other functions are illustrated at the base of the Pyramid, while functions that have the least effect on other functions are illustrated at the top. The Pyramid is illustrated below (**Chart 1**).

Fischenich (2006) found that the most critical functions include those that address hydrodynamic processes, sediment transport processes, stream stability and riparian buffer restoration. By addressing these fundamental functions and processes, a restored stream and riparian system are capable of supporting more dependent functions that typically require time to establish, such as diverse biological communities, chemical and nutrient processes, diverse habitats and improved water and soil quality. The objectives of this Project will address the most critical functional objectives that will allow for a more restored stream and riparian area over time.
