**Cat Creek Stream and Wetland Restoration
Macon County, NC**

Restoration Plan

SCO Project Number 050657901

July 2007

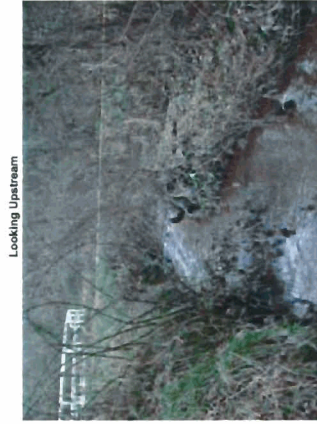
Bank Erosion Hazard Index (BEHI)			
Criteria	Value	Index	Bank Erosion Potential
Bank Height	2	7.5	high
Bank Depth	0.25	6.5	high
Root Density (%)	10	7.5	high
Bank Angle (Degrees)	88	7.5	high
Surface Protection (%)	5	10	extreme
Bank Materials	Silt/Clay	0	
Stratification		5	
		44.4	very high

Cross Section 1
Swartwout Upper Section
Riffle--Cross Section
(looking upstream-see photo)

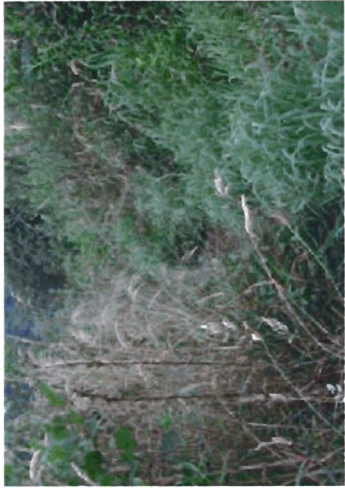
Cross Section 3
Swartwout Middle Section
Pool-Cross-Section

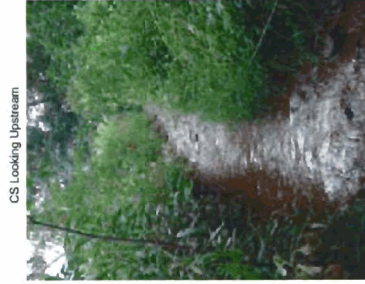
Bank Erosion Hazard Index (BEHI)			
Criteria	Value	Index	Bank
Bank H/BK Ht	1.7	6.4	high
Root Depth/Bank Ht	92	1.4	very low
Root Density (%)	56	3.7	low
Bank Angle (Degrees)	95	1.2	very low
Surface Protection (%)	Silt/Clay	5	
Bank Materials			
		19	low

Cross Section 6
Swartwout UT1
Pool Cross Section

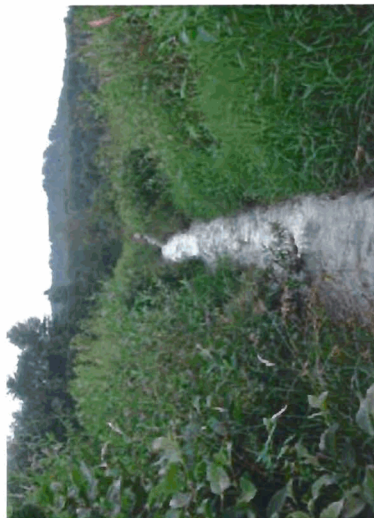
Bank Erosion Hazard Index (BEHI)			
Criteria	Value	Index	Bank Erosion
Bank Height	1.5	5.9	moderate
Bank Width	1	1	very low
Root Density (%)	95	1.2	low
Bank Angle (Degrees)	60	3.9	very low
Surface Protection (%)	95	1.2	very low
Bank Material	silt/clay	3	
TOTALS		16.2	Low

Cross Section 10
Parker Tract
Riffle Cross-Section

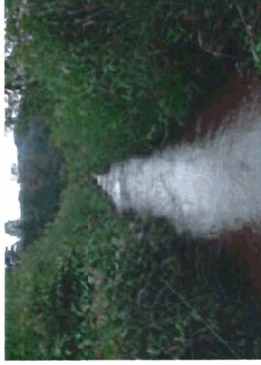
Bank Erosion Hazard Index (BEHI)			
Criteria	Value	Index	Potential
Bank H/BKF Ht	1.5	5.9	moderate
Root Depth/Bank Ht	1	1	very low
Root Density (%)	95	12	very low
Bank Angle (Degrees)	60	3.9	low
Surface Protection (%)	95	12	very low
Bank Materials Silt/Clay	5		
TOTALS	18.2		low

CS LOOKING DOWNSTREAM

Cross Section 11
Parker Tract
Pool Cross Section

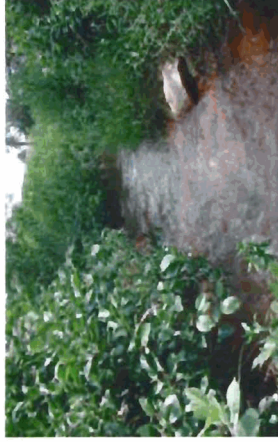
Cross Section 15
Preserve Upper Section
Rifle-Cross Section

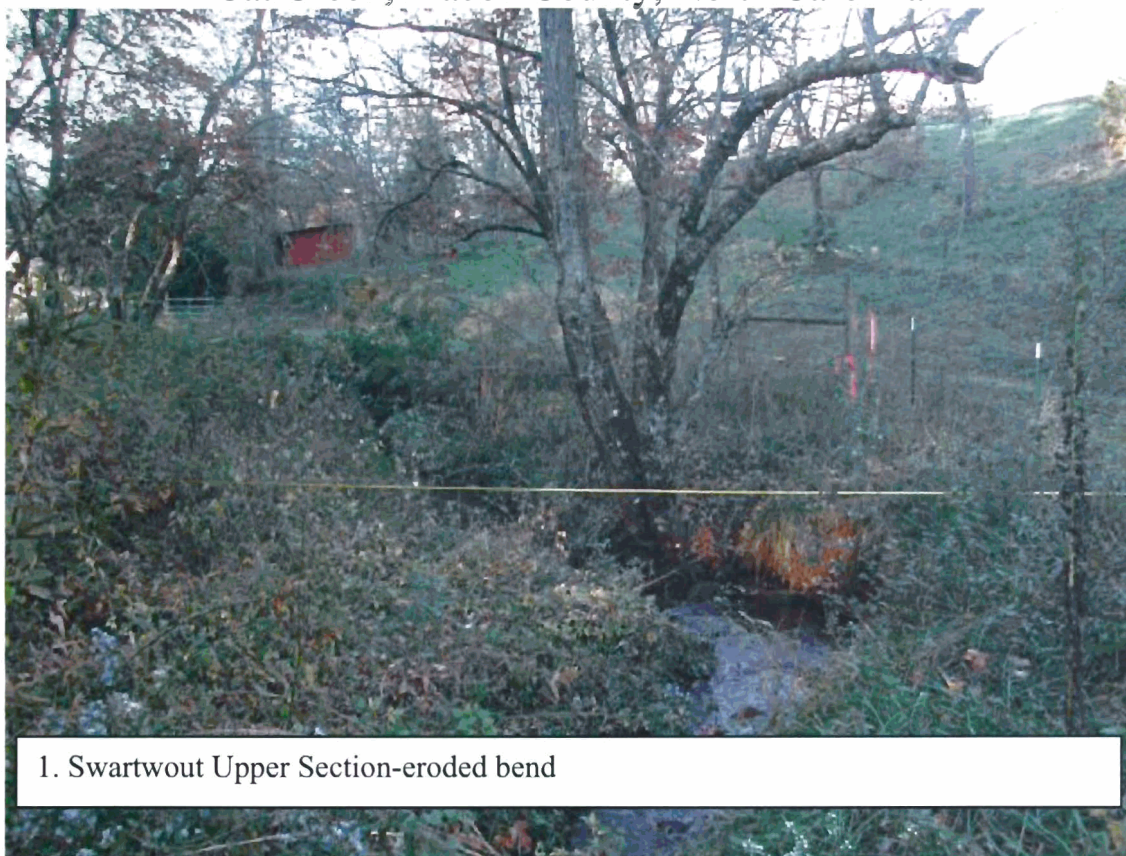
1. Swartwout Upper Section-eroded bend

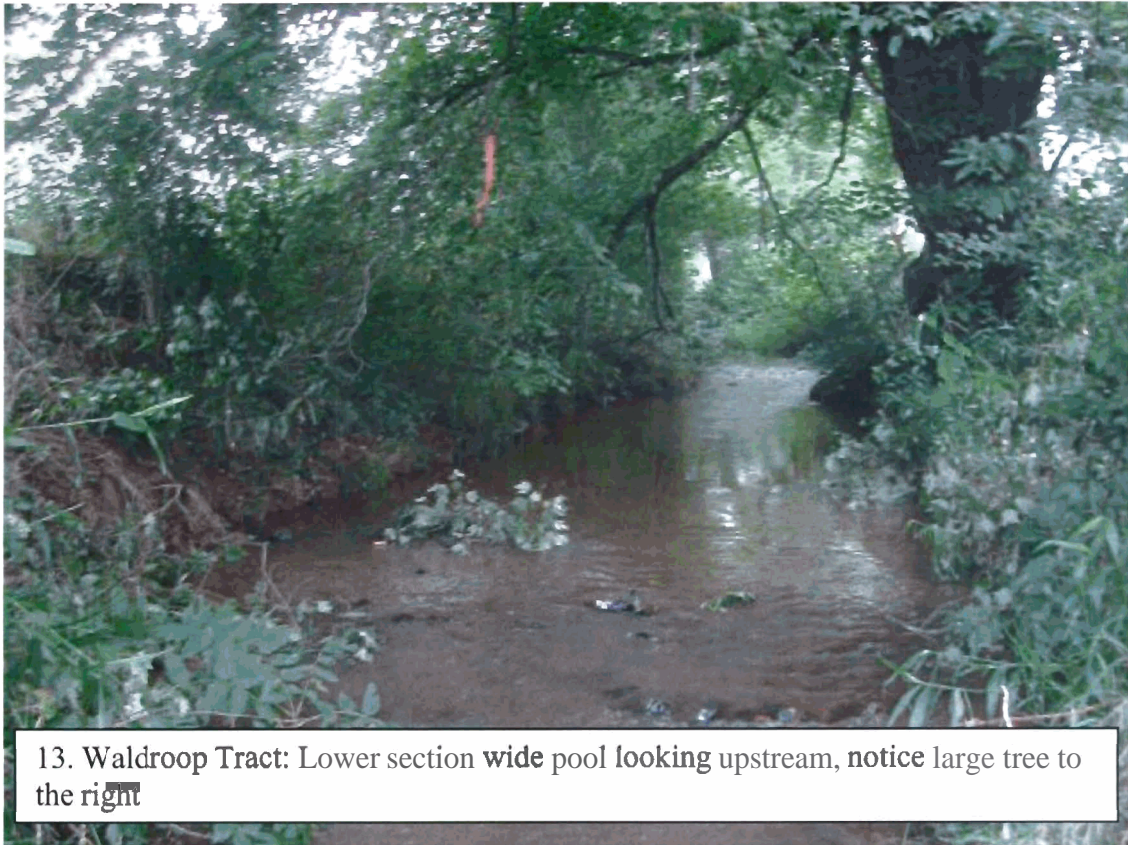
13. Waldroop Tract: Lower section wide pool looking upstream, notice large tree to the right

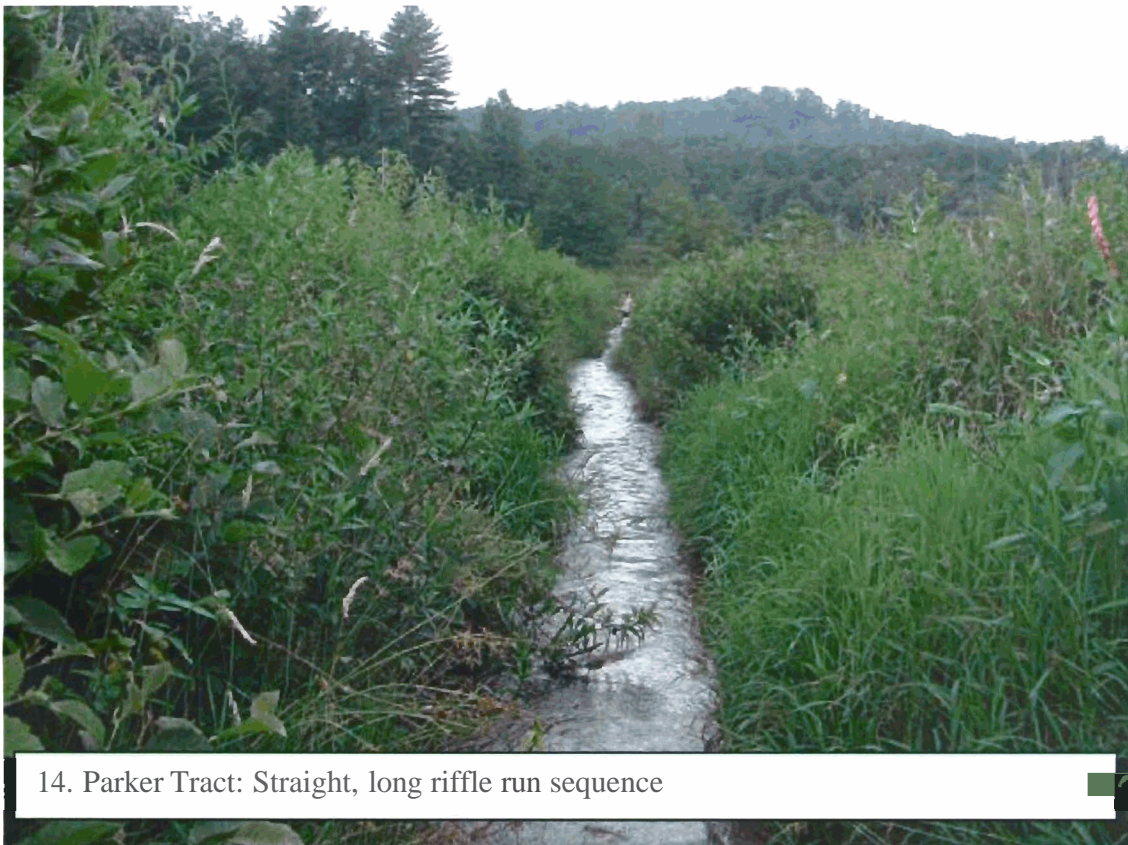
14. Parker Tract: Straight, long riffle run sequence

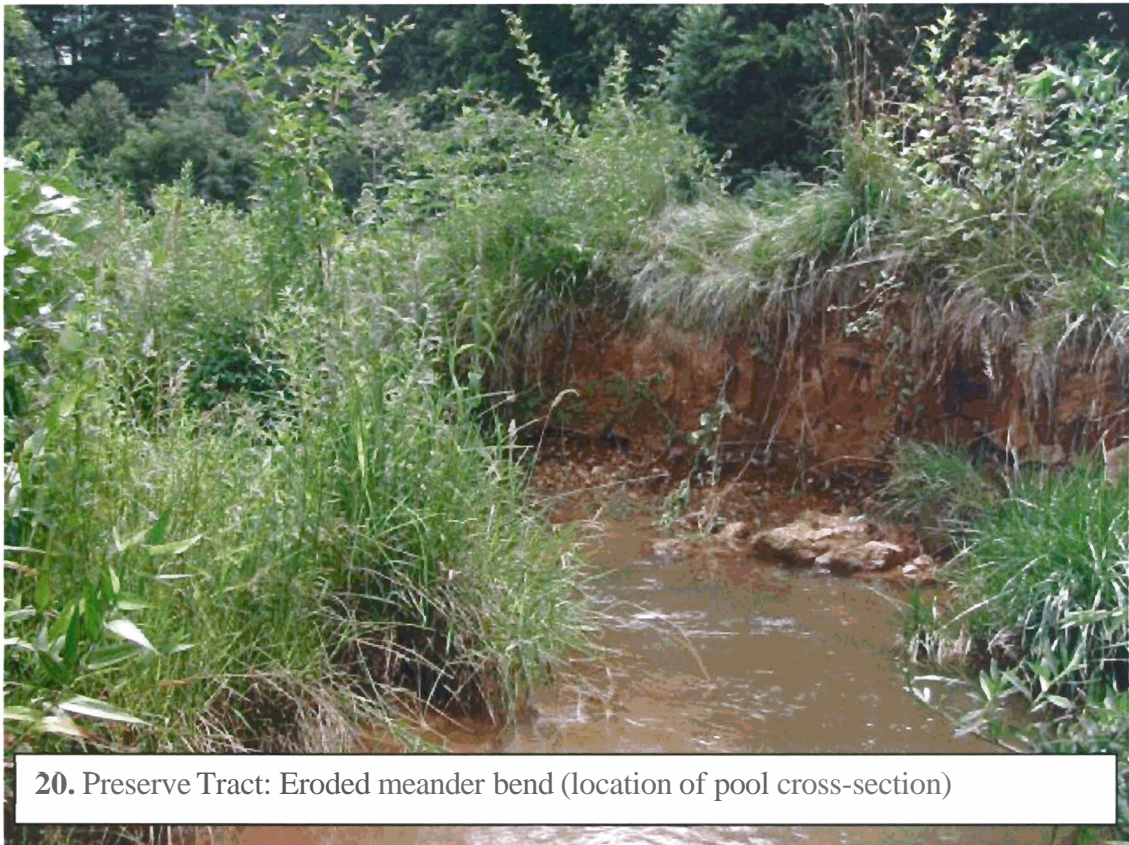
20. Preserve Tract: Eroded meander bend (location of pool cross-section)
