MITIGATION PLAN Final

CORNBREAD VALLEY MITIGATION SITE

Macon County, NC NCDEQ Contract No. 0304-01 DMS ID No. 100175

Little Tennessee River Basin HUC 06010202

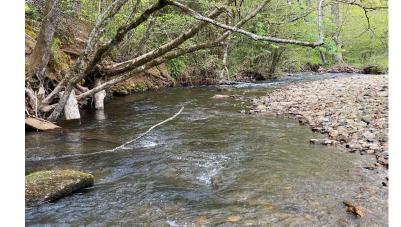
- 61.2 x-section area (ft.sq.)
- 32.8 width (ft)
- 1.9 mean depth (ft)
- 3.9 max depth (ft)
- 37.0 wetted perimeter (ft)
- 1.7 hyd radi (ft)
- 17.6 width-depth ratio
- W flood prone area (ft) 116.3
- 3.5 entrenchment ratio
- 1.0 low bank height ratio

View Downstream

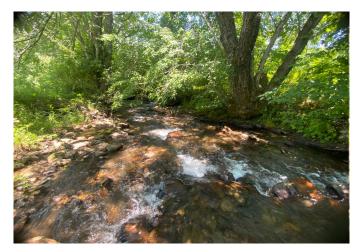
- 50.8 x-section area (ft.sq.)
- 29.8 width (ft)
- 1.7 mean depth (ft)
- 2.6 max depth (ft)
- 31.2 wetted perimeter (ft)
- 1.6 hyd radi (ft)
- 17.5 width-depth ratio
- 55.0 W flood prone area (ft)
- 1.8 entrenchment ratio
- 0.9 low bank height ratio

View Downstream

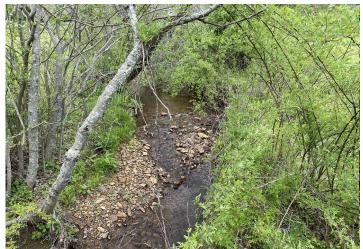
- x-section area (ft.sq.) 10.3
- 11.6 width (ft)
- 0.9 mean depth (ft)
- 1.8 max depth (ft)
- wetted perimeter (ft) 12.9
- 8.0 hyd radi (ft)
- width-depth ratio 13.0
- 32.6 W flood prone area (ft)
- 2.8 entrenchment ratio
- 1.7 low bank height ratio

View Upstream

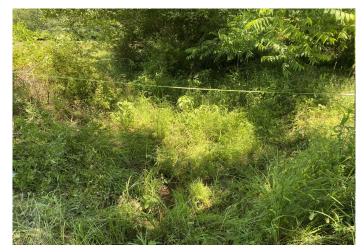
- 3.4 x-section area (ft.sq.)
- 8.5 width (ft)
- 0.4 mean depth (ft)
- 1.1 max depth (ft)
- 9.4 wetted perimeter (ft)
- 0.4 hyd radi (ft)
- 21.3 width-depth ratio
- 70.0 W flood prone area (ft)
- 8.2 entrenchment ratio
- 1.3 low bank height ratio

View Downstream

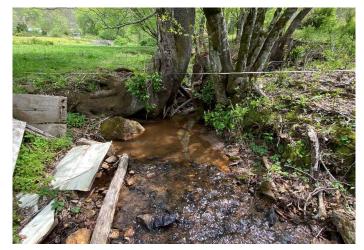
- x-section area (ft.sq.) 4.7
- 5.4 width (ft)
- 0.9 mean depth (ft)
- 1.3 max depth (ft)
- wetted perimeter (ft) 6.5
- hyd radi (ft) 0.7
- width-depth ratio 6.2
- 7.0 W flood prone area (ft)
- 1.3 entrenchment ratio
- 2.3 low bank height ratio

View Upstream

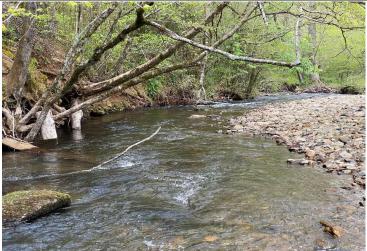
- 61.2 x-section area (ft.sq.)
- 32.8 width (ft)
- 1.9 mean depth (ft)
- 3.9 max depth (ft)
- 37.0 wetted perimeter (ft)
- 1.7 hyd radi (ft)
- 17.6 width-depth ratio
- W flood prone area (ft) 116.3
- 3.5 entrenchment ratio
- 1.0 low bank height ratio

View Downstream

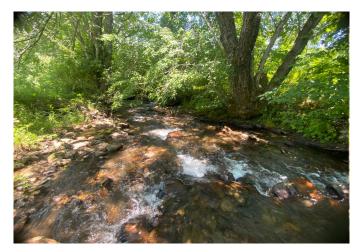
- 50.8 x-section area (ft.sq.)
- 29.8 width (ft)
- 1.7 mean depth (ft)
- 2.6 max depth (ft)
- 31.2 wetted perimeter (ft)
- 1.6 hyd radi (ft)
- 17.5 width-depth ratio
- 55.0 W flood prone area (ft)
- 1.8 entrenchment ratio
- 0.9 low bank height ratio

View Downstream

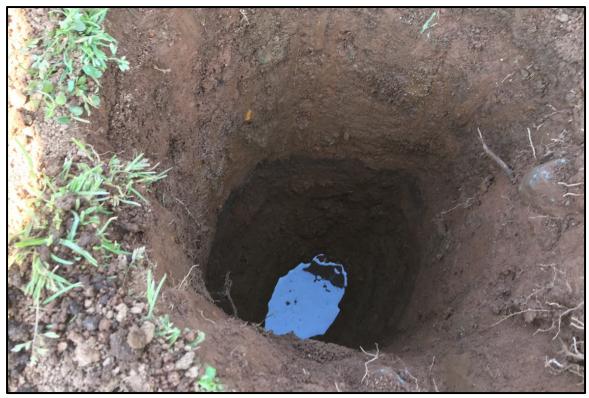
Figure 5.15. Shovel Test 6 at 31MA862.

Some shovel tests in that area (e.g., from ST 6 to 15) encountered an intermediate stratum (from eight to 19 cm thick, at depths ranging from 24 to 45 cm at its top to 32 to 60 cm at its base. This intermediate stratum appeared rather sporadically within this area, and was most prominently expressed in ST 6, which encountered a 19 cm thick stratum characterized as multicolored, dark reddish brown (5YR 2.5/2), very dark gray (5YR 3/3), and black (5YR 2.5/1) sandy loam to loamy sand, extending from 38 to 57 cm, to the top of the B horizon subsoil and the current water table (Figure 5.15). A somewhat similar (but less well expressed) stratum was also encountered in STs 9, 10, 13, 15, and 33, but was identifiable in all shovel tests

in the area. Artifacts associated with this Ab horizon stratum in this part of the site were limited to ST 6, which generated the only ceramic artifacts from the site.

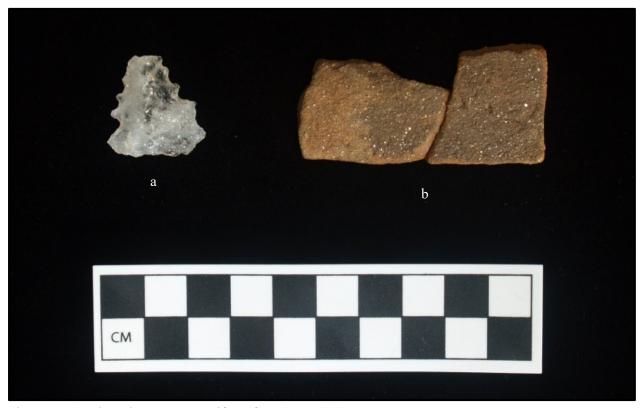
Figure 5.16. Selected precontact artifacts from 31MA862. a: quartz Palmer/Kirk PPK, ST 17; b: unidentified plain sherds, ST 6

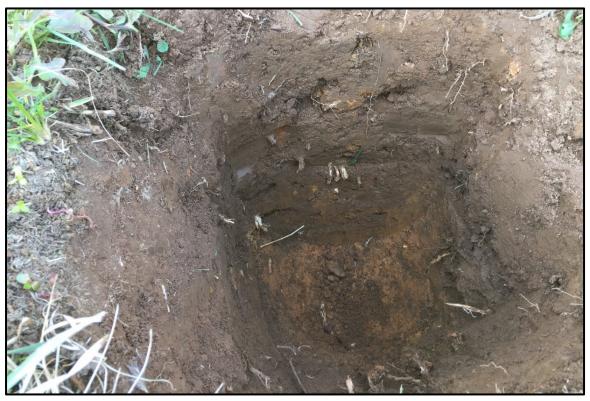
Figure 5.19. Shovel Test 68 at 31MA863.

The soils at 31MA863 are mapped as Evard-Cowee complex, 15–30% slopes (EvD). This is a well-drained, residual soil found on mountain slopes (USDA NRCS 2021). Soil profiles documented in shovel tests consisted of an 18–36 cm thick A horizon/plowzone of dark reddish brown (5YR 3/3) sandy loam, which conformably overlies a strong brown (7.5YR 5/8) sandy clay loam B horizon (Figure 5.19).

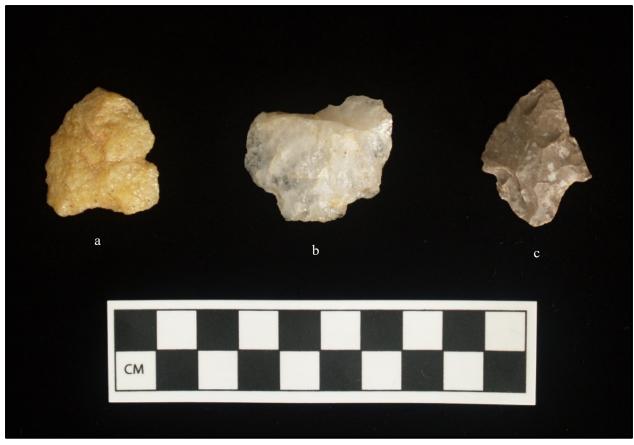
Figure 5.20. Selected lithic artifacts from 31MA863, 31MA864, and 31MA871. a: quartzite biface fragment, 31MA863 ST 69; b; quartz unidentified stemmed PPK, 31MA864 ST 63; c: chert unidentified stemmed PPK, 31MA871 ST 176

Artifacts. Ten nondiagnostic lithic artifacts were recovered from shovel tests at 31MA863. These include the distal portion of a late stage biface or projectile point preform made of quartzite (Figure 5.20a) and nine pieces of quartz debitage.

Artifacts. The single artifact is a fragmentary projectile point or preform (see Figure 5.20b). The artifact is made of quartz and represents the medial portion of an unidentified stemmed projectile point, which is most similar to broad-bladed Late Archaic varieties.

Artifacts. The assemblage includes one nearly complete projectile point made of chert and nine pieces of debitage (five of quartz, three of quartzite, and one of chert). The projectile point exhibits a slightly contracting stem with a convex base and horizontal shoulders (see Figure 5.20c) but has not been assigned to a specific type.

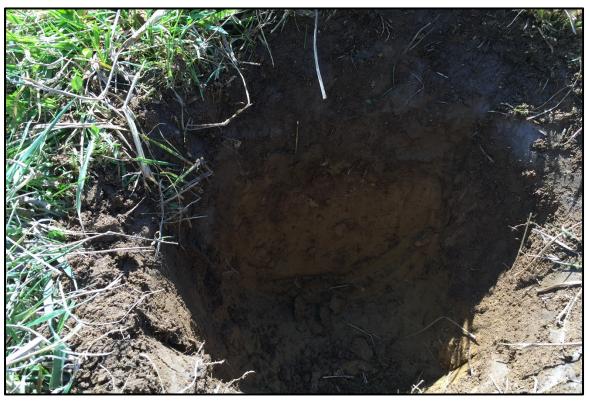
Figure 5.22. Shovel Test 66 at 31MA864.

The soils at 31MA864 are mapped as Evard-Cowee complex, 15–30% slopes (EvD), a well-drained, residual soil found on mountain slopes (USDA NRCS 2021). Shovel tests in undisturbed areas encountered a ca. 20 cm thick A or Ap horizon of dark reddish brown (5YR 3/3) or dark brown (7.5YR 3/3) sandy loam overlying yellowish red (5YR 4/6) or strong brown (7.5YR 4/6) clay loam, unless impenetrable cobbles were encountered near the base of the A horizon (Figure 5.22).

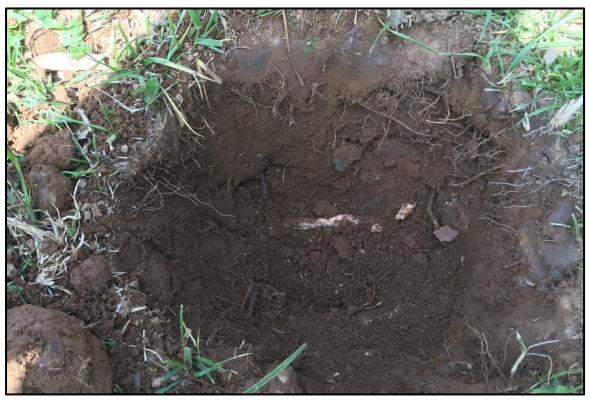
Figure 5.24. Shovel Test 81 at 31MA865.

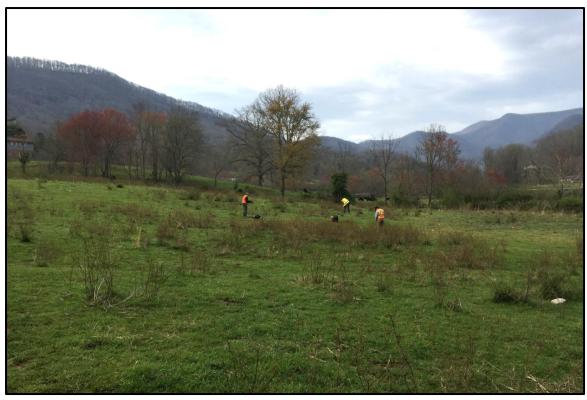
Figure 5.26. Site 31MA866, facing south.

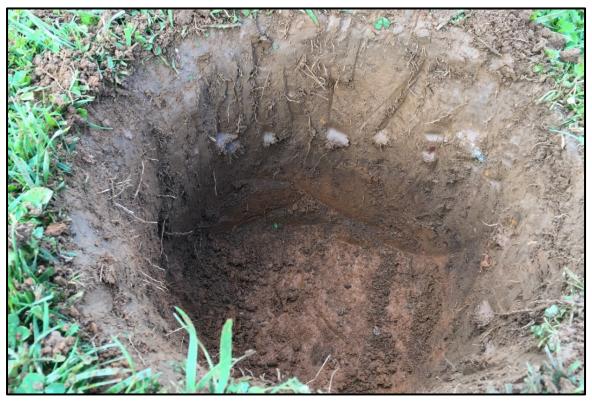
Figure 5.27. Shovel Test 118 at 31MA866.

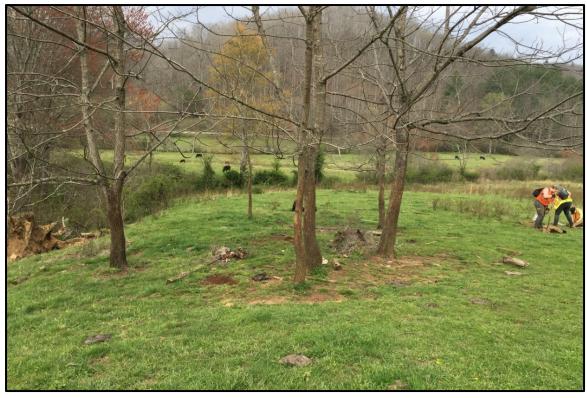
Figure 5.28. Site 31MA867, facing west.

<u>Description</u>. Site 31MA867 is a small precontact period site located on a small rise on a descending ridge toe north of a tributary branch of Jones Creek (Figure 5.28; see Figures 5.11 and 5.25). It is bounded to the north, east. and west by negative shovel tests, and to the south by Jones Creek and its associated slope. The site appears to occupy a discrete micro-landform on the ridge toe.

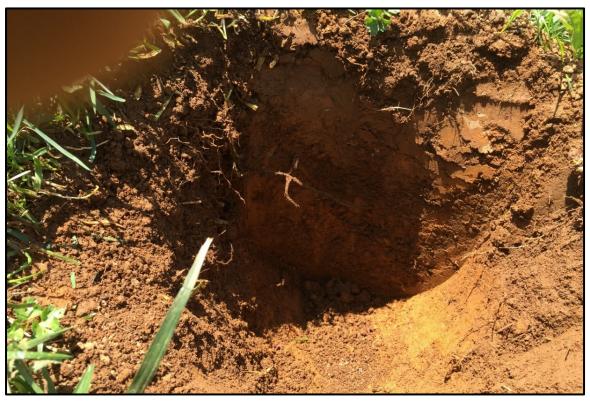
Figure 5.29. Shovel Test 127 at 31MA867.

The soils at 31MA867 are mapped as Evard-Cowee complex, 15–30% slopes (EvD), a well-drained, residual soil found on mountain slopes (USDA NRCS 2021). The single artifact-producing shovel test encountered a 25 cm thick A or Ap horizon of dark reddish brown (5YR 3/3) sandy loam that overlay yellowish red (5YR 4/6) clay loam (Figure 5.29). Part of the small landform was disturbed by a burned refuse pile.

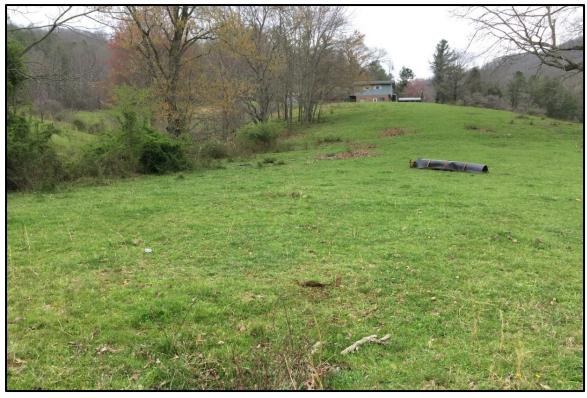
Figure 5.30. Site 31MA868, facing southeast.

<u>Description</u>. Site 31MA868 is a low-density subsurface lithic scatter situated on a slightly elevated landform south of a Jones Creek tributary and west of an adjacent ridge toe slope (Figure 5.30; see Figures 5.11 and 5.25). The site is bounded to the west by hydric, poorly drained soils, to the north by the stream channel, by negative shovel tests and the ridge side slope to the east, and by negative shovel tests and hydric areas to the south.

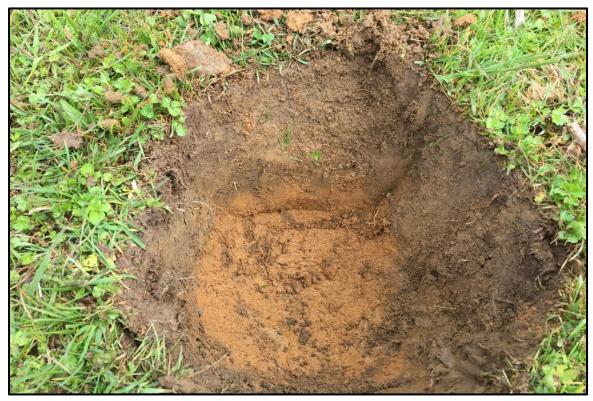
Figure 5.31. Shovel Test 167 at 31MA868.

The soils at 31MA868 are mapped as Nikwasi fine sandy loam, 0–2% slopes (NkA), a very poorly drained and frequently flooded soil formed in loamy alluvium (USDA NRCS 2021). Typical shovel tests encountered a 15–25 cm thick A or Ap horizon of dark brown (7.5YR 3/3) silt loam overlying yellowish red (5YR 4/6) clay loam, which is dissimilar to the mapped soil type and more typical of Saunook and other residual type soils (Figure 5.31).

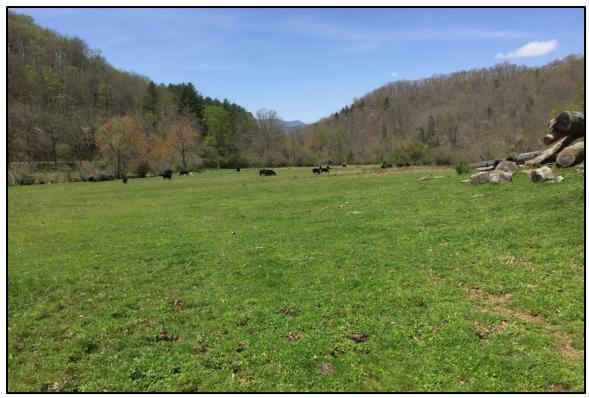
Figure 5.33. Site 31MA869, facing northwest.

<u>Description</u>. Site 31MA869 is one of four small precontact period sites situated on the broad stream terrace north of Jones Creek on slightly elevated areas between seasonal wetlands or along the edge of the ridge side slope (Figures 5.32 and 5.33; see Figure 5.11). Site 31MA869 occupies a slightly elevated landform south of an adjacent ridge toe slope, and immediately north of surrounding poorly drained, hydric soils. The site is bounded to the south by poorly drained, hydric soils, to the north by the ridge side slope, and to the east and west by negative shovel tests.

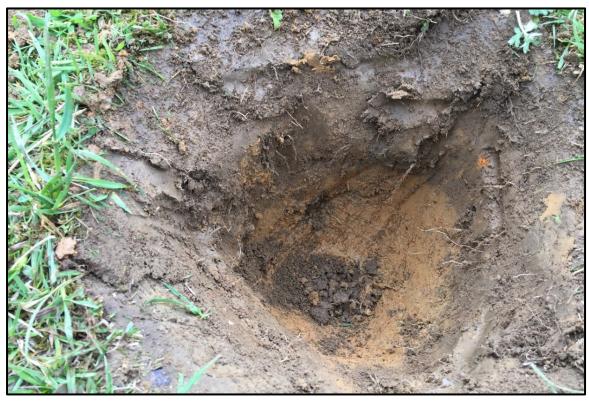
Figure 5.34. Shovel Test 168 at 31MA869.

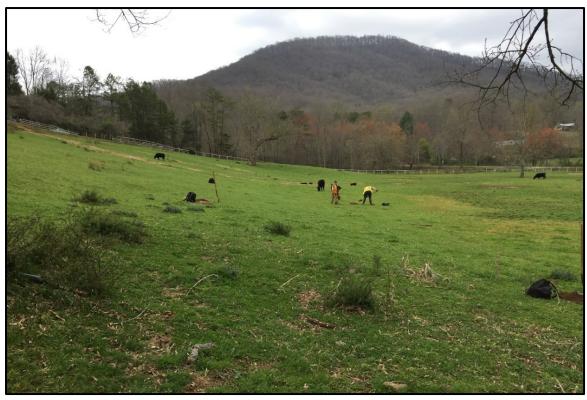
Figure 5.35. Site 31MA870, facing southeast.

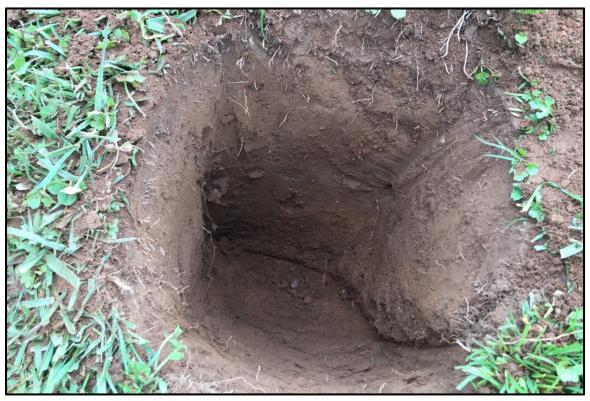
Figure 5.36. Shovel Test 173 at 31MA870.

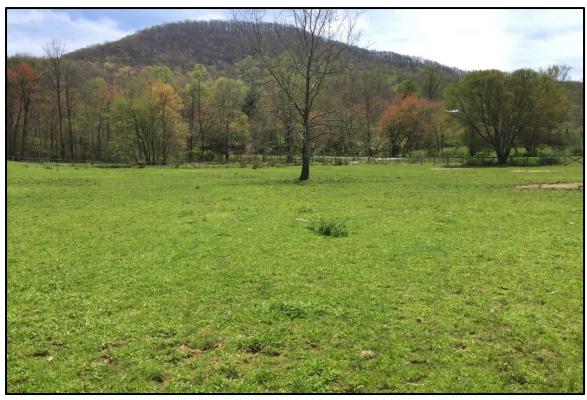
Figure 5.37. Site 31MA871, facing east.

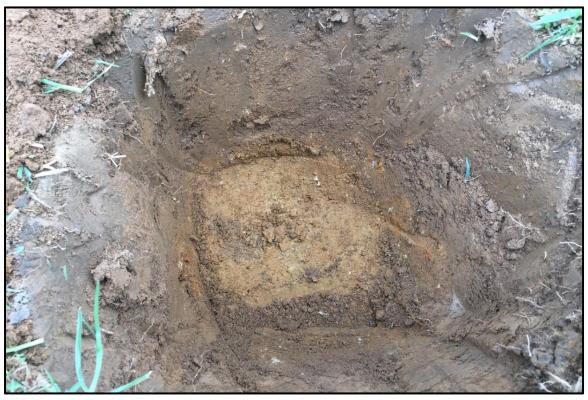
Figure 5.38. Shovel Test 181 at 31MA871.

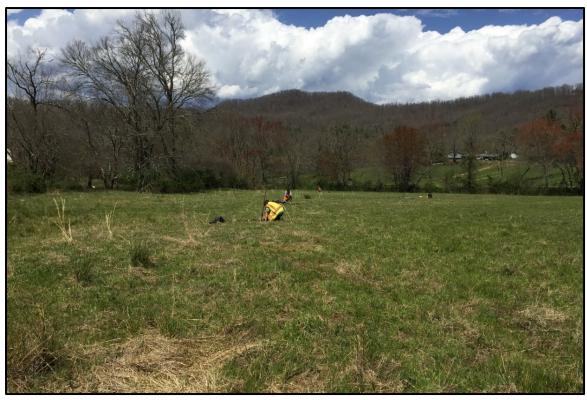
Figure 5.40. Site 31MA872, facing northwest.

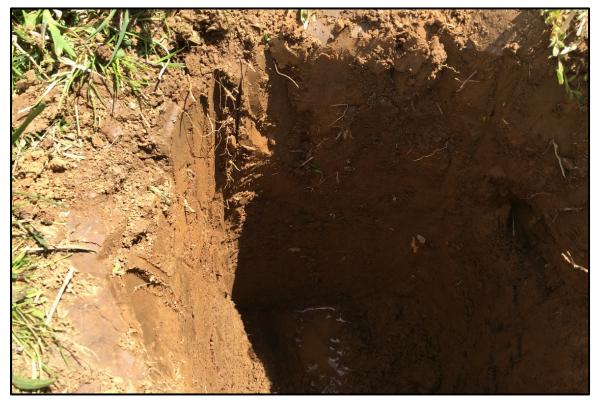
Figure 5.41. Shovel Test 231 at 31MA872.

Most soils at 31MA872 are mapped as Dellwood gravelly fine sandy loam, 0–5% slopes (DgB), a moderately well-drained and frequently flooded soil found on floodplains (USDA NRCS 2021). The site slightly overlaps an area mapped as Saunook loam, 2–8% slopes (ScB), a well-drained soil formed in colluvium (USDA NRCS 2021). Most shovel tests encountered a 25–35 cm thick plowzone (Ap horizon) composed of dark brown (10YR 3/3) silt loam overlying dark yellowish brown (10YR 4/6) or strong brown (7.5YR 4/6) clay loam (Figure 5.41).

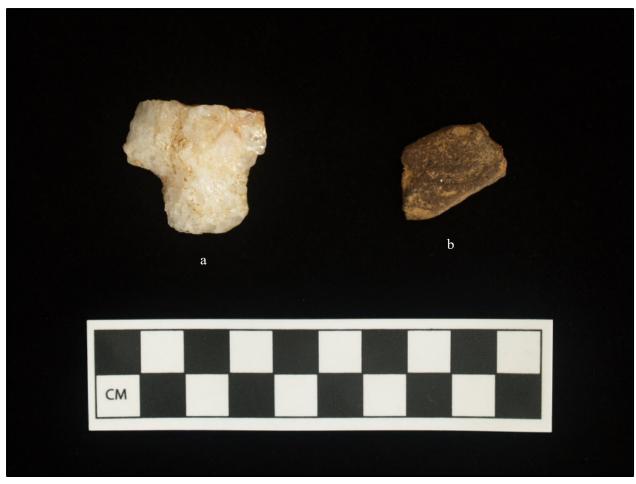
Figure 5.42. Selected precontact artifacts from 31MA872. a: unidentified quartz stemmed PPK, ST 231; b: unidentified curvilinear complicated stamped sherd, ST 244

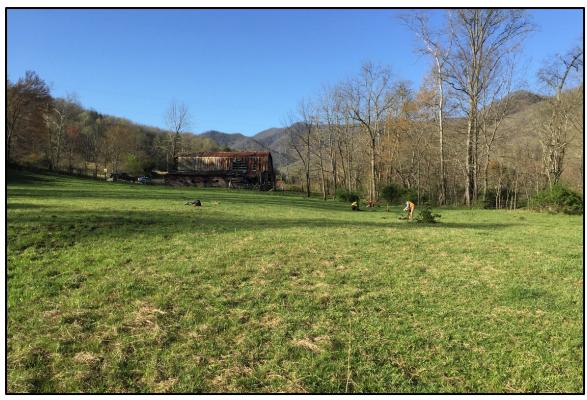
Figure 5.44. Site 31MA873, facing south.

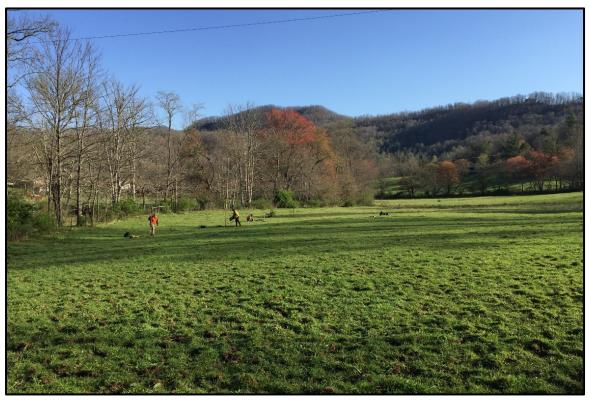
Figure 5.45. Site 31MA873, facing north.

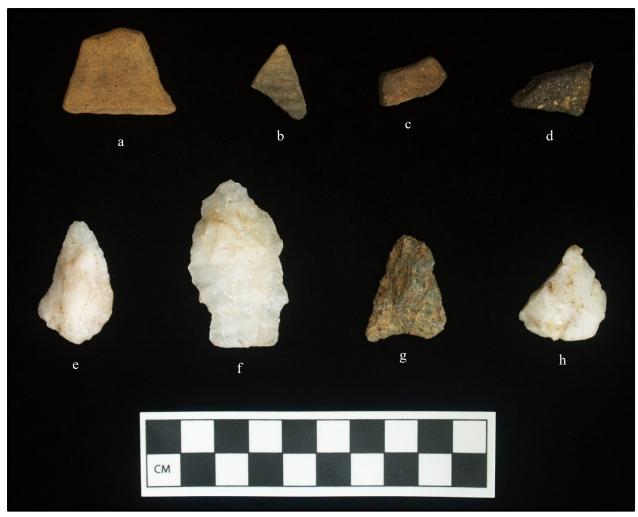
Figure 5.47. Selected ceramic and lithic artifacts from 31MA873. a: Connestee plain, ST 384; b: unidentified stamped, ST 225; c: unidentified stamped, ST 244; d: unidentified eroded, ST 379; e: quartz Morrow Mountain PPK, ST 223; f: quartz unidentified stemmed PPK, ST 383; g: metasandstone Woodland triangular PPK, ST 244; h: quartz biface fragment, ST 378

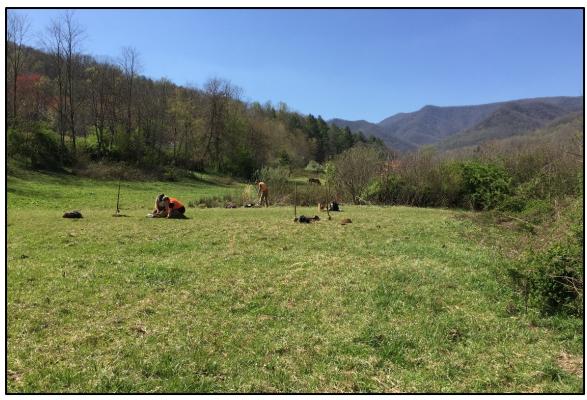
Figure 5.49. Site 31MA874, facing southwest.

<u>Description</u>. Site 31MA874 is a small precontact site situated on a stream terrace east of Jones Creek and south of Allison Watts Road (Figures 5.48 and 5.49; see Figure 5.11). The site is bounded to the north by negative shovel tests, to the south and east by wetlands, and to the west by a branch of Jones Creek.

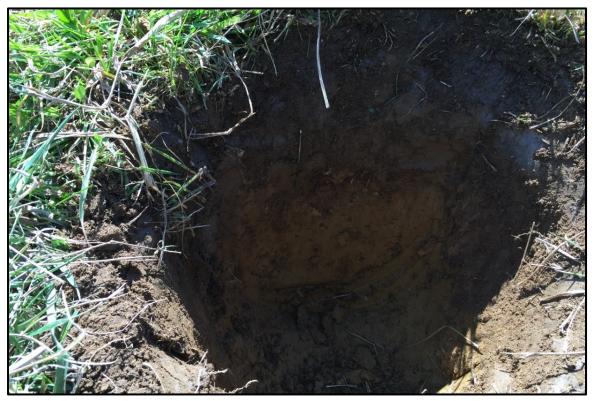
Figure 5.50. Shovel Test 273 at 31MA874.

The soils at 31MA874 are mapped as Dellwood gravelly fine sandy loam, 0–5% slopes (DgB), a moderately well-drained soil found on floodplains and derived from gravelly and cobbly alluvium (USDA NRCS 2021). Shovel tests encountered a 9–18 cm thick plowzone (Ap horizon) of dark yellowish brown (10YR 4/4) silt loam overlying brownish yellow (10YR 6/8) clay loam (Figure 5.50).

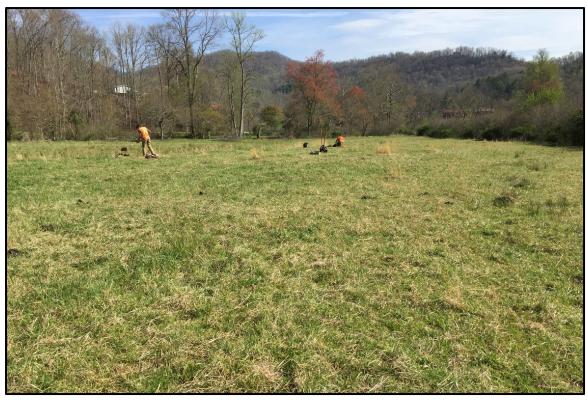
Figure 5.52. Site 31MA875, facing north.

<u>Description</u>. Site 31MA875 is a low-density, nondiagnostic lithic site located on a low rise on the terrace east of Jones Creek and south of Allison Watts Road (Figures 5.51 and 5.52; see Figure 5.11). The site is bounded to the north, east, and west by seasonal wetlands, while the southern boundary is defined by shovel tests.

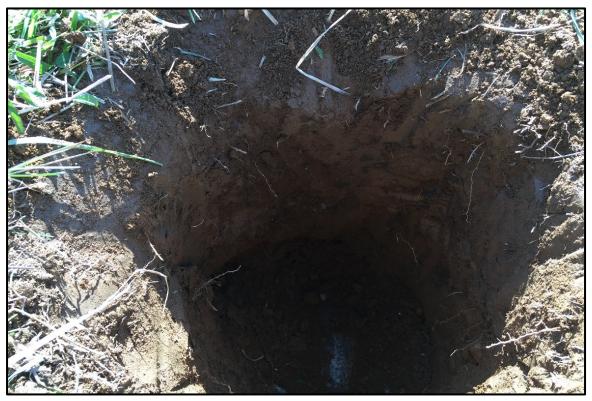
Figure 5.53. Shovel Test 388 at 31MA875.

The soils at 31MA875 are mapped as Dellwood gravelly fine sandy loam, 0–5% slopes (DgB). Shovel tests on the low rise encountered a 20–25 cm thick plowzone of dark brown (10YR 3/3) or brown (10YR 4/3) silt loam that overlay strong brown (7.5YR 4/6) or dark yellowish brown (10YR 4/6) sandy clay loam (Figure 5.53). Some tests encountered cobbles within the B horizon, and some tests along the landform margins encountered strong brown gravelly sand and gravels below the shallow plowzone.

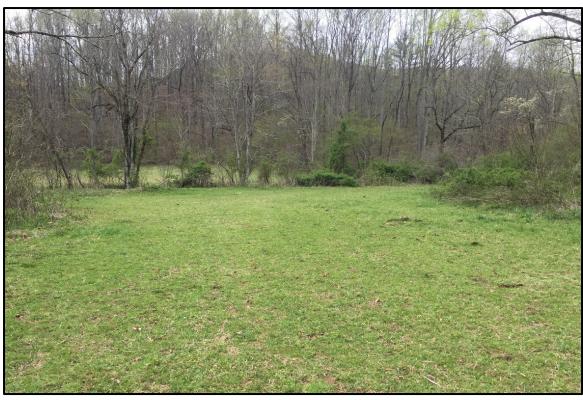
Figure 5.55. Site 31MA876, facing southwest.

<u>Description</u>. Site 31MA876 is a low-density precontact site with a Middle Archaic component situated on a stream terrace near the confluence of two branches of Jones Creek, south of Allison Watts Road (Figures 5.54 and 5.55; see Figure 5.11). The site is bounded to the north by negative shovel tests and upland slope, and to the south, east, and west by the stream channels.

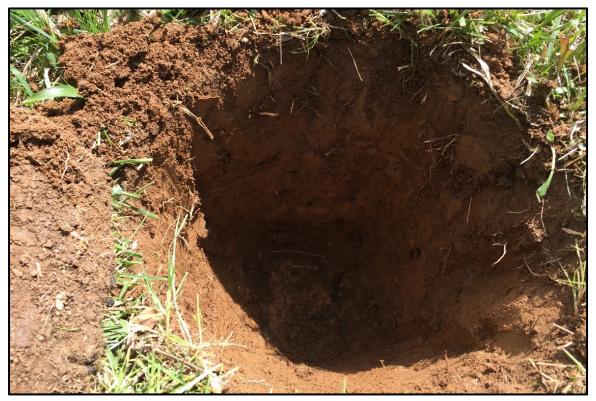
Figure 5.56. Shovel Test 397 at 31MA876.

The soil type at 31MA876 is mapped as Dellwood gravelly fine sandy loam, 0–5% slopes (DgB) (USDA NRCS 2021). Soil sequences varied within the site area, but most shovel tests encountered a 20–30 cm thick plowzone of brown (7.5YR 4/3) sandy loam that overlay semi-hydric, interlayered strong brown (7.5YR 4/6) and brown (7.5YR 4/3) sandy clay loam (Figure 5.56). Some tests near the stream banks encountered a cobbly upper stratum overlying hydric, grayish brown (10YR 5/2) clay loam.

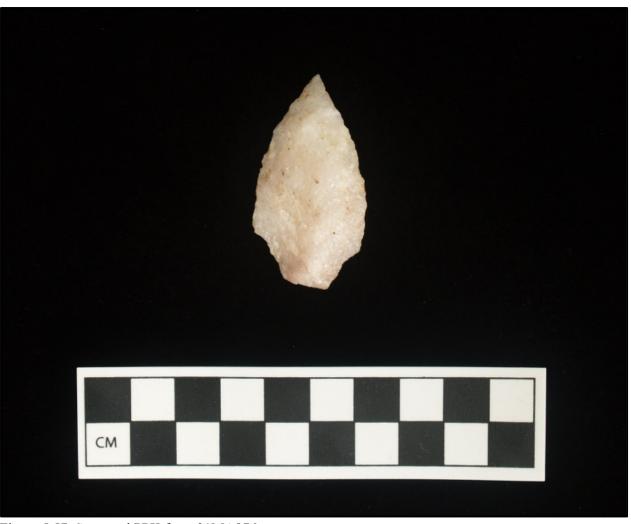
Figure 5.57. Stemmed PPK from 31MA876. ST 392

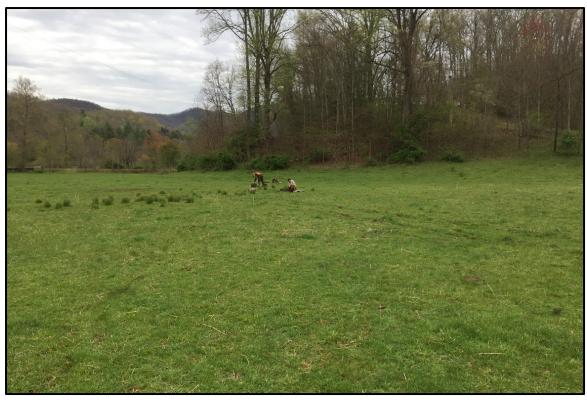
Figure 5.59. Site 31MA877, facing south.

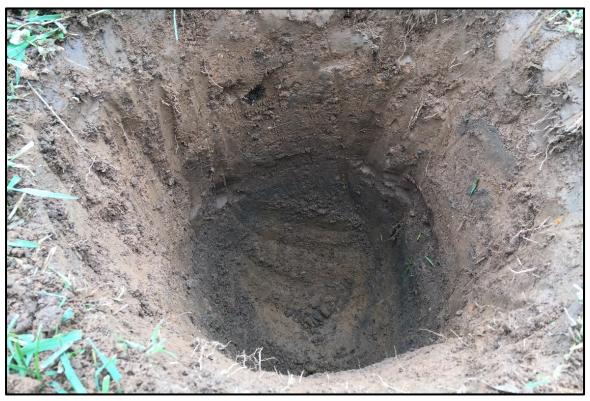
Figure 5.60. Shovel Test 425 at 31MA877.

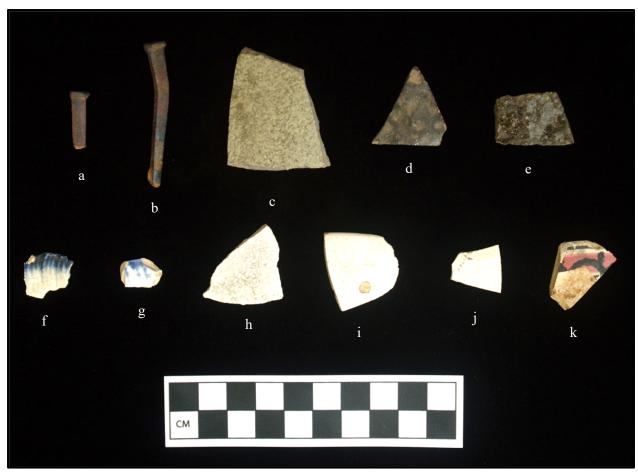
Figure 5.61. Selected postcontact (historic period) artifacts from 31MA877. a: cut nail, ST 425; b: cut nail, ST 354; c: salt glazed stoneware, ST 361; d: alkaline glazed stoneware, ST 413; e: alkaline glazed stoneware, ST 421; f: blue molded shell edge refined earthenware, ST 422; g: blue edged whiteware, ST 420; h: undecorated whiteware, ST 354; i–j: undecorated whiteware, ST 413; k: handpainted whiteware, ST 421
