**CUTAWHISKIE CREEK STREAM AND WETLAND RESTORATION SITE  
2008 ANNUAL MONITORING REPORT (YEAR-1)**

**HERTFORD COUNTY, NORTH CAROLINA  
NCEEP CONTRACT NO. D06066-A**

**SITE LOCATION  
CUTAWHISKIE CREEK  
RESTORATION SITE  
MONITORING REPORT  
YEAR-1**

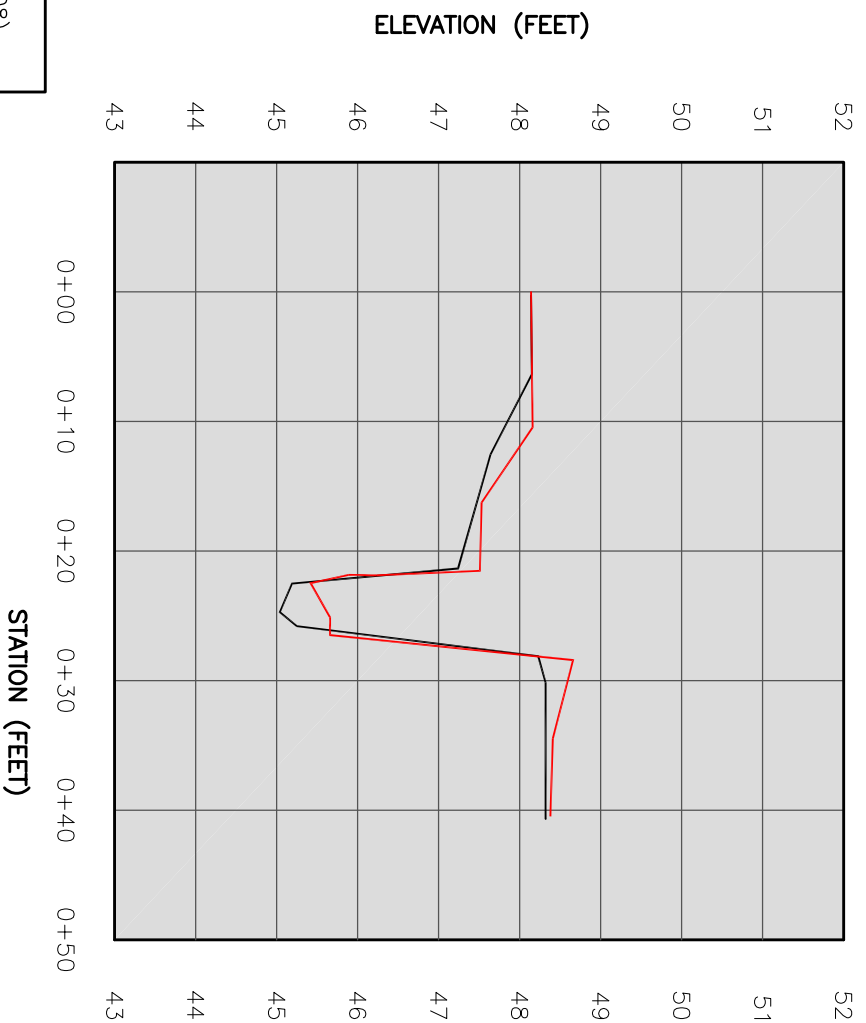
**XS1 (Pool)**

AS-BUILT SURVEY  
YEAR-1 SURVEY (2008)

BANKFULL CROSS SECTIONAL AREA	18.9 SQ. FT.
BANKFULL WIDTH	17.4 FT.
BANKFULL MEAN DEPTH	1.1 FT.
BANKFULL MAX DEPTH	2.7 FT.
WIDTH-DEPTH RATIO	15.9
ENTRENCHMENT RATIO	8.6
CLASSIFICATION	N/A

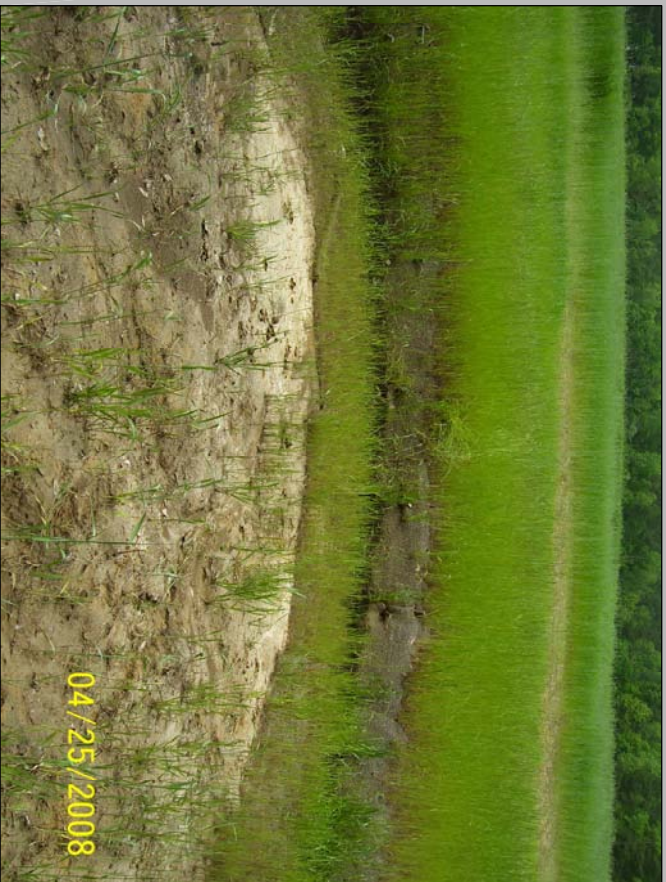
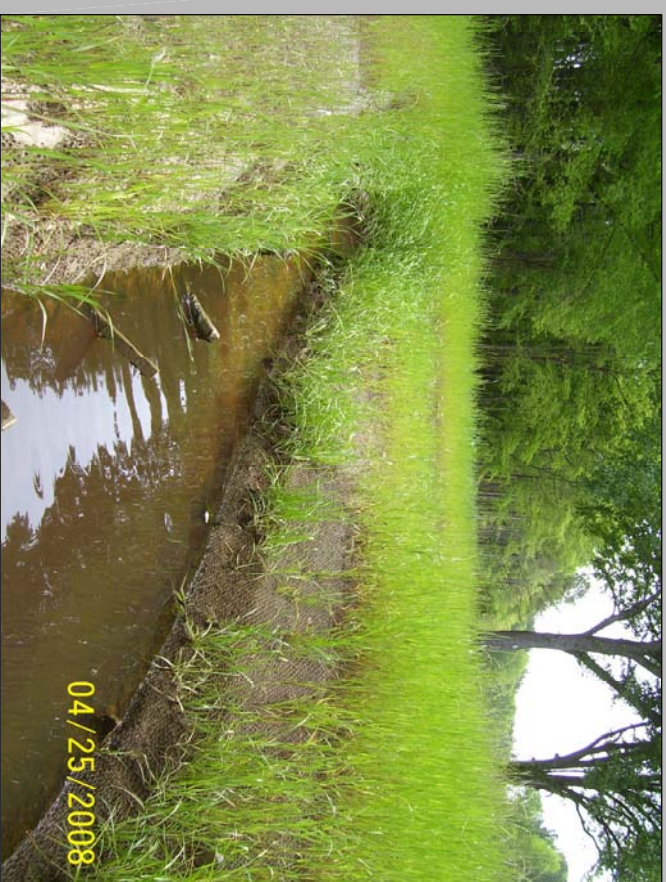
XS1 LEFT BANK LOOKING RIGHT BANK

XS1 LOOKING DOWNSTREAM

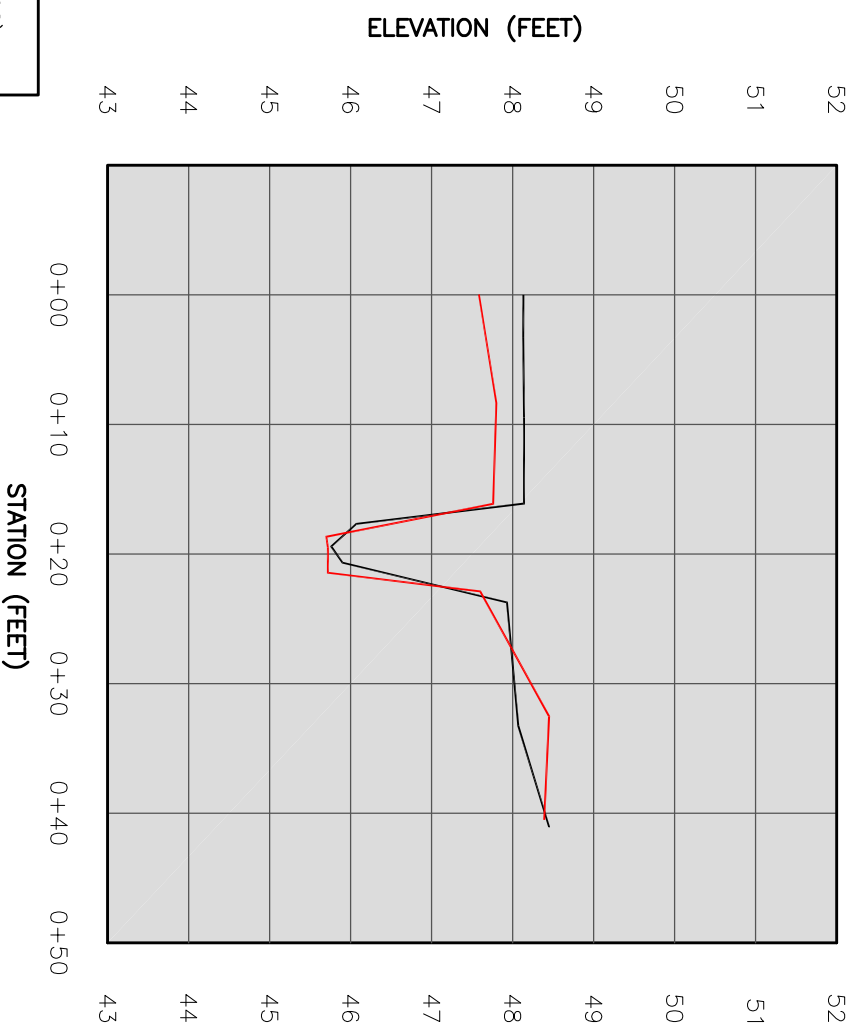
**XS2 (Riffle)**

AS-BUILT SURVEY  
YEAR-1 SURVEY (2008)

BANKFULL CROSS SECTIONAL AREA	9.0 SQ. FT.
BANKFULL WIDTH	9.1 FT.
BANKFULL MEAN DEPTH	1.0 FT
BANKFULL MAX DEPTH	1.9 FT
WIDTH-DEPTH RATIO	9.2
ENTRENCHMENT RATIO	16.5
CLASSIFICATION	E5

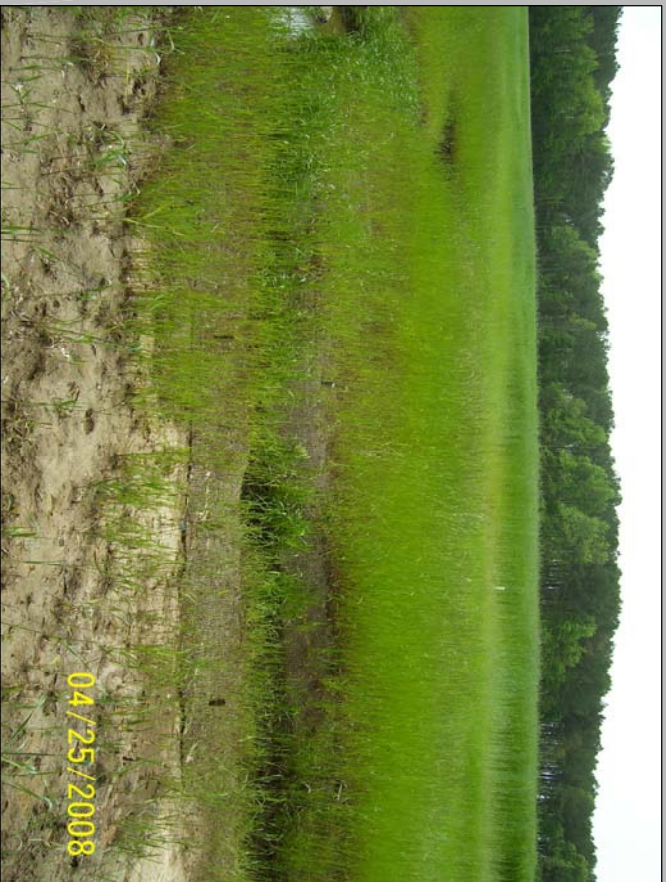
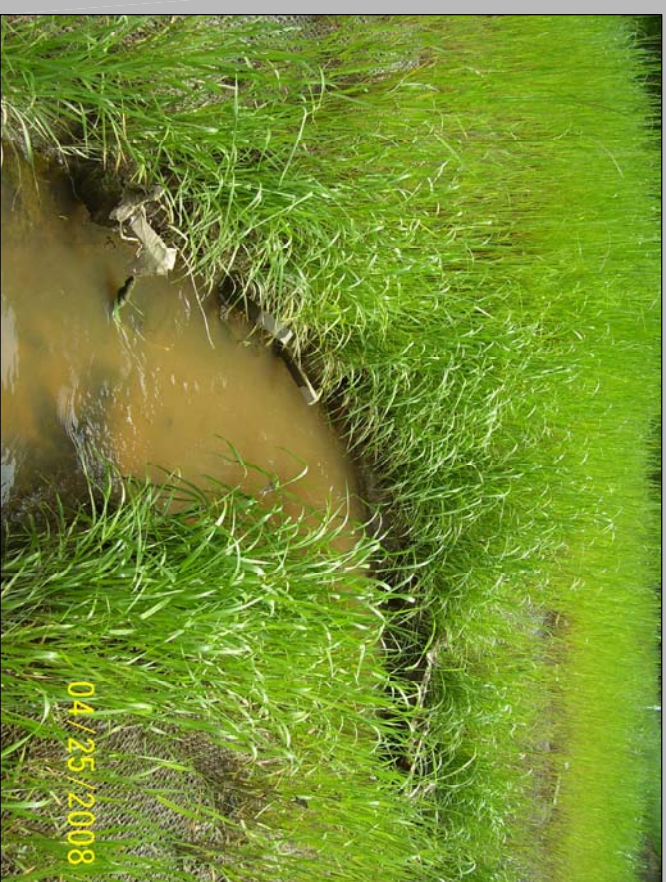
XS2 LEFT BANK LOOKING RIGHT BANK

XS2 LOOKING DOWNSTREAM

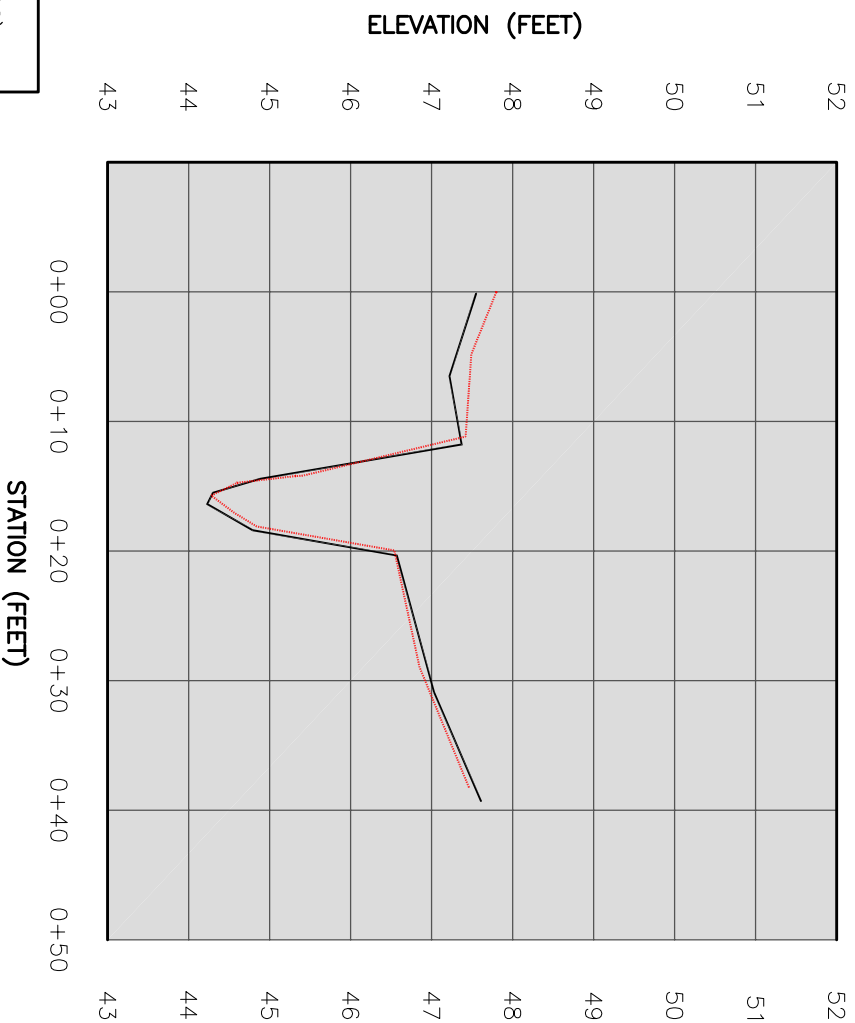
**XS3 (Pool)**

AS-BUILT SURVEY  
YEAR-1 SURVEY (2008)

BANKFULL CROSS SECTIONAL AREA	26.4 SQ. FT.
BANKFULL WIDTH	26.9 FT.
BANKFULL MEAN DEPTH	1.0 FT.
BANKFULL MAX DEPTH	3.1 FT.
WIDTH-DEPTH RATIO	27.5
ENTRENCHMENT RATIO	5.6
CLASSIFICATION	N/A

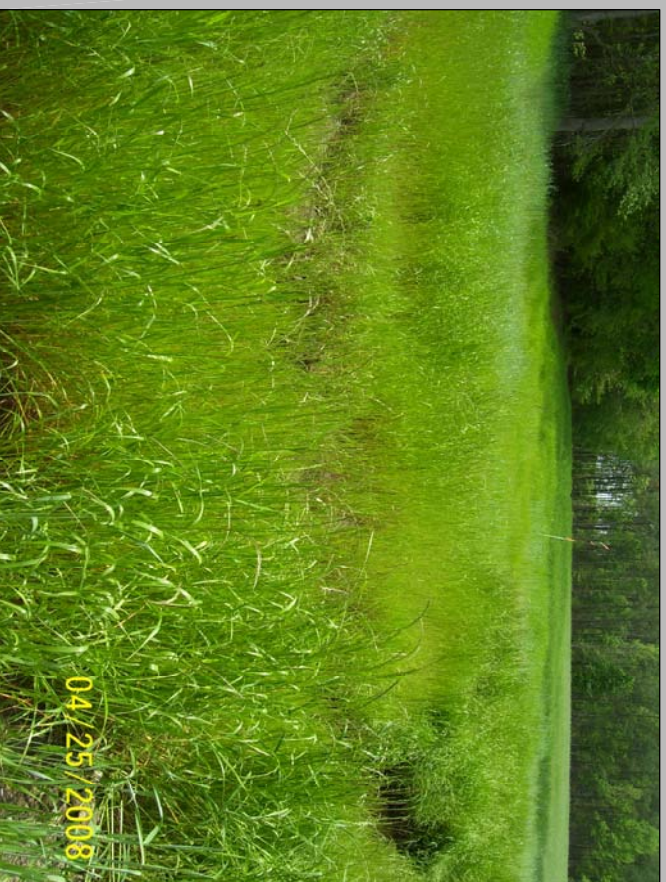
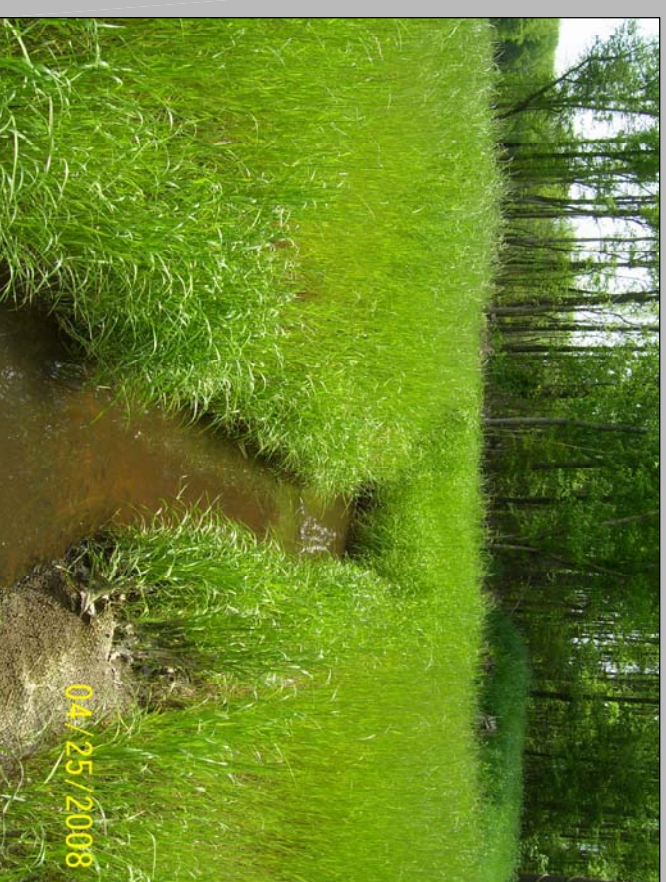
XS3 LEFT BANK LOOKING RIGHT BANK

XS3 LOOKING DOWNSTREAM

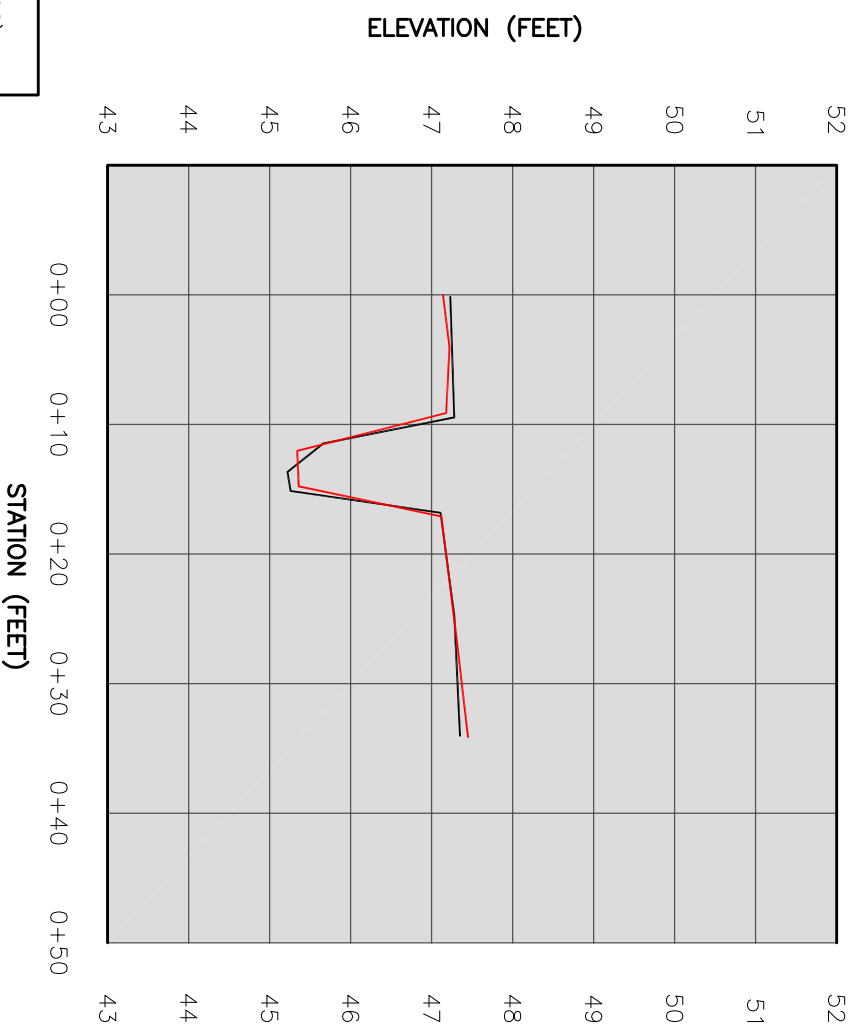
**XS4 (Riffle)**

AS-BUILT SURVEY  
YEAR-1 SURVEY (2008)

BANKFULL CROSS SECTIONAL AREA	9.4 SQ. FT.
BANKFULL WIDTH	7.9 FT.
BANKFULL MEAN DEPTH	1.2 FT.
BANKFULL MAX DEPTH	1.8 FT.
WIDTH-DEPTH RATIO	6.6
ENTRENCHMENT RATIO	19.0
CLASSIFICATION	E5

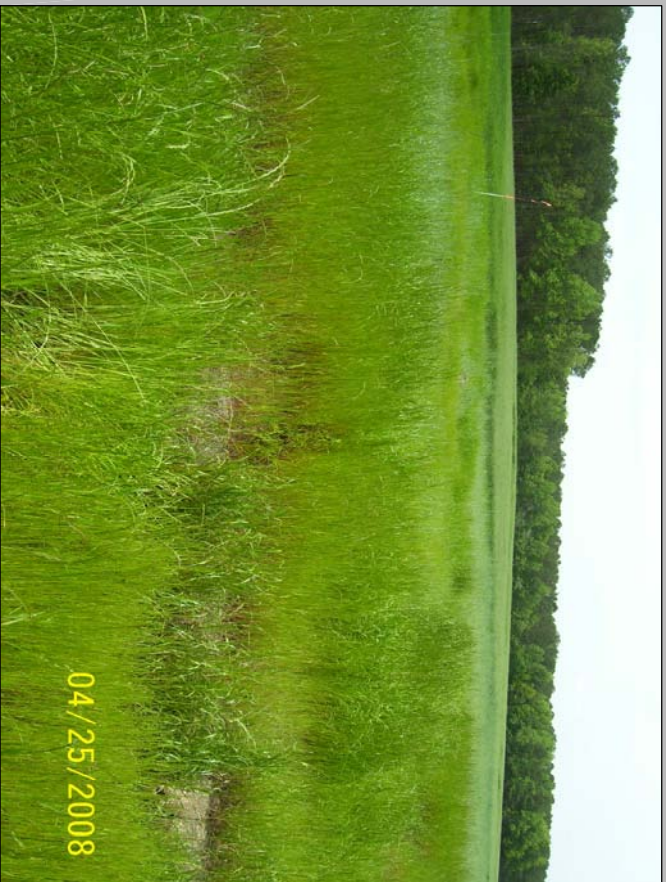
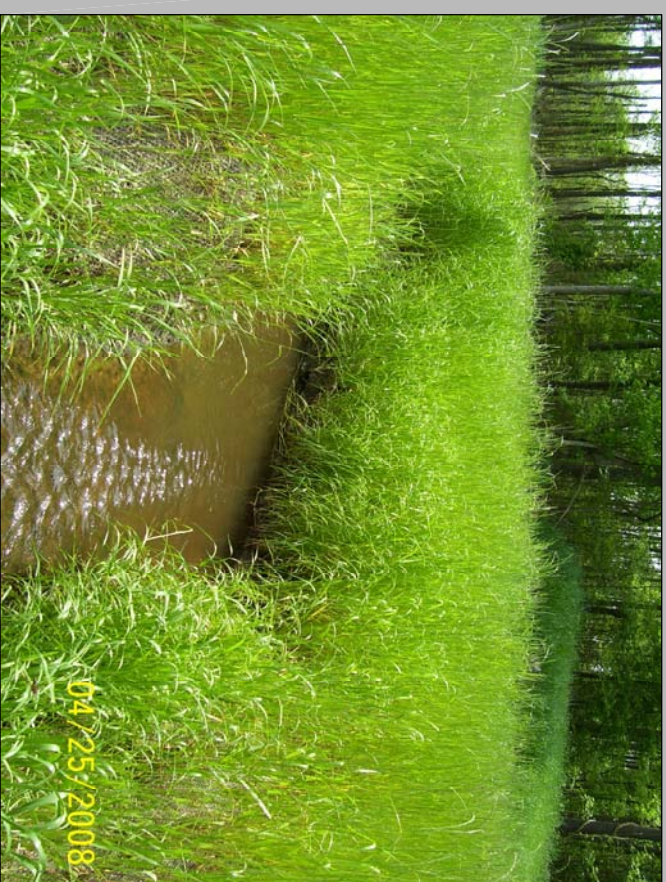
XS4 LEFT BANK LOOKING RIGHT BANK

XS4 LOOKING DOWNSTREAM

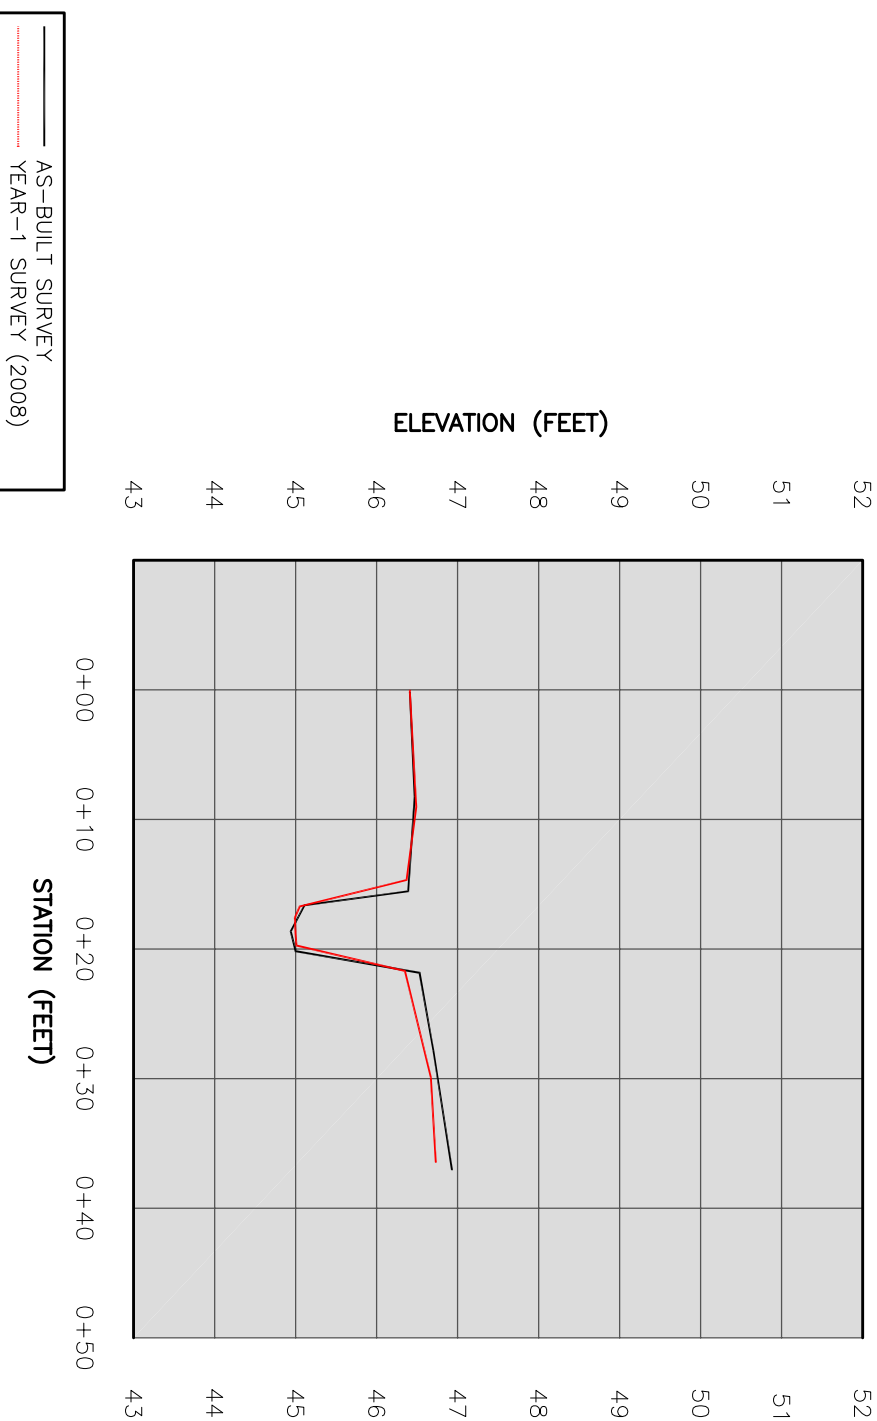
**XS5 (Riffle)**

STATION	ELEVATION	FEATURE	STATION	ELEVATION	FEATURE
0.00	46.36	LPIN			
0.28	46.36				
9.13	46.44				
14.77	46.32				
16.81	45.00				
17.69	44.94				
19.01	44.95				
19.82	44.96				
21.79	46.30				
29.99	46.62				
36.35	46.68				
36.98	46.83	RPIN

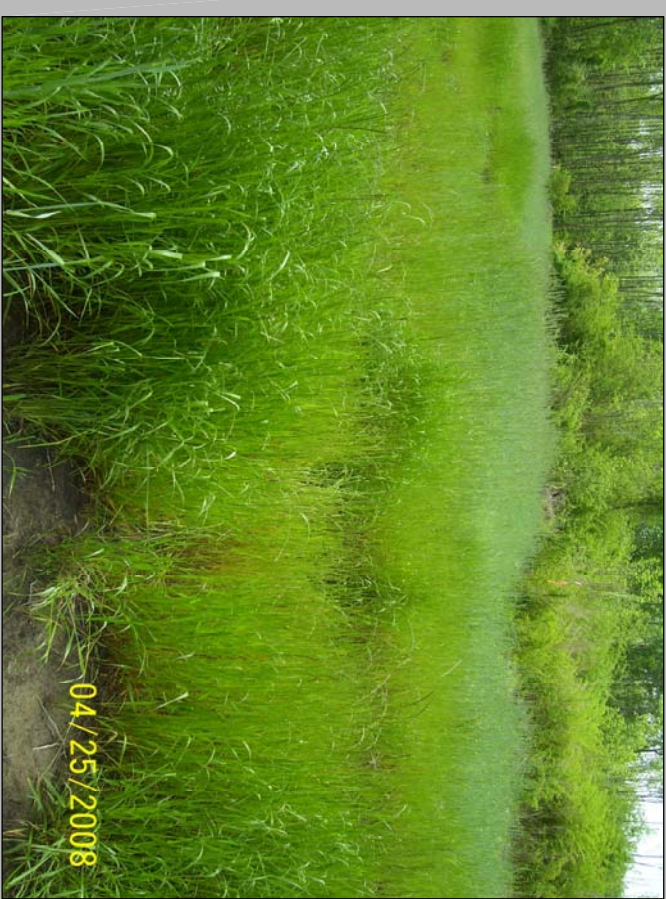
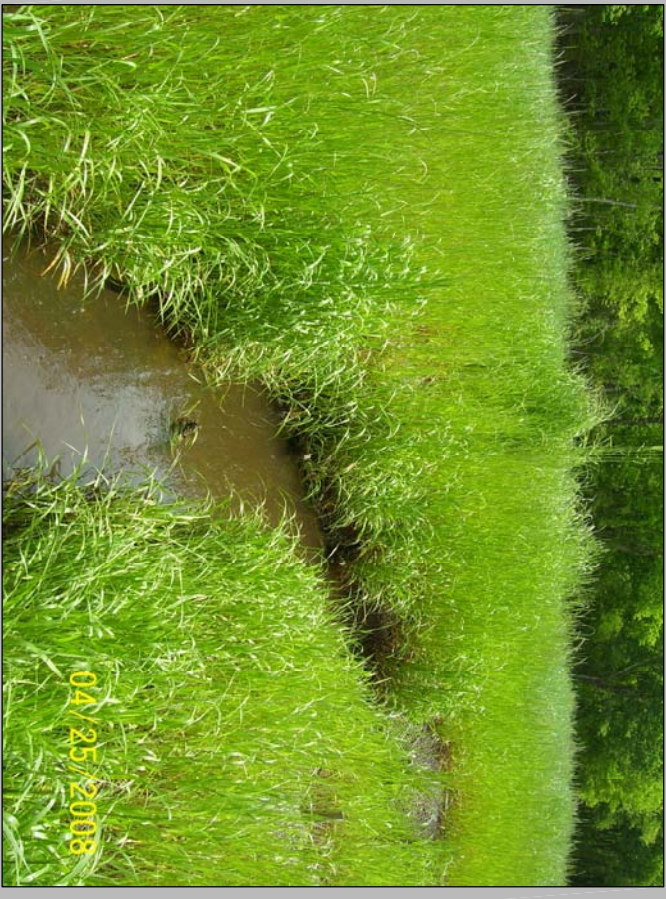
XS5 LEFT BANK LOOKING RIGHT BANK

XS5 LOOKING DOWNSTREAM

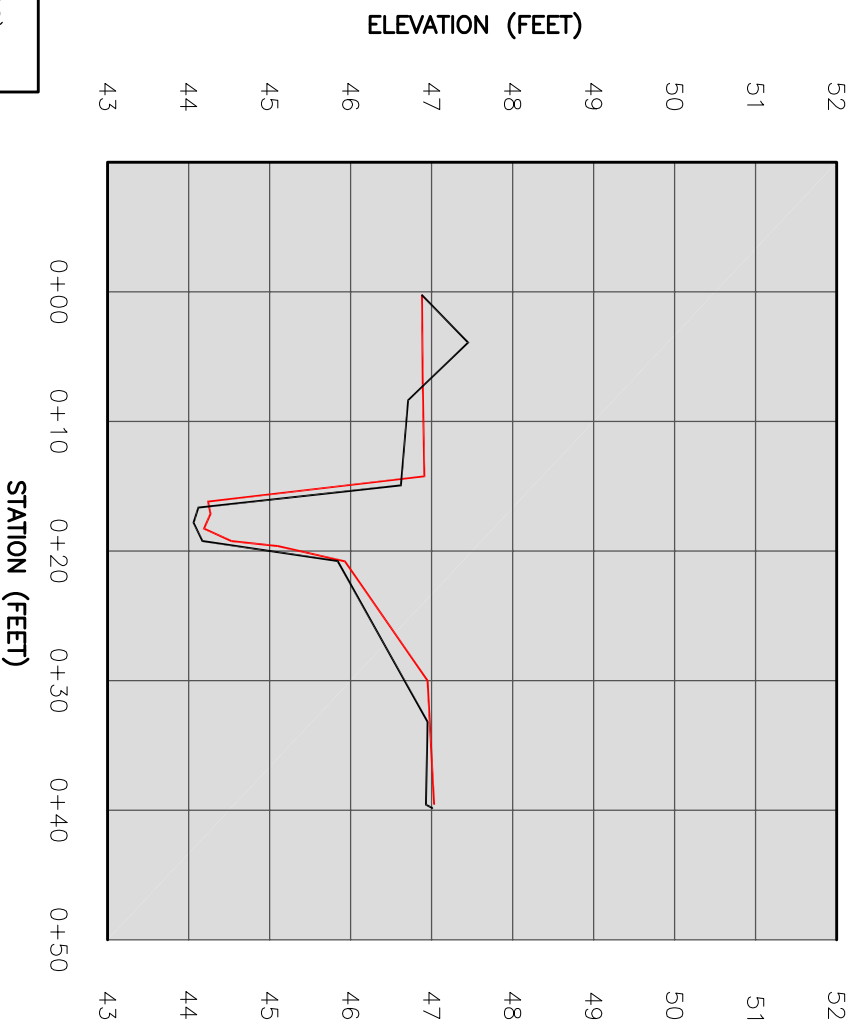
**XS6 (Pool)**

AS-BUILT SURVEY  
YEAR-1 SURVEY (2008)

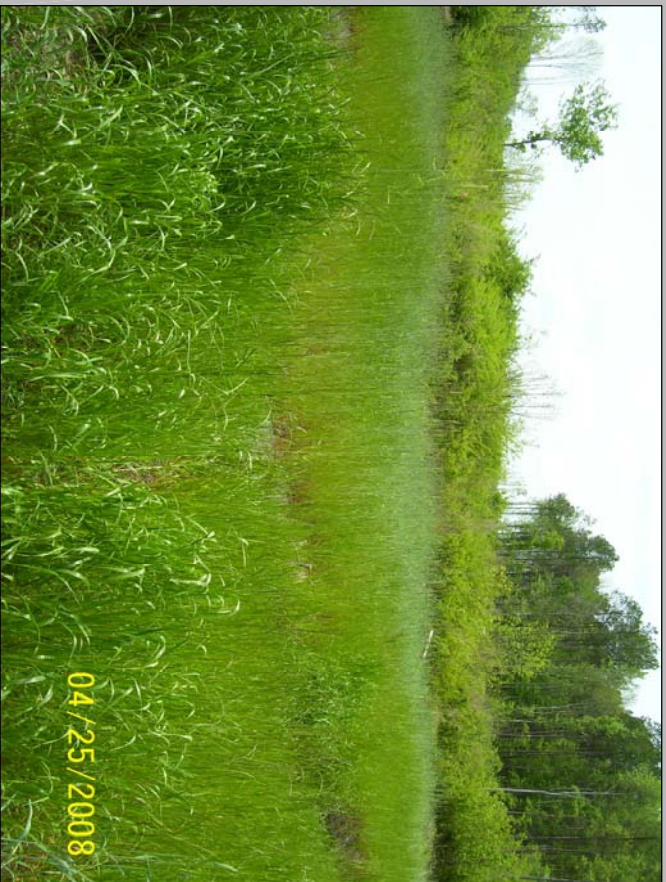
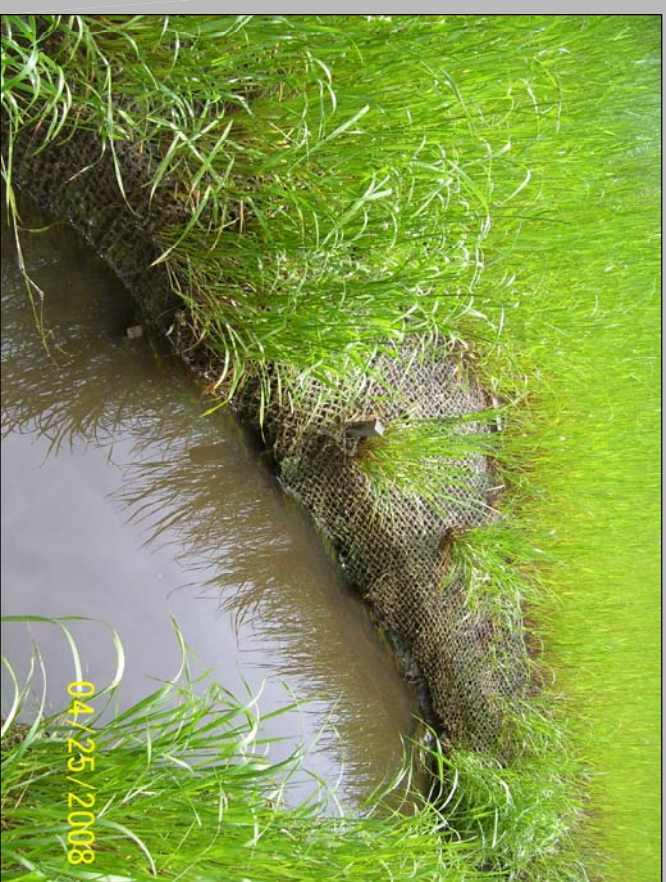
XS6 LEFT BANK LOOKING RIGHT BANK

XS6 LOOKING DOWNSTREAM

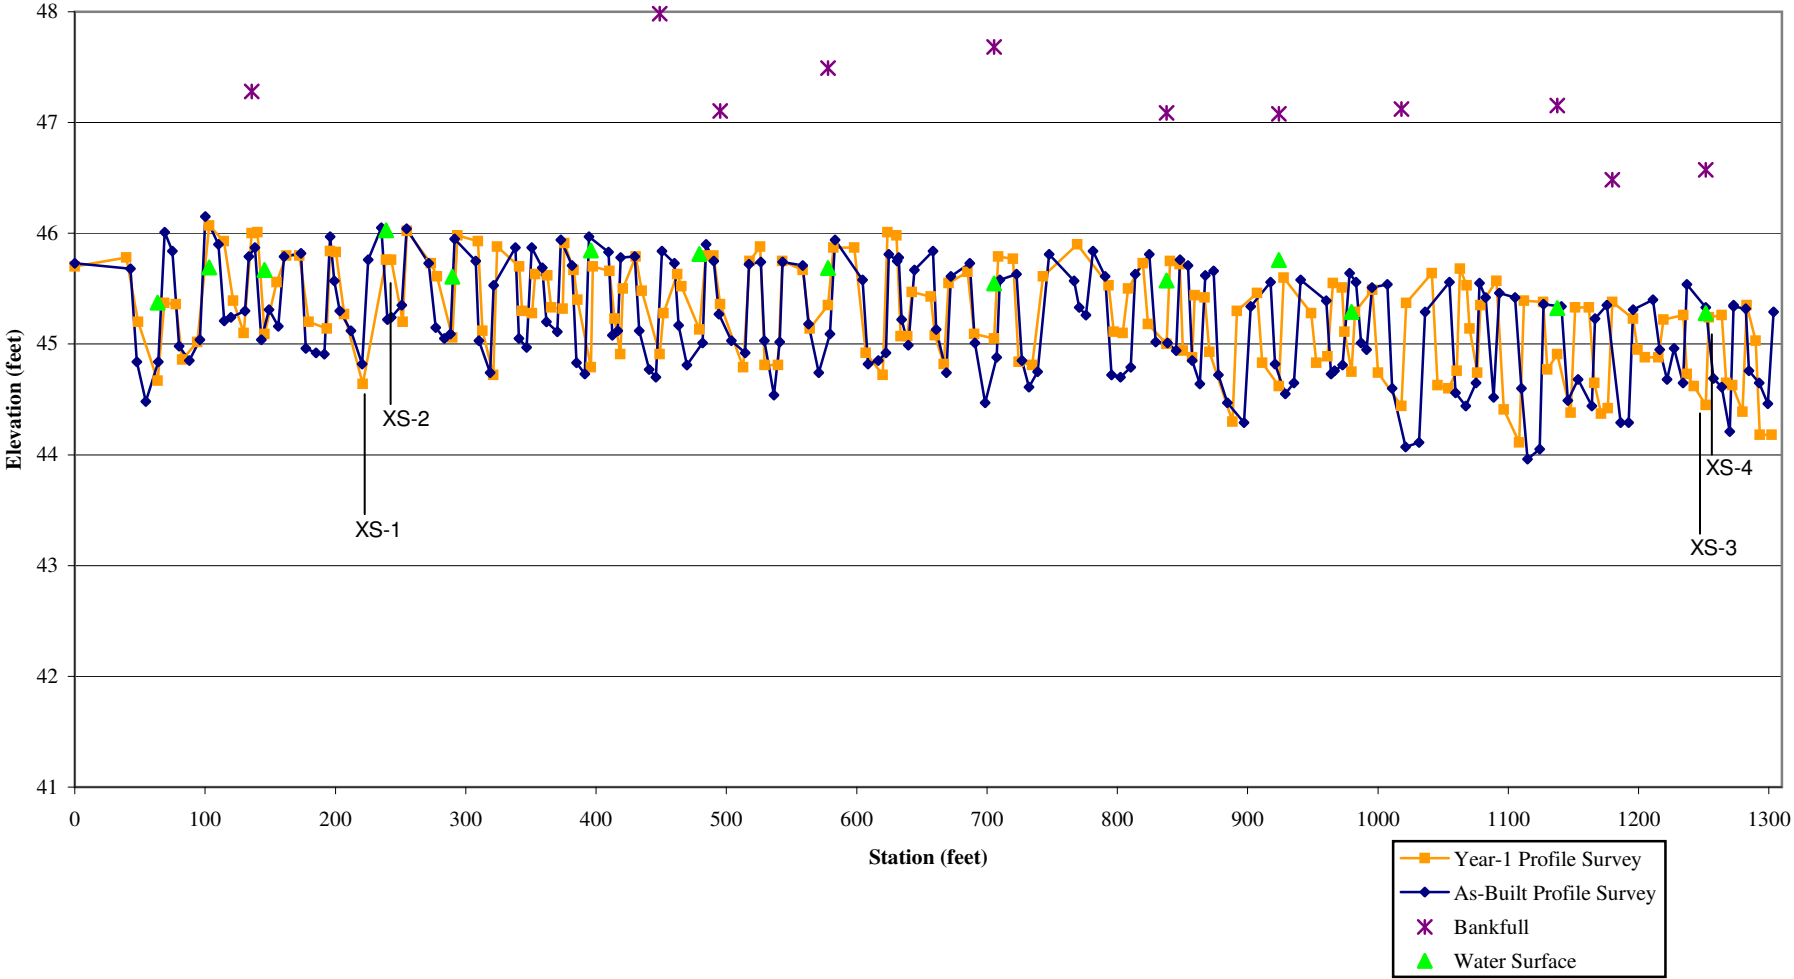
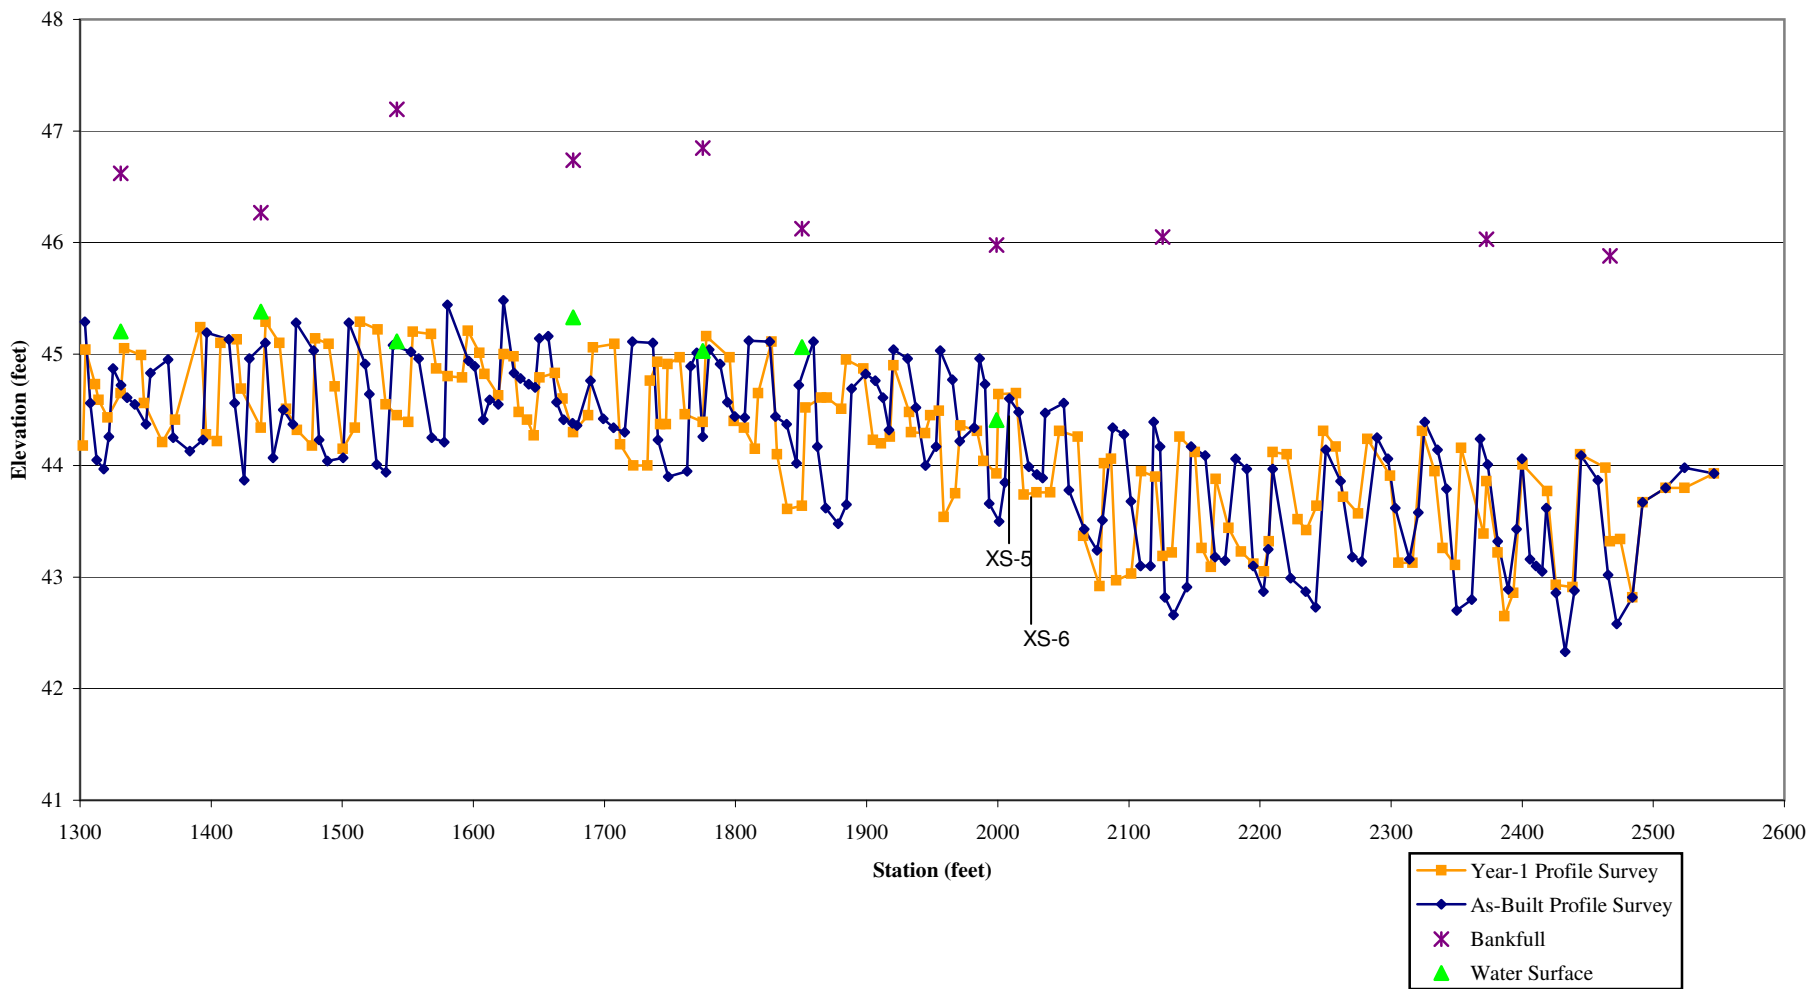
### Longitudinal Profile- Cutawhiskie Creek Year-1 Monitoring

To ensure stable bankfull dimension, pattern, and profile along the restored channel, annual stream assessment surveys were undertaken. A longitudinal profile along the entirety of the UT and six stream channel cross-sections were established and surveyed to monitor any potential instability and adverse changes in channel geometry (Integrated Problem Area Plan View [Appendix D] for cross-section locations). Profile and cross-section plots are located in Appendix C. Channel geomorphic data is summarized on Tables VIII and IX. Success criteria for stream restoration and Level 1 enhancement will include 1) successful classification of the reach as a functioning system (Rosgen 1996) and 2) channel stability indicative of a stable stream system. No stream problem areas were identified during Year-1 monitoring.

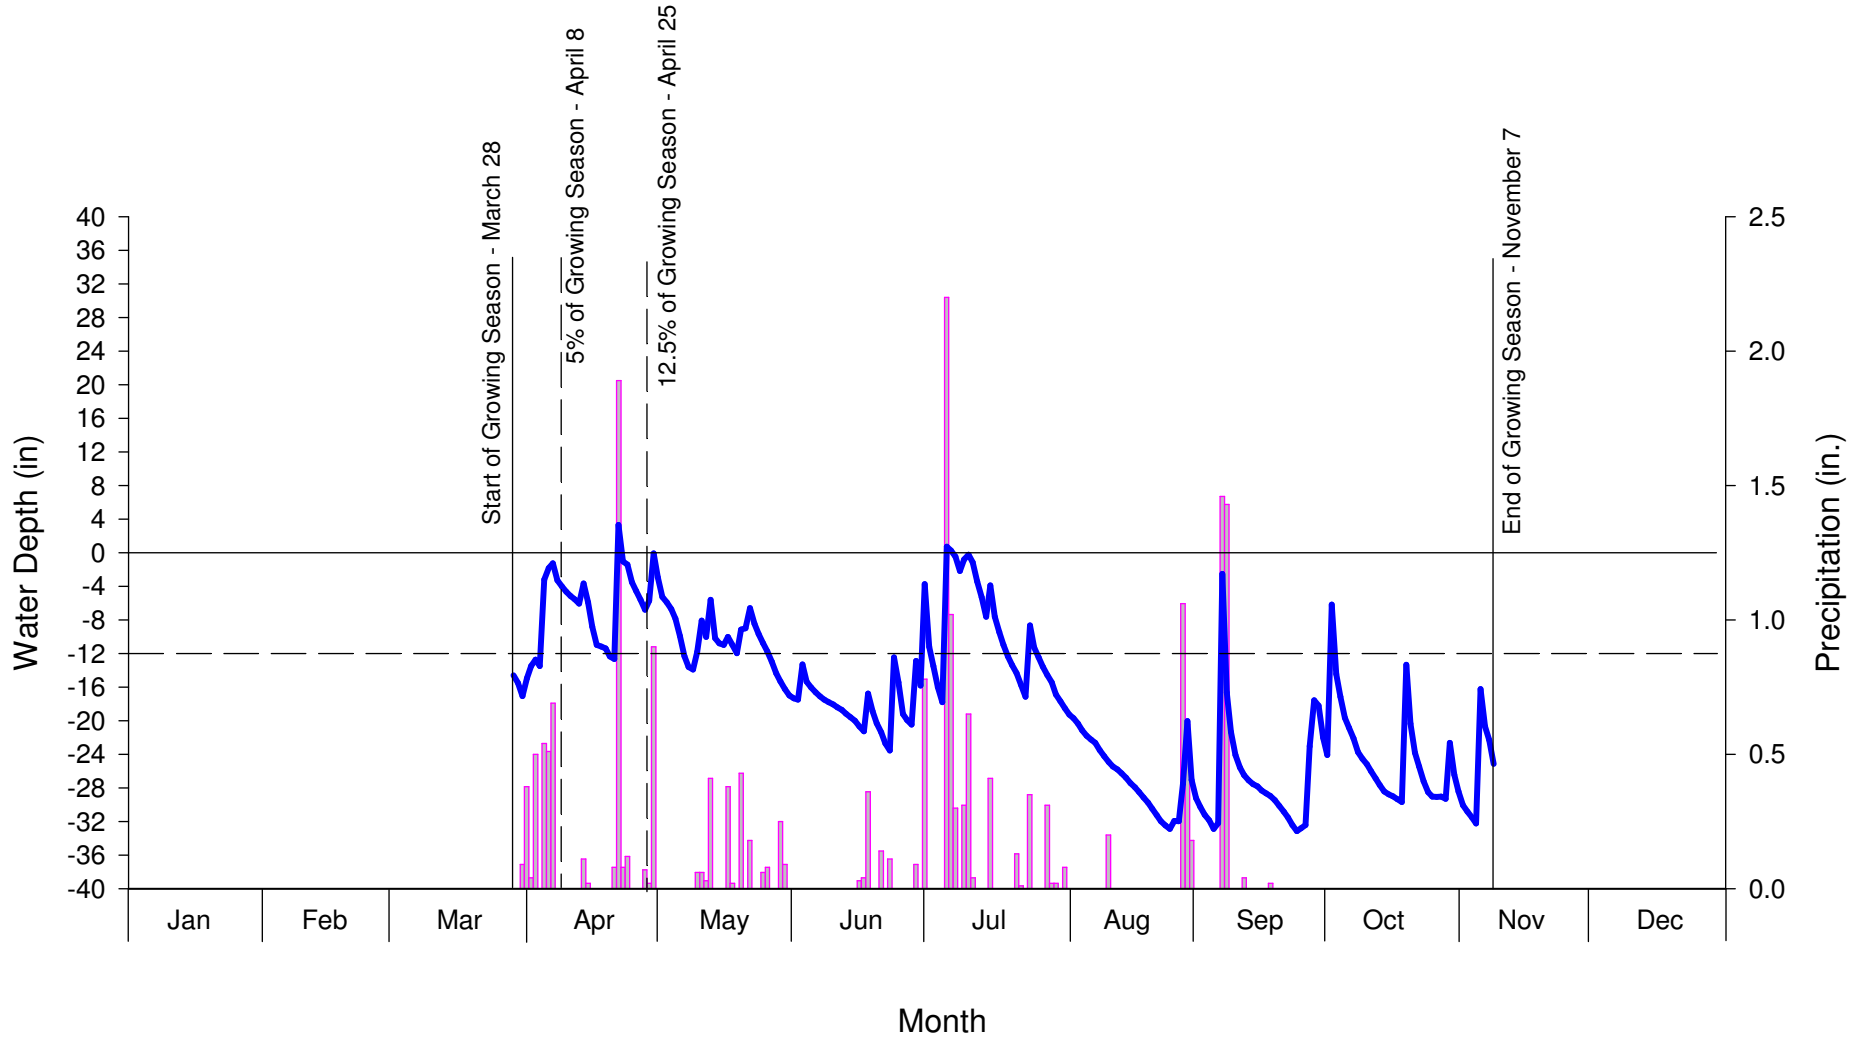
# Cutawhiskie Creek Year-1 Monitoring - 2008 Monitoring Gauge 1: N47BAC28

The 2008 hydrologic monitoring results indicate moderate hydrologic success within the Site. Two of the on-Site gauges (Gauges 3 and 4) exhibited saturation within 12 inches of the ground surface for at least 12.5 percent (consecutive days) of the growing season (March 28 – November 7 or 225 days). Gauges 1, 2, and 5 exhibited saturation within 12 inches of the ground surface for 5 to 12.5 percent of the growing

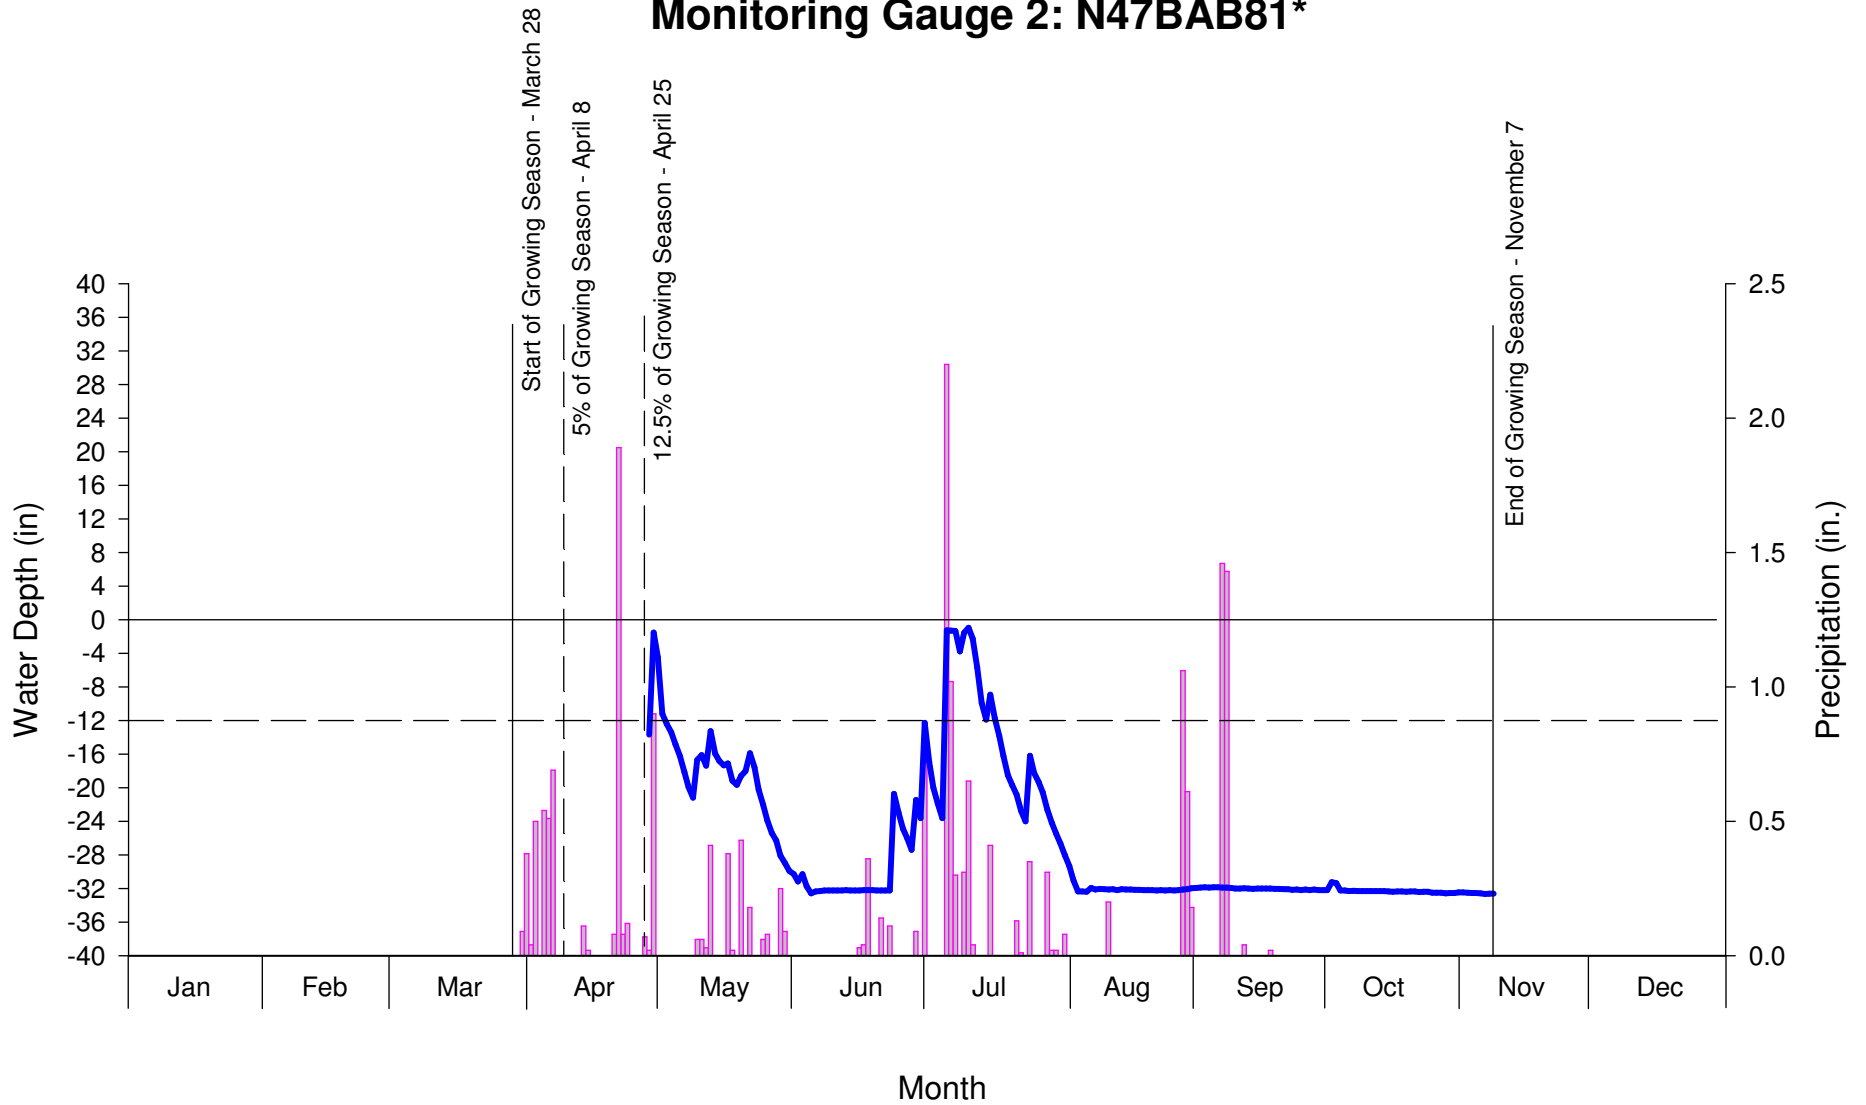
# Cutawhiskie Creek Year-1 Monitoring - 2008 Monitoring Gauge 2: N47BAB81\*

\* Gauge installed April 28, 2008
