**CUTAWHISKIE CREEK STREAM AND WETLAND RESTORATION SITE  
2008 ANNUAL MONITORING REPORT (YEAR-1)**

**HERTFORD COUNTY, NORTH CAROLINA  
NCEEP CONTRACT NO. D06066-A**

**SITE LOCATION  
CUTAWHISKIE CREEK  
RESTORATION SITE  
MONITORING REPORT  
YEAR-1**

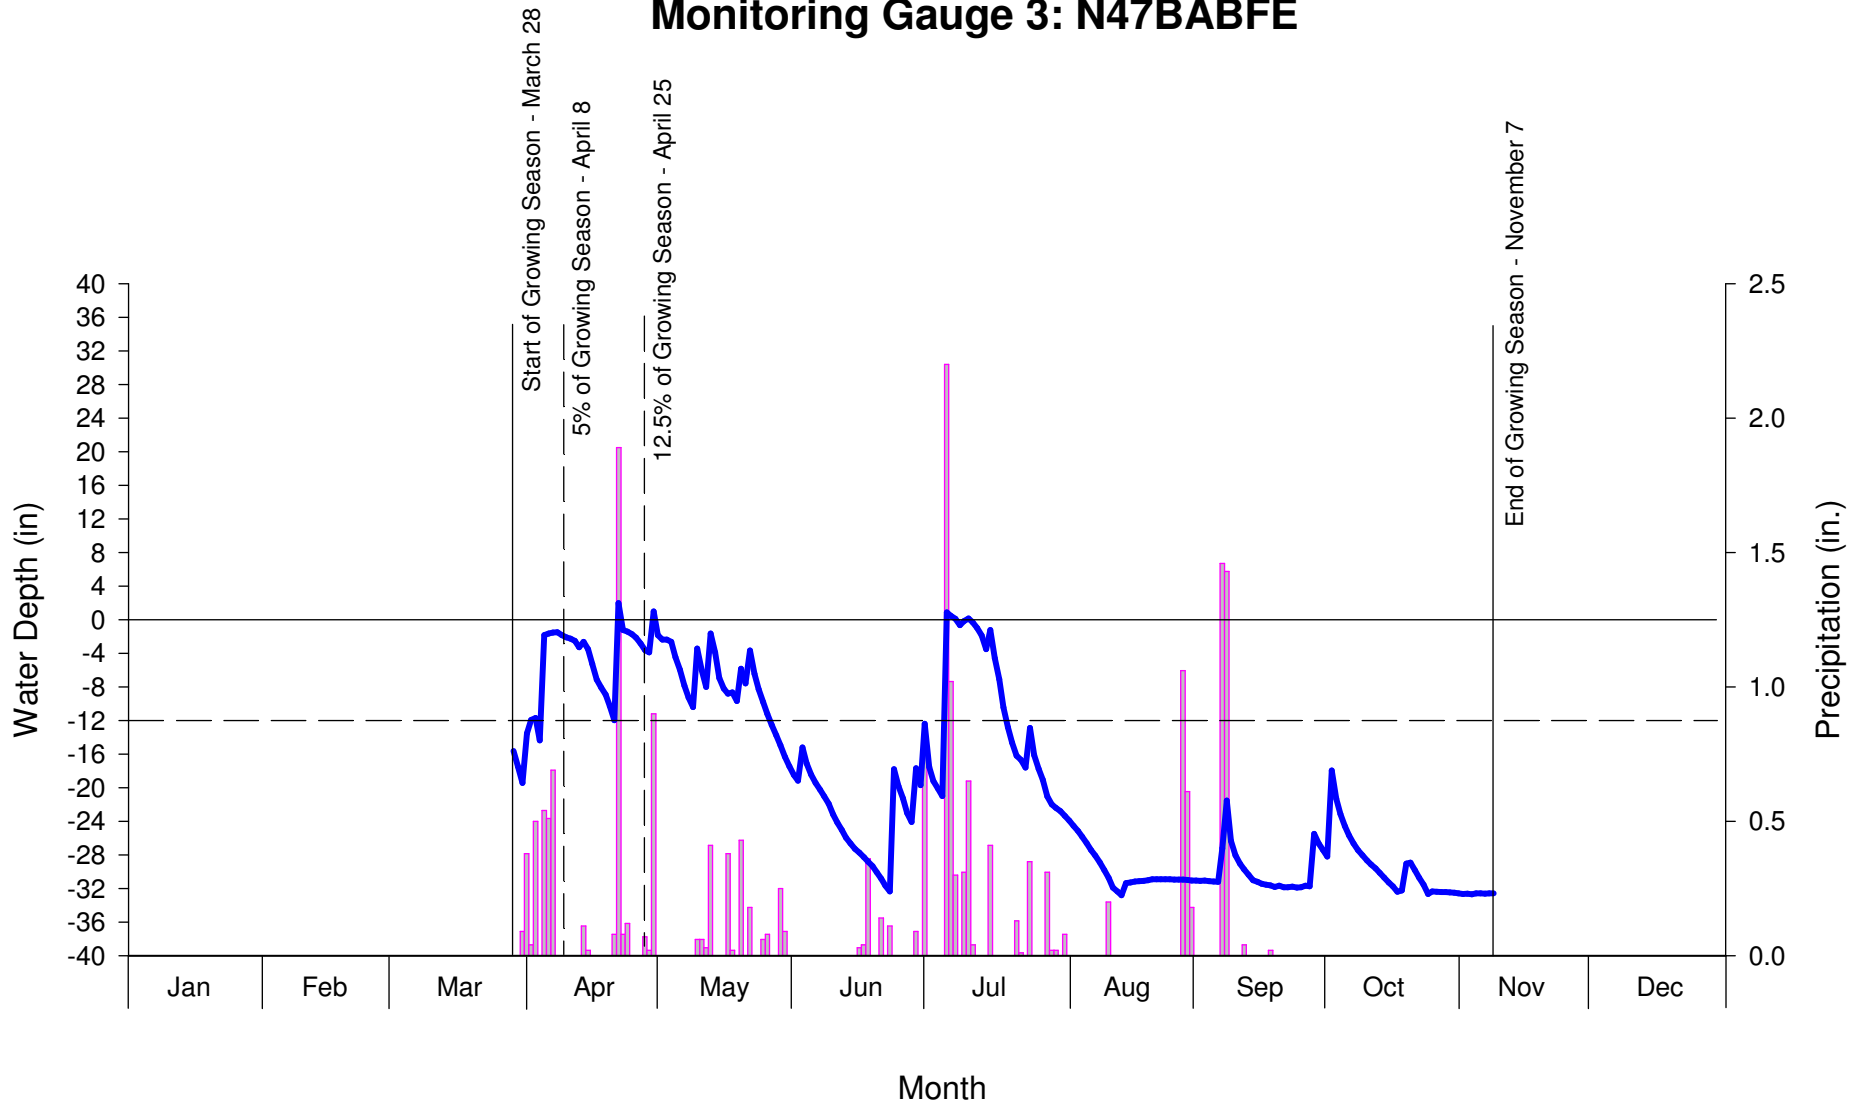
# Cutawhiskie Creek Year-1 Monitoring - 2008 Monitoring Gauge 3: N47BABFE

The 2008 hydrologic monitoring results indicate moderate hydrologic success within the Site. Two of the on-Site gauges (Gauges 3 and 4) exhibited saturation within 12 inches of the ground surface for at least 12.5 percent (consecutive days) of the growing season (March 28 – November 7 or 225 days). Gauges 1, 2, and 5 exhibited saturation within 12 inches of the ground surface for 5 to 12.5 percent of the growing

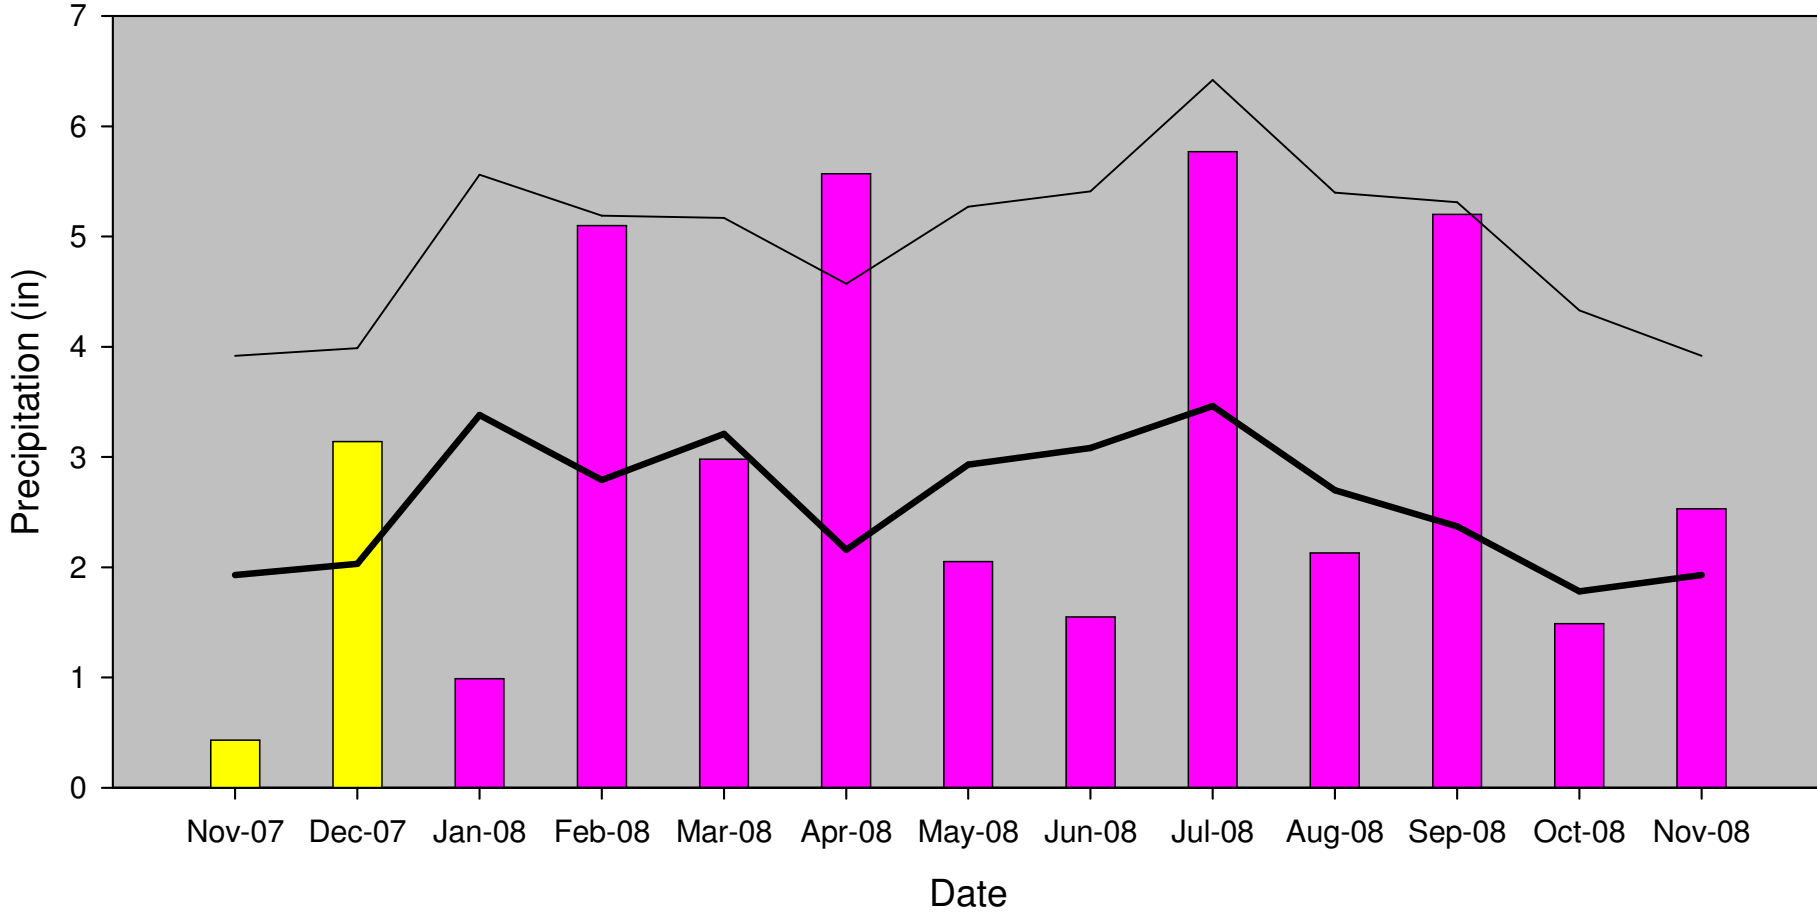
### Figure 3. Cutawhiskie Creek 2008 Precipitation Graph Hertford County, NC

season. Drought conditions throughout the monitoring period likely contributed to the lower than expected hydrologic saturation periods. Data obtained from the North Carolina Drought Management Advisory Council indicates that drought conditions have persisted within Hertford County almost continuously since on-Site construction in November 2007. Figure 3 (Appendix C) shows the monthly precipitation in Hertford County during 2008 compared to the historic monthly rainfall. Figure 4 (Appendix C) displays drought conditions in North Carolina during Year-1 monitoring and shows the progression of drought intensity in the Cutawhiskie Creek watershed.

Data Sources:  
Monthly Precipitation- State Climate Office of NC (CRONOS database [online])  
30-70 Percentile-NRCS National Water and Climate Center (online)

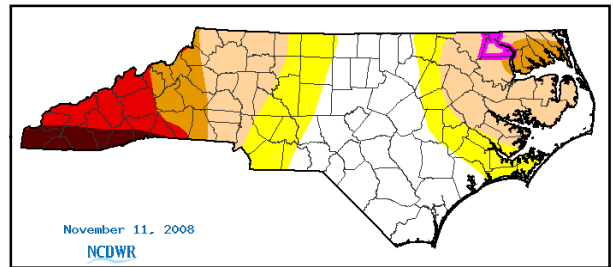
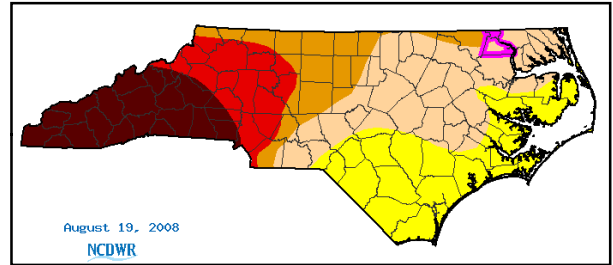
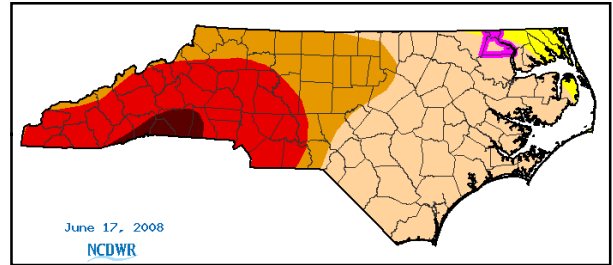
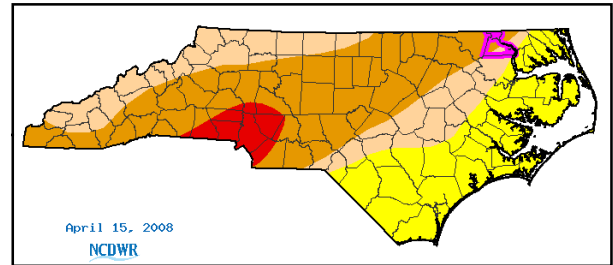
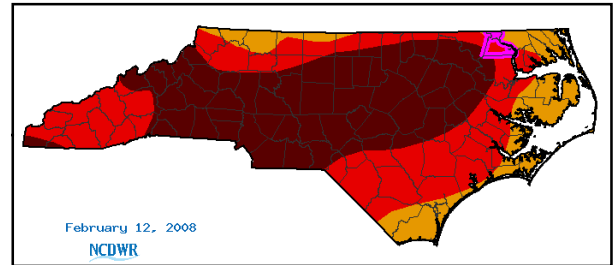
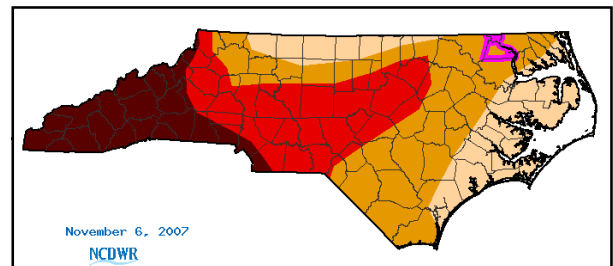
FIGURE  
**4**

**North Carolina  
Drought Monitor Data**  
Cutawhiskie Creek Stream  
and Wetland Restoration Site  
Hertford County, North Carolina

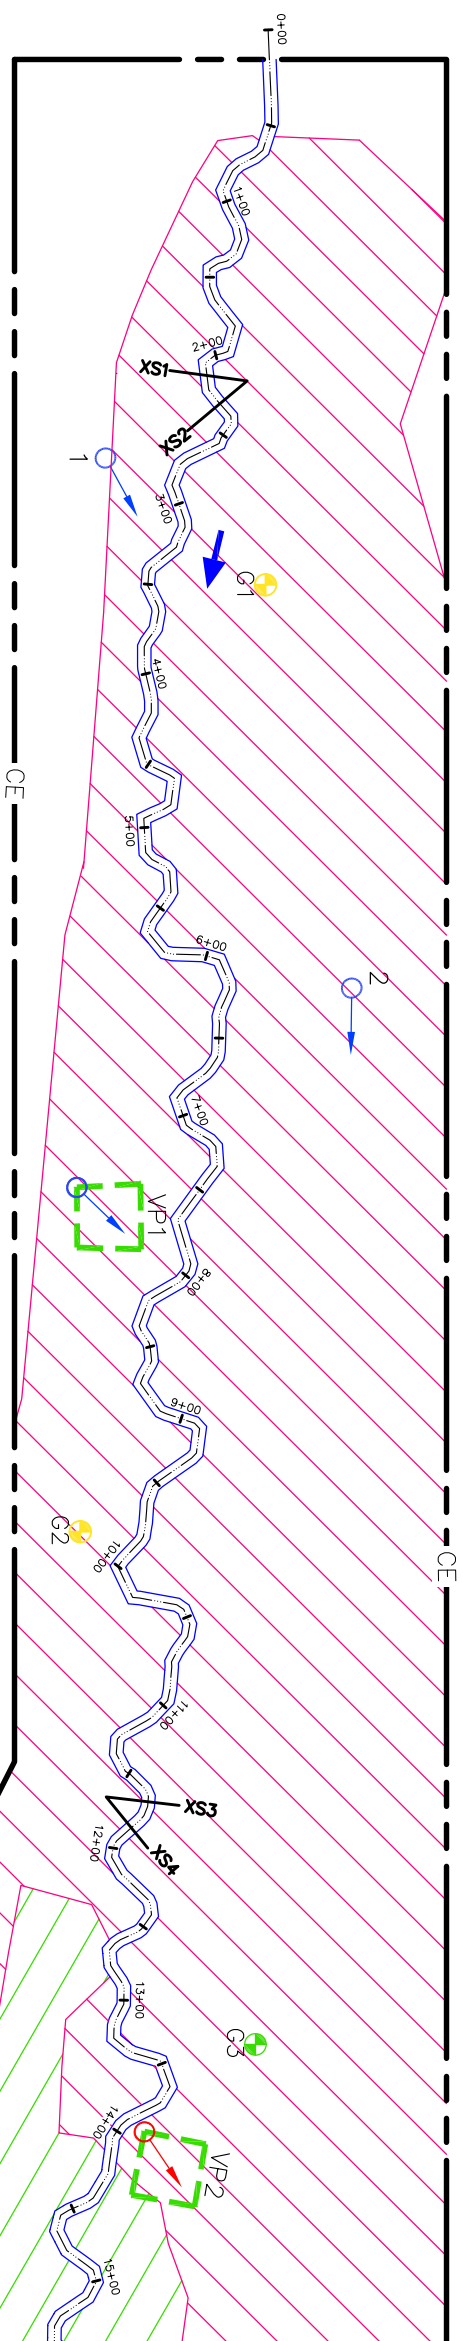
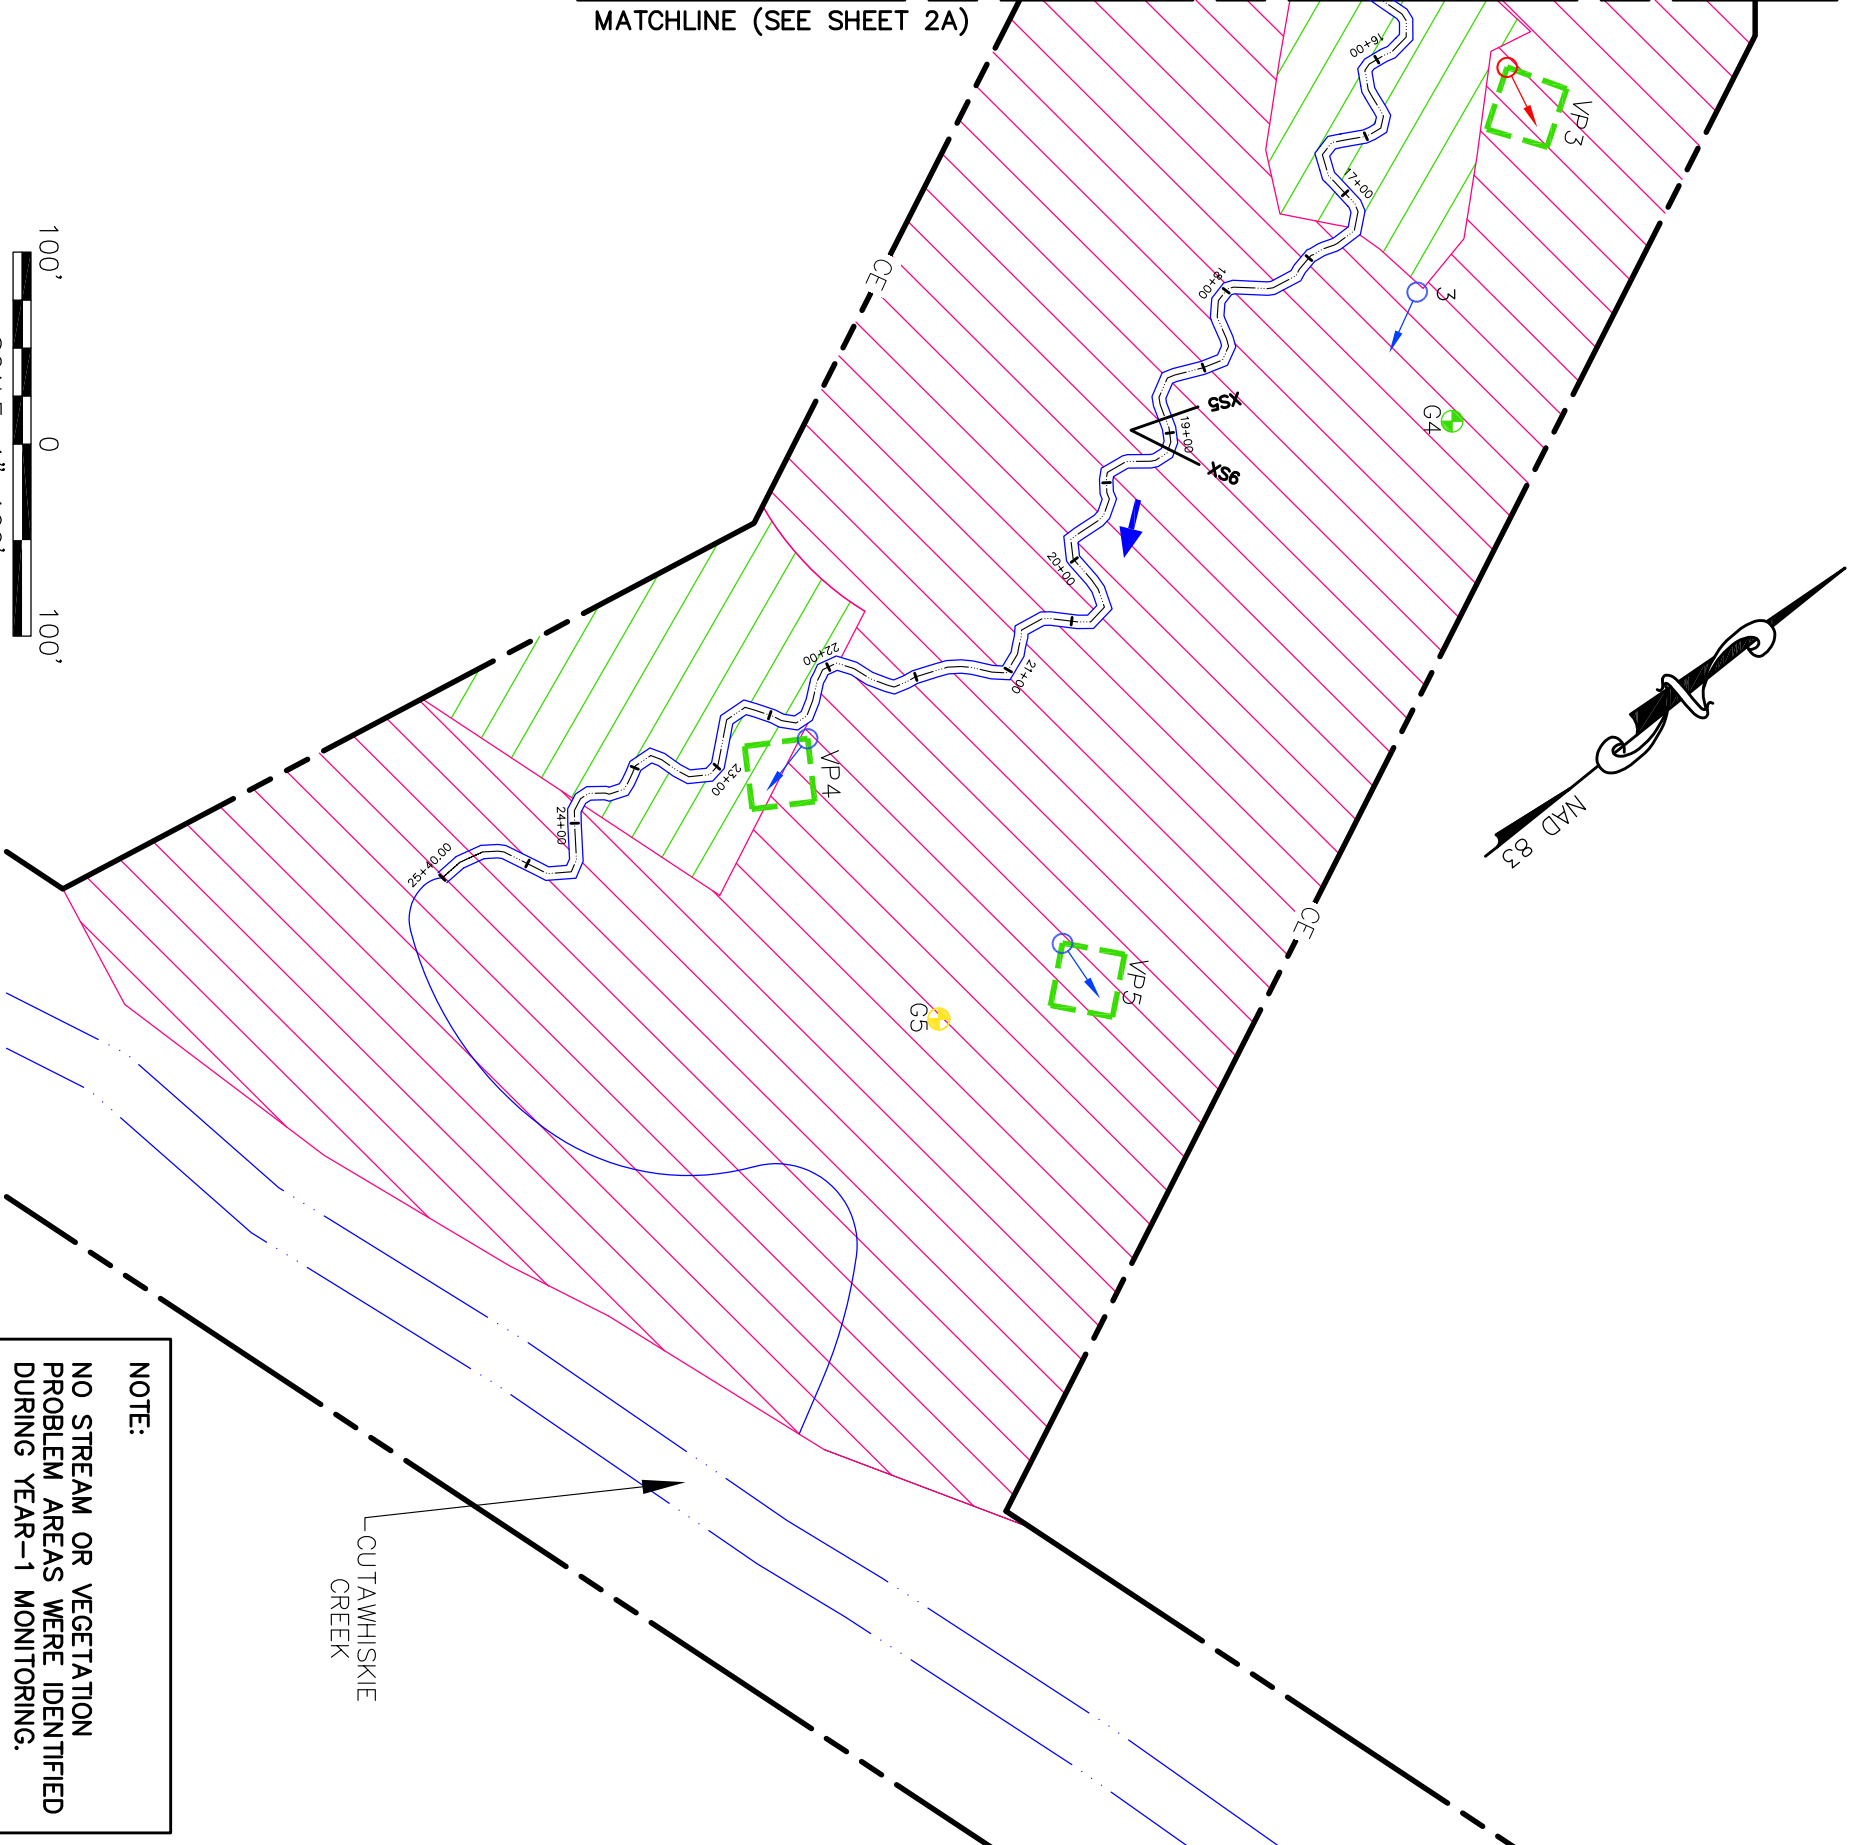
- VEGETATIVE MONITORING PLOT (5)  
(SUCCESS CRITERIA MET)
- GROUNDWATER MONITORING GAUGE (5)  
HYDROLOGY 5–12.5% OF GROWING SEASON  
HYDROLOGY >12.5% OF GROWING SEASON
- PERMANENT PHOTO STATIONS (8)
- PERMANENT CROSS-SECTIONS (6)
- STREAM FLOW DIRECTION
