Year Four Monitoring Report  
for  
Deep Creek Mitigation Bank

Yadkin County, North Carolina

S&EC Project No. 6170

January 2007

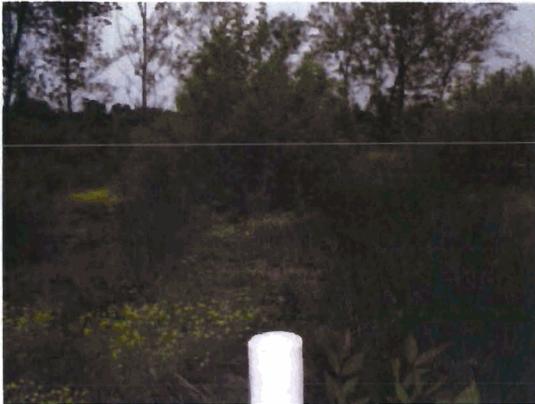
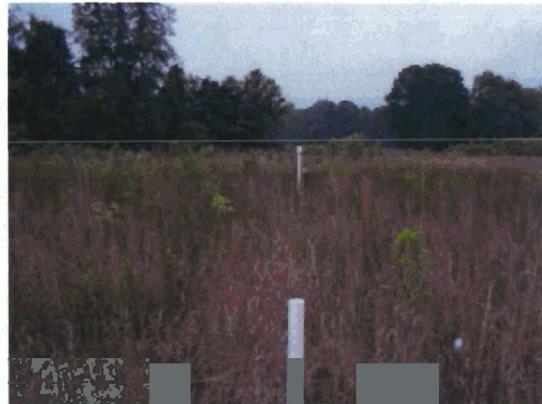
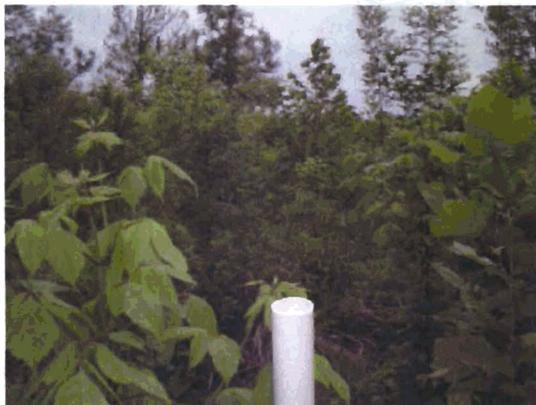
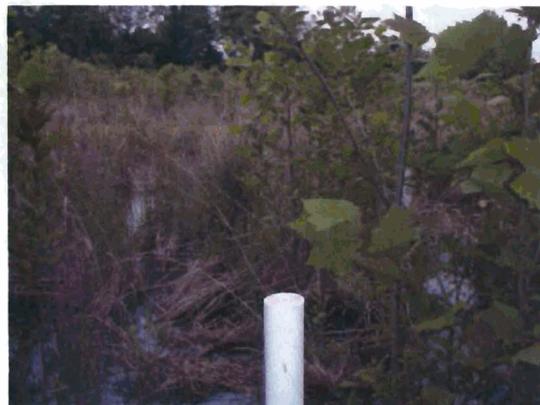
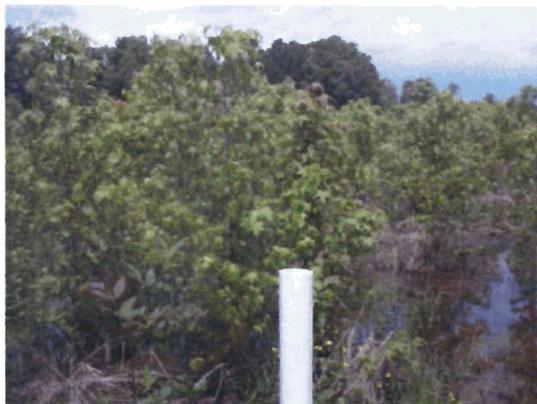
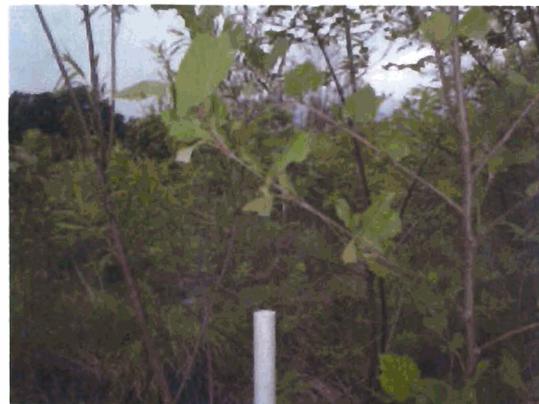
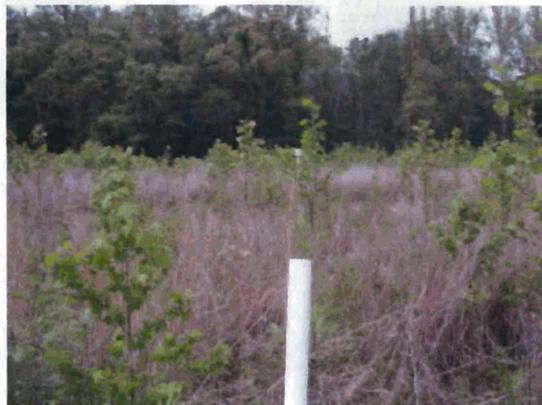
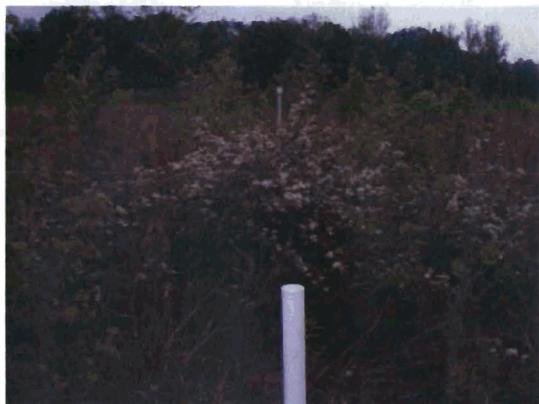
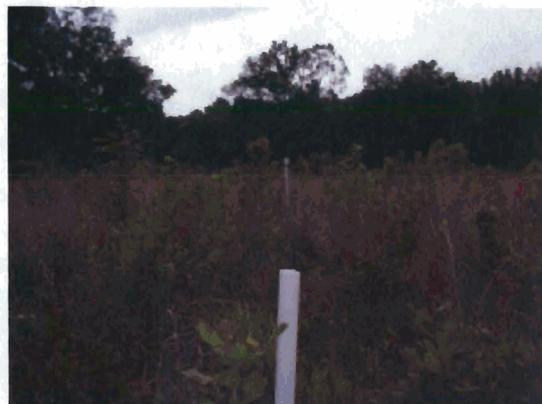
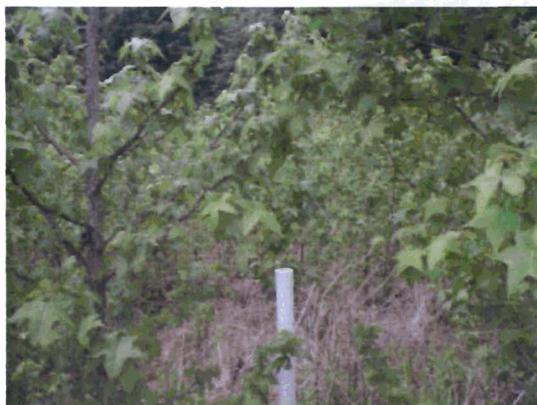
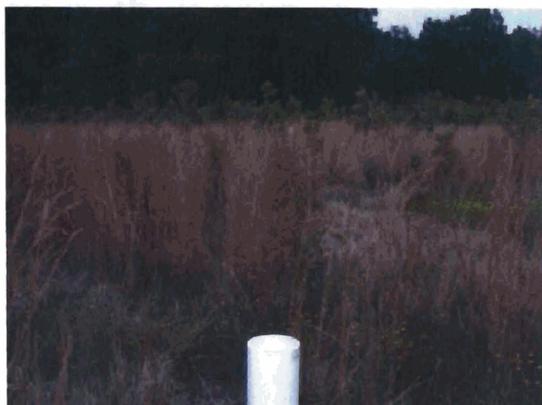
A photograph of each of the ten (10) sample plots is included below. Each view is from the southeast corner of the plot toward the northwest corner where the groundwater monitoring gauge is located. The photos were taken in the 2006 growing season.

The average stems per sample plot is 11.67 stems. The sample plot median is 12.5 stems. A review of the sample plots (averaging 11.67 stems per plot) reveals a **current (2006 – Year Four) site survival density of approximately 473 stems per acre.** Plot photographs are attached as Appendix D.
