# *Monitoring Report*

## Year 01

### **Third Fork Creek, Forest Hills Park Durham, North Carolina**

**December 2005**

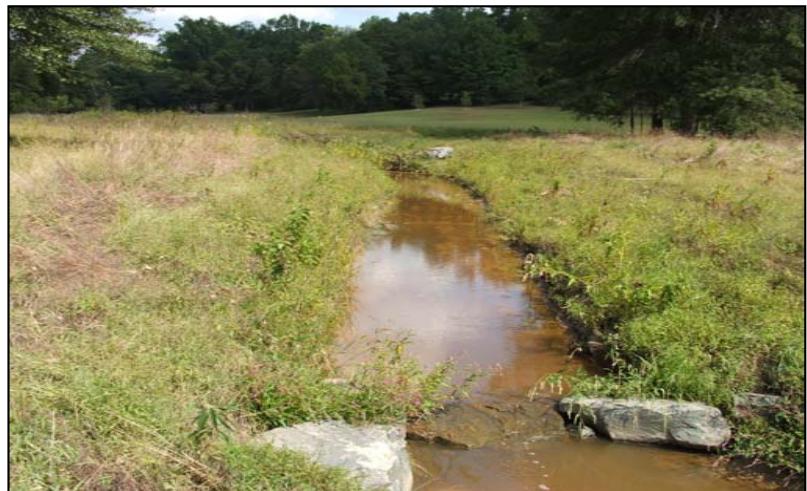
River Basin:	Cape Fear
Watershed:	Third Fork Creek
XS ID	XS 1 (riffle)
Reach:	Upstream
Date:	9/27/2005
Field Crew:	A. Spiller and Z. Wendling

SUMMARY DATA	
Bankfull Elevation:	297.54
Bankfull Cross-Sectional Area:	61.37
Bankfull Width:	27.11
Flood Prone Area Elevation:	301.49
Flood Prone Width:	240.00
Max Depth at Bankfull:	3.95
Mean Depth at Bankfull:	2.26
W / D Ratio:	12.0
Entrenchment Ratio:	8.85
Bank Height Ratio:	1.00

View of cross-section #1 looking upstream

Stream Type: C5c

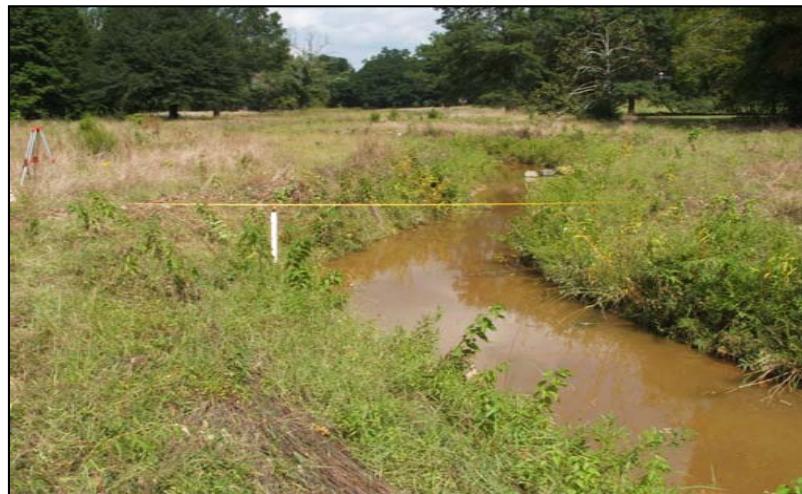
River Basin:	Cape Fear
Watershed:	Third Fork Creek
XS ID	XS 2 (pool)
Reach:	Upstream
Date:	9/27/2005
Field Crew:	A. Spiller and Z. Wendling

Bankfull Elevation:	297.10
Bankfull Cross-Sectional Area:	72.88
Bankfull Width:	26.39
Flood Prone Area Elevation:	302.21
Flood Prone Width:	240.00
Max Depth at Bankfull:	5.11
Mean Depth at Bankfull:	2.76
W / D Ratio:	-
Entrenchment Ratio:	-
Bank Height Ratio:	1.03

View of cross-section #2 looking upstream

Stream Type: C5c

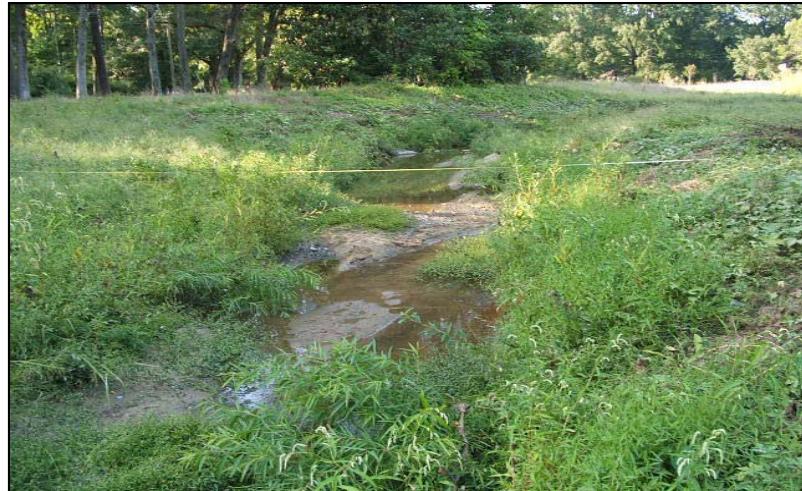
River Basin:	Cape Fear
Watershed:	Third Fork Creek
XS ID	XS 3 (riffle)
Reach:	Downstream
Date:	9/27/2005
Field Crew:	A. Spiller and Z. Wendling

Bankfull Elevation:	292.27
Bankfull Cross-Sectional Area:	53.46
Bankfull Width:	29.00
Flood Prone Area Elevation:	295.75
Flood Prone Width:	240.00
Max Depth at Bankfull:	3.48
Mean Depth at Bankfull:	1.84
W / D Ratio:	15.7
Entrenchment Ratio:	8.28
Bank Height Ratio:	1.04

View of cross-section #3 looking upstream

Stream Type: C5c

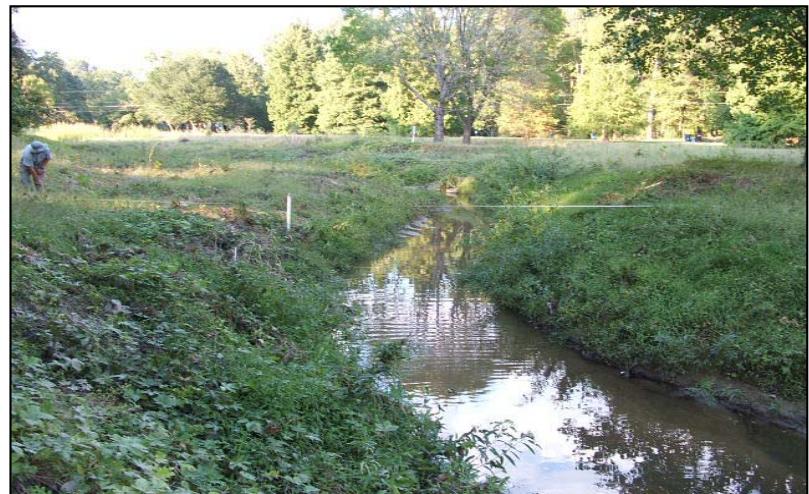
River Basin:	Cape Fear
Watershed:	Third Fork Creek
XS ID	XS 4 (pool)
Reach:	Downstream
Date:	9/27/2005
Field Crew:	A. Spiller and Z. Wendling

SUMMARY DATA	
Bankfull Elevation:	292.53
Bankfull Cross-Sectional Area:	60.40
Bankfull Width:	23.29
Flood Prone Area Elevation:	297.50
Flood Prone Width:	240.00
Max Depth at Bankfull:	4.97
Mean Depth at Bankfull:	2.59
W / D Ratio:	-
Entrenchment Ratio:	-
Bank Height Ratio:	0.96

View of cross-section #3 looking upstream

Stream Type: C5c

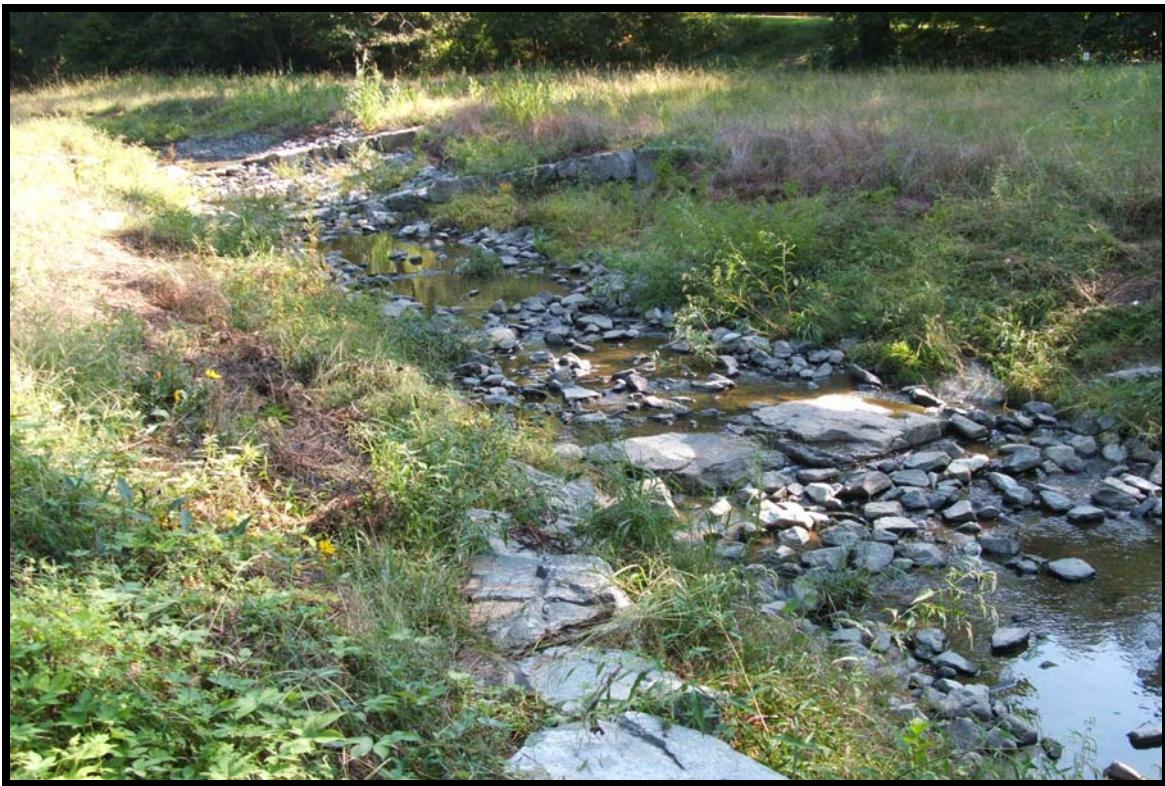
PRP 10 – Looking upstream. Note the stone from stream repair.

Maintenance actions conducted after construction involved stabilization of stream banks in two sections. The first section is in the upstream section of the project near station 29+25 where a 10-inch terracotta sewer pipe crossed the channel. The scouring that was occurring around the pipe on the banks was stabilized with rip rap (Appendix D, see PRP 10 upstream photo). Maintenance was also necessary in the downstream section near station 33+50, where local bank erosion was occurring. This area was repaired with stone installed at the toe of the slope (Appendix D, see left side of PRP 11 downstream photo). Both of the maintenance areas were replanted with a seed mix to provide a fast growing herbaceous cover to prevent soil erosion.

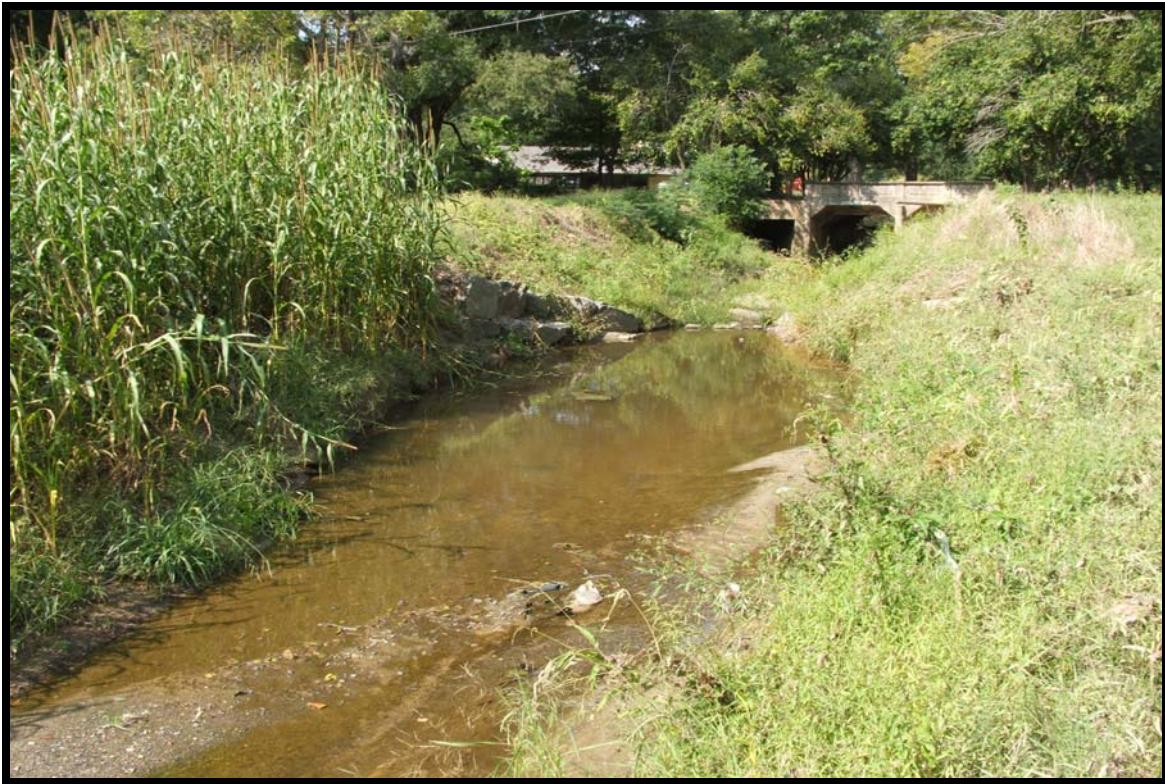
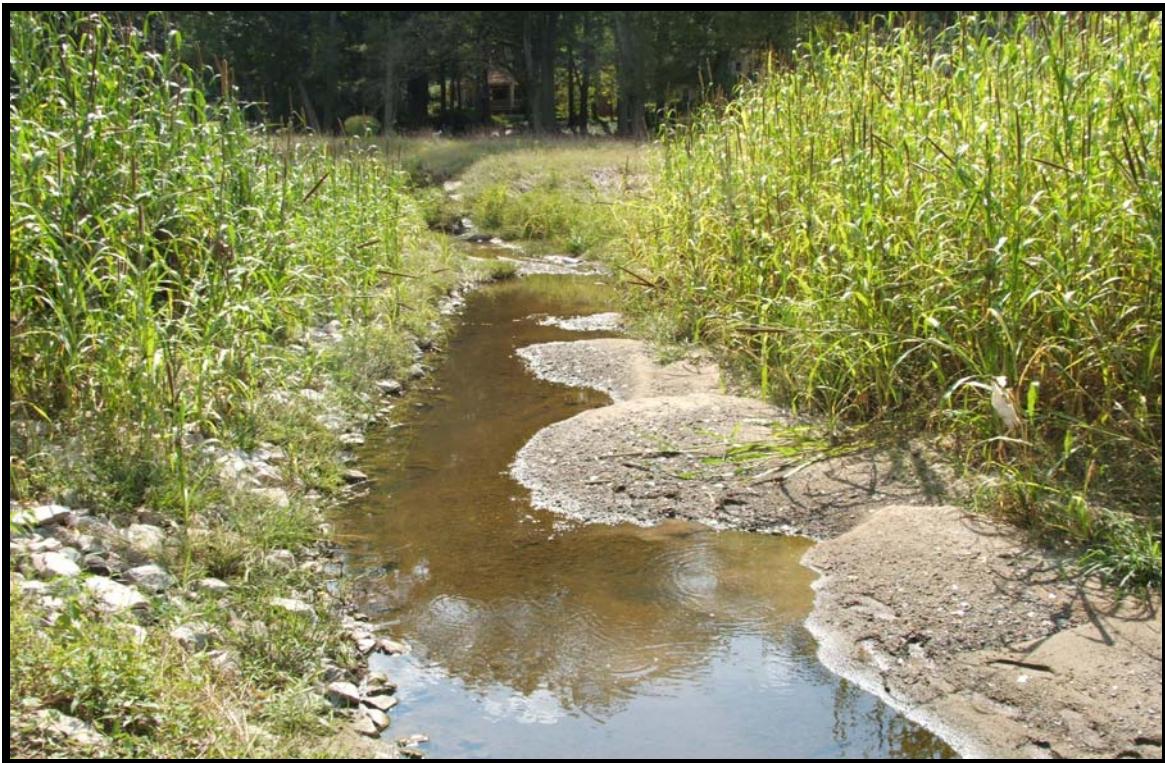
PRP 11 – Looking upstream.\*

PRP 11 – Looking downstream.\*

\* Note – PRP 11 photos were taken from the bank opposite of the permanent photo location because tall vegetation obscured the view from the permanent location. Also, in PRP 11 downstream photo, note the stone on the left bank from stream maintenance.

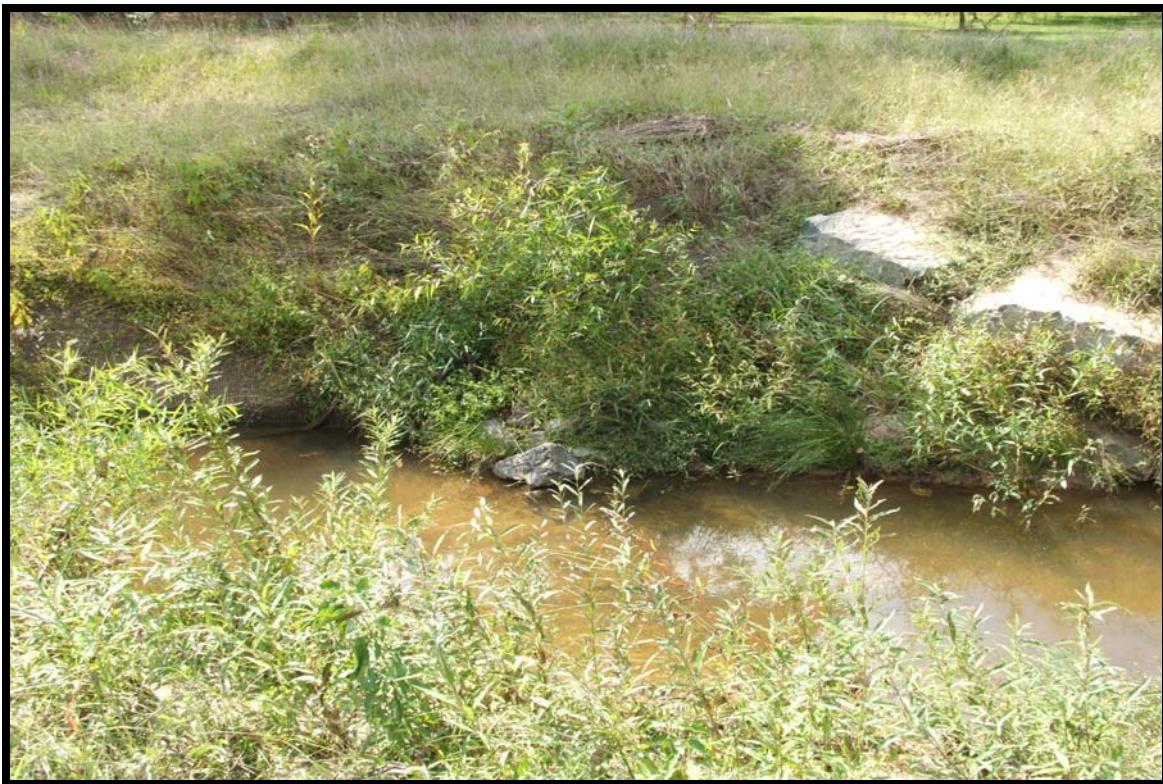
PRP 12 – Looking at 15' CMP coming into Third Fork Creek; pipe is obscured from view because of vegetation.
