# RESTORATION PLAN

## Glade Creek Stream Restoration Alleghany County, North Carolina

Prepared for:  
NCDENR-Ecosystem Enhancement Program  
2728 Capital Blvd., Suite 1H 103  
Raleigh, NC 27604

December 2007

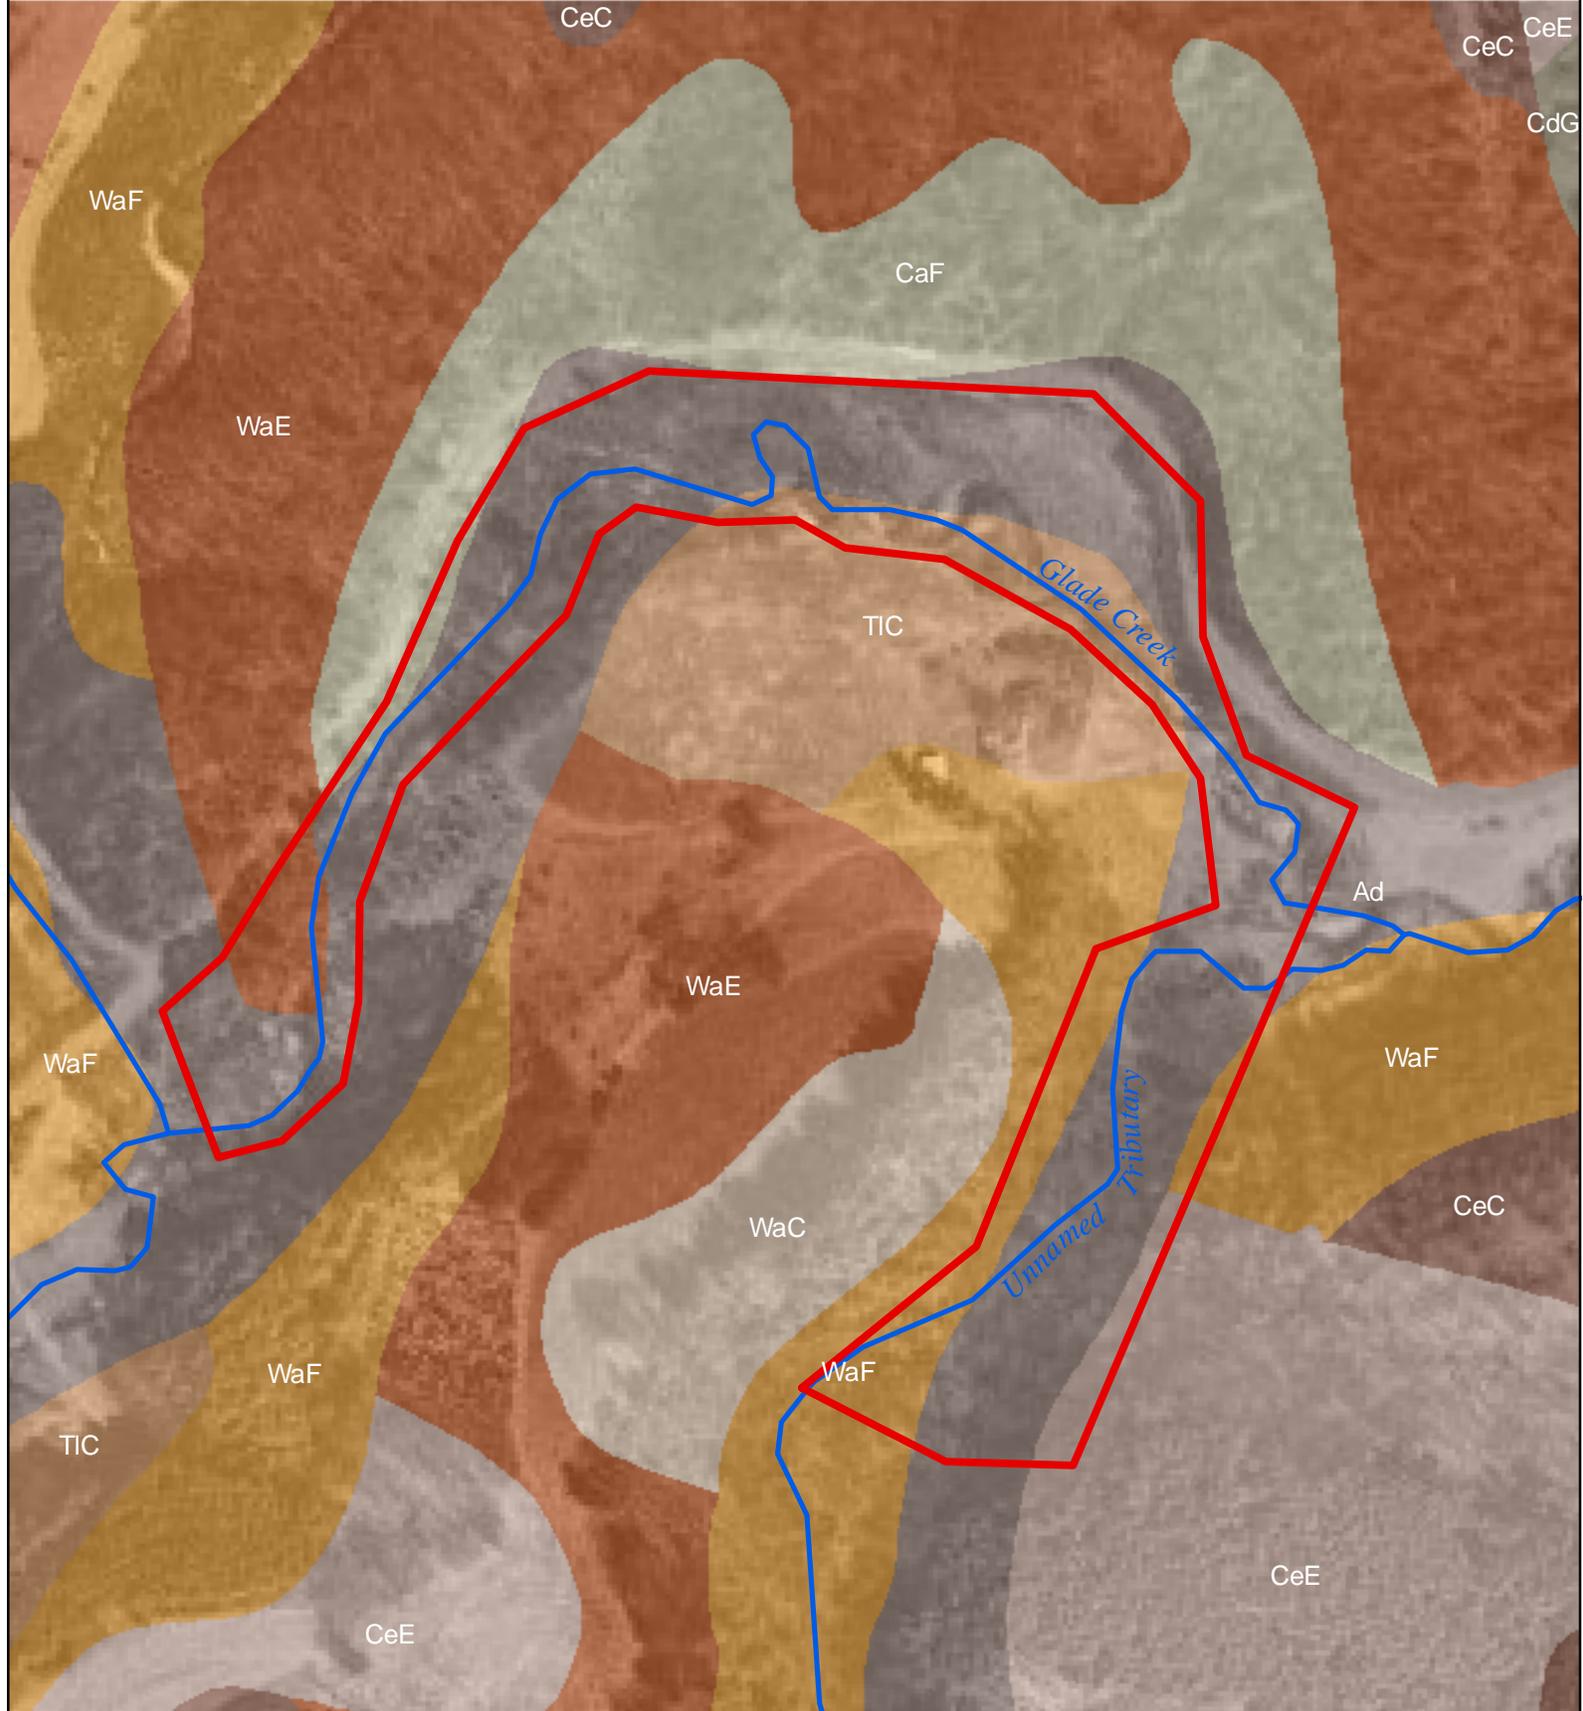
**Figure 3. Project Site NRCS Soil Survey Map**  
**Glade Creek Stream Restoration**  
 Alleghany County, North Carolina  
 December 2007

| | Chandler stony silt loam, 25-45% slope, CdG | Tusquee loam, 6-10% slopes, TIC | |

The NRCS is currently revising the soil survey of Alleghany County, and limited information is available on the Web Soil Survey 2.0 website. However, Biohabitats was able to get GIS soils information from the 1973 Soil Survey from the State NRCS office and analyze it (Figure 3). The results for the combined Glade Creek and unnamed tributary watersheds are listed below.

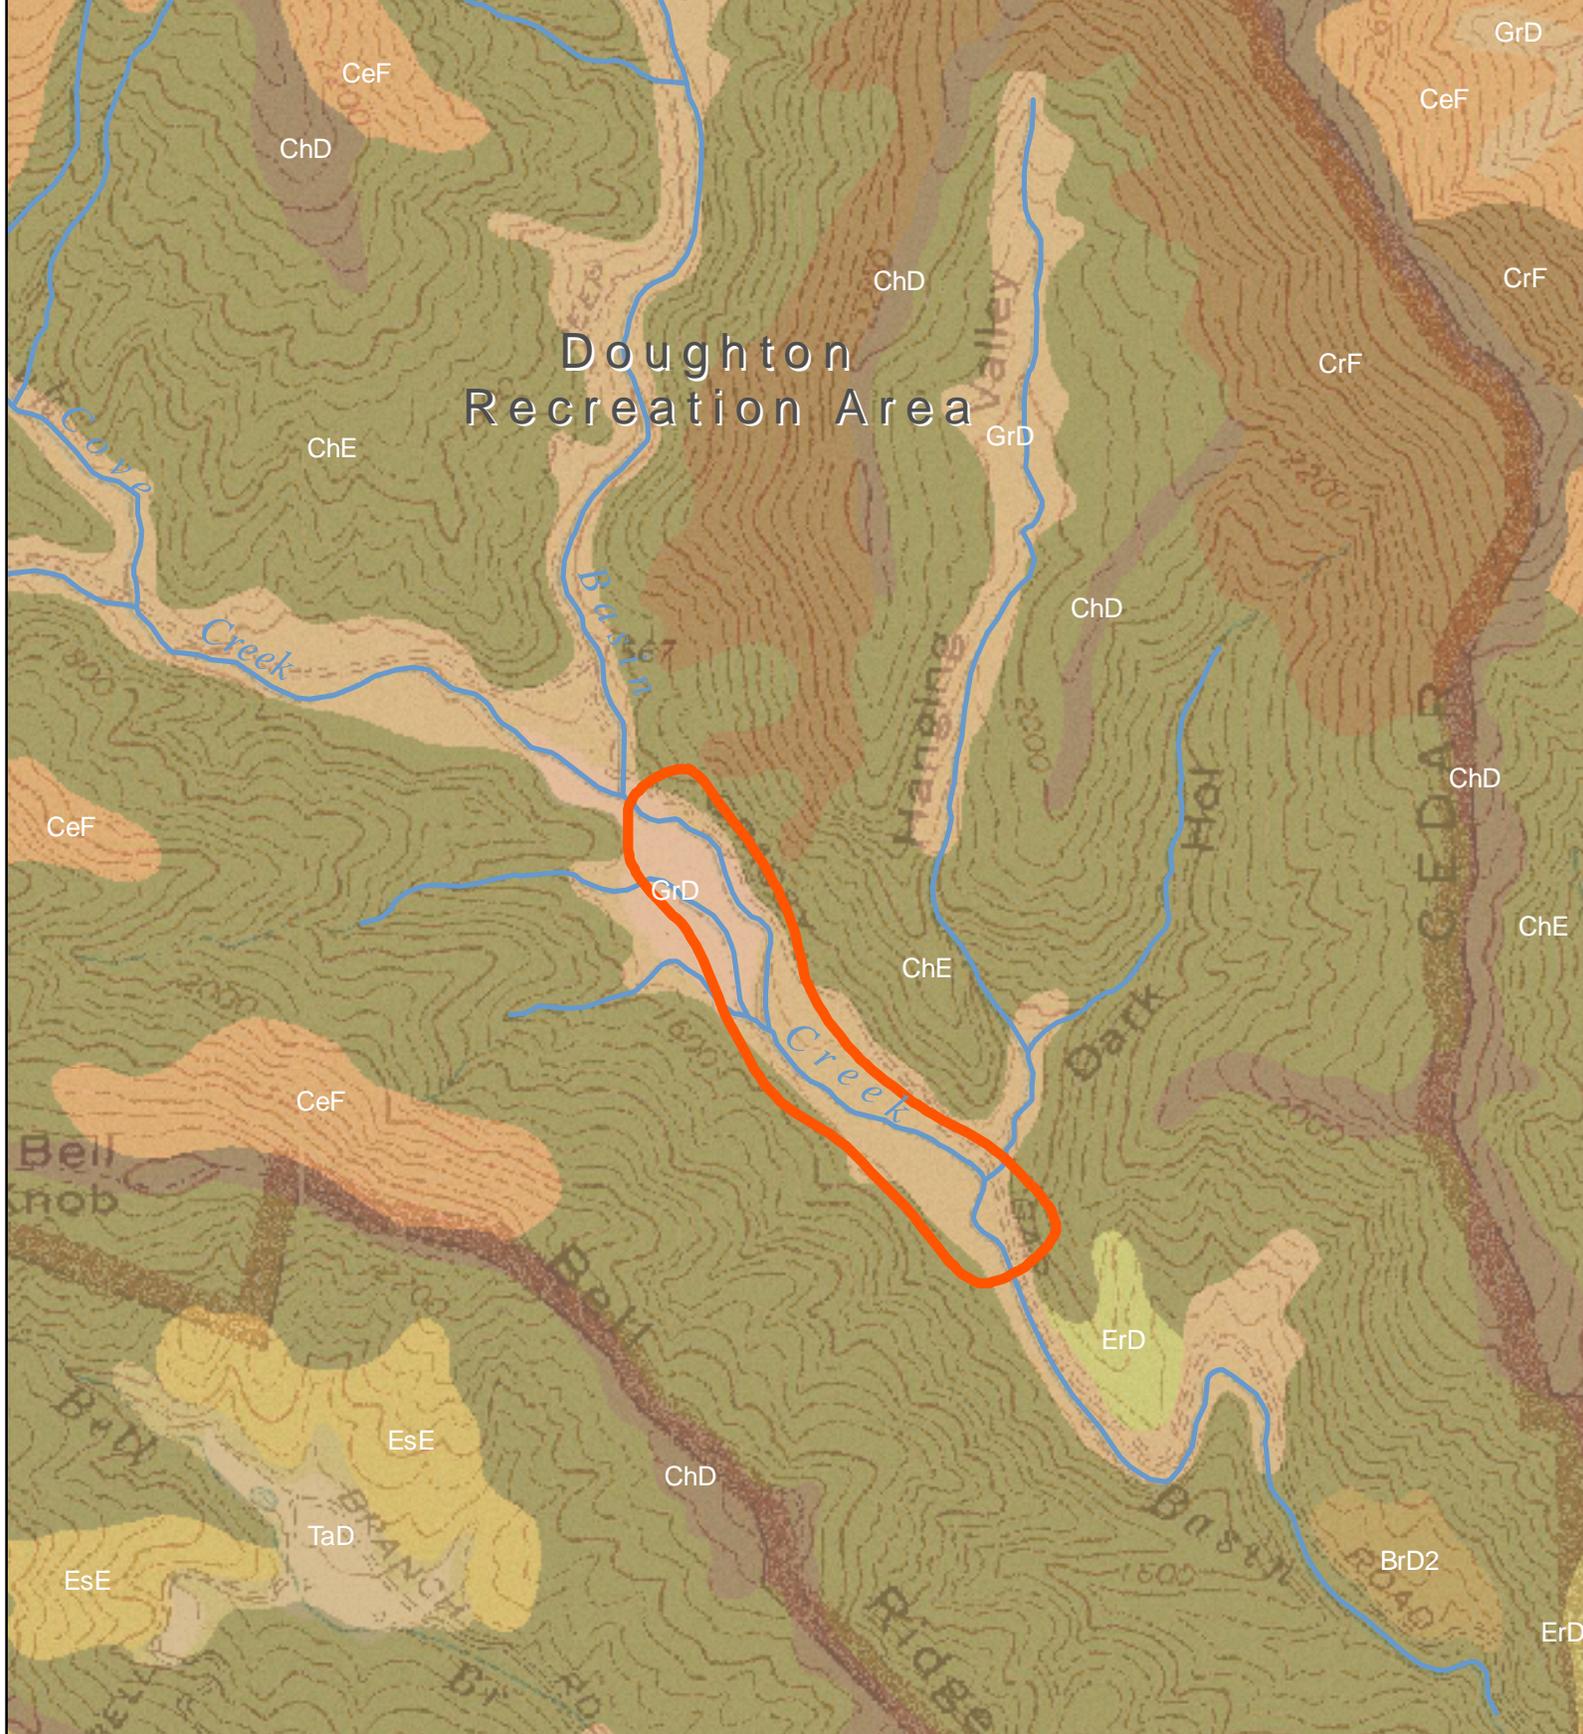
**Figure 7. Reference Site NRCS Soil Survey Map**

- ▭ Reference Reach Site
- ▬ Streams/Creeks
- Reference Reach Site Soils**
- ▭ Braddock clay loam, 8-25%, BrD2
- ▭ Chestnut-Ashe, 25 to 90 % slopes, CeF
- ▭ Chestnut-Edneyville, 25-60% percent slopes, ChE
- ▭ Chestnut-Edneyville, 8 to 25 % slopes, ChD
- ▭ Cleveland-Rock outcrop, 8 to 90 % slopes, CrF
- ▭ Eard gravelly sandy loam, 15 to 25 % slopes, ErD
- ▭ Evard-Cowee complex, 25 to 60 % slopes, EsE
- ▭ Greenlee-Ostin complex, 3 to 40 % slopes, GrD
- ▭ Tate fine sandy loam, 8 to 25 % slopes, TaD

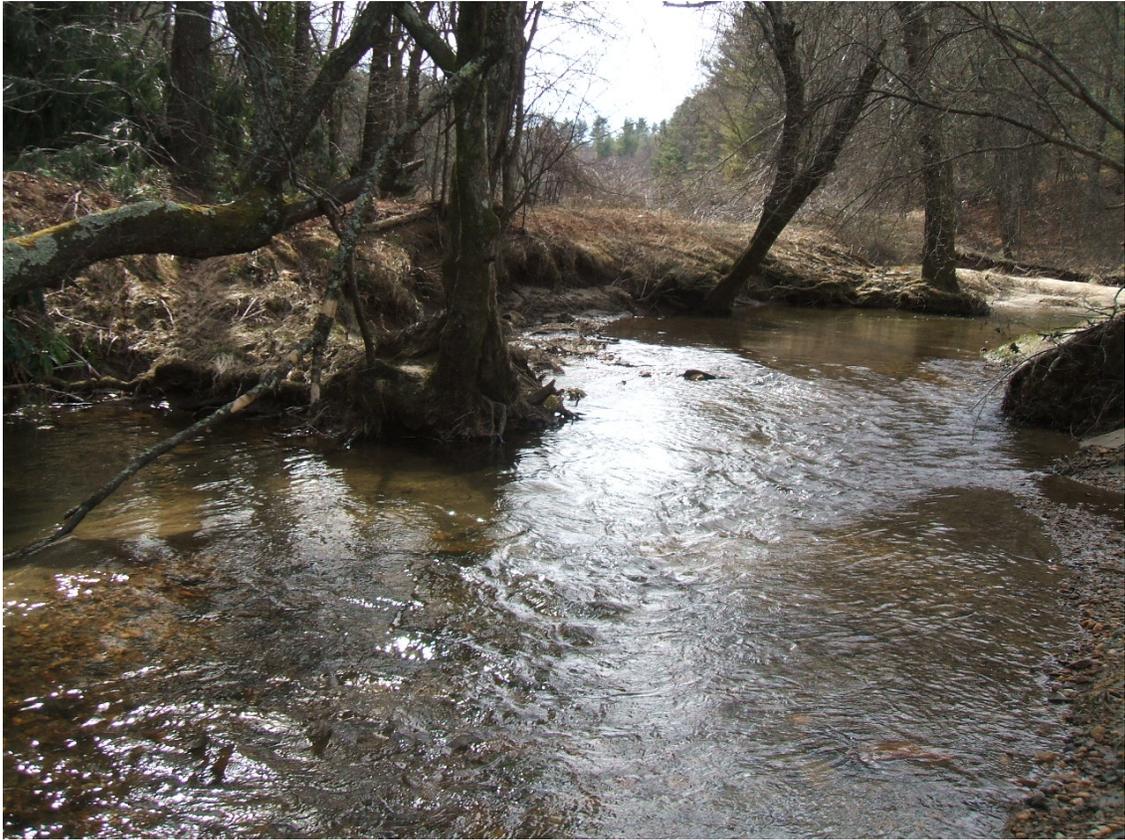
Upstream view at ~ sta 0+00 on Glade Creek

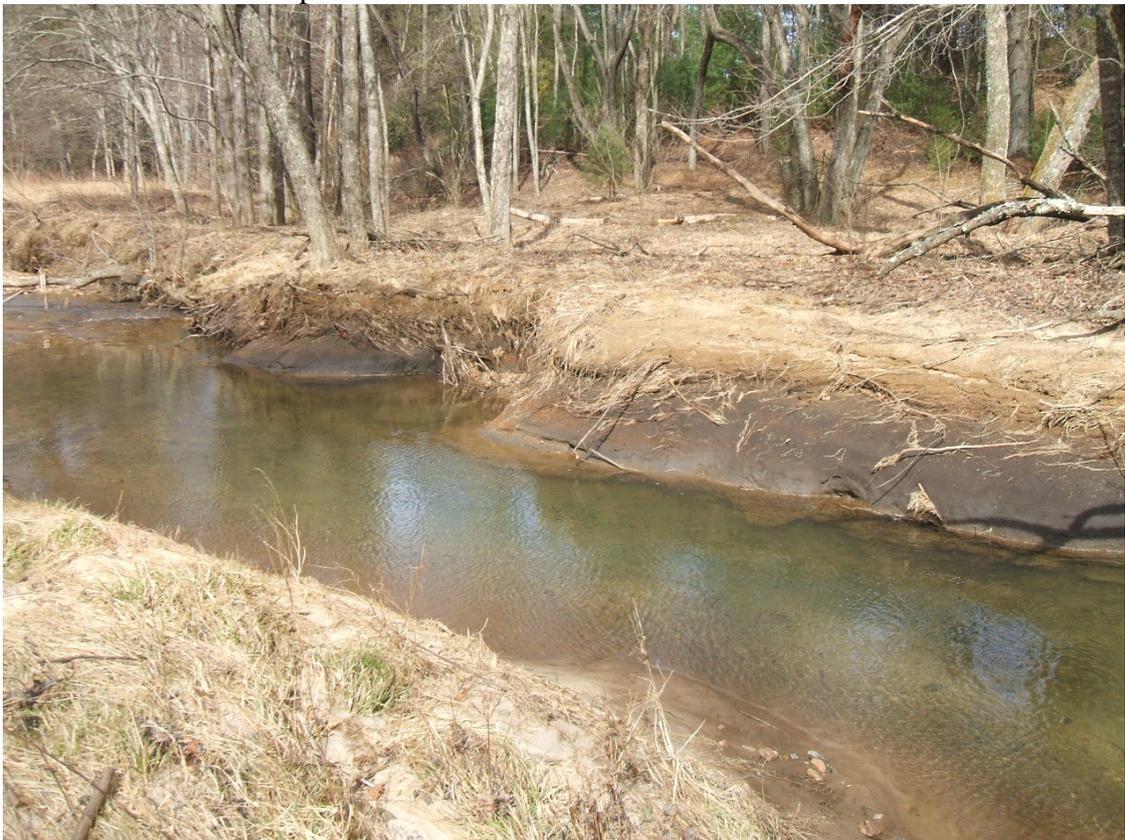
Glade Creek-right bank at ~ sta 2+00

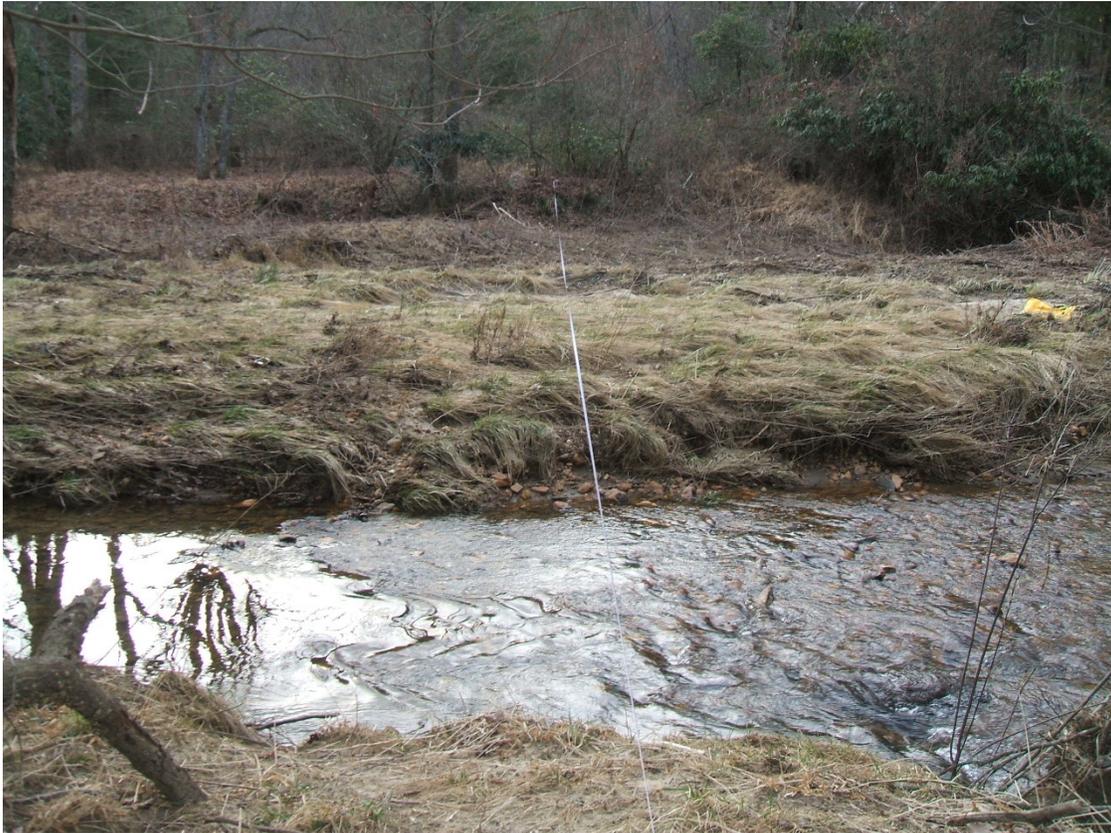
Upstream cross section view from right bank at ~ sta 2+25 on Glade Creek

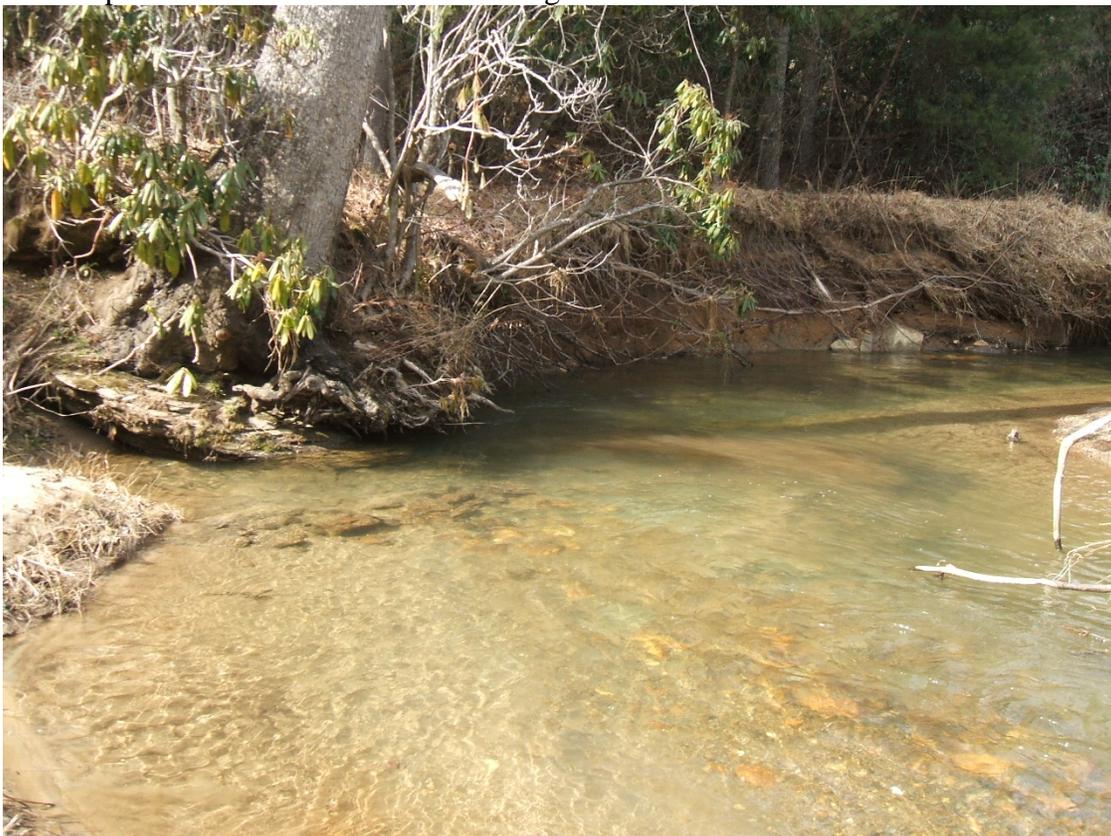
Pool beside large 30'' white oak at ~ sta 3+25

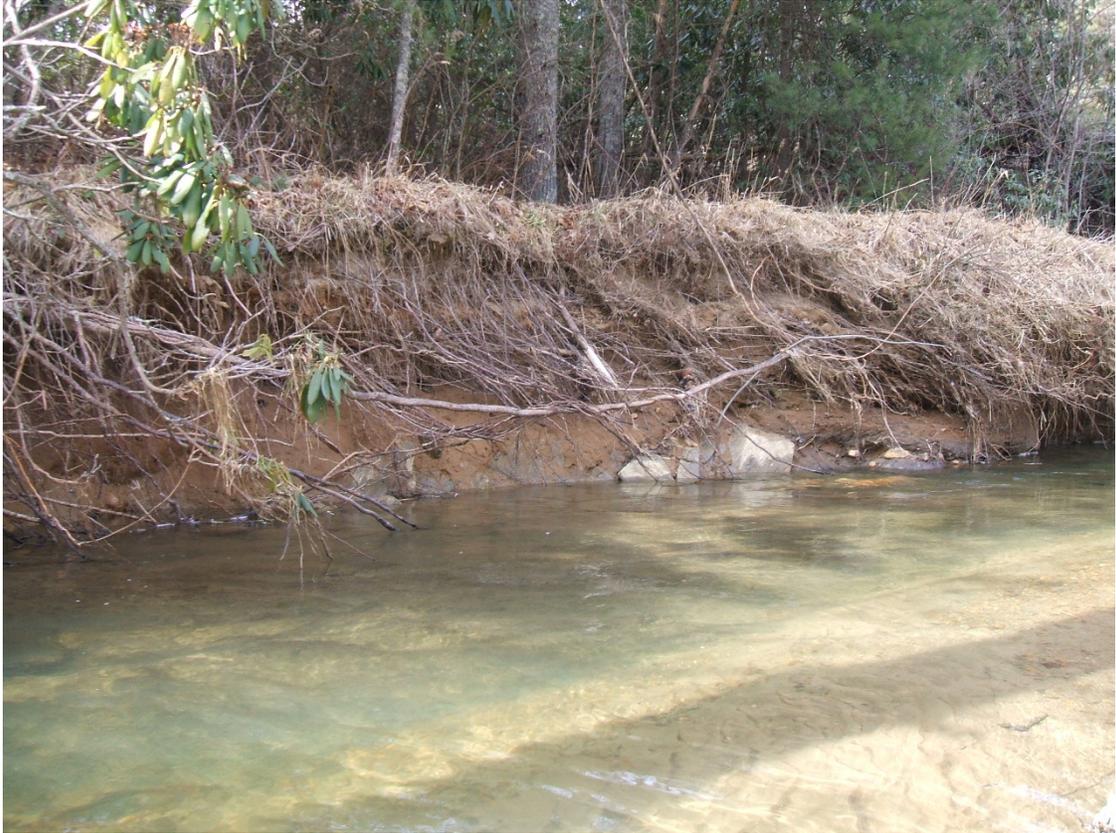
View of left bank d/s of the 30'' white oak at ~ sta 3+25 on Glade Creek

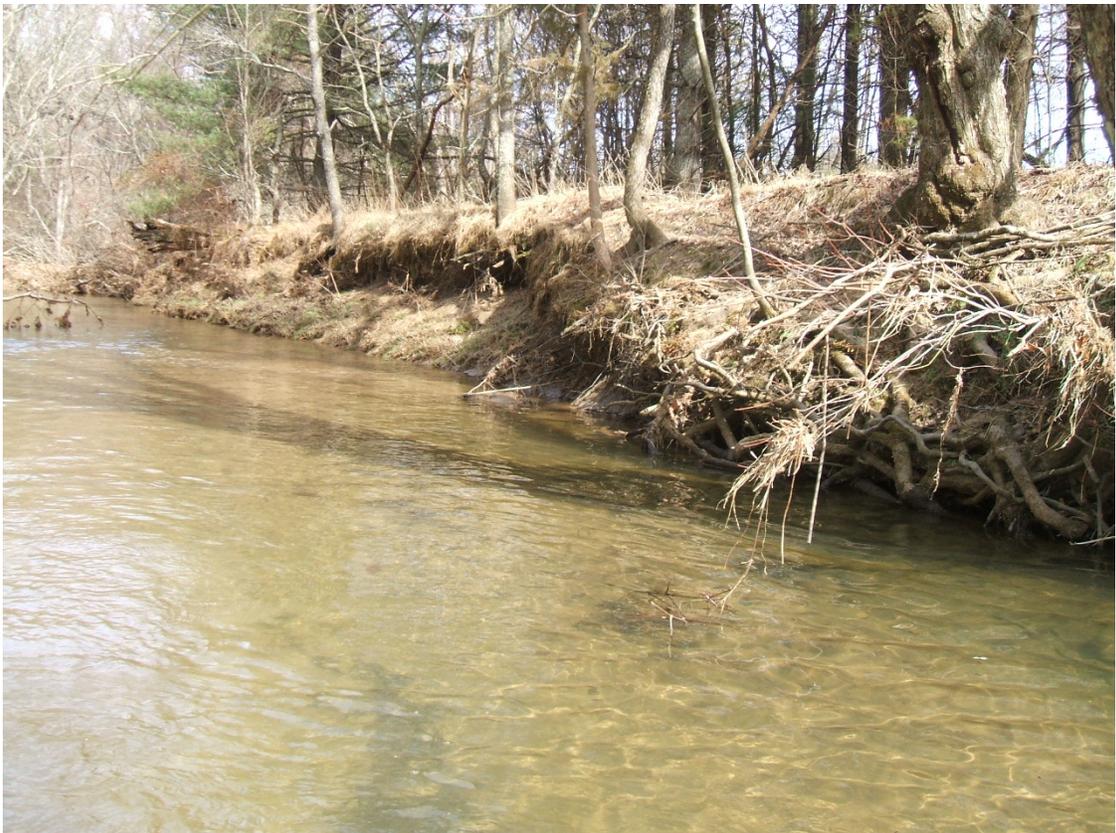
Glade Creek-right bank at ~ sta 6+75 - 8+00

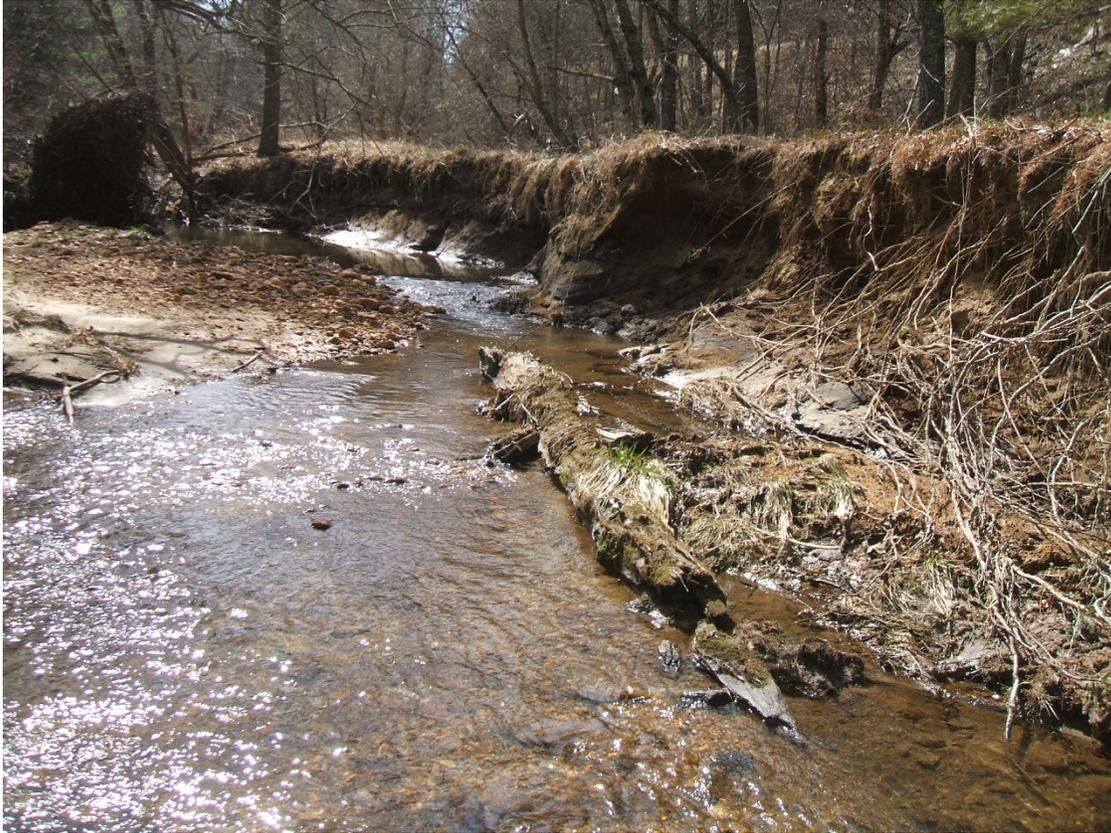
Mid-channel bar and eroding right bank at ~ sta 10+00 on Glade Creek

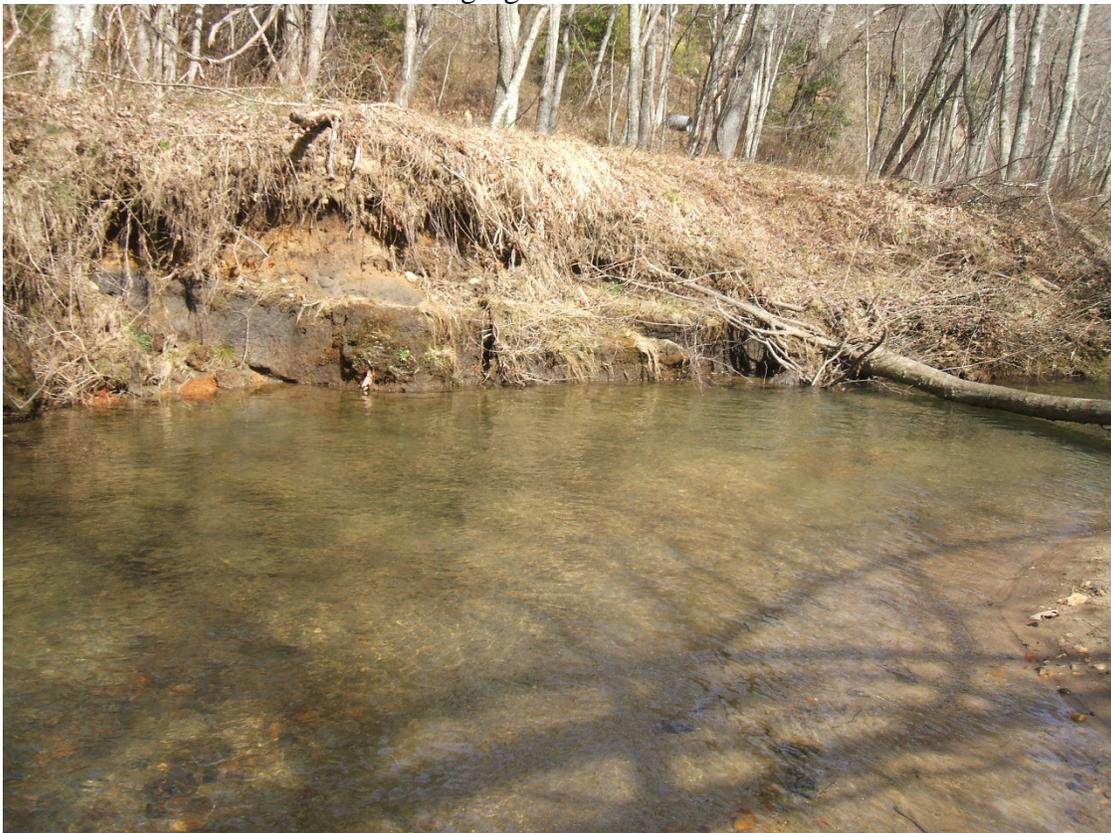
Left bank on meander right ~ sta 11+50 on Glade Creek

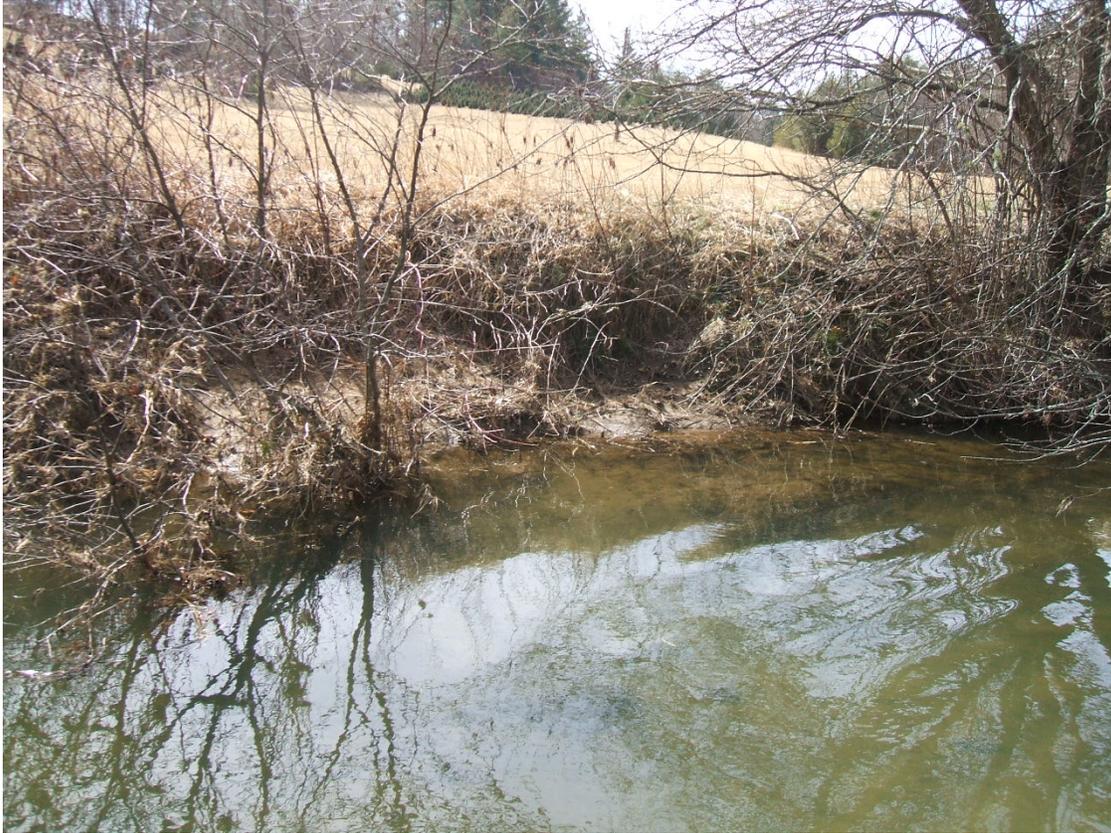
View of right bank, just upstream of beaver pond ~ sta 16+00 on Glade Creek

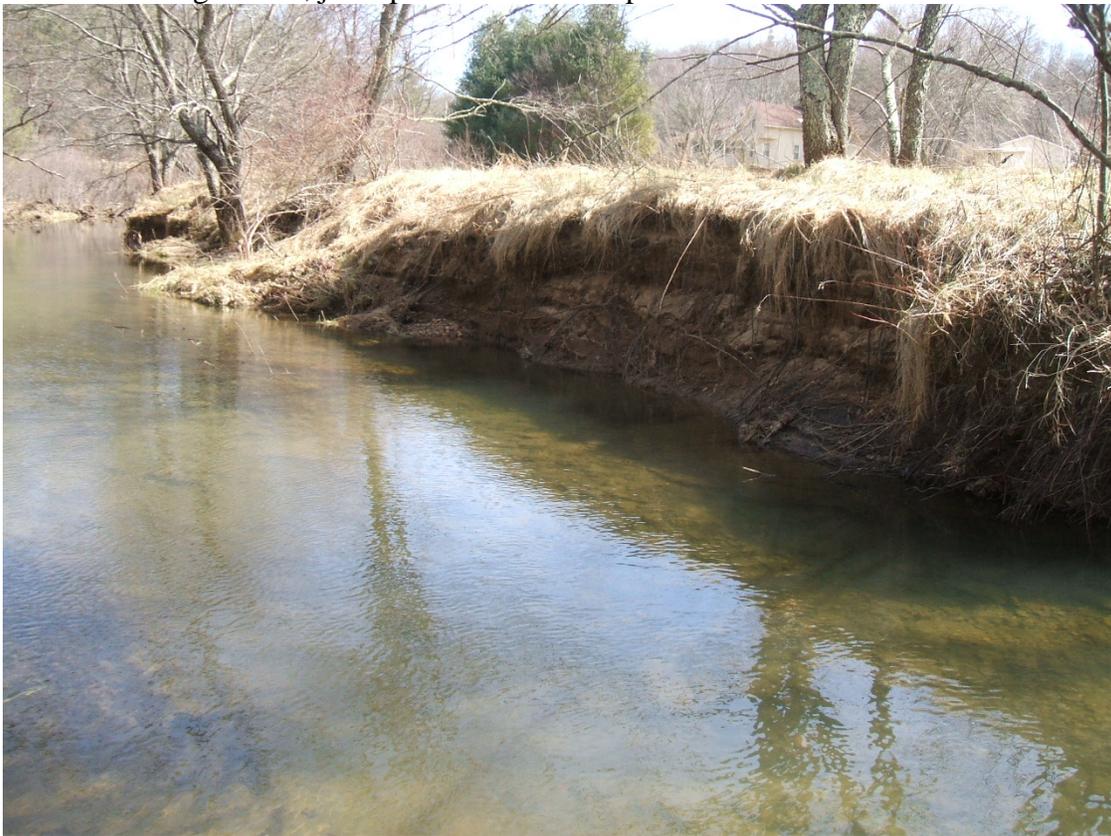
Glade Creek-right bank at ~ sta 16+50 u/s of beaver pond

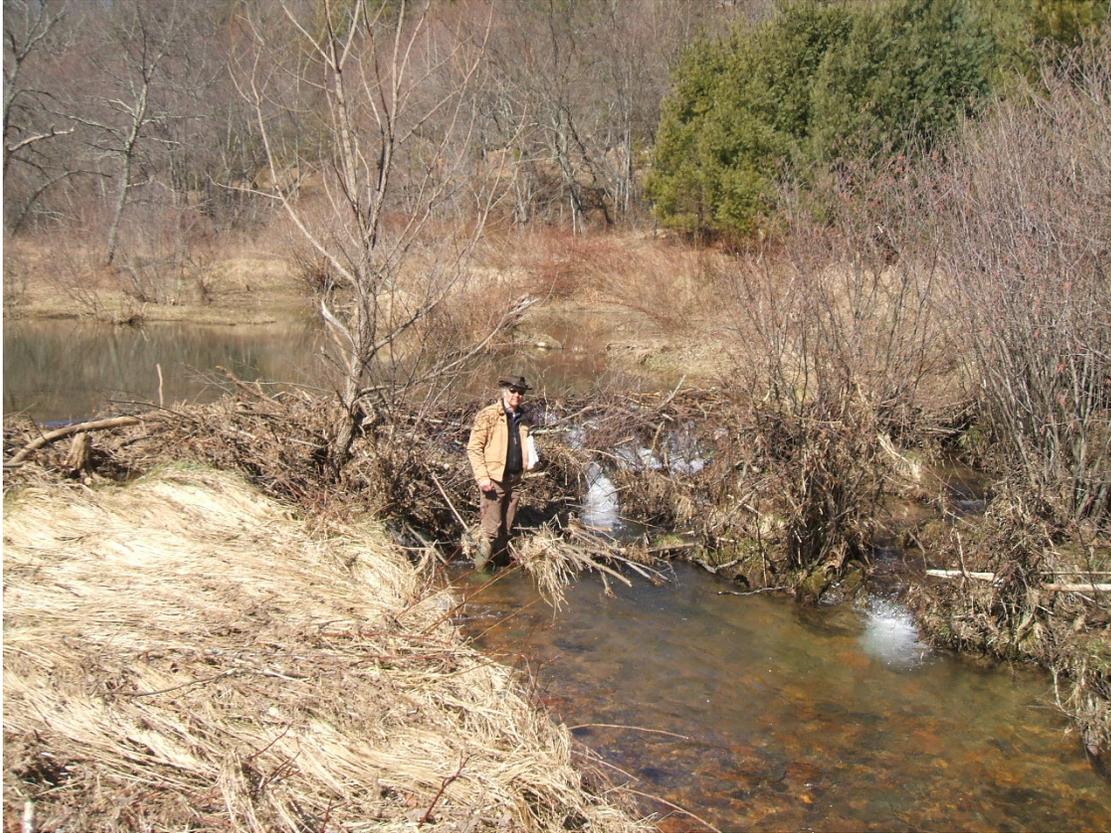
Beaver dam view at ~ sta 17+75 on Glade Creek

There is an existing beaver dam and pond along Glade Creek at station 17+75. Beavers built this feature during the fall of 2006 and then enlarged it in the winter of 2007. The proposed design will construct a stable channel directing flow beside and around the pond, preserving its present size and configuration. The mud and stick beaver dam will be removed and replaced with somewhat more permanent channel bed material. During higher flows the pond area will serve as additional floodplain capacity, and during low flows the stream thalweg will be adjacent to the pond area, flowing around it. This will allow the beaver impoundment area to persist, with a stable channel adjacent to it, thus providing stability while still allowing unimpeded sediment transport in the channel. The water table is expected to be high enough to maintain water in the adjacent pond area during periods of low flow.

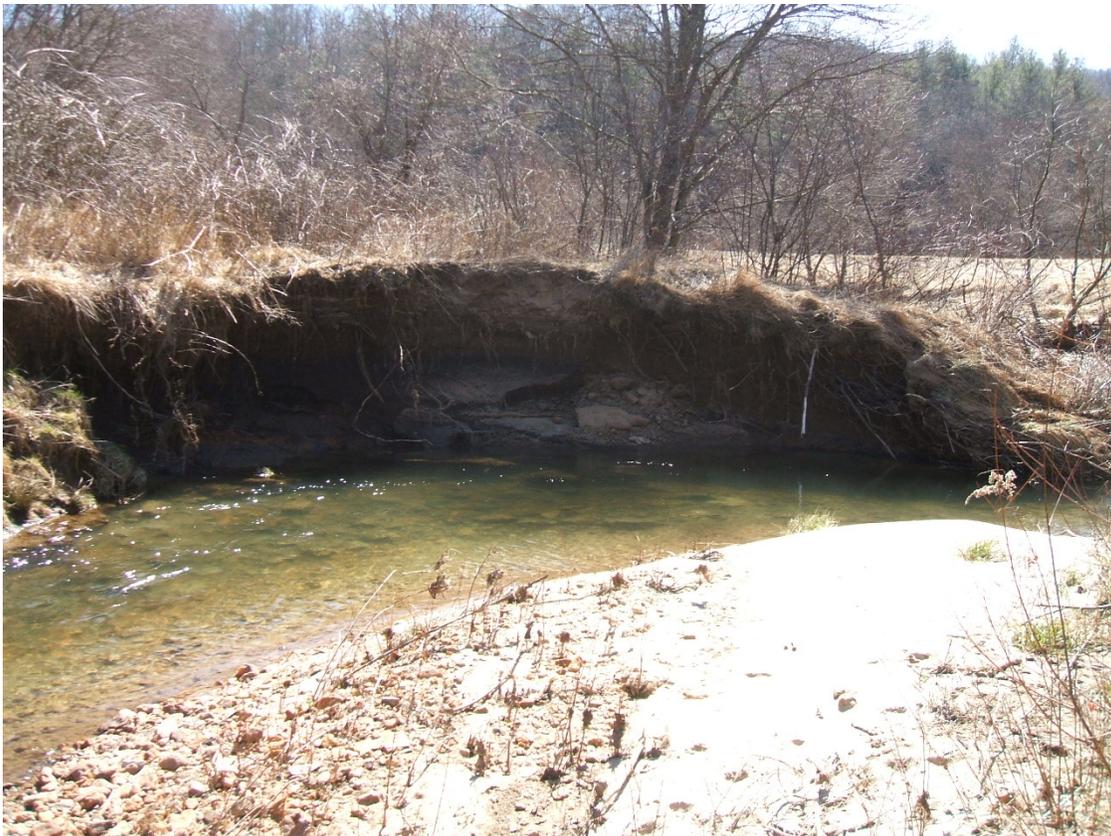
View of left bank d/s of beaver dam at ~ sta 19+75

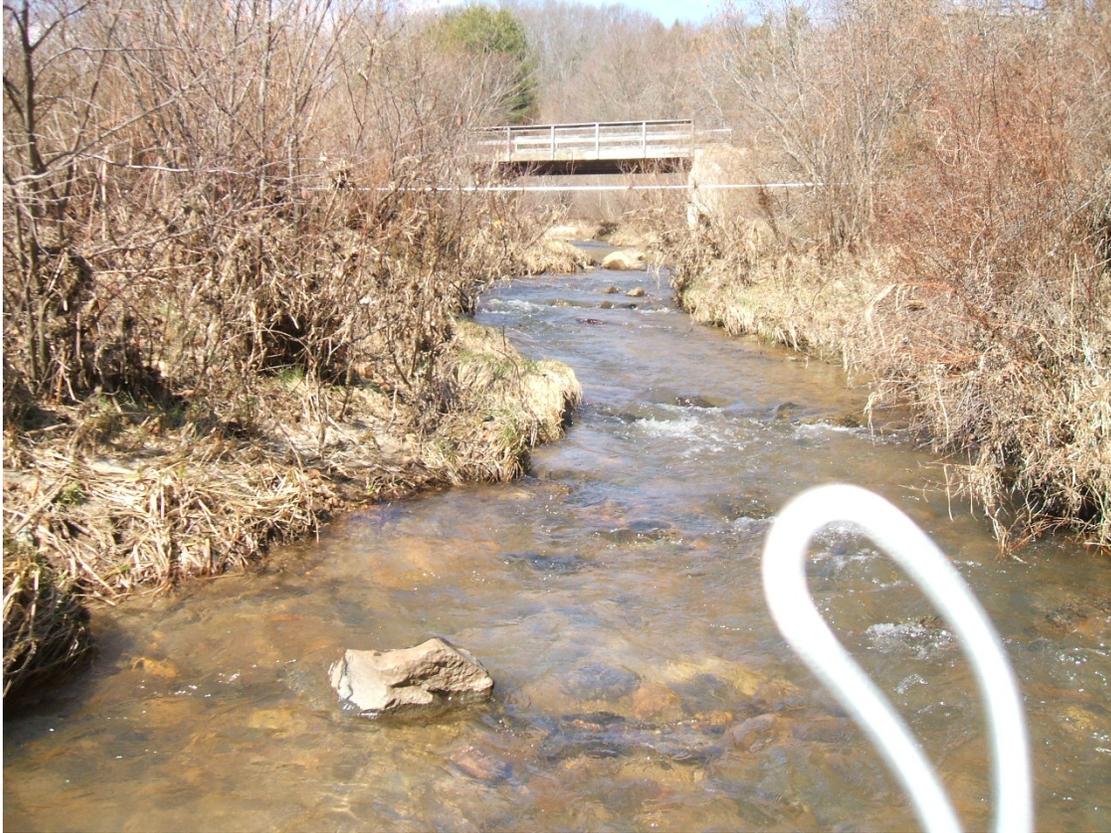
Looking upstream from downstream of bridge at cross section ~ sta 23+00 on Glade Cr.

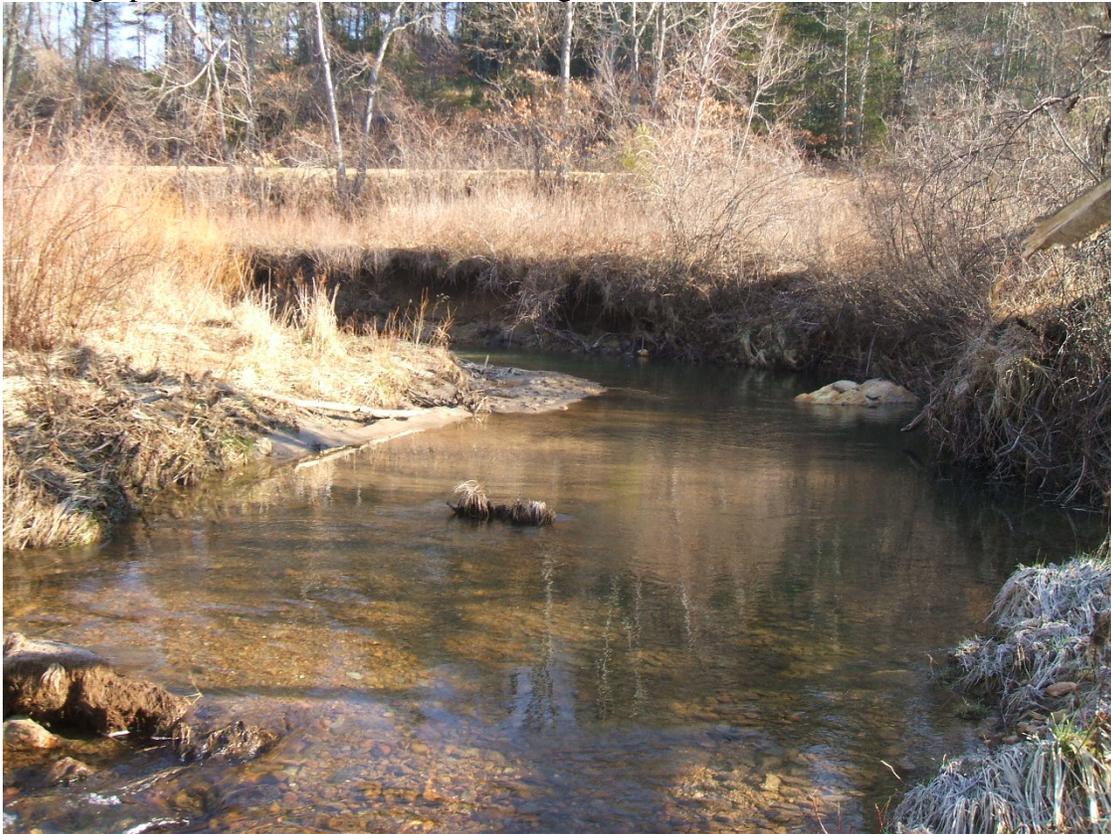
Looking upstream at ~ sta 24+75 on Glade Creek

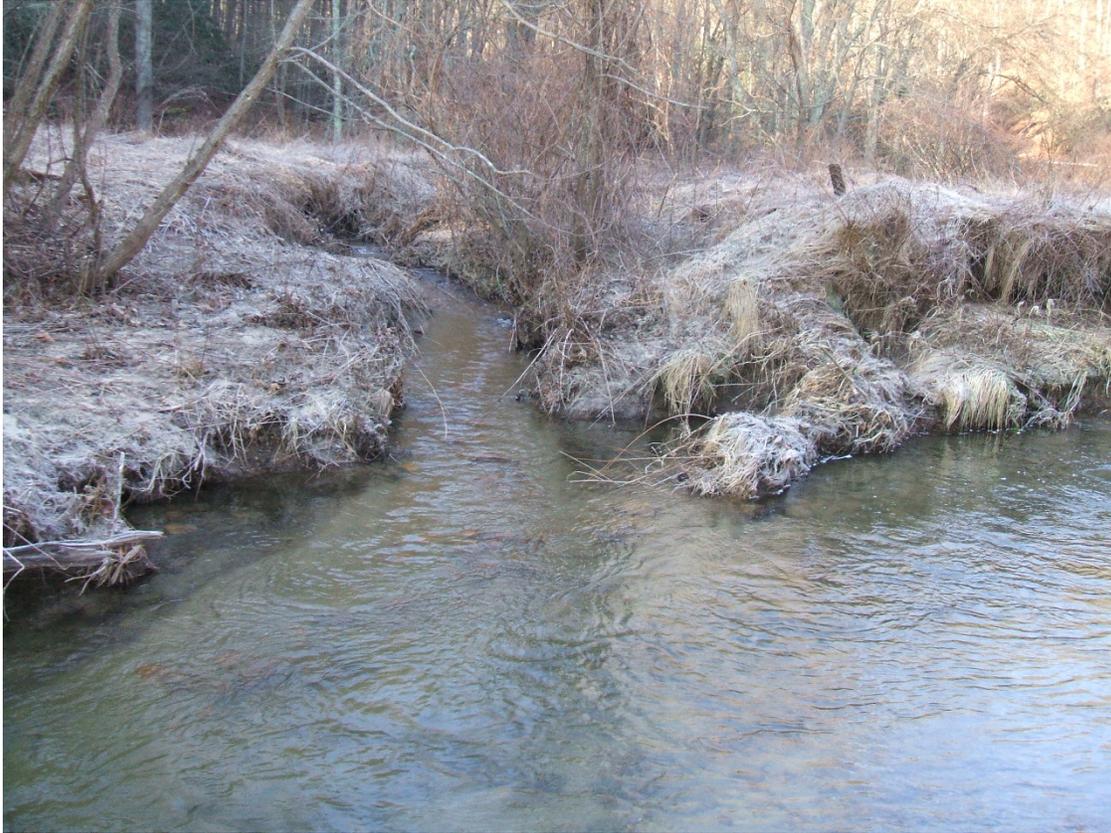
Confluence of unnamed tributary and Glade Creek just downstream of project boundary

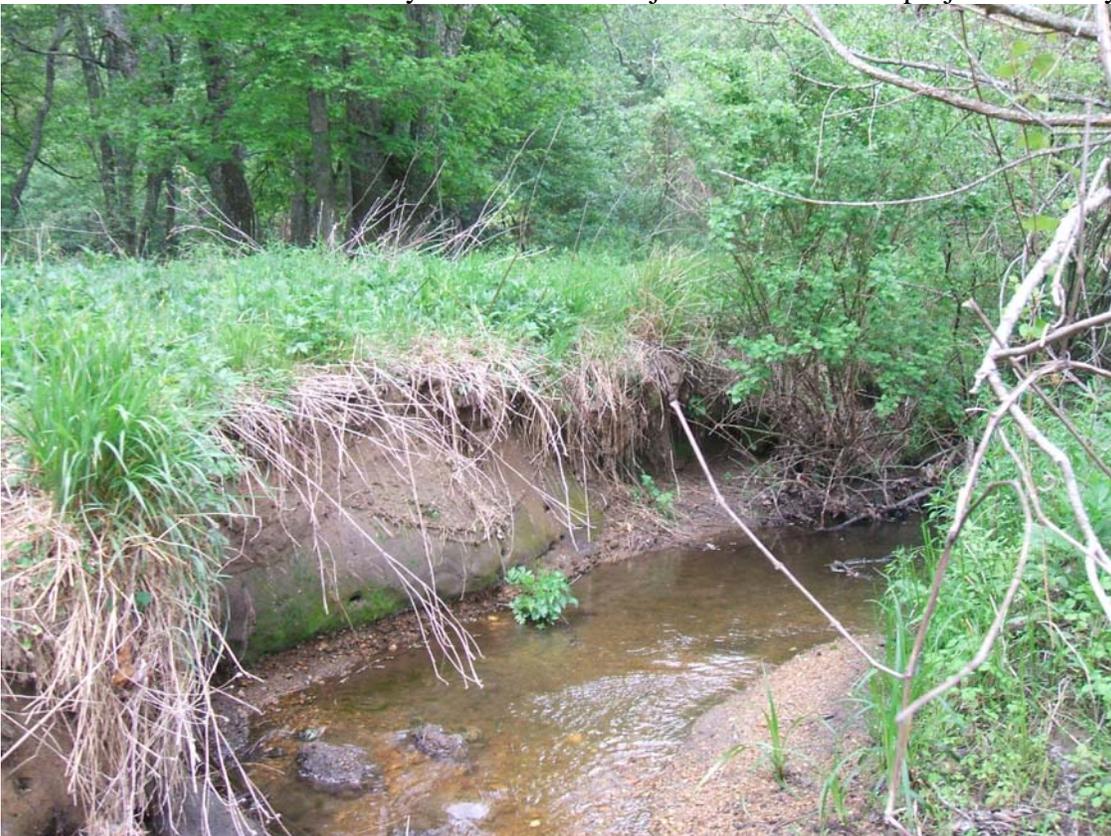
Upstream view of unnamed tributary at d/s end of property line, ~ sta 0+00

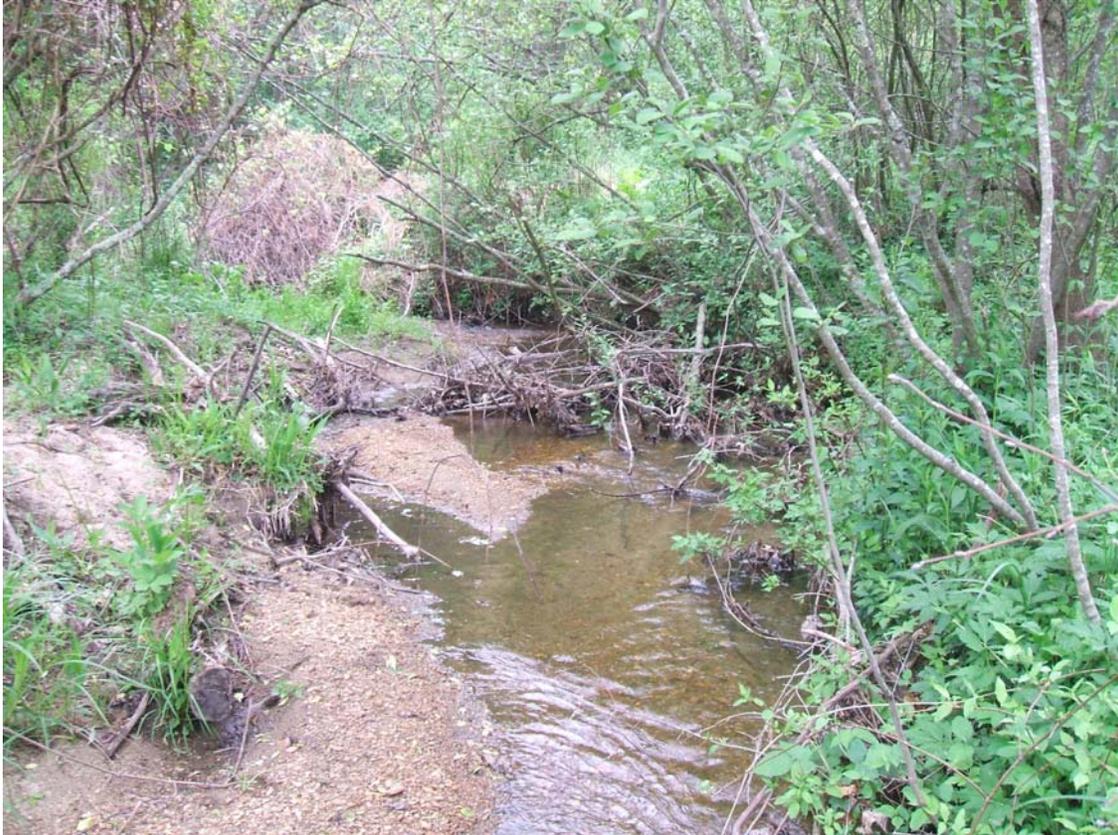
Upstream view at ~ sta 0+50 on unnamed tributary

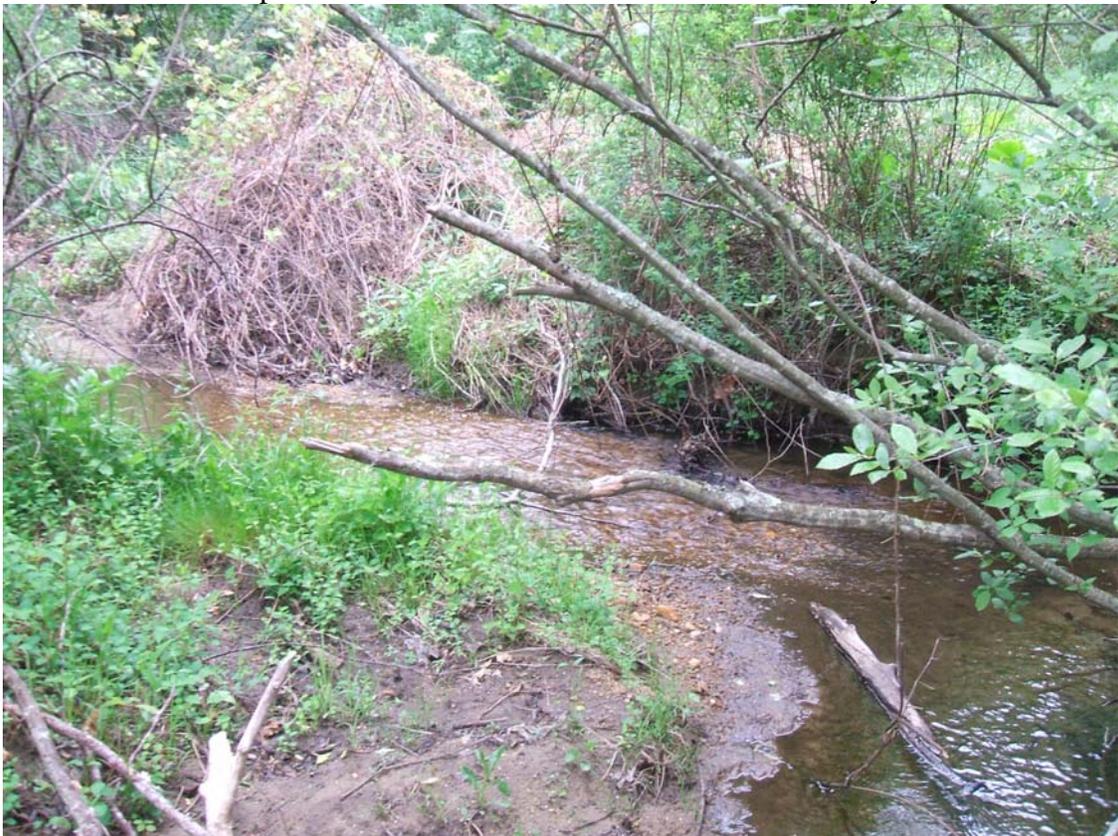
Upstream view at ~ sta 1+00 on unnamed tributary
