# RESTORATION PLAN

## Glade Creek Stream Restoration Alleghany County, North Carolina

Prepared for:  
NCDENR-Ecosystem Enhancement Program  
2728 Capital Blvd., Suite 1H 103  
Raleigh, NC 27604

December 2007

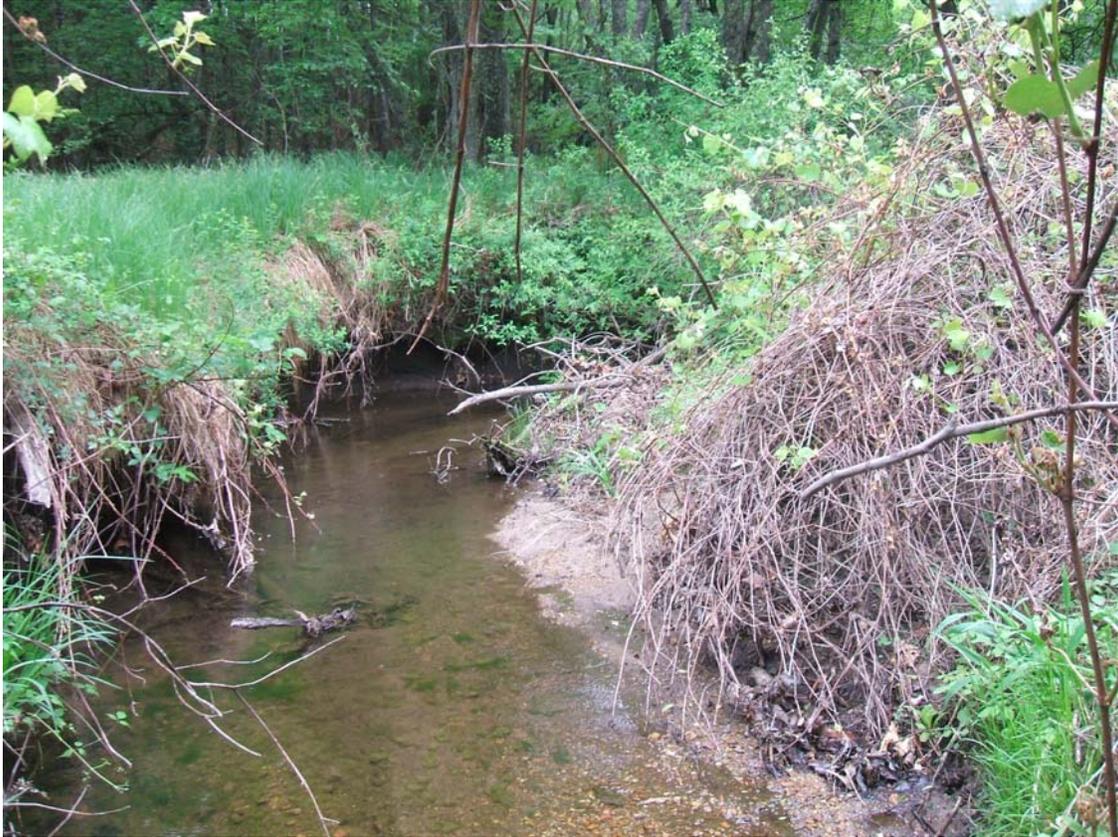
Upstream view at ~ sta 1+75 on unnamed tributary

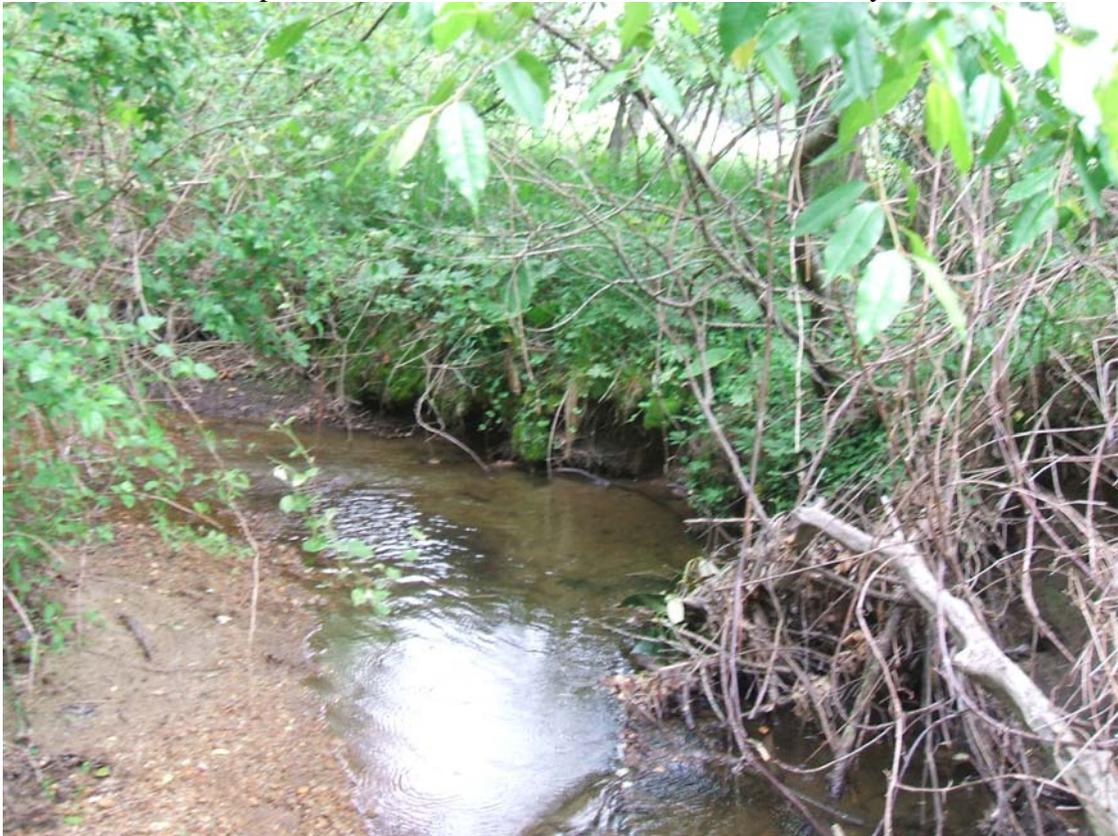
Upstream view at ~ sta 2+25 on unnamed tributary

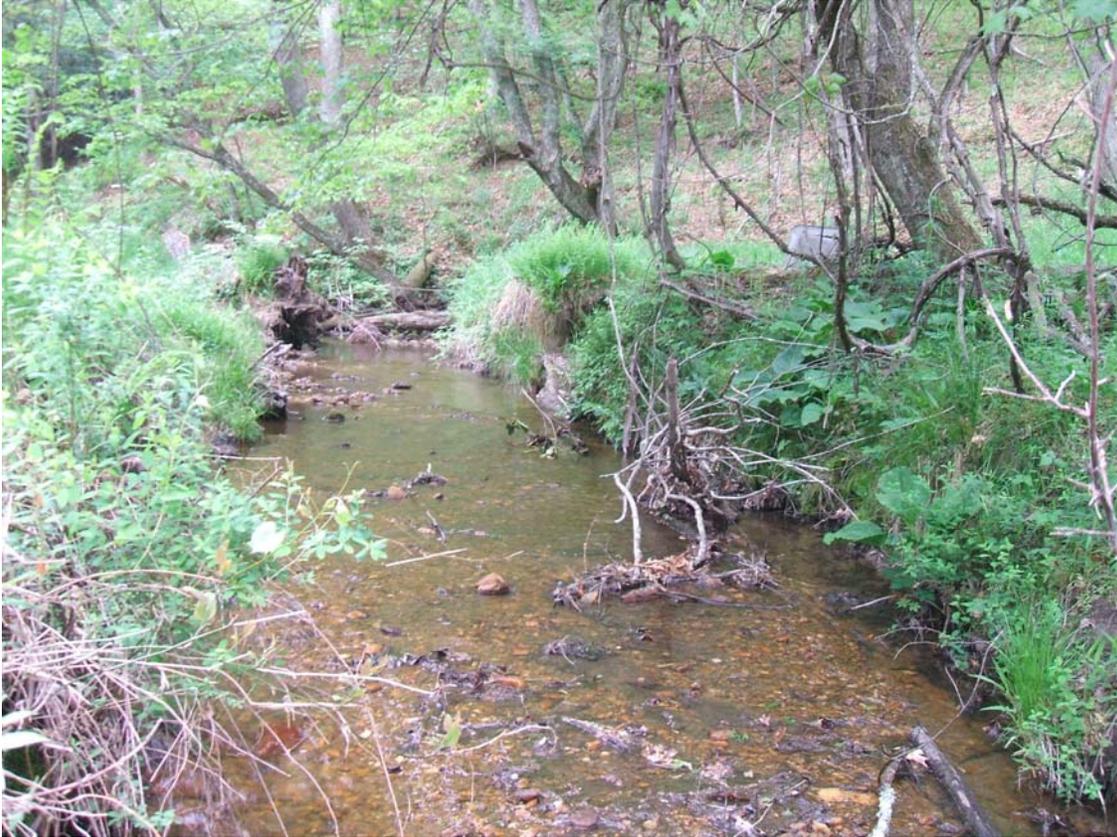
Upstream view at ~ sta 2+00 to u/s beginning of restoration reach on unnamed tributary

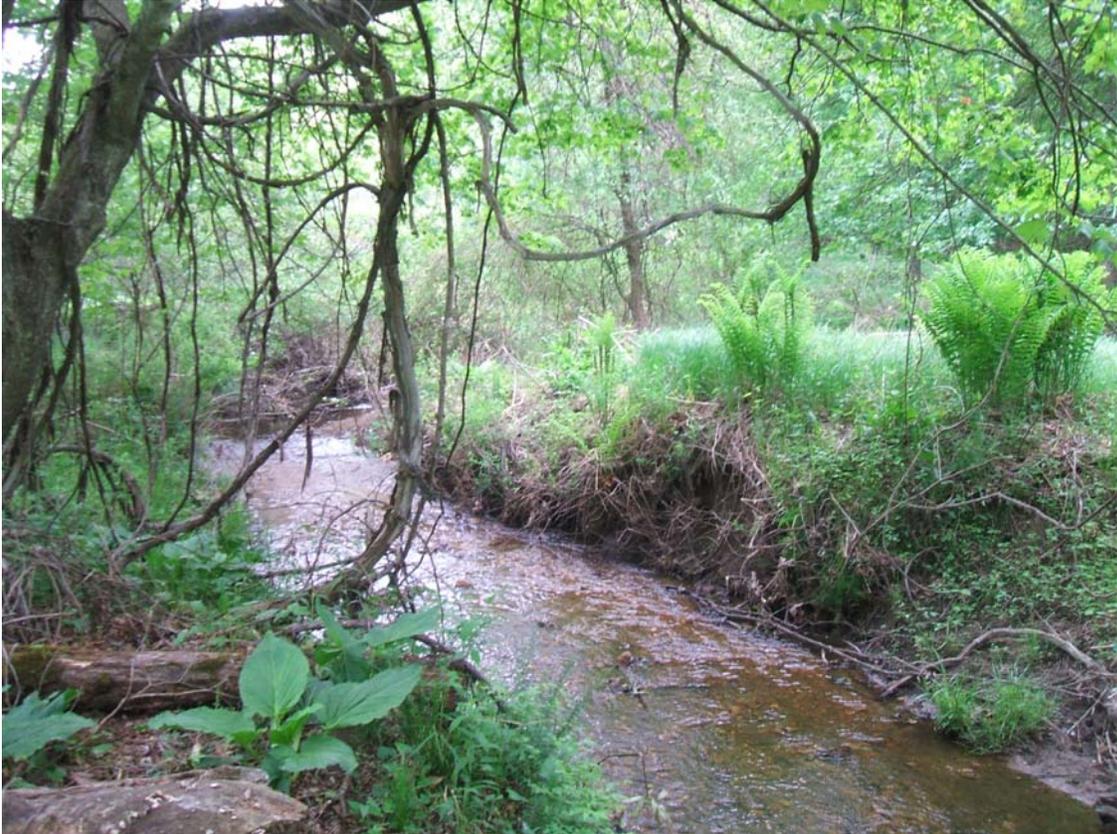
Downstream view at ~ sta 2+50, beginning of restoration reach, on unnamed tributary

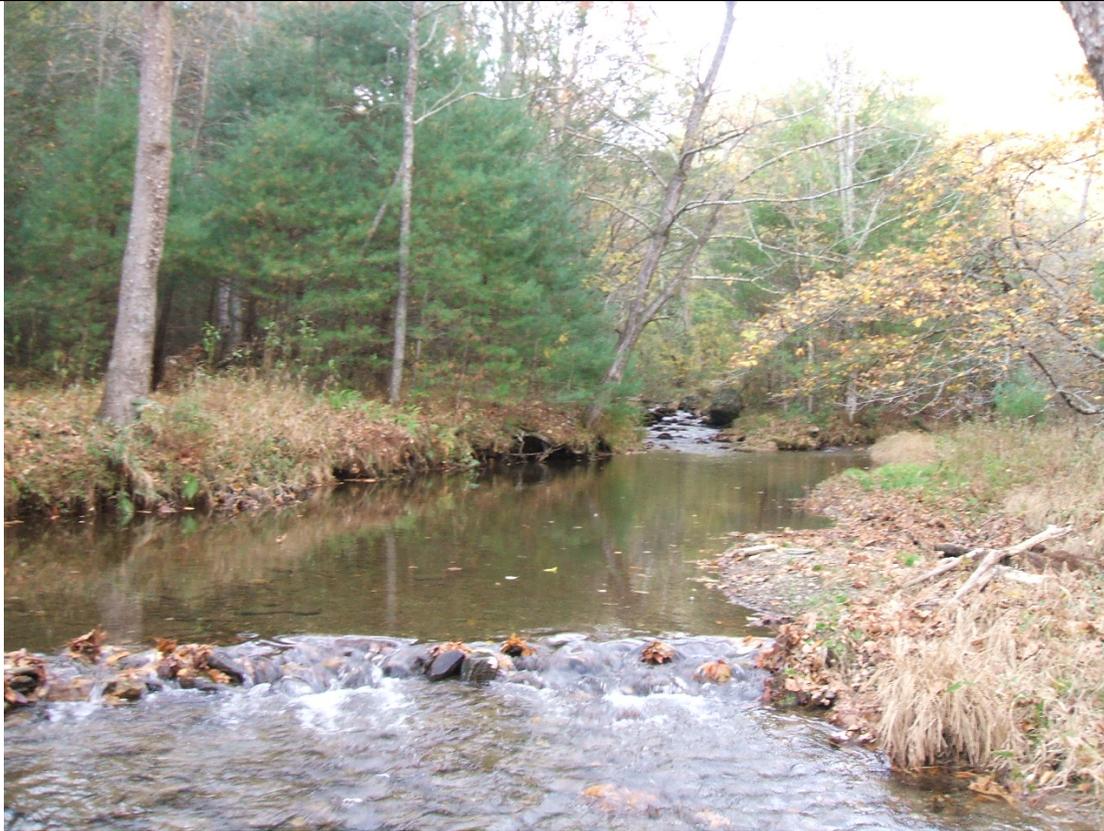
Upstream view at ~ sta 0+60 on Basin Creek

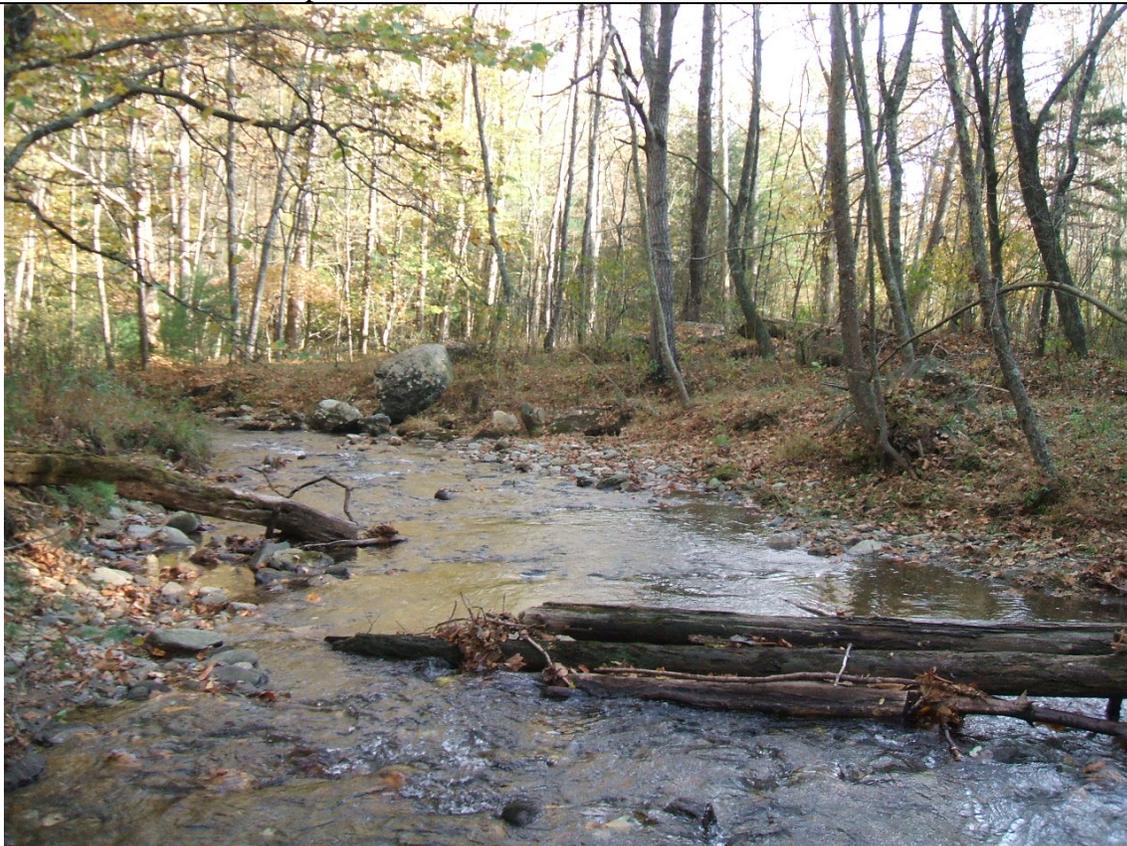
Downstream view at ~ sta +70, beginning of reference reach, on Basin Creek

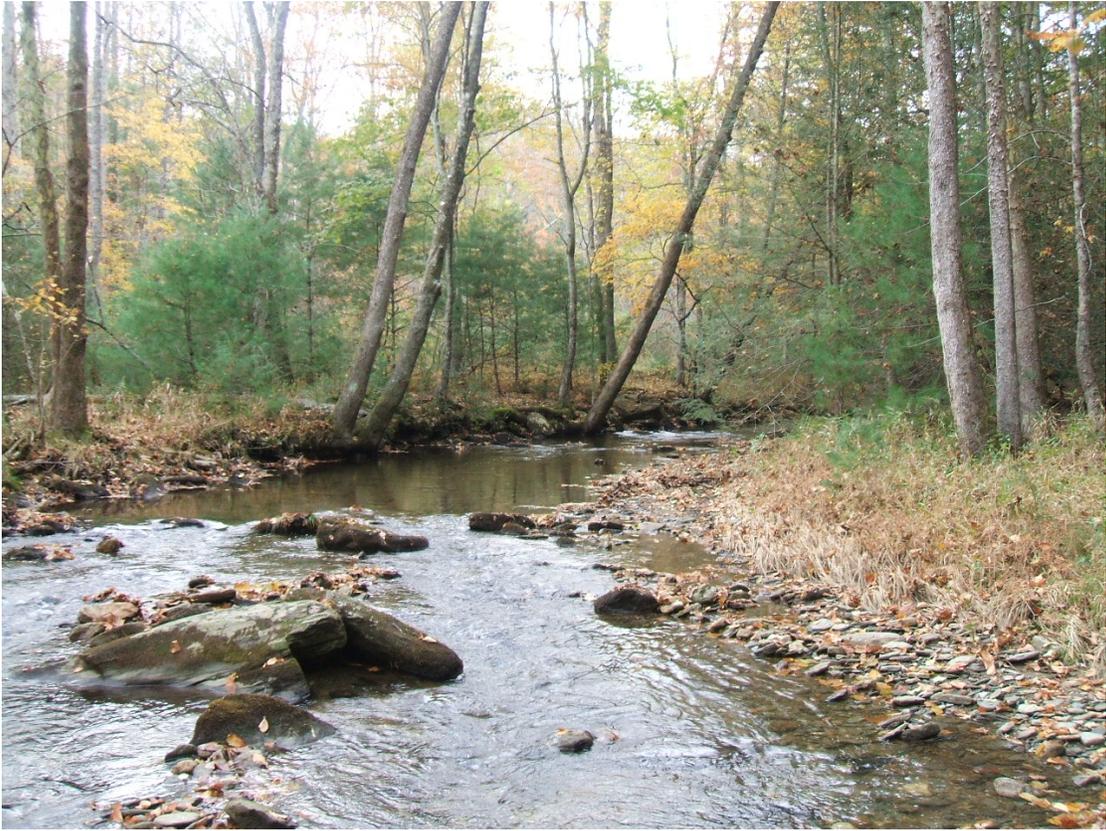
Upstream view of reference stream- Basin Creek

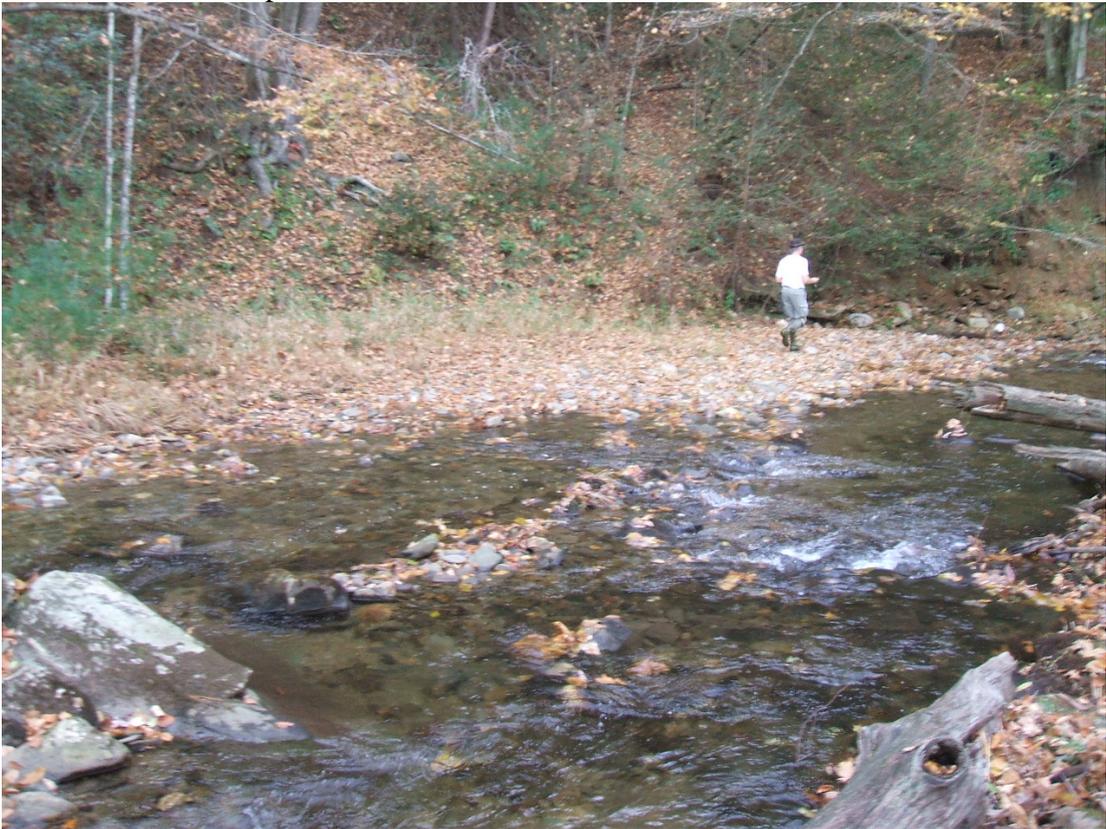
Downstream view of reference stream, Basin Creek
