# ANNUAL REPORT FOR 2003

**Grimesland Sand Pit Phase II Site**  
**Pitt County**  
**Project No. 8.T221801**  
**TIP No. R-2510 WM**

Office of Natural Environment & Roadside Environmental Unit  
North Carolina Department of Transportation  
December 2003

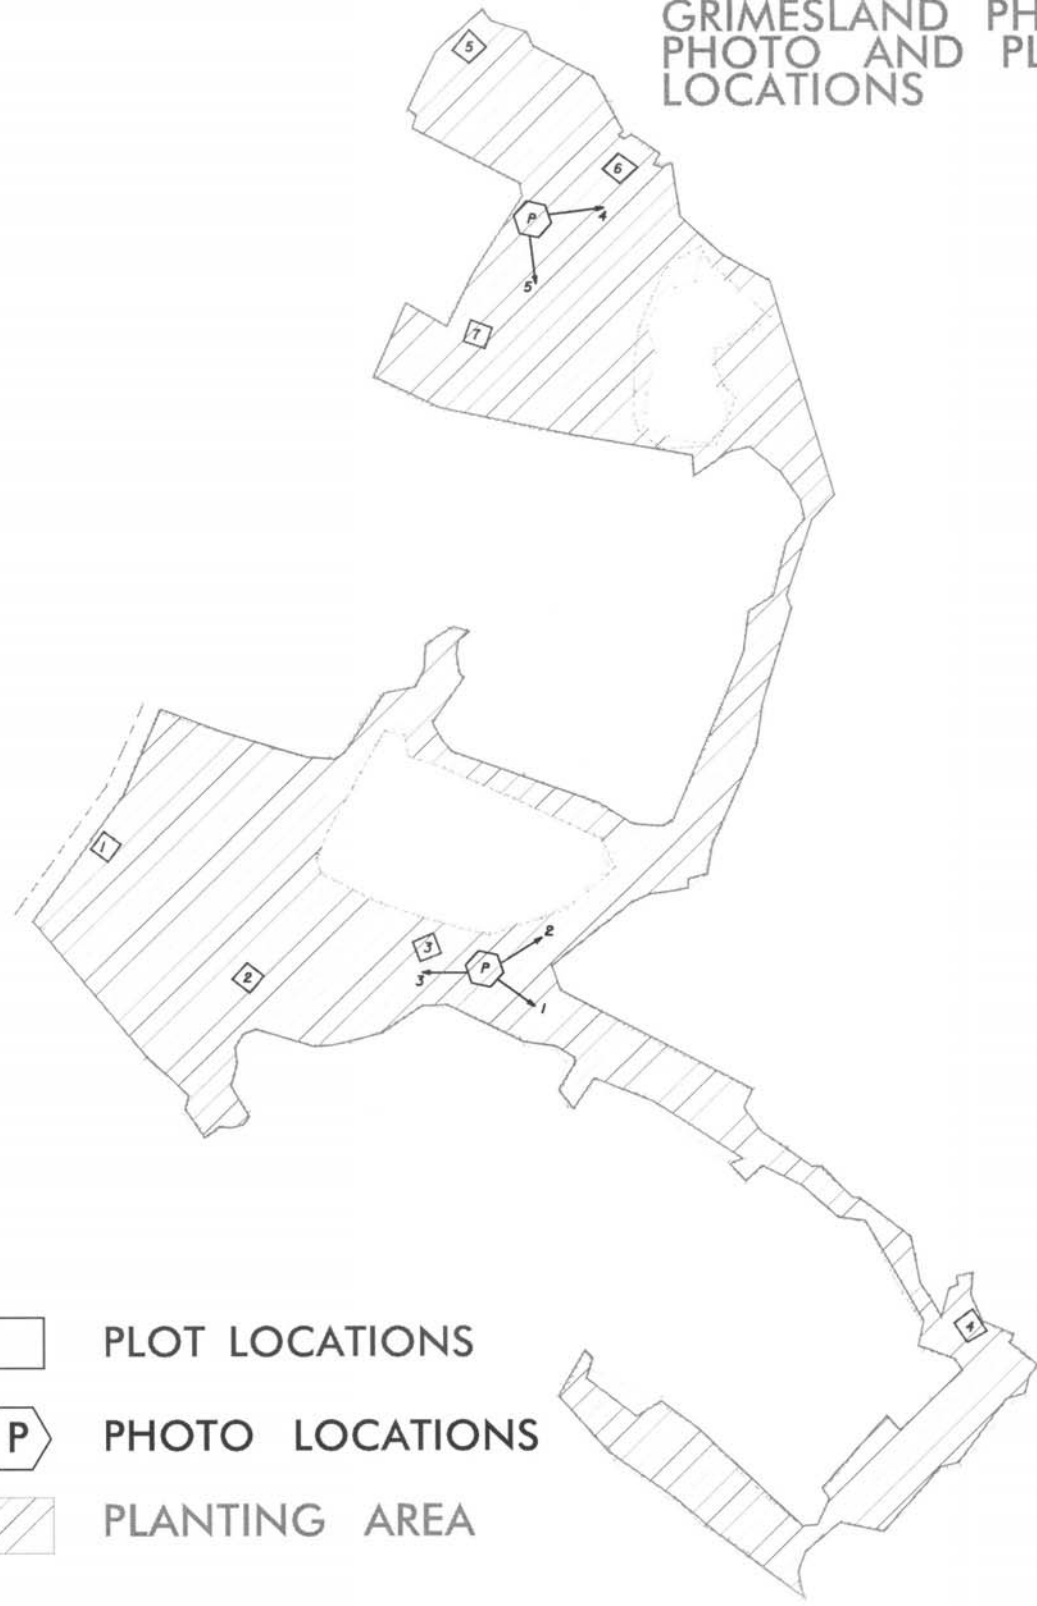
# GRIMESLAND PHASE II PHOTO AND PLOT LOCATIONS

-   PLOT LOCATIONS
-   PHOTO LOCATIONS
-   PLANTING AREA
