**Hammocks Beach Shoreline Stabilization and  
Wetland Restoration Project  
Hammocks Beach State Park  
Swansboro, Onslow County, North Carolina**

*2005 Annual Monitoring Report  
Year 5 of 5*

NCEEP Project Number: .00040  
BLWI Project Number: 050033  
NCDENR contract: D05056S

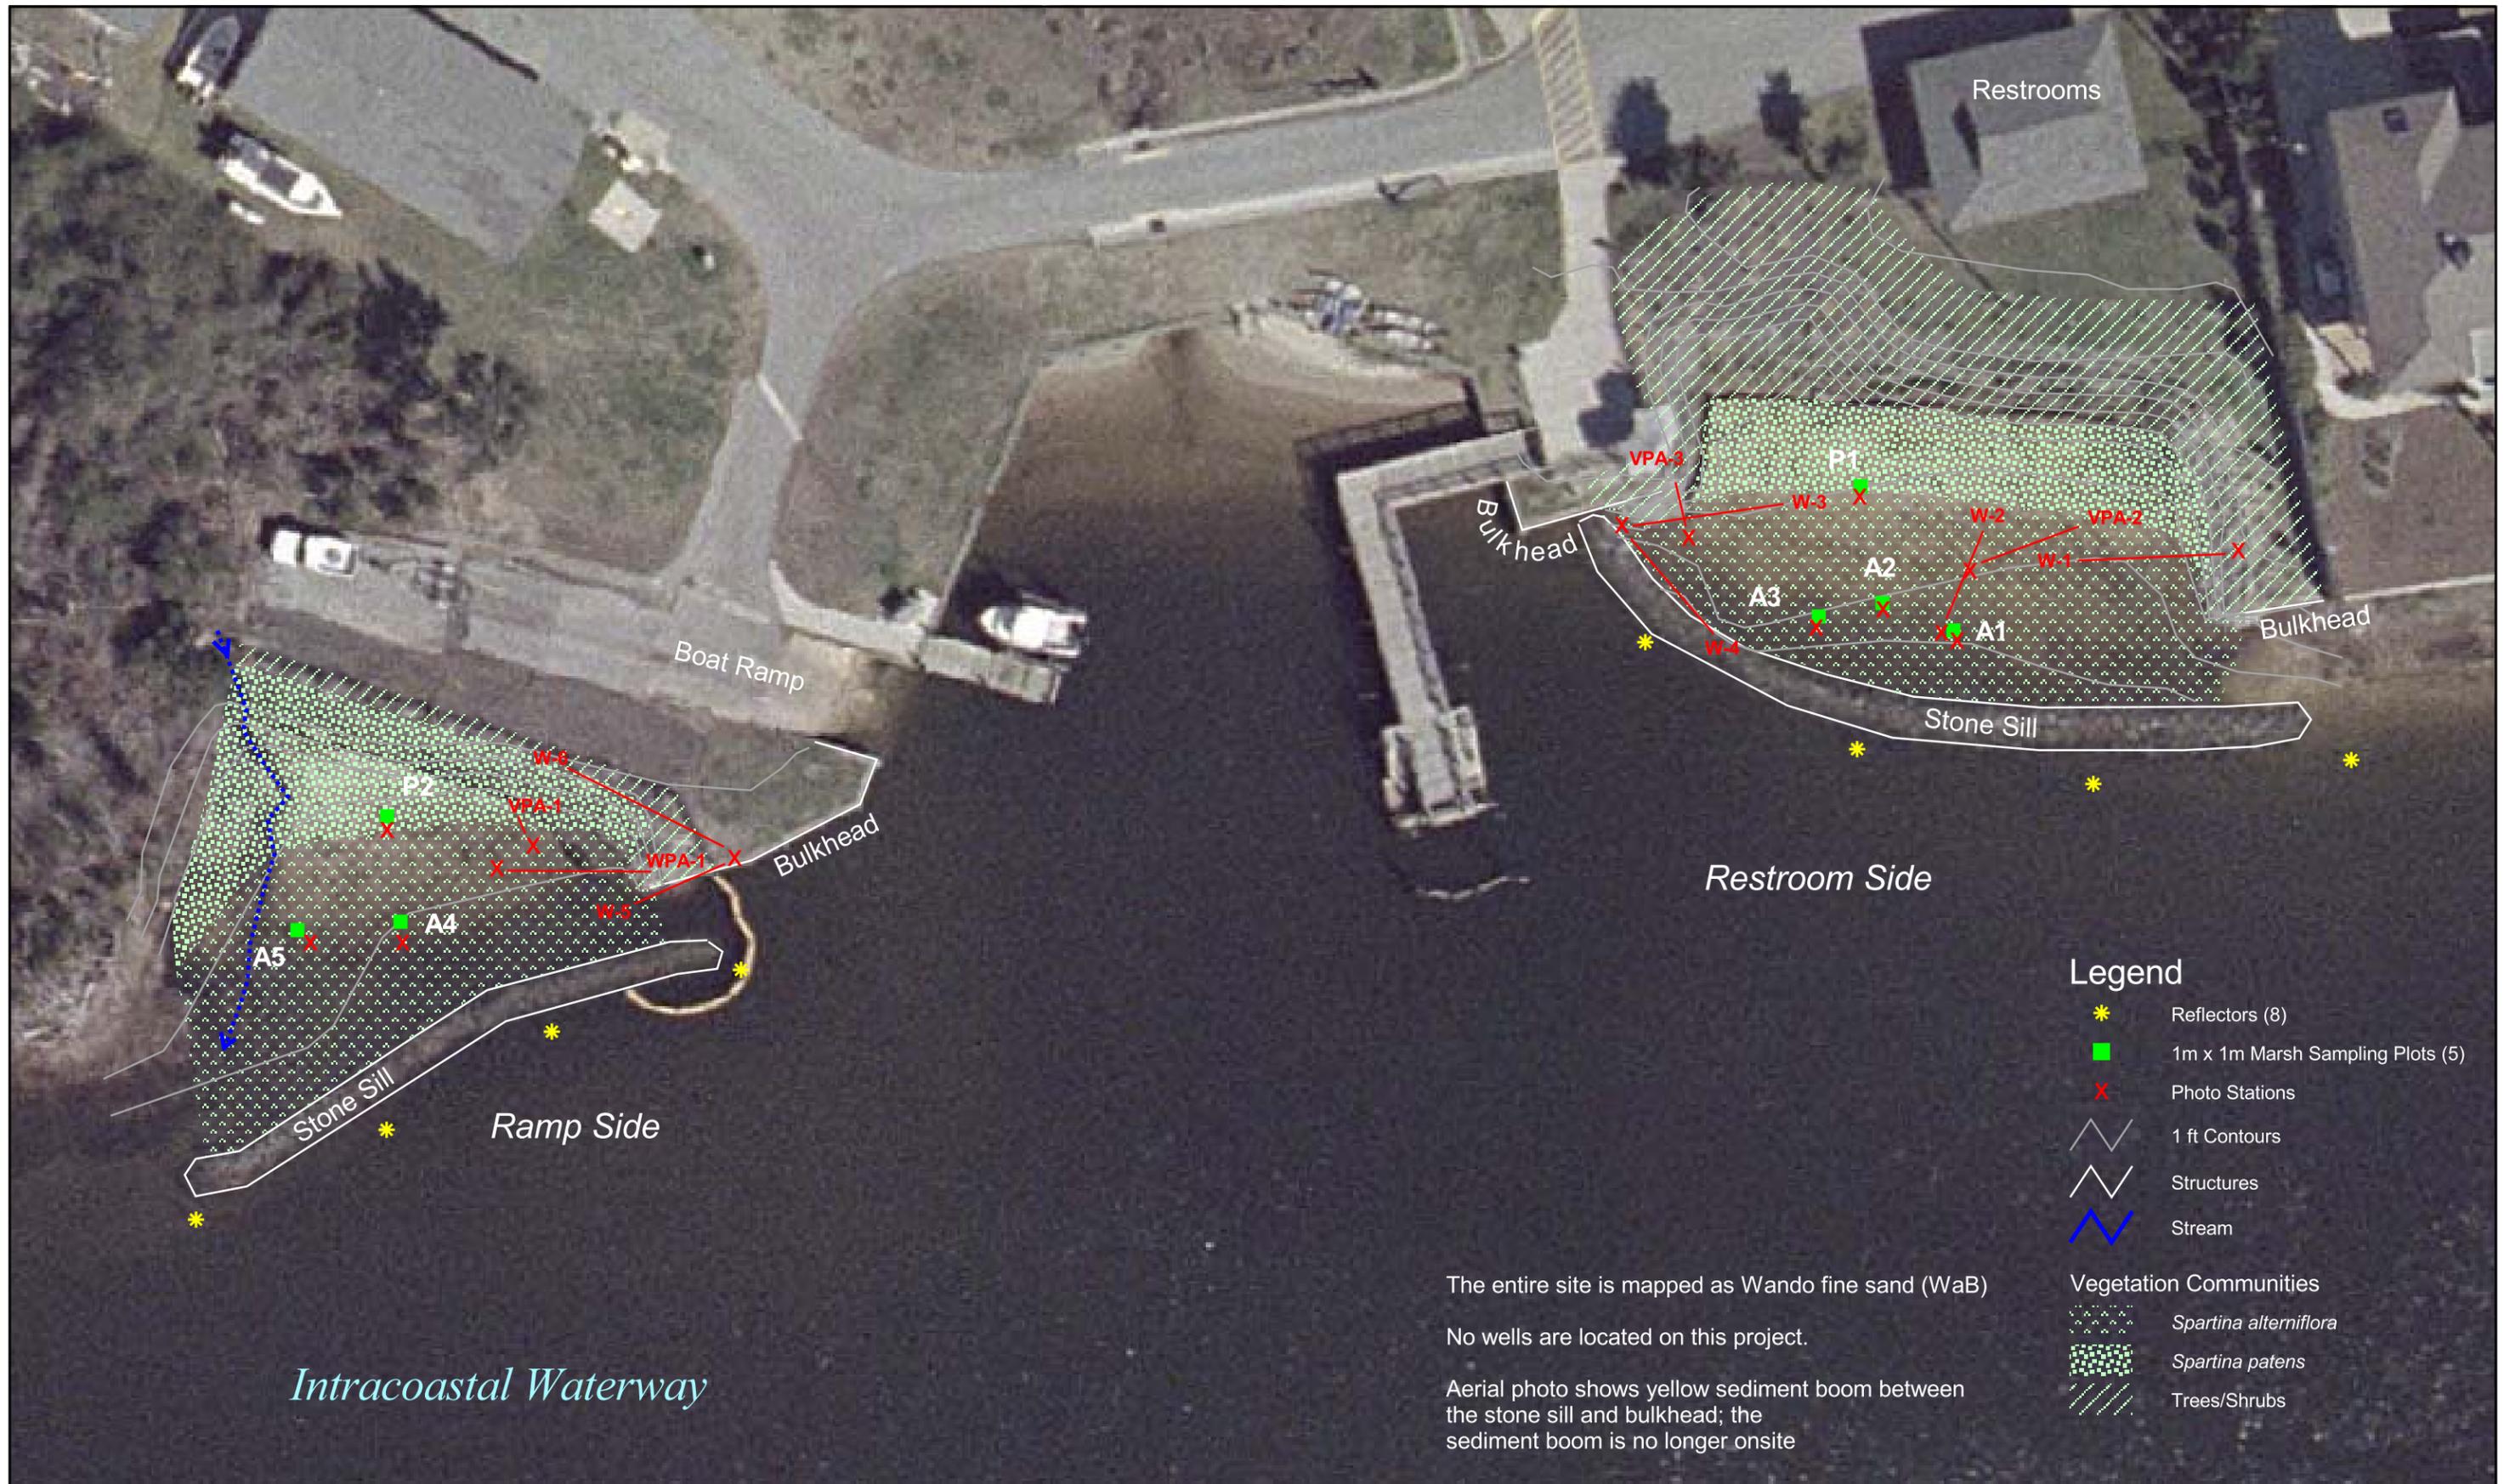
Figure 2. Monitoring Plan View  
 Hammocks Beach Shoreline Stabilization and Wetland Restoration Project  
 Hammocks Beach State Park, Onslow County, NC  
 2005 Annual Monitoring - Year 5 of 5

A total of seven 1m X 1m plots were monitored in the restored marsh area, five in the *Spartina alterniflora* and two in the *Spartina patens*. Height, stem counts and % cover were recorded in each plot.

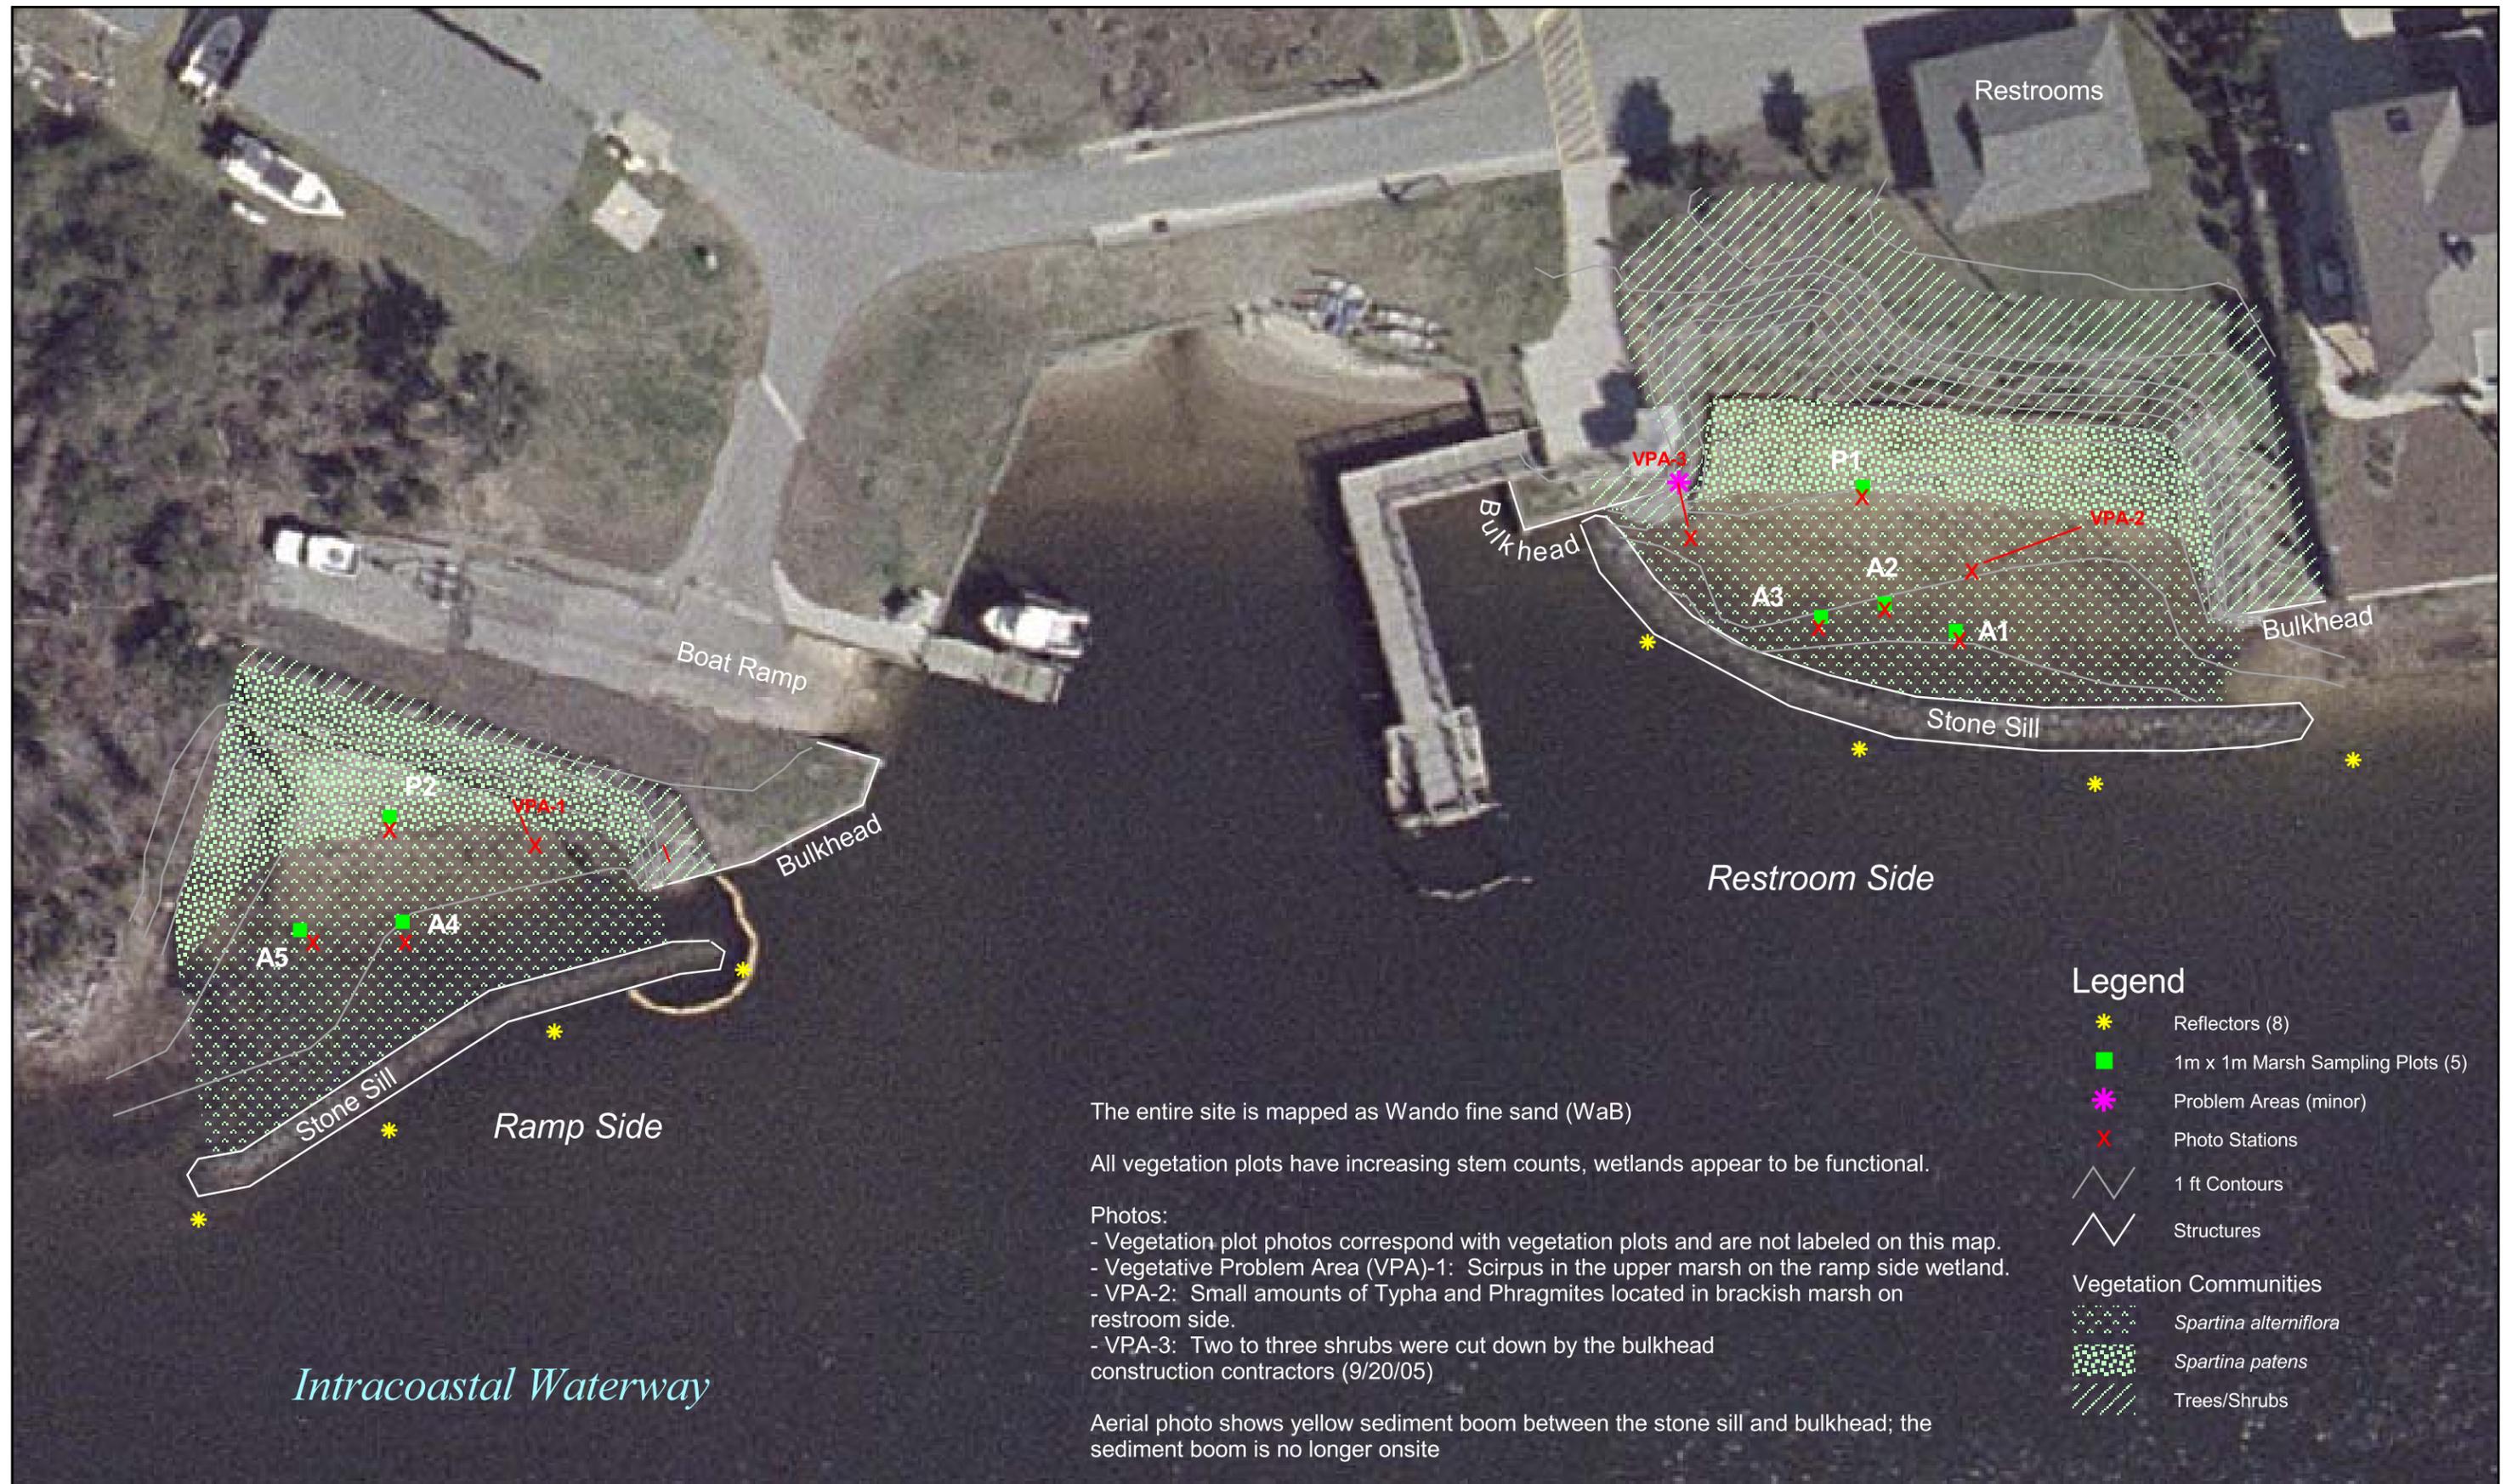
Figure 3. Vegetative Problem Area Plan View  
 Hammocks Beach Shoreline Stabilization and Wetland Restoration Project  
 Hammocks Beach State Park, Onslow County, NC  
 2005 Annual Monitoring - Year 5 of 5

Table VII. Vegetative Problem Areas			
Project Number and Name: 050033 Hammocks Beach Wetland			
Feature/Issue	Area	Probable Cause	Photo #
Volunteer Species	Ramp Side	<i>Scirpus</i> prolific within upper marsh area	VPA-1
	Restroom Side	Minor amount of <i>Typha</i> and <i>Phragmites</i> located in marsh	VPA-2
Vegetation Removal	Shrubs-Restroom Side	A few shrubs removed due to bulkhead construction	VPA-3
Vegetation Damage	Shrubs-Ramp Side	Minor shrub damage likely due to bulkhead construction equip.	VPA-4
Wetland Impact	Ramp Side	Fill placed in small area at the end of the bulkhead	VPA-4

The plan view shows the location of the noted problems.

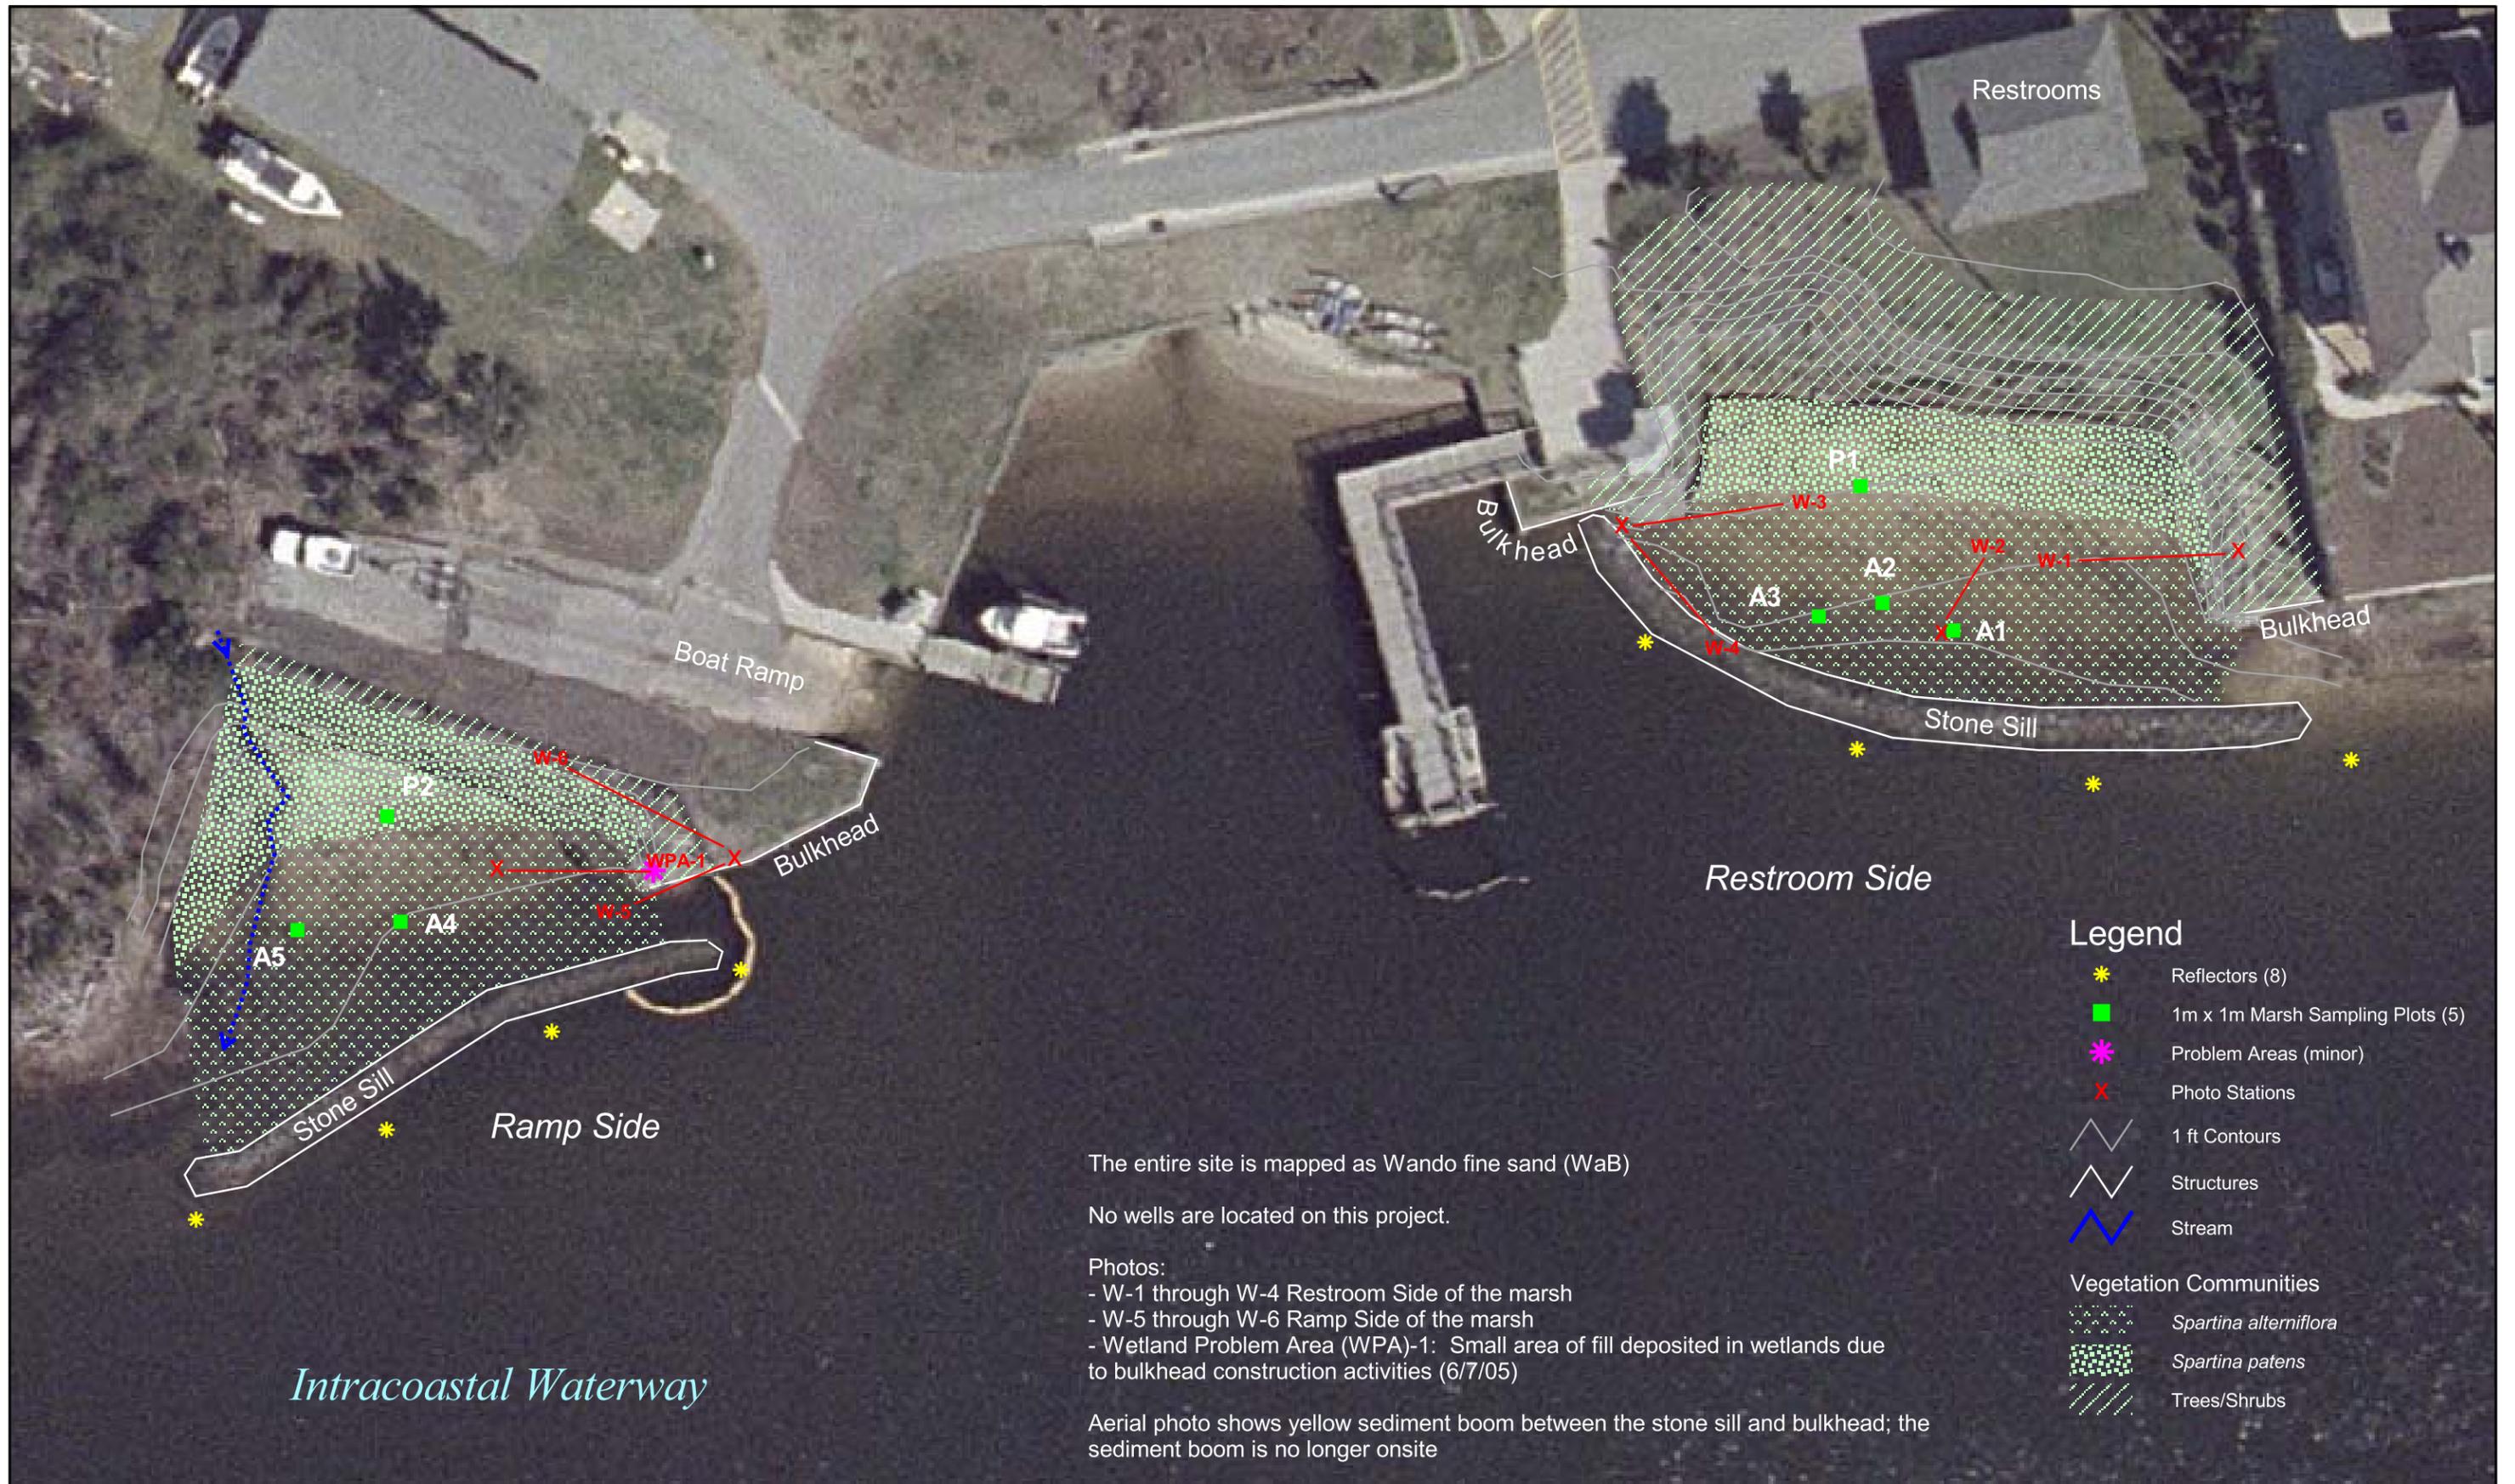
Figure 4. Wetland Problem Area Plan View  
 Hammocks Beach Shoreline Stabilization and Wetland Restoration Project  
 Hammocks Beach State Park, Onslow County, NC  
 2005 Annual Monitoring - Year 5 of 5

There are no wells present on the Hammocks Beach project. The salt marsh appears to exhibit appropriate hydrology to support the targeted marsh grass species.

- W-1 through W-4 Restroom Side of the marsh
- W-5 through W-6 Ramp Side of the marsh
- Wetland Problem Area (WPA)-1: Small area of fill deposited in wetlands due to bulkhead construction activities (6/7/05)

Aerial photo shows yellow sediment boom between the stone sill and bulkhead; the sediment boom is no longer onsite

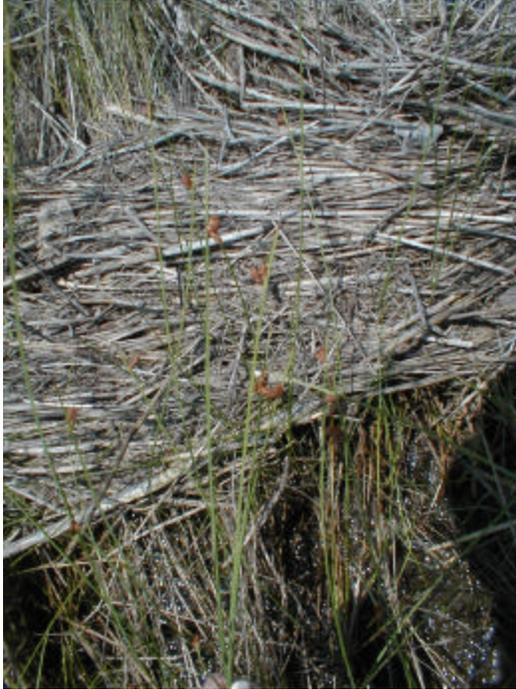
Monitoring results show that the planted marsh is doing well. Both species are surviving with minimal invasion from non-planted species. *Scirpus americanus*, *Aster sp.* and *Limonium sp.* are present in the transition zone, but this is a common occurrence within natural marshes. The range for the number of stems counted in the *S. alterniflora* plots doubled from 2004 to 2005. Recorded heights and % cover of both species are comparable to the previous years.

VPA-1 *Scirpus americanus*

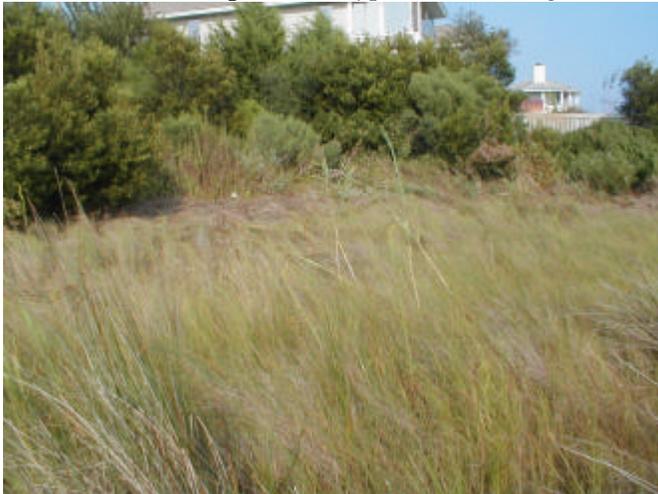
Small patches of *Typha sp.* and *Phragmites australis* were noted on the east/restroom side. An application of a herbicide may be necessary if these areas increase in size.

VPA-2 Invasive species – *Typha* and *Phragmites*

Problems areas are few. There is some presence of *Typha sp.* and *Phragmites australis* which could be controlled with spraying. Most impacts of vegetative loss are in the shrub/scrub zone during repairs to the bulkhead.

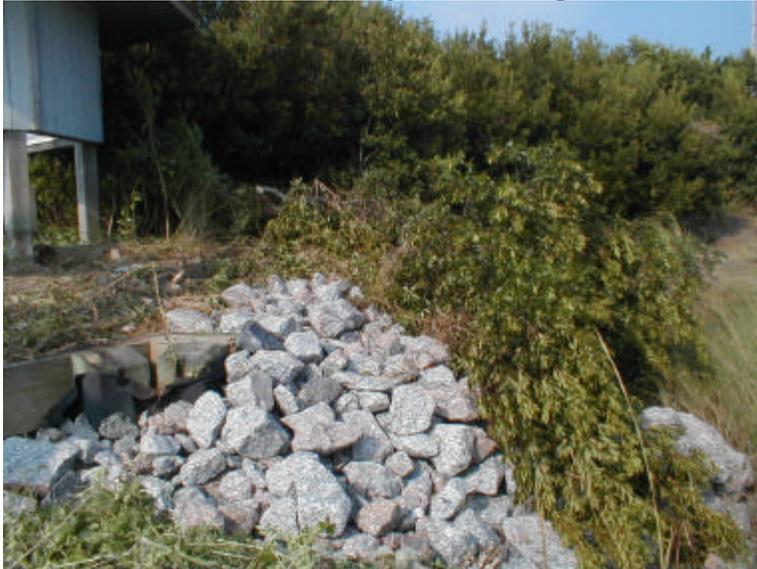
Except for those shrubs removed during recent bulkhead repair, there is good growth and survival of the planted species.

VPA-3 Shrubs removed during bulkhead replacement

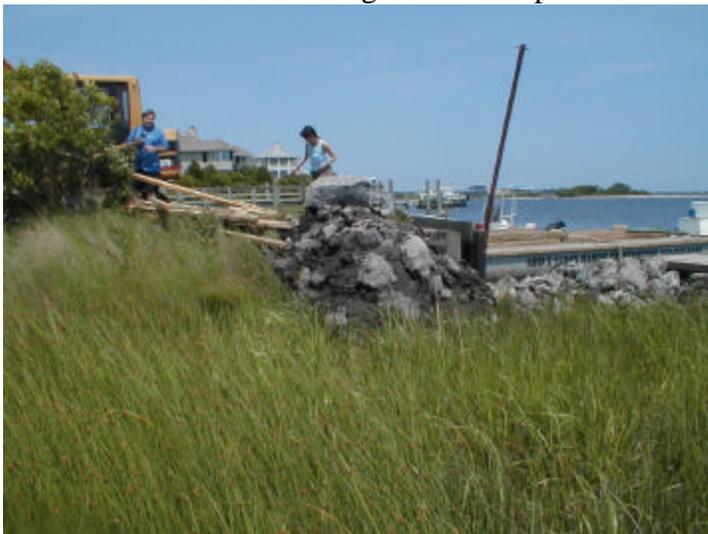
VPA-4 Fill in wetland during bulkhead replacement

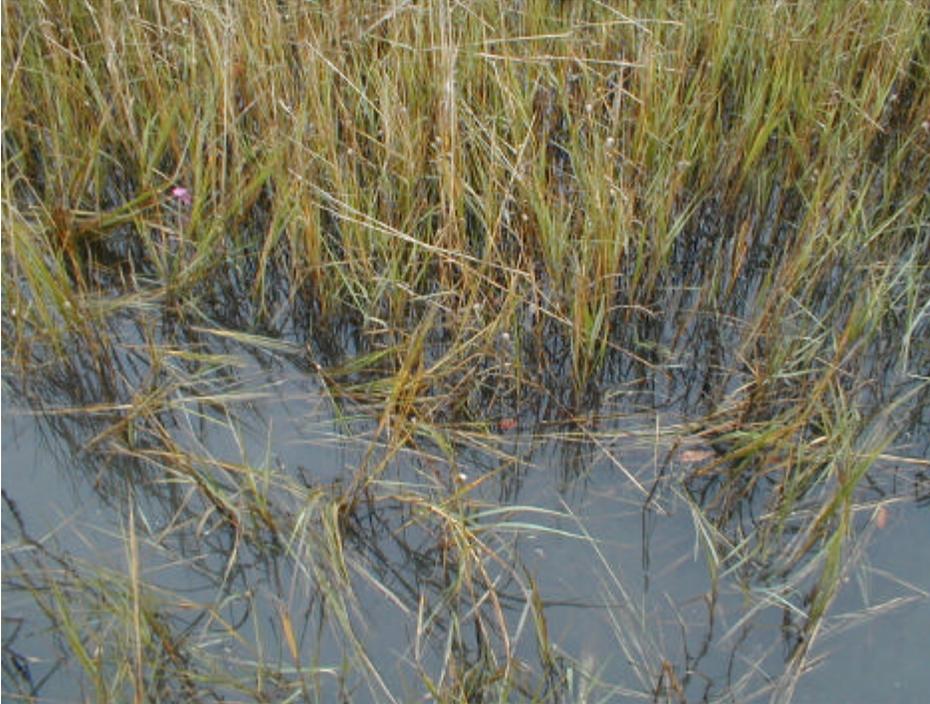
**Plot 1 *S. alterniflora***

Table VIII. Stem Counts (Marsh Transects)				
Project Number and Name: 050033 Hammocks Beach Wetland				
Transect 1 – East – Restroom Side				
Species	Plot	Count	Height (m)	Cover%
<i>Spartina alterniflora</i>	A1	423	0.5-0.9	65
	A2	295	0.6-1.1	40
	A3	303	0.5-1.0	55
<i>Spartina patens</i>	P1	n/a	0.9-1.2	90
Transect 2 – West – Ramp Side				
Species	Plot	Count	Height (m)	Cover%
<i>Spartina alterniflora</i>	A4	317	0.7-1.5	45
	A5	274	0.7-1.2	45
<i>Spartina patens</i>	P2	n/a	0.9-1.1	85
