**HAW RIVER SWAMP WETLAND RESTORATION SITE
ANNUAL WETLAND MONITORING REPORT
YEAR 5 (YEAR 2009)
GUILFORD AND ROCKINGHAM COUNTIES, NORTH CAROLINA
CONTRACT #'S AW03001 and D04011**

August 2009

**HAW RIVER SWAMP WETLAND RESTORATION SITE
ANNUAL MONITORING REPORT
YEAR 5 (2009)
GUILFORD AND ROCKINGHAM COUNTIES, NORTH CAROLINA**

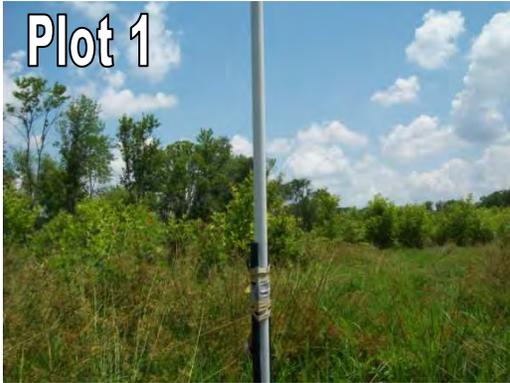
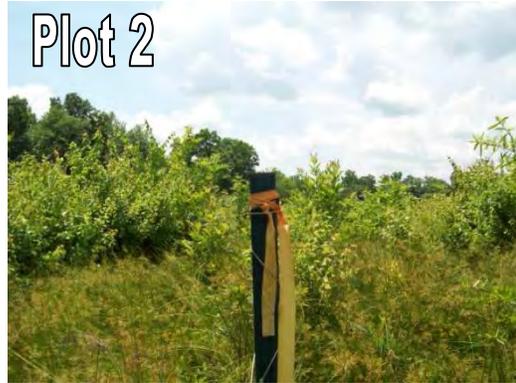
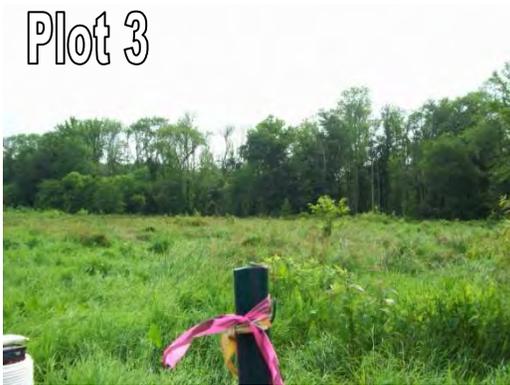
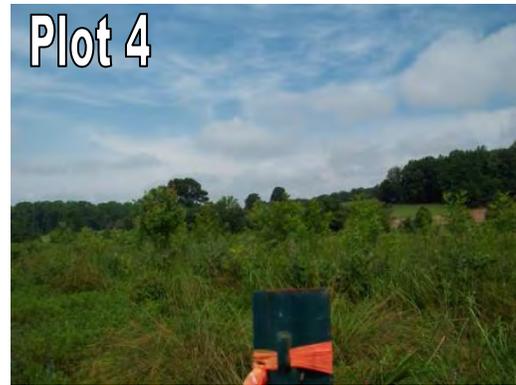
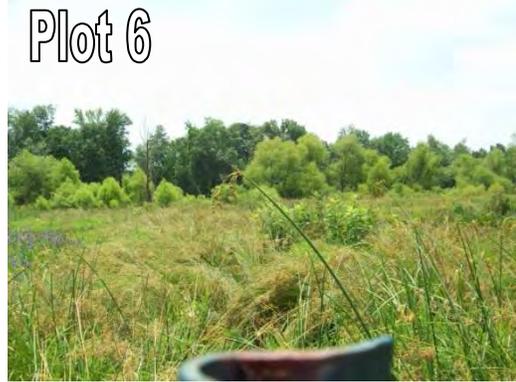
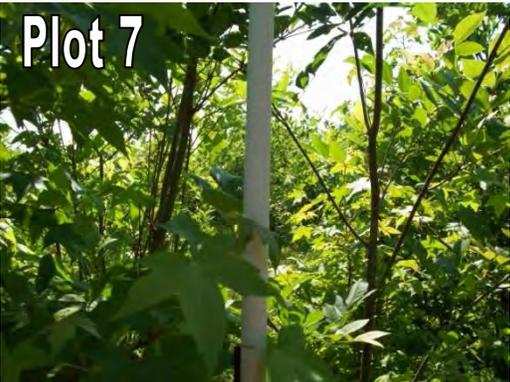
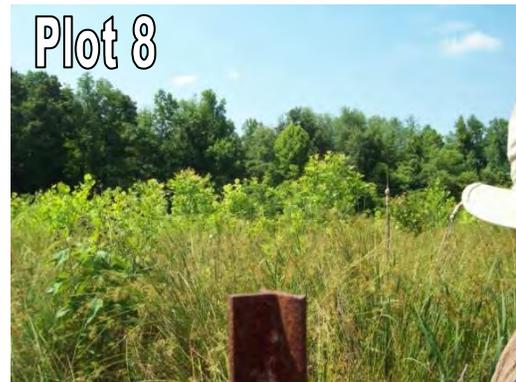
**Haw River Swamp Wetland Restoration Site
Year 5 (2009) Annual Monitoring
Vegetation Plot Photographs (Taken June 2009)**

Quantitative sampling of vegetation was conducted in June 2009. Results are provided in Table 5. Vegetation success criteria for year 5 (260 tree stems per acre) were exceeded for the 2009 annual monitoring year with an average of 1597 stems per acre across the Site. In addition, each individual vegetation plot met success criteria with the exception of plot number 3. This plot is primarily characterized by herbaceous freshwater emergent vegetation including swamp rosemallow (*Hibiscus moscheutos*), arrowhead (*Sagittaria* sp.), toothcup (*Rotala ramosior*), Pennsylvania smartweed (*Polygonum pensylvanicum*), and various other smartweeds (*Polygonum* spp.). However, the number of woody stems within this plot continues to increase each year with the establishment of natural recruits; this trend is expected to continue.
