**FINAL MONITORING REPORT
YEAR 4 of 5**

**Hockett Dairy Site
Riparian Buffer Restoration
DMS Project ID Number 003993 – DMS Site 95013**

**Randolph County, North Carolina
Cape Fear River Basin
HUC 03030003010070**

**Construction Completed: October 2012
Data Collection Period: December 2016
Submission Date: January 2017**

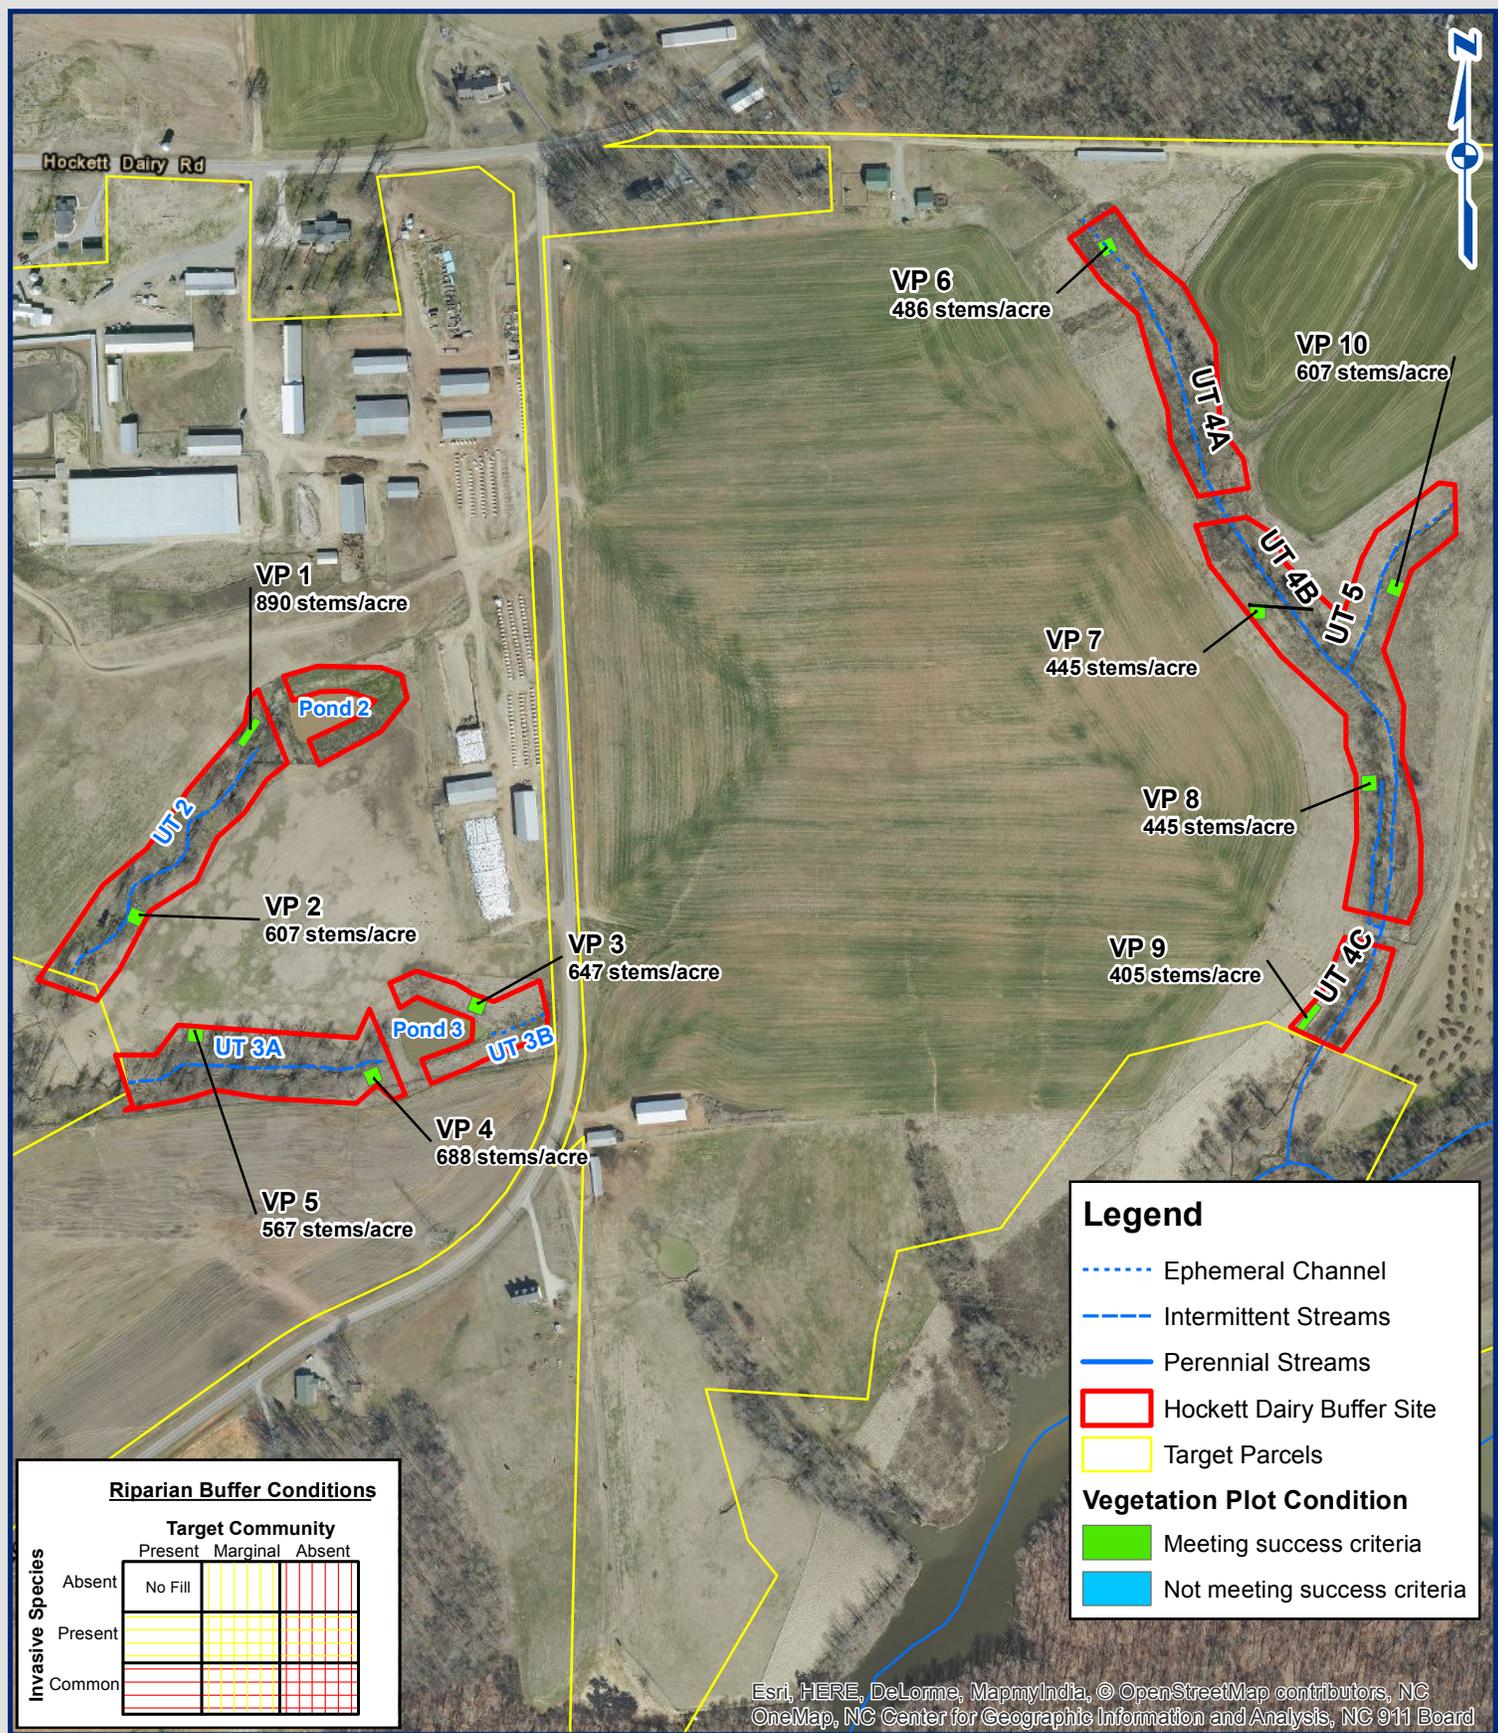
Figure 2a. Current Condition Plan View
 Hockett Dairy Riparian Buffer Restoration Site

The measure of vegetative success for the site is the survival of at least 320 five-year old planted trees per acre at the end of year five of the monitoring period. During early December 2016, CVS Level 2 was performed in Year 4 to document any volunteer generation. A total of 15 volunteers were observed across all 12 vegetation plots. Year 4 monitoring recorded an average of 594 planted stems per acre and 644 total stems per acre (planted and volunteers) across all vegetation plots. All plots achieved success criteria in Year 4 and are on track to meeting the Year 5 success criteria. During MY3 activities, low stem density areas around vegetation plots 2, 6, and 7 were identified. A supplemental replant was performed in these low density areas as well as any sparsely vegetated area across the site during April 2016. Approximately 500 1-gallon containerized trees were planted throughout these areas. Tree species planted during the supplemental replant included River Birch (*Betula nigra*), Northern Red Oak (*Quercus rubra*), Swamp Chestnut Oak (*Quercus michauxii*), and Green Ash (*Fraxinus pennsylvanica*). On June 10th 2016, DMS and North Carolina Division of Water Resources conducted a site inspection to evaluate the supplemental replanting and site conditions. MY4 conditions are shown on the Current Condition Plan View which is provided in **Appendix B, Figure 2**.
