Mitigation Plan
Horne Creek Tributaries Mitigation Project
Surry County, North Carolina
FINAL VERSION

NCDEQ DMS Project Identification # 100026
NCDEQ DMS Contract # 7181
Yadkin River Basin (Cataloging Unit 03040101)
USACE Action ID Number: SAW-2017-01510
Contracted Under RFP # 16-006993

July 2019

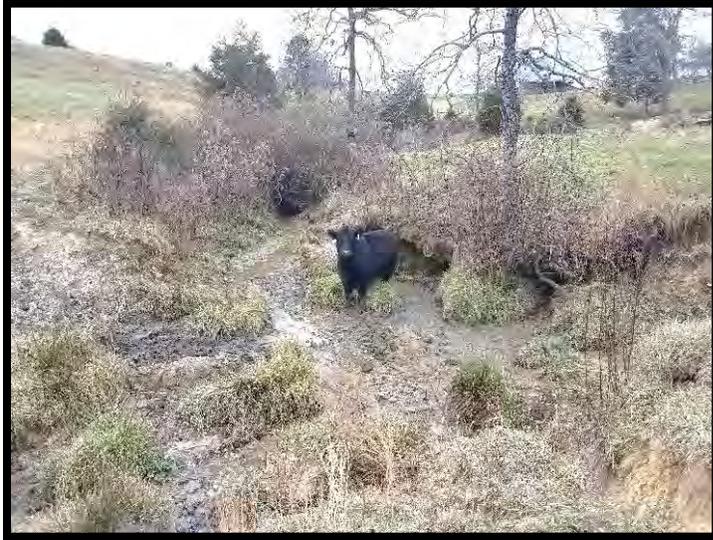
Photo of R1 showing severe cattle trampling and a lack of woody riparian buffer vegetation.

ratios throughout R1 exceed 4.0 and the reach has a low sinuosity ($k=1.12$). Severe bank erosion and channel aggradation was observed throughout the reach. A few larger mature trees exist along the downstream portion; however, cattle have unrestricted access to 100 percent of R1, which has resulted in sparse understory vegetation establishment.

R1 is actively subject to water quality stressors, mainly in the form of cattle trampling and minimal riparian buffer widths. Based on the existing channel conditions and historic anthropogenic disturbances, R1 is classified as a severely incised E5b/F5b stream type throughout most of its length.

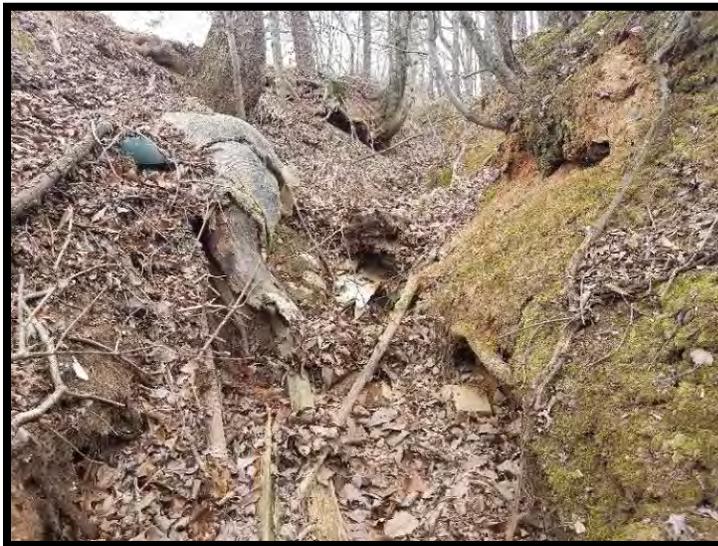
Looking upstream at headcut, debris in channel, and severe bank erosion along R2.

The channel is severely incised in most locations. Cattle intrusion has degraded the riparian and aquatic habitat and many areas has resulted is poor channel definition. Bank erosion is widespread throughout as a result of hoof shear and lack of deep rooting vegetation. The riparian buffer along most of the reach is nonexistent as a result of the removal of riparian vegetation along both streambanks.

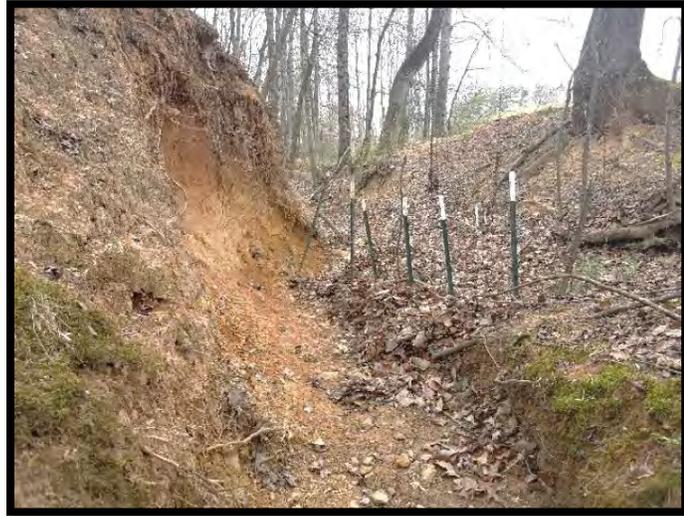
Photo depicts degraded stream channel conditions along R2 near its confluence with R3.

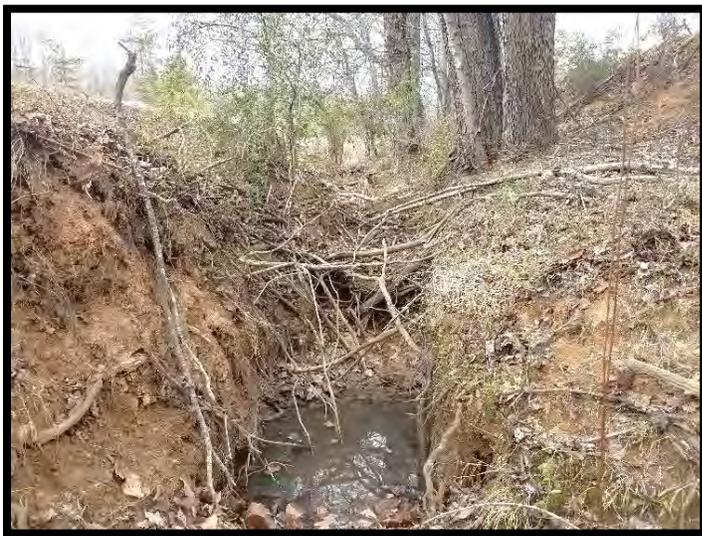
R3 looking upstream towards existing headcut from confluence with R2 and R4.

Bank erosion is widespread throughout the reach. The entire reach is subject to active water quality stressors, mainly resulting from hoof shear from unrestricted cattle access and little to no riparian buffers on the streambanks. Based on the existing conditions, R3 is classified as an incised E6b stream type.

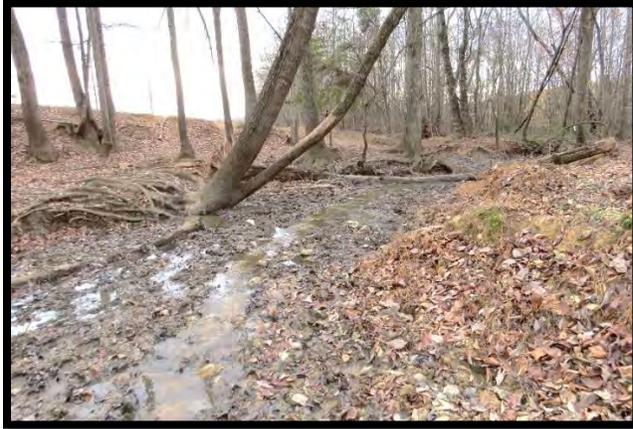
Looking downstream at cattle wallowing area of R4. Note poor channel definition resulting from cattle intrusion.

The lower end of R4 at its confluence with R4a has poor channel definition resulting from cattle intrusion and associated trampling and wallowing. R4 is subject to water quality stressors, mainly in the form of cattle access and minimal riparian buffer widths. Based on the existing channel conditions and anthropogenic disturbances, R4 is classified as B4 stream type for most of its length.

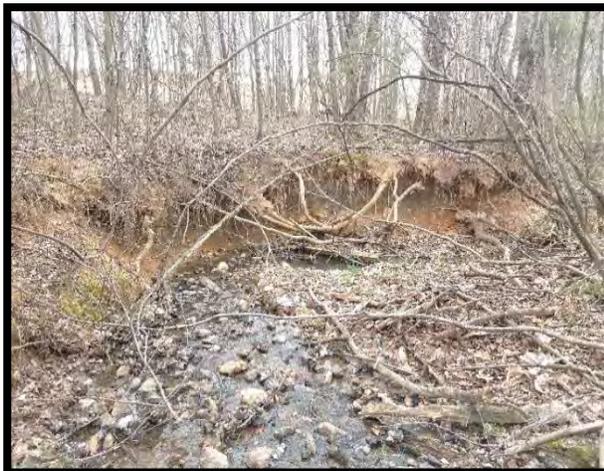
Looking downstream along R5. Note severe bank erosion and lack of mature buffer vegetation.

The channel is severely incised and the upper 1,400 feet exhibits moderate planform geometry. The lower 1,120 feet of the reach appears to have been manipulated and straightened. This is evidenced through its position in valley and observed spoil piles along the top of the streambanks. Bank erosion is widespread throughout this reach. The riparian buffer is nonexistent or consists of immature vegetation, and there is clear evidence that the riparian vegetation has been removed along both streambanks.

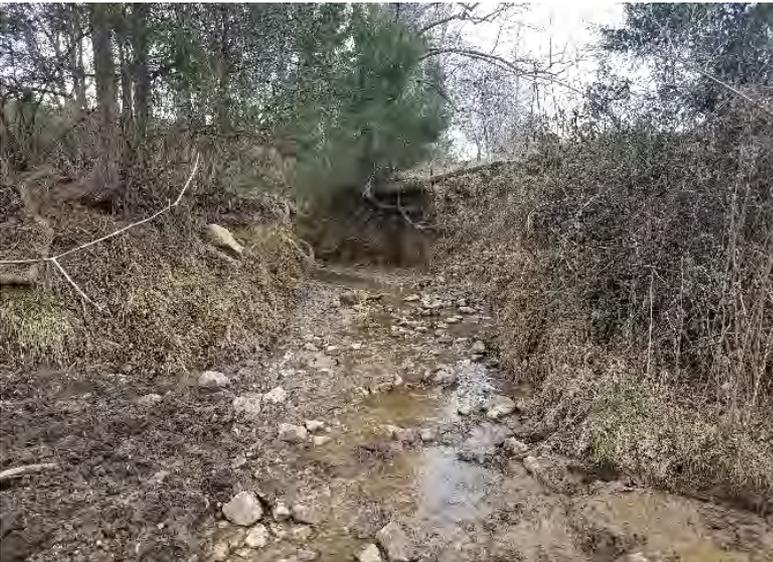
Photo 1: R1 – Looking upstream at bank erosion and incision (1/2/2017)

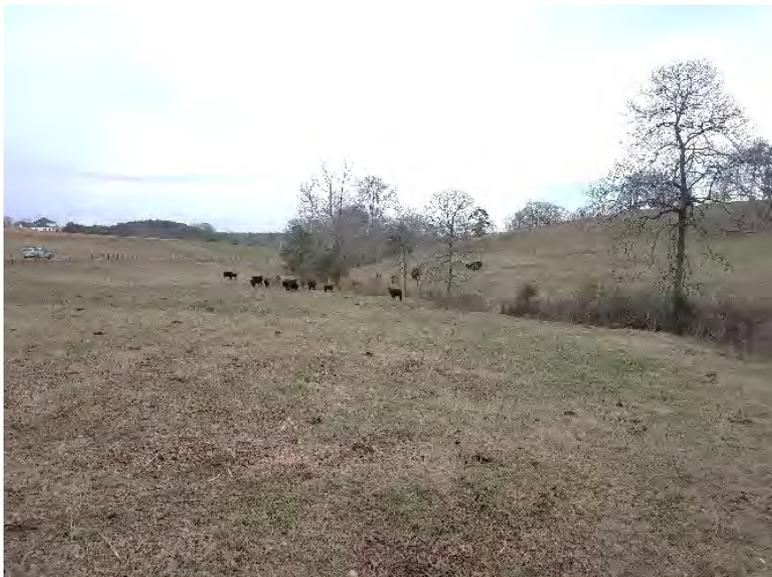
Photo 4: Reach R1 – Looking downstream at drainage and lack of mature riparian buffer (1/2/2017)

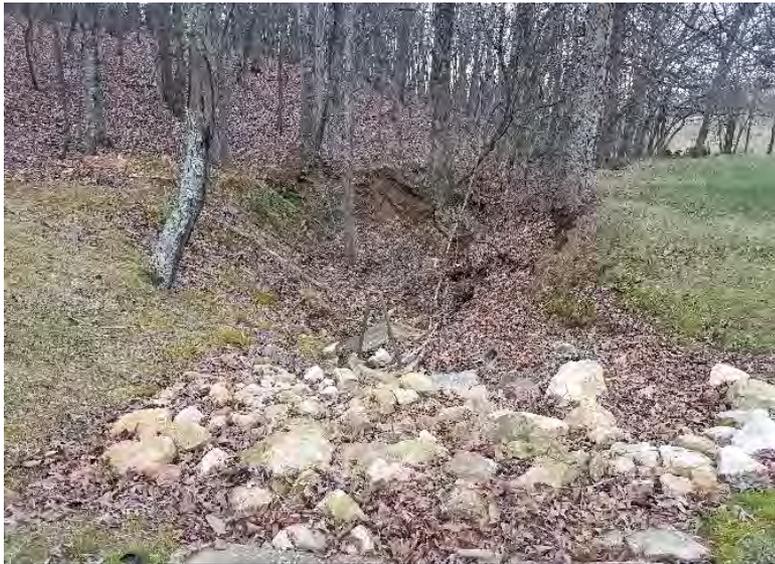
Photo 5: R2 – Looking downstream at project start (1/2/2017)

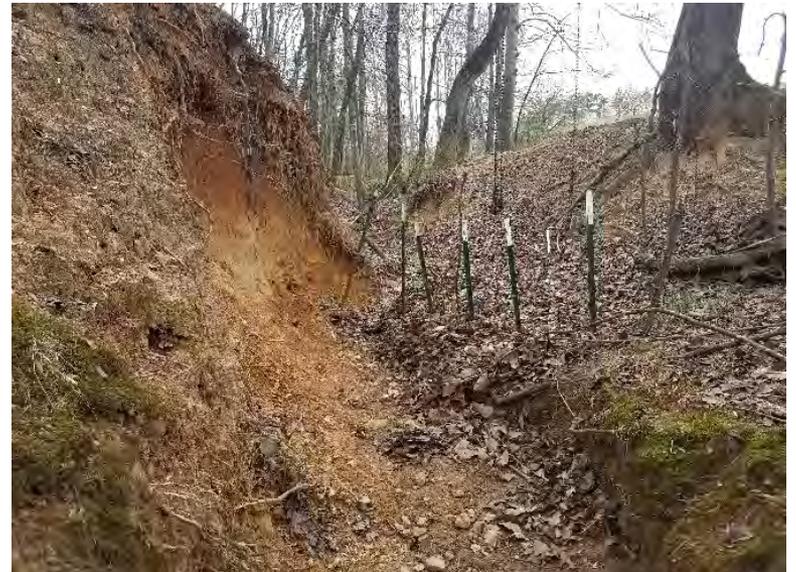
Photo 8: R2 – Looking downstream bank erosion and confluence with R3 (1/2/2017)

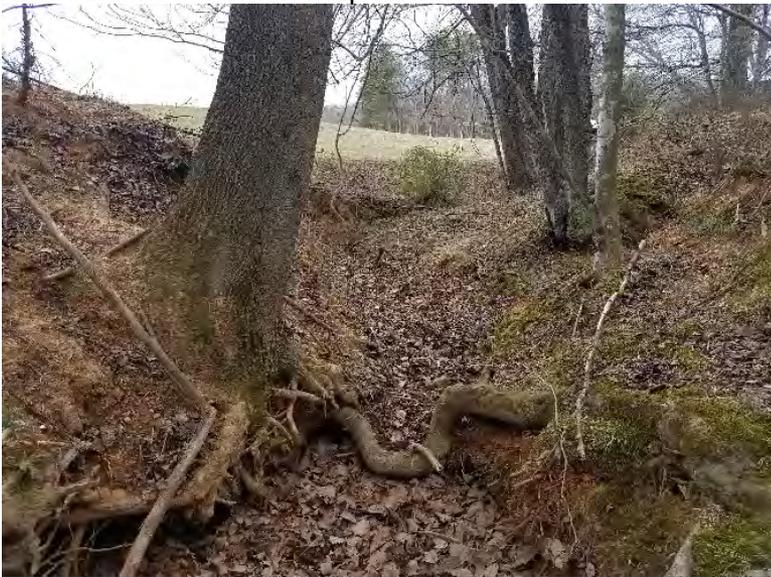
Photo 9: R3 – Looking upstream at bank erosion (1/2/2017)

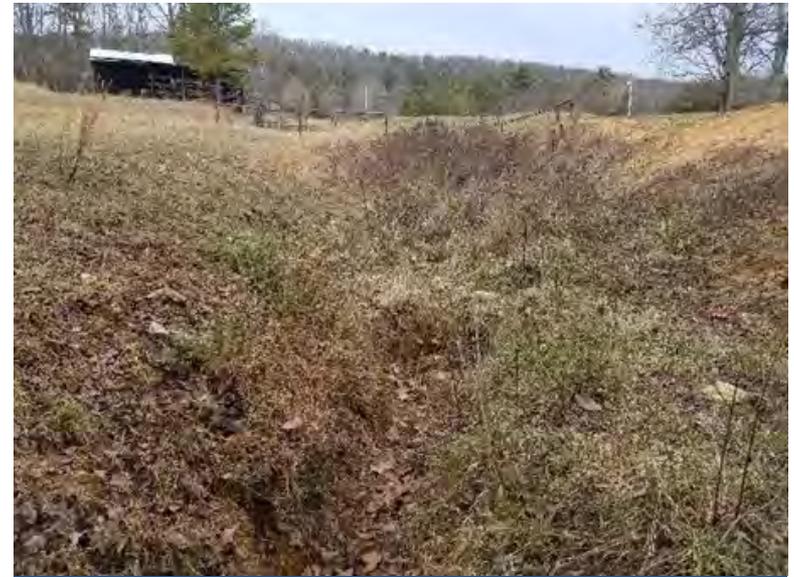
Photo 12: R3 – Looking upstream at BMP location (1/2/2017)

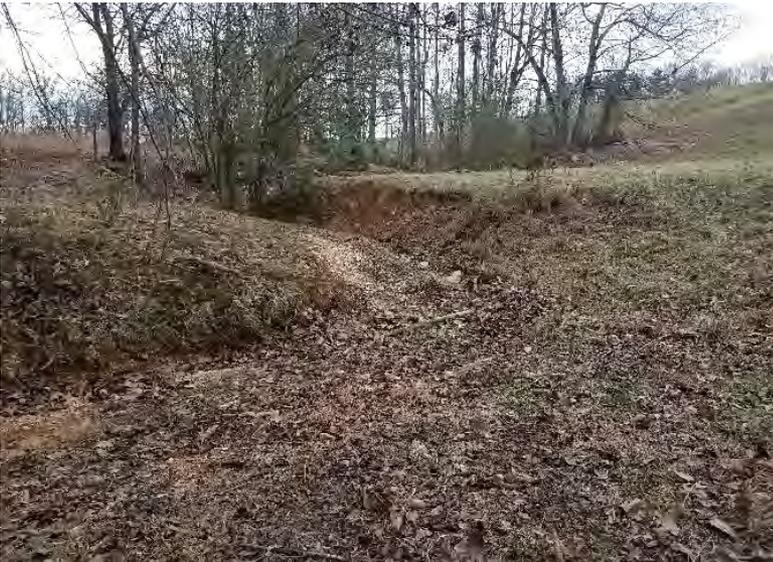
Photo 13: R4 – Looking downstream at bank erosion and US stream crossing location (1/2/2017)

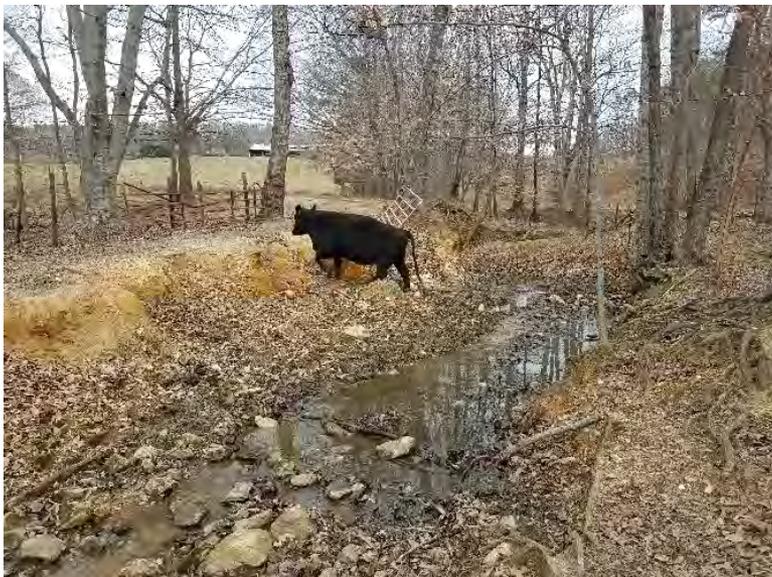
Photo 16: R4 – Looking upstream at hoof shear and direct cattle access (1/2/2017)

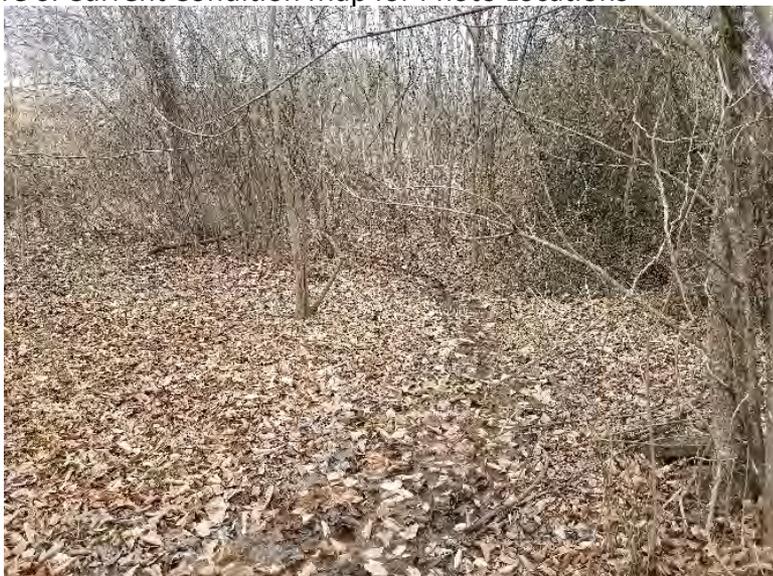
Photo 17: R4b – Looking at stream/wetland area (1/2/2017)

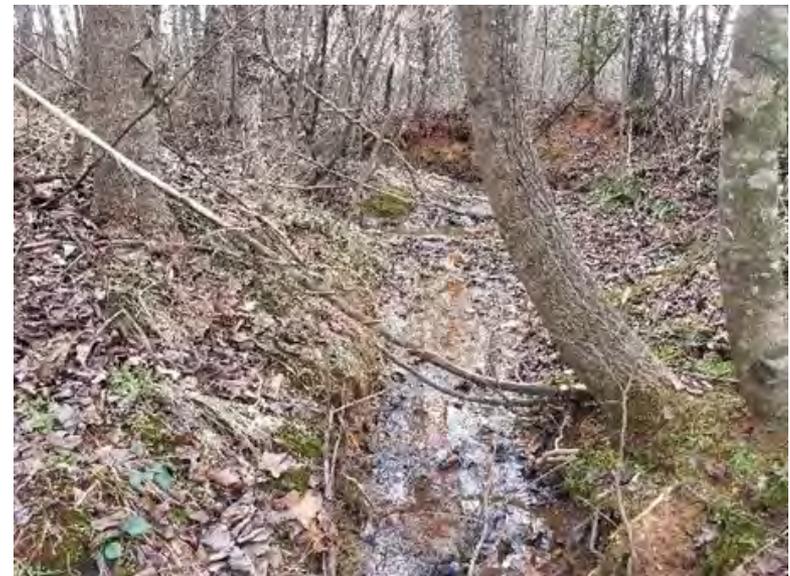
Photo 20: R4b – Looking downstream at channel incision and confluence with R4 (1/2/2017)

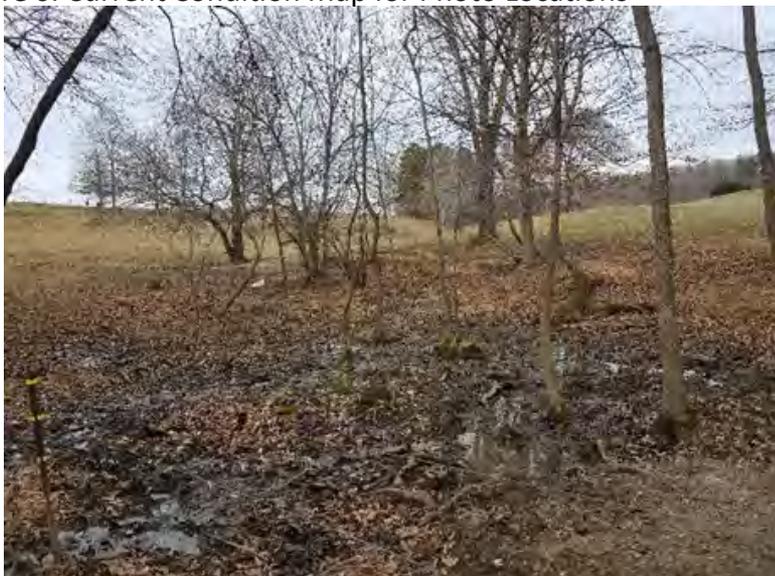
Photo 21: R4a – Looking upstream at start of reach at cattle wallowing area (1/2/2017)

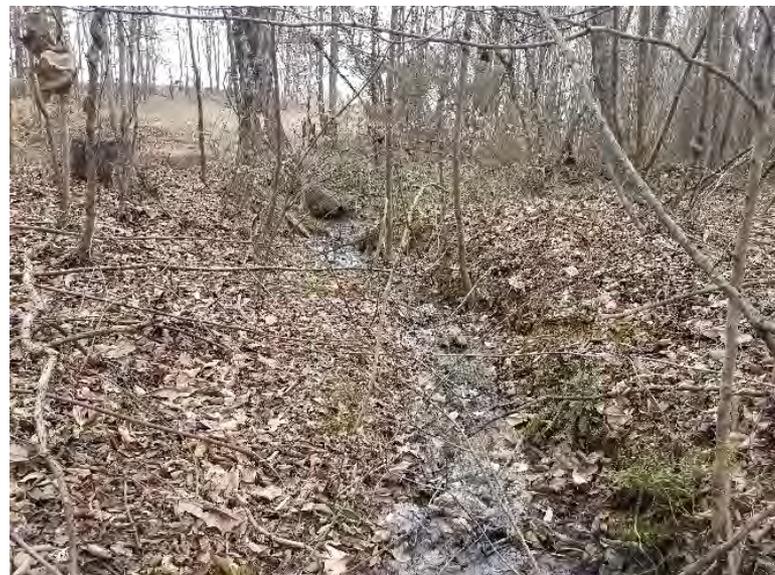
Photo 24: R4a – Looking downstream at stable channel and confluence with R4 (1/2/2017)

11. Looking at the photos of reach R4a, particularly at the downstream reach and its confluence with R4, there does not appear to be a need for any channel construction. Please substantiate why channel construction is needed in this area. Response: Reaches R4/R5 are incised and will be raised to provide access to their historic floodplain and maximize functional uplift. As a result of this restoration approach, WLS needed to raise the existing stream bed along oversized channel portions of R4a (and R4b) to avoid a backwater condition and to restore the natural connection between Reaches R4/R5.

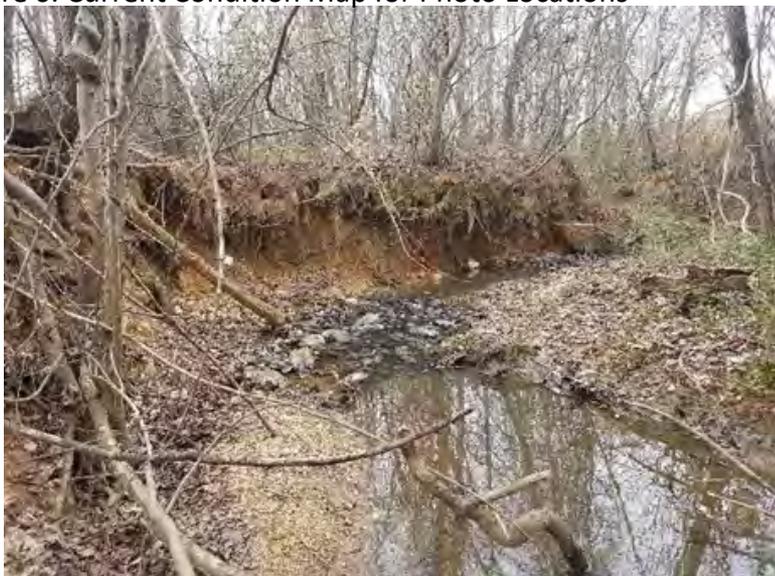
Photo 25: R5 – Looking downstream at bank erosion and channel incision (1/2/2017)
