**FINAL
MY2 (2023) MONITORING REPORT**

LAUREL SPRINGS STREAM AND WETLAND MITIGATION SITE

Avery County, North Carolina
French Broad River Basin
Cataloging Unit 06010108

DMS Project No. 100122
Full Delivery Contract No. 7890
DMS RFP No. 16-007725 (issued 11/13/18)
USACE Action ID No. SAW-2019-00835
DWR Project No. 2019-0865

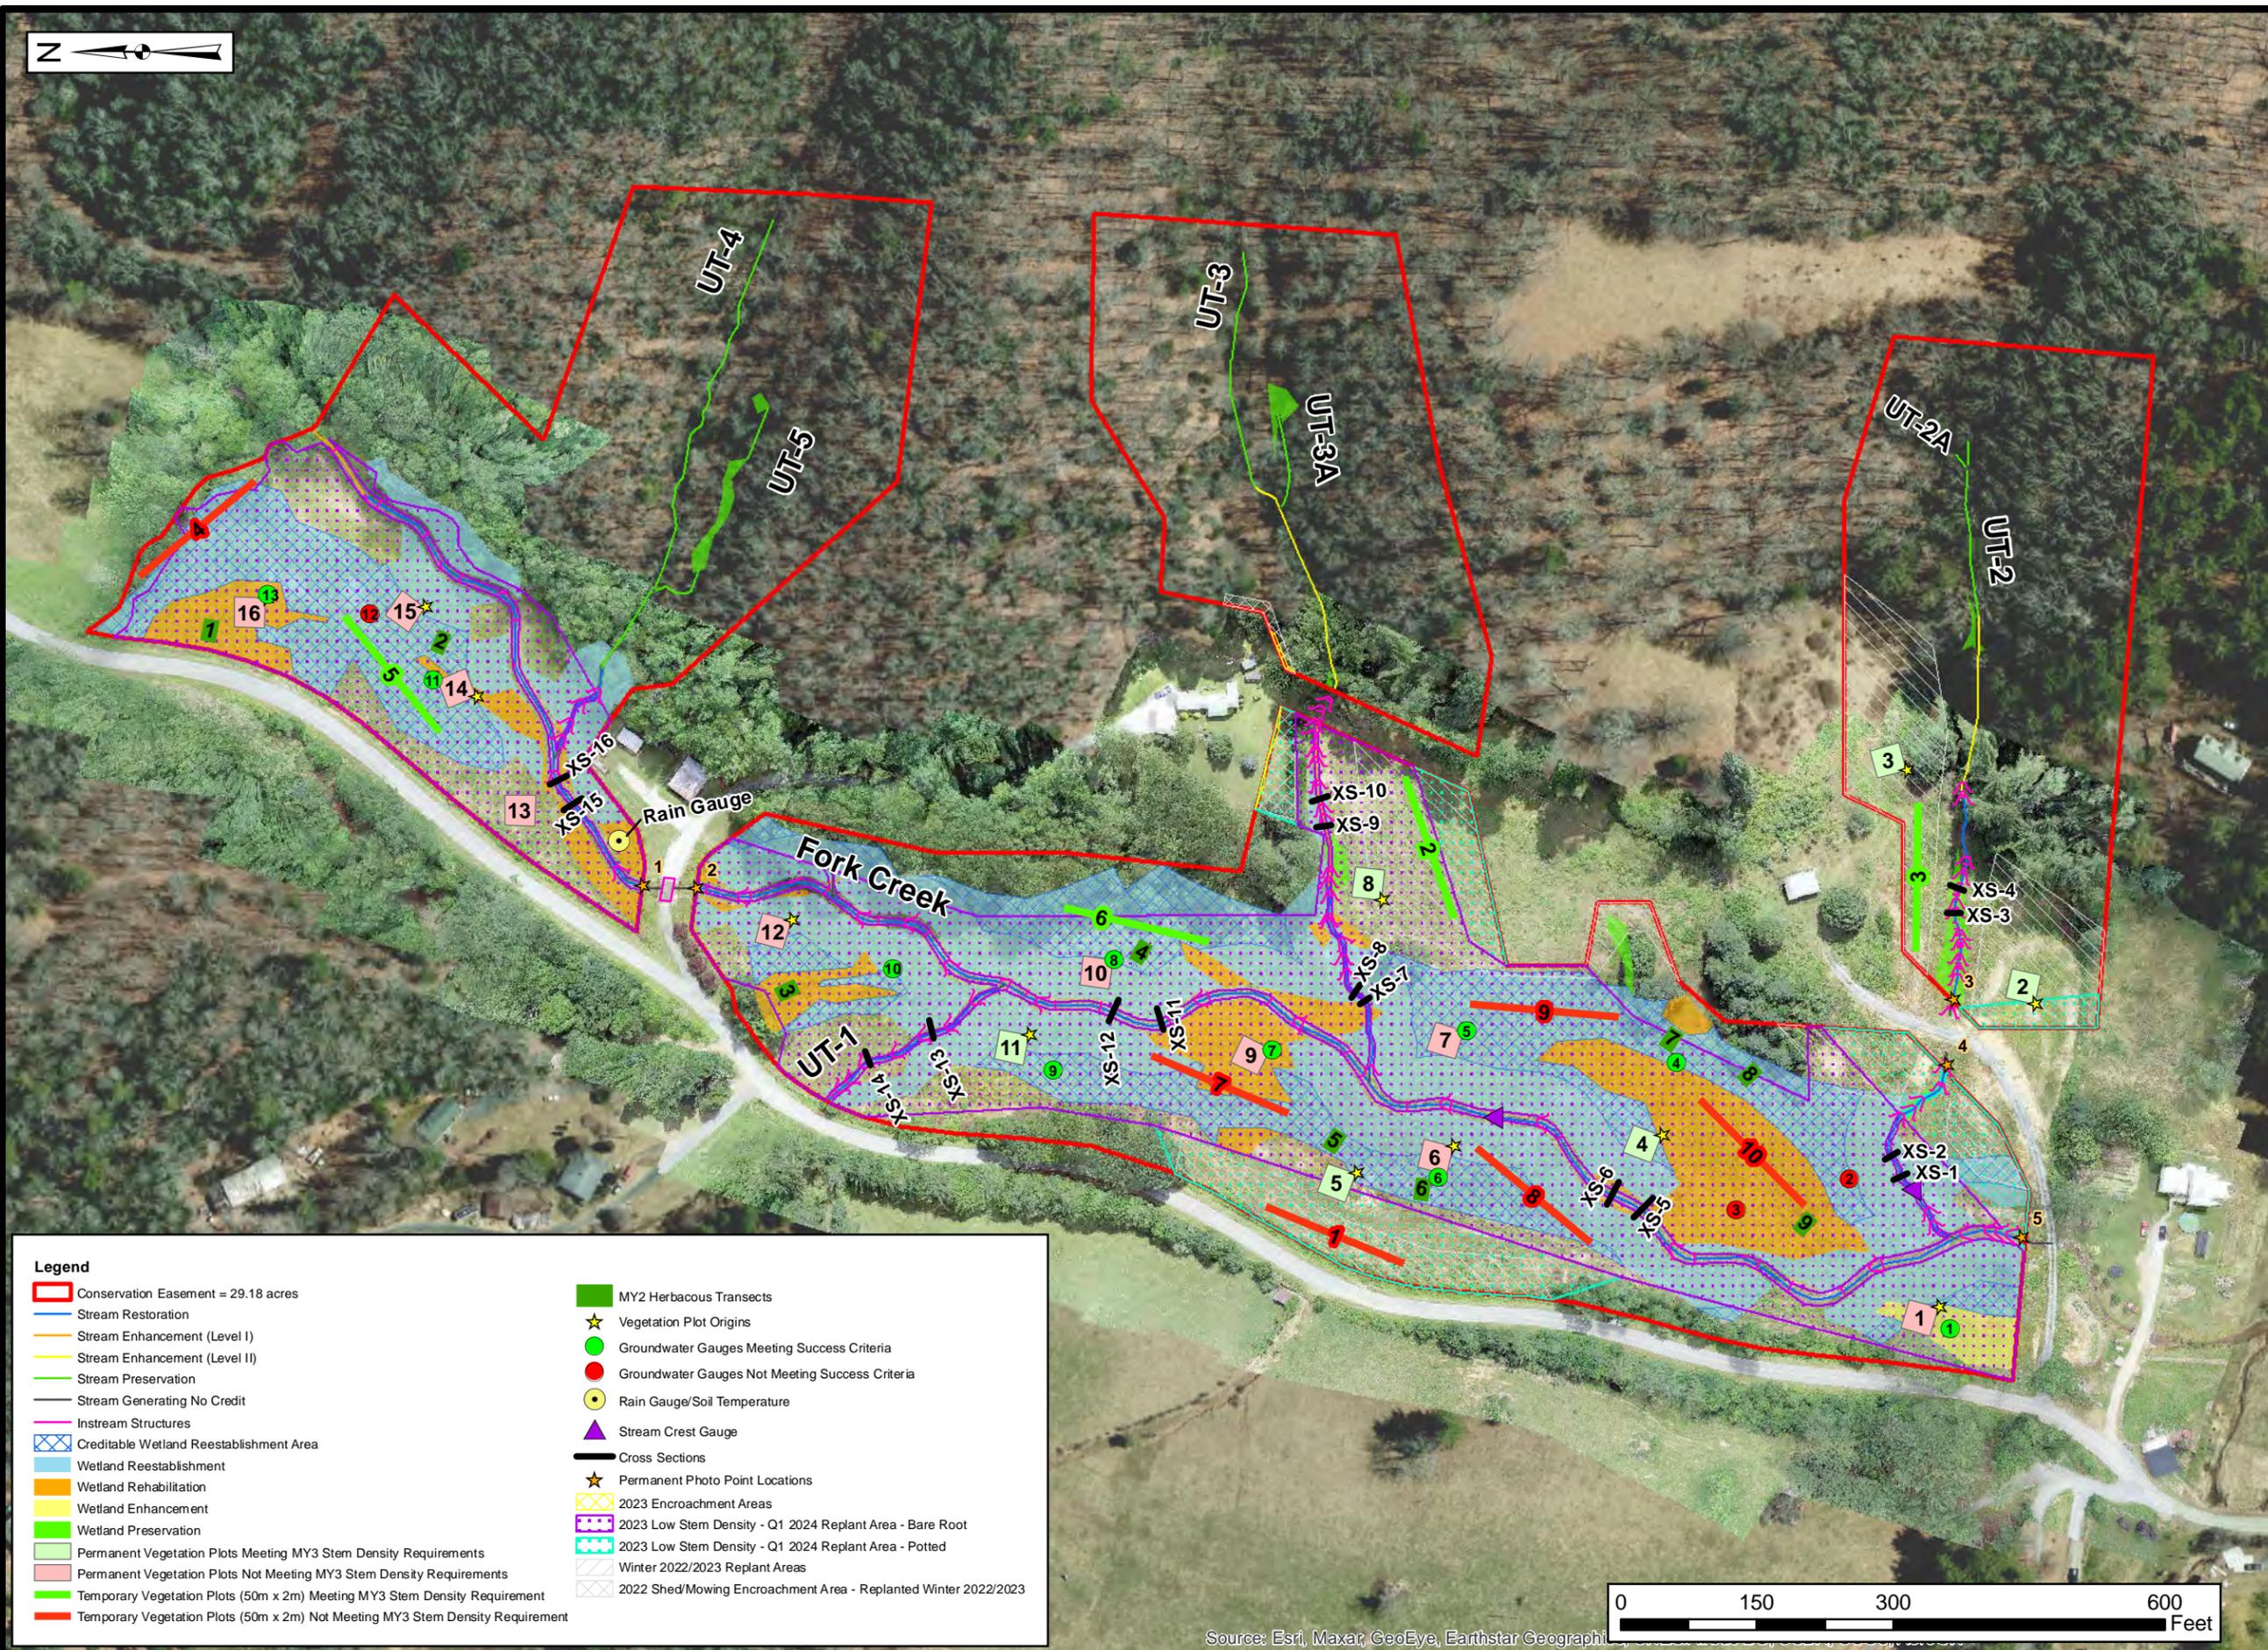
The small encroachment area observed during MY1 was addressed, and the easement was re-marked, however, several new areas (0.008 total acres) of encroachment were observed in the same area during an October 18, 2023 DMS boundary inspection. Additional marking has been added and the area will be planted during the Q1 2024 AMP action. These areas are depicted on Figure 1 and are quantified in Table 5 (Appendix A).

**CURRENT
CONDITIONS
PLAN VIEW**

The MY2 (2023) vegetative survey was completed on September 21, 2023. Measurements of all 16 permanent plots and 10 temporary plots resulted in an average of 240 planted stems/acre. Additionally, 10 of the 26 individual plots met the MY3 stem density requirement during MY2 (Appendix B). Due to low stem density observed during MY1, RS supplementally planted 2.67 acres of the site, predominantly along upland slope (Acidic Cove Forest) areas including a 0.107-acre area of easement encroachment, with 1800 bare-root stems during the dormant season 2022/2023 (Remedial Planting Plan (Q1-2023), Appendix F). Due to continued stem-density issues reflected in the MY2 vegetation data, RS will implement a site-wide adaptive management plan during the 2023/2024 dormant season. The 2023 Adaptive Management Plan includes supplementally planting 13 acres of the Site at a density of 200 stems per acre. The plan was approved by the IRT on November 29, 2023, and is detailed in Appendix F. Areas proposed for supplemental planting are depicted on Figure 1 (Appendix A).

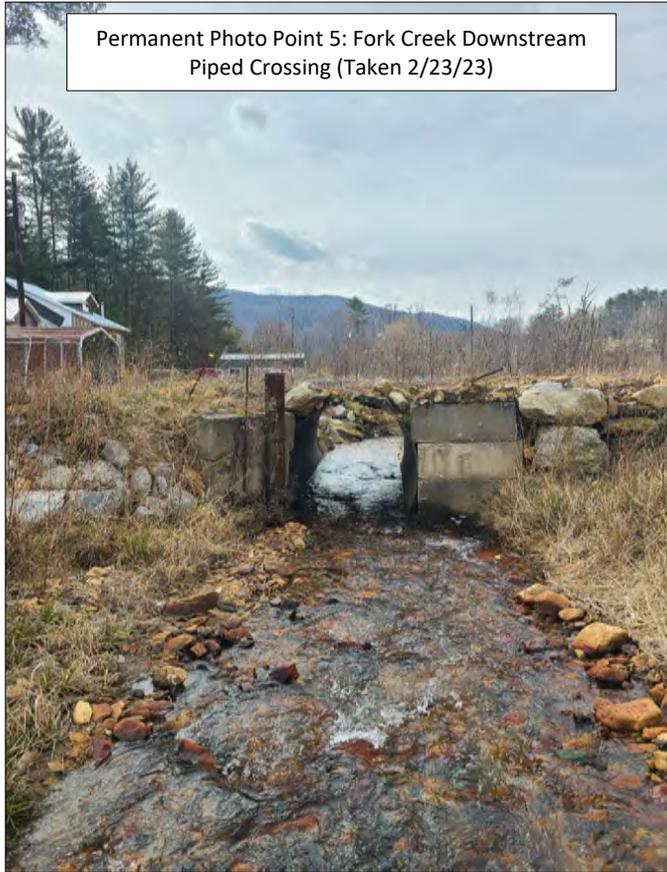
Permanent Photo Point 5: Fork Creek Downstream
Piped Crossing (Taken 2/23/23)

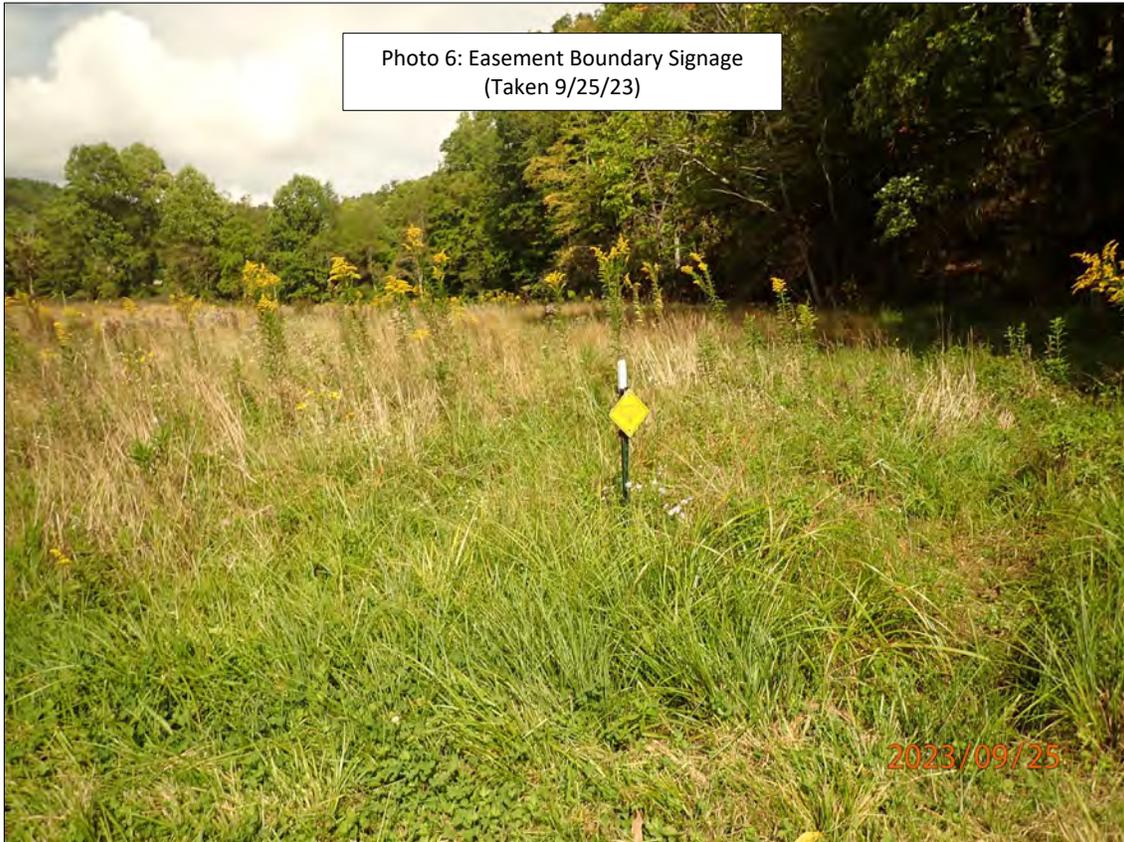
Photo 6: Easement Boundary Signage
(Taken 9/25/23)

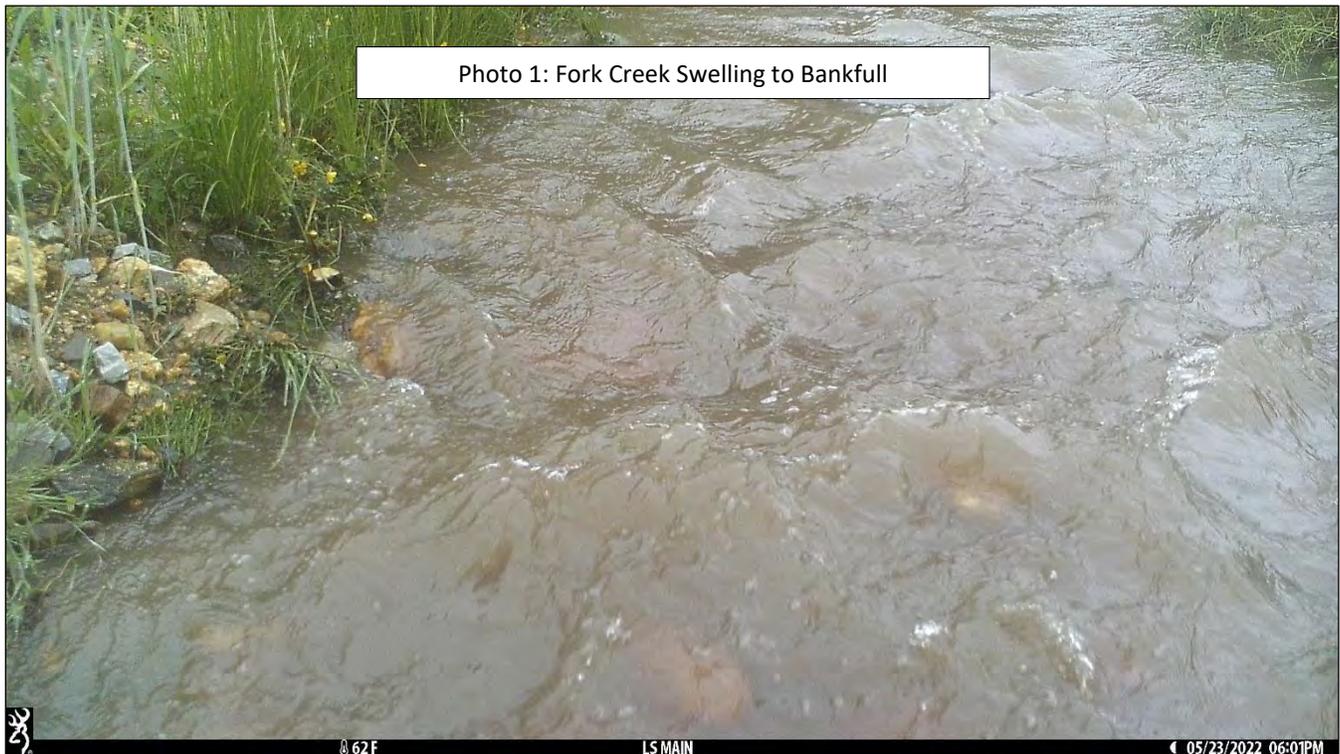
Date of Data Collection	Date of Occurrence	Method	Photo (if available)	Monitoring Year
May 23, 2022	May 23, 2022	A bankfull event was documented on the Fork Creek trail camera and stream gauge after 1.13 inches of rain fell per the on-site rain gauge.	1	MY1
August 6, 2022	August 6, 2022	A bankfull event was documented on the Fork Creek trail camera and stream gauge after 0.98 inches of rain fell per the on-site rain gauge.	2	MY1
September 5, 2022	September 5, 2022	A bankfull event was documented on the Fork Creek trail camera and stream gauge after 1.45 inches of rain fell per the on-site rain gauge.	3	MY1
September 25, 2023	May 28, 2023	A bankfull event was documented on the Fork Creek trail camera and stream gauge after 1.71 inches of rain fell per the on-site rain gauge.	4	MY2
September 25, 2023	June 20, 2023	A bankfull event was documented on the Fork Creek trail camera and stream gauge after 2.56 inches of rain fell per the on-site rain gauge.	5	MY2

Photo 2: Bankfull Event Documented on Fork Creek

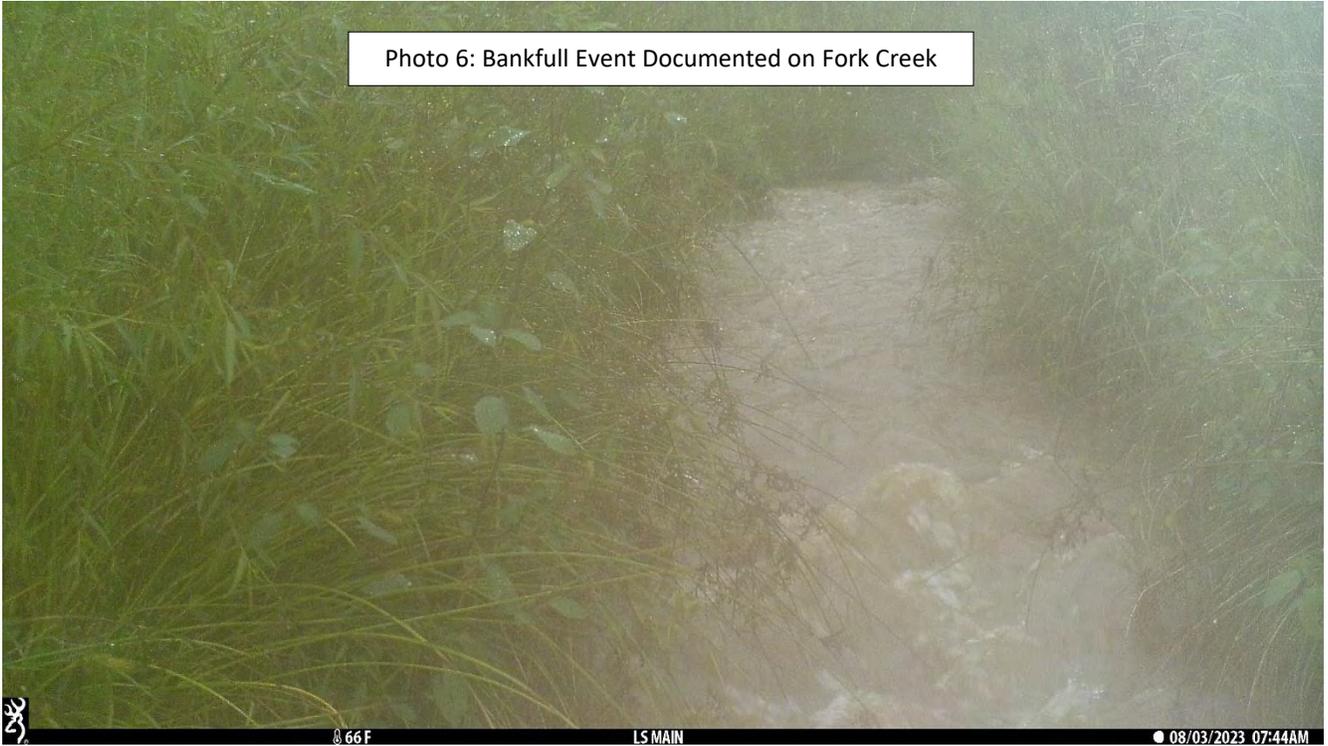
September 25, 2023	August 8, 2023	A bankfull event was documented on the Fork Creek trail camera and stream gauge after 2.95 inches of rain fell per the on-site rain gauge.	6	MY2

Photo 6: Bankfull Event Documented on Fork Creek

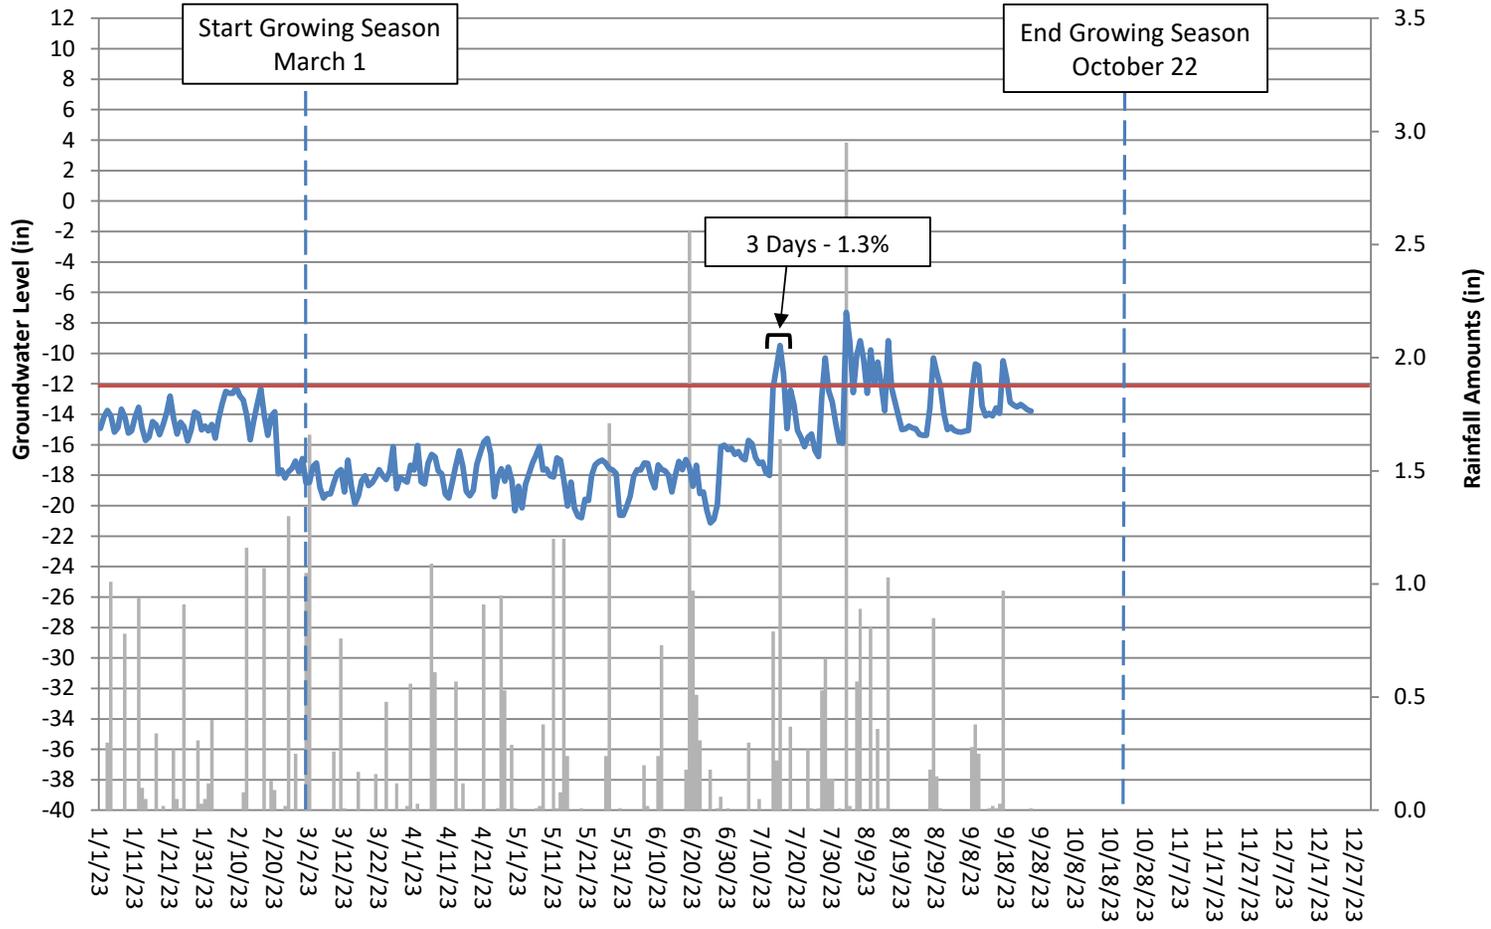
Laurel Springs Groundwater Gauge 2 (2023 Data)

Ten of the thirteen groundwater gauges met success criteria for the year 2 (2023) monitoring period (Table 12, Appendix D). During a 2023 IRT Site visit, it was noted that the area surrounding gauges 2 and 3 are obvious wetlands and that a gauge malfunction is likely the cause of the lack of wetland hydrology at these gauges. AXE confirmed a malfunction with the Site barometer, which caused somewhat erratic readings through the first half of the growing season on all gauges. The barometer was replaced on June 28, 2023 and has been functioning properly since. Rainfall data from an on-site gauge shows average rainfall for the year through September compared with the 30-year 30-70th percentile data at a nearby WETS station (Figure D1, Appendix D), and it is expected that all site wetlands would have met performance standards had the barometer functioned properly.

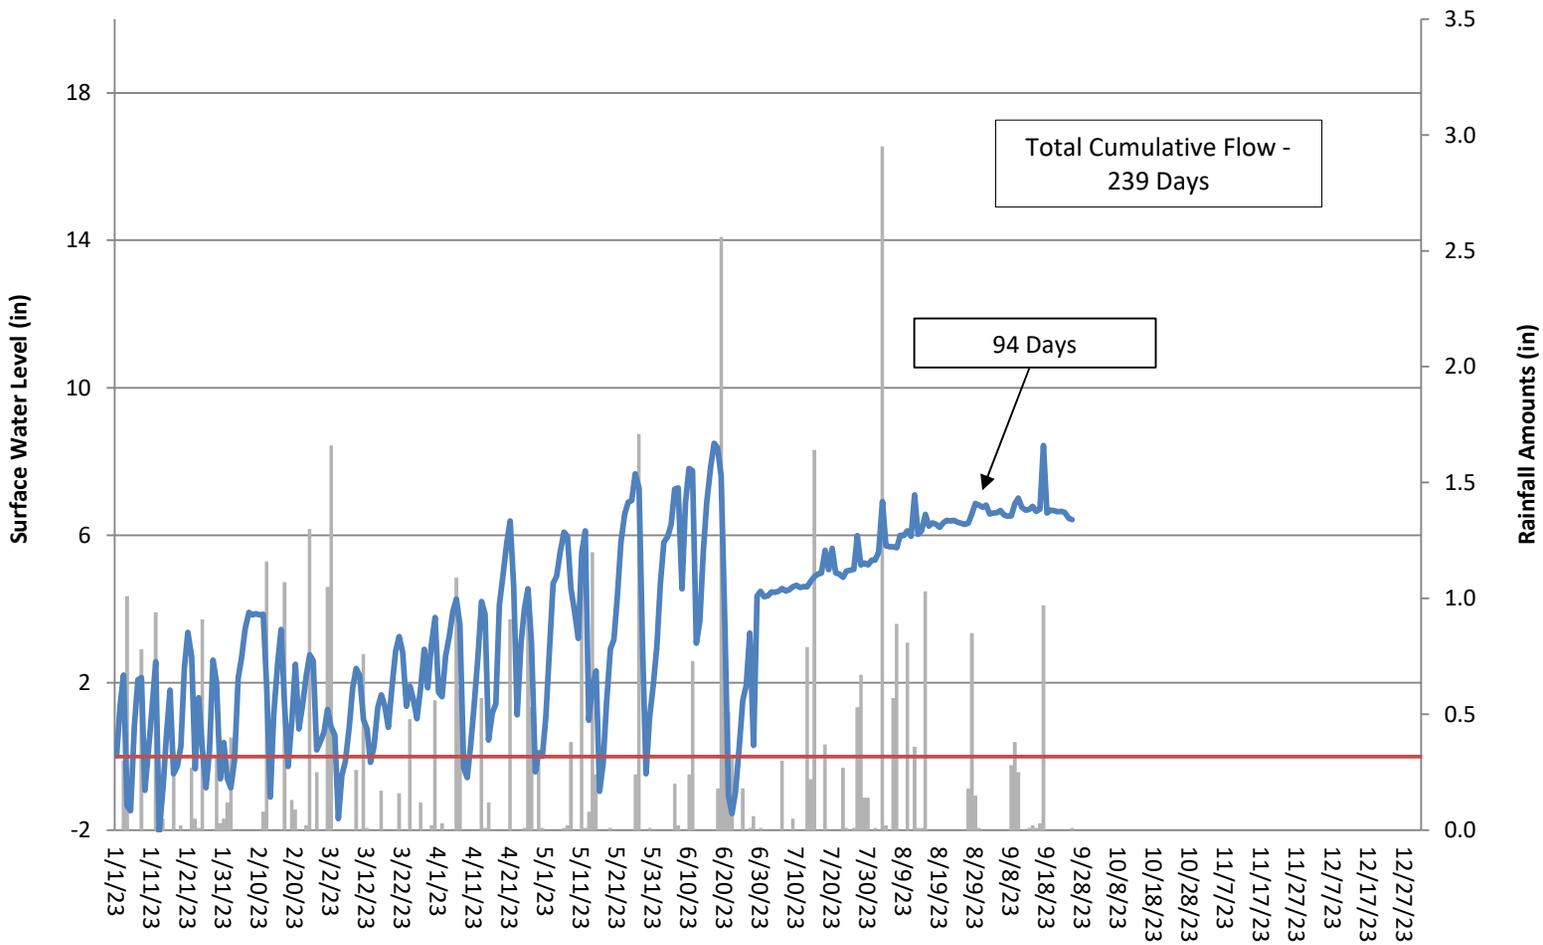
Laurel Springs UT2 Stream Flow (2023 Data)

UT-1 Upstream Channel Evidence	Year 1 (2022)	Year 2 (2023)
Max consecutive days channel flow	166	94
Presence of litter and debris (wracking)	Yes	Yes
Leaf litter disturbed or washed away	Yes	Yes
Matted, bent, or absence of vegetation (herbaceous or otherwise)	Yes	Yes
Sediment deposition and/or scour indicating sediment transport	Yes	Yes
Water staining due to continual presence of water	Yes	Yes
Formation of channel bed and banks	Yes	Yes
Sediment sorting within the primary path of flow	Yes	Yes
Sediment shelving or a natural line impressed on the banks	Yes	Yes
Change in plant community (absence or destruction of terrestrial vegetation and/or transition to species adapted for flow or inundation for a long duration, including hydrophytes)	Yes	Yes
Development of channel pattern (meander bends and/or channel braiding) at natural topographic breaks, woody debris piles, or plant root systems	Yes	Yes
Exposure of woody plant roots within the primary path of flow	No	No

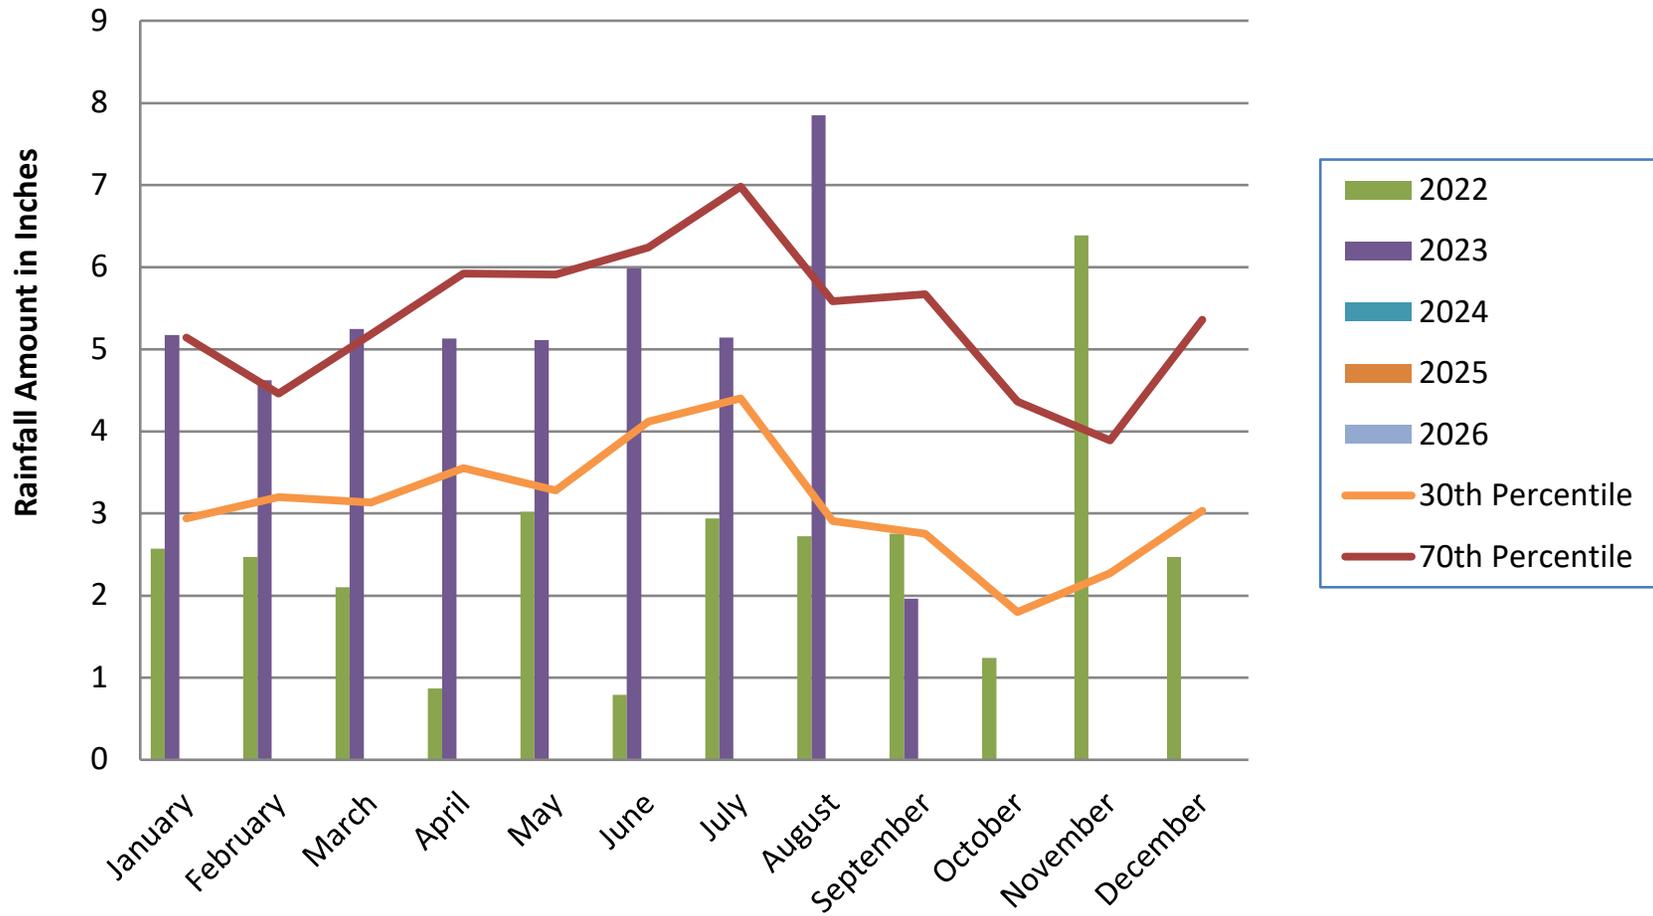
Figure D1: Laurel Springs
30-70 Percentile Graph for Rainfall
30-70th percentile data from WETS Station: Banner Elk, NC

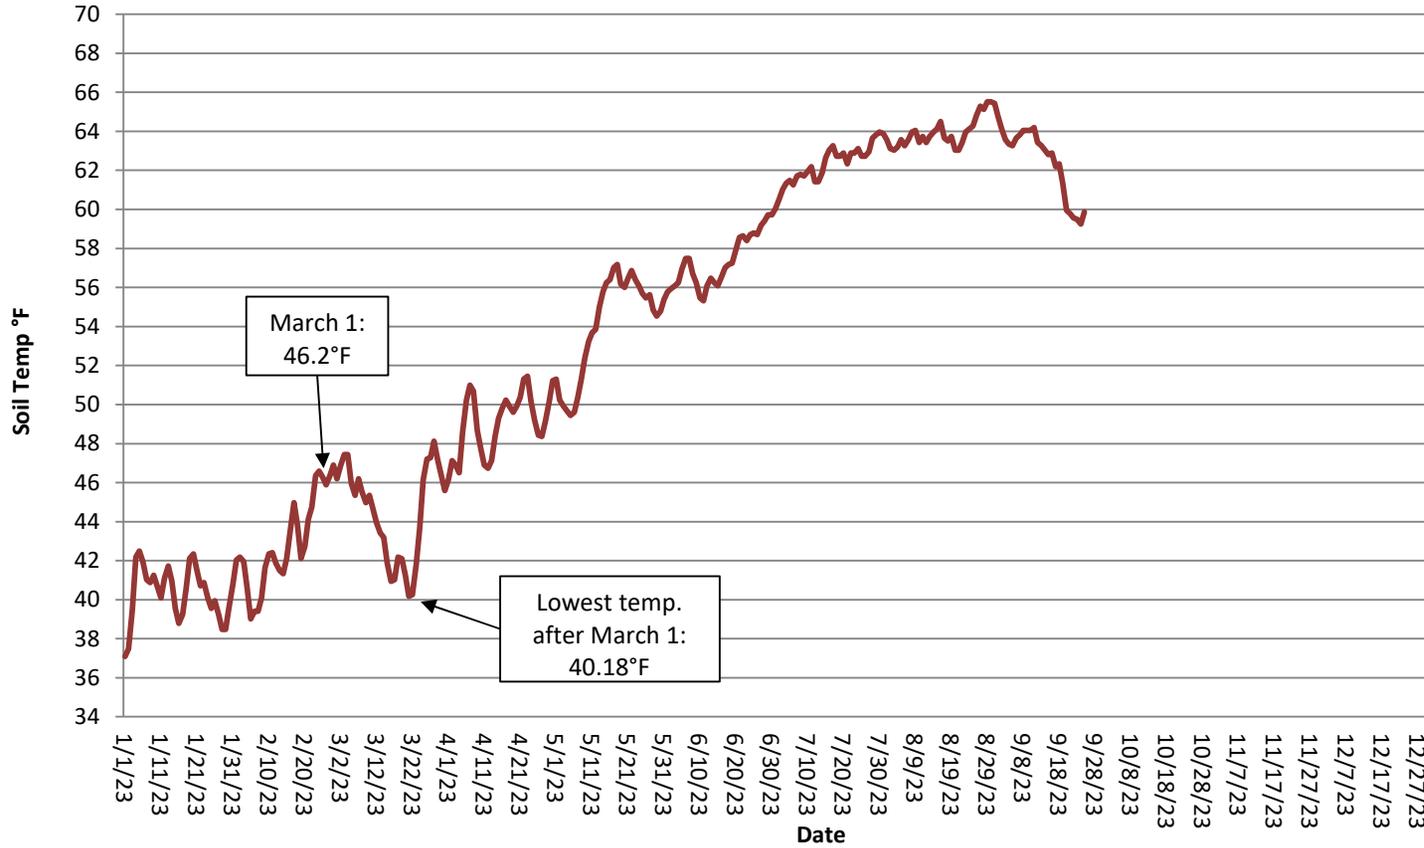
Laurel Springs Soil Temperature (2023 Data)

**Based on observed/documented bud burst on the Site on March 7, 2023, and soil temperature of 46.20°F documented on March 1, 2023. Although the soil temperature dropped below 41°F for 3 days in mid-March (40.95°F, 40.18°F, and 40.26°F on March 16, 21, and 22, respectively), it climbed above 46 again within 3 days (March 25). Observed bud burst onsite indicates that the period of biological activity had already begun March 1, and this short drop in soil temperature did not likely affect the growing season start date.
