Little River Farm Site Stream Enhancement, Preservation, and Restoration Plan Montgomery County, North Carolina

Little River Farm Site Stream Restoration, Enhancement and Preservation Plan Montgomery County, North Carolina

Design Report Prepared by Michael Baker Engineering, Inc.

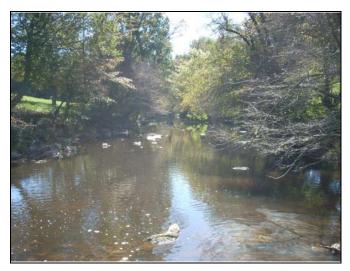
Little River - enhancement reach (M1)

Little River - preservation reach (M2)

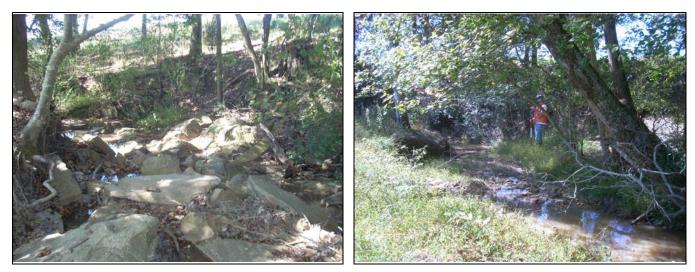
UT1 - enhancement reach

UT1 -enhancement reach

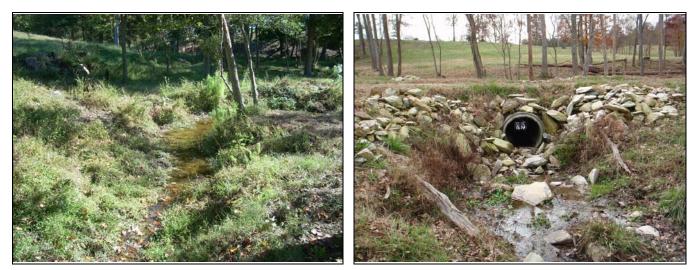
UT2 - enhancement reach

Crossing at UT2 – to be improved

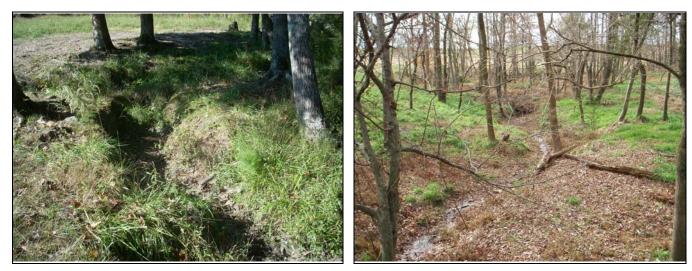
UT3a - enhancement reach

UT3 - enhancement reach

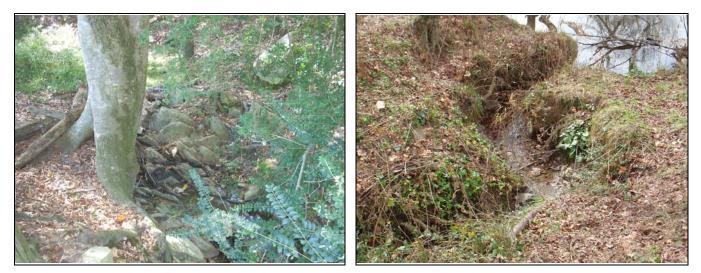
UT3

UT4 at confluence with Little River

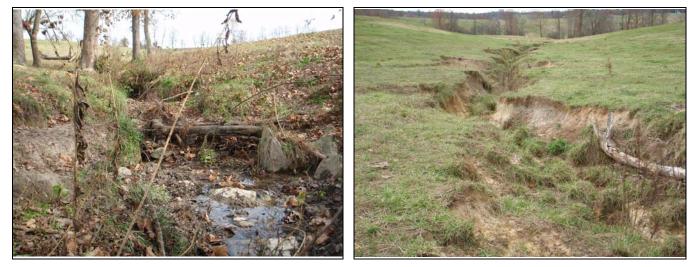
UT4 - enhancement reach

UT4 –restoration reach

As described in Section 3, UT4 is the most highly degraded and unstable stream reach on the project site. As a result, full restoration of the channel is proposed for the most unstable portions of the stream that flows through cattle pasture (station 10+00 to 16+00), and enhancement is proposed for the lower portion of the stream that is more stable (station 16+00 to 18+42).
