Annual Monitoring Report (MY2)

MAPLE SWAMP BUFFER MITIGATION SITE

Edgecombe County, NC

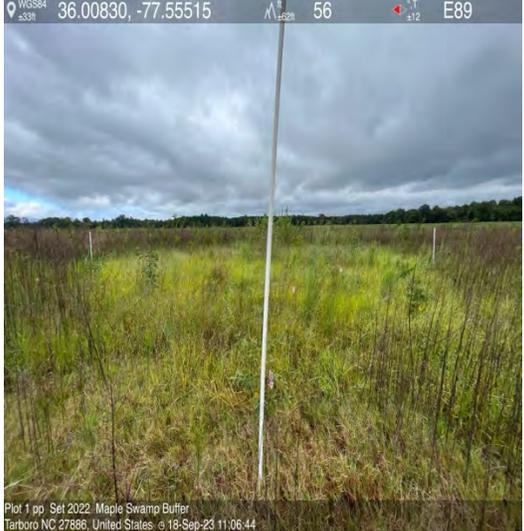
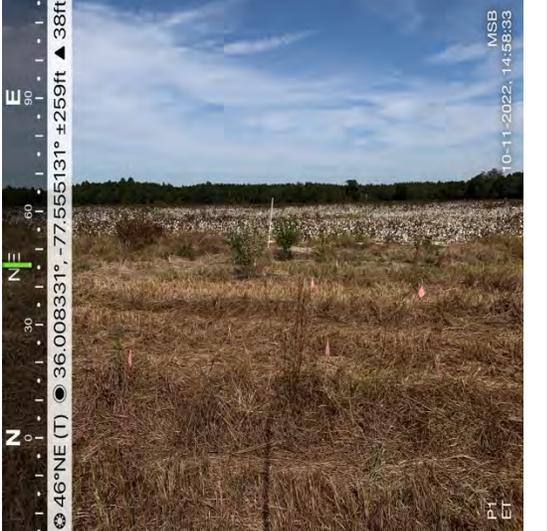
Photo #1 Date: 09/18/2023 Feature: Plot 1 Direction: East

36.00841422	-77.55509863	Laurel Oak (Quercus laurifolia)	50	4	1
36.00839676	-77.55508398	Swamp Chestnut Oak (Quercus michauxii)	62	4	1
		trees/ac	640		
		# of Individuals	16

# of Species	7		
		Min Ht	38		
		Max Ht	243		
		Avg Ht. - Avg Vigor	101	3.9

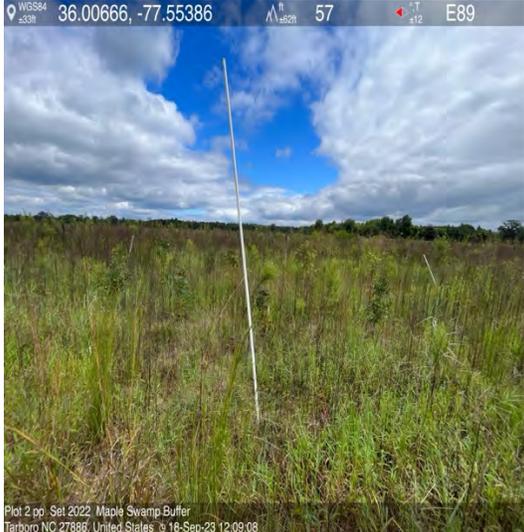
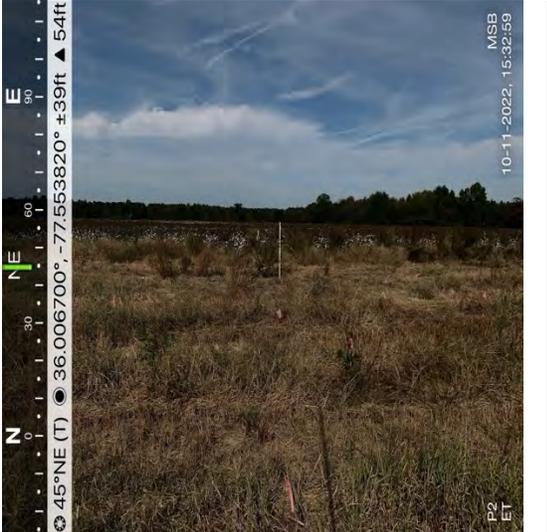
Photo #2 Date: 09/18/2023 Feature: Plot 2 Direction: East

36.00670904	-77.55377676	Swamp Chestnut Oak (Quercus michauxii)	154	4	2
36.00671846	-77.55379498	Swamp Chestnut Oak (Quercus michauxii)	131	3	2
		trees/ac	520

# of Individuals	13		
		# of Species	5		
		Min Ht	25		
		Max Ht	157		
		Avg Ht. - Avg Vigor	101	3.6

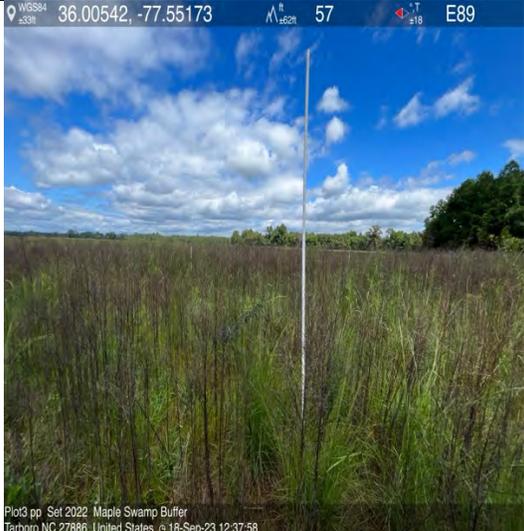
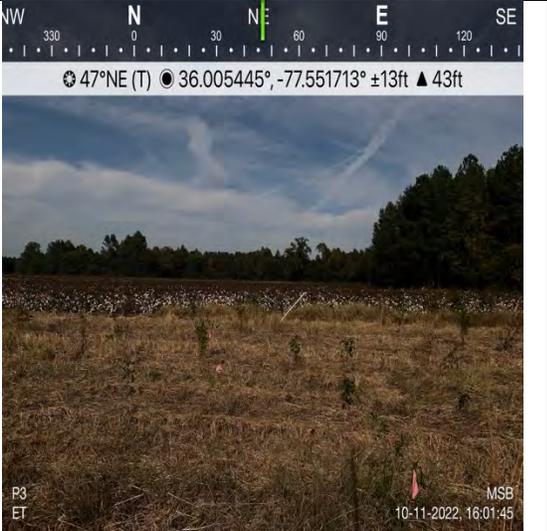
Photo #3 Date: 09/18/2023 Feature: Plot 3 Direction: East

36.00551709	-77.5517057	Bald Cypress (Taxodium distichum)	71	3	3
36.00550321	-77.55169329	Bald Cypress (Taxodium distichum)	72	3	3
36.00549674	-77.55168479	Swamp Chestnut Oak (Quercus michauxii)	102	4	3
		trees/ac	560

# of Individuals	14		
		# of Species	6		
		Min Ht	20		
		Max Ht	203		
		Avg Ht. - Avg Vigor	110	3.7
