**MASON SITE WETLAND MITIGATION PLAN**

**Hyde County  
USGS Catalog Unit 03020105030010  
EEP Project No 16-D06001  
Design Firm: Albemarle Restorations, LLC**

**October 2007  
Revised: November 14, 2007**

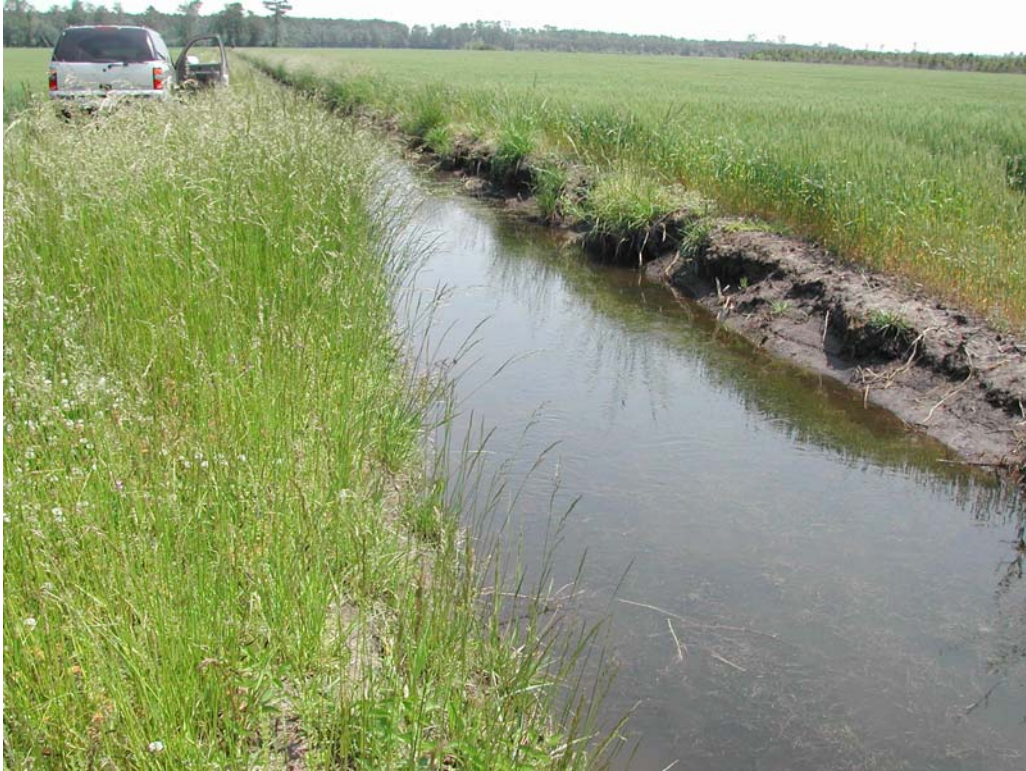
**Photo 1. “Mason Ditch” near downstream limits of project area prior to construction.**

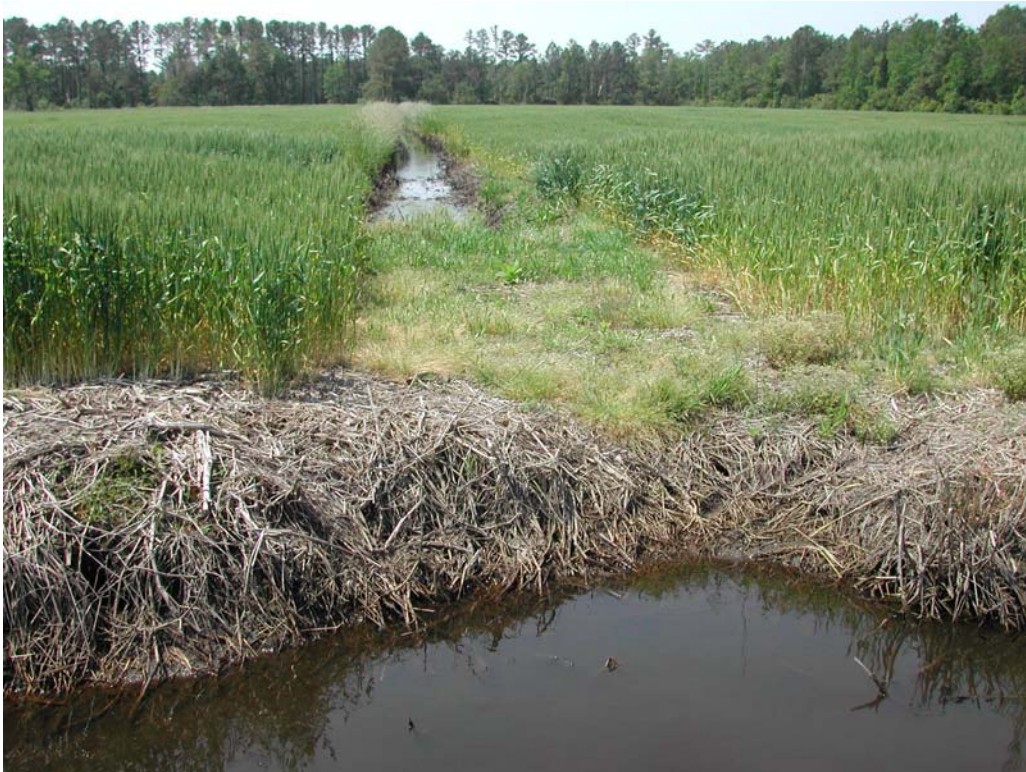
**Photo 2. Typical lateral ditch between crop fields in project area prior to construction.**

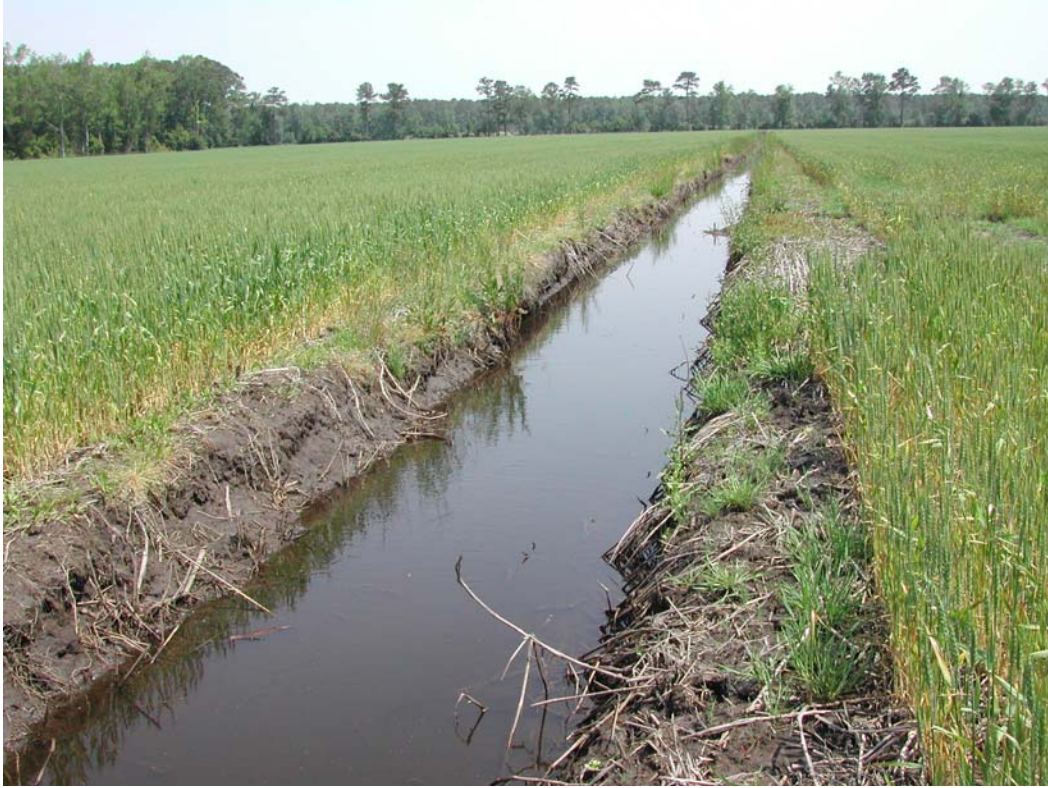
**Photo 3. “Mason Ditch” with crops planted to edge pre-construction.**

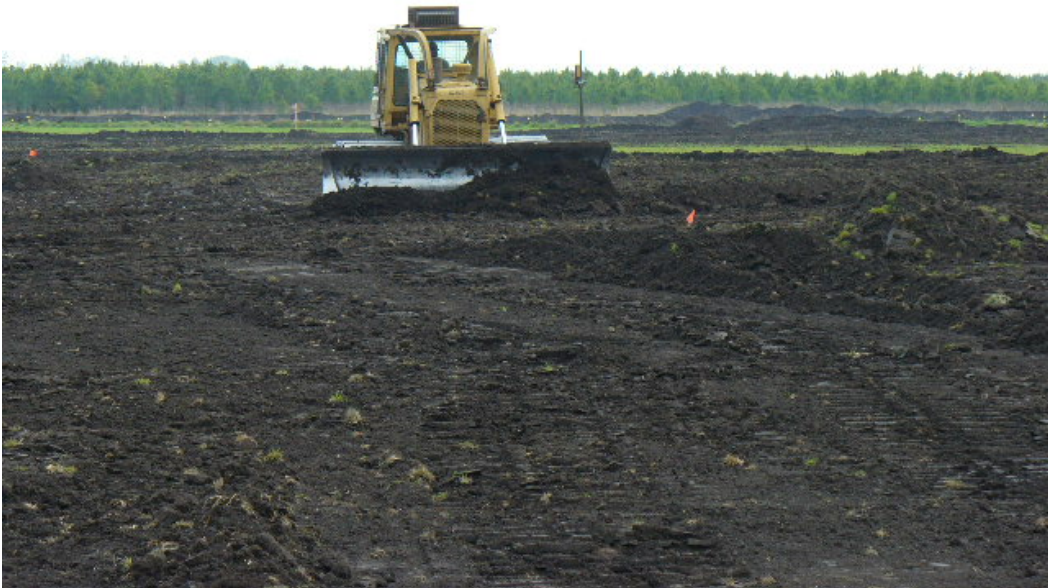
**Photo 4. Deep organically rich soils encountered throughout the site during construction.**

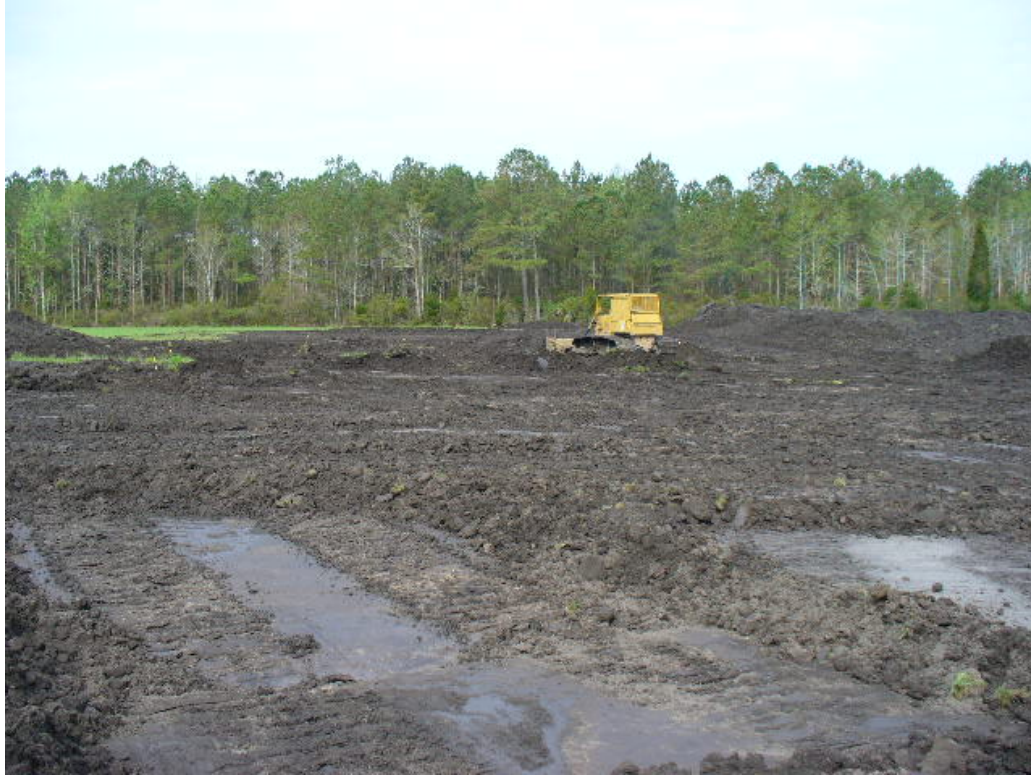
**Photo 5. Wetland hydrology evident during construction. April, 2007**

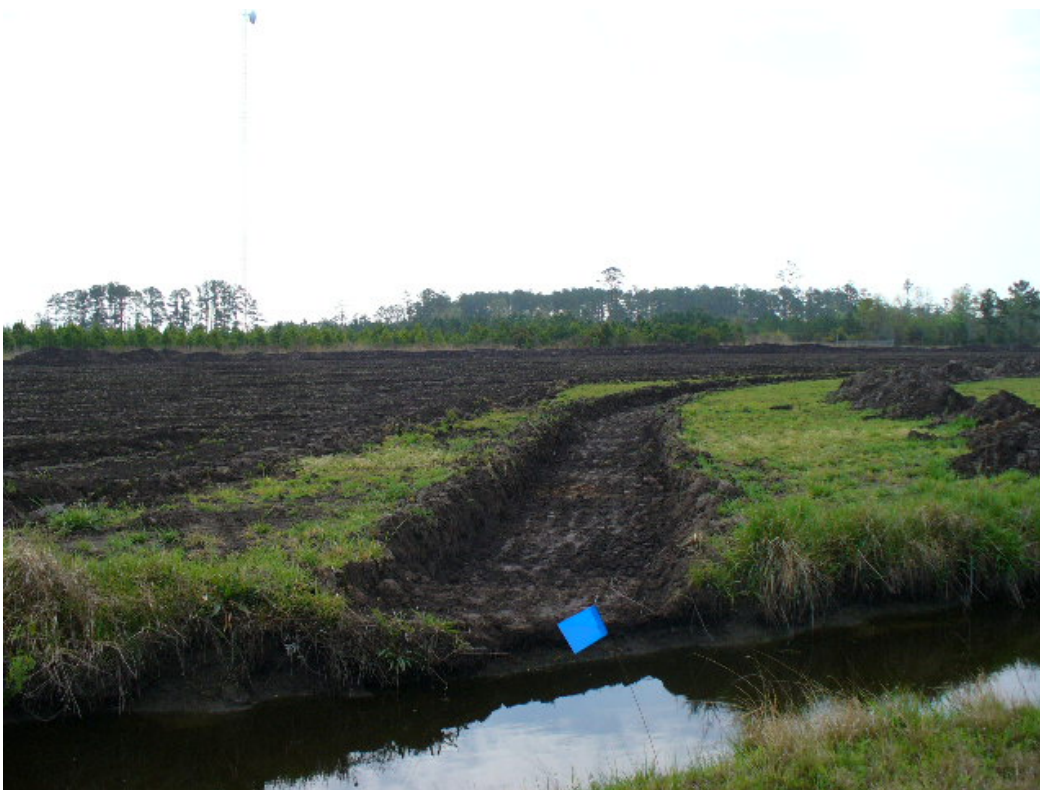
**Photo 6. Rough grading of meandering channel shows minimal grading required to restore wetland hydrology to site. April, 2007**

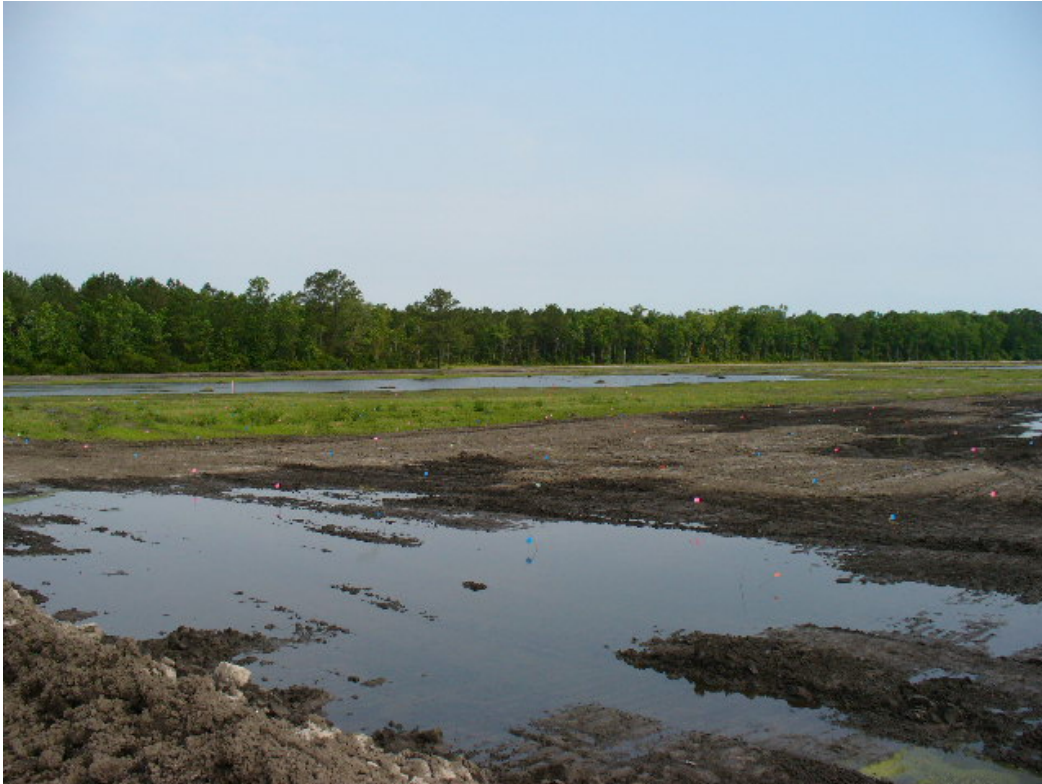
**Photo 7. Riverine wetlands (foreground) and non-riverine wetlands just after completion of construction. Pin flags mark locations of woody stock. May, 2007**

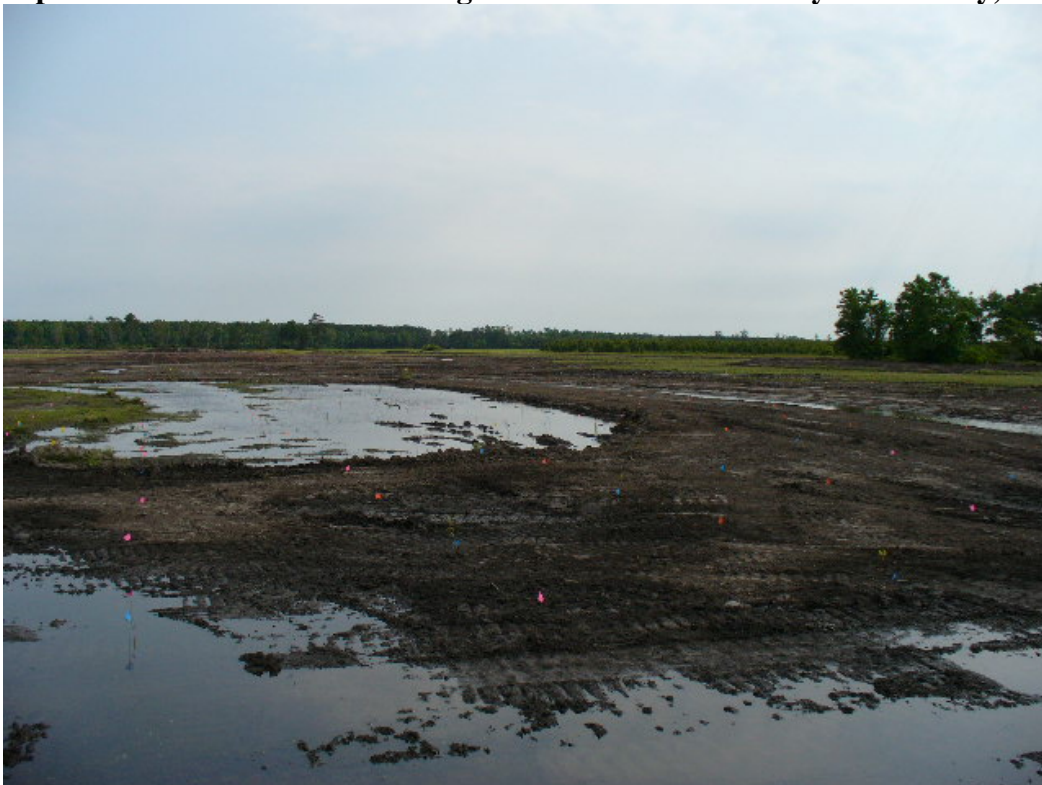
**Photo 8. Successful wetland hydrology evident just after completion of construction. May, 2007**

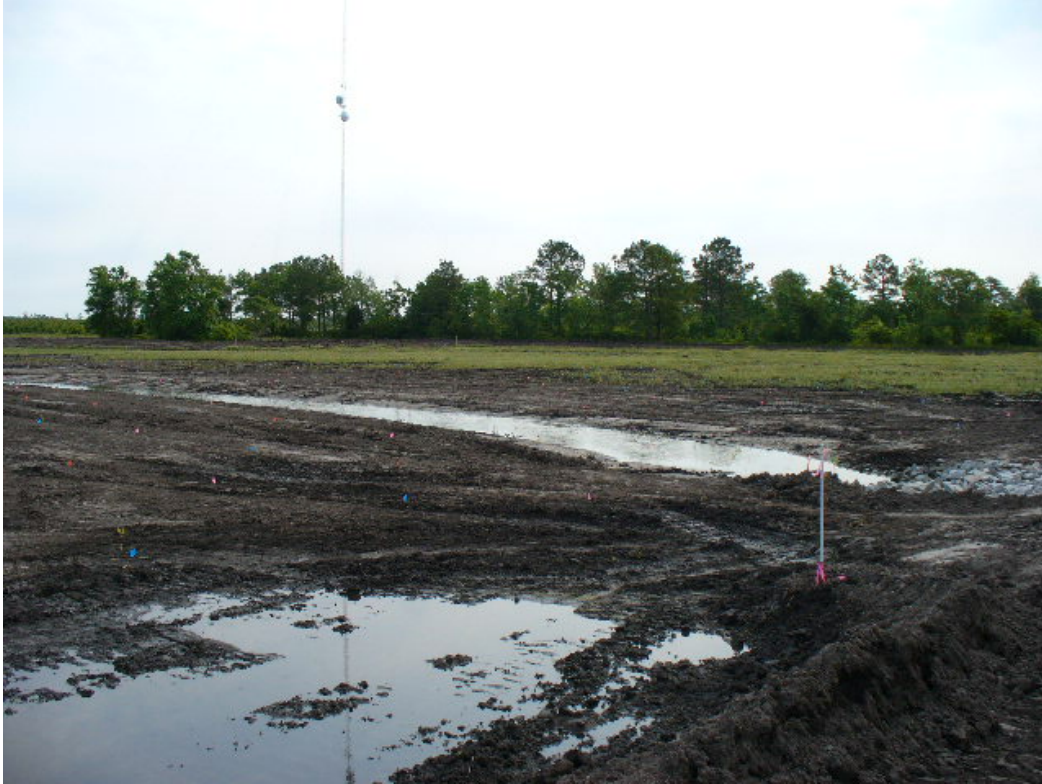
**Photo 9. Downstream limits of project area post construction. May, 2007**

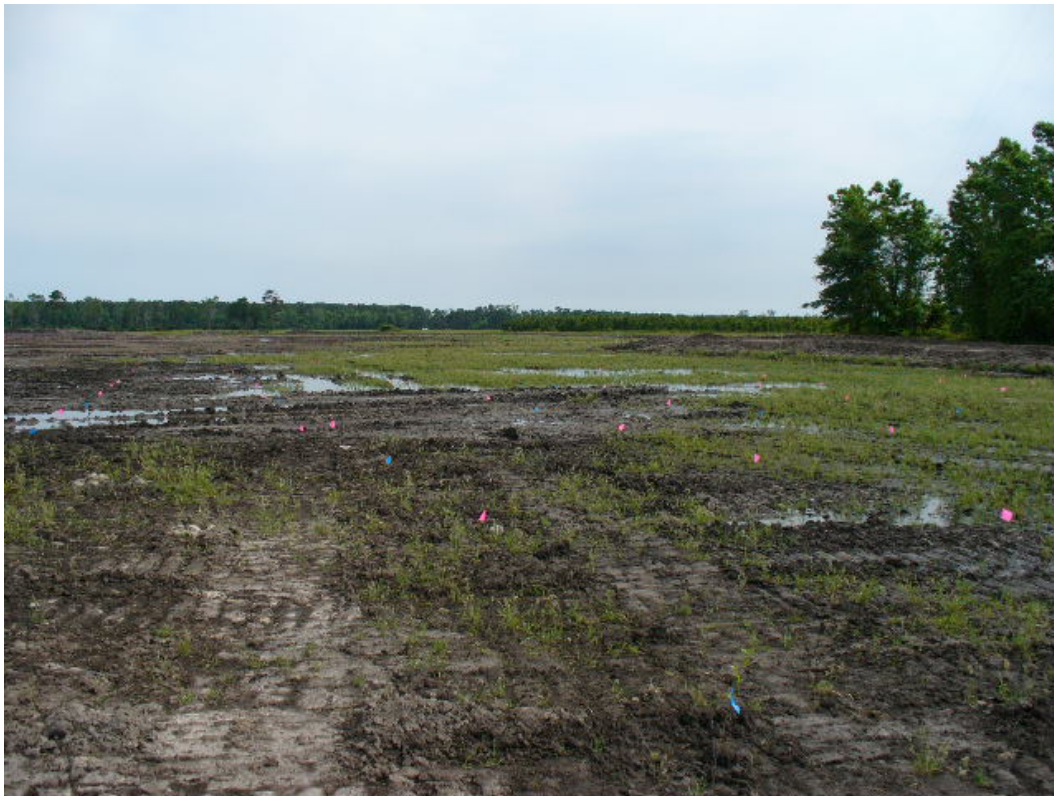
**Photo 10. Emergent seed beginning to germinate in riverine wetland areas two weeks after construction completed. May, 2007**
