**Moccasin Creek Buffer & Wetland
Restoration, Enhancement &
Preservation
Wake and Franklin Counties
North Carolina**

Report and Restoration Plan

November 22, 2004

Report and Restoration Plans Prepared By:

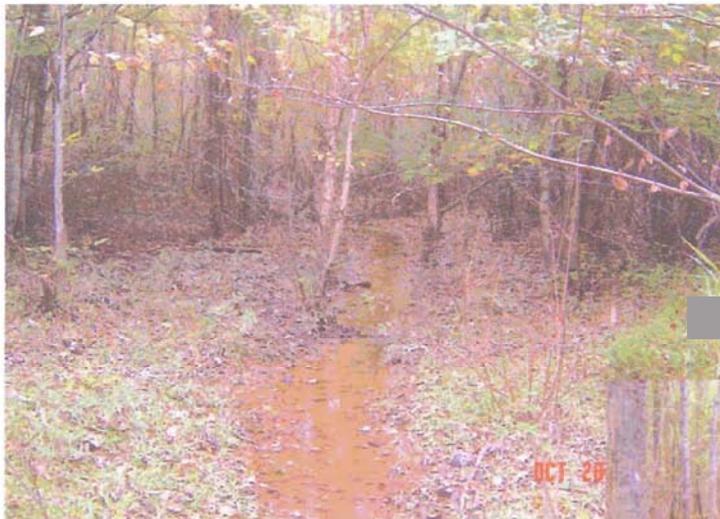
Wolf Creek as viewed looking north from the existing culvert.

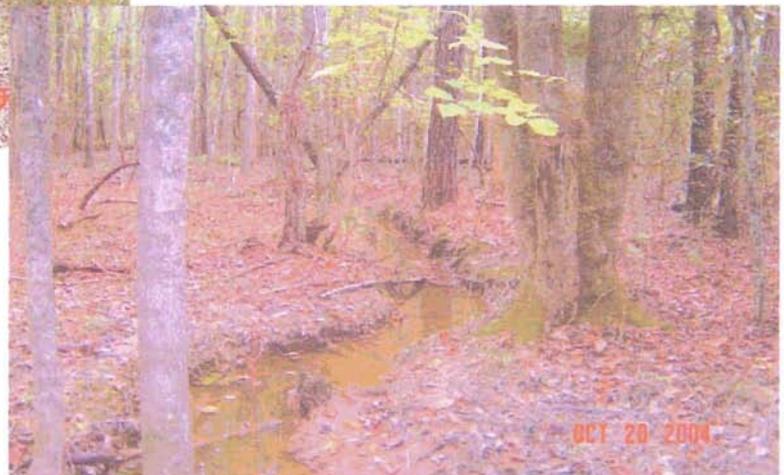
Stream S1 in a previously logged area of the site. The photograph below shows the stream condition outside of the logging area just upstream of the haul road culvert on S1.

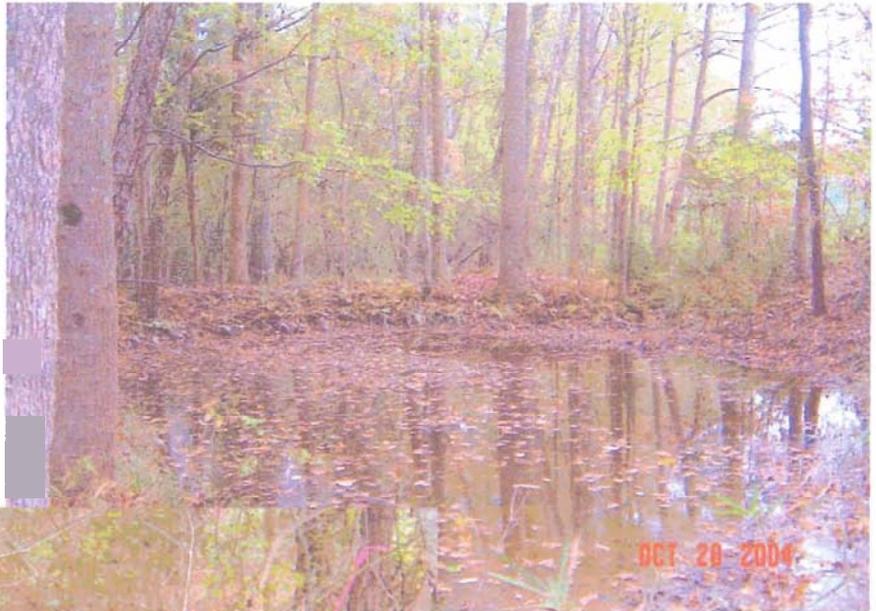
Existing pond located on line with stream S2 at the south east corner of the project site.

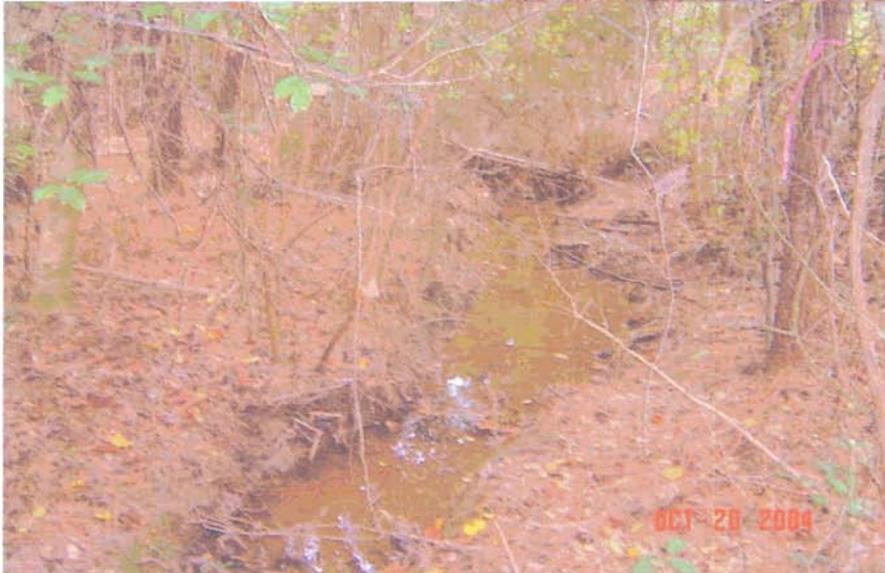
Stream S2 located downstream of the pond. Stream recovering from timbering impacts.
