Fourth Annual Monitoring Report – 2009 Growing Season

Moccasin Creek Riparian Buffer Restoration (EEP Contract: 005015)

December 2009

**Moccasin Creek Riparian Buffer Restoration
Fourth Annual Monitoring Report (2009 Growing Season)**

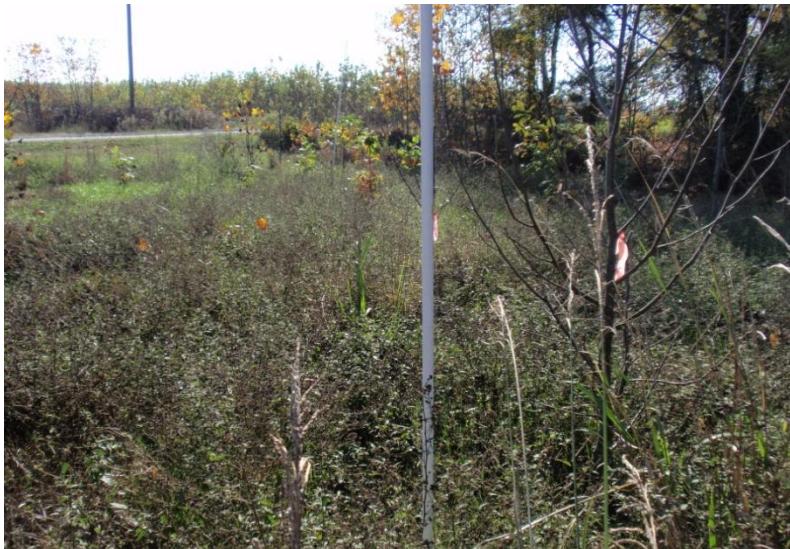
Plot A-1

As noted in the 2008 monitoring report, portions of Tract A, especially near Plots A-1 and A-4 were not achieving as much growth success; this area contains dense stands of pre-existing or invading pasture grasses, including coastal Bermuda grass (Figure 2). Consequently, in January 2009 remedial plantings of approximately 200 bareroot seedlings of *Platanus occidentalis*, *Liriodendron tulipifera* and *Taxodium distichum* were planted in under-performing portions of the tract. Additionally, approximately 300 bareroot seedlings of *Taxodium distichum* on the south side of main tributary bisecting the project between Plots B-1 and C-5 in an area altered by channel modification activities and washout during flooding. These remedial plantings will be included in the next annual monitoring report (Year 2010) and any areas underperforming will be address with additional planting and herbicide application if necessary.
