Monitoring Report

Norman's Pasture Restoration Site

Norman's Pasture II Restoration Site

Monitoring Year 02

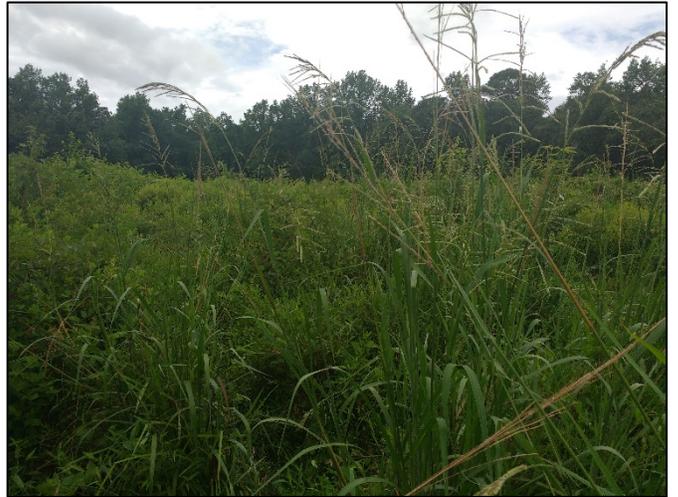
Plot 14 – MY-02 – 8/11/17

4. Appendix C, Tables 6 and 8: These tables show vegetation plot (VP) 14 as meeting success with 364 stems per acre. In looking at MY 1 data, VP 14 failed to meet success based on only 283 stems per acre. Since there was no discussion in the MY 2 report of a supplemental planting effort, please explain how VP 14 was successful in MY 2 and not in MY 1.
KCI Response: During the baseline monitoring, 17 stems were reported in VP14. When the vegetation counts for MY01 were performed, 5 of these 17 stems were reported as missing (and 5 were reported as dead). When MY02 vegetation counts were performed, only one new dead stem

was reported and 2 of the missing stems were located. It is likely that these stems were not found in MY01 due to the thick tear thumb and blackberry that is present in that area. Then by MY02 they had achieved sufficient height to be noticed amidst the thick herbaceous vegetation.

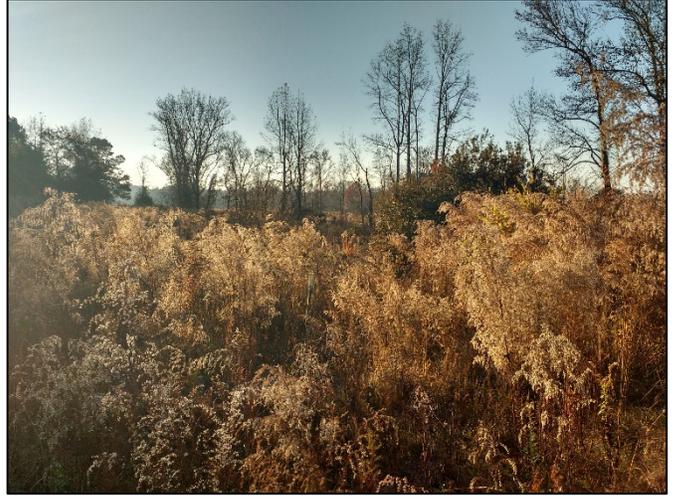
PP01 – MY-02 – 11/30/17

A yearly visual assessment of the enhanced stream on NPII will occur every year. The second year monitoring visual assessment found the stream to be in good condition. As the photos show, there has been a high survival rate of live stakes and herbaceous streamside vegetation is thriving. One small area of erosion developed shortly after construction and was repaired before the end of the first growing season. Despite numerous large flow events, the stream has shown no additional signs of erosion since. The stream corridor is also showing signs of a higher water table, which was a goal of raising the streambed elevation. This is evidenced by more standing surface water compared to pre-construction conditions and the gauge data from the adjacent monitored wetlands.

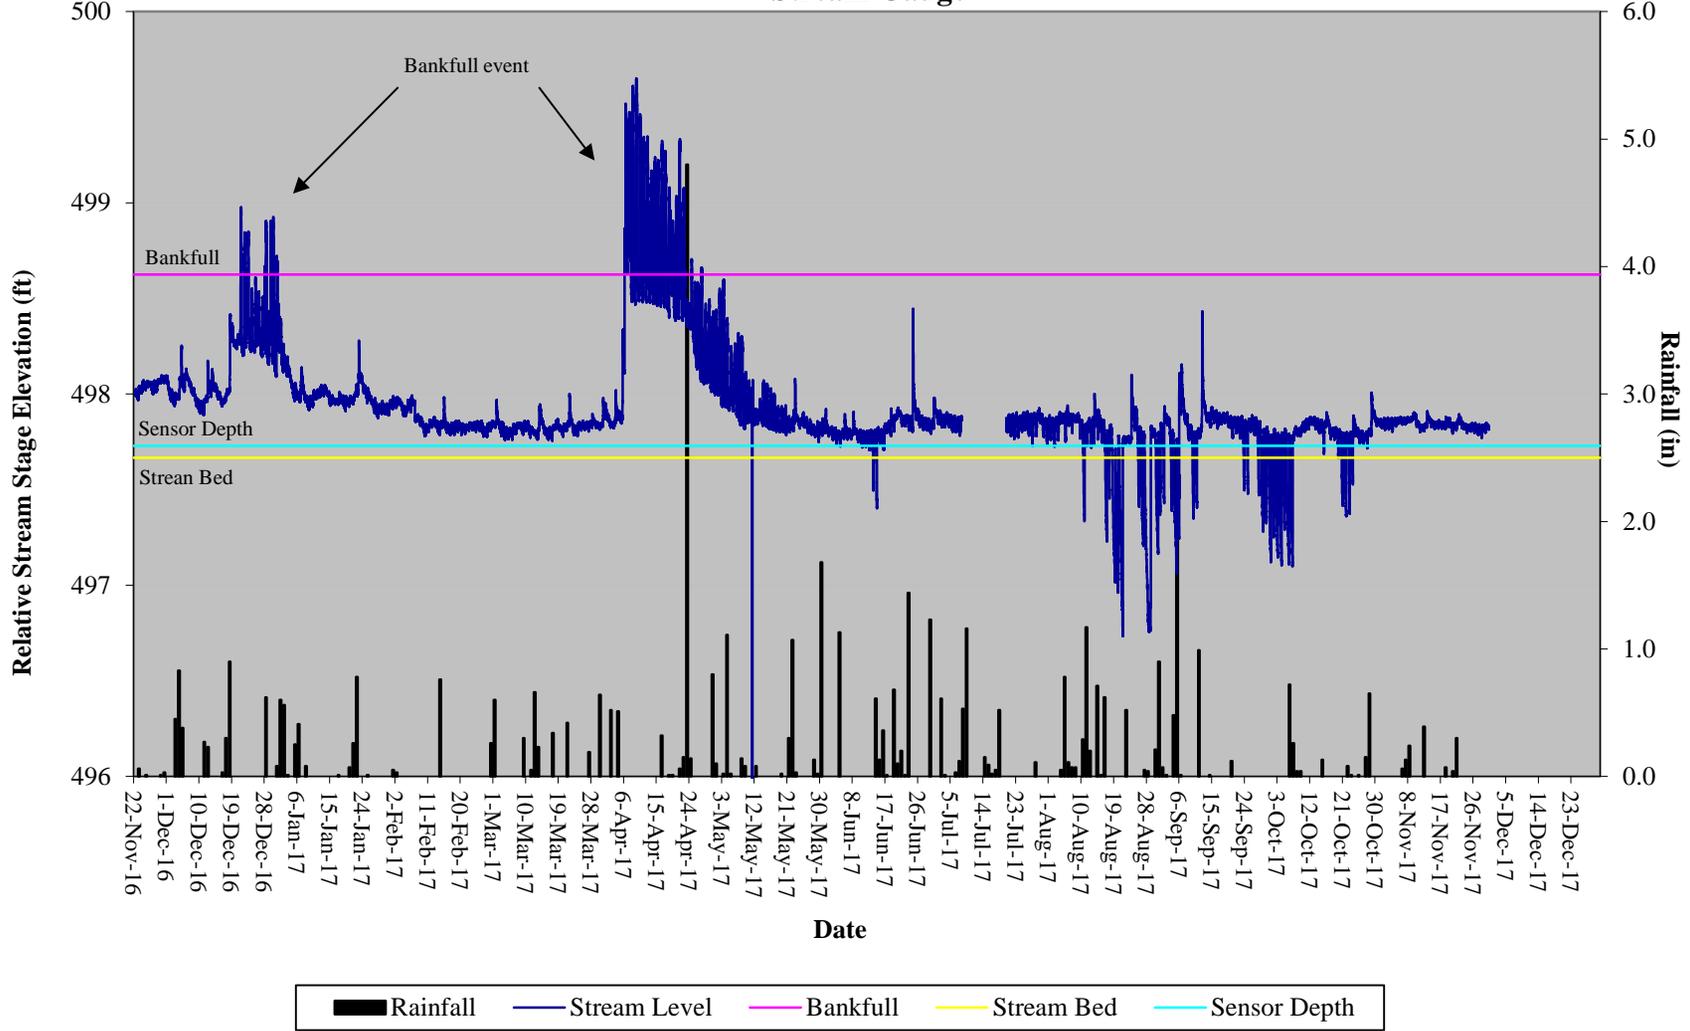
Norman's Pasture II Restoration Site Hydrograph Stream Gauge

As part of the site success criteria the stream must experience two bankfull events in separate years. The stream experienced several bankfull events in both 2016 and 2017 and has met this criteria. See Table 9 in Appendix D.

3. Section 2.2, last paragraph: Report states that the stream portion of Norman's Pasture II experienced several bankfull events in 2017. Table 9 in Appendix D also shows that there were several bankfull events in 2016 (MY 1). Please state that the stream met the bankfull standard.
KCI Response: This change has been made.

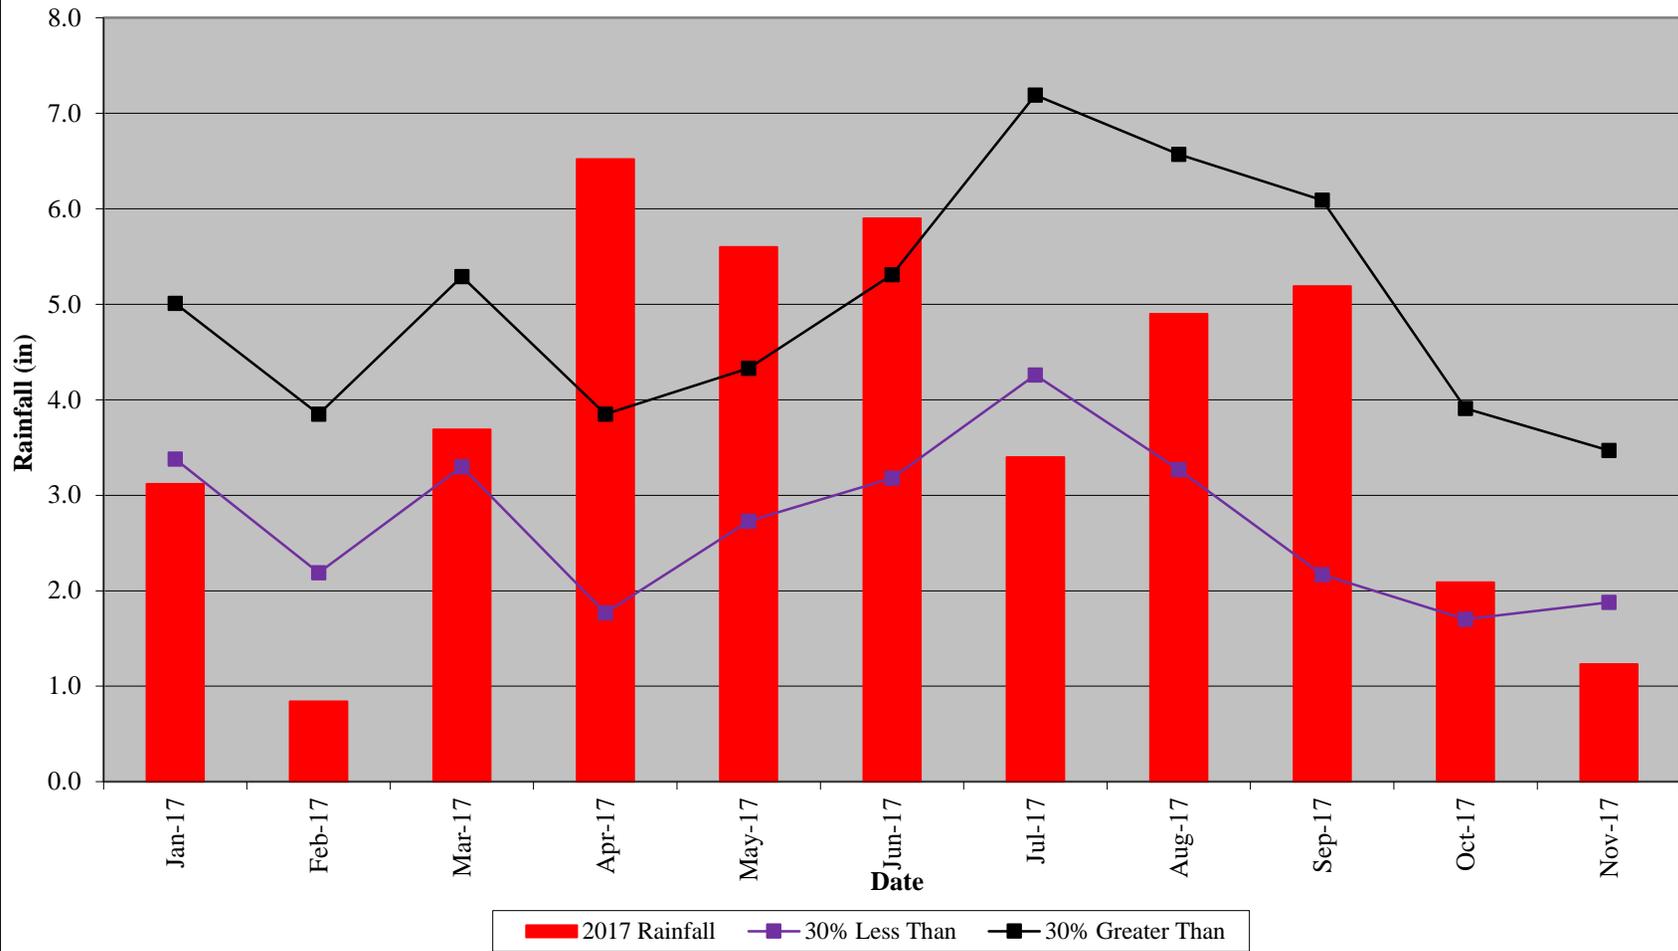
**Norman's Pasture Wetland Restoration Site
30-70 Percentile Graph
WETS Station Name: Clinton 2 NE, NC**

The daily rainfall data was obtained from a local weather station in Clinton, NC; provided by the NC State Climate Office. For the 2017-year, the months of April, May, and June experienced an above average rainfall, while March, August, September, and October experienced average rainfall. The months of January, February, July, and November recorded below average rainfall for the site. Overall, the area experienced average rainfall during the 2017 growing season.
