Monitoring Report

Norman's Pasture Restoration Site
DMS Contract 005010
DMS Project Number 95717

Norman's Pasture II Restoration Site
DMS Contract 5787
DMS Project Number 96310

Monitoring Year 06

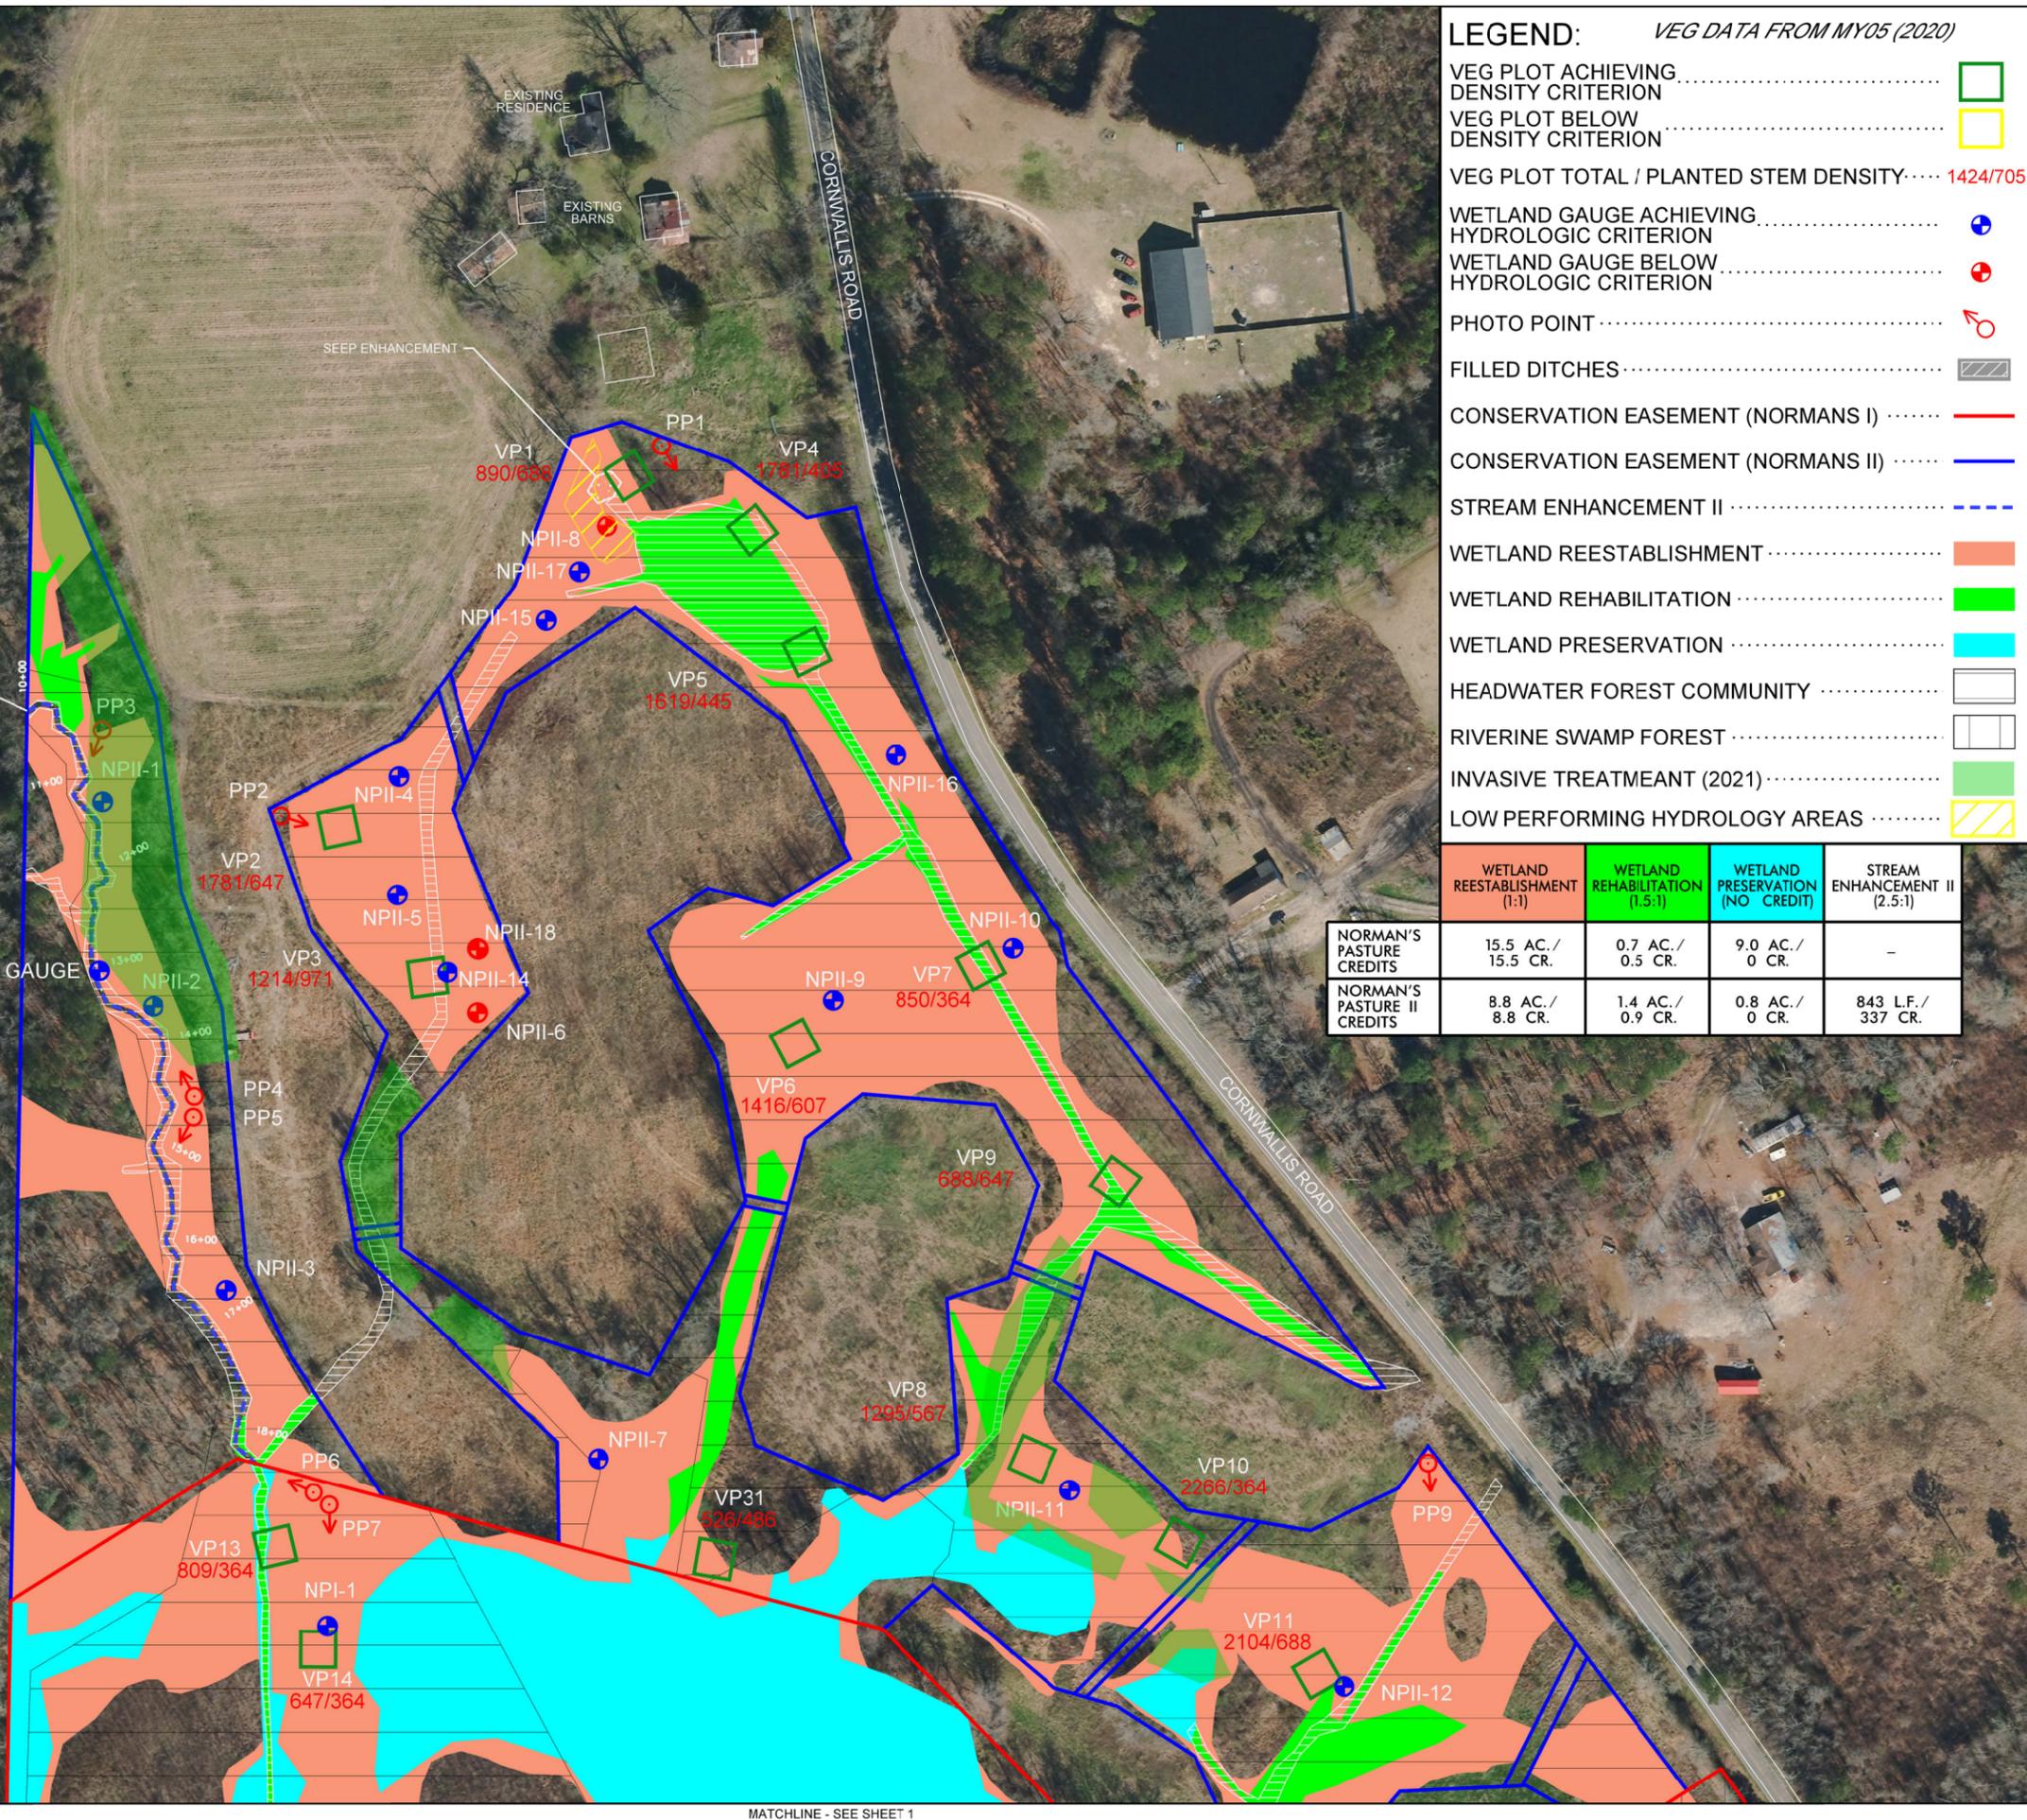
- LEGEND:** *VEG DATA FROM MY05 (2020)*
- VEG PLOT ACHIEVING DENSITY CRITERION
 - VEG PLOT BELOW DENSITY CRITERION
 - VEG PLOT TOTAL / PLANTED STEM DENSITY 1424/705
 - WETLAND GAUGE ACHIEVING HYDROLOGIC CRITERION
 - WETLAND GAUGE BELOW HYDROLOGIC CRITERION
 - PHOTO POINT
 - FILLED DITCHES
 - CONSERVATION EASEMENT (NORMANS I)
 - CONSERVATION EASEMENT (NORMANS II)
 - STREAM ENHANCEMENT II
 - WETLAND REESTABLISHMENT
 - WETLAND REHABILITATION
 - WETLAND PRESERVATION
 - HEADWATER FOREST COMMUNITY
 - RIVERINE SWAMP FOREST
 - INVASIVE TREATMENT (2021)
 - LOW PERFORMING HYDROLOGY AREAS

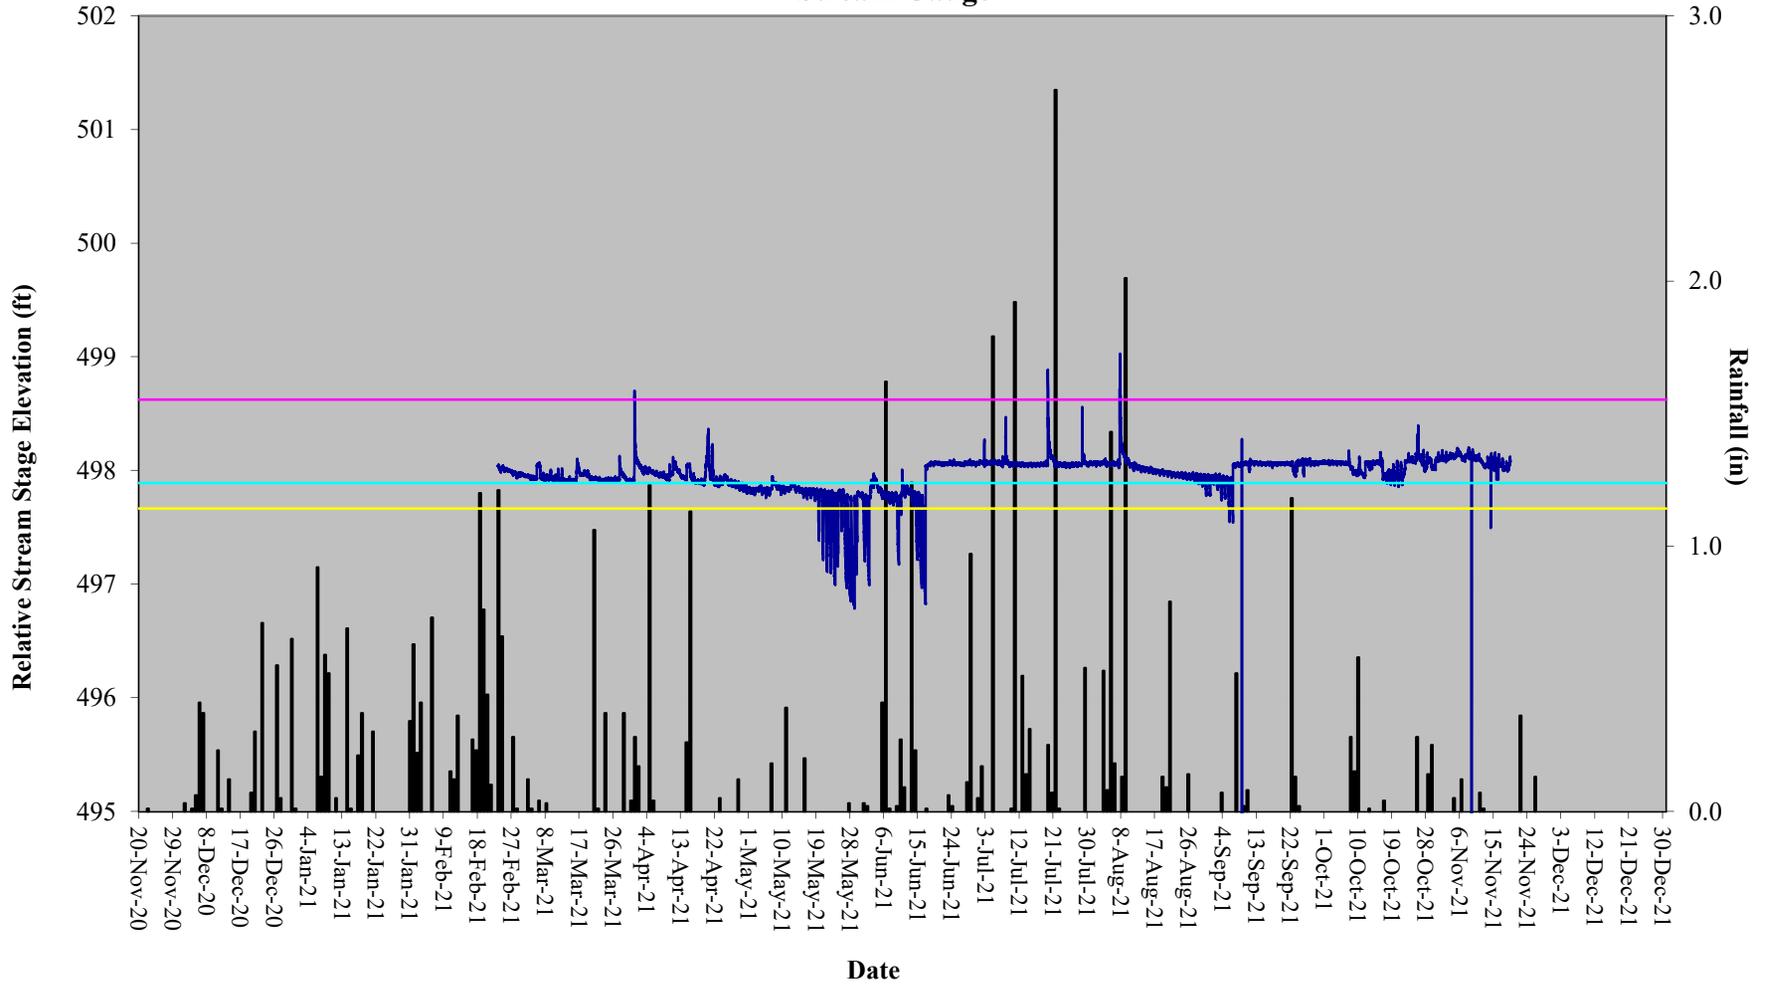
Norman's Pasture II Restoration Site Hydrograph Stream Gauge

As part of the site success criteria the stream must experience two bankfull events in separate years. The stream experienced several bankfull events in all six monitoring years, including three in 2021, and has met this criteria. See Table 7 in Appendix D.

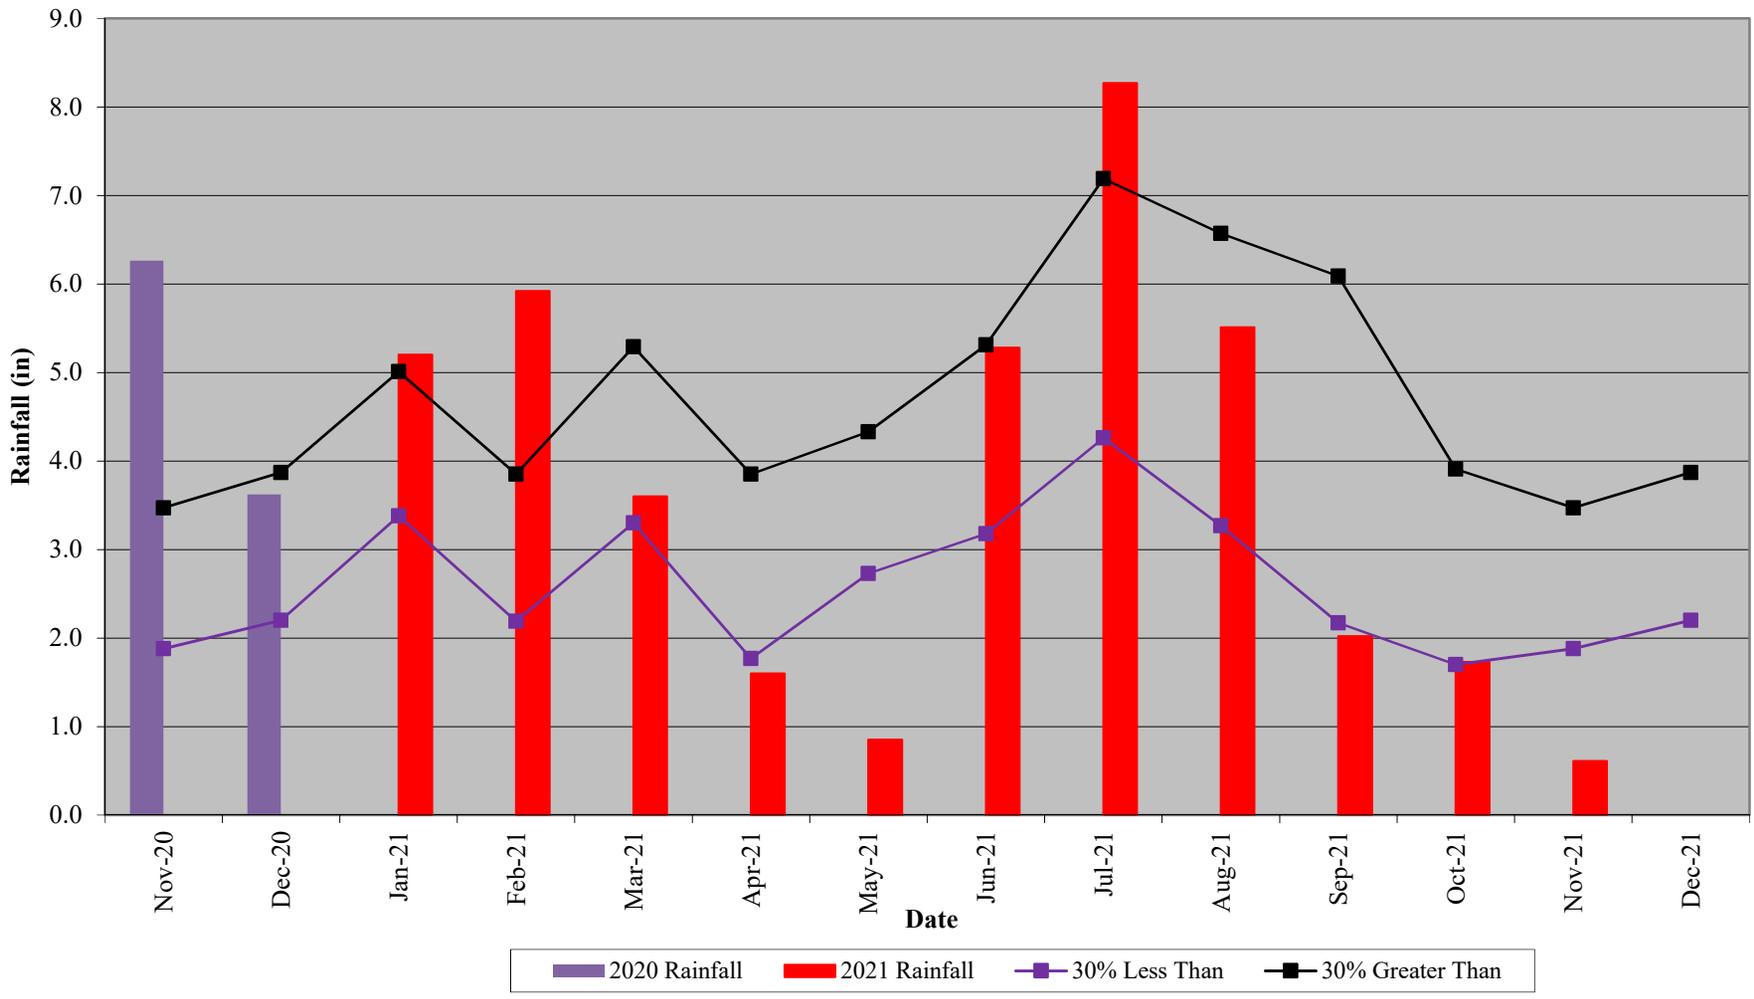
**Norman's Pasture Wetland Restoration Site
30-70 Percentile Graph
WETS Station Name: Clinton, NC**

The daily rainfall data was obtained from a local weather station in Clinton, NC; provided by the NC State Climate Office. For the 2021 year, the months of January, February, and July experienced above average rainfall, March, June, August experienced average rainfall. The months of April, May, September, October, and November recorded below average rainfall for the site. Overall, the area experienced average rainfall during the 2021 growing season.

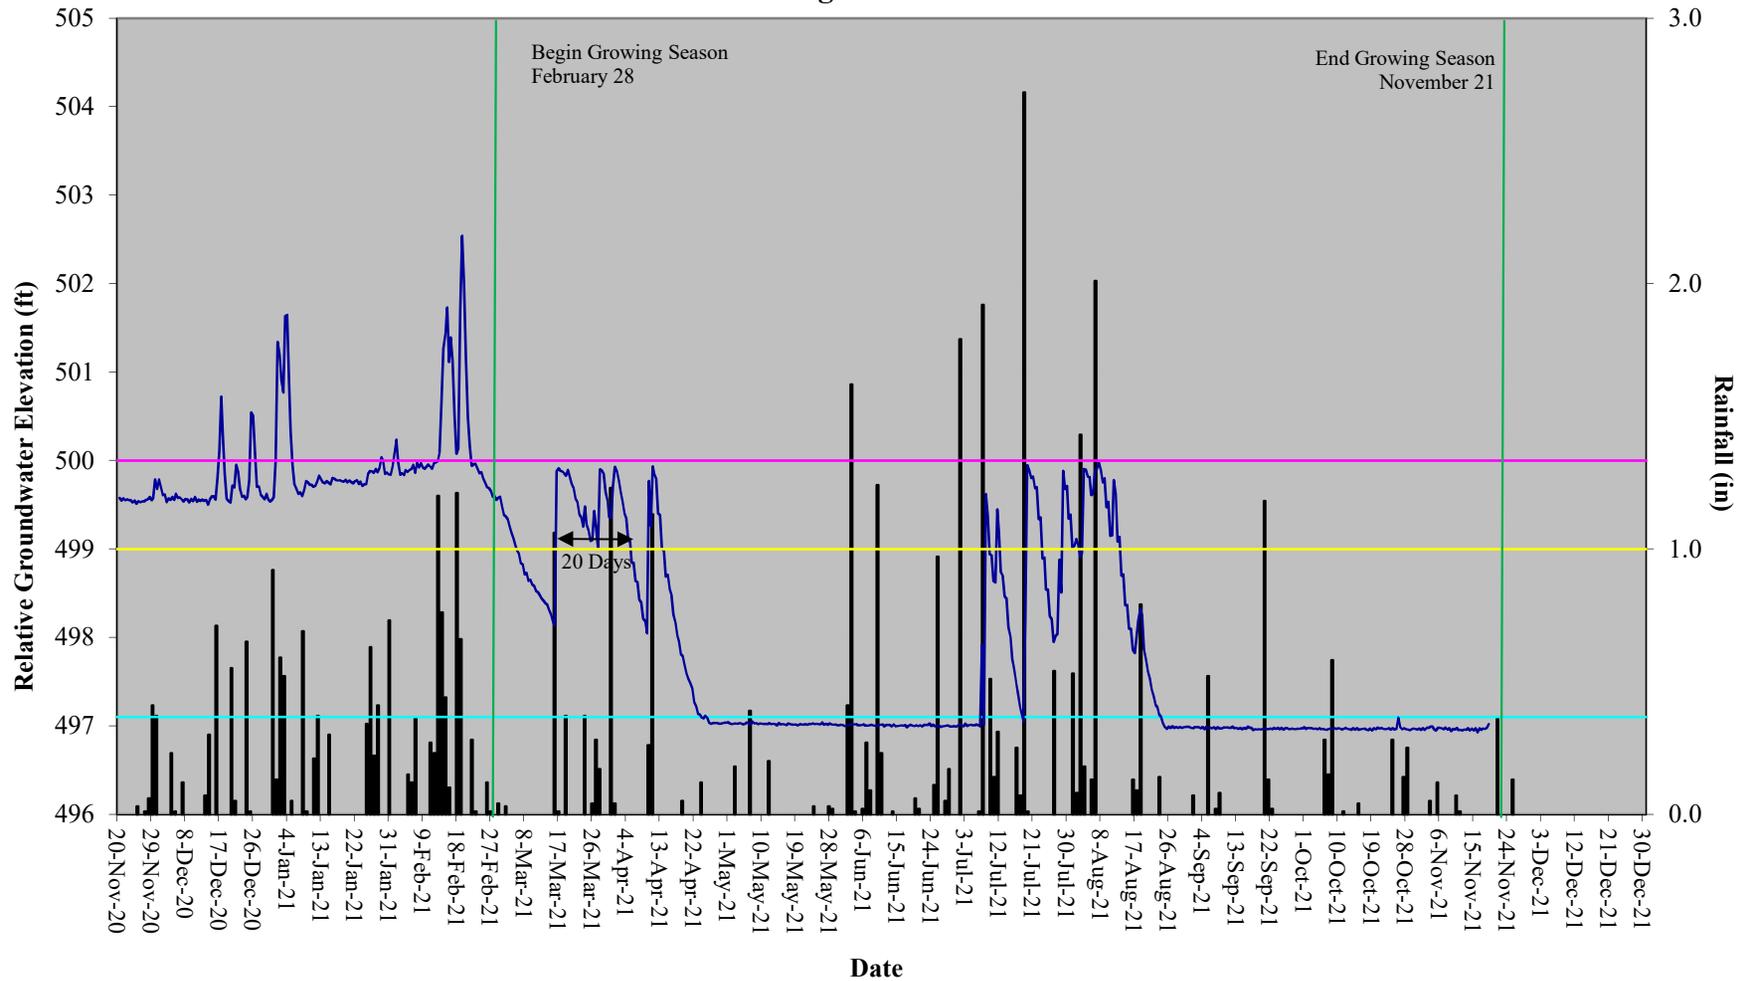
Norman's Pasture II Restoration Site Hydrograph Wetland Gauge 6 - Headwater Forest

outside of the easement. Both NPII-6 and NPII-18 are located within about 30 feet of the easement boundary and so it is unsurprising that the area around them would be transitional. Although the hydrology in this area has been less than the success criteria that is to be expected, this area has not been designated as “at-risk” in the same way as the area around NPII-8 because of these mitigating factors. Please refer to Table 8 in Appendix D for gauge data.
