PAYNE DAIRY-JUMPING RUN
STREAM RESTORATION
YEAR 2 MONITORING REPORT
JANUARY 2003

Introduction

Soil & Environmental Consultants, PA (S&EC) was contracted by the North Carolina Wetland Restoration Program (WRP) to complete the second year monitoring of the Jumping Run Stream Mitigation Site located in Alexander County, North Carolina within the Payne Dairy Property.

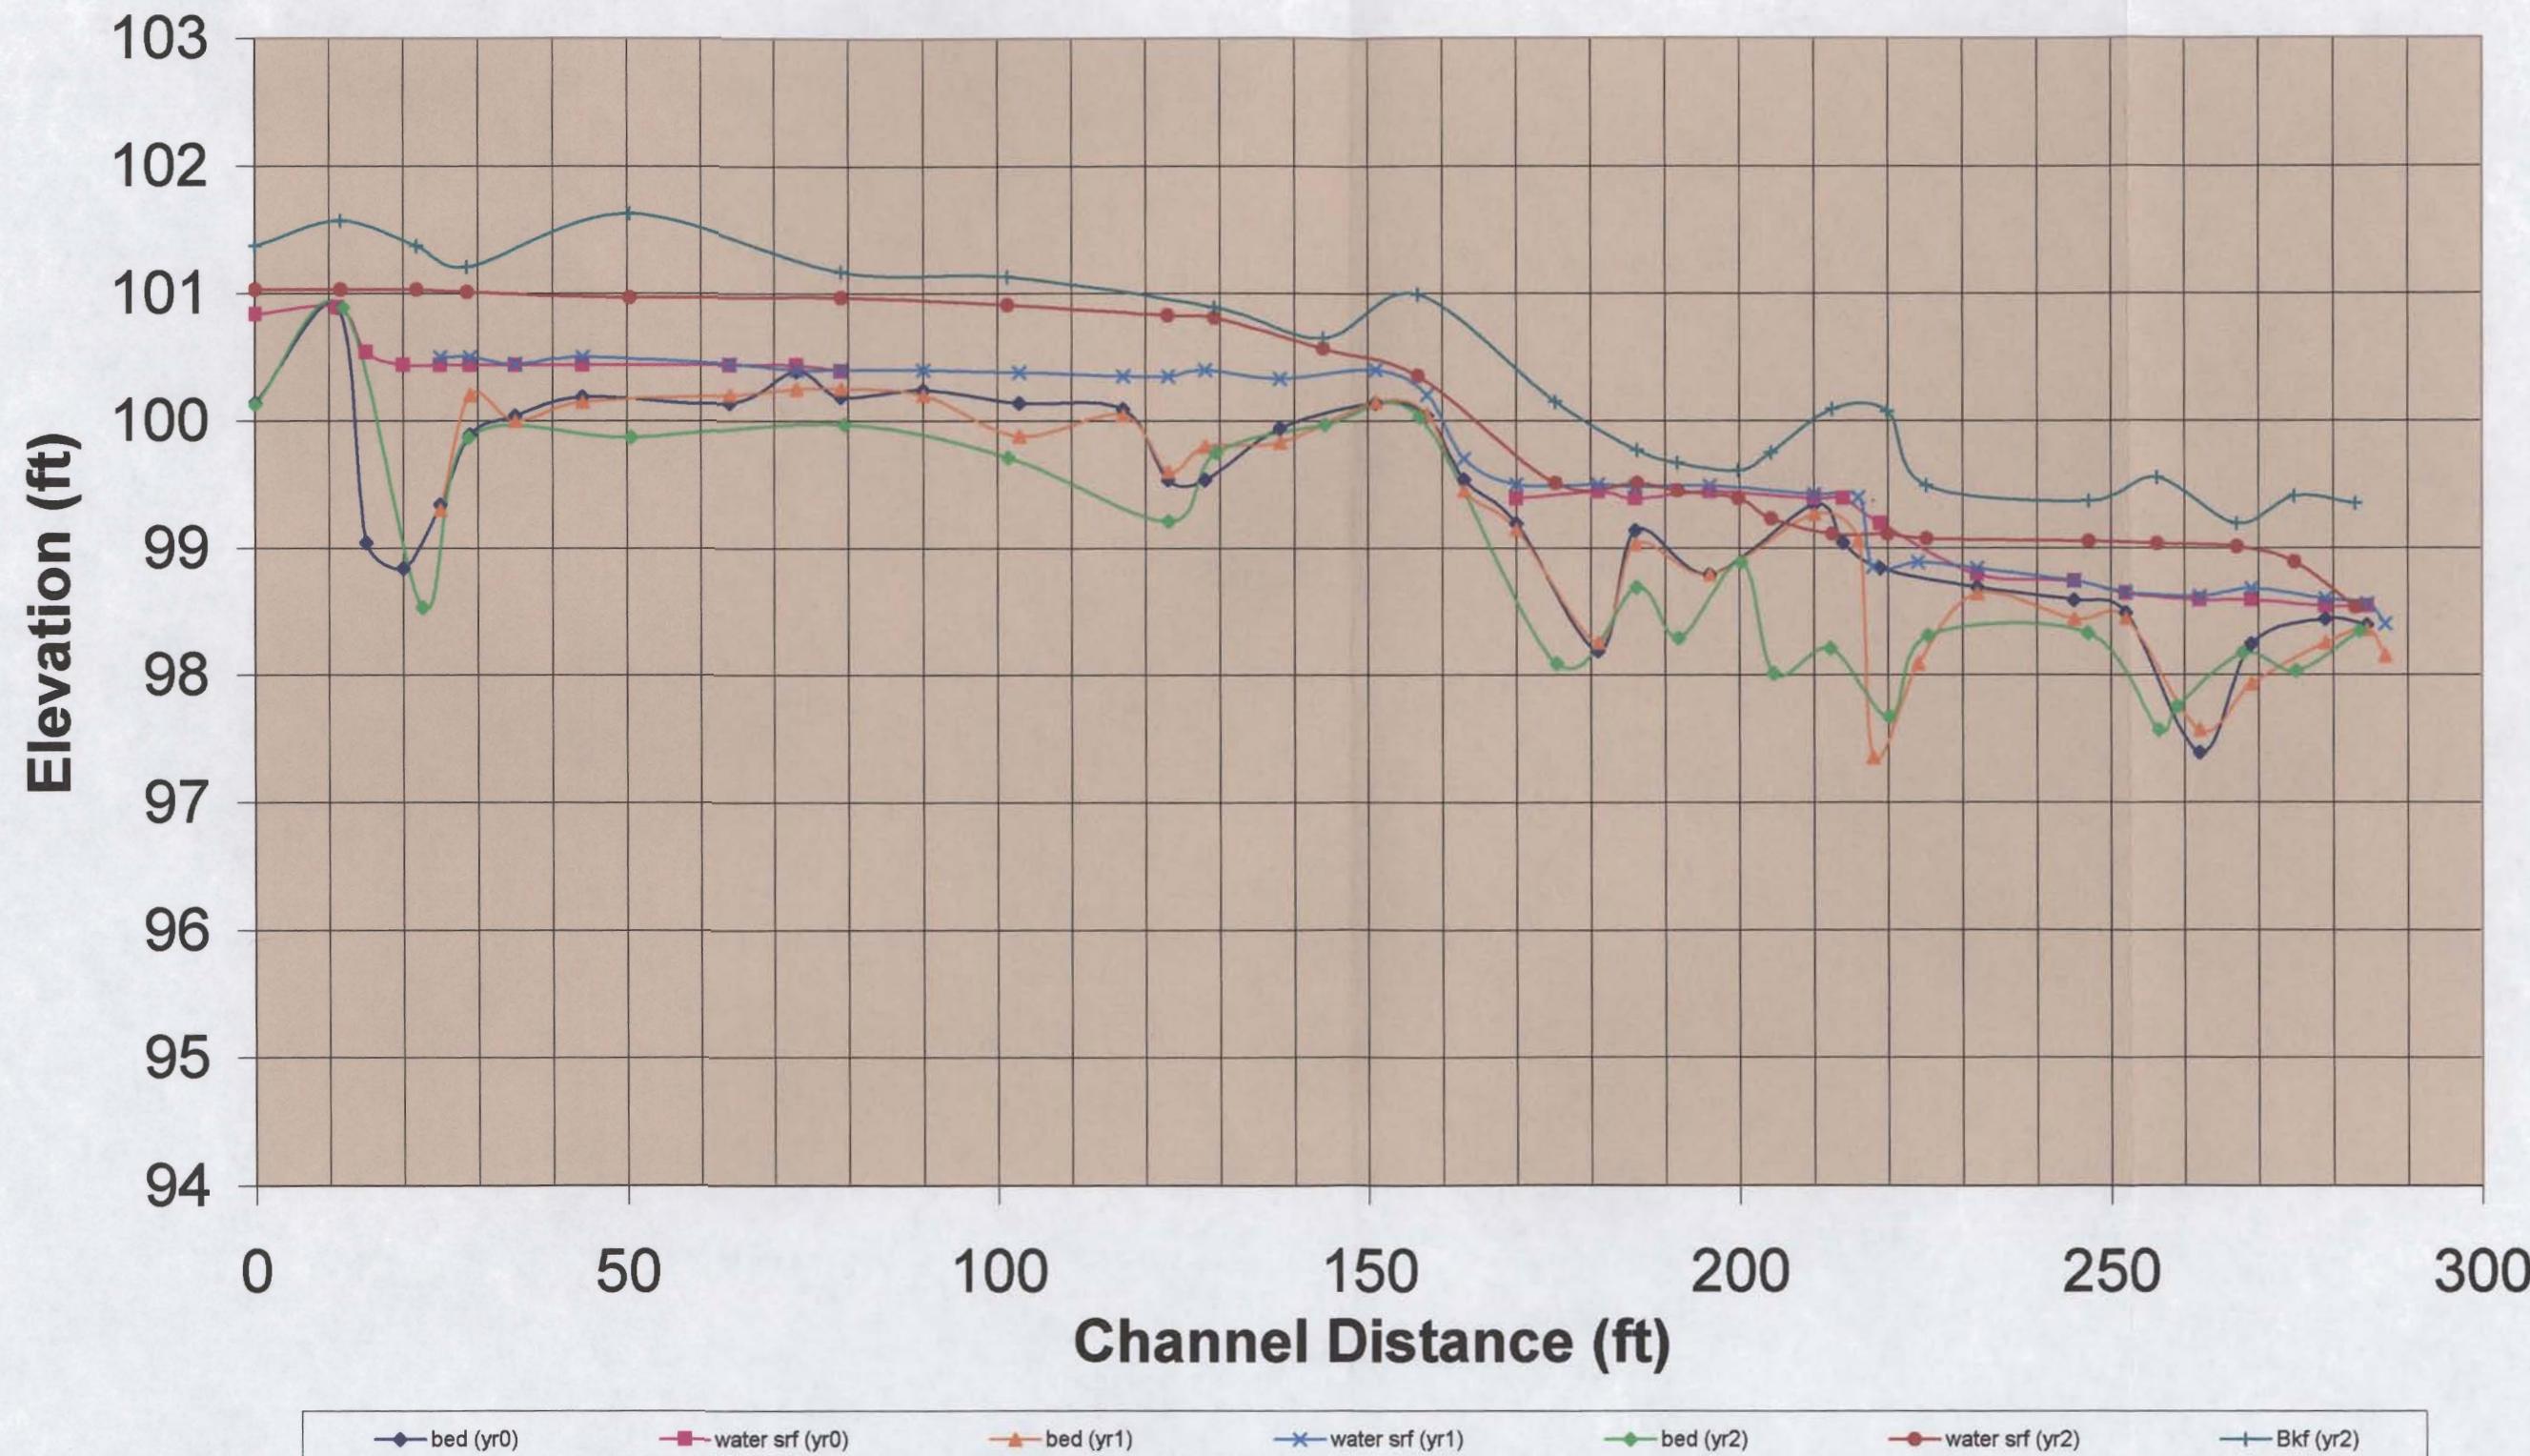
Longitudinal Profile (AREA 1)

The riffle cross-section compared to the two previous surveys has begun to degrade slightly and the pool cross-section continues to aggrade following the trend evident from the previous surveys. The conditions of the banks appear to be relatively stable. Apparently, this section of channel dried up this past summer during the drought for an extended period of time allowing herbaceous plants consisting primarily of *Juncus* and *Carex* spp. to become established within the channel thalweg. As a result the channel has become well vegetated further stabilizing and protecting the banks from potential erosive storm flows. Despite the aggressive vegetation growth, the headcut identified last year at station 2+18 has extended approximately 20 feet upstream. Another trend observed after plotting the Year 2 data over the previous profiles, is that the majority of this reach is degrading and that the longitudinal profile is likely adjusting after every bankfull or near bankfull event.

Although, the vertical profile is actively adjusting the trend does not currently appear to be detrimental. The recommendation is to closely monitor this section as prescribed and allow the channel to naturally equilibrate.

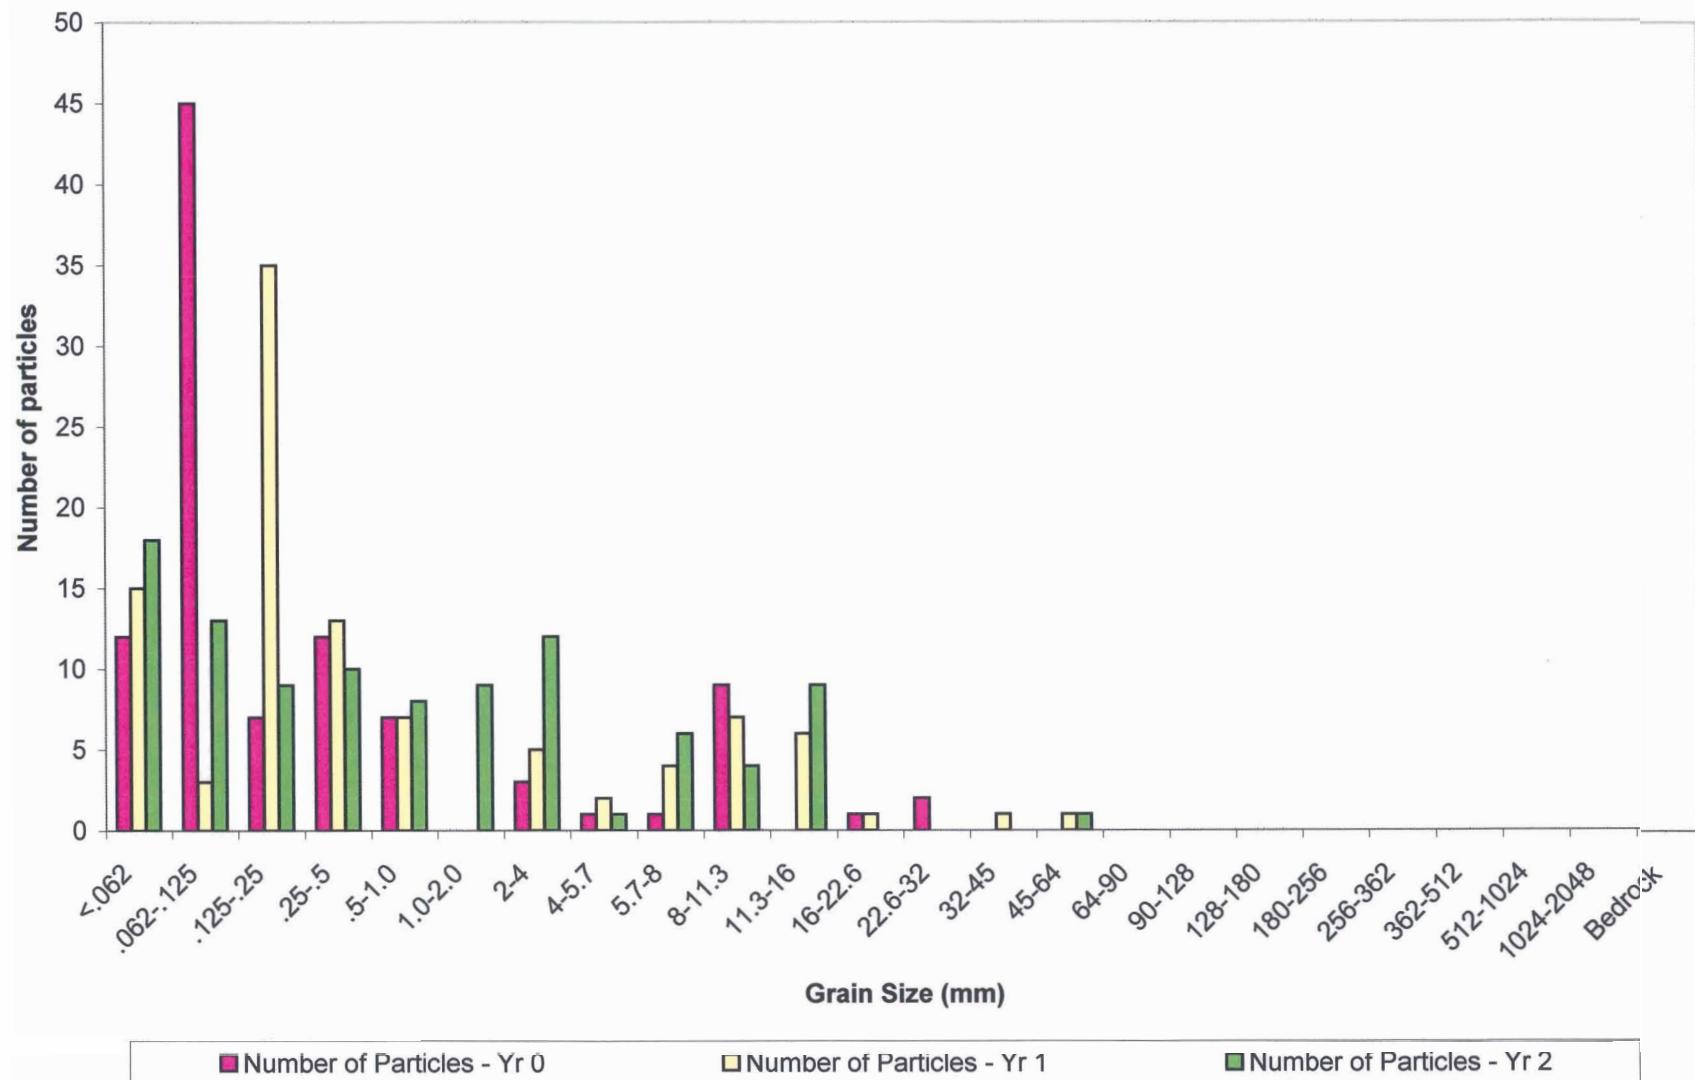
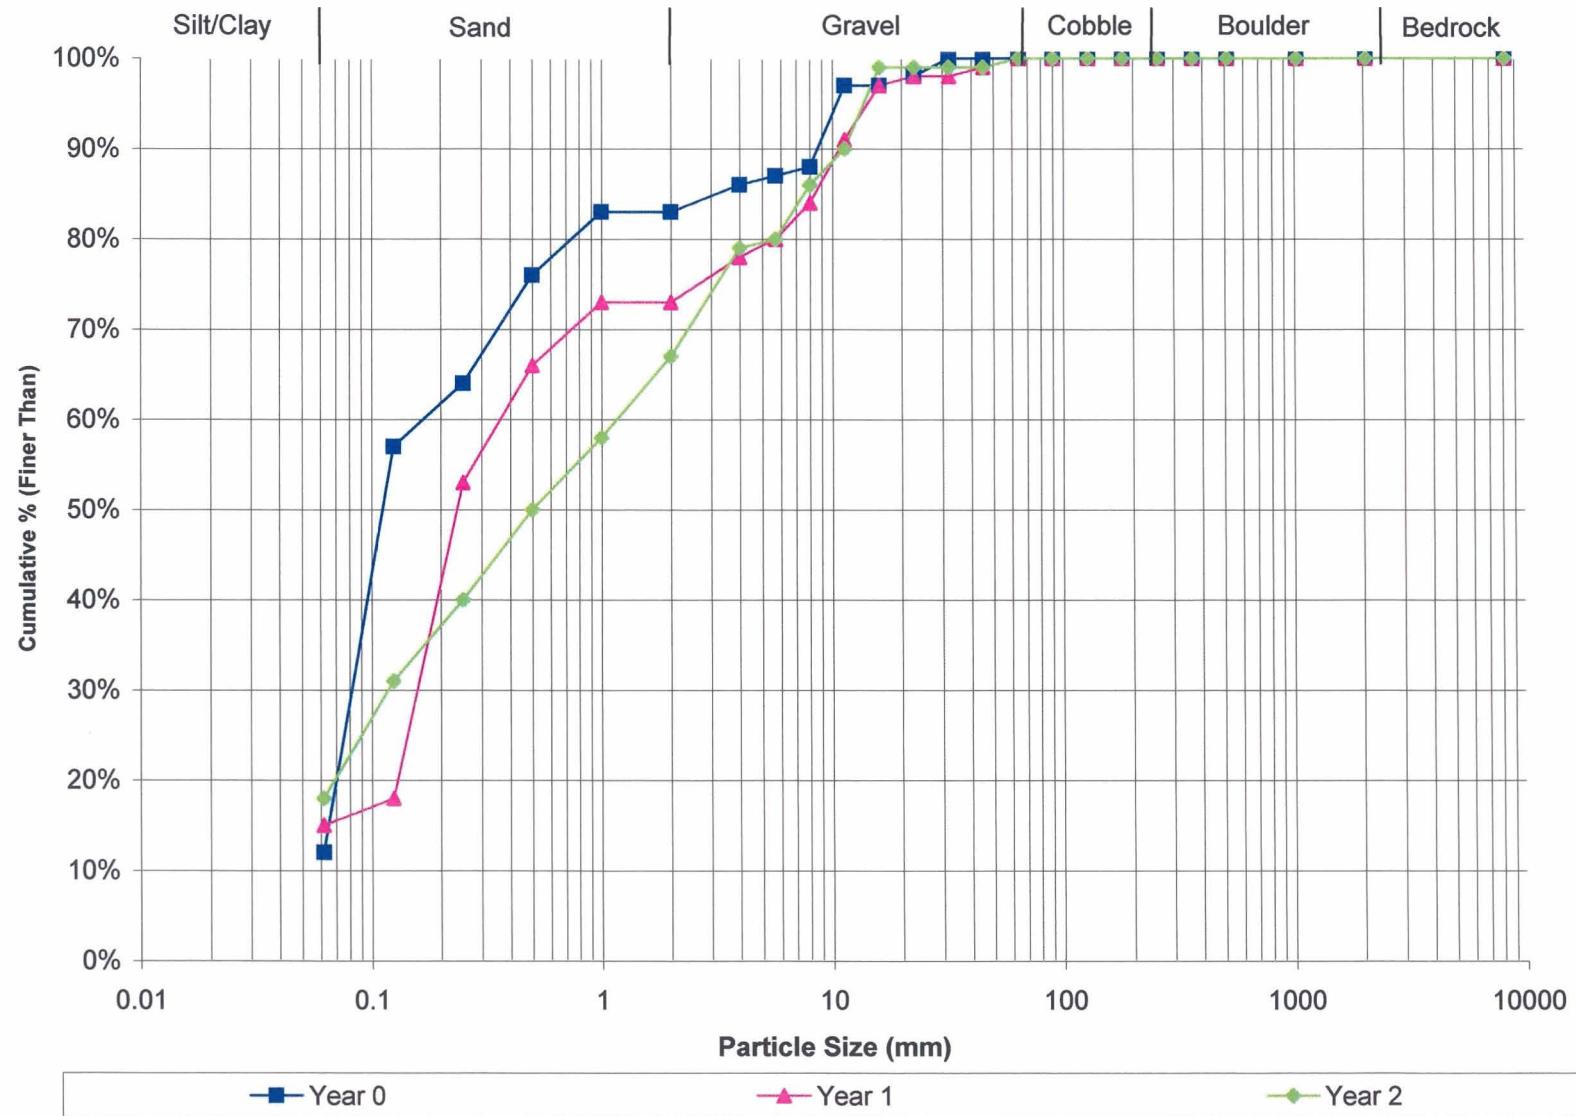
Area 1 - Modified Wolman Pebble Count

Although the cumulative pebble count (combination of the pool and riffle pebble counts) for this section shows an increase in particle coarseness, the pool is significantly coarser than the riffle. This may be due to the degradation observed along the majority of this reach compounded by the characteristics of the parent material excavated when the channel was realigned to the current configuration.

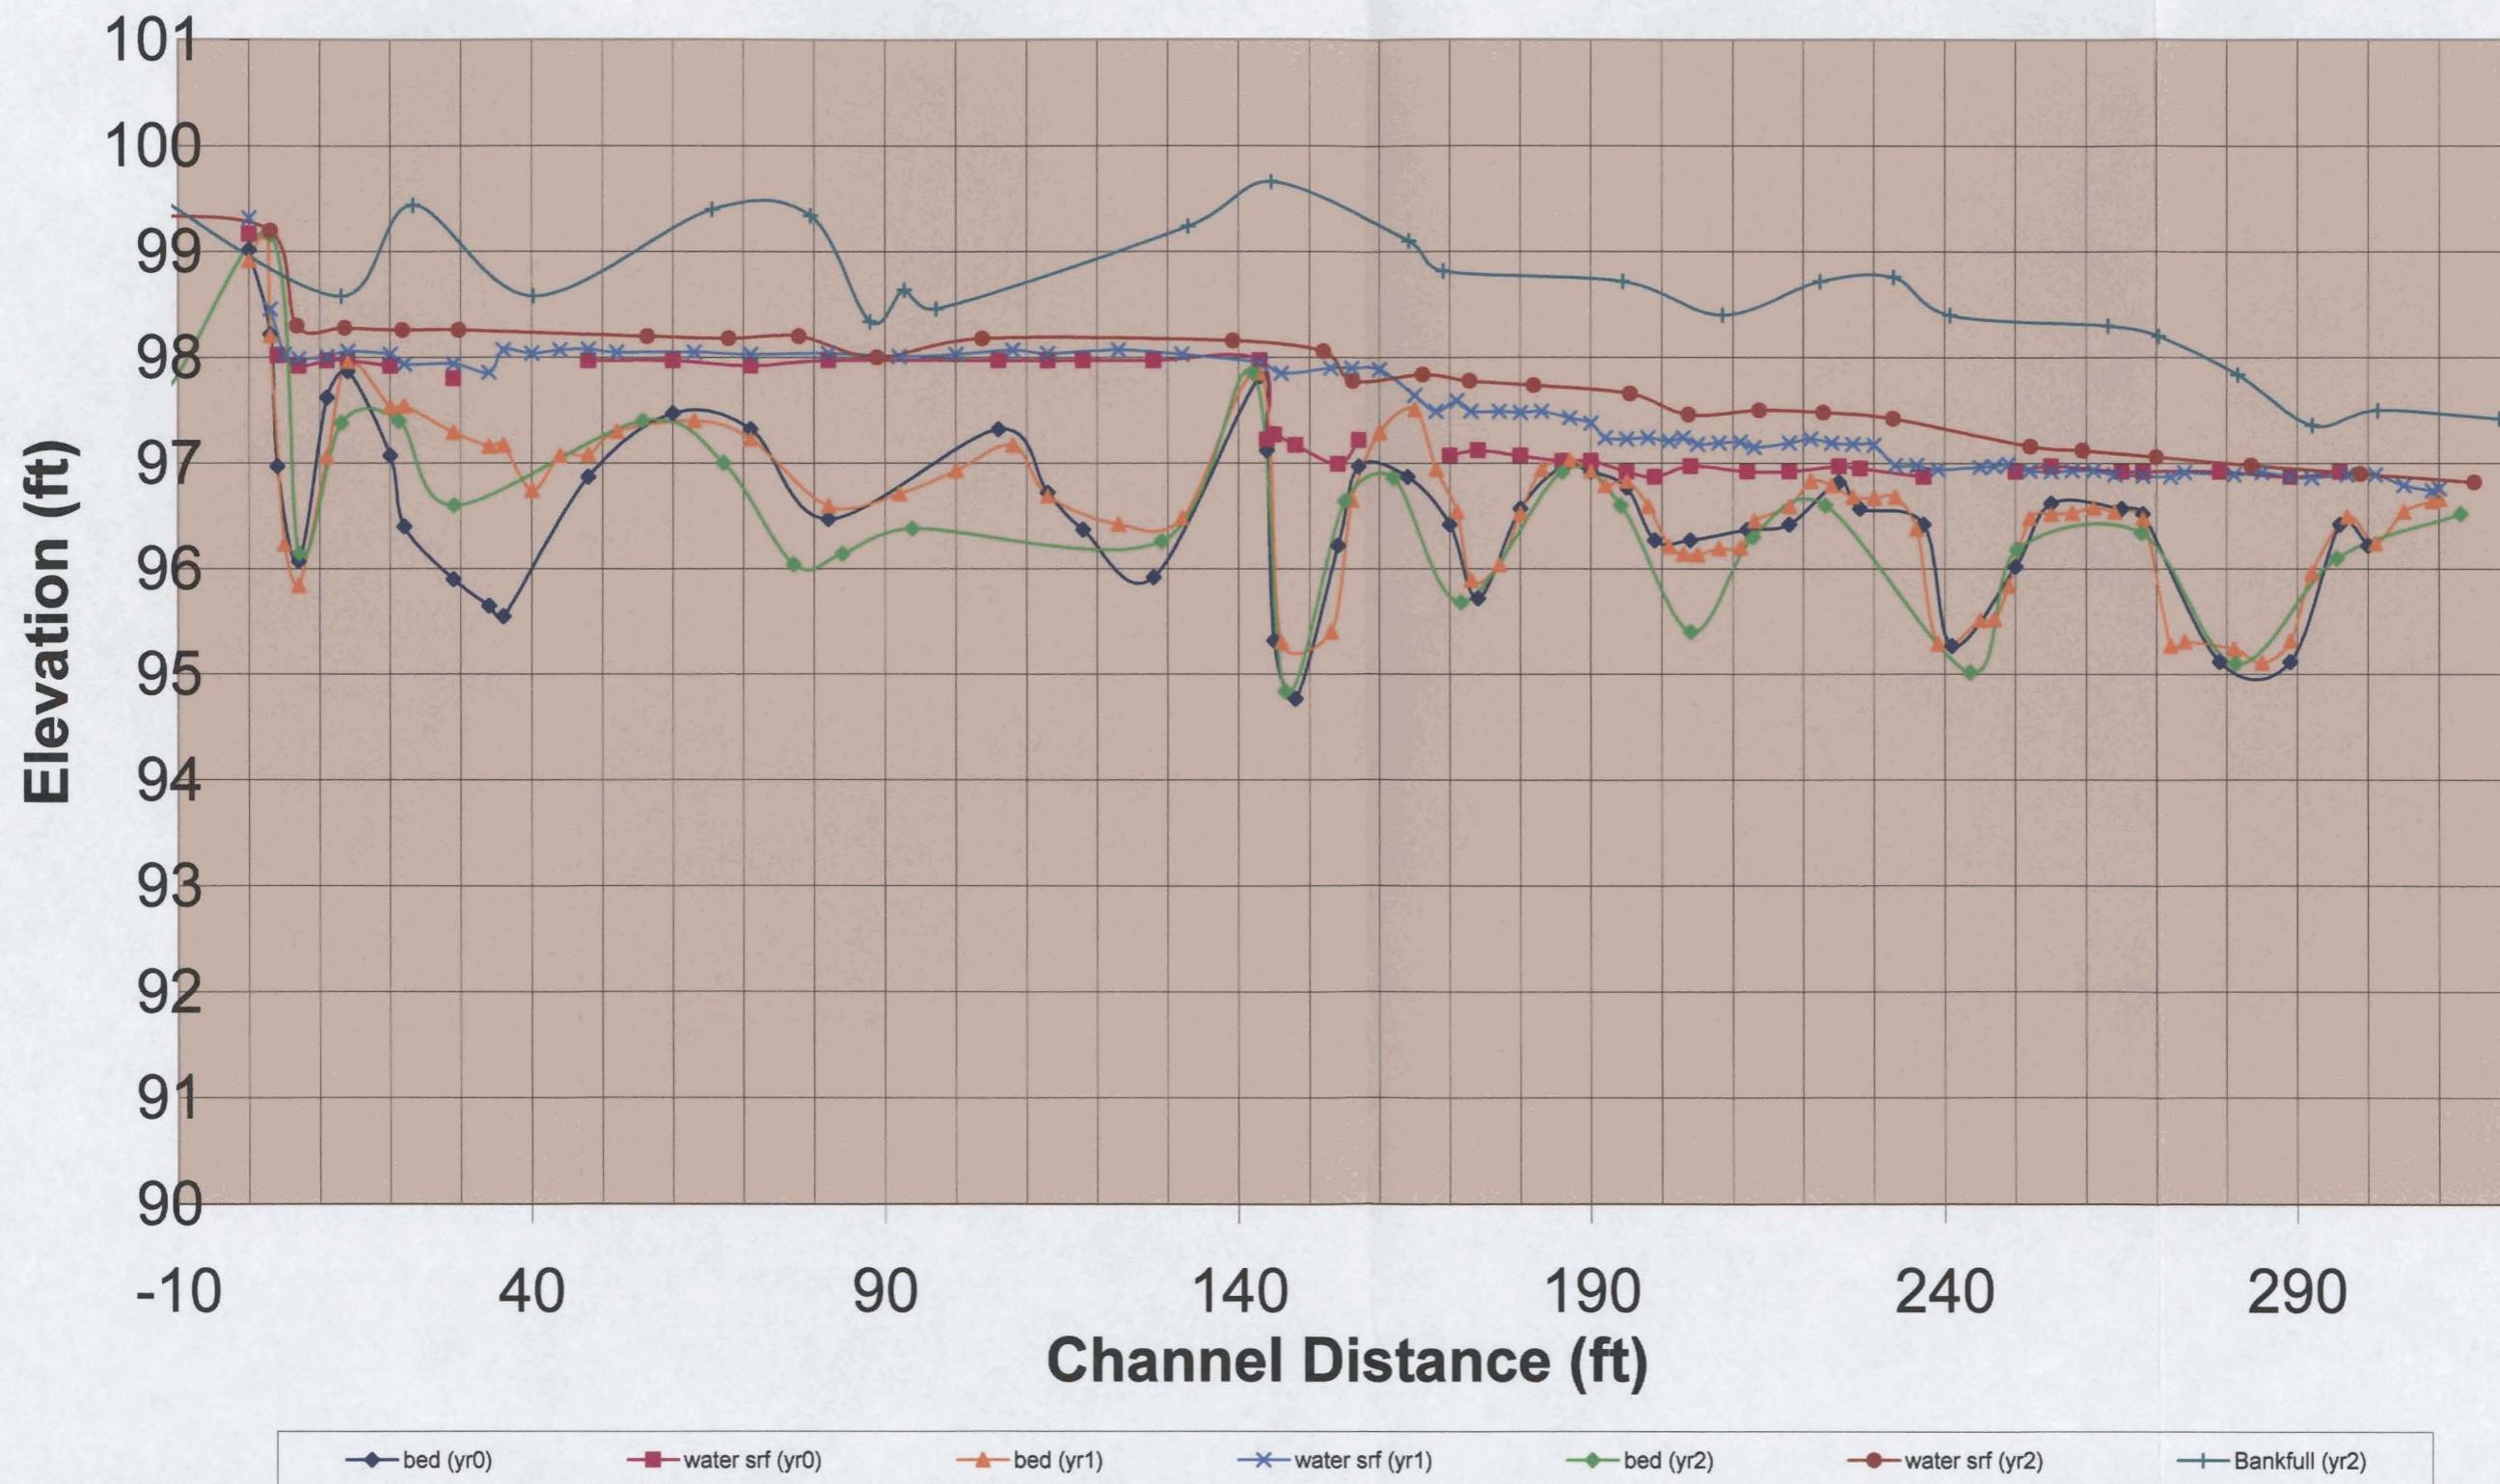
Longitudinal Profile (AREA 2)

The cross-section profiles remain essentially identical to the previous year's data; the most prominent change was the slight increase of the pool depth. As notice in Area 1, the channel longitudinal profile is apparently adjusting and as a result is primarily degrading resulting in the formation of more defined bed features subsequently diversifying channel habitat. Herbaceous vegetation has also become established within the active channel along this section of reach, which has provided bank protection and stability. The horizontal alignment appears to be stable despite the obvious vertical adjustments. Bank slump and erosion was minimal along this area.

Based on the field observation and the comparison of the previously compiled monitoring data, the recommendation is to allow this section to continue to vertically adjust naturally without any intervention, while closely monitoring the project.

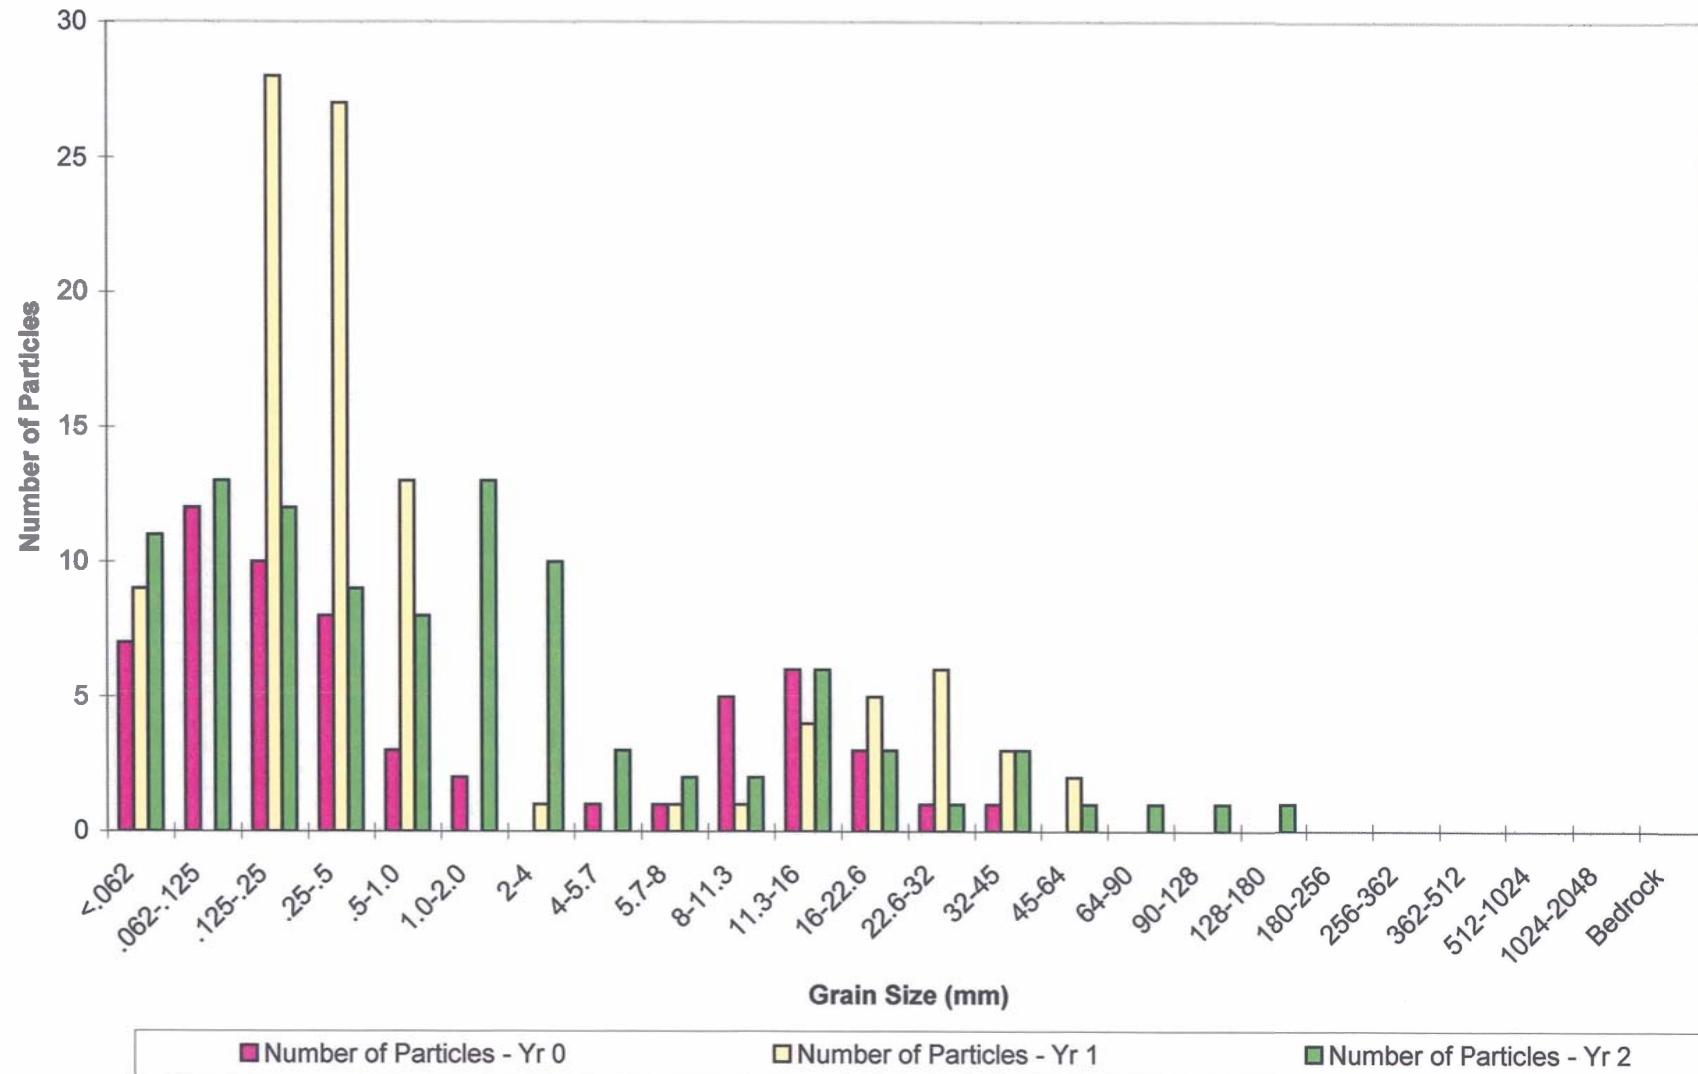
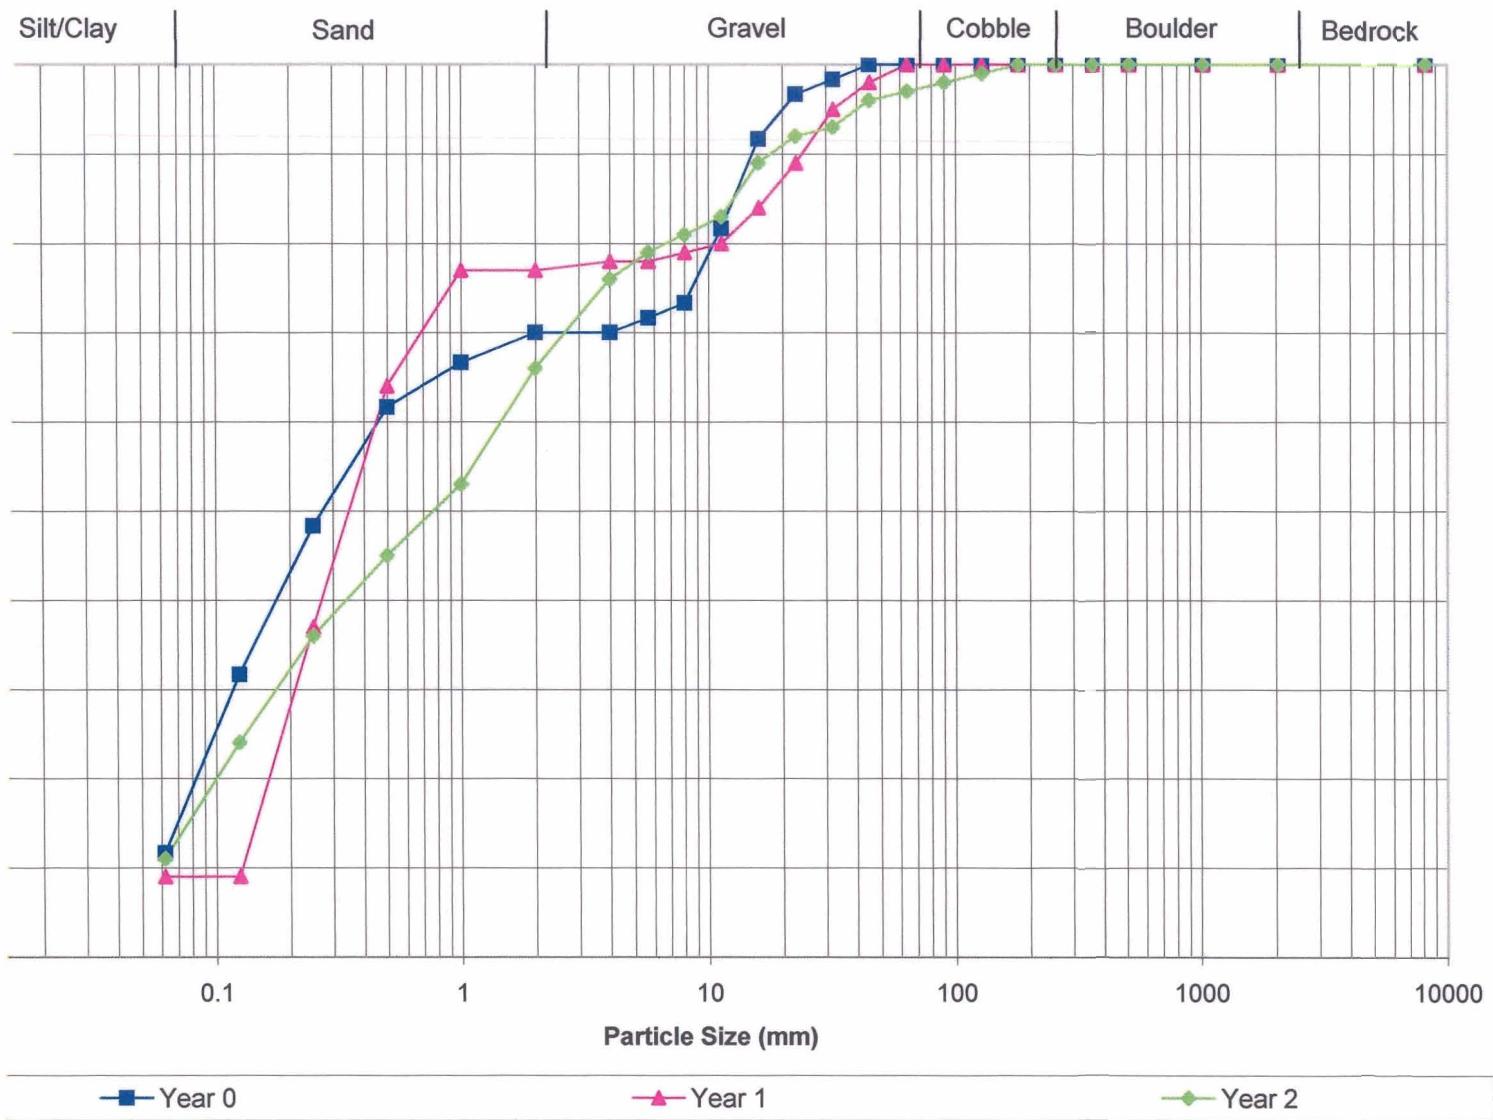
Area 2 - Modified Wolman Pebble Count

Based on the completed pebble count the channel pavement is coarsening. The riffle is significantly coarser than the pool which is what is typically expected.

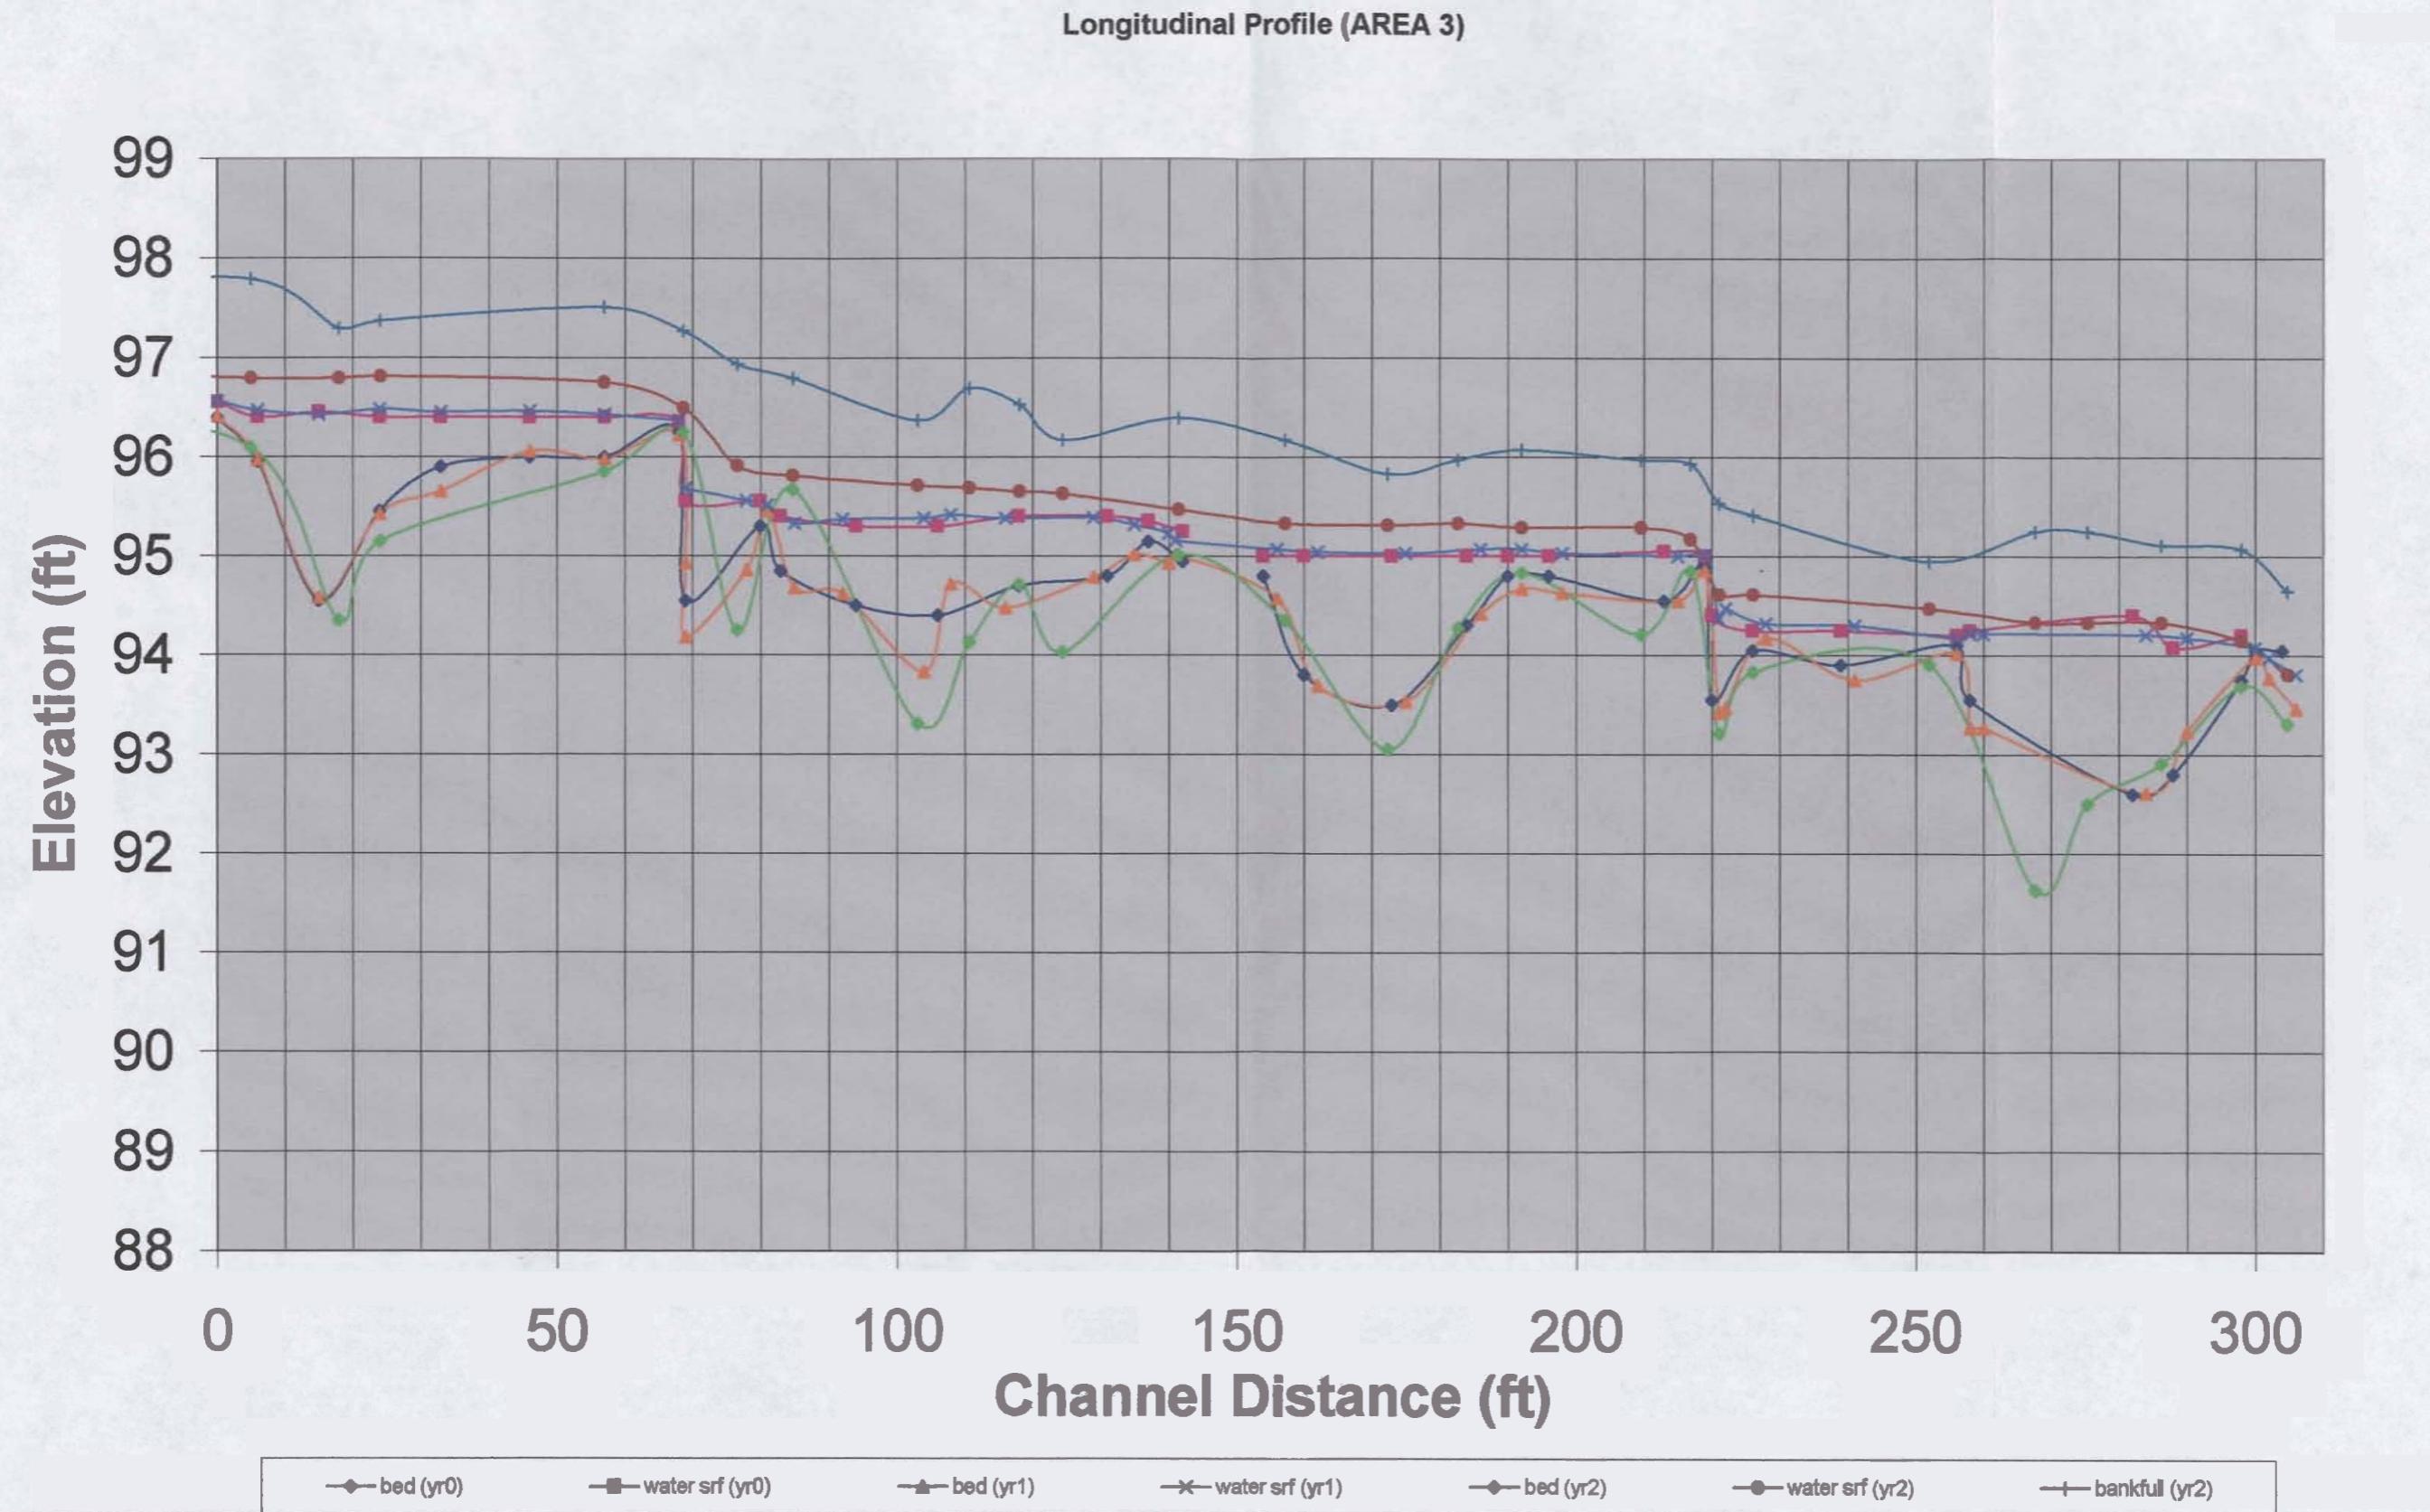
Longitudinal Profile
Jumping Run Creek
Monitoring Document

The longitudinal profile has become more defined as the pools have deepened and the installed grade control structures are effectively holding the invert elevation at those points. Although the pools are becoming deeper, there was no indication that the overall length of channel was becoming degraded.

No maintenance recommendations are being proposed for this section of channel other than continual monitoring.

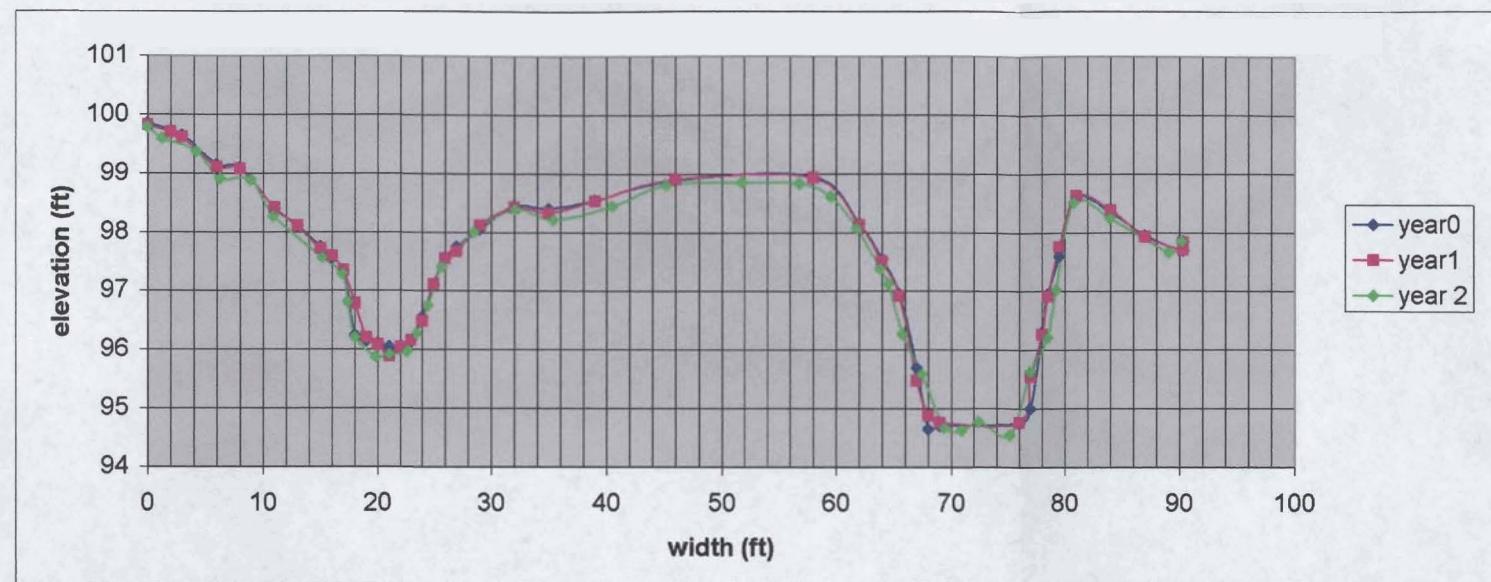
AREA 3
Section Riffle CLASSIFICATION
Location STA (PINS I,J)

The riffle cross-section was essentially identical to the previously plotted profiles from year 0 and 1. The pool cross-section is skewed to the left as compared to previously collected profile data. During the field reconnaissance a depositional feature was observed immediately downstream which may be an indication that the right bank of the pool is becoming undercut and eroding, which could potentially lead to lateral channel migration. This may be the result of a poorly installed and aligned root wad that is refracting storm flows under itself increasing shear stress along the near bank area versus deflecting flows away from the high stress bank as is the intent of this structure.
