PAYNE DAIRY-JUMPING RUN
STREAM RESTORATION
YEAR 2 MONITORING REPORT
JANUARY 2003

Introduction

Soil & Environmental Consultants, PA (S&EC) was contracted by the North Carolina Wetland Restoration Program (WRP) to complete the second year monitoring of the Jumping Run Stream Mitigation Site located in Alexander County, North Carolina within the Payne Dairy Property.

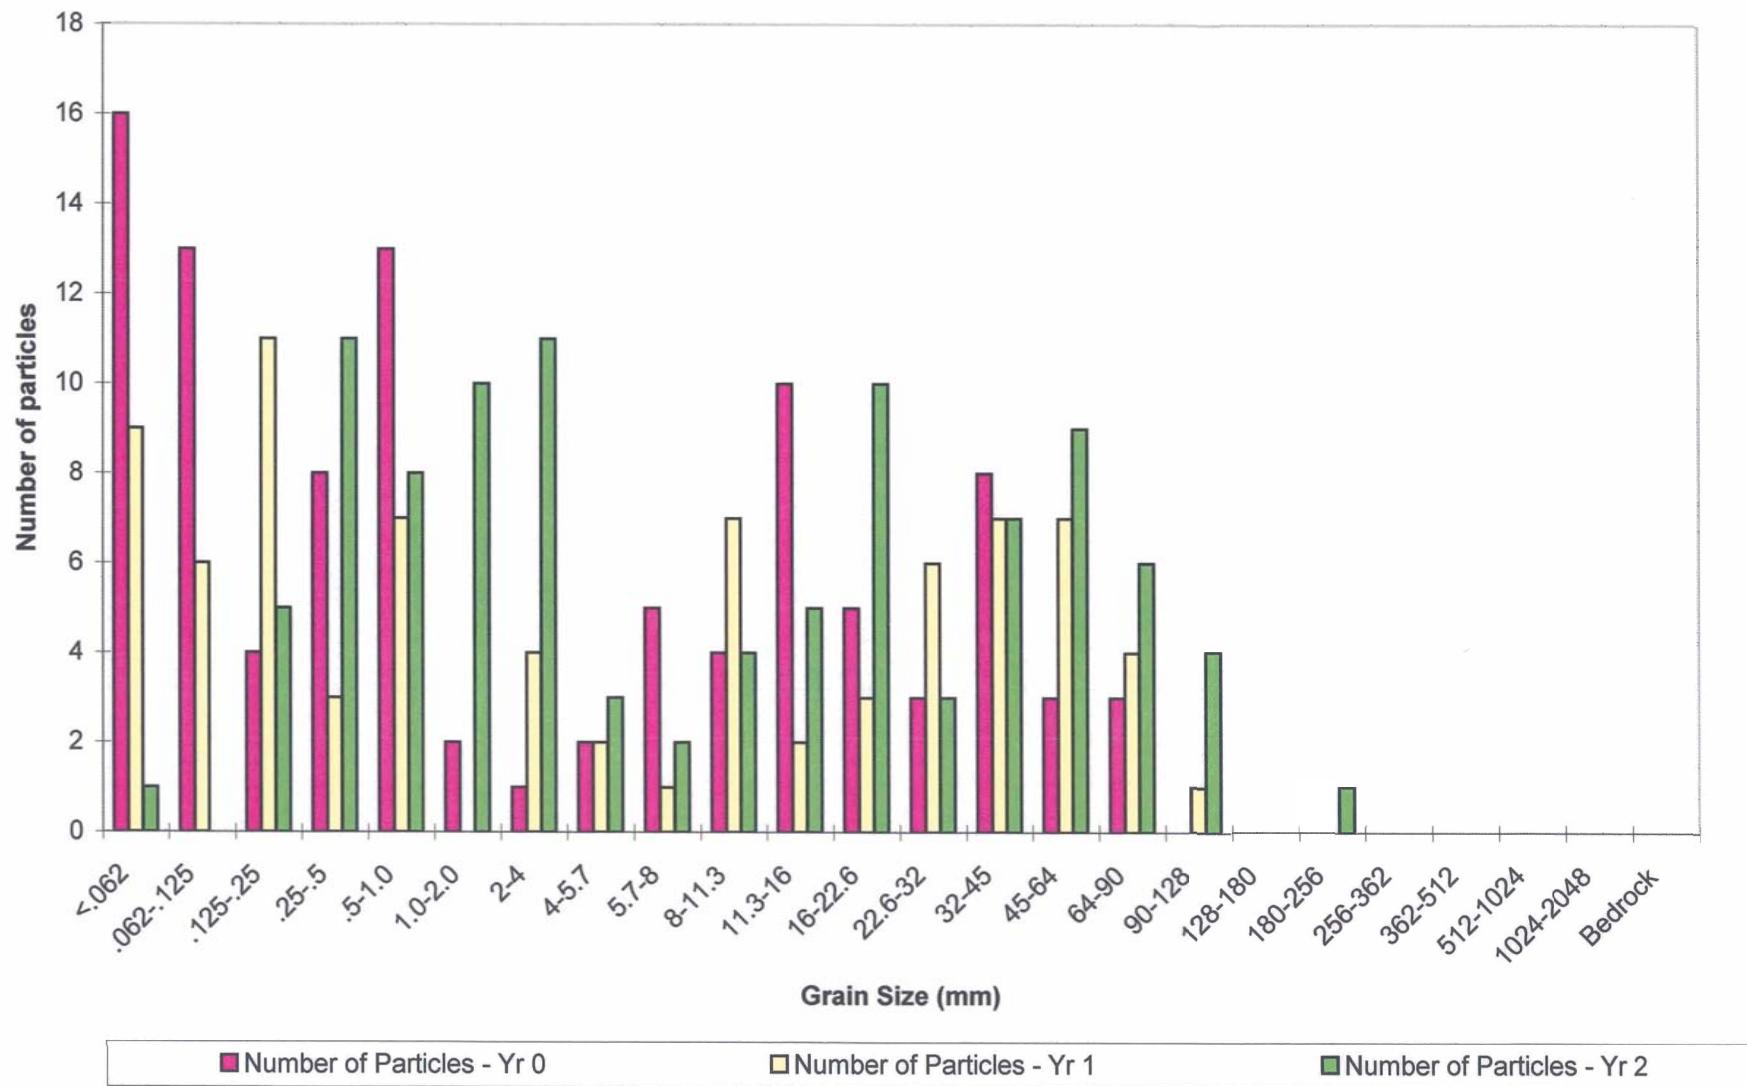
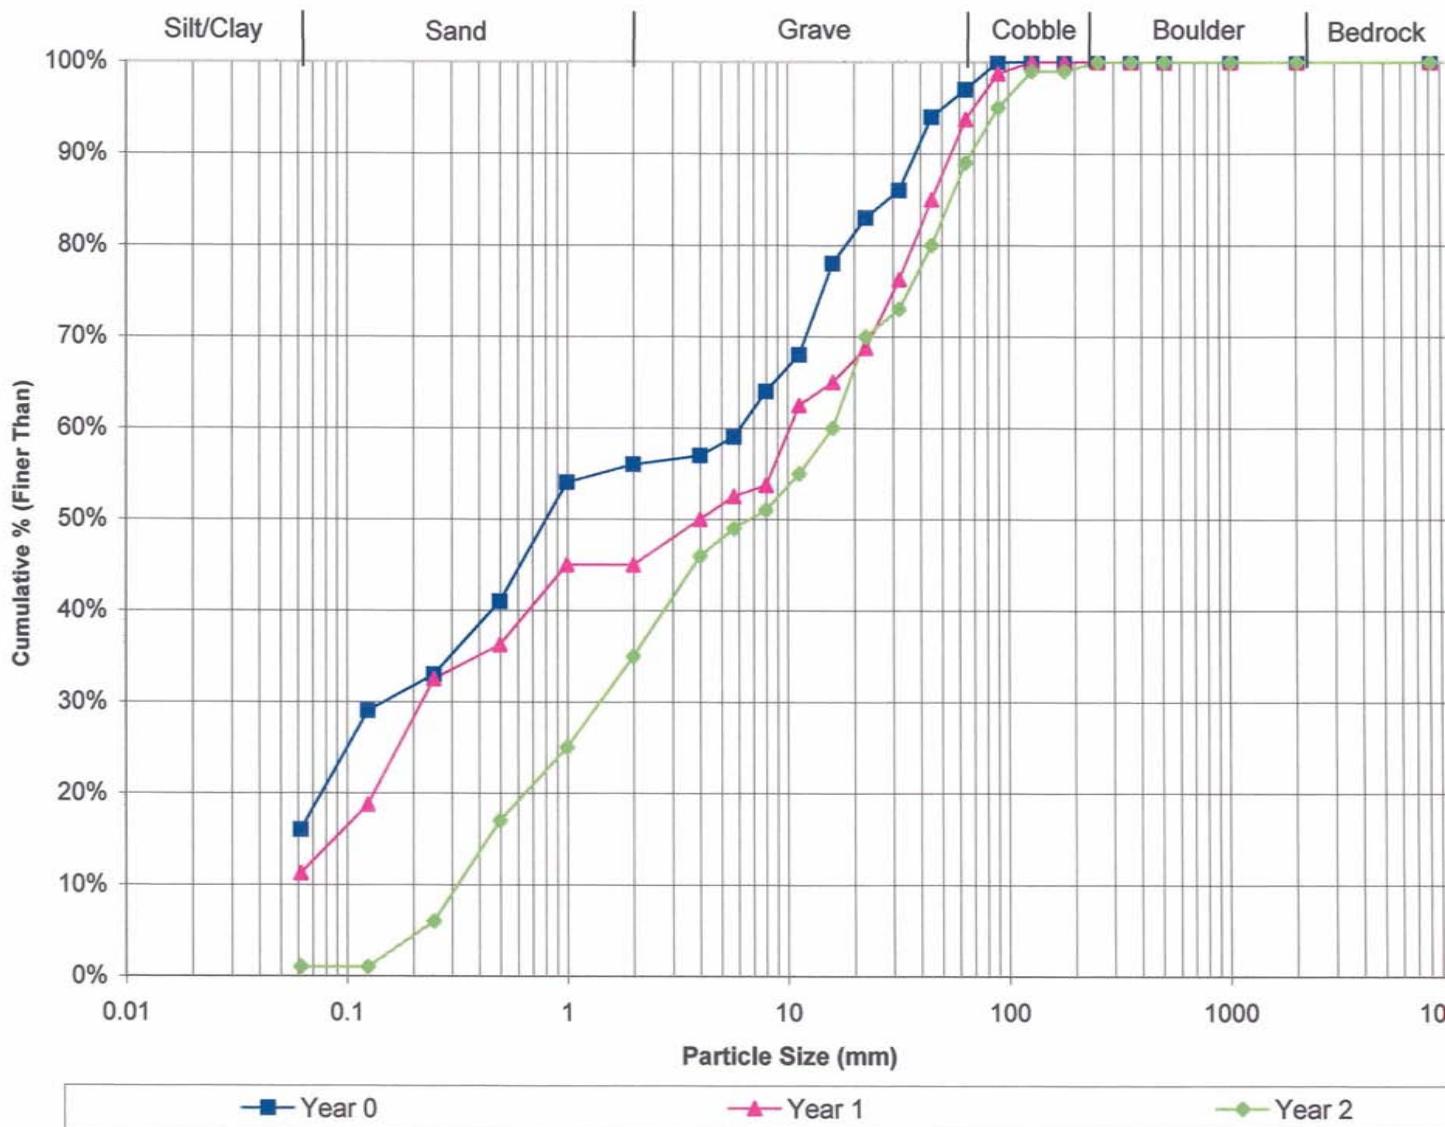
Area 3 - Modified Wolman Pebble Count

The channel substrate continues to coarsen over time as depicted by the pebble count data plotted for Area 3 represented by the shift of the graph to the right. The riffle within this section was coarser than the pool.

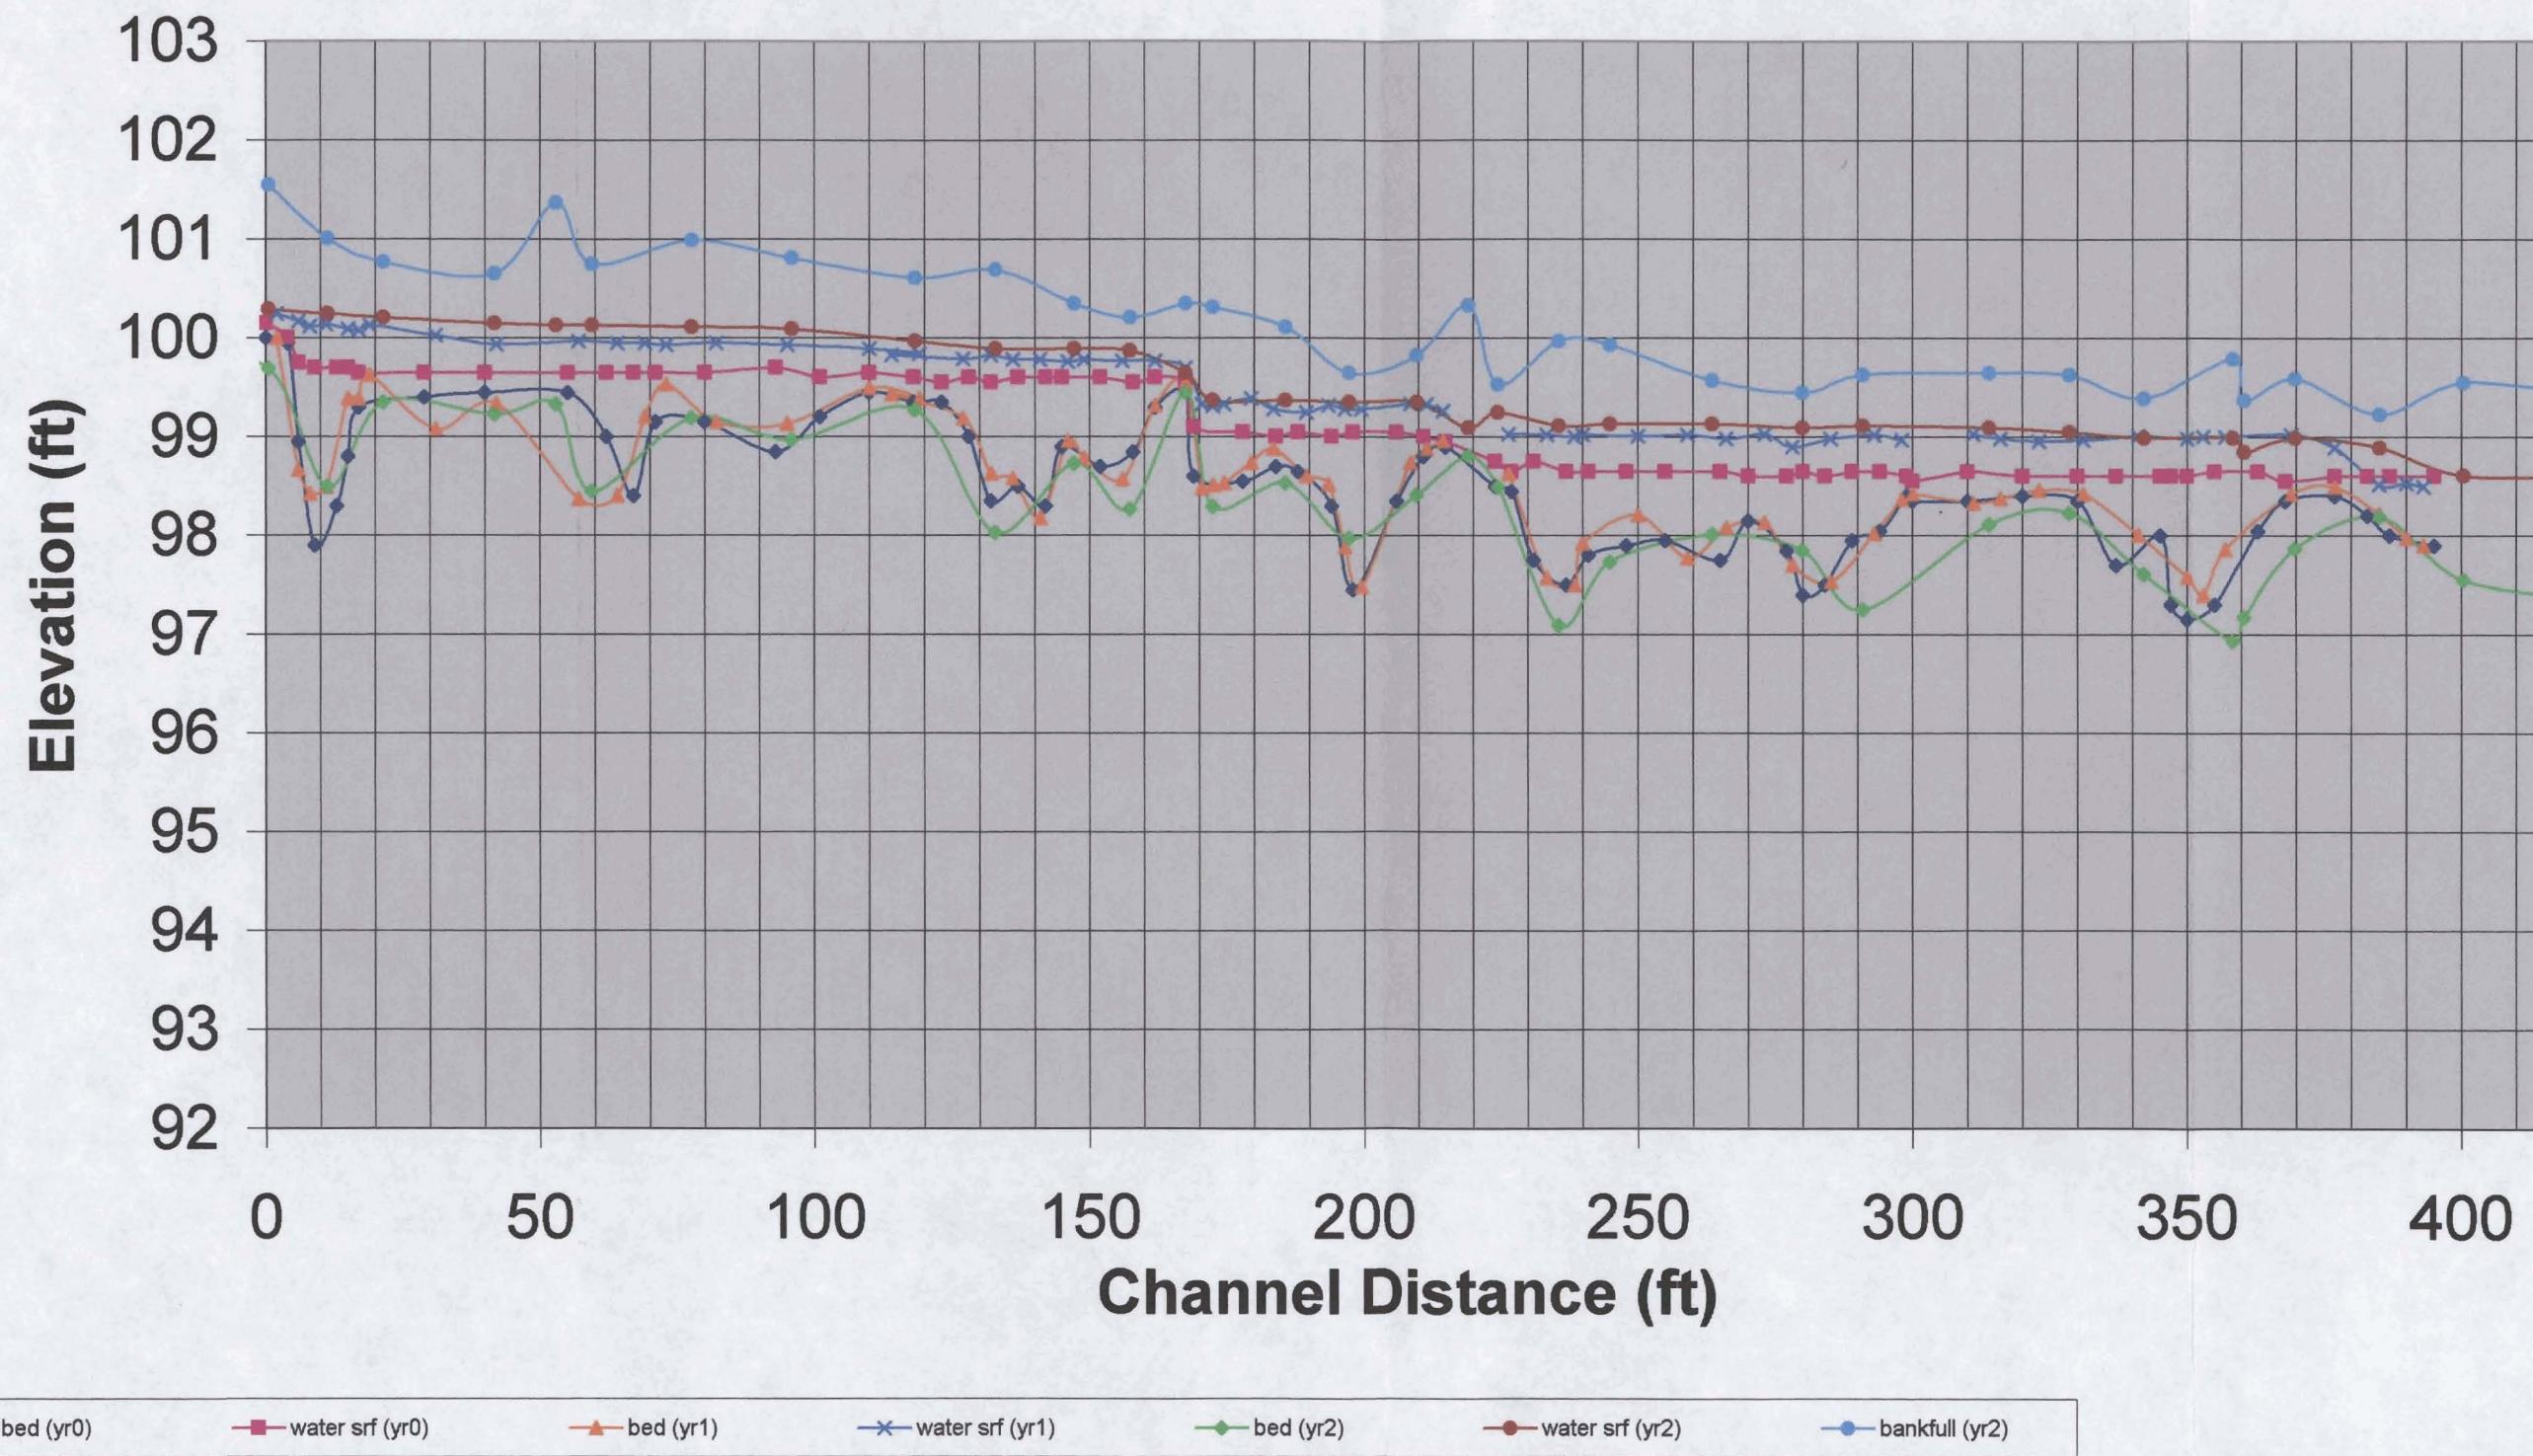
Longitudinal Profile (AREA 4)

The cross-sections surveyed were similar to previous surveys, although the outside bend of the pool cross-section continues to erode as is evident from the plotted cross-section data and the enclosed photographs. The longitudinal profile as observed in the previously discussed channel sections is adjusting vertically and several of the pools located within this segment are apparently elongating. Channel degradation is minimal.

The only recommendation for this section of channel is to stabilize the outside bend of the pool cross-section, which continues to erode. This could be achieved by flattening the vertical slope, lining it with an erosion control blanket and live staking the area.

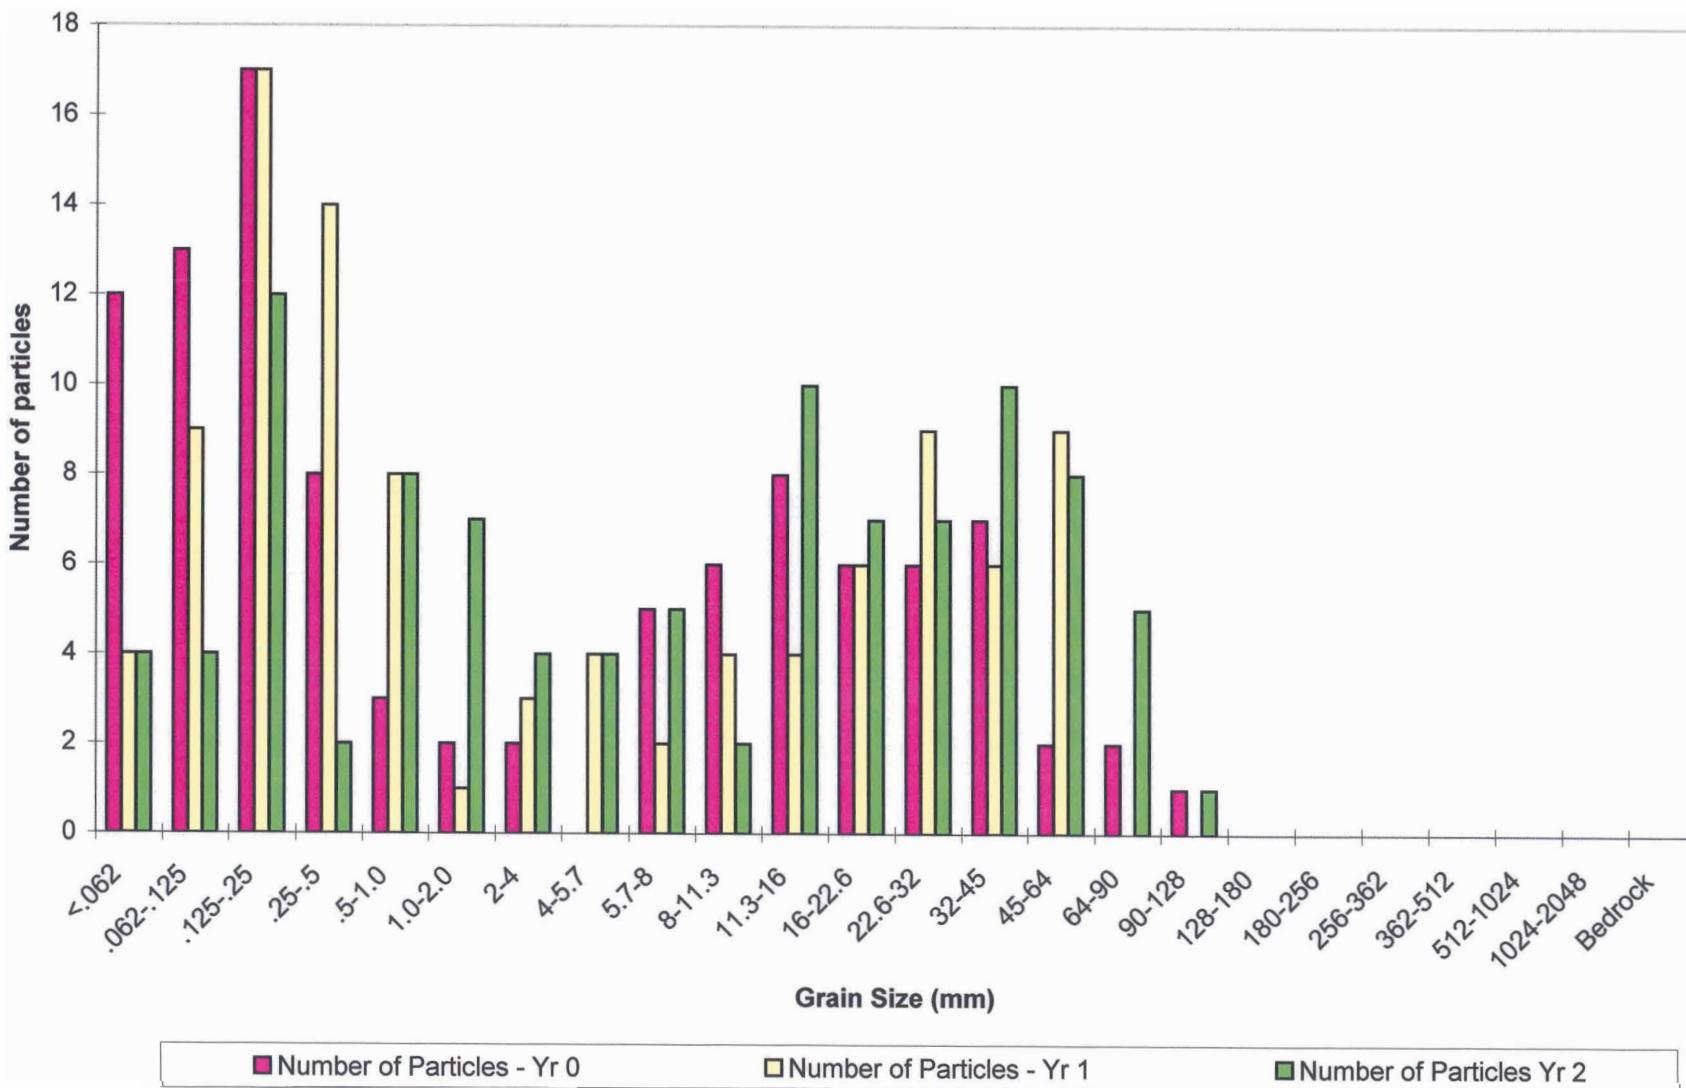
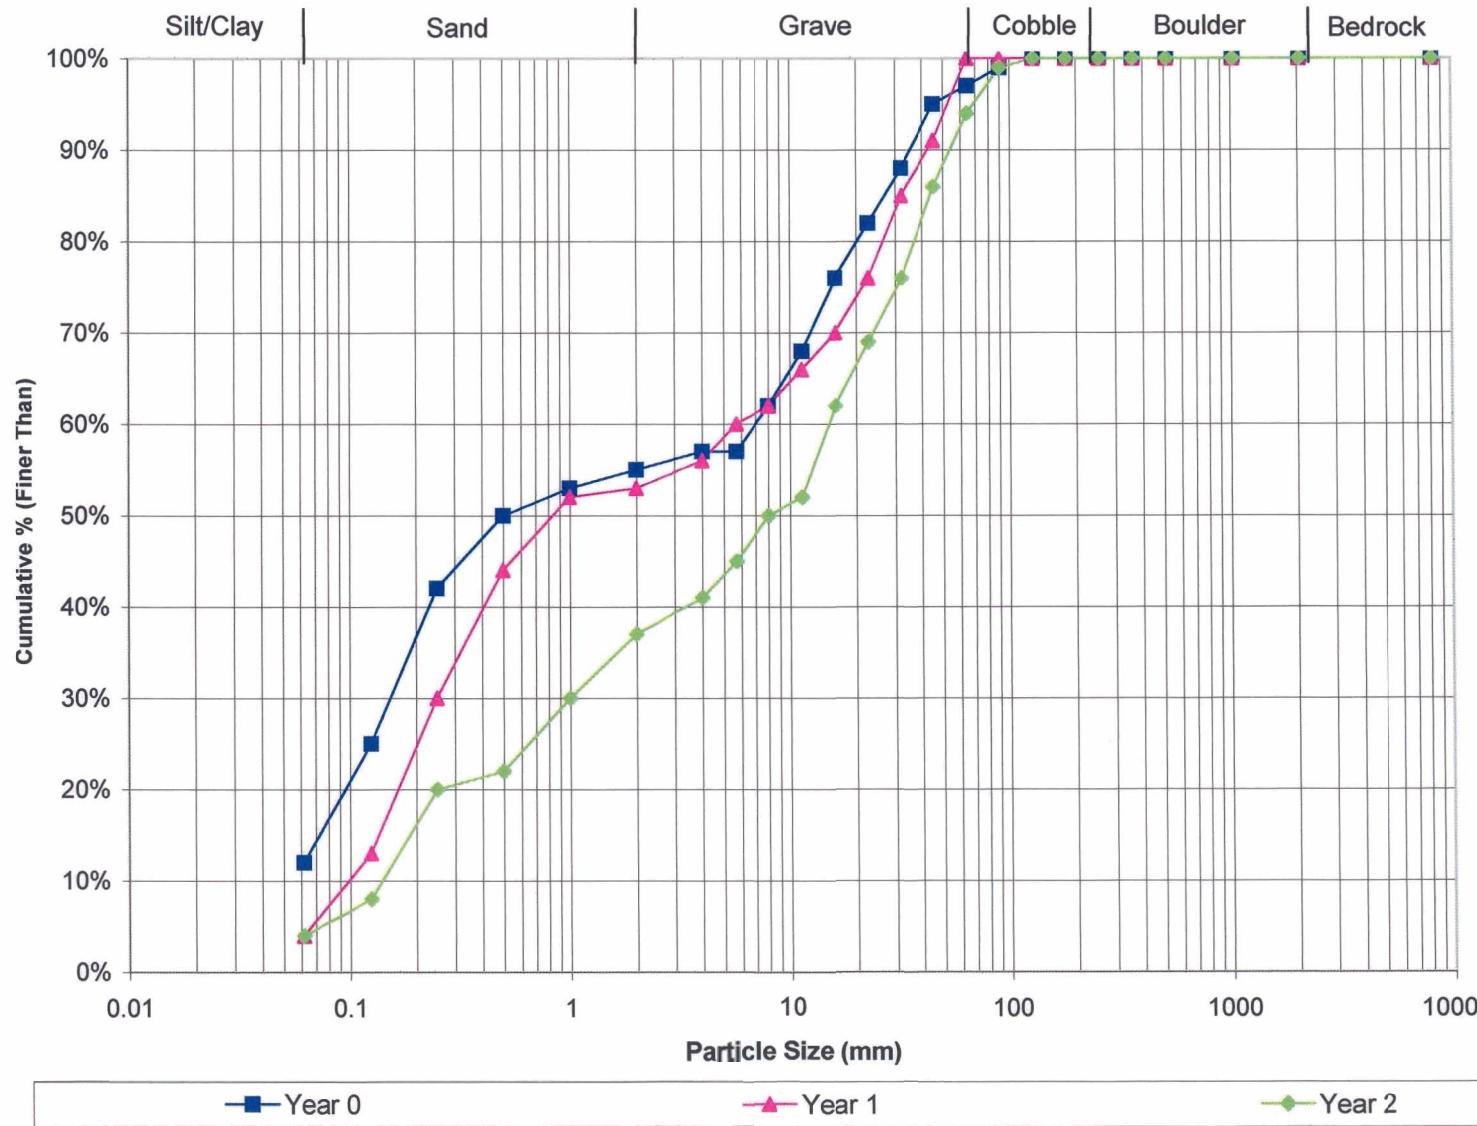
Area 4 - Modified Wolman Pebble Count

The pebble count indicates that the bed material is continuing to coarsen as indicated with a shift to the right of the Wolman Pebble Count curve.

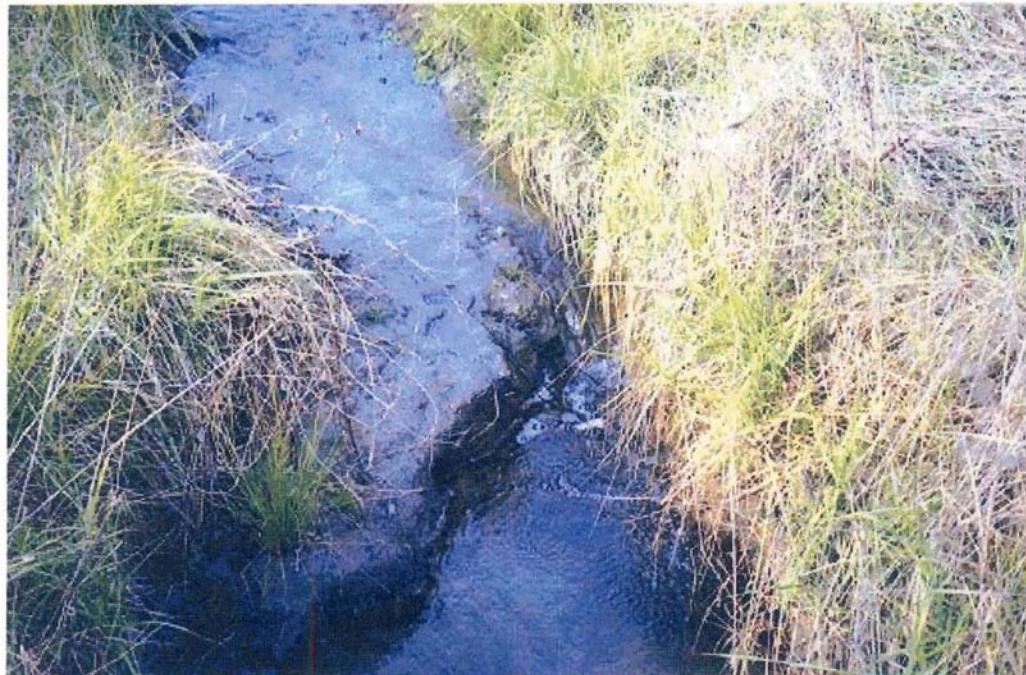
Area 1 – Headcut observed at Year 1

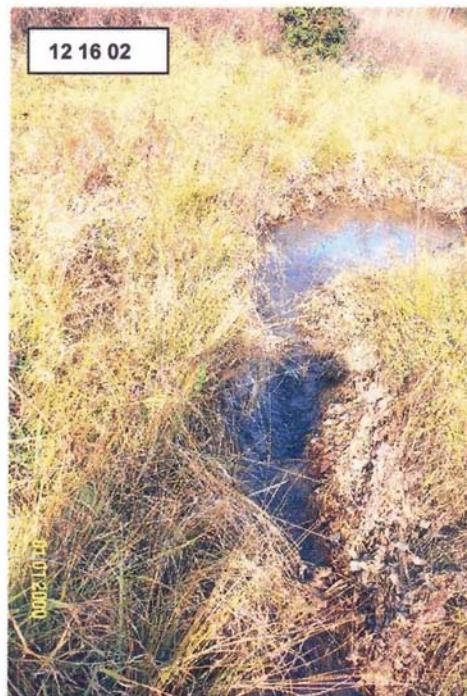
The riffle cross-section compared to the two previous surveys has begun to degrade slightly and the pool cross-section continues to aggrade following the trend evident from the previous surveys. The conditions of the banks appear to be relatively stable. Apparently, this section of channel dried up this past summer during the drought for an extended period of time allowing herbaceous plants consisting primarily of *Juncus* and *Carex* spp. to become established within the channel thalweg. As a result the channel has become well vegetated further stabilizing and protecting the banks from potential erosive storm flows. Despite the aggressive vegetation growth, the headcut identified last year at station 2+18 has extended approximately 20 feet upstream. Another trend observed after plotting the Year 2 data over the previous profiles, is that the majority of this reach is degrading and that the longitudinal profile is likely adjusting after every bankfull or near bankfull event.

Area 1-Migrating headcut at Year 2

Although, the vertical profile is actively adjusting the trend does not currently appear to be detrimental. The recommendation is to closely monitor this section as prescribed and allow the channel to naturally equilibrate.

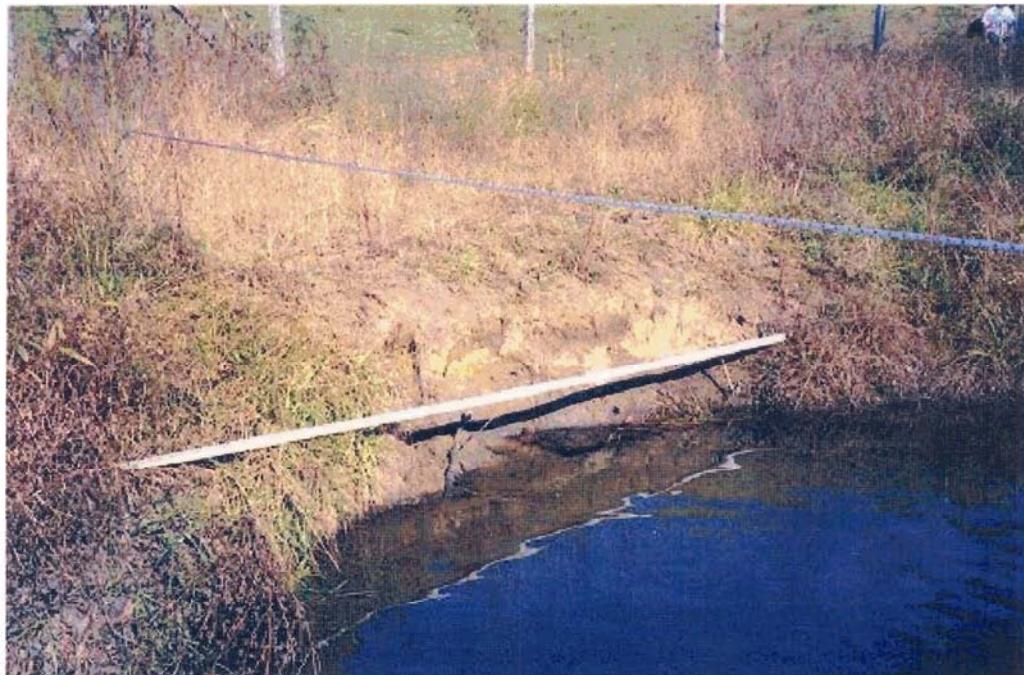
Area 4 – Severe Bank Erosion Observed – Year 1

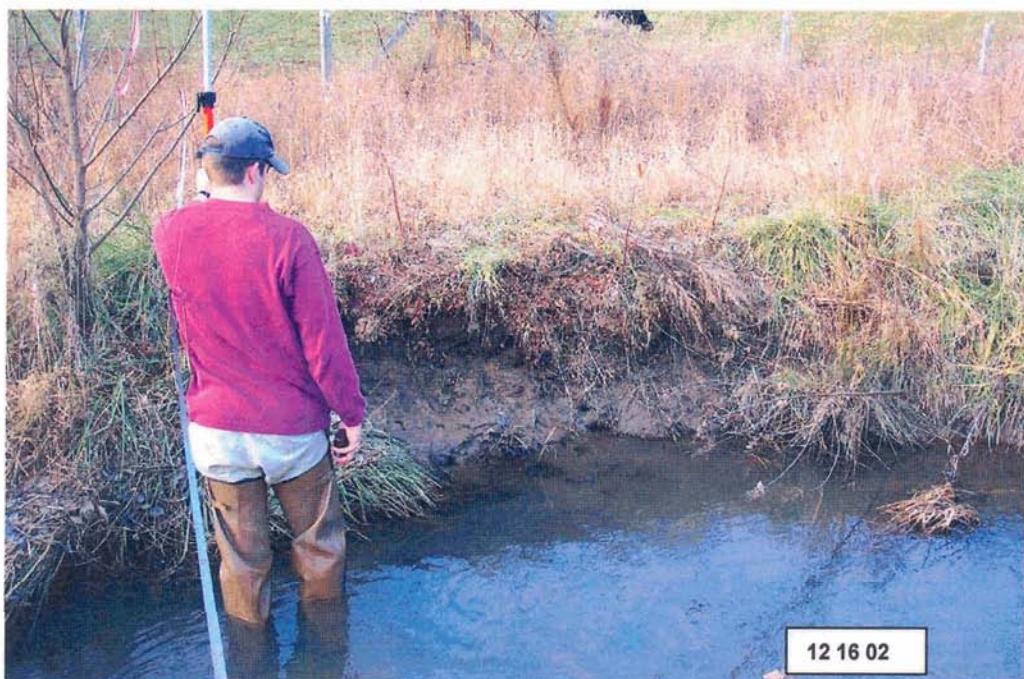
Area 4: Continuing bank erosion-Year 2
