PLUM CREEK WETLAND MITIGATION SITE
Brunswick County, NC
Lumber River Basin
Cataloging Unit: 03040207
EEP Project Number D06040-A

Plum Creek Wetland Mitigation Plan and As-Built Baseline Report
FINAL

Submitted
April 2009

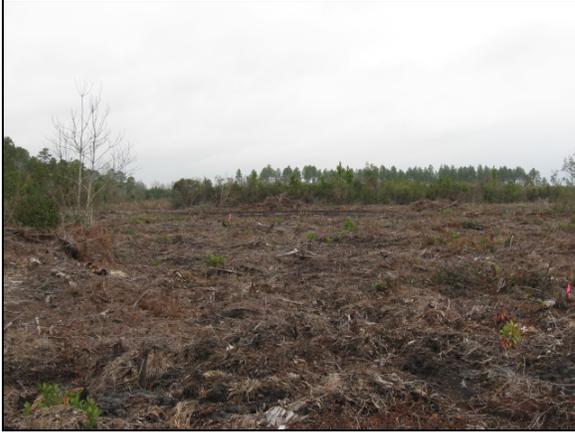
Photo Station 1: View looking north
December 22, 2008

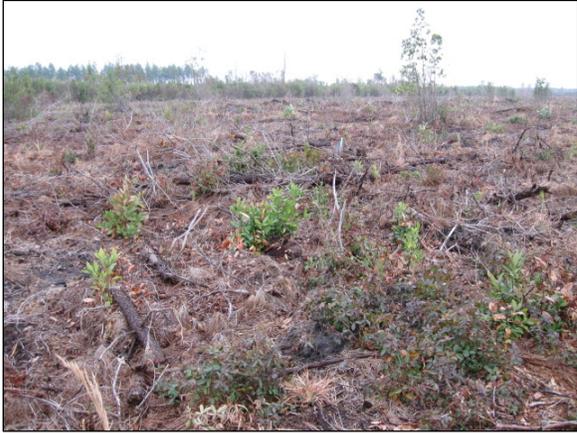
Veg Plot 1
January 7, 2009
