#### Roquist Wetland Restoration Site Phase I Mitigation Report

Bertie County, North Carolina

SCO# 04-0627901A

NC DENR# D050315

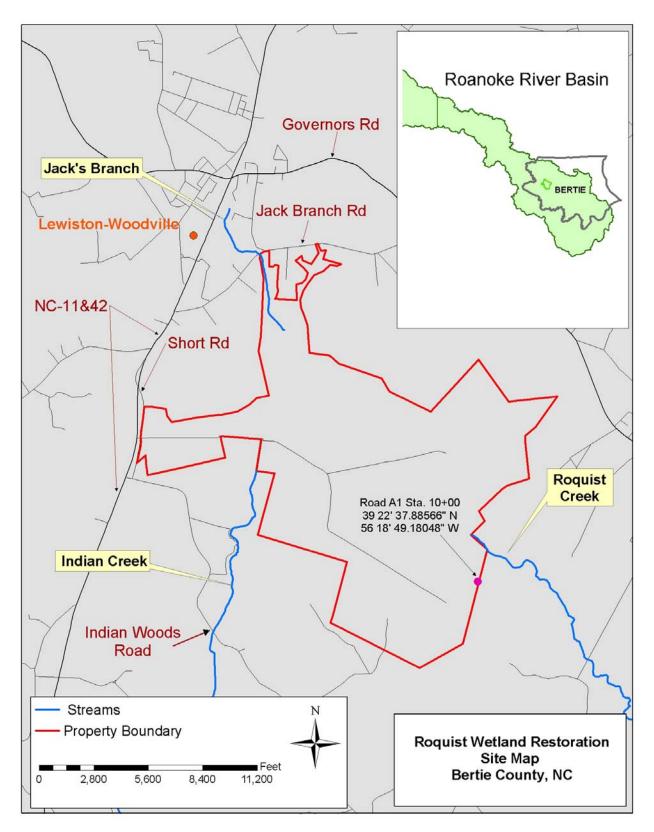
Figure 1. Site Map

The North Carolina Ecosystem Enhancement Program (EEP) developed a regional wetlands mitigation site in eastern North Carolina. The Roquist Wetland Restoration Site is located in western Bertie County south of Lewiston-Woodville, North Carolina within Hydrologic Unit 03010107 of the Roanoke River Basin (Figure 1).

There are three jurisdictional streams located within the Site. These streams include Jack's Branch, Roquist Creek, and Indian Creek (Figure 1). On the USGS topographic map Jack's Branch appears to have a continuous channel through the Roquist wetland and connecting with Indian Creek. Historically, this may have been accurate but field investigations (2003) of Jack's Branch revealed no continuous channel through the Roquist wetland, but Jack's Branch does have 4,000 ft of clearly defined channel in the northern section of the Site. Non-jurisdictional surface waters observed within the Site include drainage ditches located adjacent to and perpendicular to the existing logging roads.

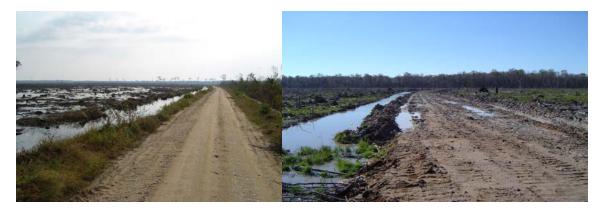
Figure 2. Logging Roads

Timber records from International Paper indicate the Roquist Wetland Restoration Site has been timbered for nearly a century with the oldest stands being established in 1905 and 1910. However, the majority of the existing forest within the Site ranges from twelve to sixty years of age. The most recent timbering activities occurred in 2003 with a final 927 ac harvested from April to October. In addition, logging records reveal a pine plantation was established within timbered wetlands near the western entrance of the Site. Timbering in the Roquist wetland required elevated logging roads to be constructed throughout the Site to aid in removal of timber. Aerial photographs of the Site indicate that five miles of logging roads were present as early as 1964. These roads include ditches located adjacent and perpendicular to the logging roads ranging in width from 2 to 25 ft. Prior to construction, 12 mi of logging roads traversed the Site including a small segment in the north. Figure 2 is an example of the logging roads and adjacent ditches that were in place prior to construction.

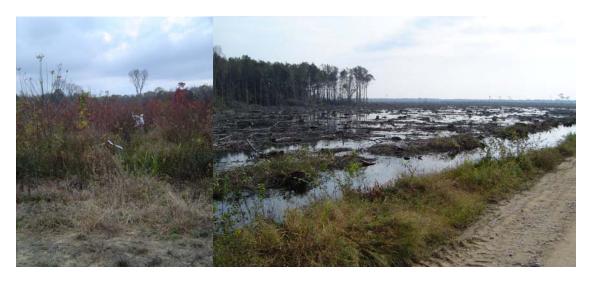
Figure 3. Old-fields community (left) and clear-cut community (right)

Old-field communities within the Site include early stages of Nonriverine Swamp and Wet Hardwood Forests and accounted for approximately 25% of the Site's plant community. These communities were classified as those that have been intensively logged within 1 to 10 years of the investigation (October 2003). Clear-cut communities were classified as areas that had been intensively logged within one year of the Site investigation. Clear-cut communities included approximately 32% of the Site's plant community.

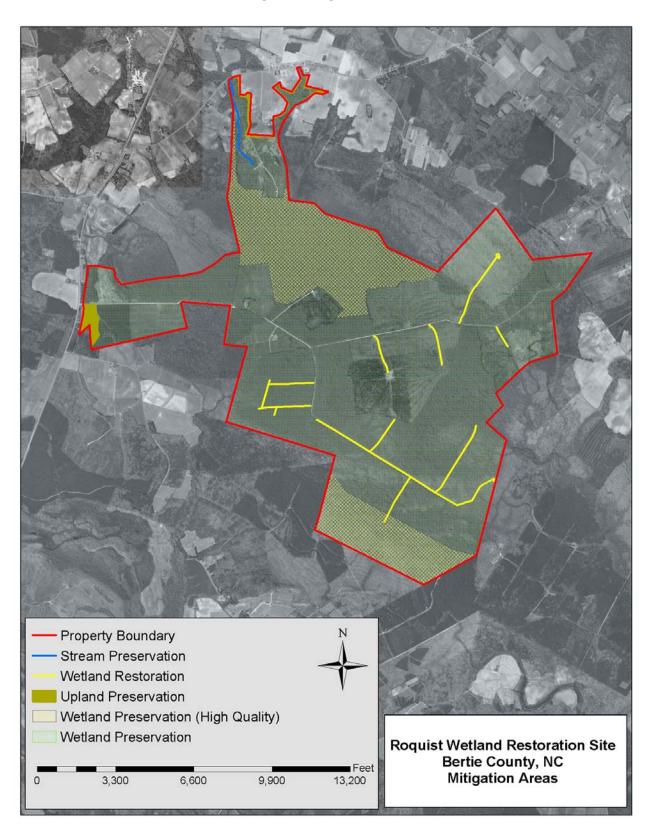
Figure 4. Mitigation Areas

The Site consists of 2 types of mitigation: restoration and preservation (Figure 4).

Wetland restoration efforts for Phase I of the Roquist Wetland Restoration Site included 45 ac of nonriverine wetlands (see Appendix H for Record Drawing produced at completion of construction). The restoration efforts consisted of grading the existing logging roads and spoil areas to their original wetland elevations, filling the existing roadside ditches to their original wetland elevations, and soil preparation (ripping/disking) of the restoration areas.

The stream preservation component consists of 3,660 linear feet of channel on Jack's Branch in the northern portion of the Site. This stream is on a site that contains habitat for 4 Federal Species of Concern and the area upland of the stream is a High Quality Wetland Preservation area which makes this a viable stream preservation reach. The portion of the stream within the project boundary is protected by the conservation easement surrounding it. There is a small portion of Jack's Branch that does not have a 50 ft buffer on both sides of the stream within the easement as can be seen by the gap in the stream preservation area in Figure 4.

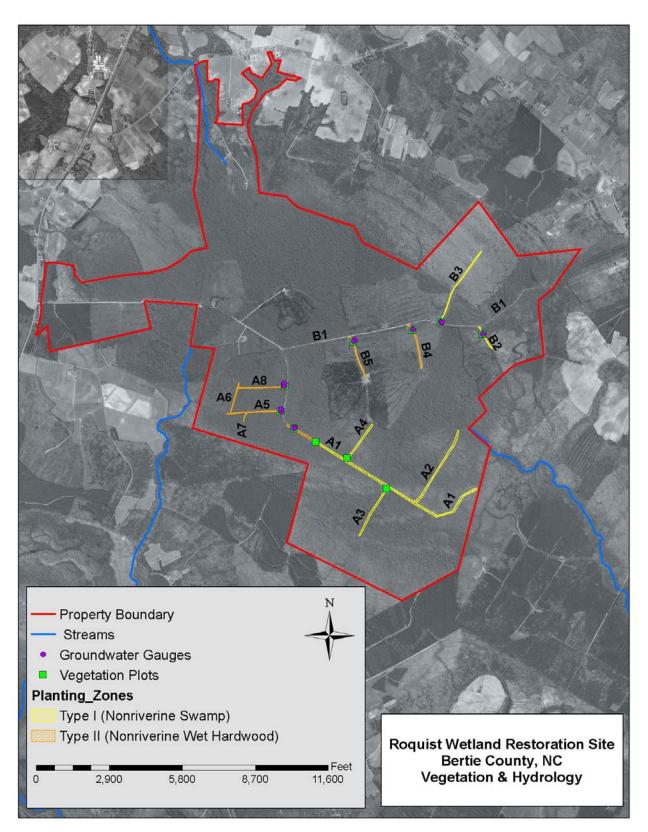
Figure 5. Vegetation & Gauges

Figures 4 and 5 within this report summarize the mitigation areas, vegetation plot and groundwater gauge locations, and the planting zones.

HSMM established ten quantitative sampling plots (10 meter (m) x 10 m) for vegetation on April 15, 2008 in the wetland restoration areas. The plots were set in accordance with specifications in *CVS-EEP Protocol for Recording Vegetation, All Levels of Plot Sampling* (Version 4.0, 2006) and at the direction of EEP. Seven of the ten plots were placed so that a groundwater gauge was just inside of the plot edge (Appendix H). Photos were taken on April 15, 2008 at each sampling plot at to provide a visual record of vegetation development over time (Appendix E). Vegetation plots will be inventoried during each growing season and will be in accordance with CVS Level II protocol. Baseline monitoring was completed October 29, 2008. The collected data can be found in Appendix F along with the established photo stations in Appendix G.

Initially, 11 groundwater gauges were installed in 5 locations on the Site and data has been collected since May 11, 2005. Currently, there are 12 gauges in 7 locations throughout the Site (Sheet 4 and 6-7 of Record Drawing, Appendix H). Ten of the current twelve gauges are set in pairs with one being located in a reference wetland adjacent to the restoration area and the other inside of the restoration area. These gauges record data once daily and will be in operation throughout the year. Data will be retrieved monthly throughout the growing season to provide effective monitoring and assessment of success criteria for wetland hydrology during the five-year monitoring period.
