# Snowbird Creek Tributaries Restoration Plan Graham County, North Carolina

EEP No. 000613

# **Snowbird Creek Tributaries Restoration Plan (Draft)**

Report Prepared and Submitted by Michael Baker Engineering, Inc.

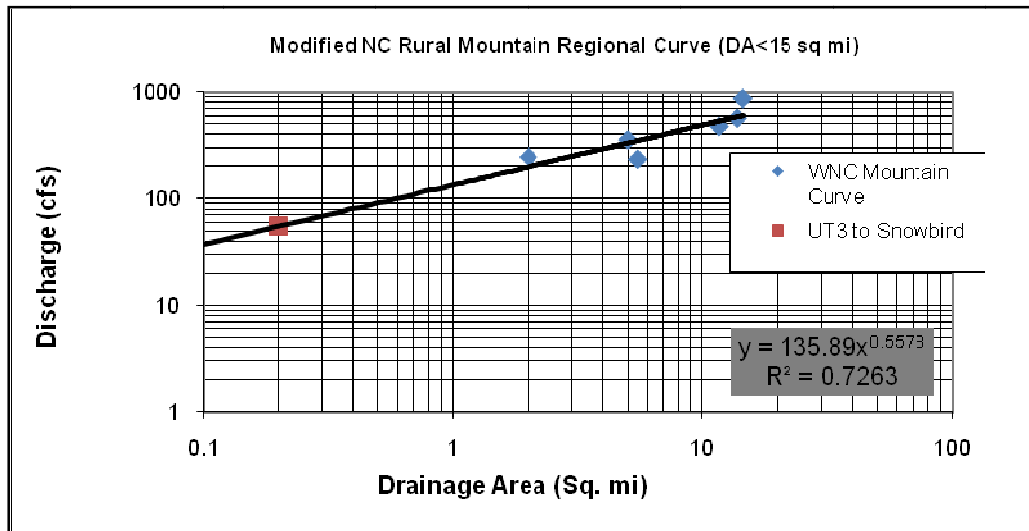
**Figure 3.2 NC Mountain Regional Curve for Discharge ( $Q_{UT3} \approx 55$  cfs)**

Bankfull indicators were identified in the field; indicators include a break in slope, an intermittent flat depositional feature, and a consistent scour line. Depth and area measurements of stable cross-sections with bankfull indicators were compared to regional curve data to verify the quality of the indicators. Surveyed cross sections with bankfull indicators were plotted on the regional curve. UT3 data points plotted near the North Carolina Mountain Regional Curve (Harman et al, 2000), indicating that the bankfull stage selected in the field was comparable with that of other Mountain streams of similar drainage area. The resulting extension and adjustment of the best fit line did not significantly alter the results or the design mean bankfull stage of 0.66 ft.

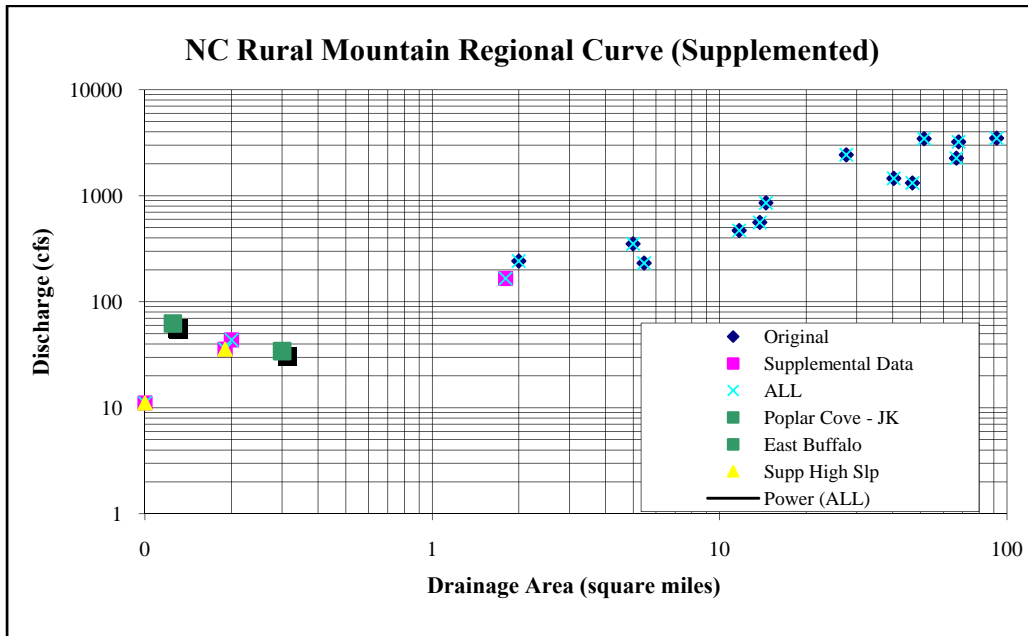
**Figure 3.4 Supplemented Project Curve for Bankfull Discharge**

The plot predicts a flow rate of approximately 41 cfs for the 1.5-year return interval event.

All of the sources mentioned provided information for selecting the design discharge, as summarized in Table 3.5. The design discharge was ultimately calculated based on the channel dimensions selected and a Manning’s “n” estimate of 0.05. This served as a check of the compiled geometry data against reasonable estimates of discharge prepared in the table below. As mentioned earlier, reference reach geometries and step-pool design guidance were given more weight for ultimate design decisions than was the selected discharge. The design discharge calculation supports the proposed channel geometry.

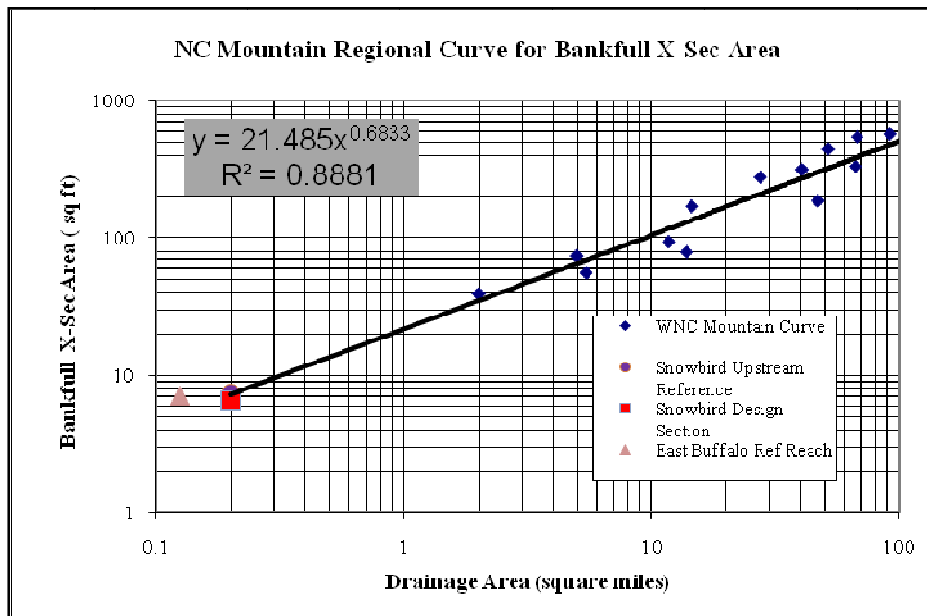
**Figure 4.1 NC Mountain Regional Curve for Bankfull X-Sec Area ( $A_{UT3} \approx 6.66$  sf)**

In the process, applicable geomorphic data for watersheds of comparable drainage area to the project site and located within the same or similar physiographic regions were utilized to extend the NC Mountain Regional Curve. By acquiring data points on the low end of the curve, beyond the range of the published data, Baker was able to develop modified regional curve power functions for use in the design decision making process. The regional curve results were used as part of the design decision making process. Values derived from these new power functions are summarized in Section 7 where design criteria are presented in numeric form. Figure 4.1 depicts the bankfull cross sectional area from the Regional Curve at 6.66 sq ft for a watershed of 0.18 square miles vs. a design x-sectional area of 6.5 sq ft.

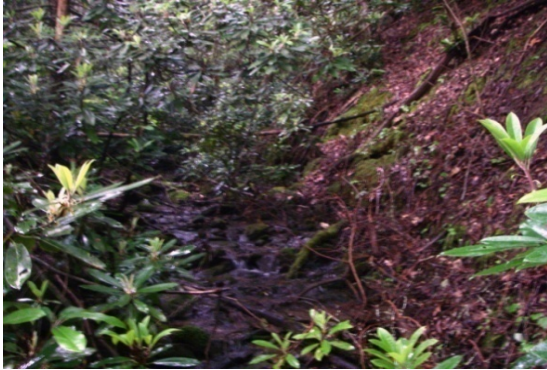
UT1 against a valley wall.

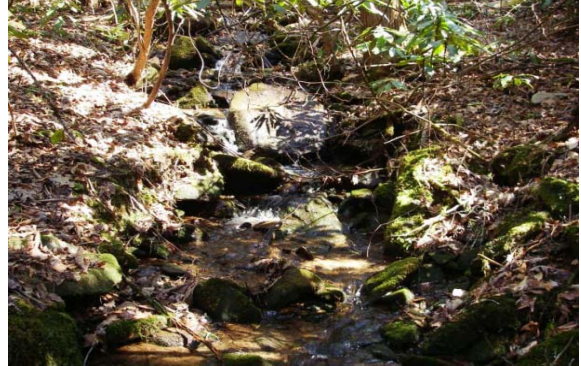
As evidenced in previous photo and photo above, UT1 is characterized by a semi-cascading profile on moderate to steep slopes

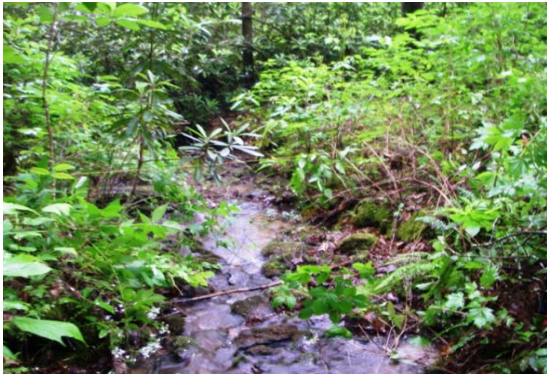
Cross section location on UT1

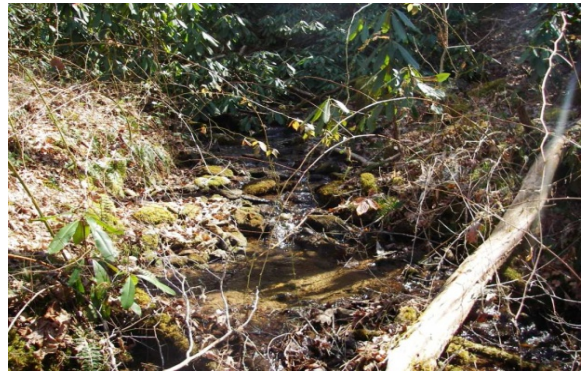
Riffle-pool section of UT 1

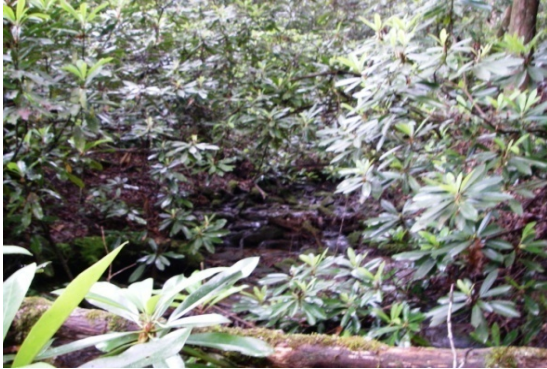
Step-pool profile on UT2

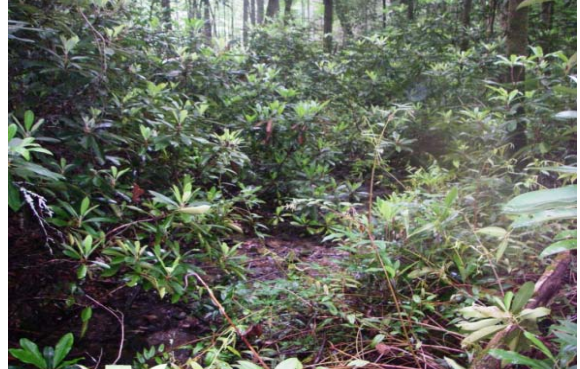
Rhododendron prevalent along UT2; particularly where there are breaks in the forest canopy

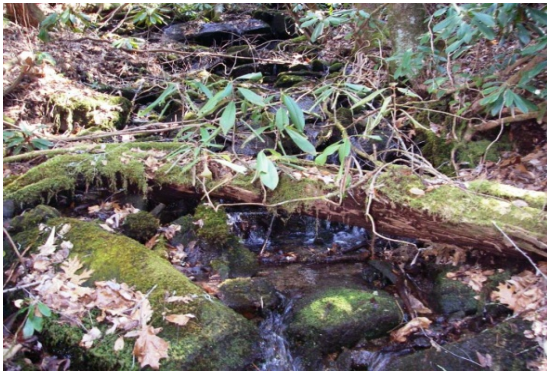
Typical substrate in preservation reaches

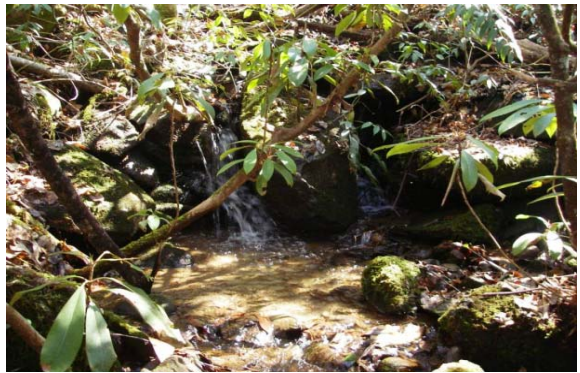
Step-pool features typical on UT2

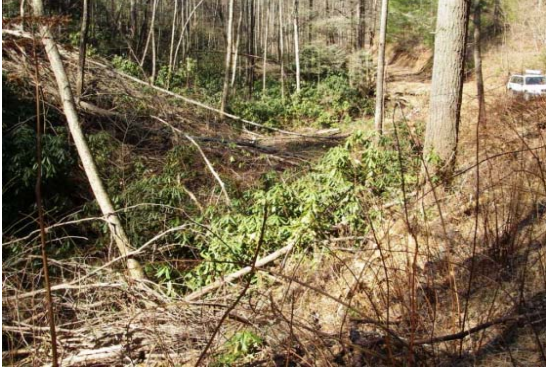
Upper extent of UT2 enhancement area facing downstream

The enhancement reach (UT2 - Reach 2) is where a logging road approaches the stream and debris from logging activities has been left in the stream. The banks have degraded and invasive plant species are present in the riparian buffer. Along with logging debris and invasive plant removal, buffer planting will be performed.

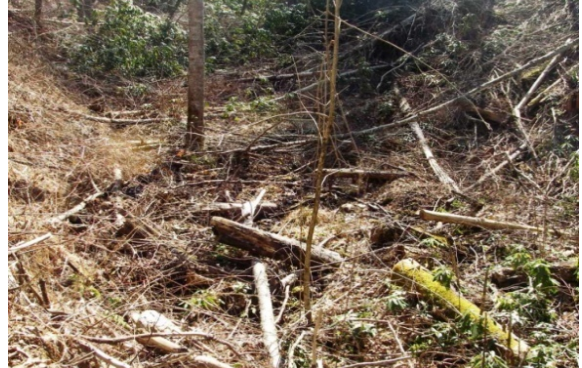
Area where debris left discarded in UT2

The enhancement section is either in a stage of channel degradation or in an early stage of recovery. There is local instability and bank erosion due to the extensive debris jams from the earlier logging. The channel will continue to headcut below the debris jams, and locally evolve toward a “G” stream without enhancement. Debris removal should return it to the path of a recovering B4a type stream.

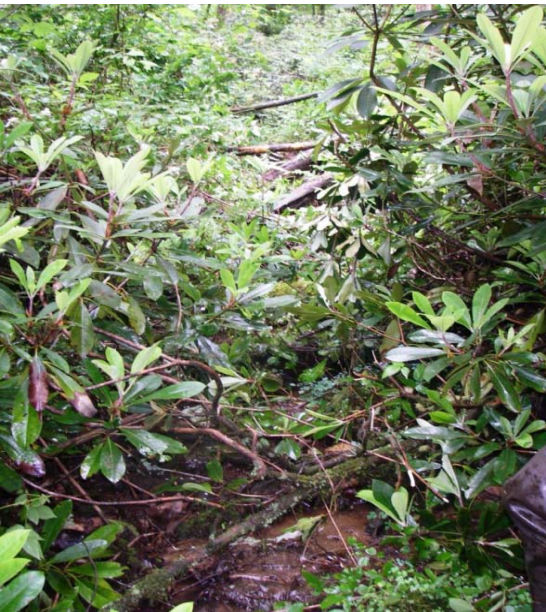
Cross section location on UT2

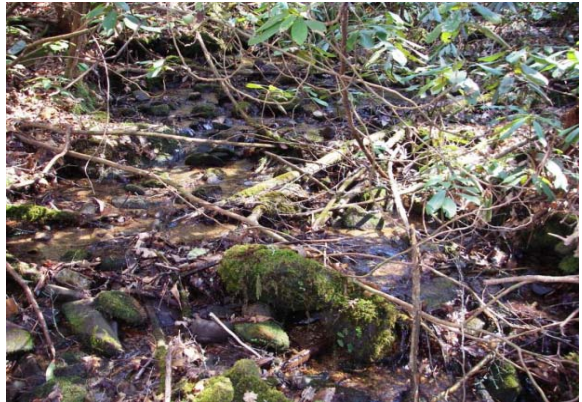
UT2 channel widens in areas where bedrock is exposed and where slope changes

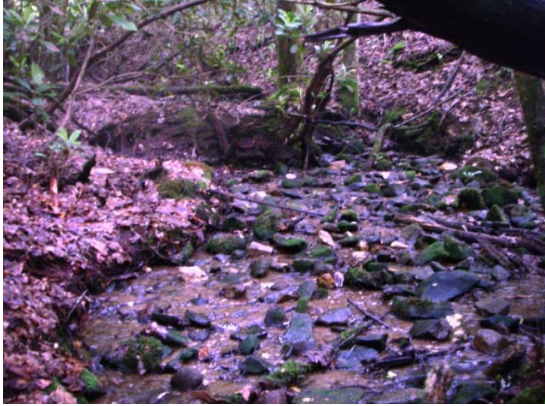
Typical dimension of UT3 on more moderate to gentle slopes

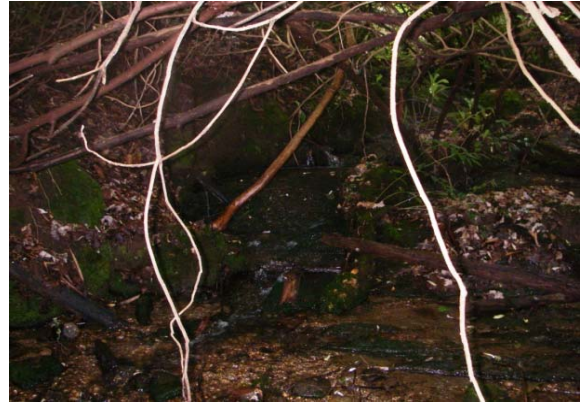
Rhododendron lines much of the riparian zone along UT3

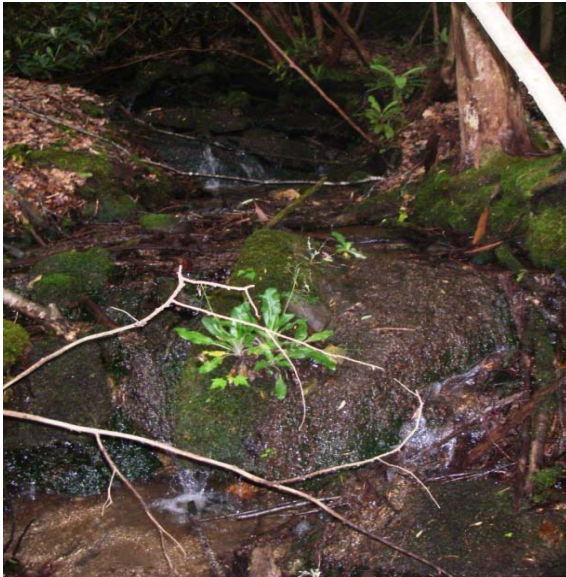
UT3 also features step-pool features similar to that of UT1 and UT2

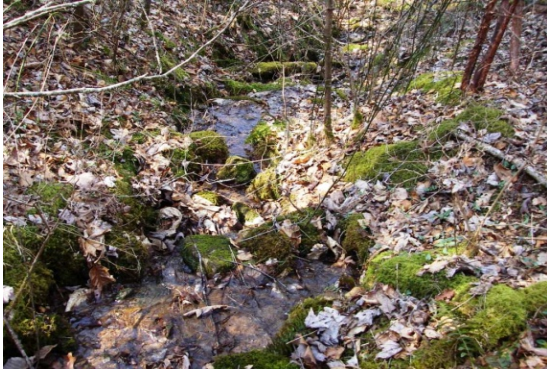
UT3 channel conditions near zone between preservation and restoration reaches

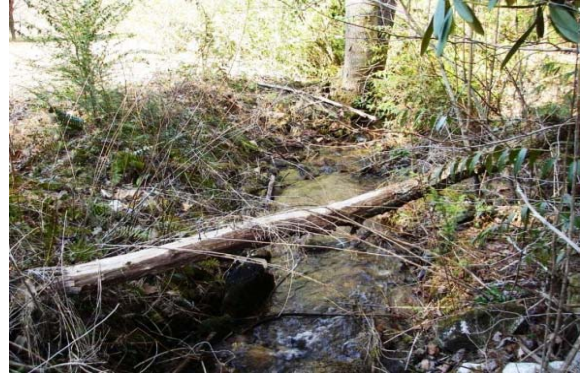
UT3 adjacent to field clearing; previous grading resulted in UT3 having less access to its floodplain

The restoration reach (UT 3 – Reach 2) is at the downstream end of UT3. There is a limited riparian buffer along this reach with invasive plant species present in the existing corridor and in the proposed relocation corridor. In addition to an off-line channel restoration along the historical channel path, invasive plant removal and buffer planting will be performed.

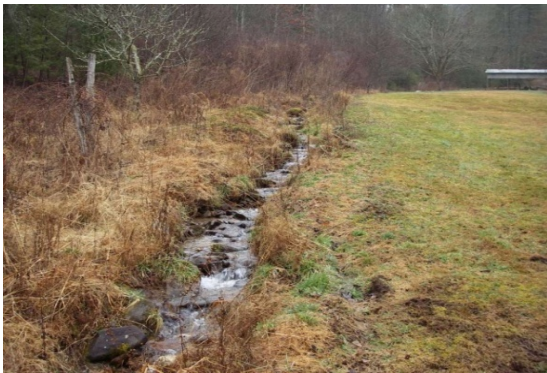
Existing location of UT3 in valley

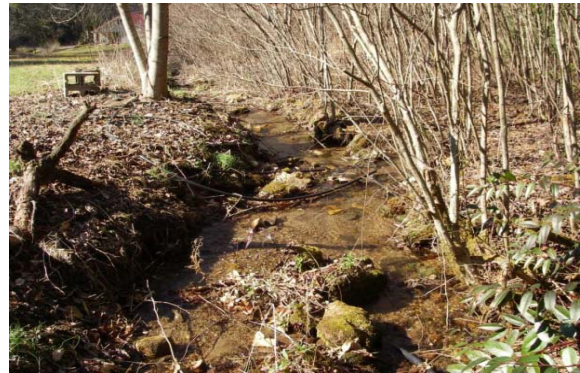
New alignment of UT3 would begin in the vicinity of location shown

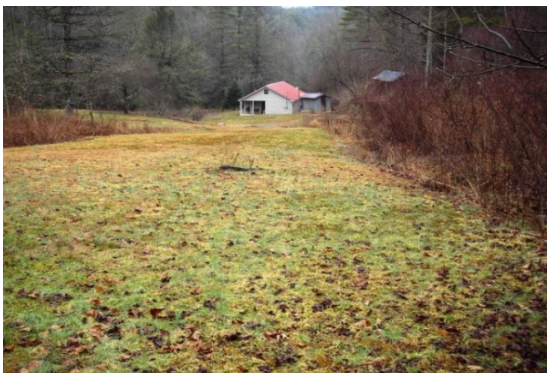
UT3 would be restored in the lowest part of the valley located in the left portion of this photo.

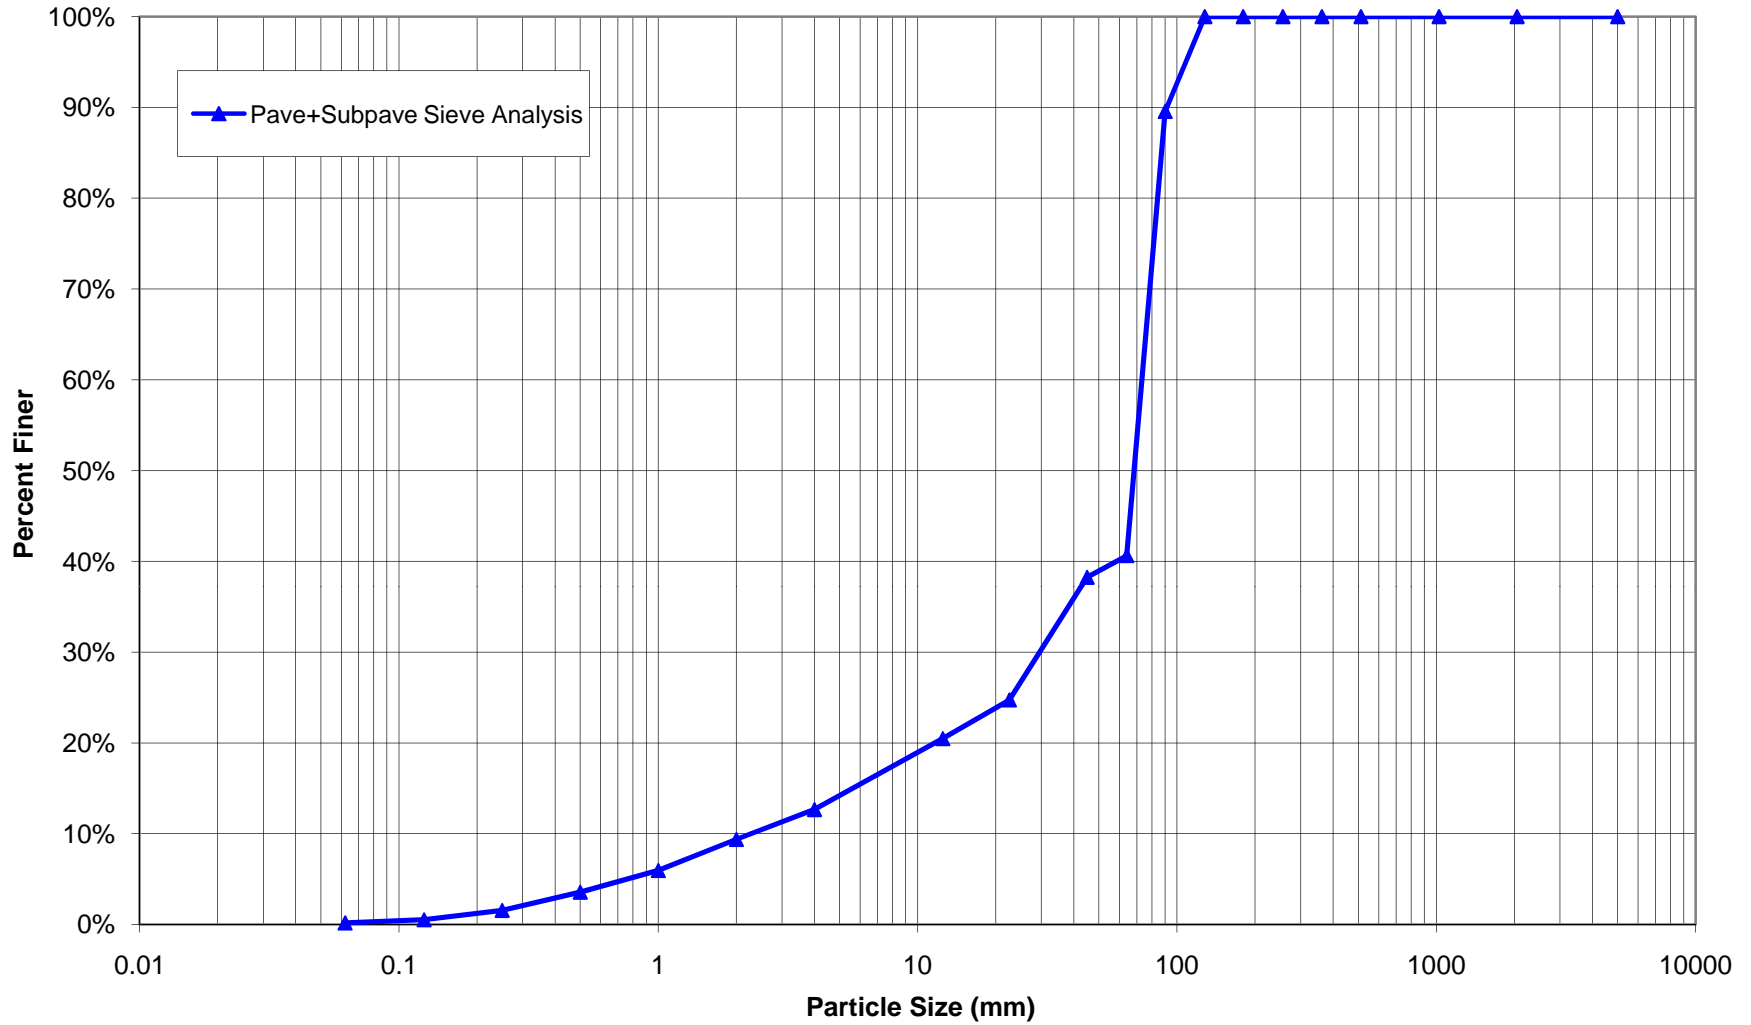
UT 3 to Snowbird Creek  
Reach 2  
Particle Size Distributions

SIEVE ANALYSIS			Summary	
MATERIAL	PARTICLE	SIZE (mm)	RAW	TARE	NET	Class %	% Cum
SILT/CLAY	Silt / Clay	< .062	13.9		13.9	0%	0%
SAND	Very Fine	.062 - .125	27.4		27.4	0%	1%
	Fine	.125 - .25	83.6		83.6	1%	2%
	Medium	.25 - .50	162.2		162.2	2%	4%
	Coarse	.50 - 1.0	190.4		190.4	2%	6%
	Very Coarse	1.0 - 2.0	275.2		275.2	3%	9%
GRAVEL	Very Fine	2.0 - 4.00	265.1		265.1	3%	13%
	Fine - Medium	4.00 - 12.5	628.0		628.0	8%	20%
	Medium- Coarse	12.5 - 22.6	341.8		341.8	4%	25%
	Coarse	22.6 - 45	1087.0		1087.0	14%	38%
	Very Coarse	45 - 64	191.0		191.0	2%	41%
COBBLE	Small	64 - 90	3932.7		3932.7	49%	90%
	Small	90-128	841.0		841.0	10%	100%
	Large	128 - 180					
	Large	180 - 256					
BOULDER	Small	256 - 362					
	Small	362 - 512					
	Medium	512 - 1024					
	Large - Very Large	1024 - 2048					
BEDROCK	Bedrock	> 2048					
<b>Total</b>					<b>8039.3</b>
