EAST PRONG ROARING RIVER STREAM RESTORATION, Wilkes County, North Carolina

ANNUAL MONITORING REPORT

North Carolina State University, Water Quality Group,
NC Stream Restoration Institute

March 25, 2002

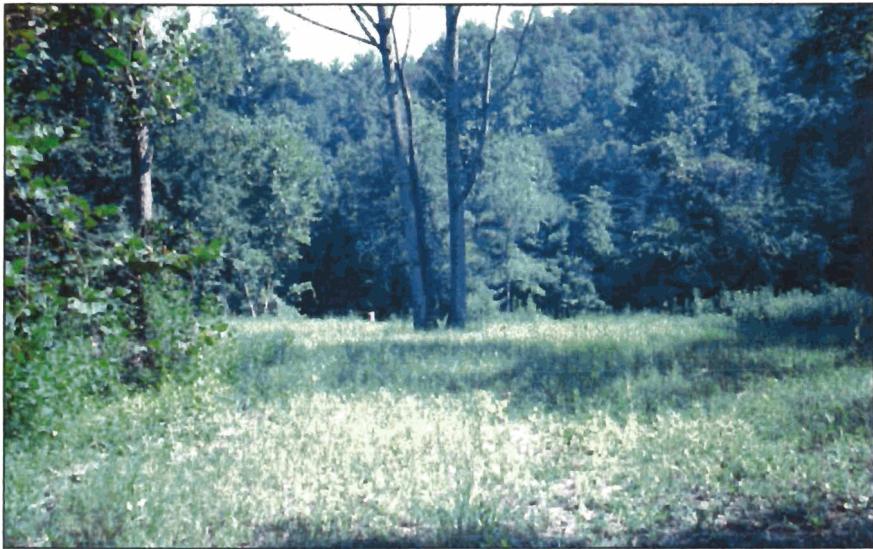
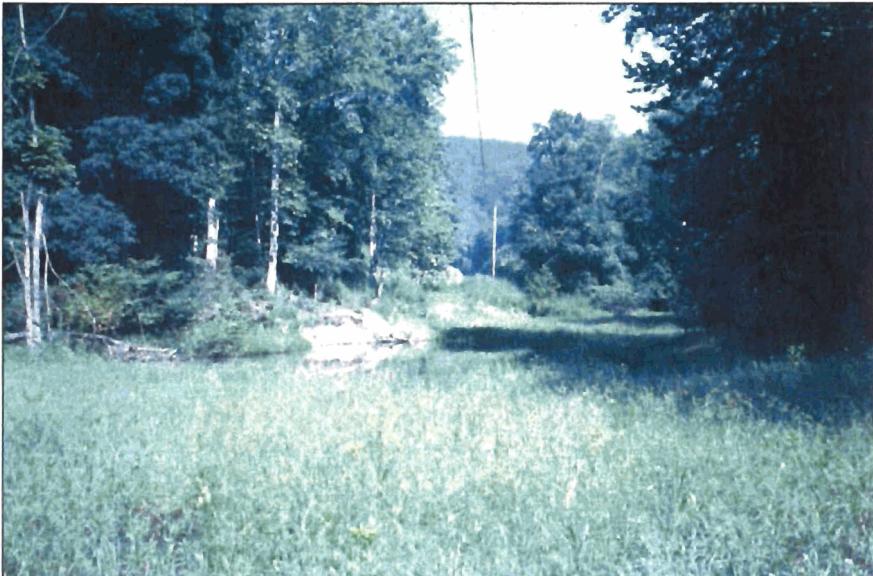
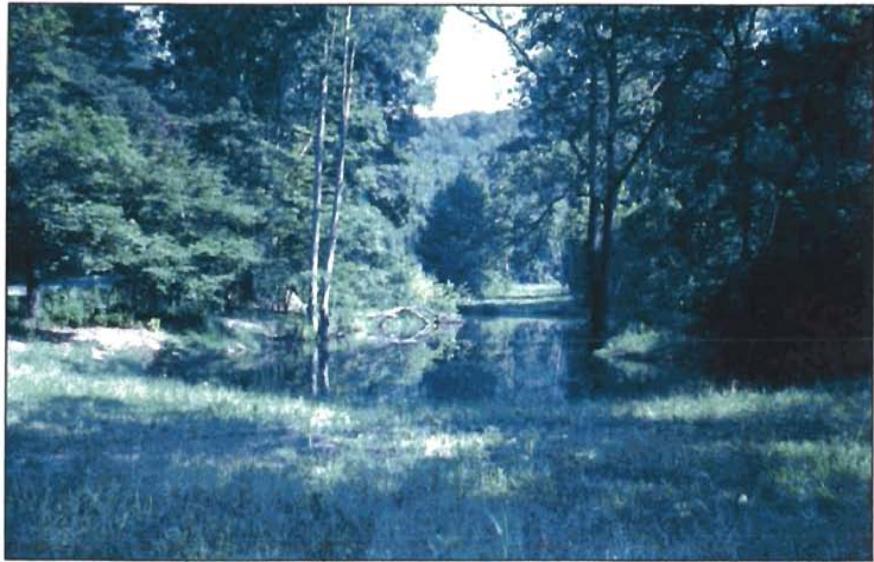
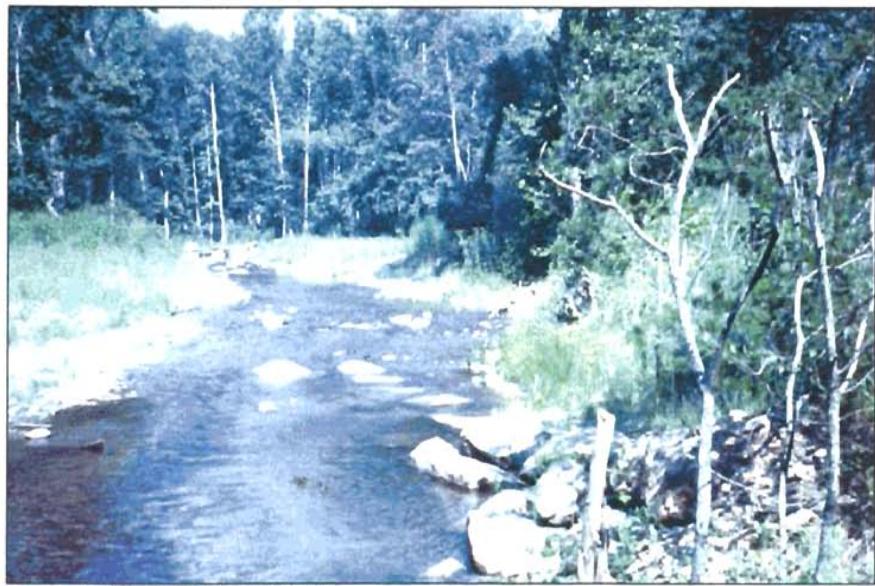
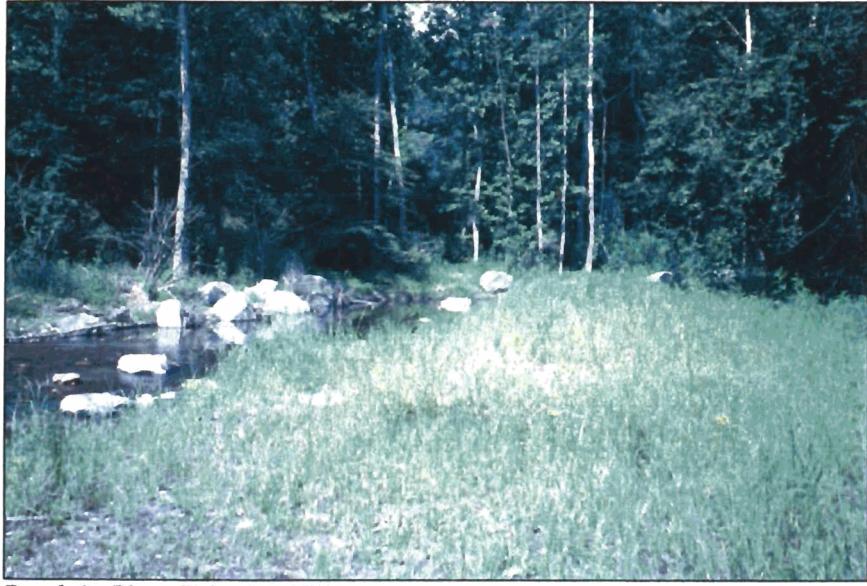
The photo points taken along the channel in Reaches 2 and 4 show the vegetation that has come up and survived (such as transplants). Also, the channel appears stable with no development of unstable depositional features or erosion of the banks.

Reach 2: Photo Point 1(2001).

Reach 2: Photo Point 2 (2001).

Reach 2: Photo Point 3 (2001).

Reach 2: Photo Point 4 (2001).

Reach 2: Photo Point 5 (2001).

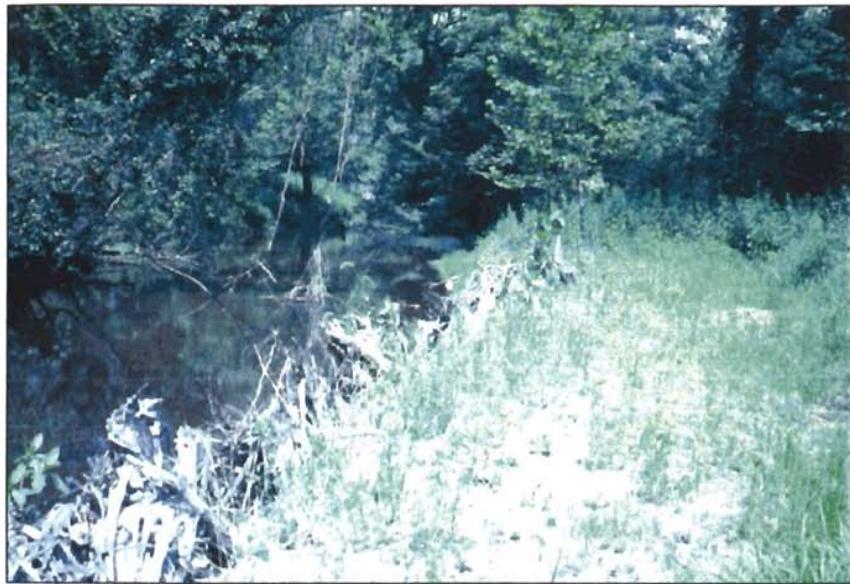
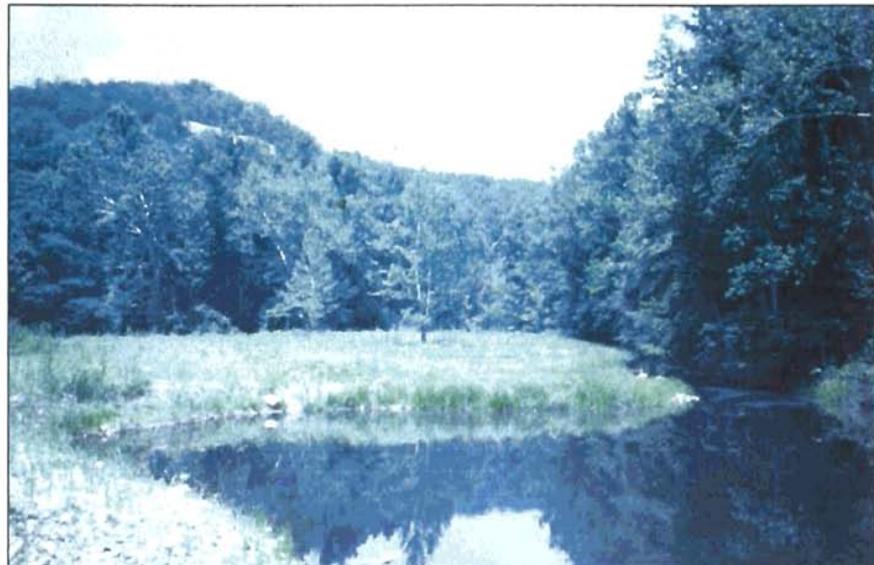
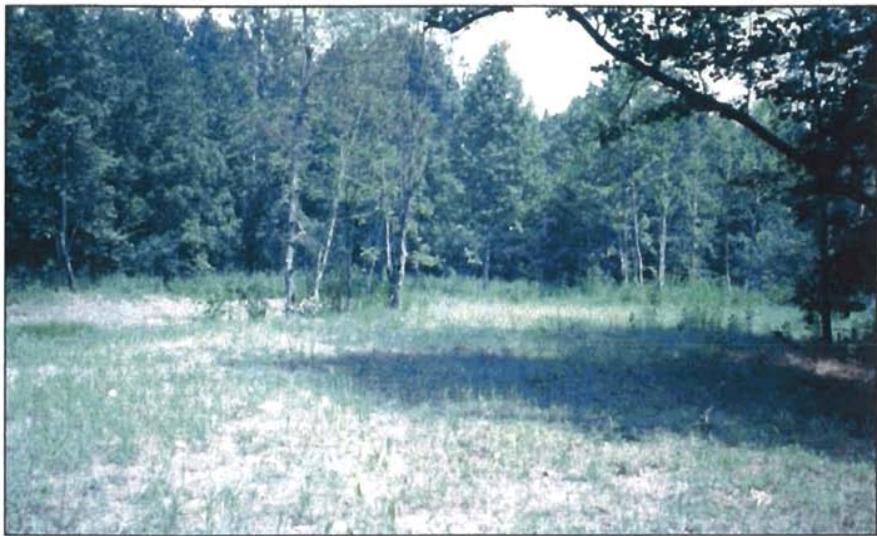
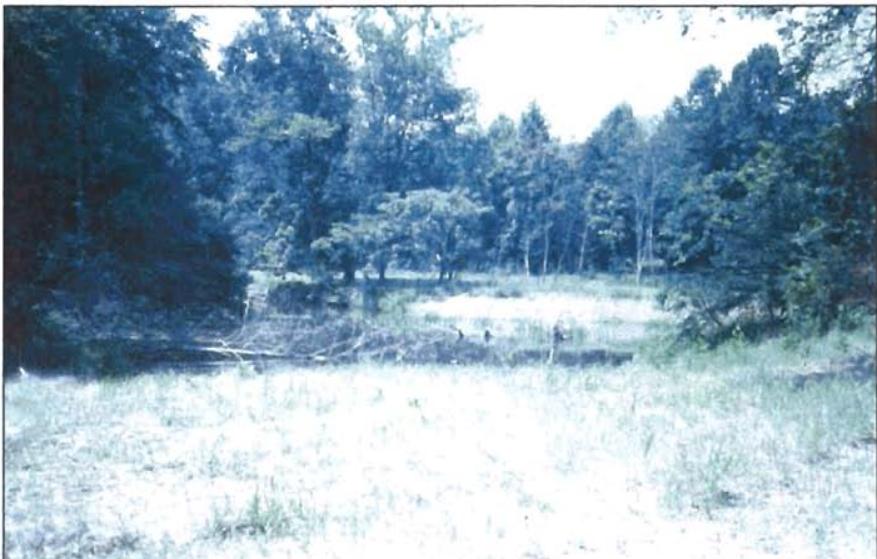
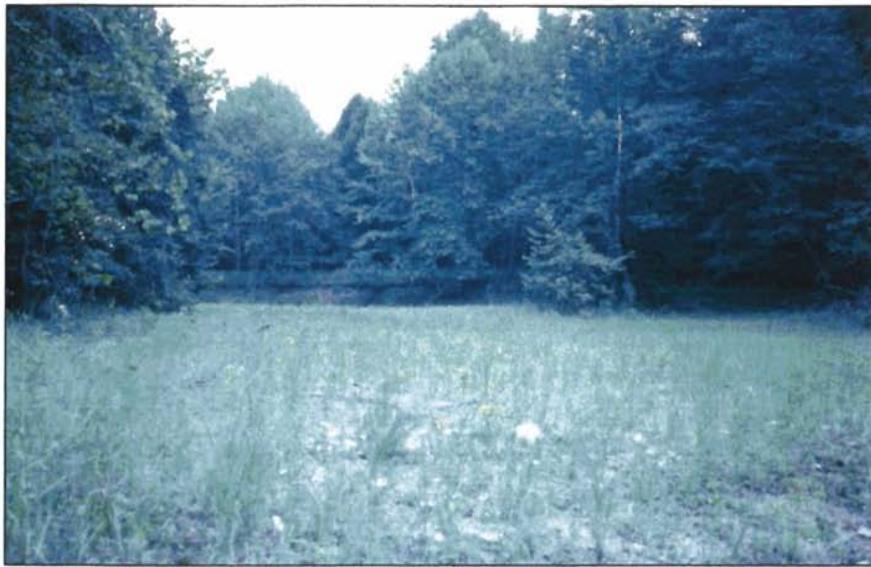
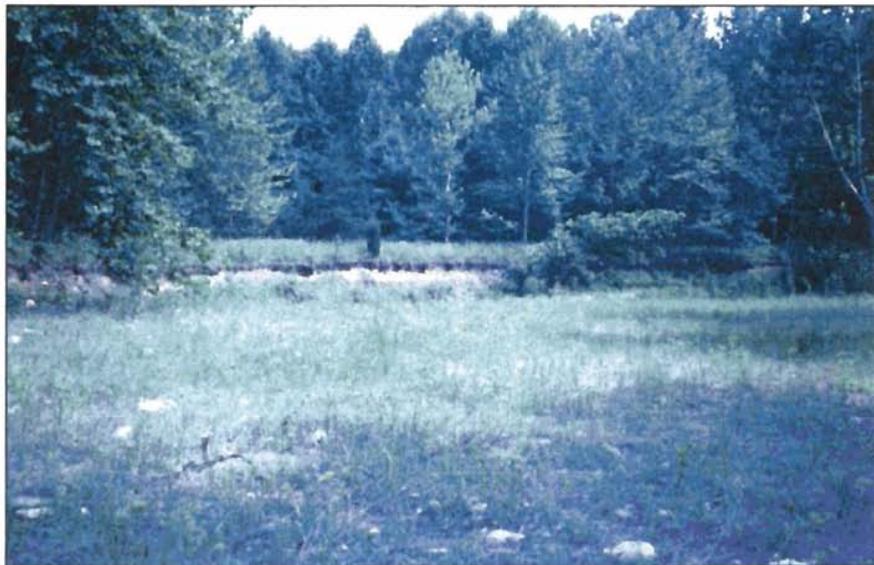
Reach 4: Photo Point 1(2001).

Reach 4: Photo Point 2 (2001).

Reach 4: Photo Point 3 (2001).

Reach 4: Photo Point 4 (2001).

Reach 4: Photo Point 5 (2001).

Reach 4: Photo Point 6 (2001).
