**Wetlands Resource Center**  
3970 Bowen Road  
Canal Winchester, Ohio 43110  
Project Manager: Cal Miller  
P: (614) 864-7511  
F: (614) 866-3691

**EMH&T, Inc.**  
5500 New Albany Road  
Columbus, Ohio 43054  
Project Manager: Miles F. Hebert, PE  
P: (614) 775-4205  
F: (614) 775-4802  
Main: (614) 775-4500

## THOMPSONS FORK RESTORATION

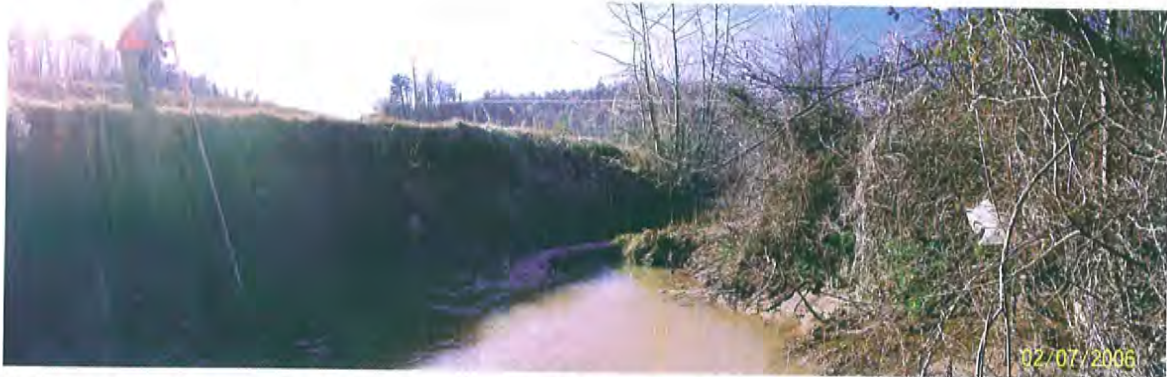
*Thompsons Fork Mainstem Pool Cross-Section from left to right looking downstream.*

*Photograph at Thompsons Fork Mainstem Pool Cross-Section looking upstream. The confluence of the Unnamed Tributary with Thompsons Fork is the small gravel fan deposit shown in the lower right corner of the photograph.*

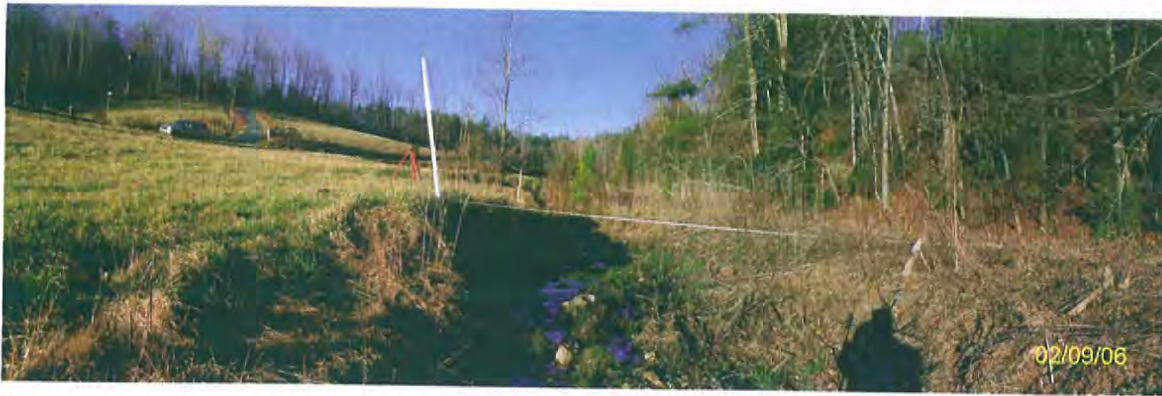
*Thompsons Fork Unnamed Tributary Riffle Cross-Section, photograph taken from left to right looking upstream.*

From this location to just upstream from the 30-inch diameter corrugated metal pipe (CMP) that carries the Unnamed Tributary under South Creek Road, the floodprone width is approximately 45 feet and the channel geometry and dominant substrate material (small cobble) exhibits Rosgen C3 cross-sectional geometry. The existing width to depth ratio along this reach is approximately 16 with a mean depth of 0.82 feet, bankfull width of 13.1 feet, bankfull cross-sectional area of 10.7 square feet with a mean bankfull discharge of 54.9 cubic feet per second (cfs), based on profile gradient and riffle bed particle distribution.

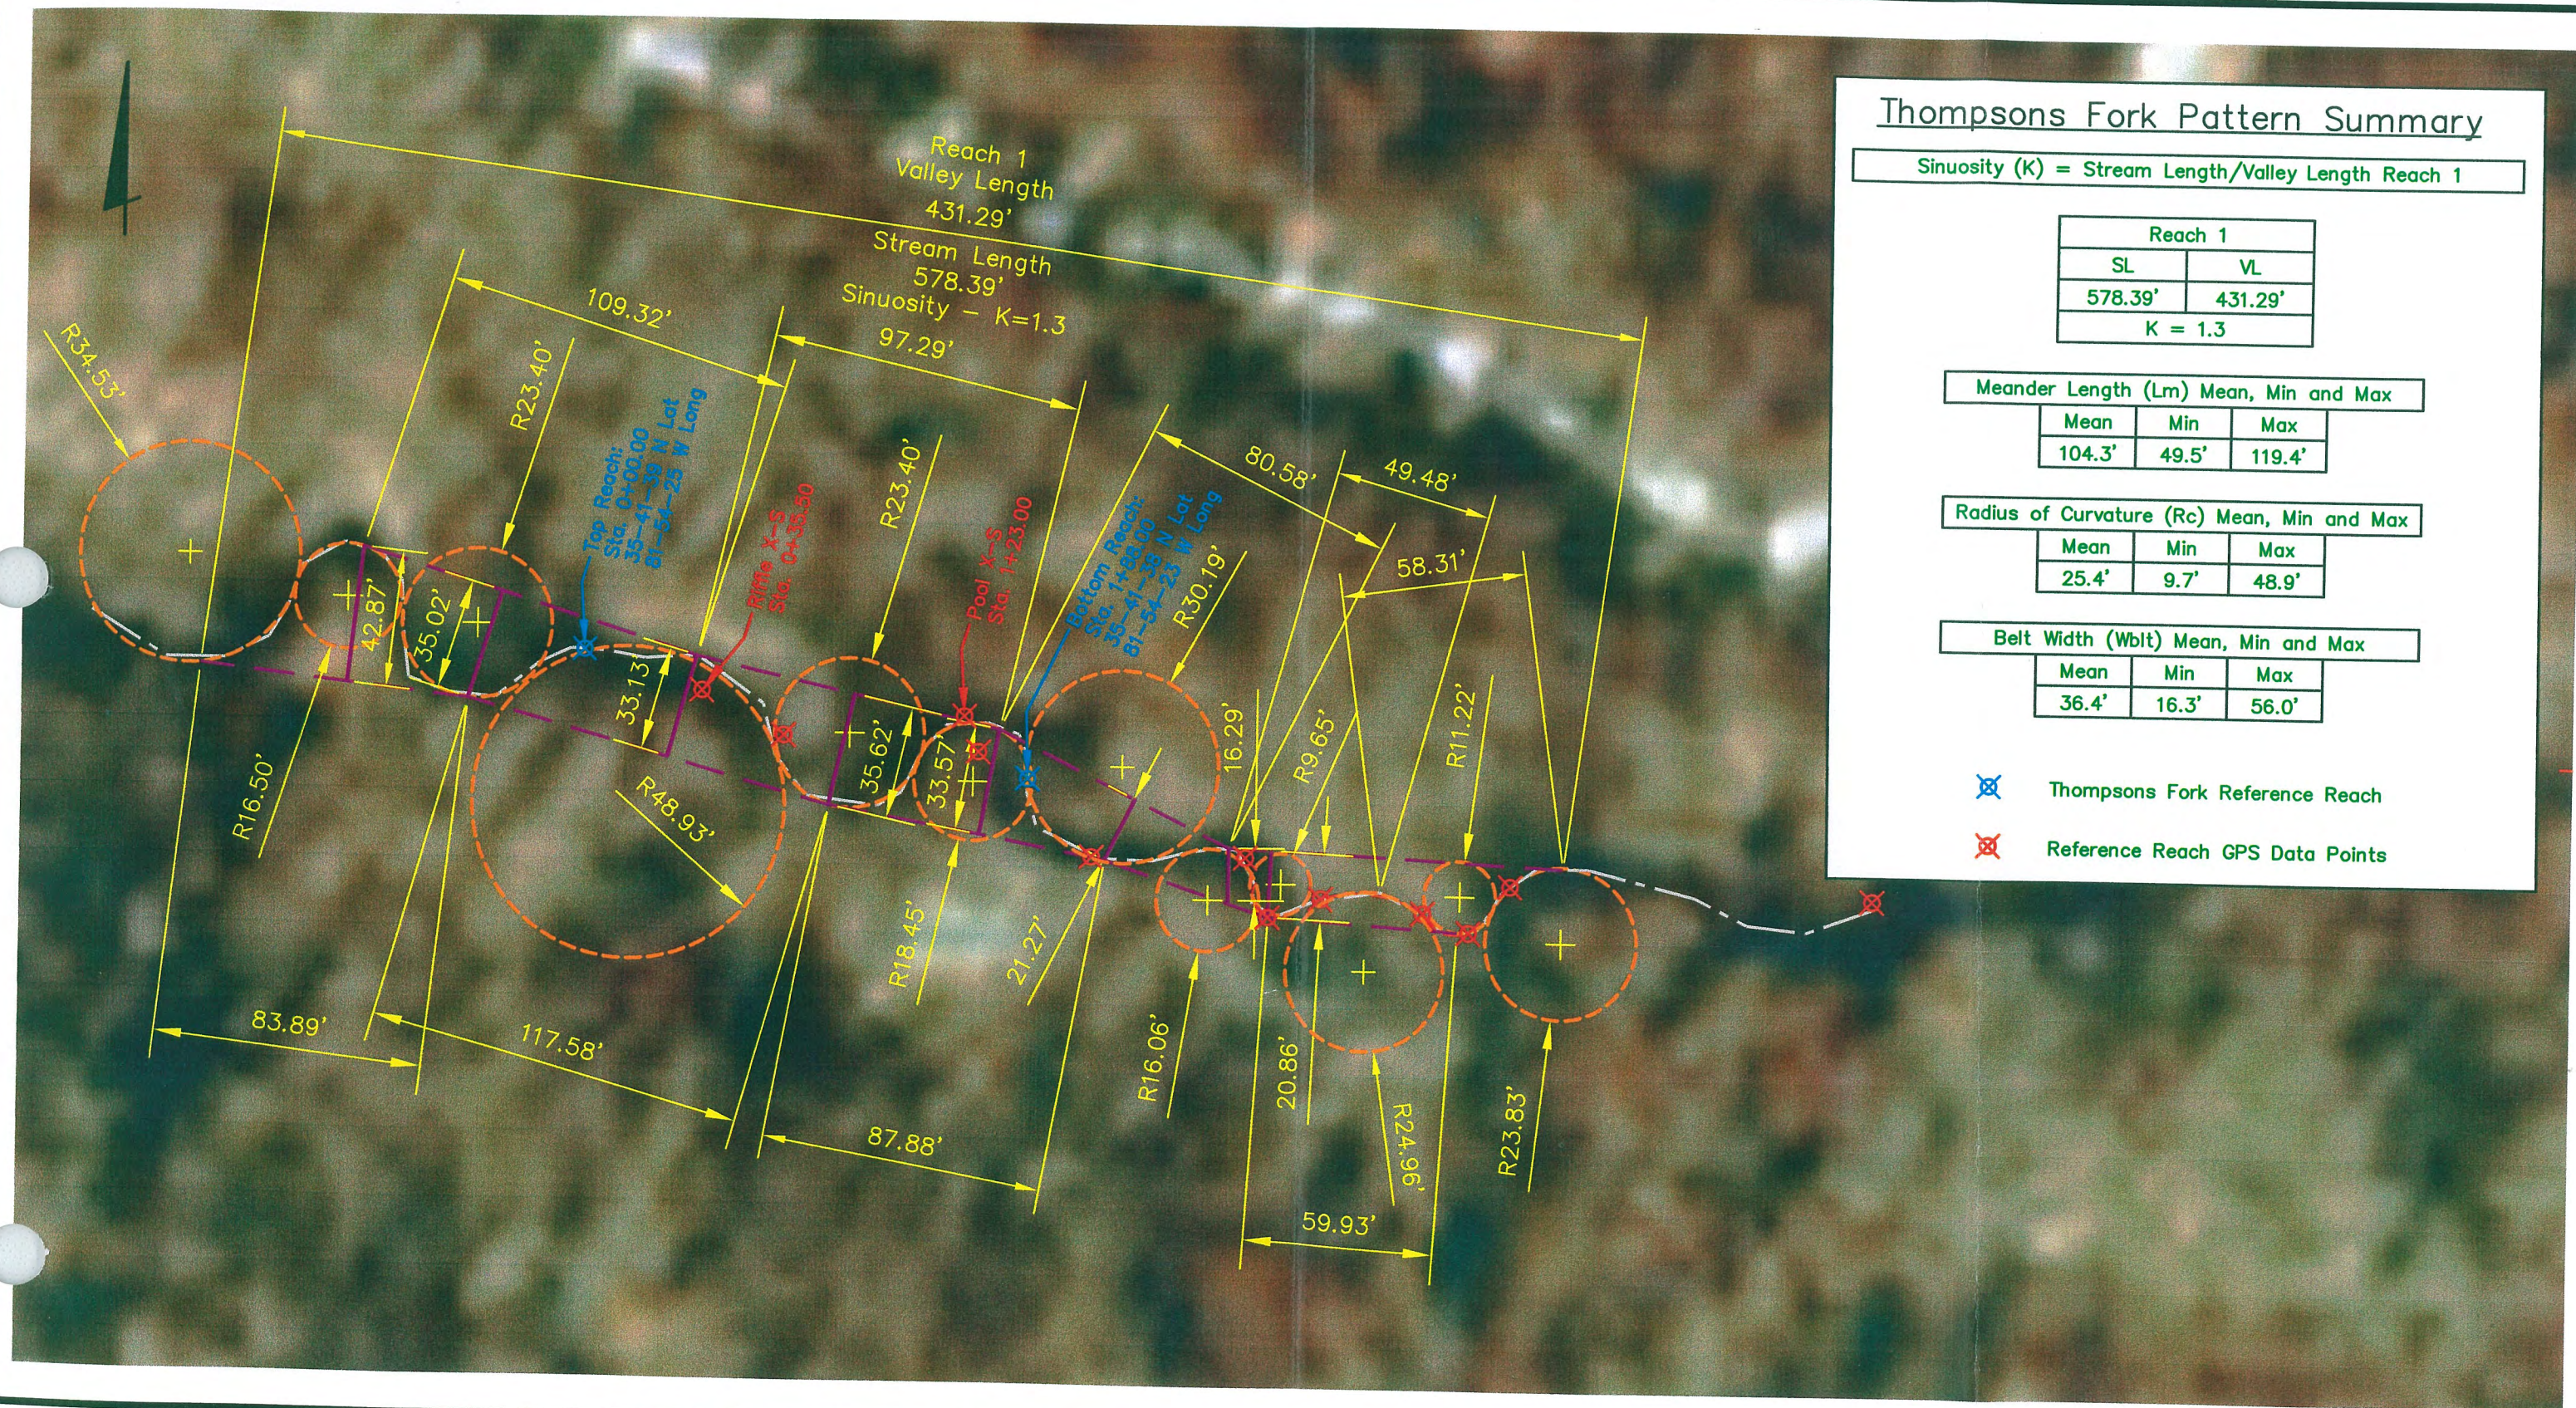
Sheet: 1 of 2

### REFERENCE REACH - PATTERN SUMMARY EXHIBIT

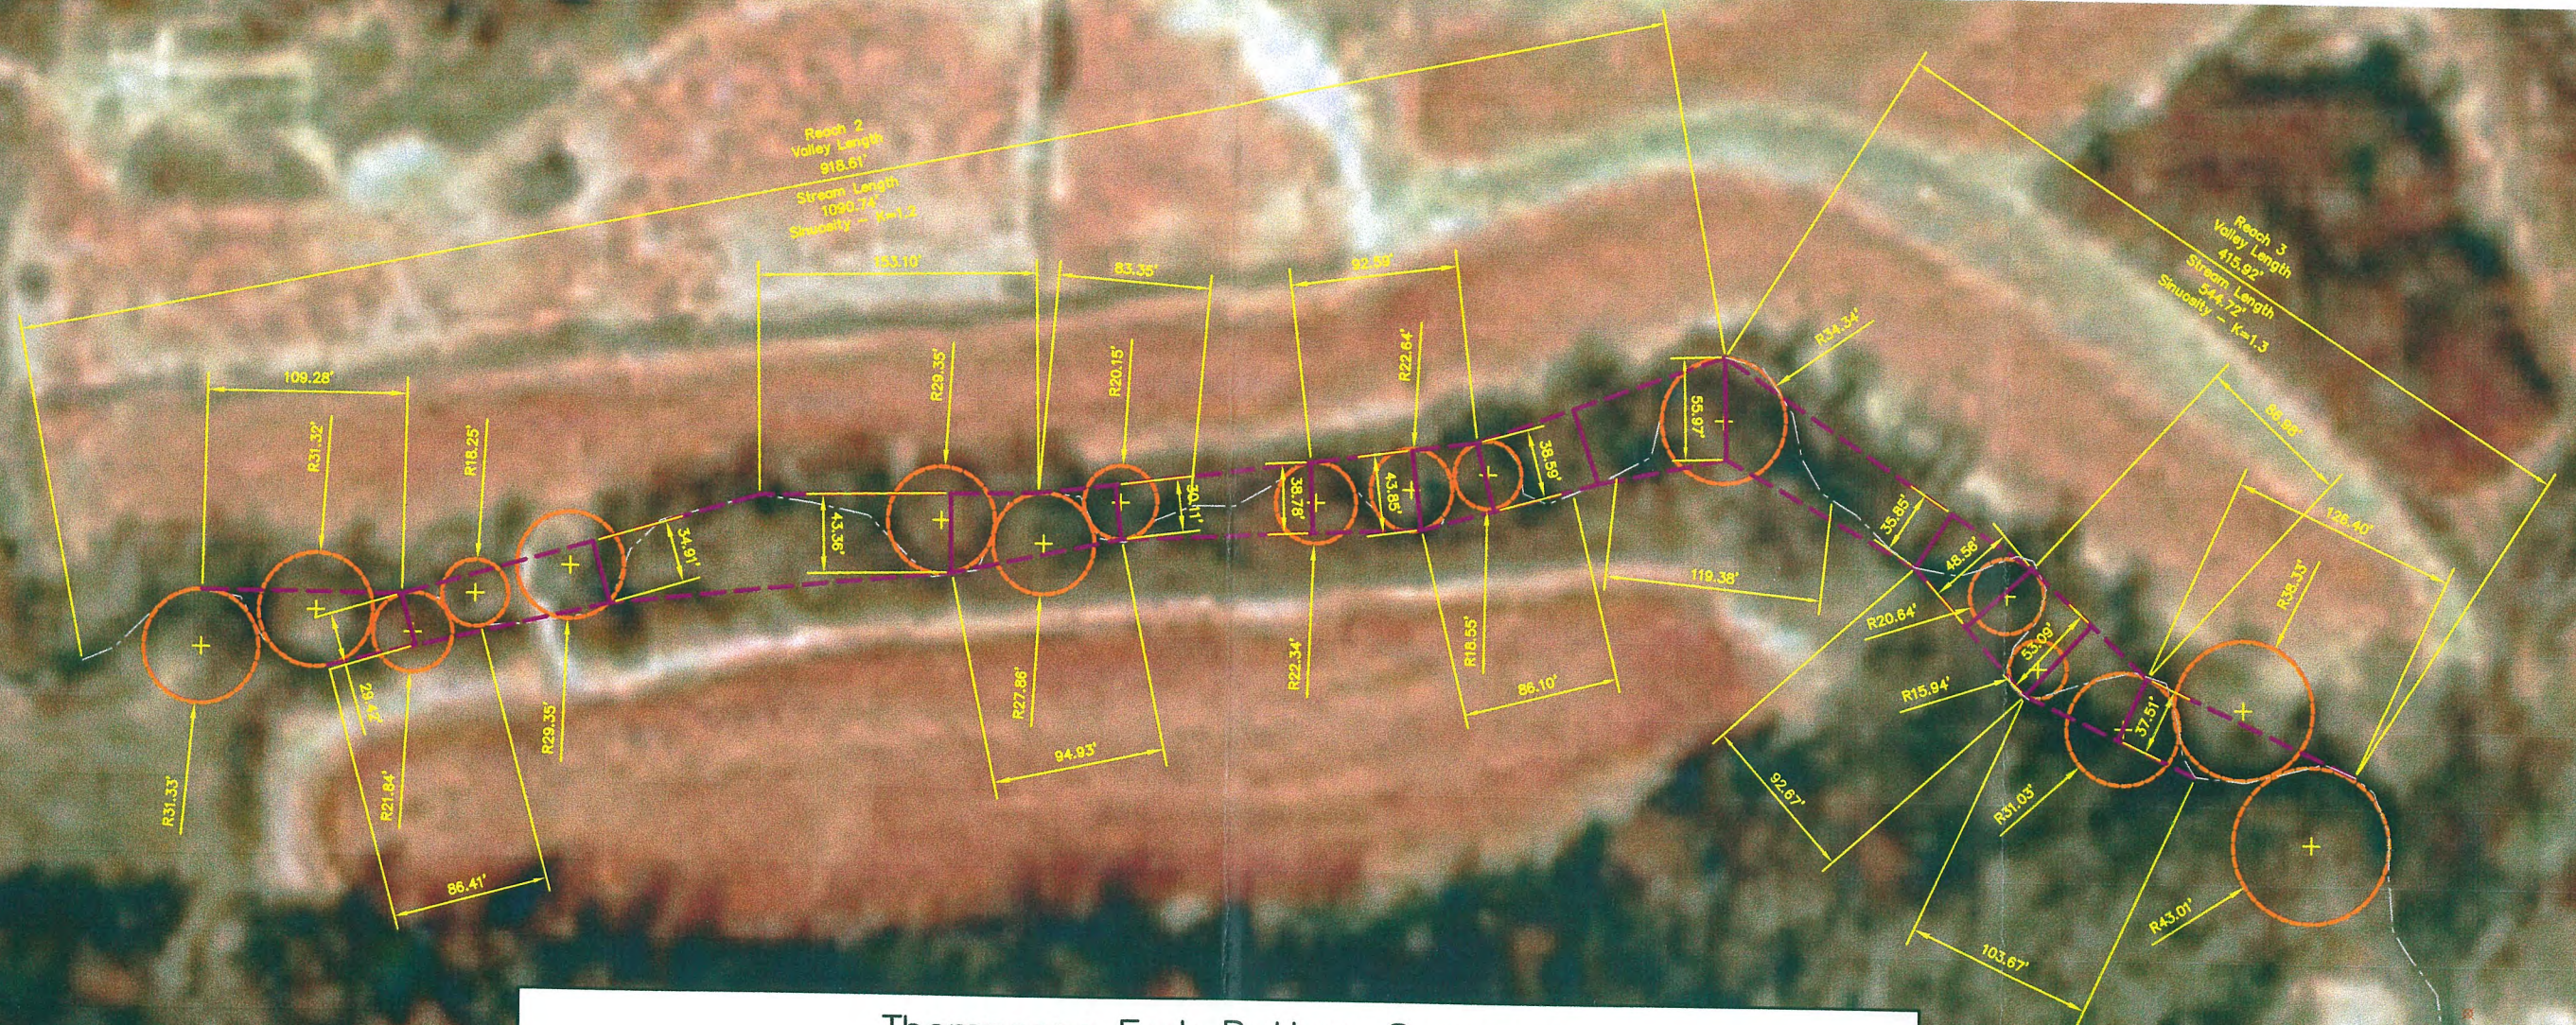
Sheet: 2 of 2

### Thompsons Fork Pattern Summary

Sinuosity (K) = Stream Length/Valley Length Reach 2 & 3

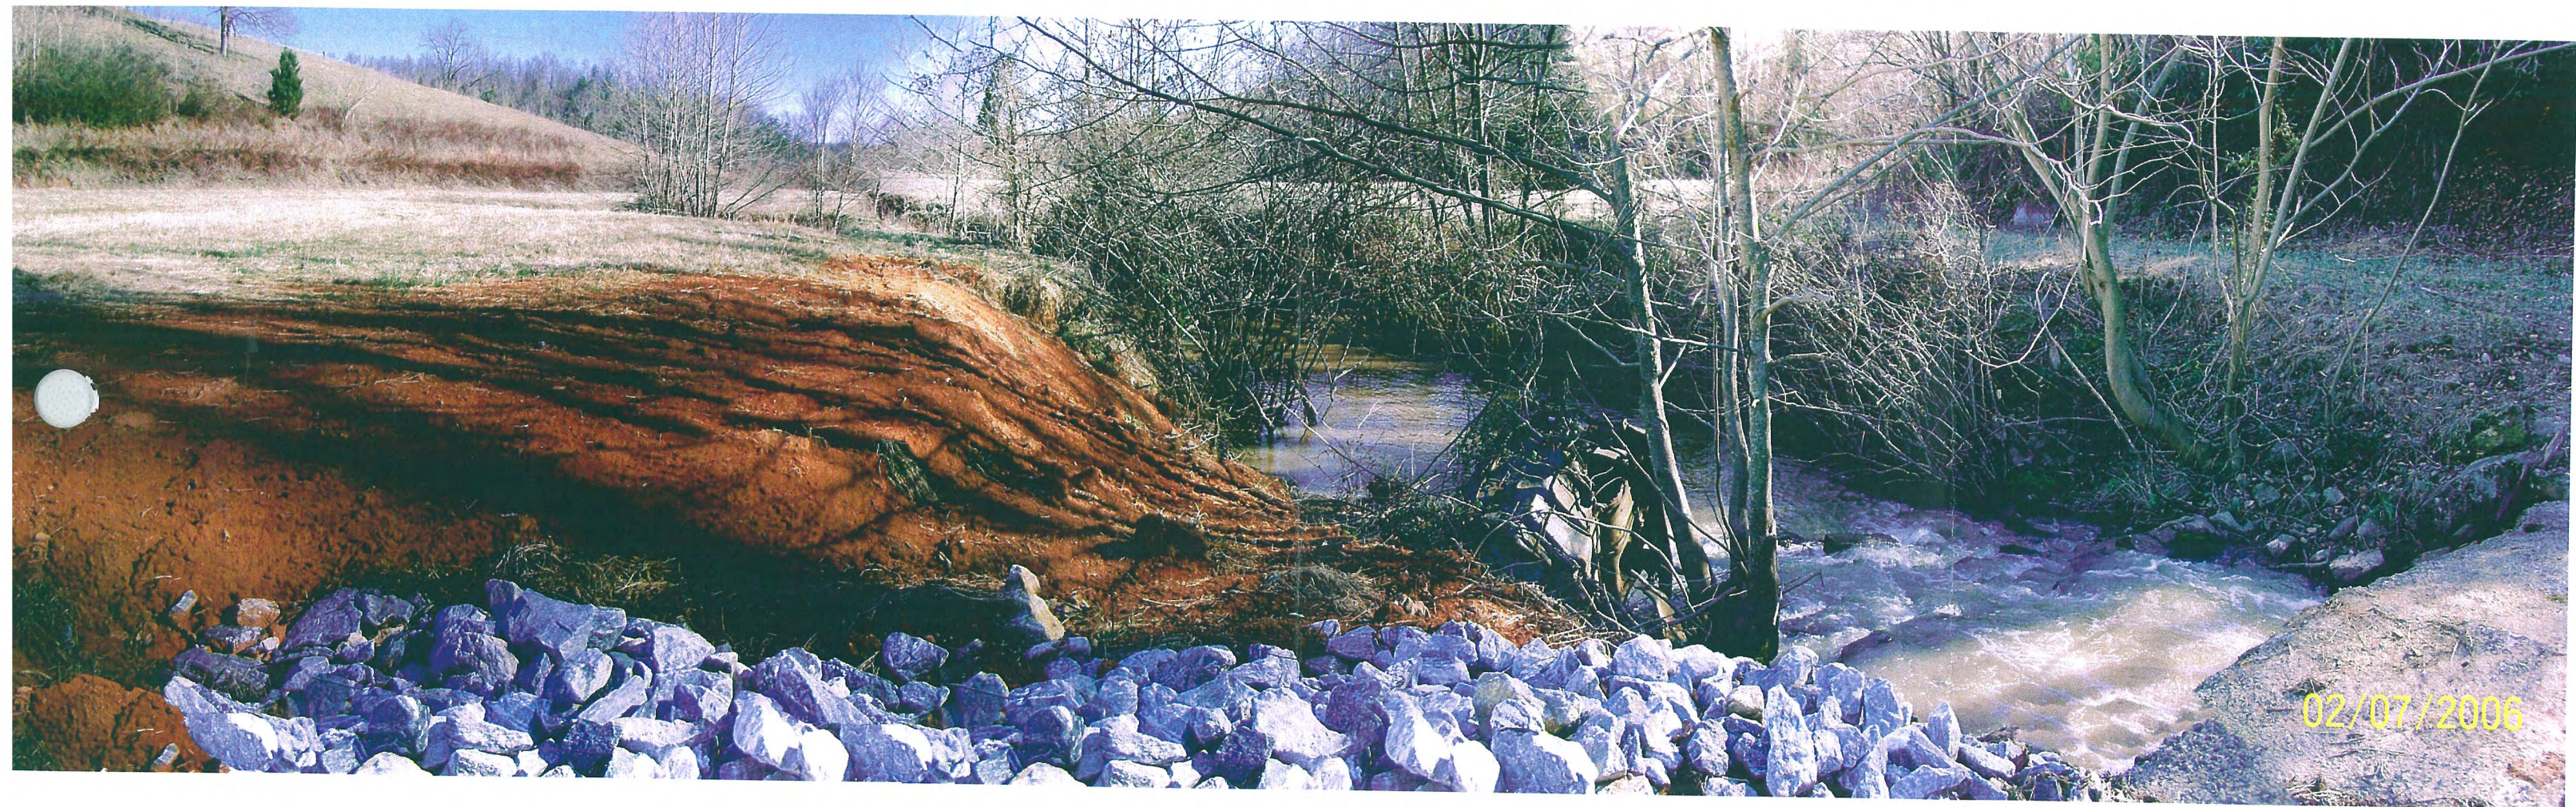
Existing Stream Crossing  
Thompsons Fork Mainstem  
Looking Down Stream  
February 7, 2006

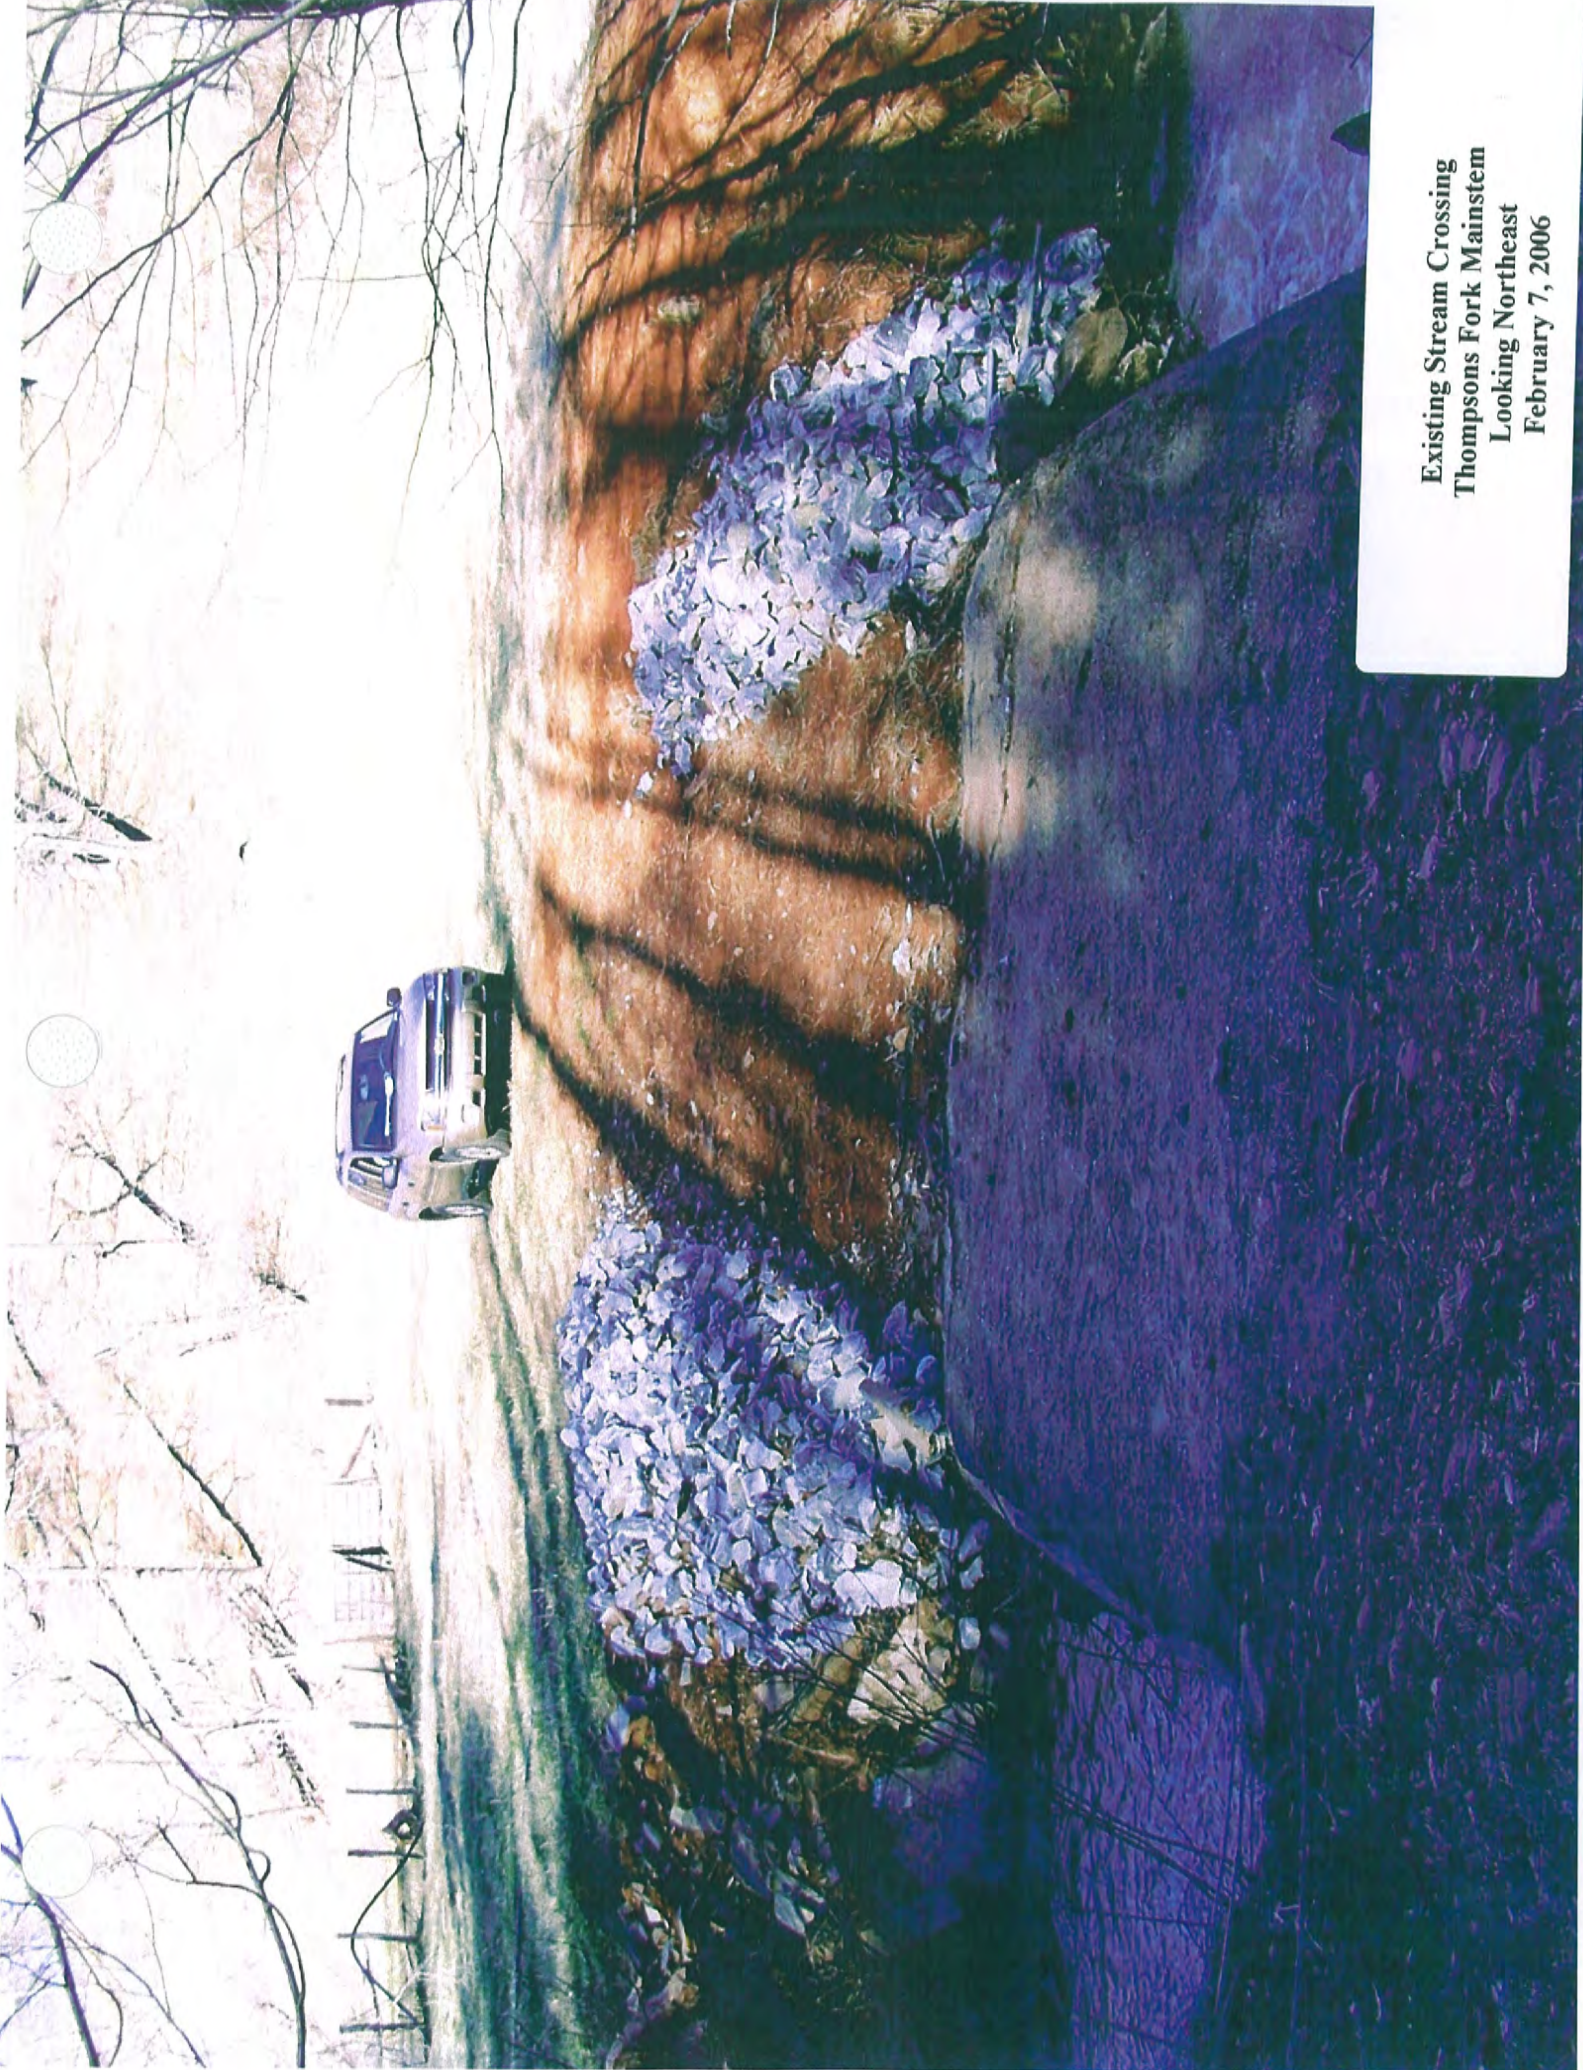
Existing Stream Crossing  
Thompsons Fork Mainstem  
Looking Northeast  
February 7, 2006

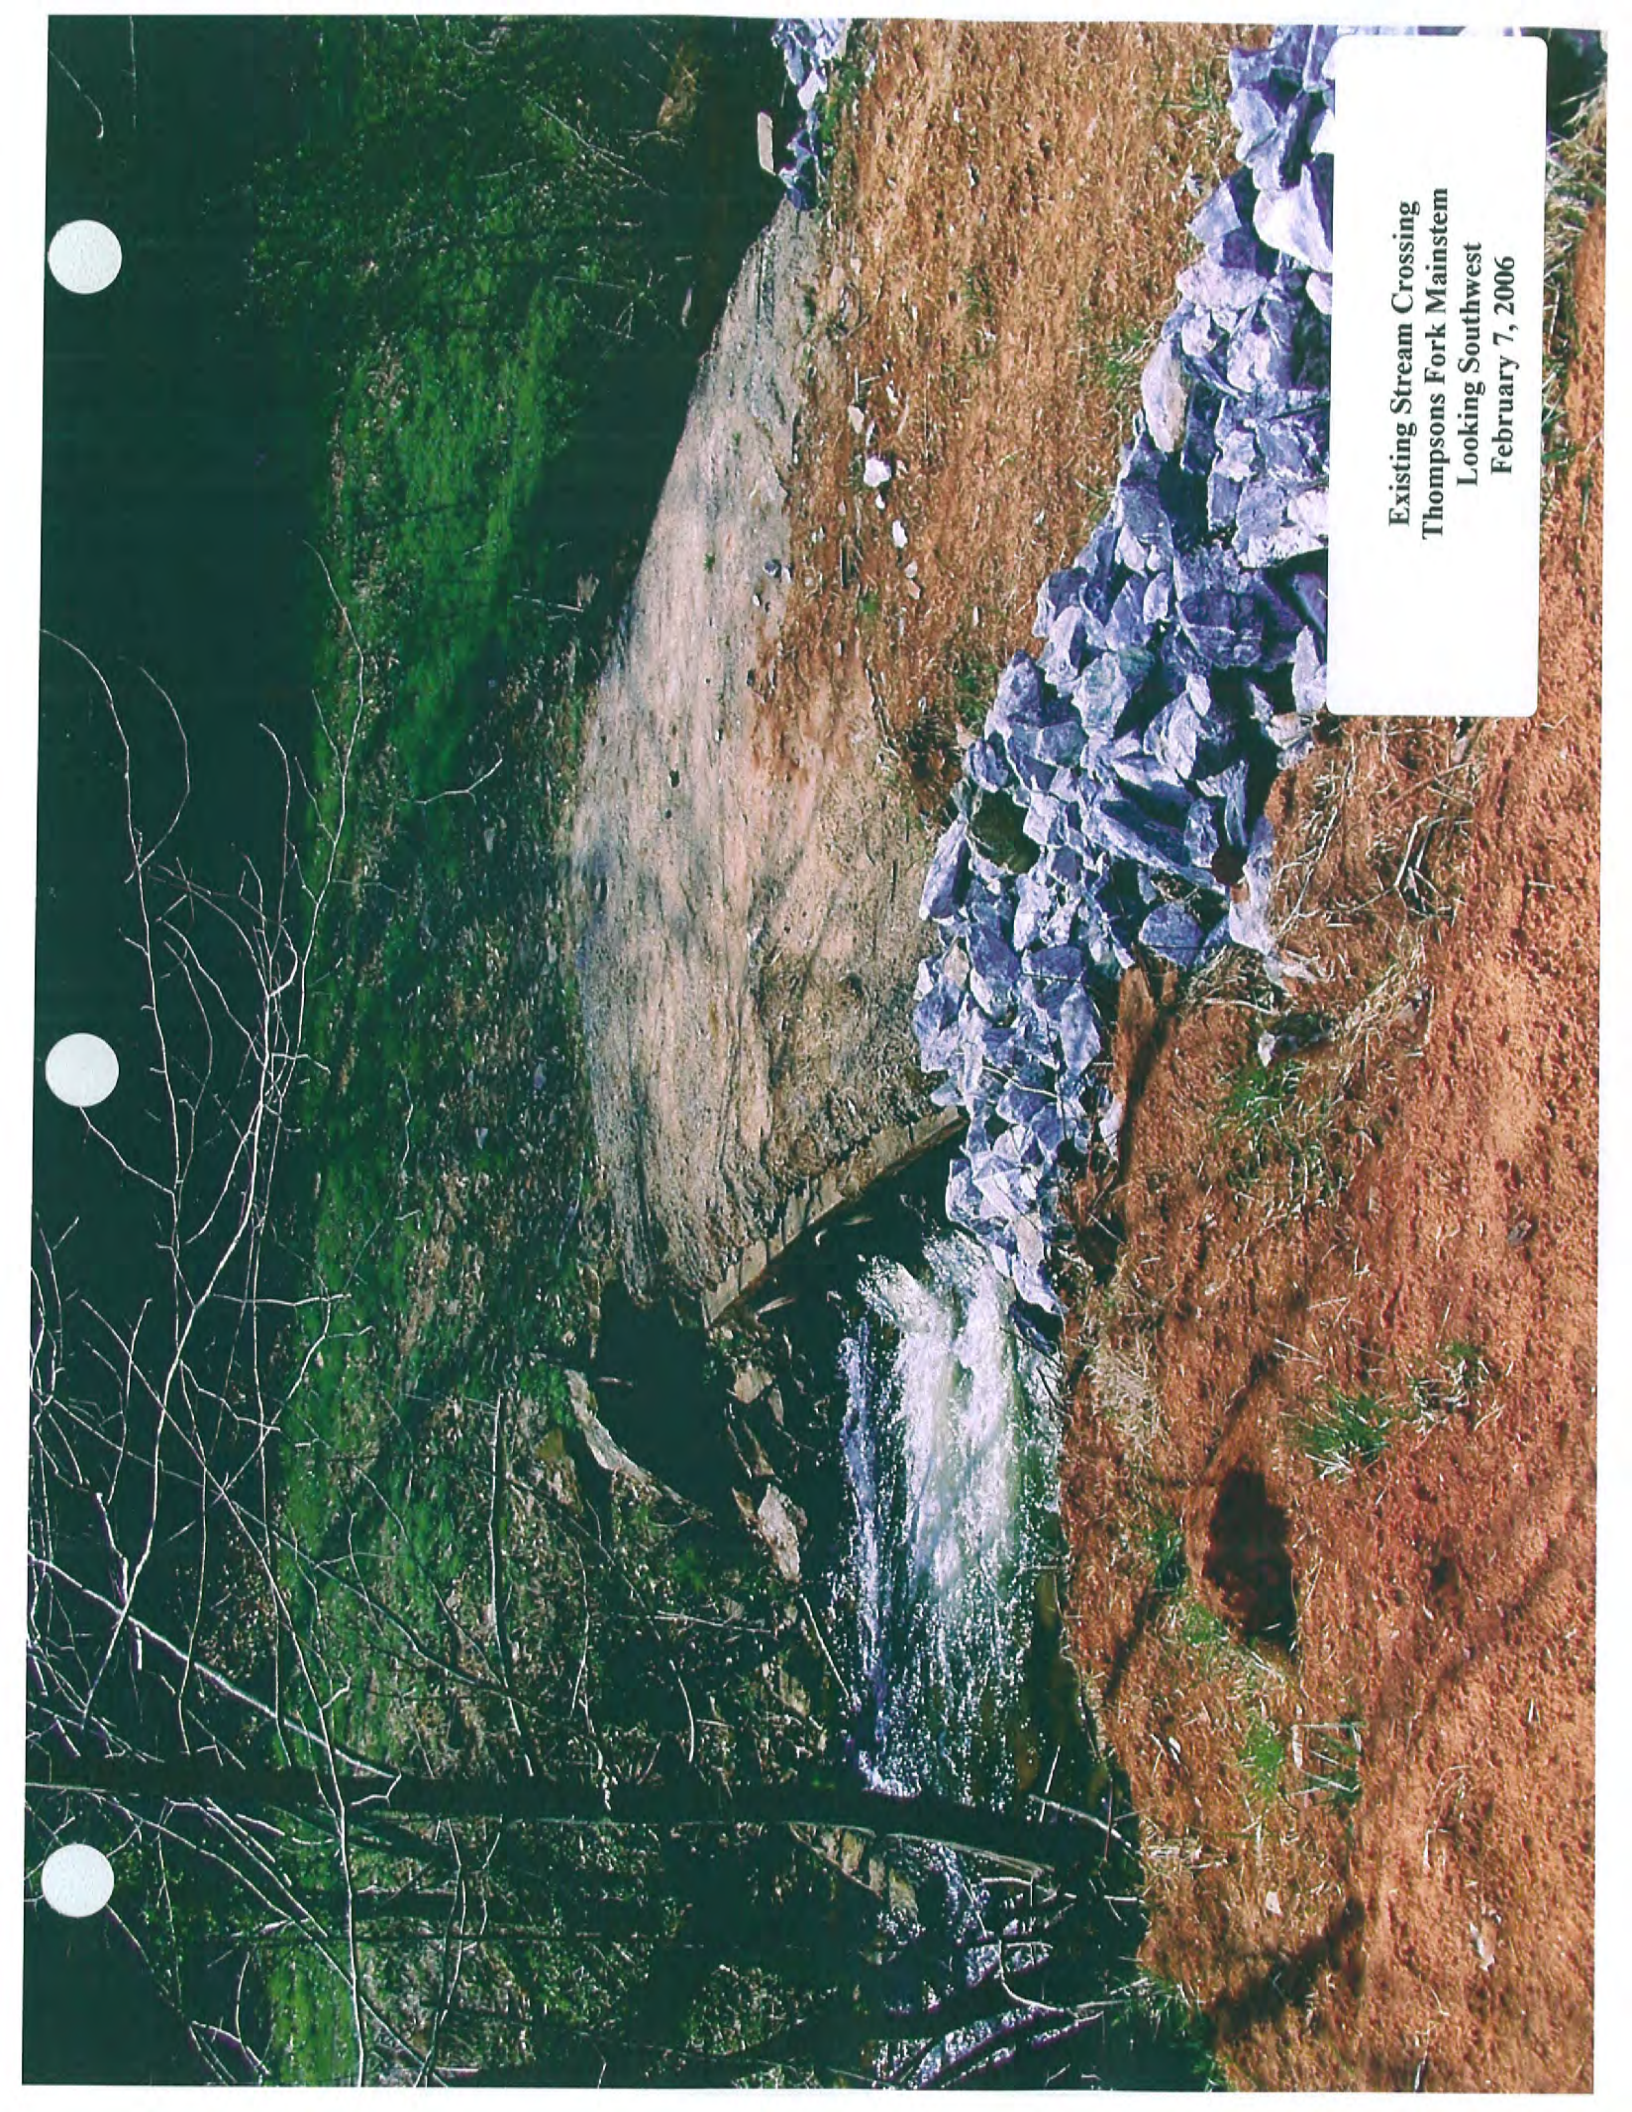
Existing Stream Crossing  
Thompsons Fork Mainstem  
Looking Southwest  
February 7, 2006

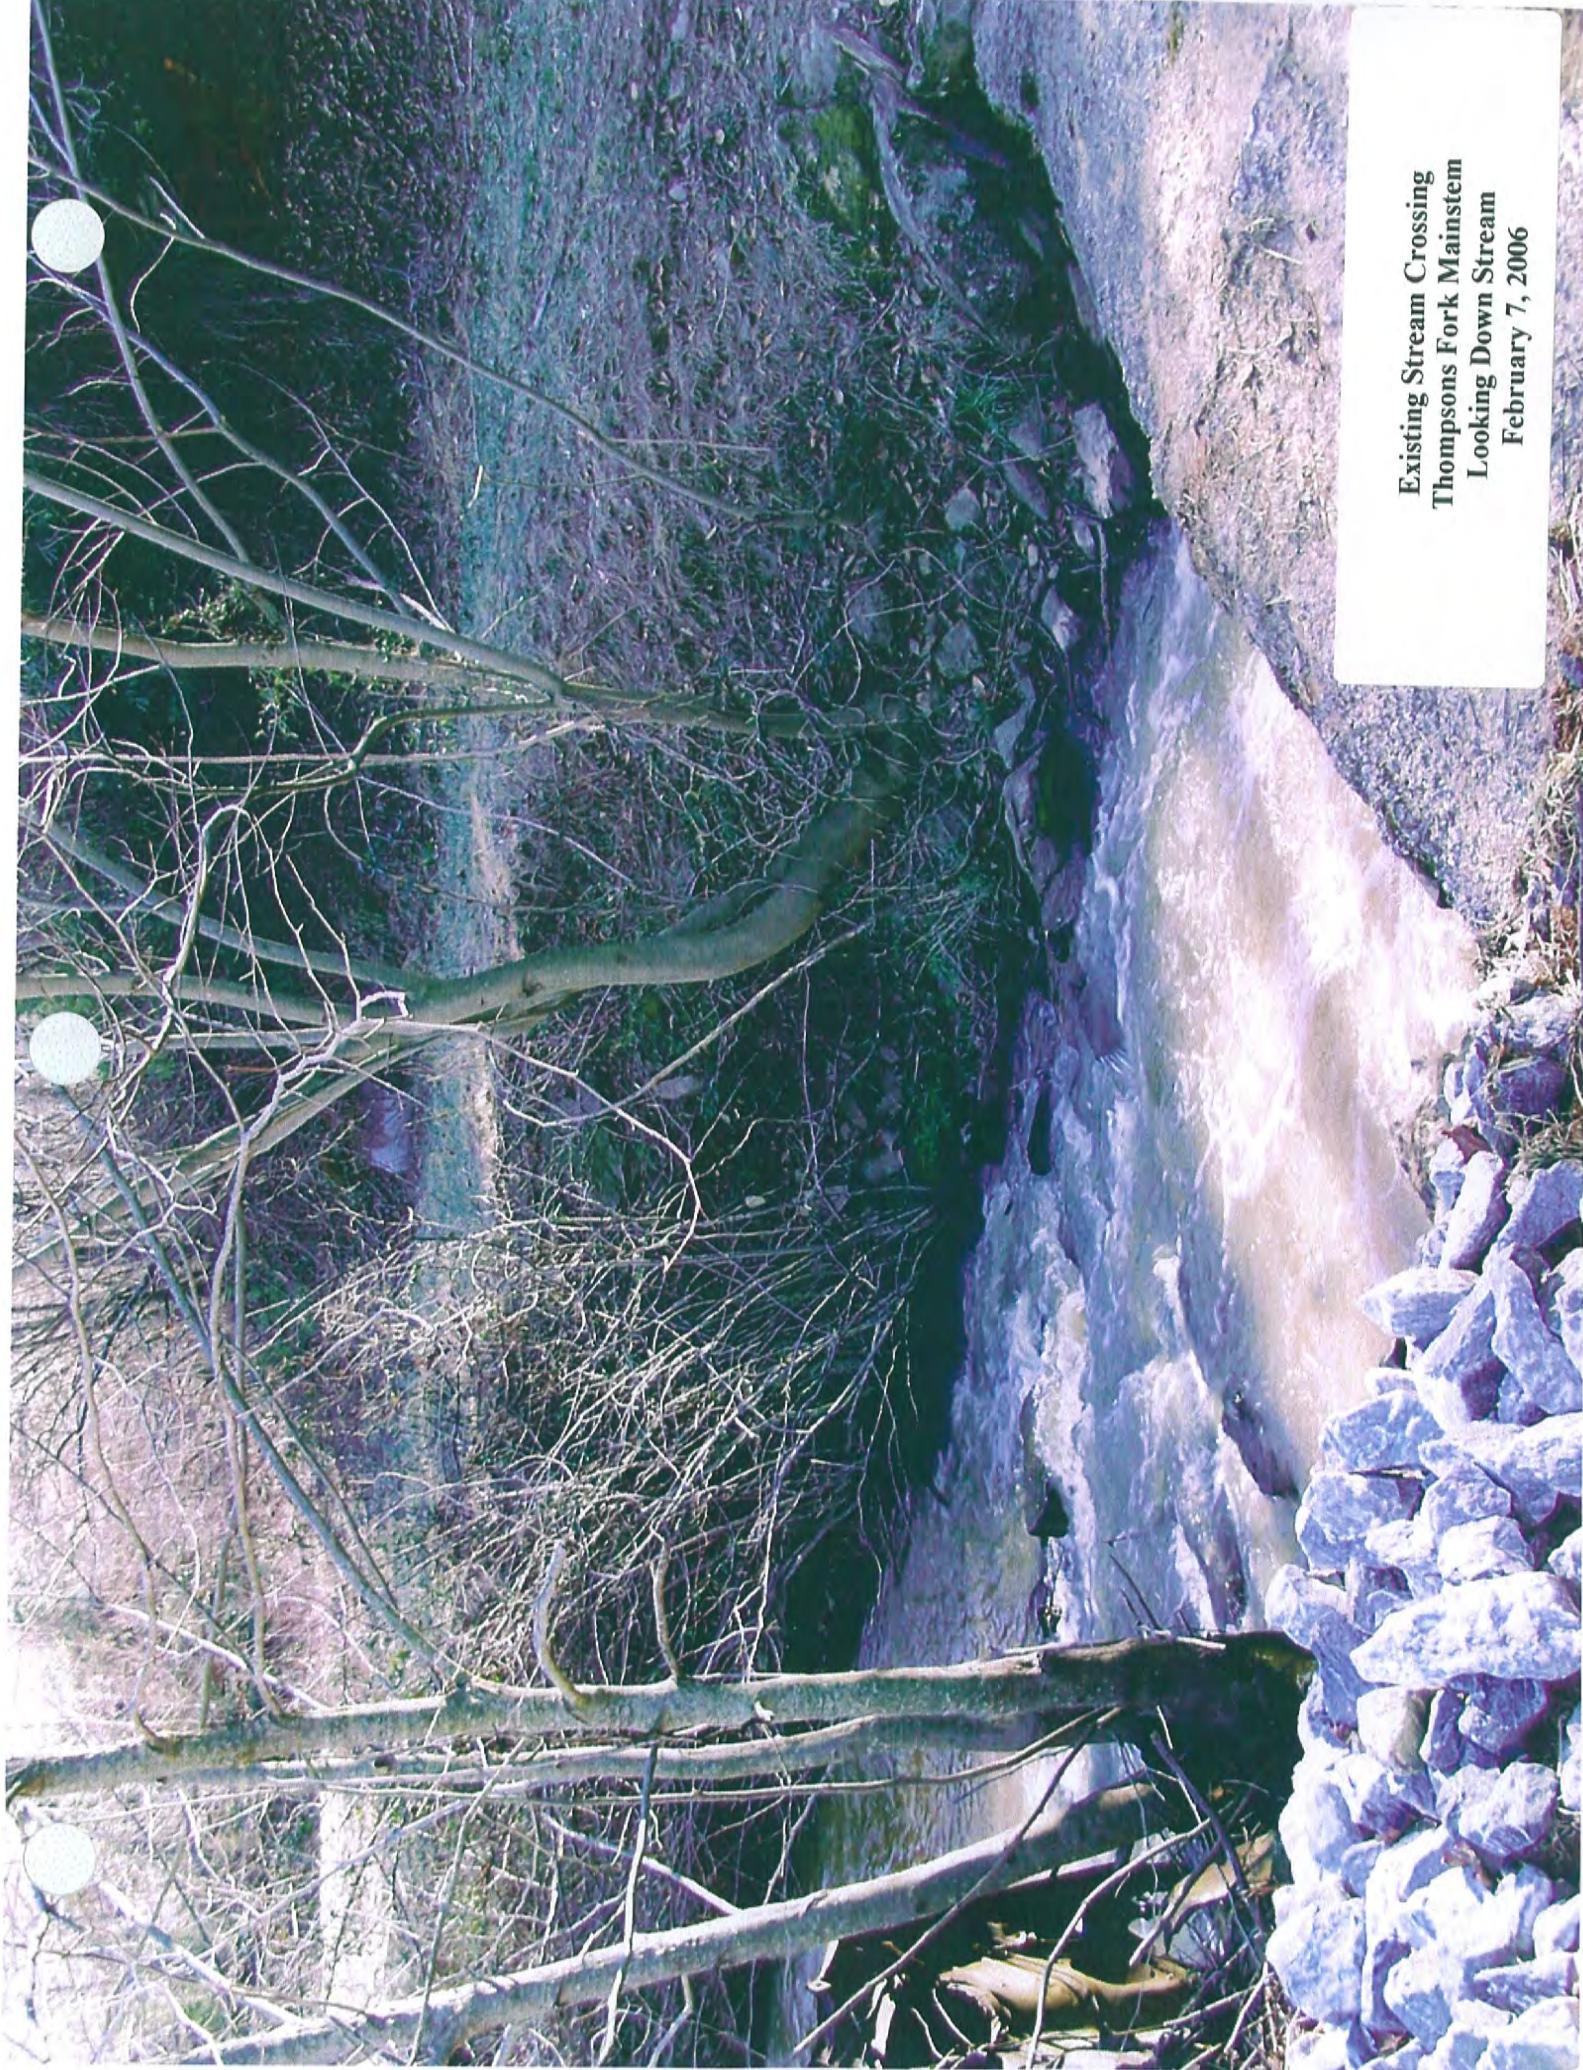
Thompsons Fork Mainstem  
Existing Conditions  
Upstream of Stream Crossing  
February 7, 2006

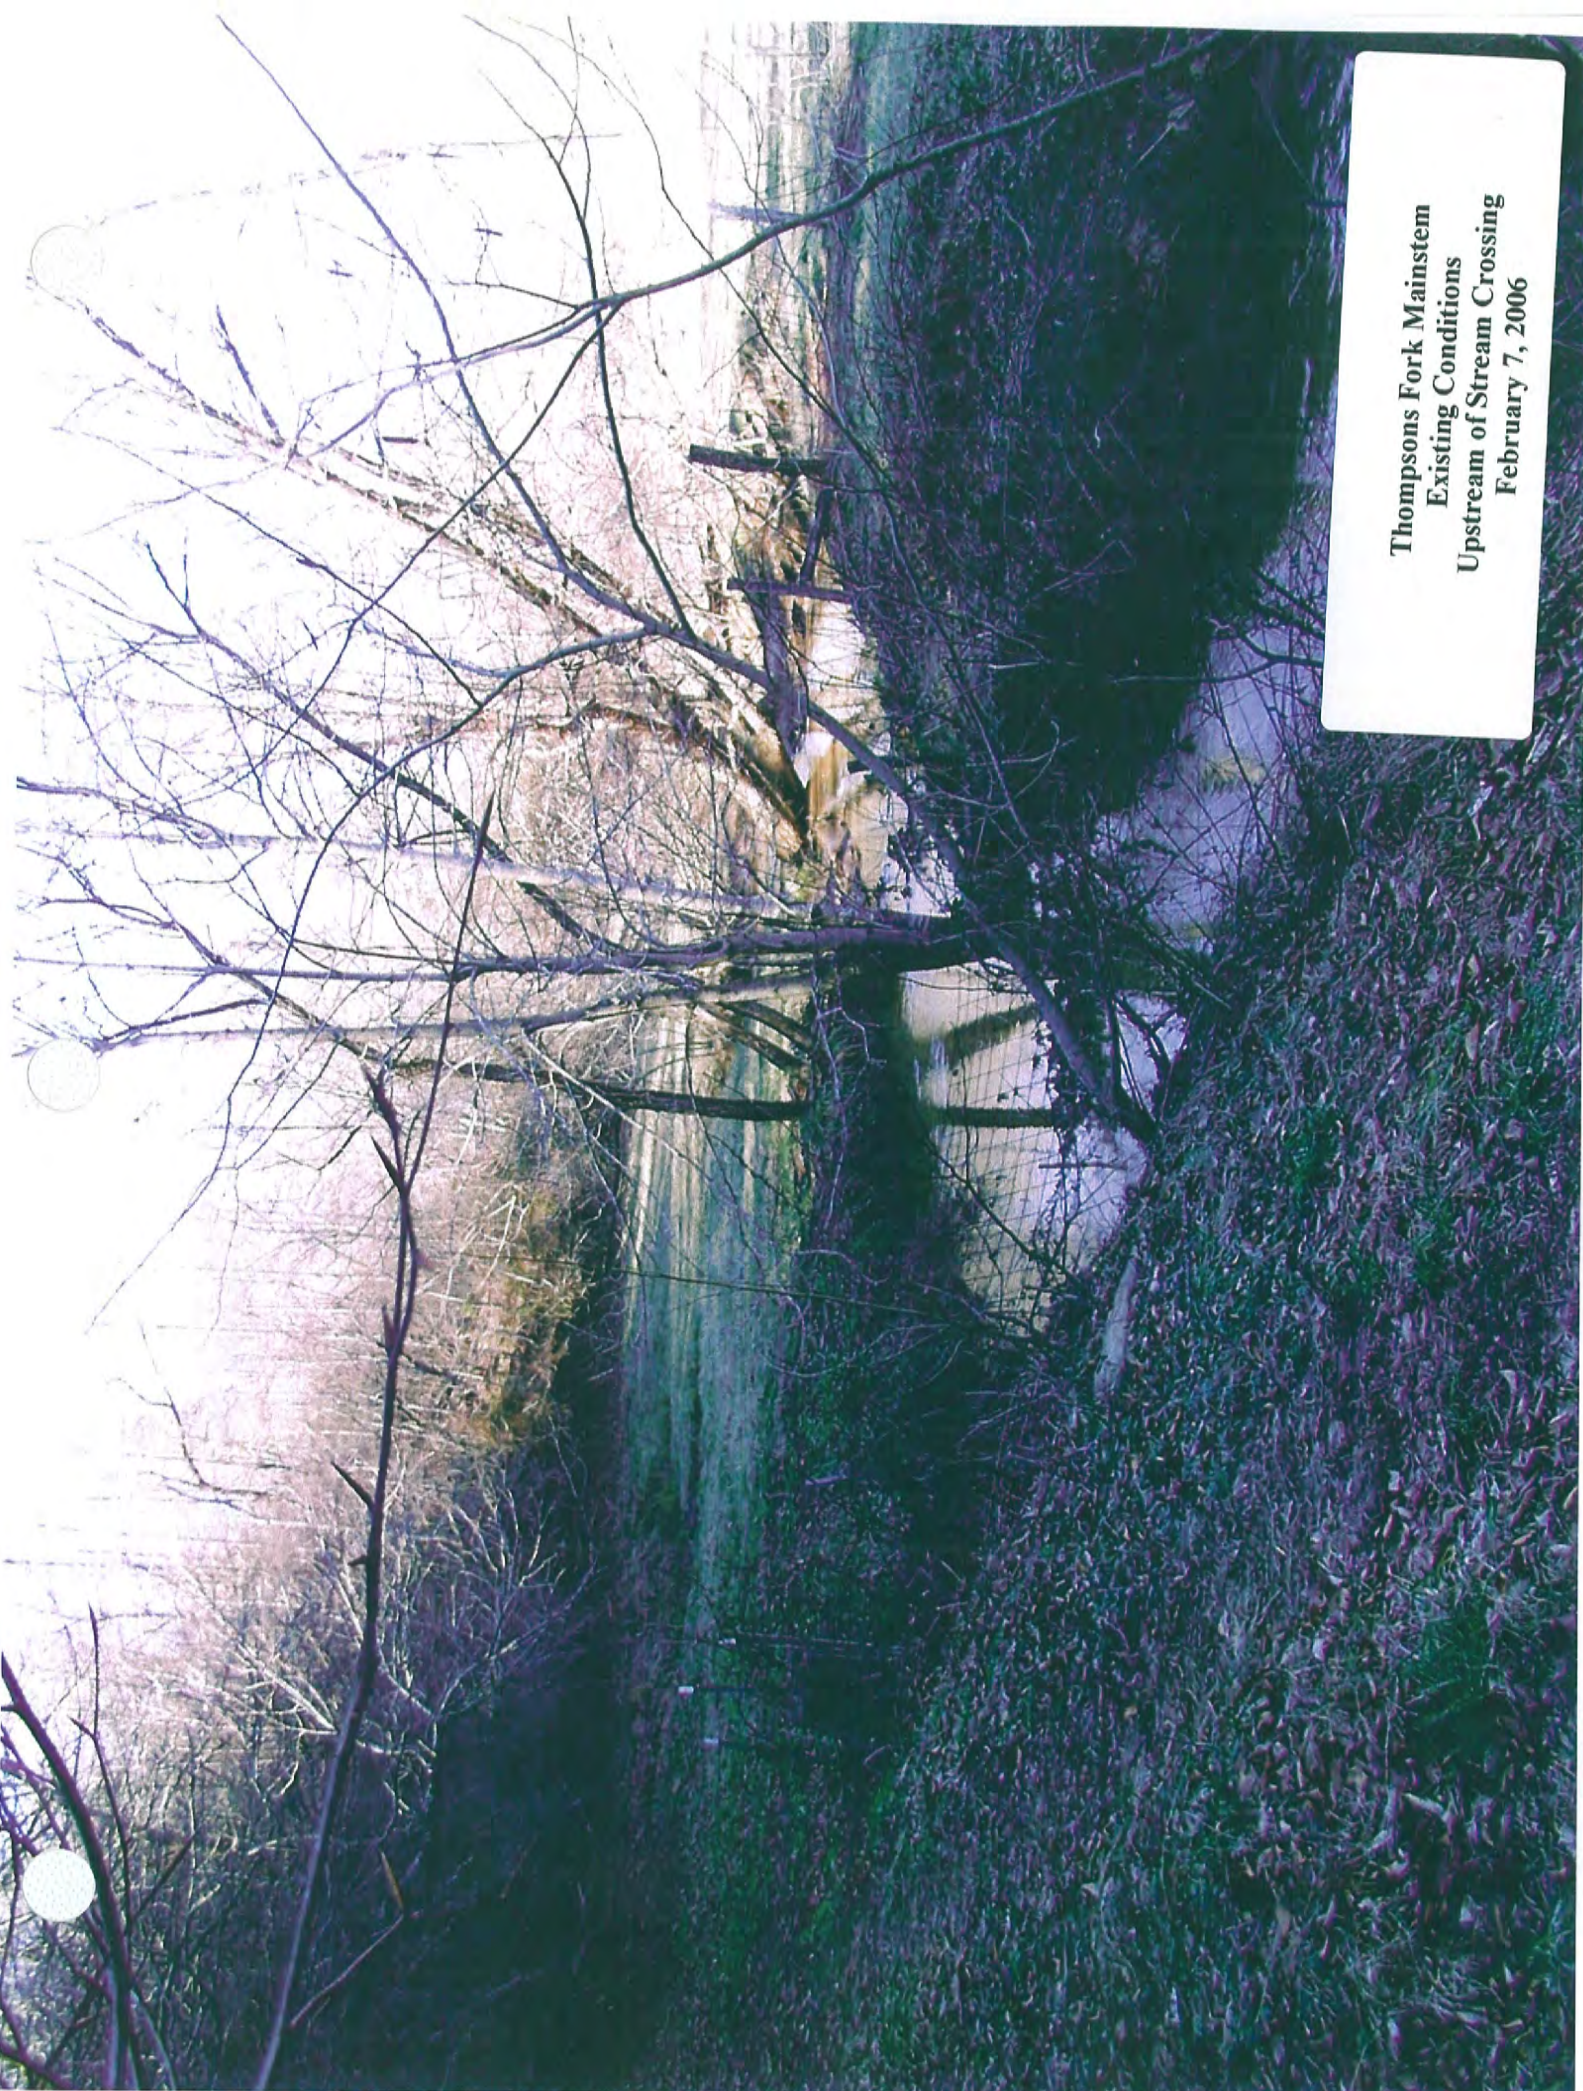
**Thompsons Fork Mainstem  
Existing Conditions  
Downstream of Stream Crossing  
February 7, 2006**
