**Wetlands Resource Center**  
3970 Bowen Road  
Canal Winchester, Ohio 43110  
Project Manager: Cal Miller  
P: (614) 864-7511  
F: (614) 866-3691

**EMH&T, Inc.**  
5500 New Albany Road  
Columbus, Ohio 43054  
Project Manager: Miles F. Hebert, PE  
P: (614) 775-4205  
F: (614) 775-4802  
Main: (614) 775-4500

## THOMPSONS FORK RESTORATION

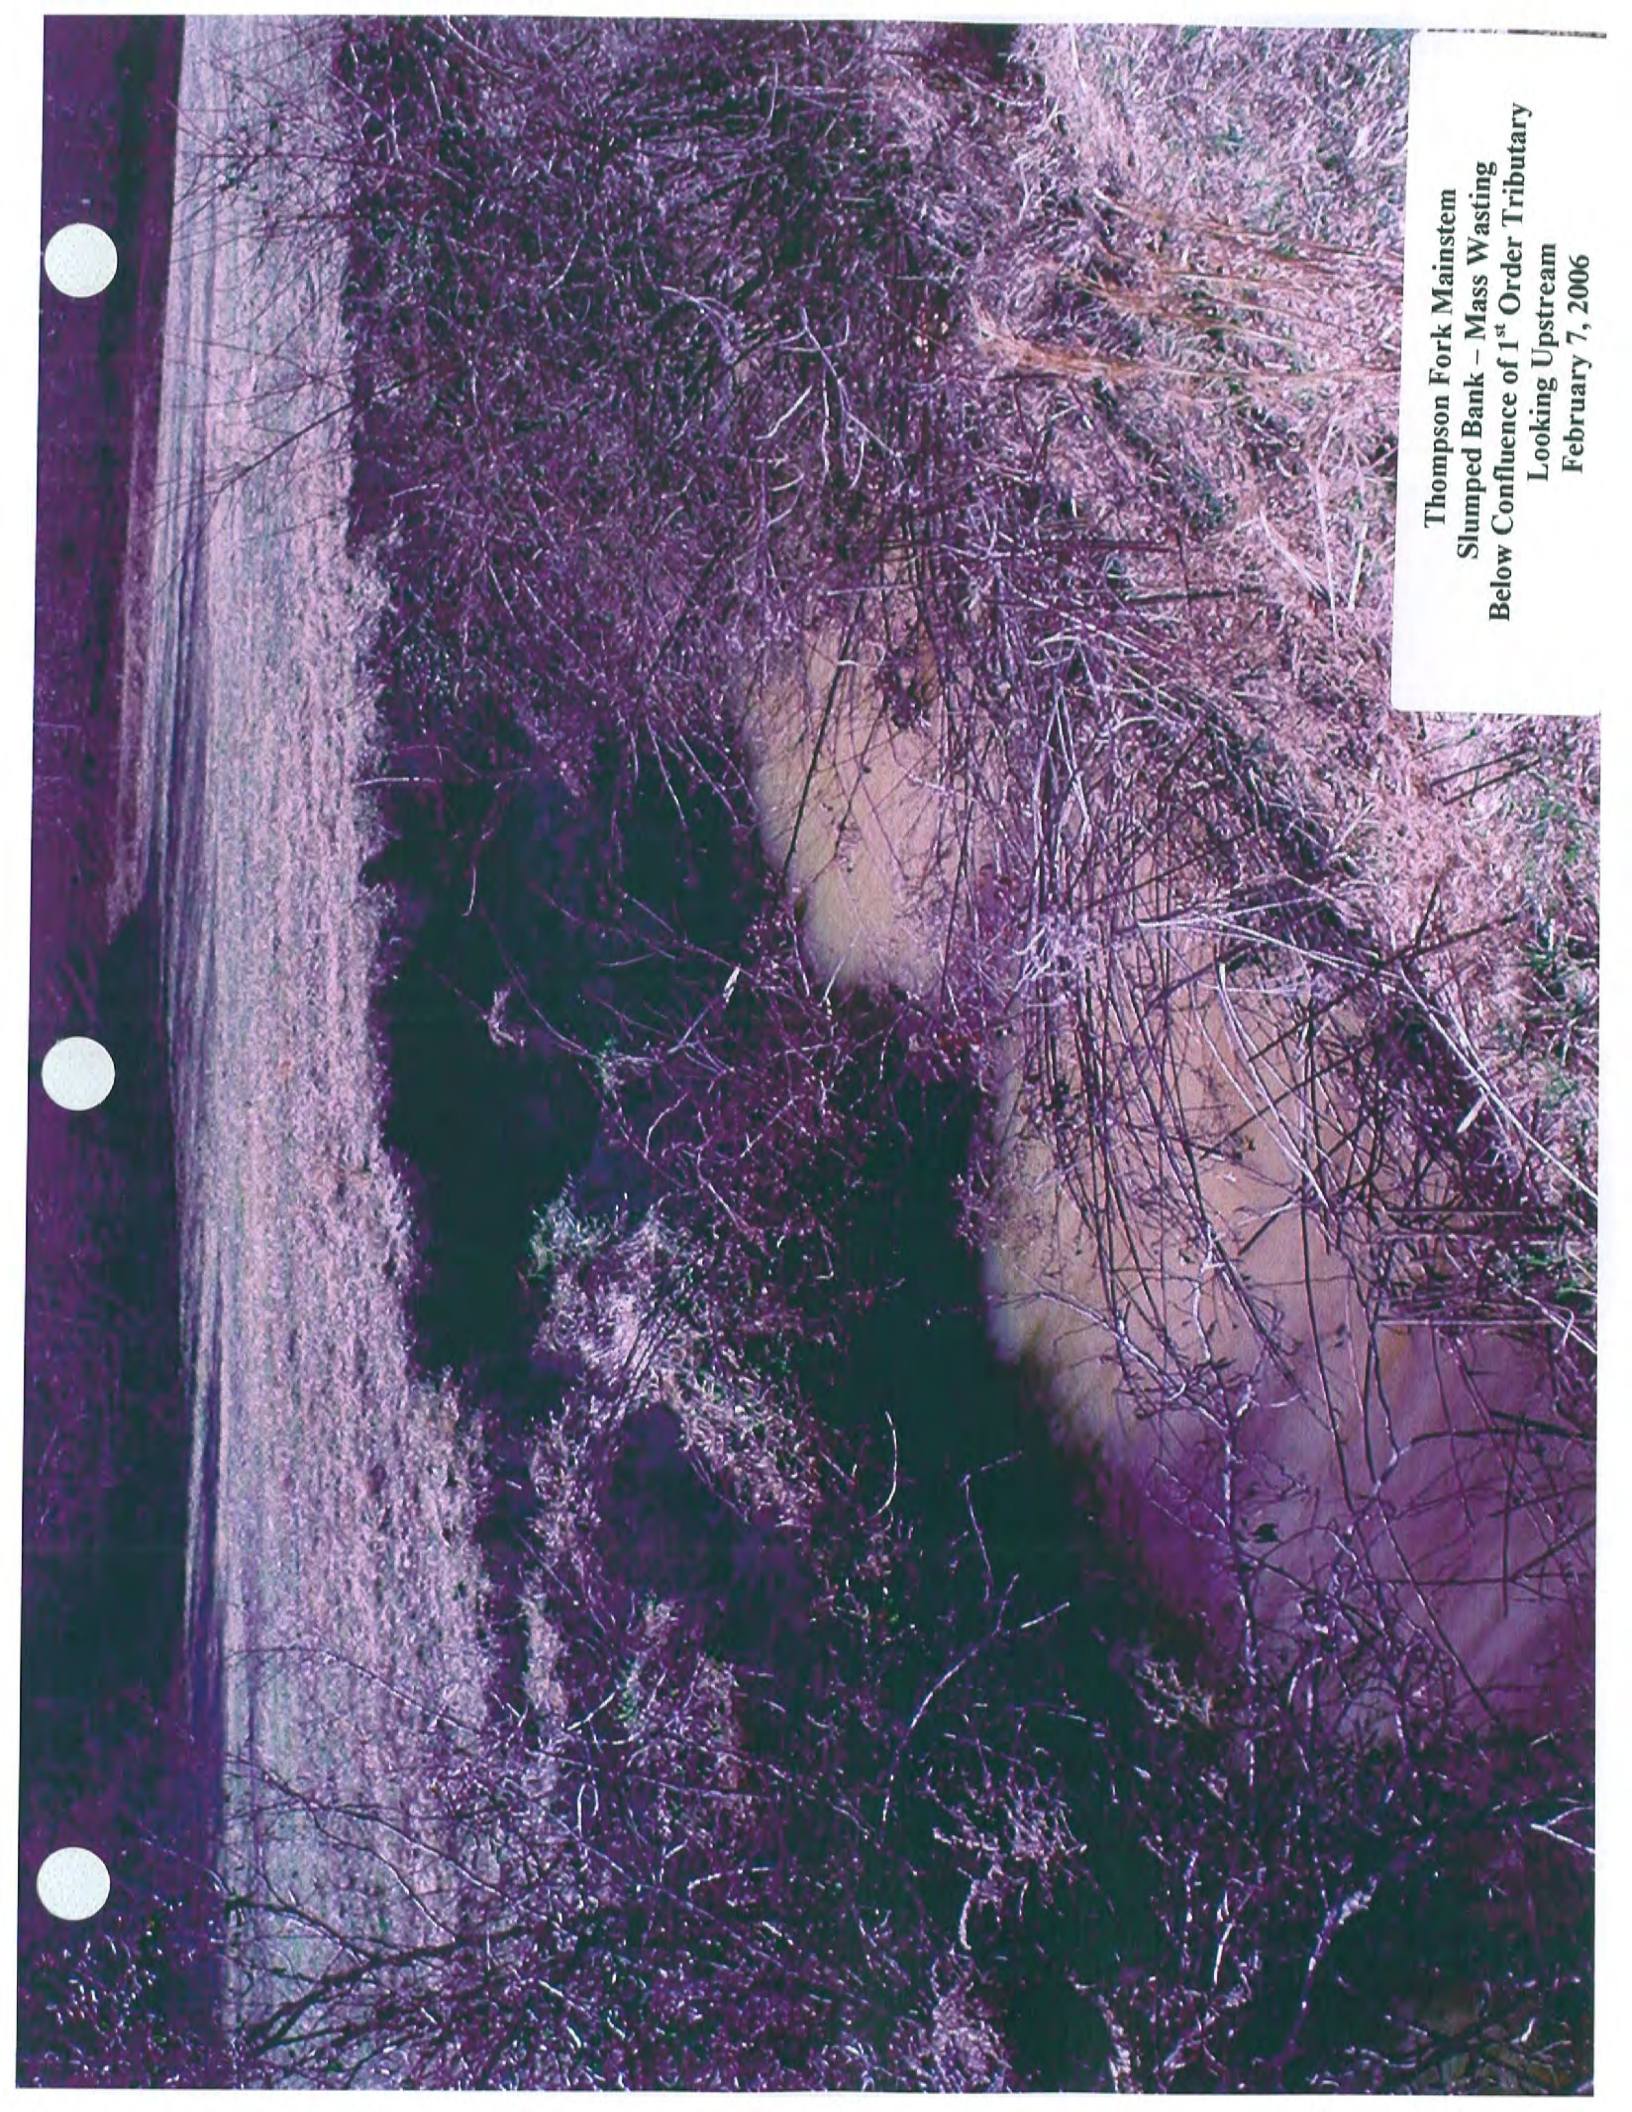
Thompson Fork Mainstem  
Slumped Bank - Mass Wasting  
Below Confluence of 1<sup>st</sup> Order Tributary  
Looking Upstream  
February 7, 2006

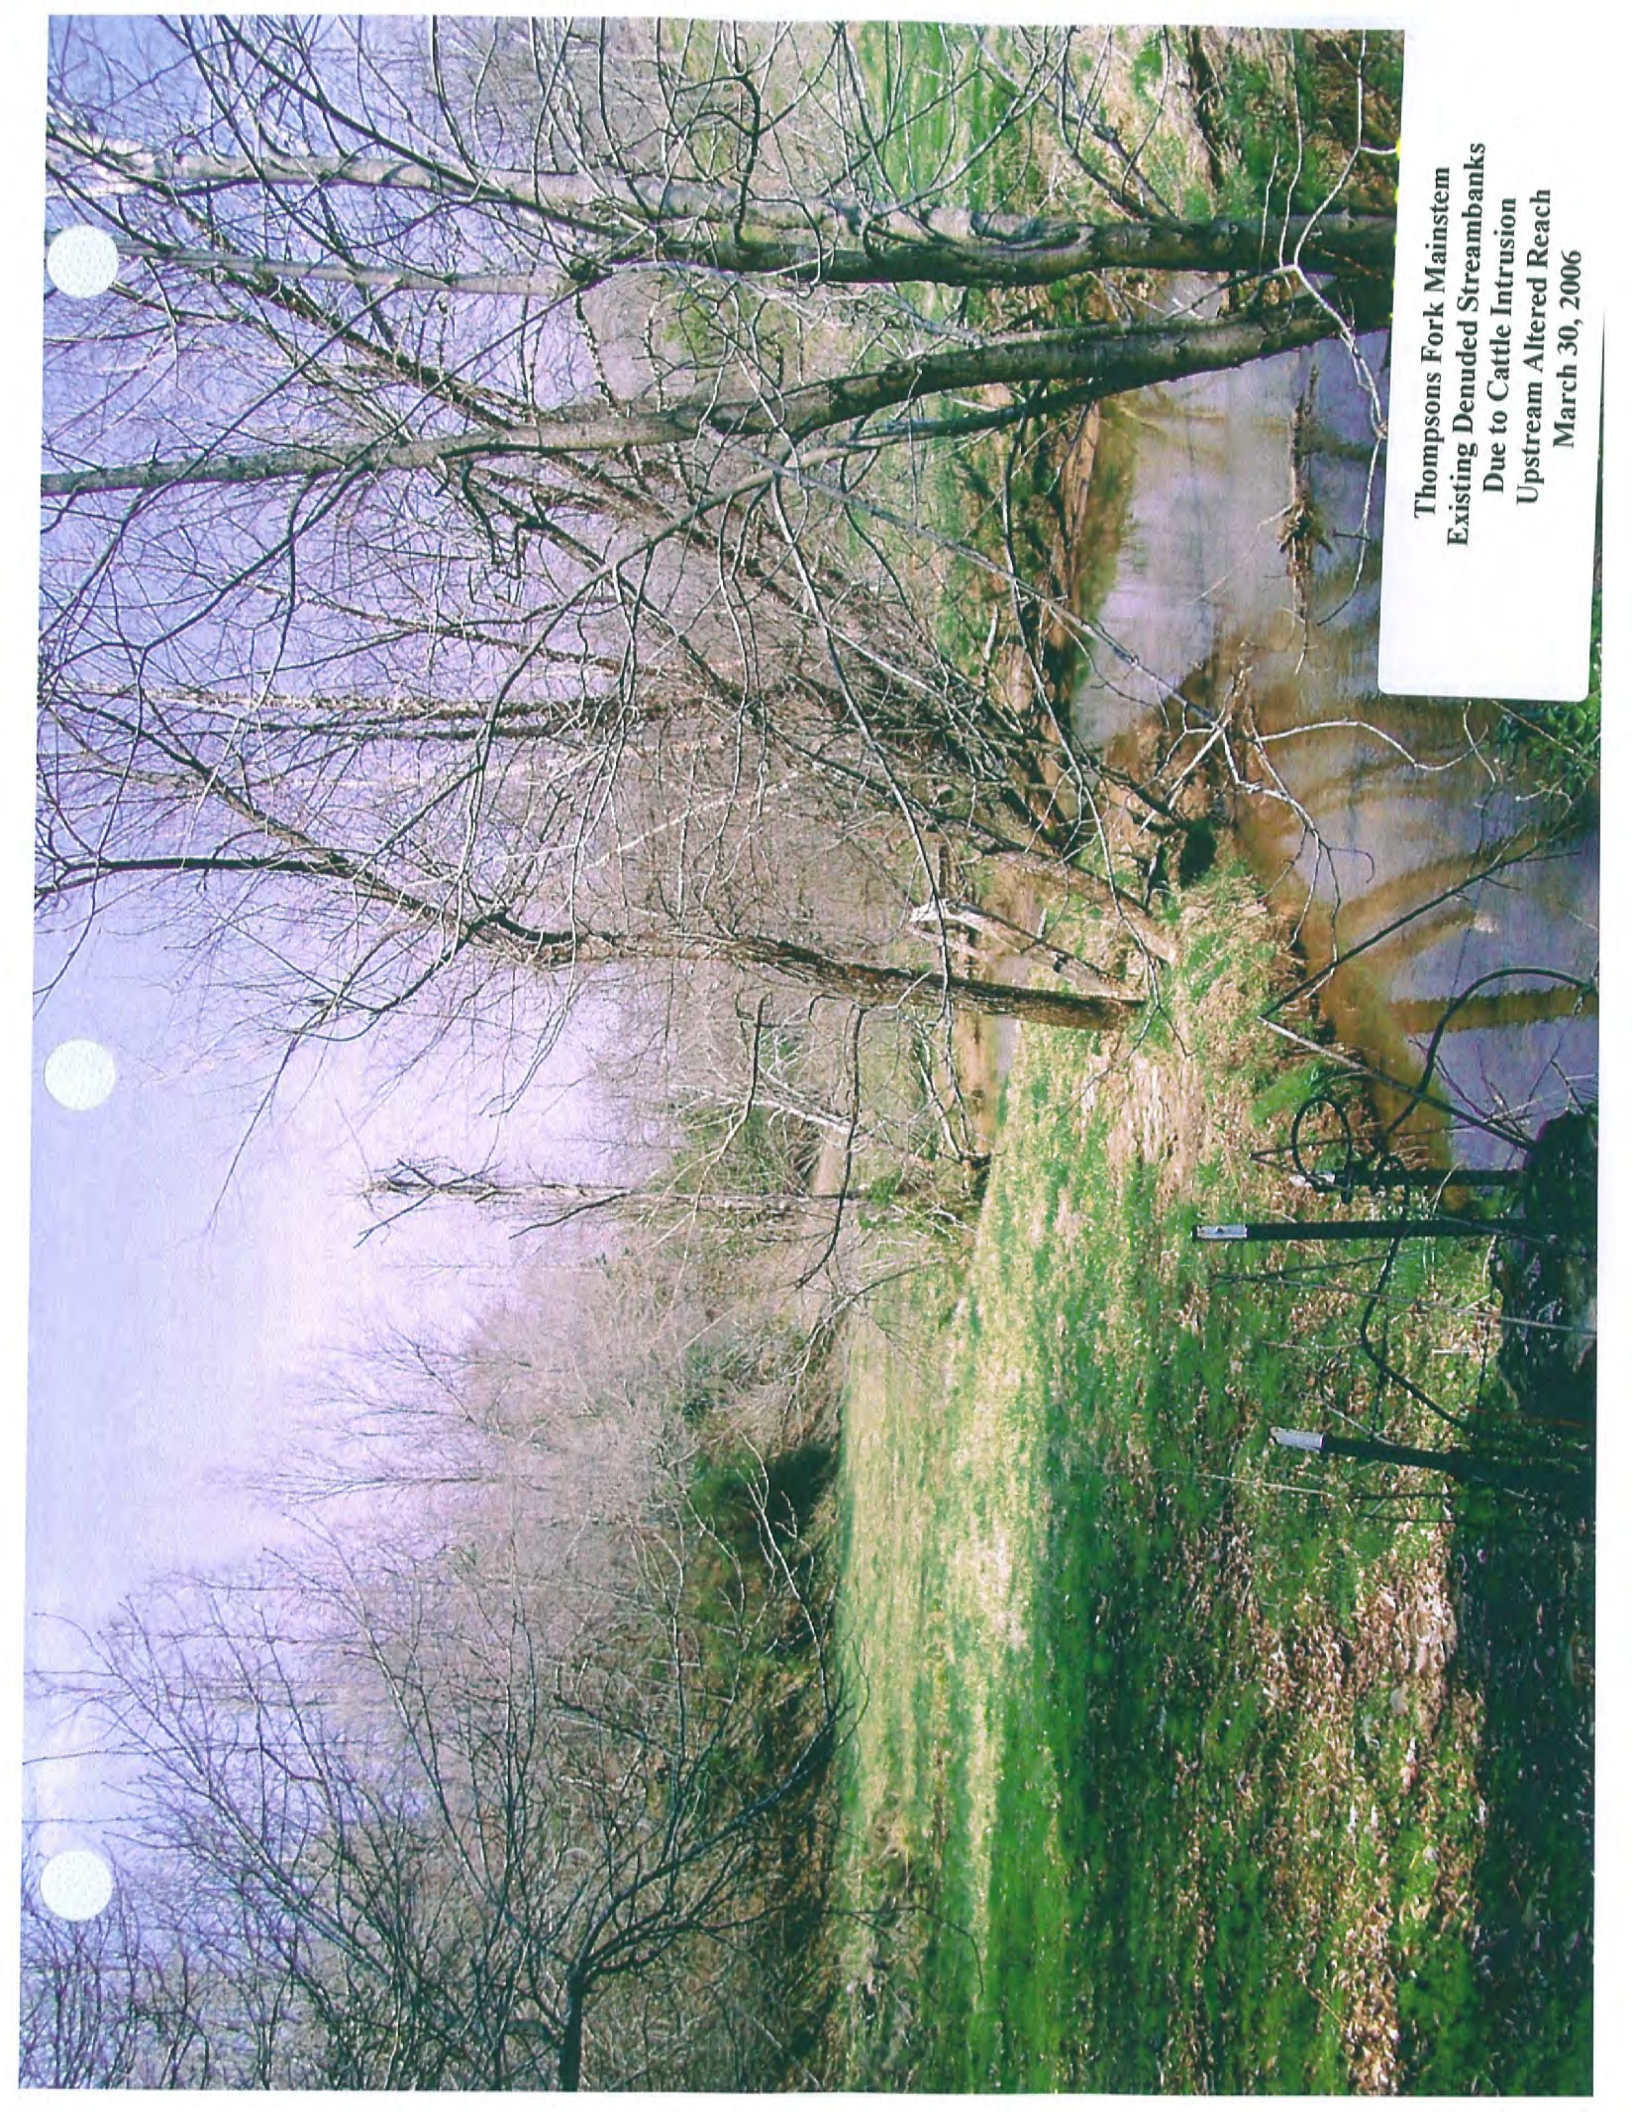
Thompsons Fork Mainstem  
Existing Denuded Streambanks  
Due to Cattle Intrusion  
Upstream Altered Reach  
March 30, 2006

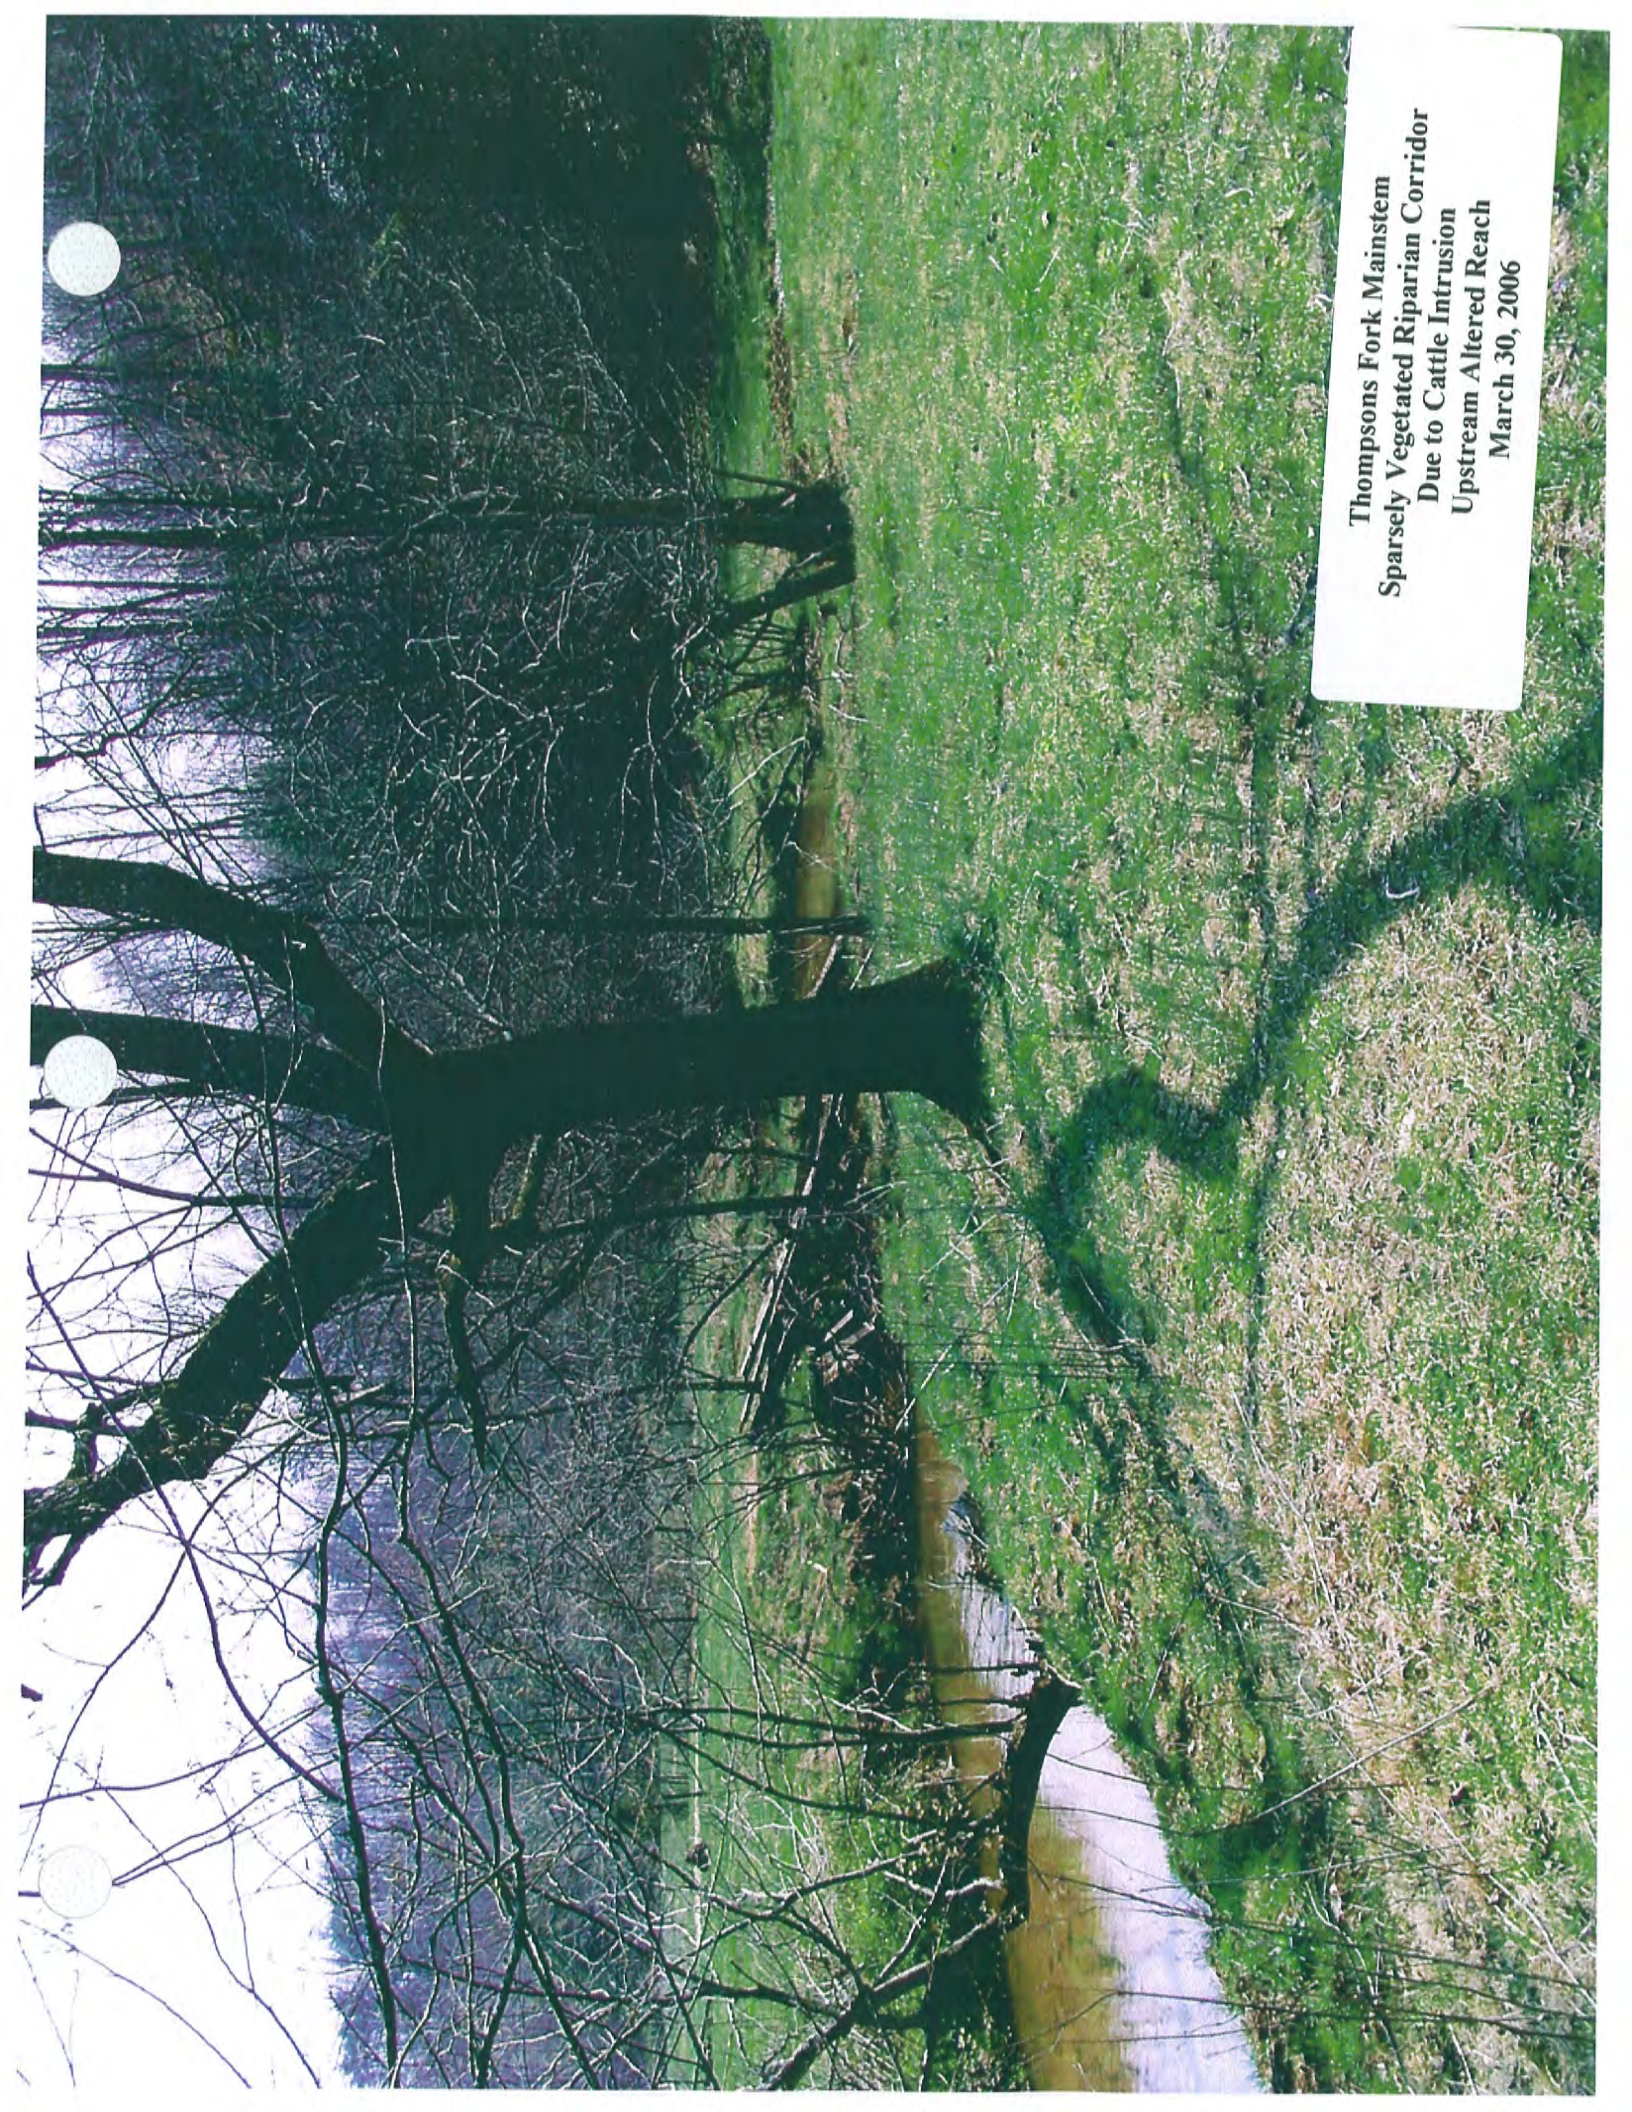
Thompsons Fork Mainstem  
Sparsely Vegetated Riparian Corridor  
Due to Cattle Intrusion  
Upstream Altered Reach  
March 30, 2006

The existing riparian corridor along Thompsons Fork is extremely thin (5 to 10 feet wide) within the project area, widening for only a short distance at the downstream end near the box culvert under Interstate 40. The stream banks are highly degraded and denuded in several areas. Where present, the corridor contains few woody species, including *Alnus rugosa* (tag alder), *Platanus occidentalis* (Eastern sycamore), and *Cornus amomum* (silky dogwood), as well as some *Carex scoparia* (broomsedge). Cattle pasturelands are present immediately adjacent to the corridor. Photographs of the Thompsons Fork corridor are included within **Appendix 4**.

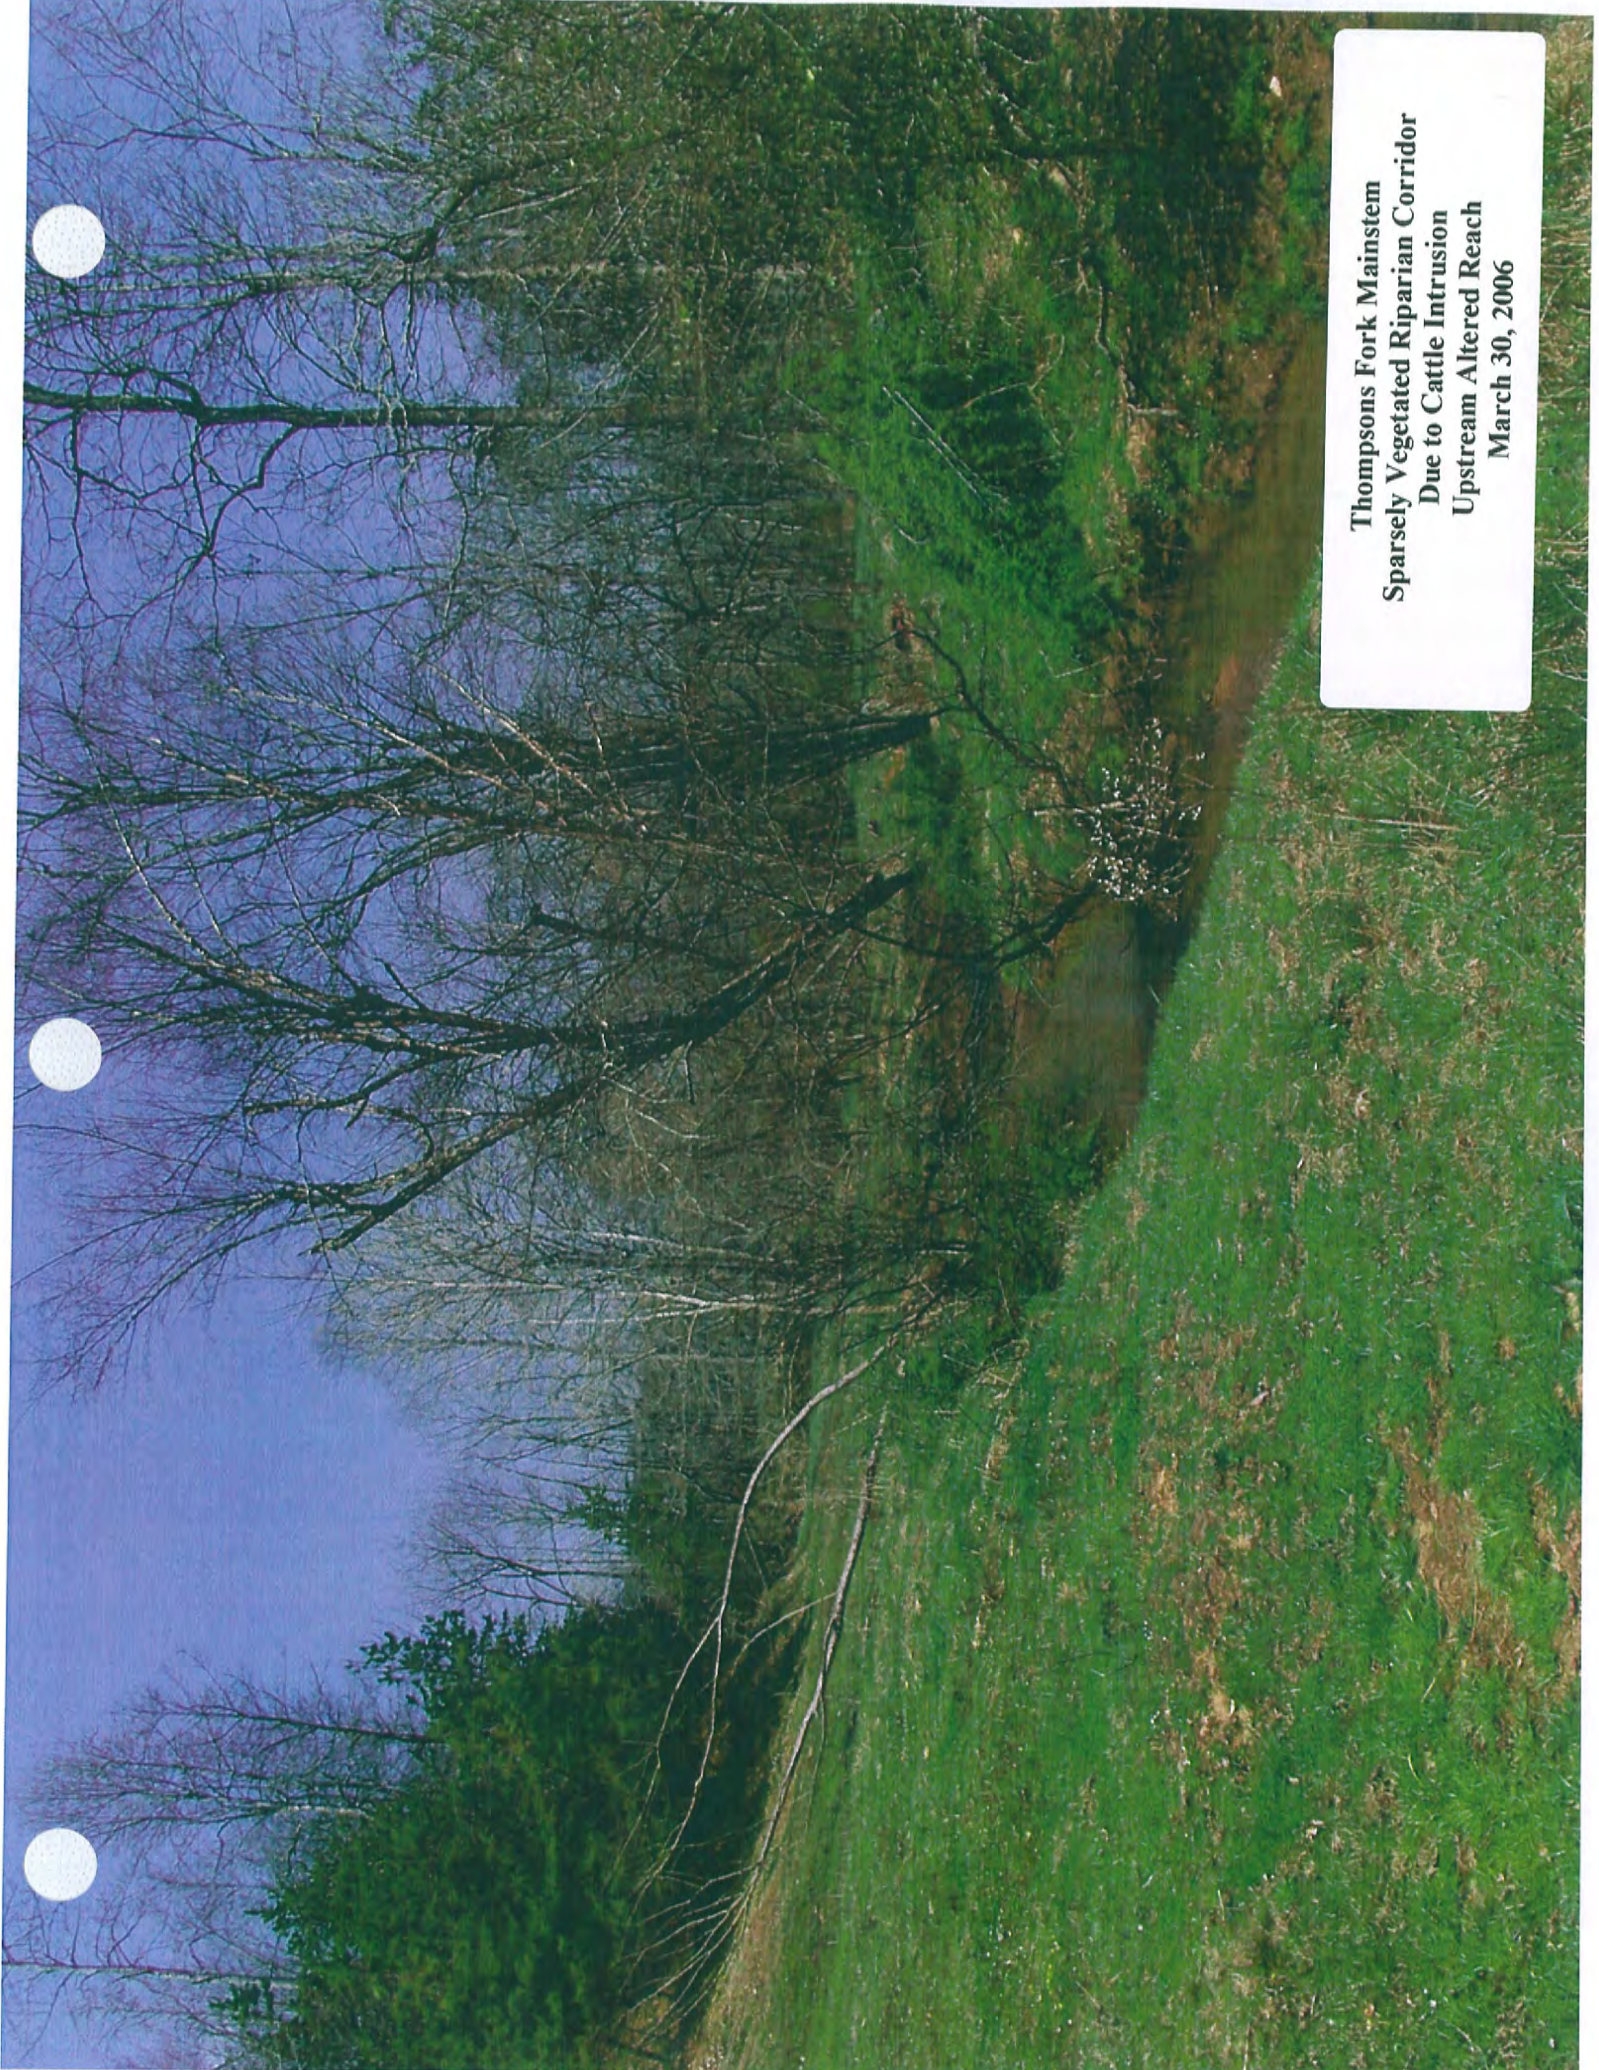
Thompsons Fork Mainstem  
Sparsely Vegetated Riparian Corridor  
Due to Cattle Intrusion  
Upstream Altered Reach  
March 30, 2006

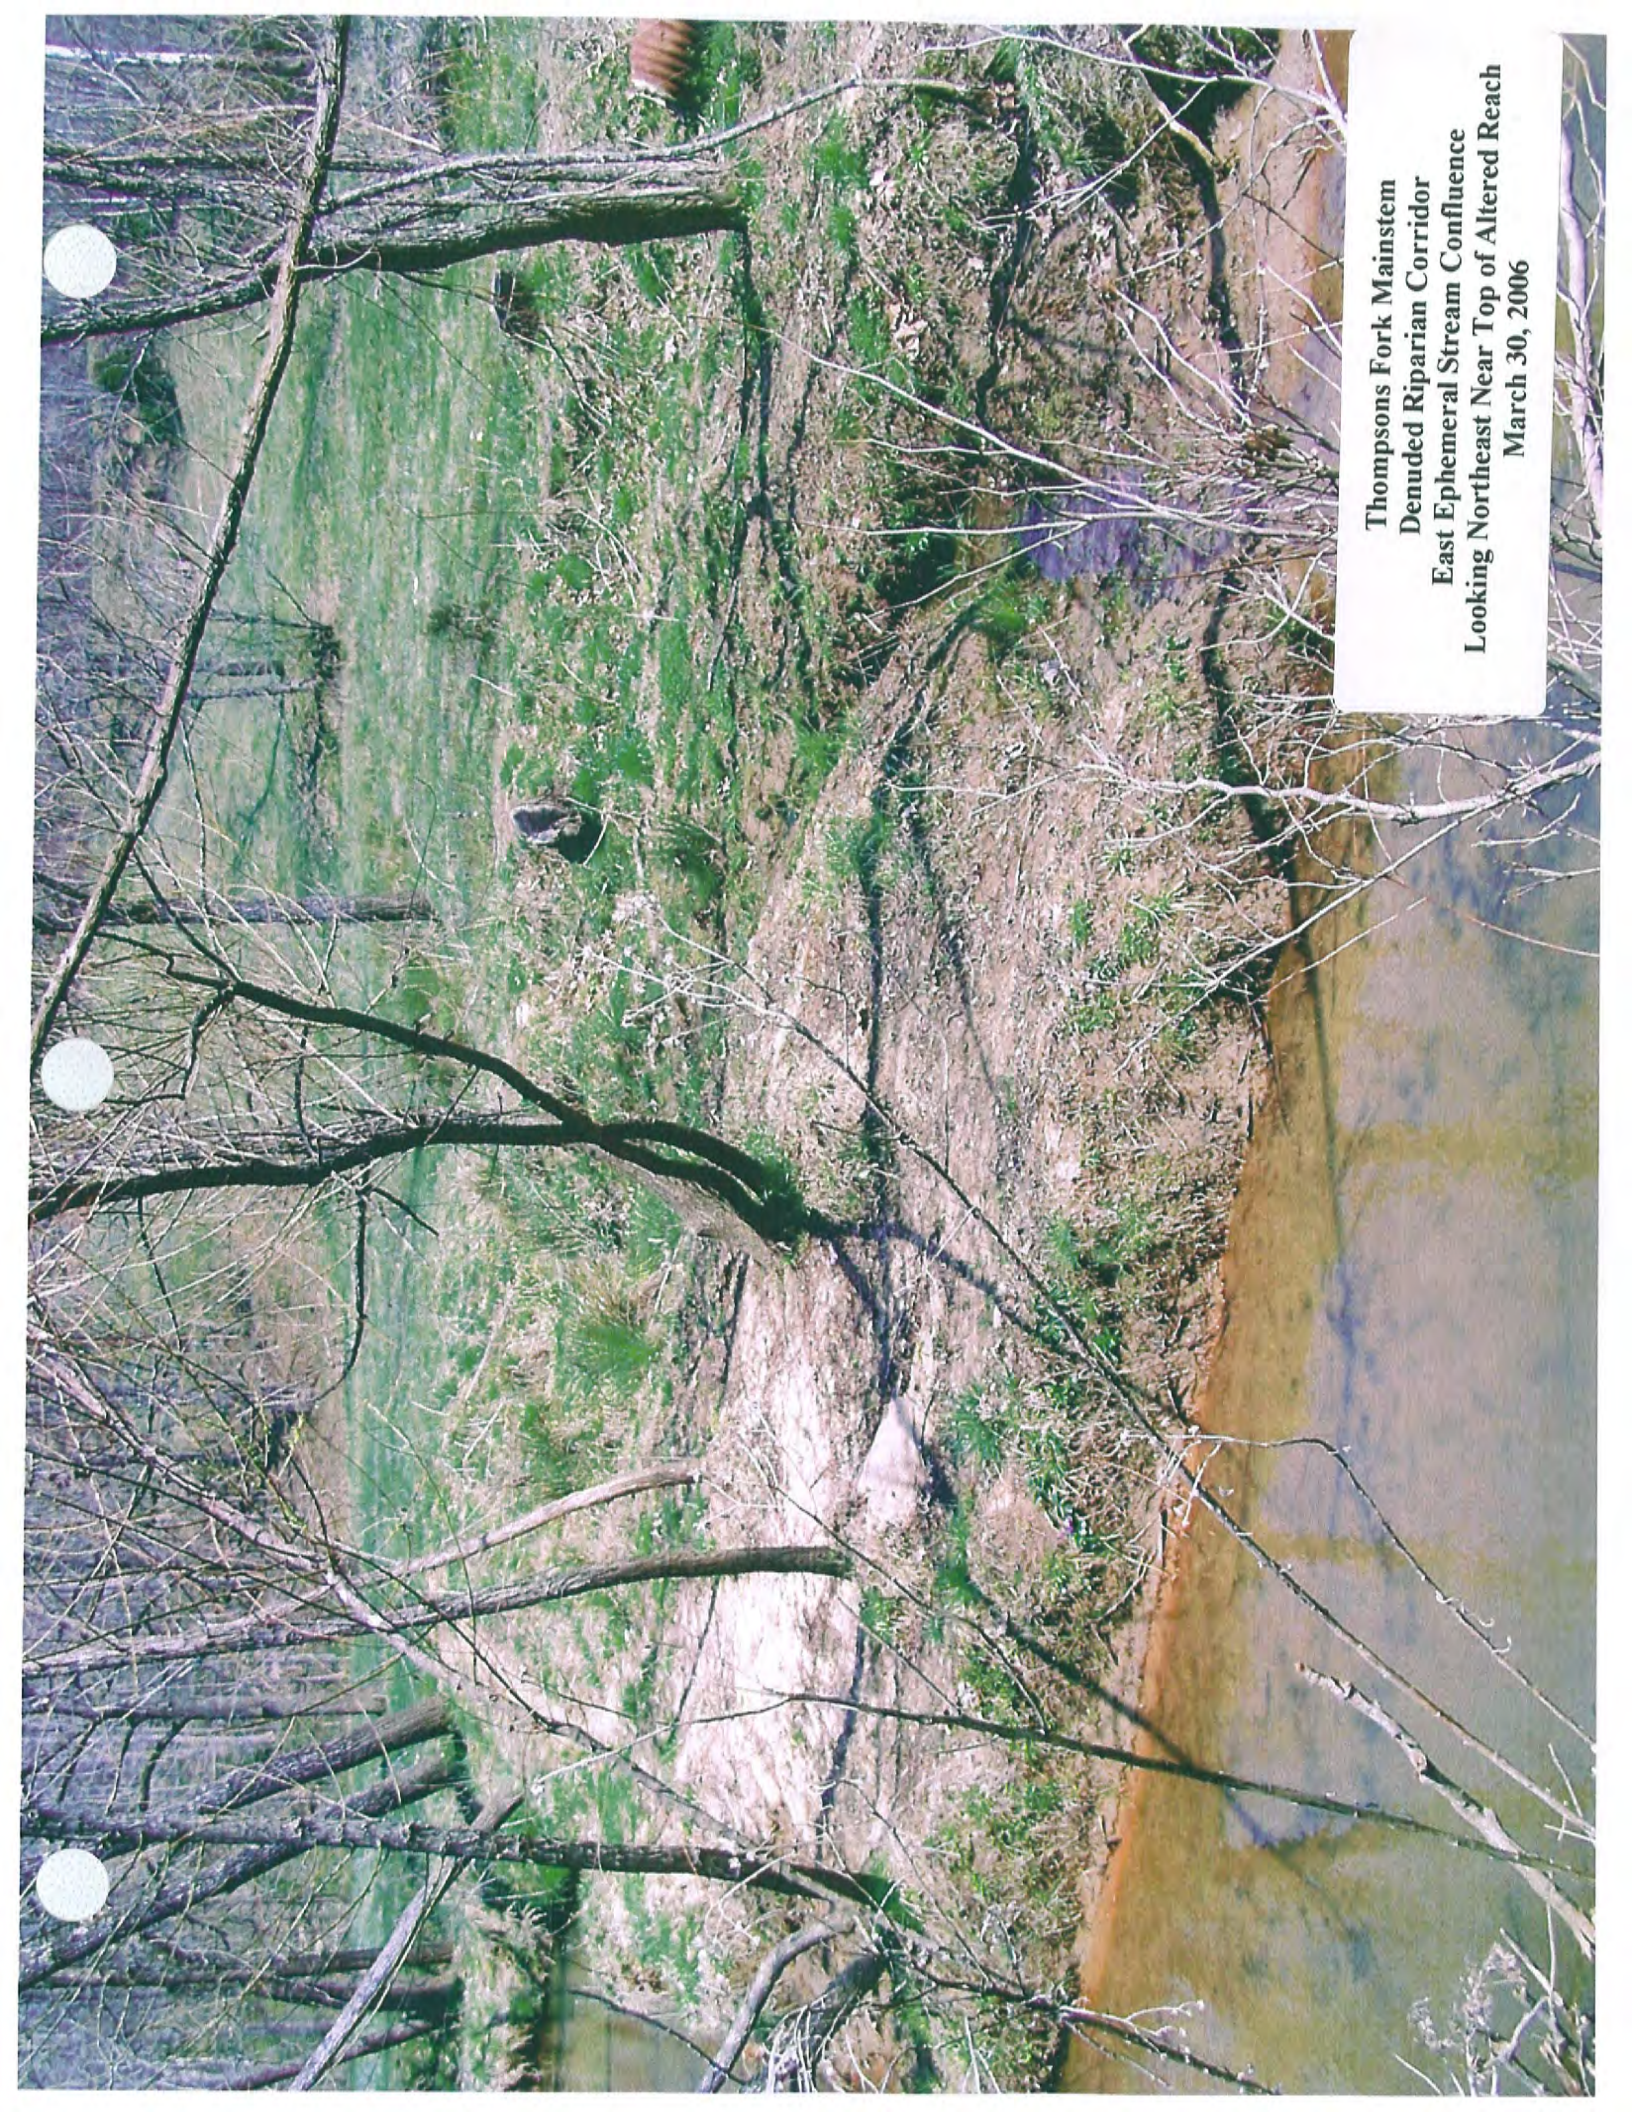
Thompsons Fork Mainstem  
Denuded Riparian Corridor  
East Ephemeral Stream Confluence  
Looking Northeast Near Top of Altered Reach  
March 30, 2006

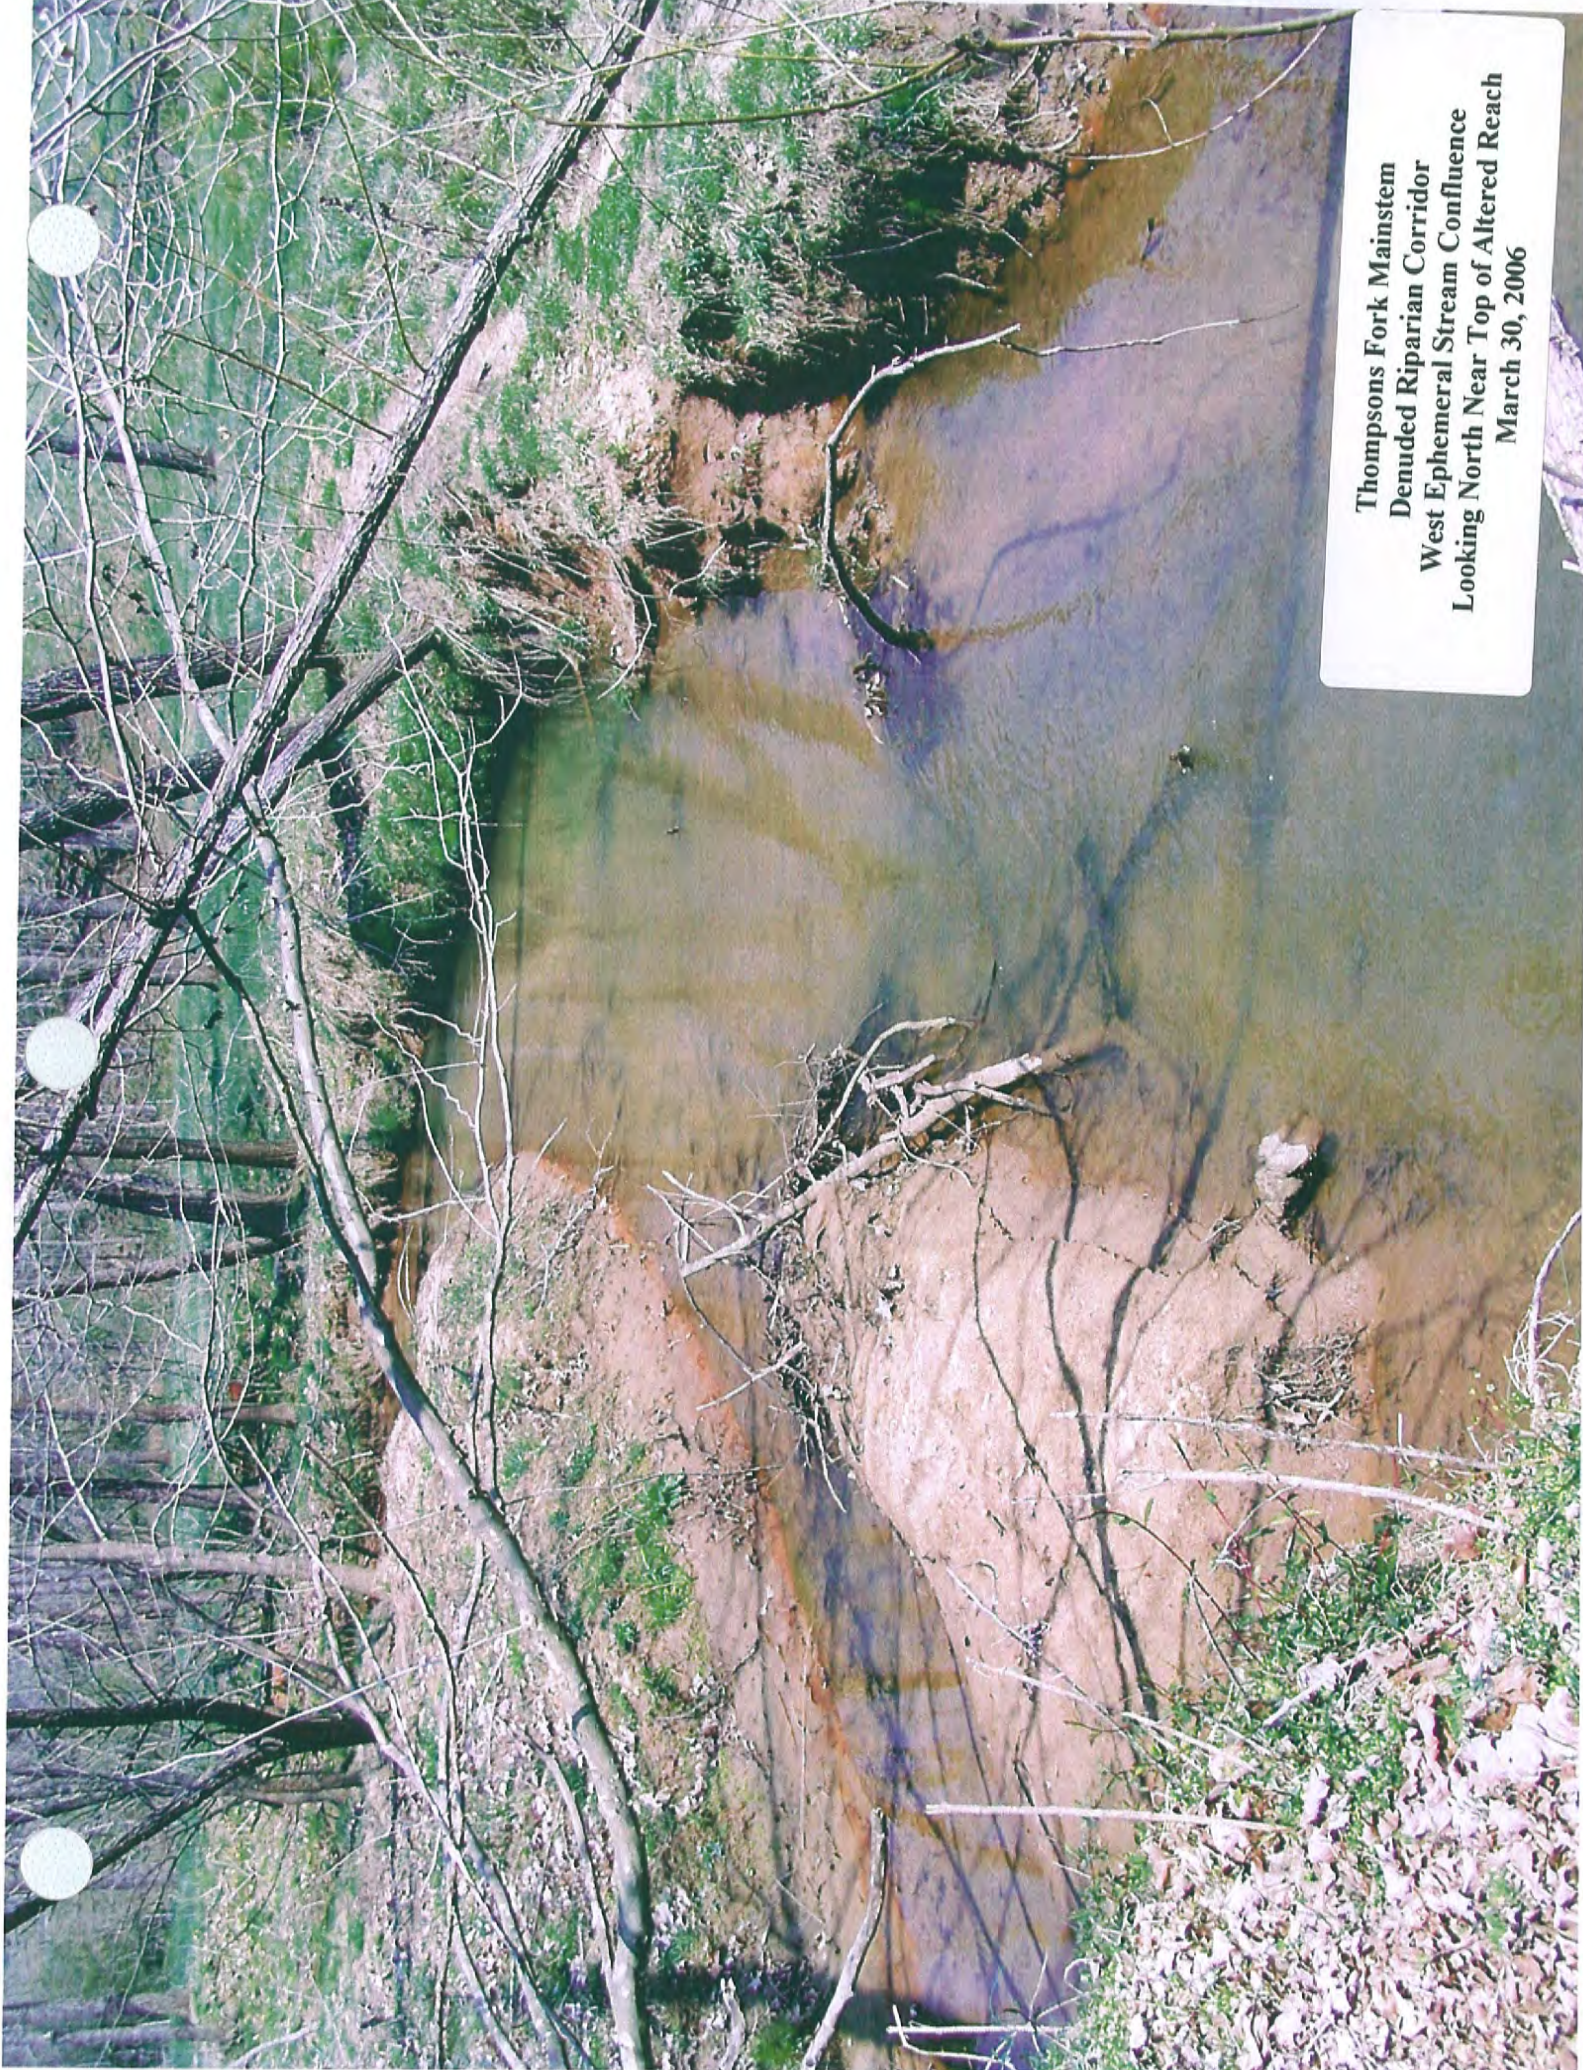
Thompsons Fork Mainstem  
Denuded Riparian Corridor  
West Ephemeral Stream Confluence  
Looking North Near Top of Altered Reach  
March 30, 2006
