**Wetlands Resource Center**  
3970 Bowen Road  
Canal Winchester, Ohio 43110  
Project Manager: Cal Miller  
P: (614) 864-7511  
F: (614) 866-3691

**EMH&T, Inc.**  
5500 New Albany Road  
Columbus, Ohio 43054  
Project Manager: Miles F. Hebert, PE  
P: (614) 775-4205  
F: (614) 775-4802  
Main: (614) 775-4500

## THOMPSONS FORK RESTORATION

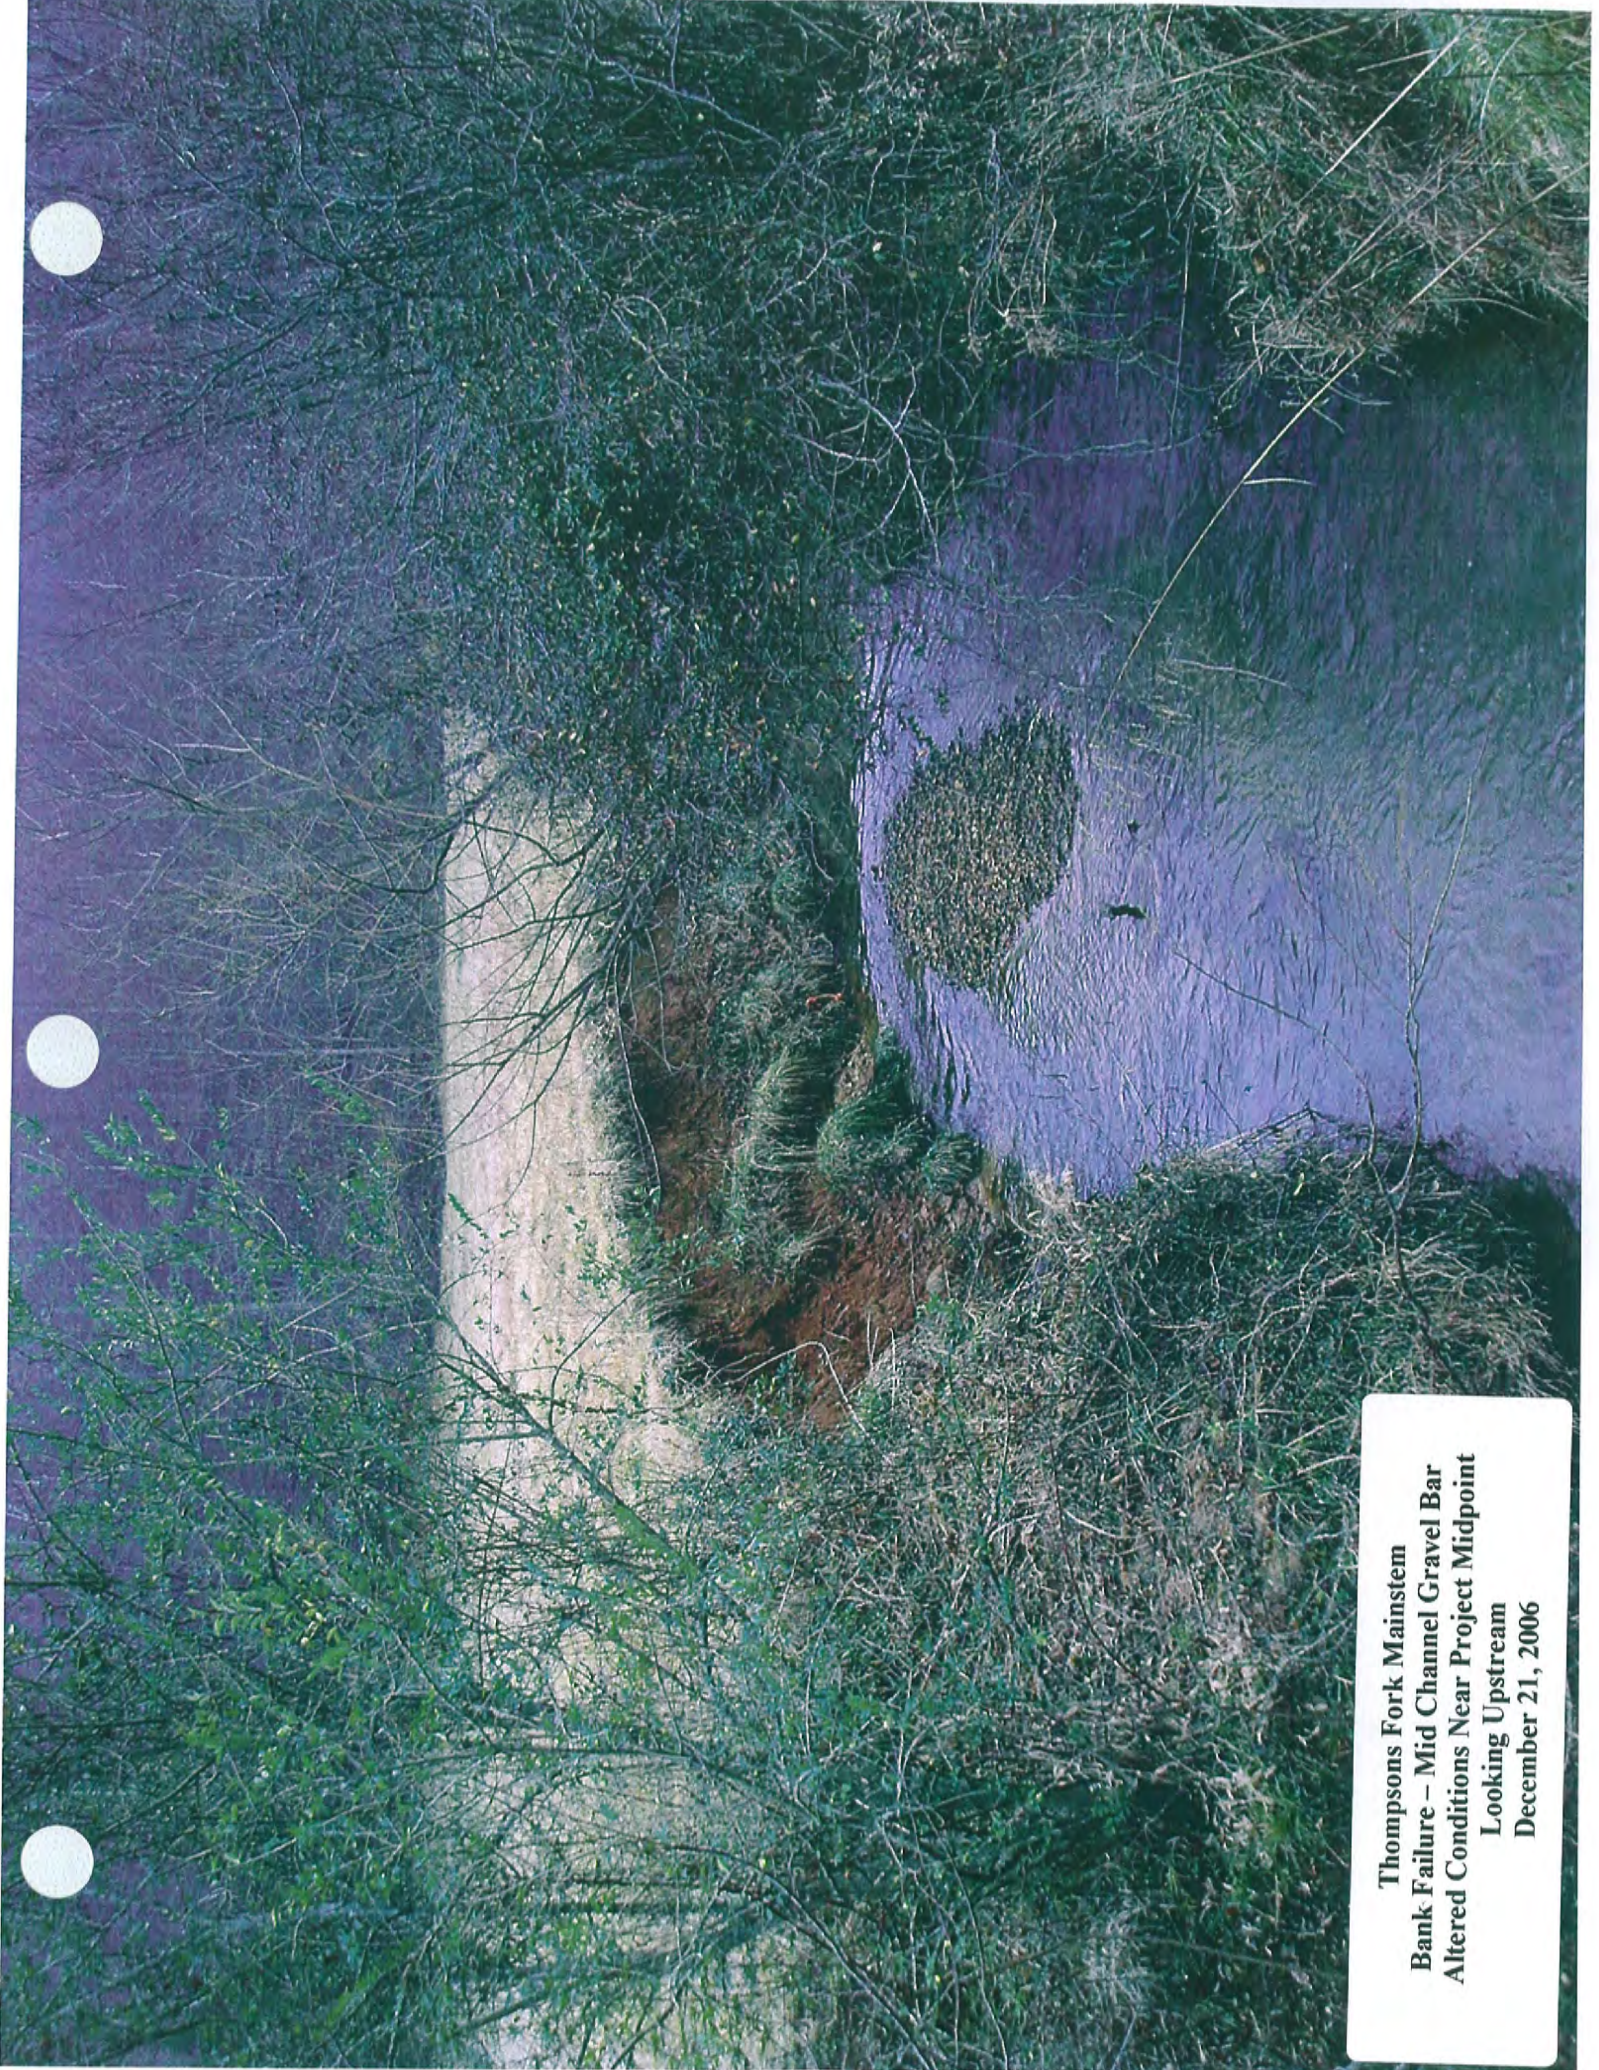
Thompsons Fork Mainstem  
Bank Failure – Mid Channel Gravel Bar  
Altered Conditions Near Project Midpoint  
Looking Upstream  
December 21, 2006

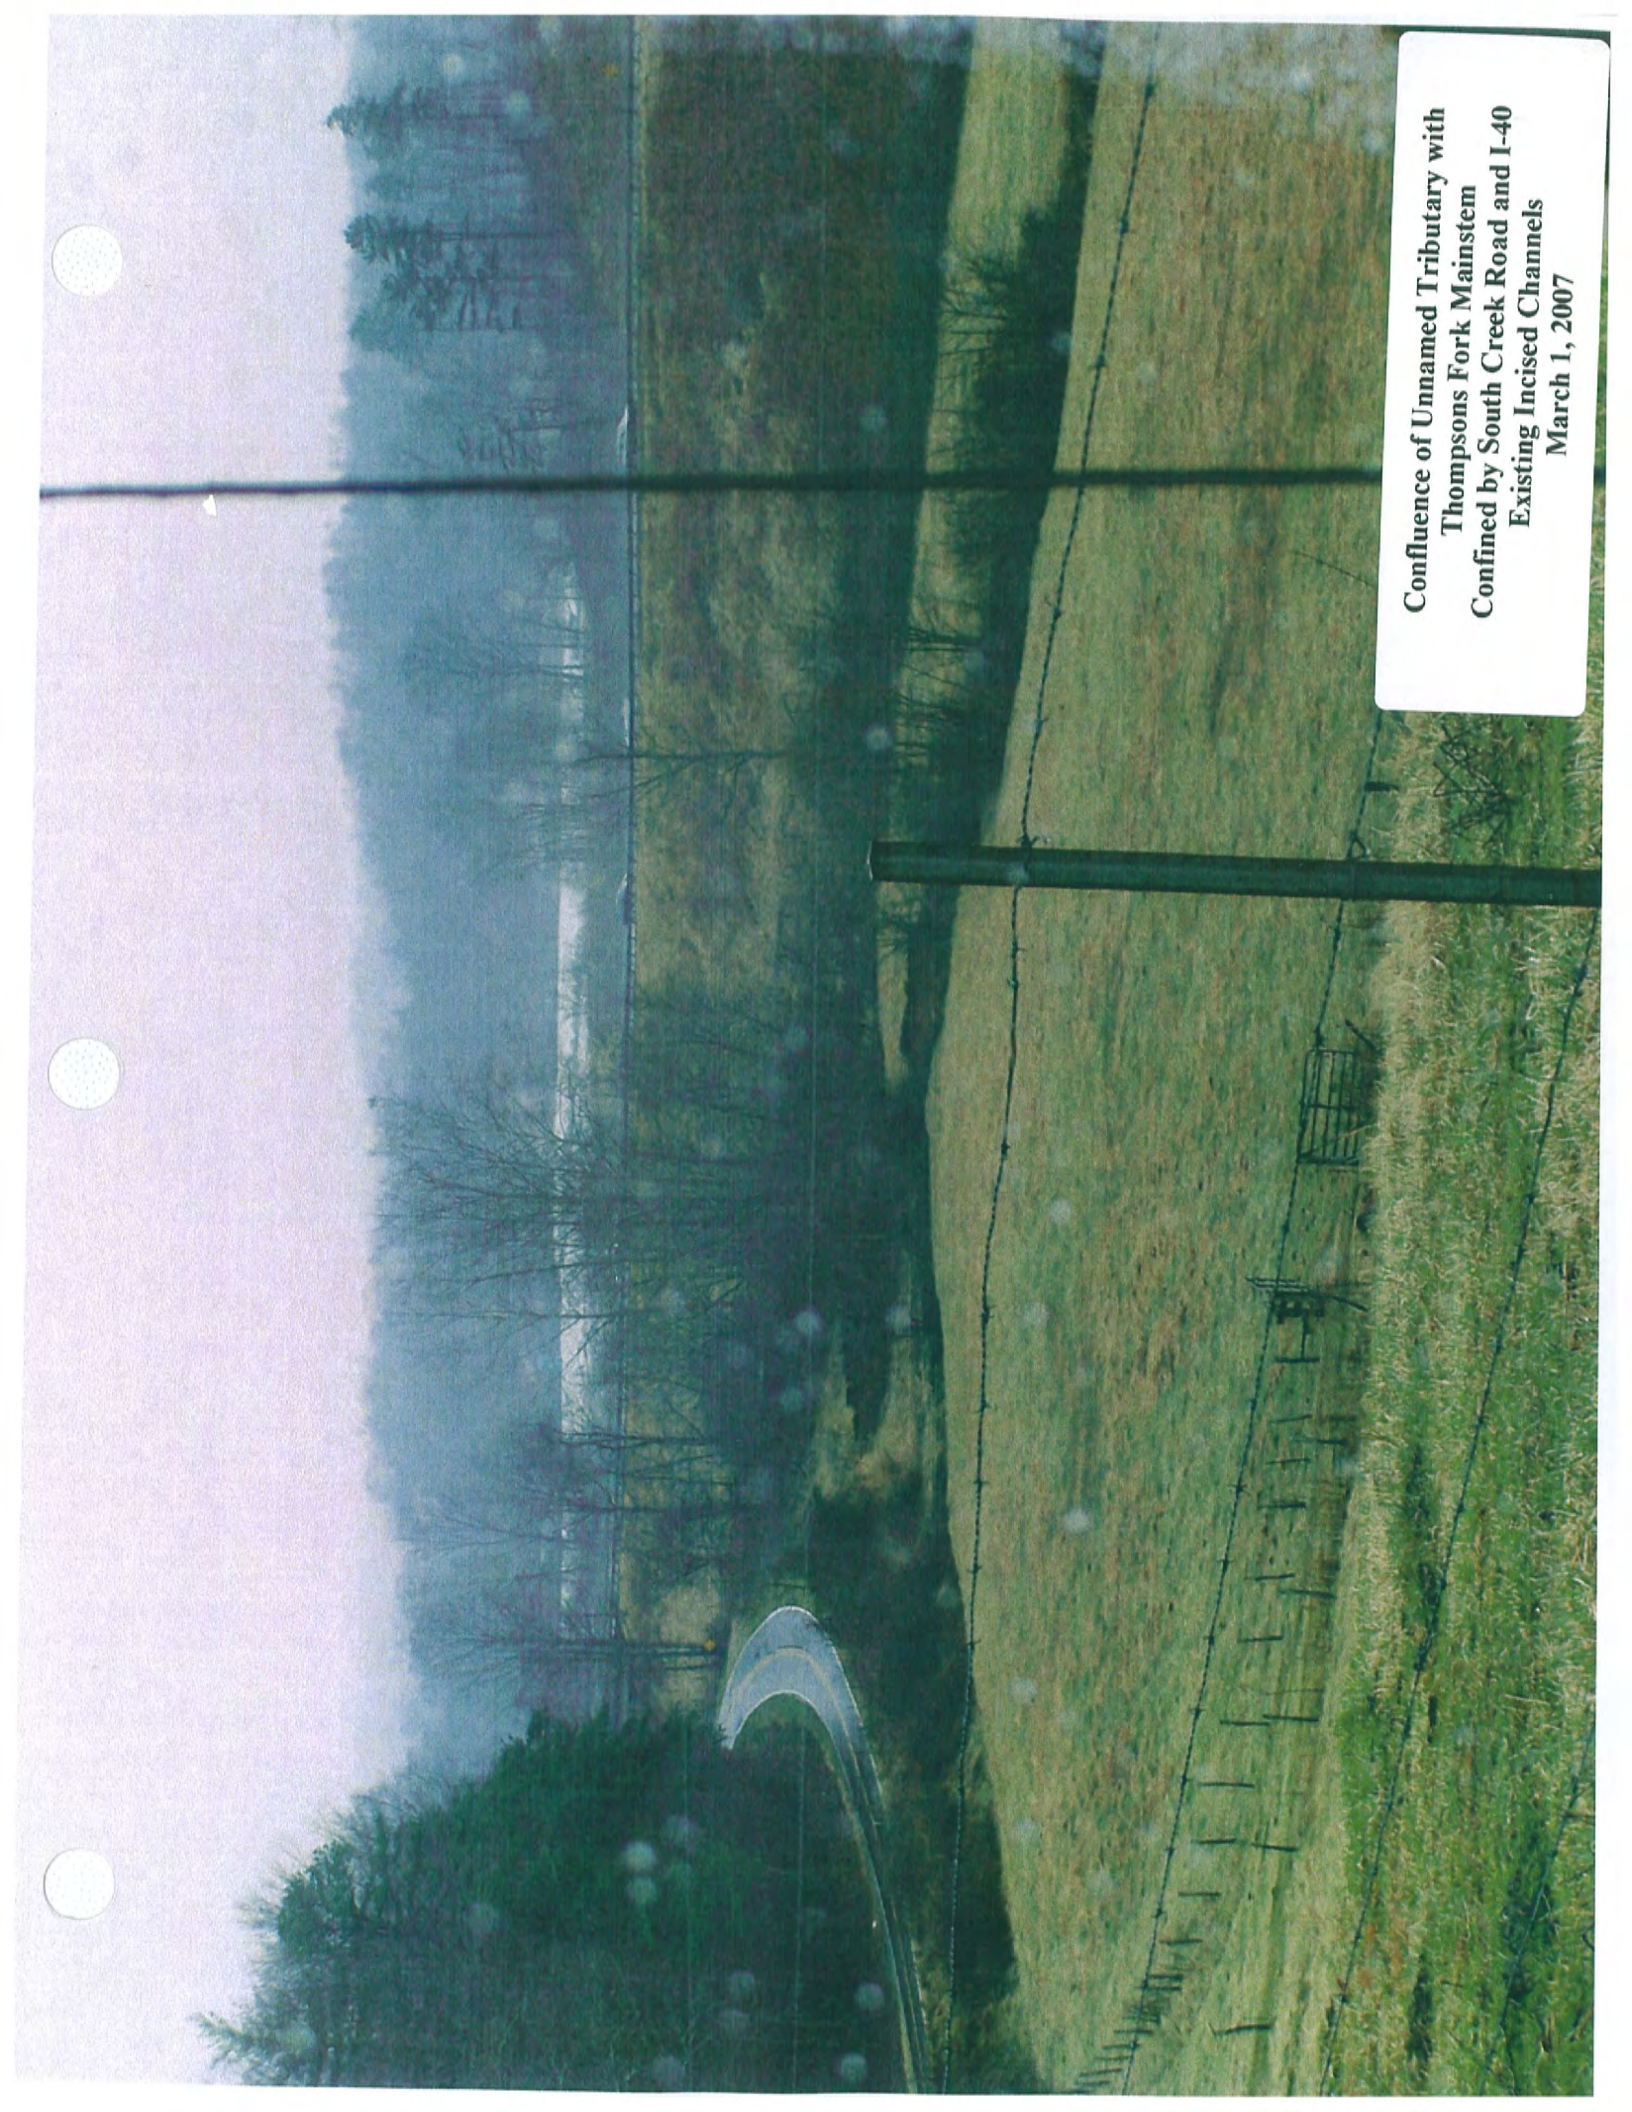
Confluence of Unnamed Tributary with  
Thompsons Fork Mainstem  
Confined by South Creek Road and I-40  
Existing Incised Channels  
March 1, 2007

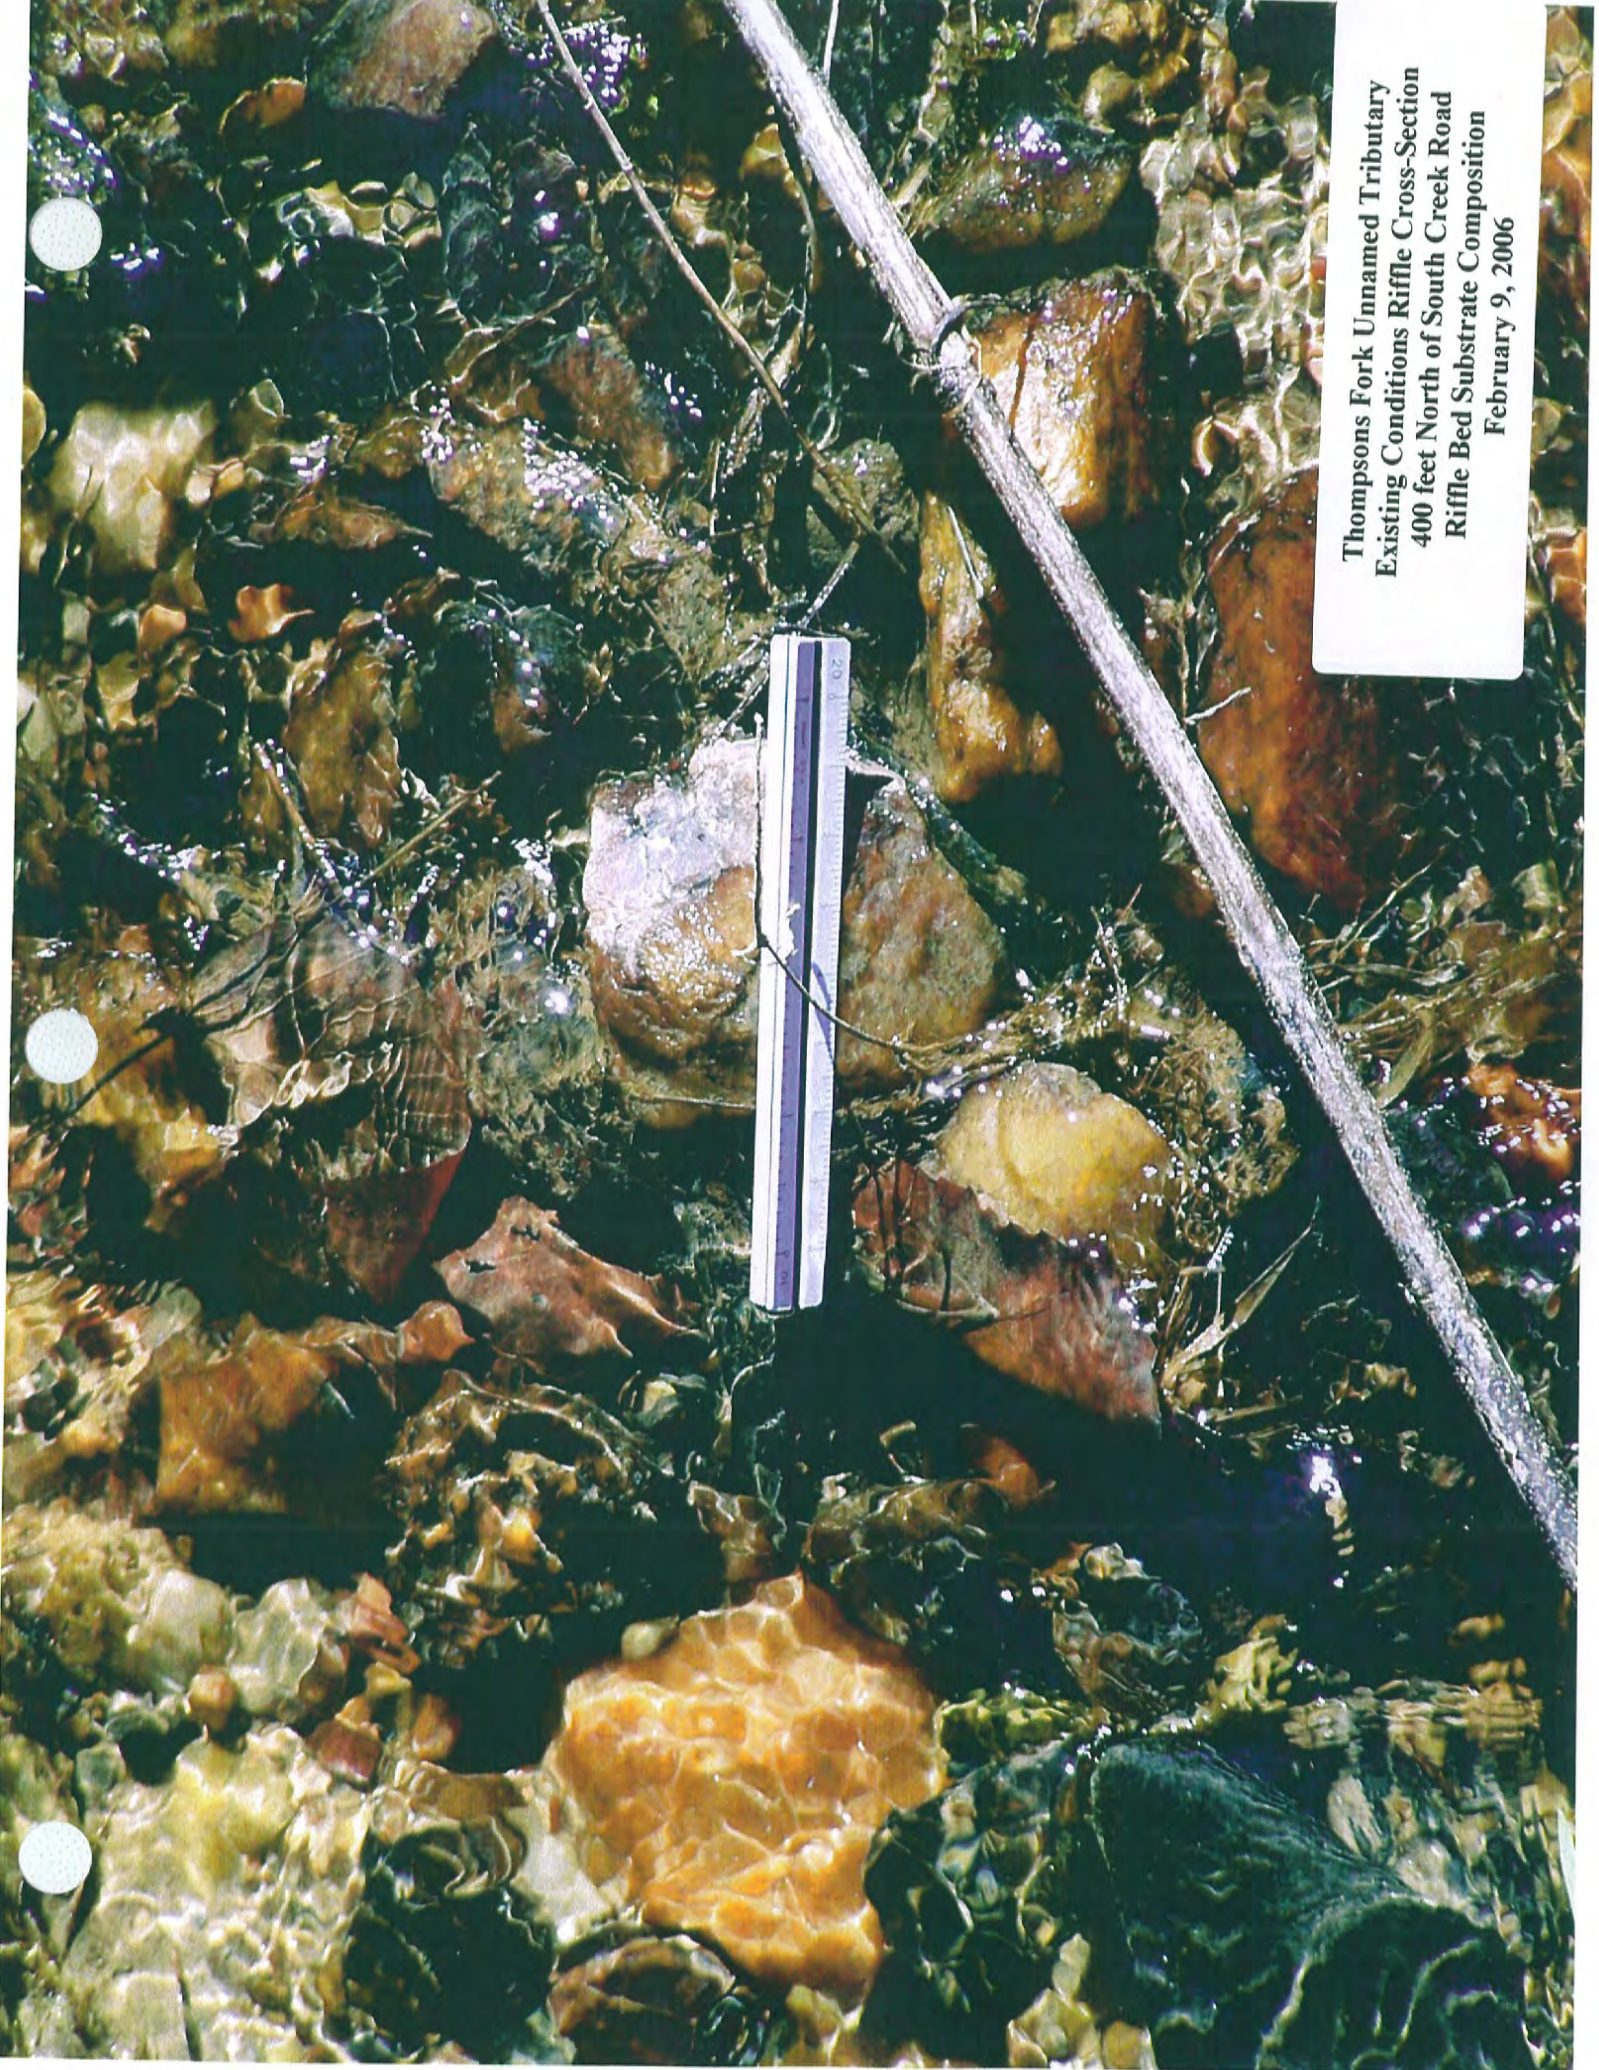
Thompsons Fork Unnamed Tributary  
Existing Conditions Riffle Cross-Section  
400 feet North of South Creek Road  
Riffle Bed Substrate Composition  
February 9, 2006

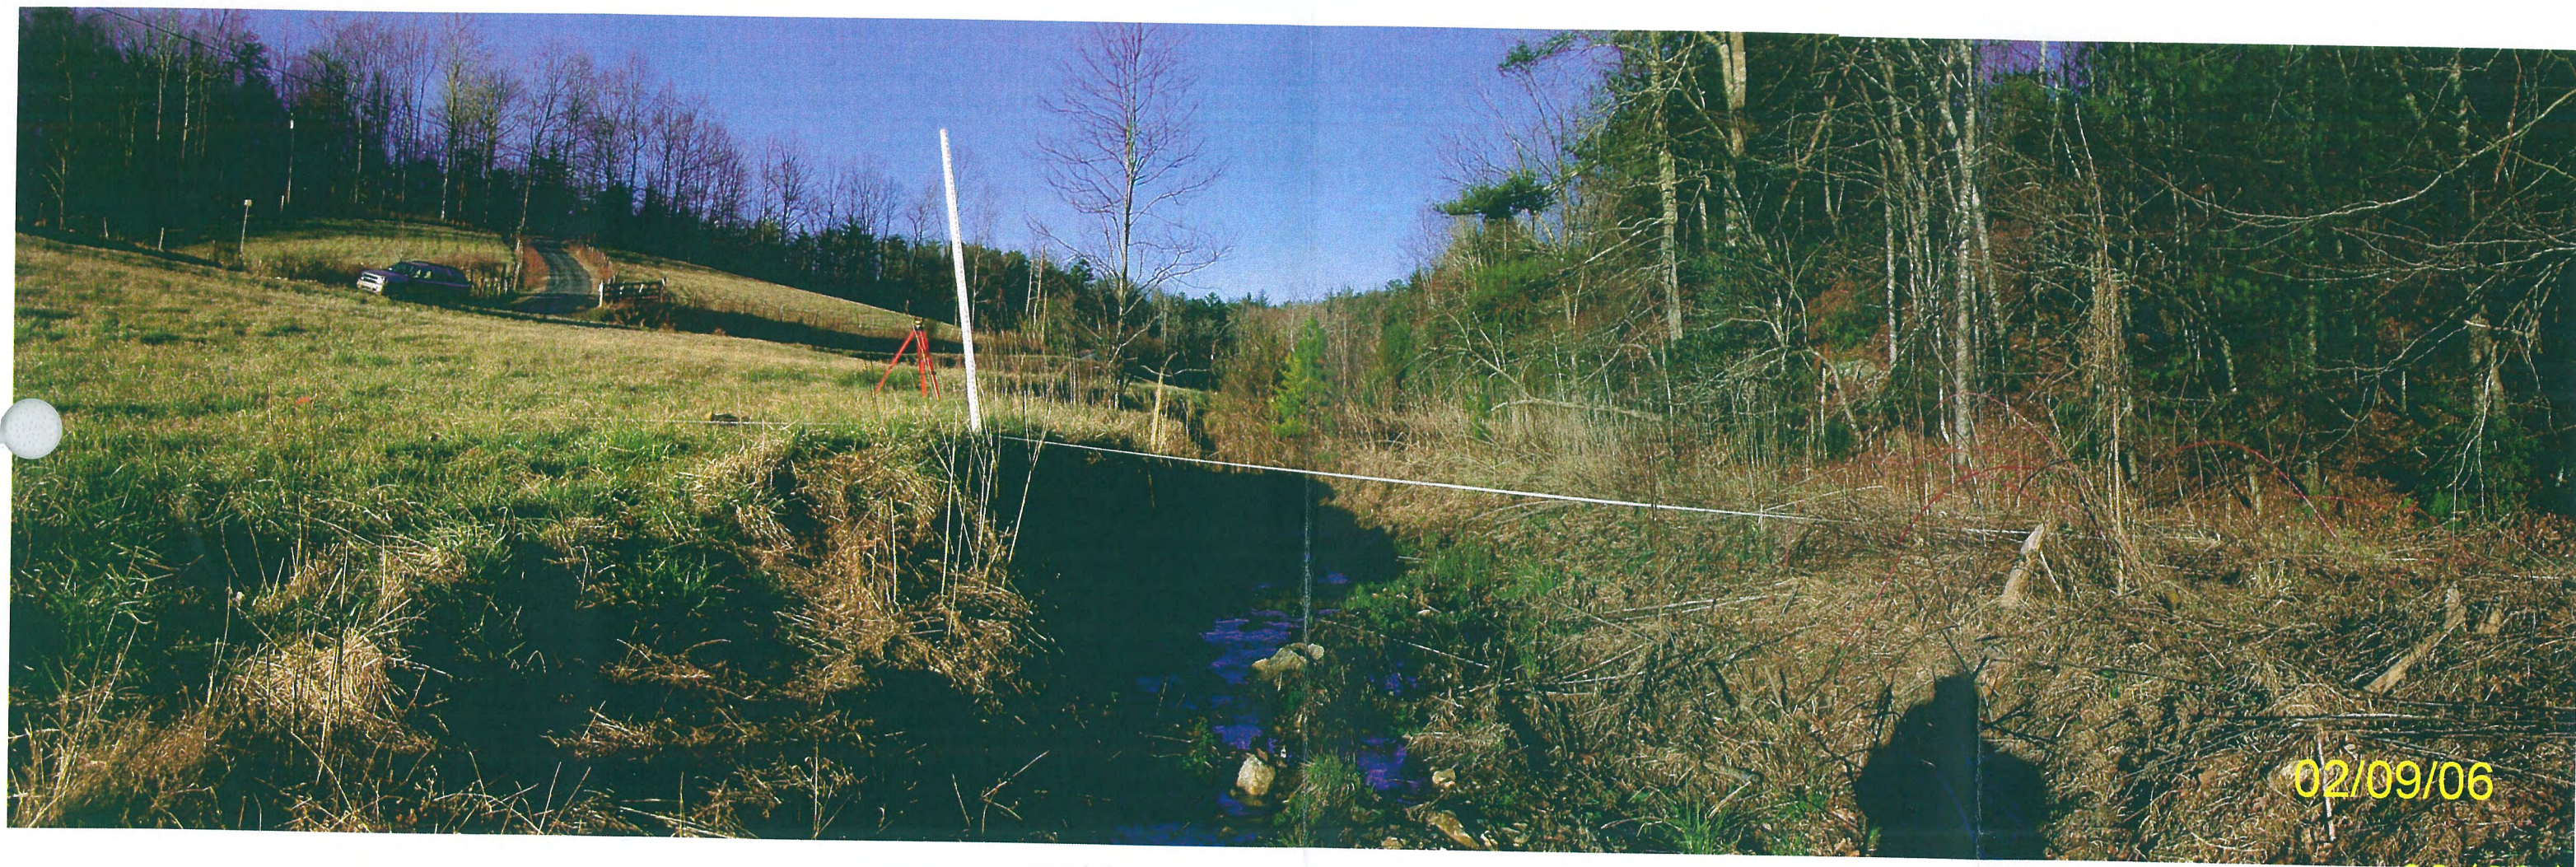
Thompsons Fork Unnamed Tributary  
Existing Conditions Riffle Cross-Section  
400 feet North of South Creek Road  
Looking Upstream  
February 9, 2006

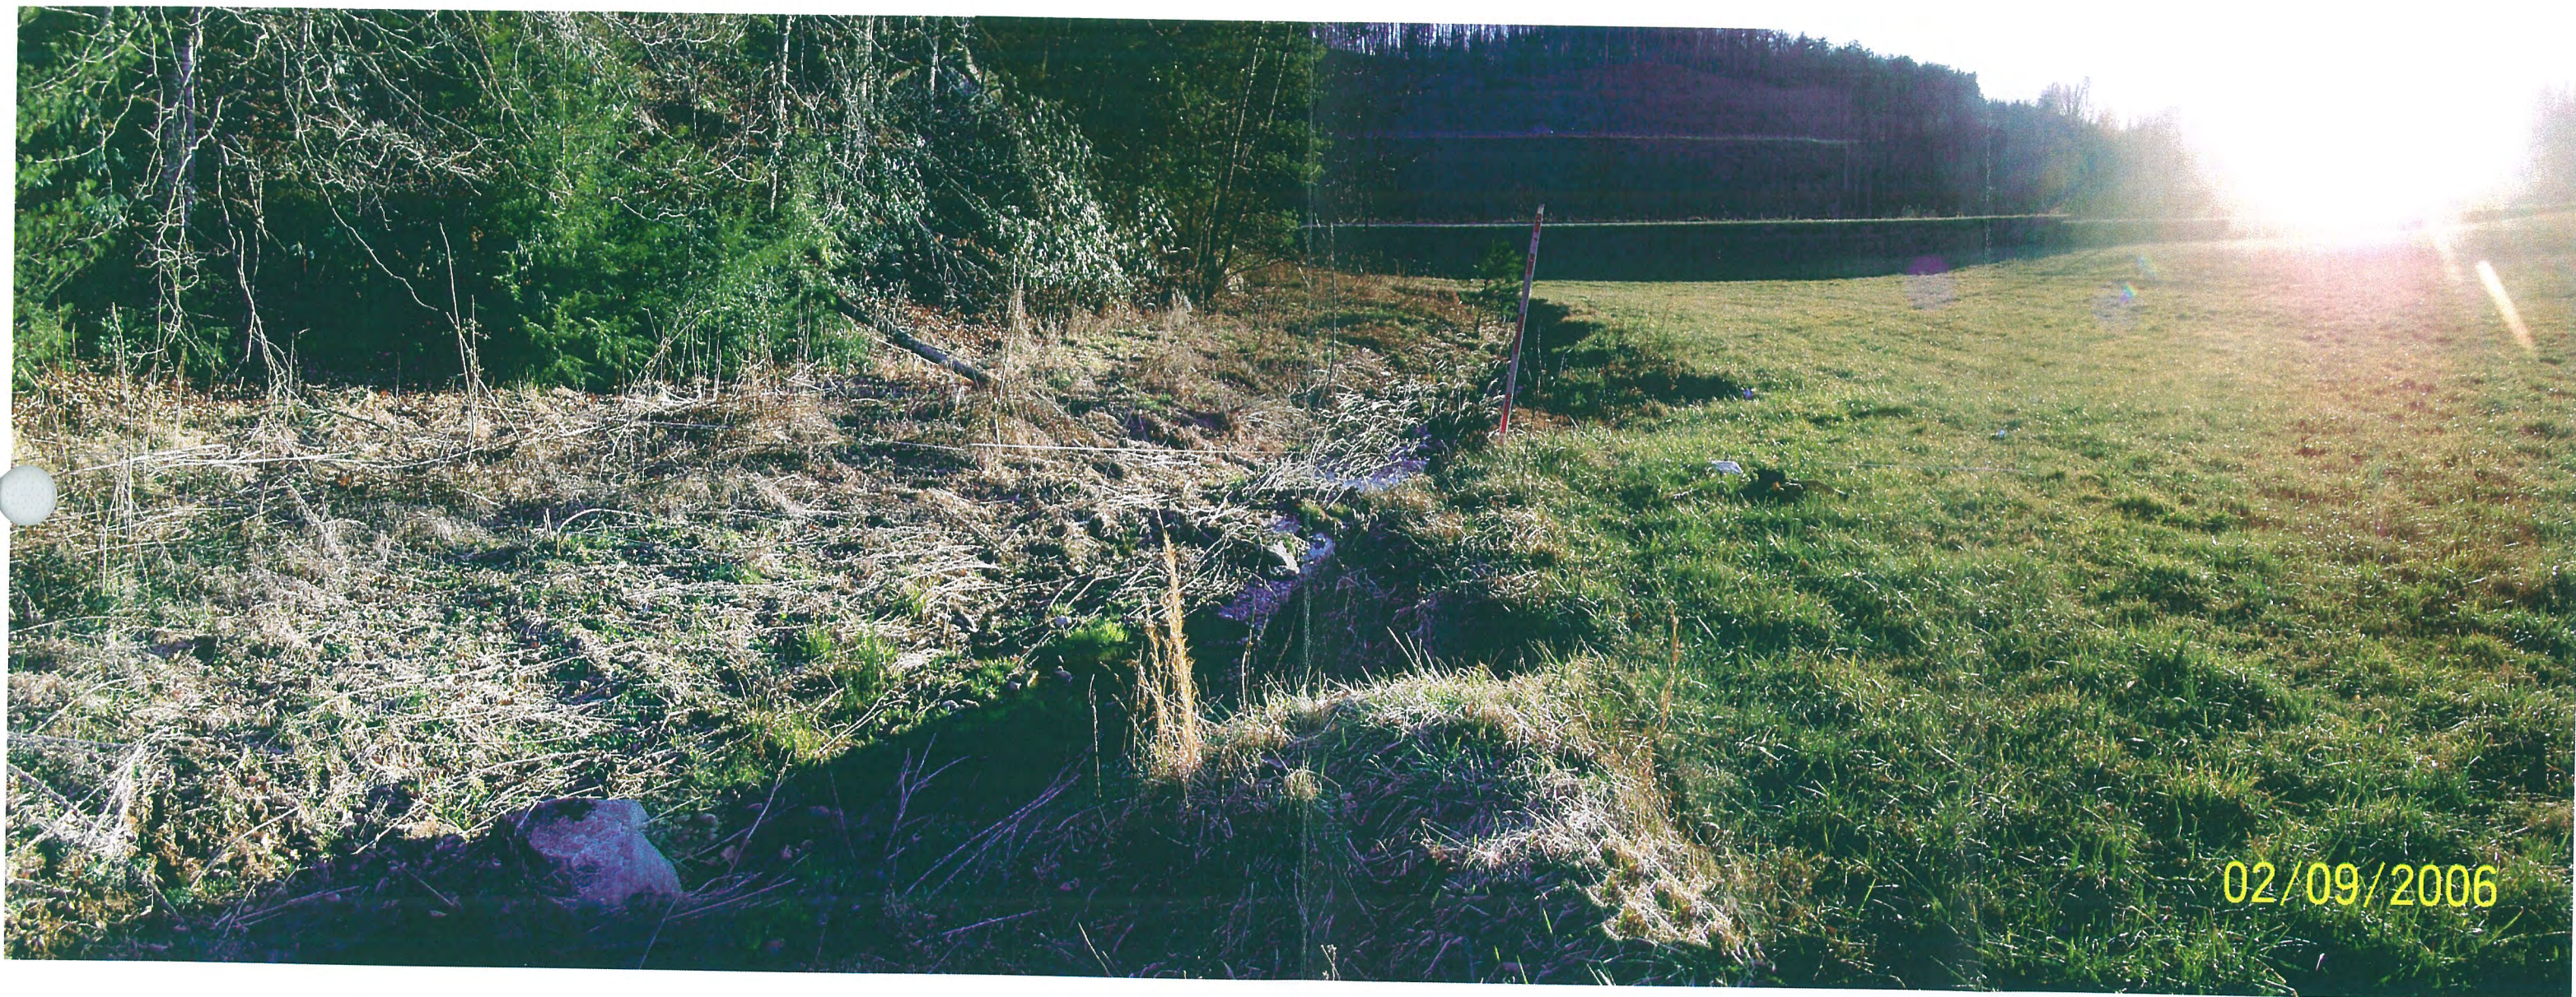
**Thompsons Fork Unnamed Tributary  
Existing Conditions Riffle Cross-Section  
400 feet North of South Creek Road  
Looking Down Stream  
February 9, 2006**

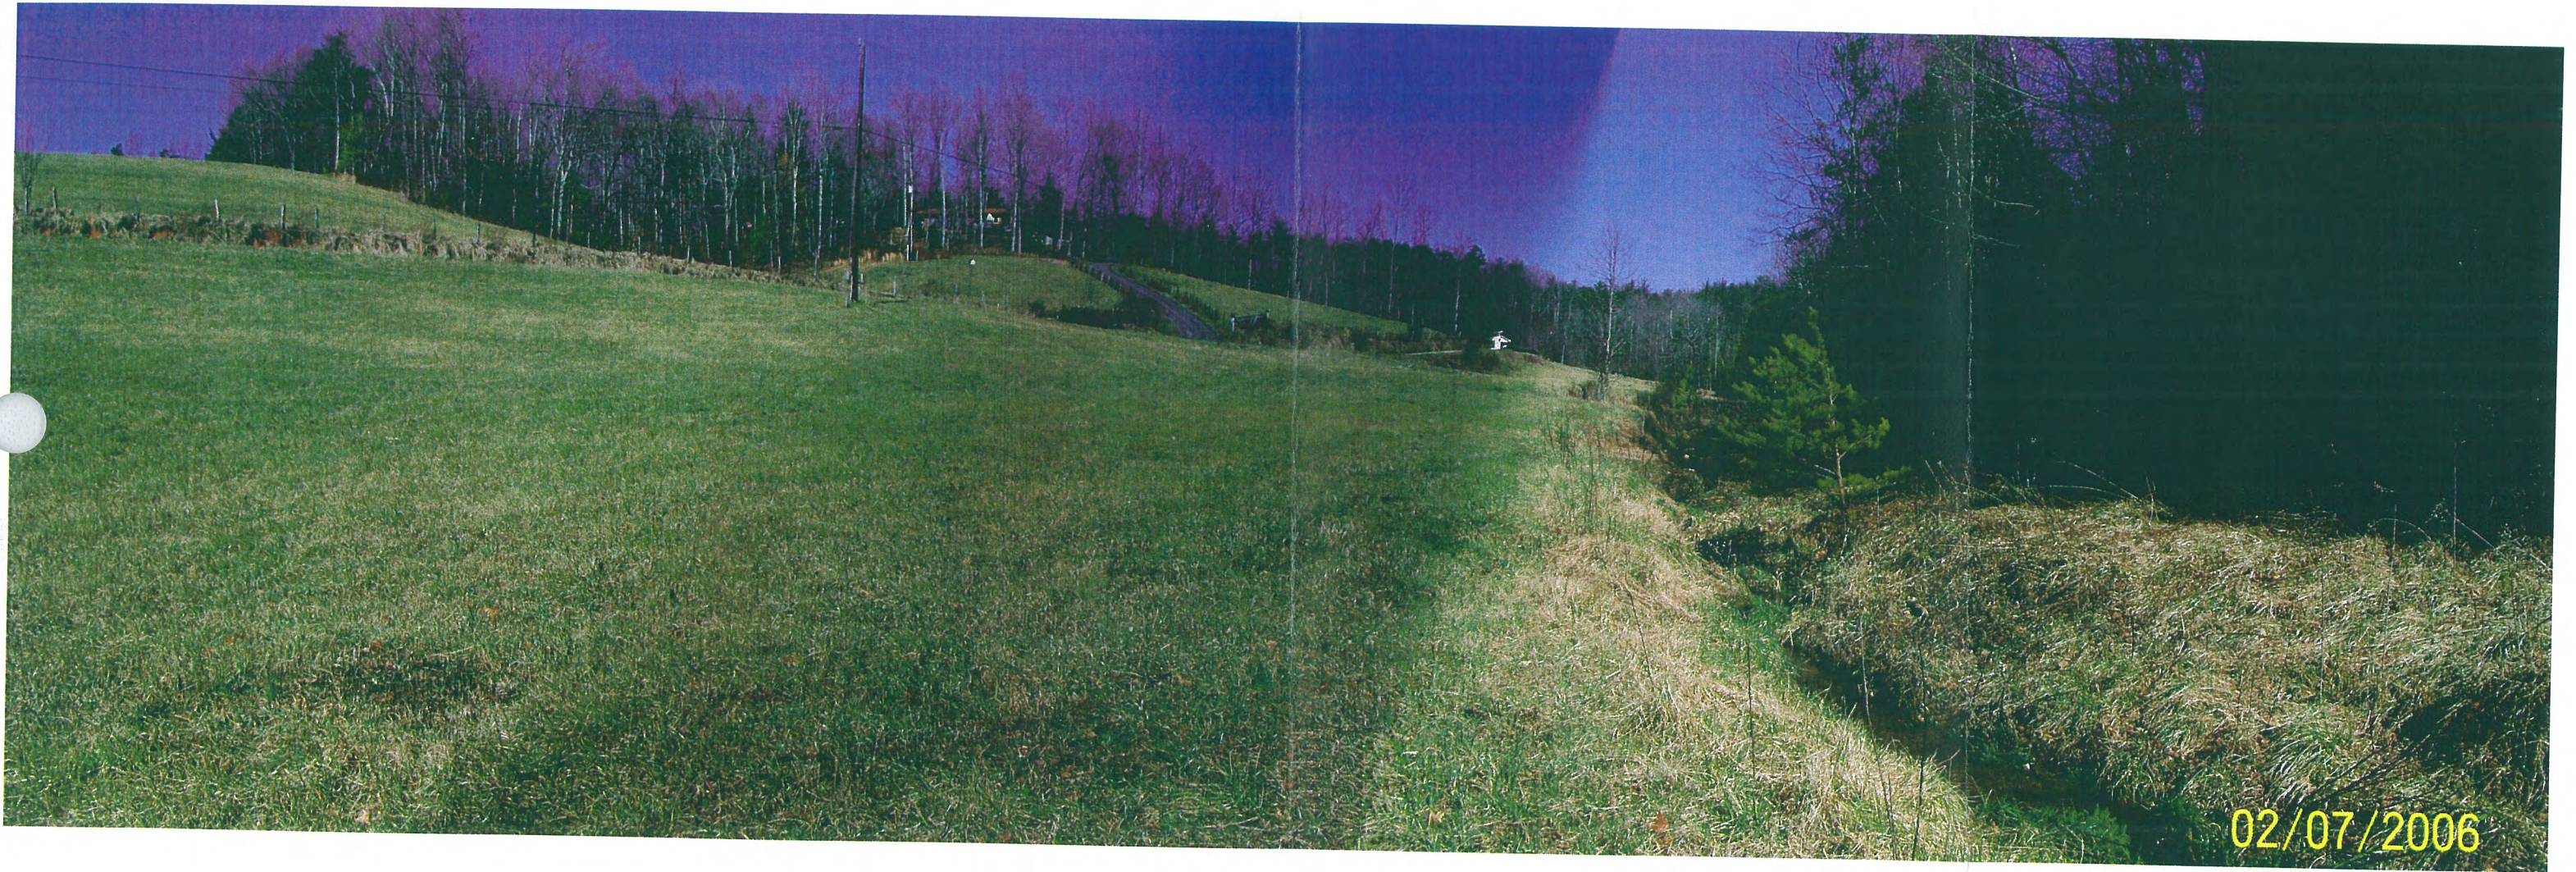
Thompsons Fork Unnamed Tributary  
Existing Conditions  
Proposed Priority Level 1 Reach  
Lower Section Looking Upstream  
February 7, 2006

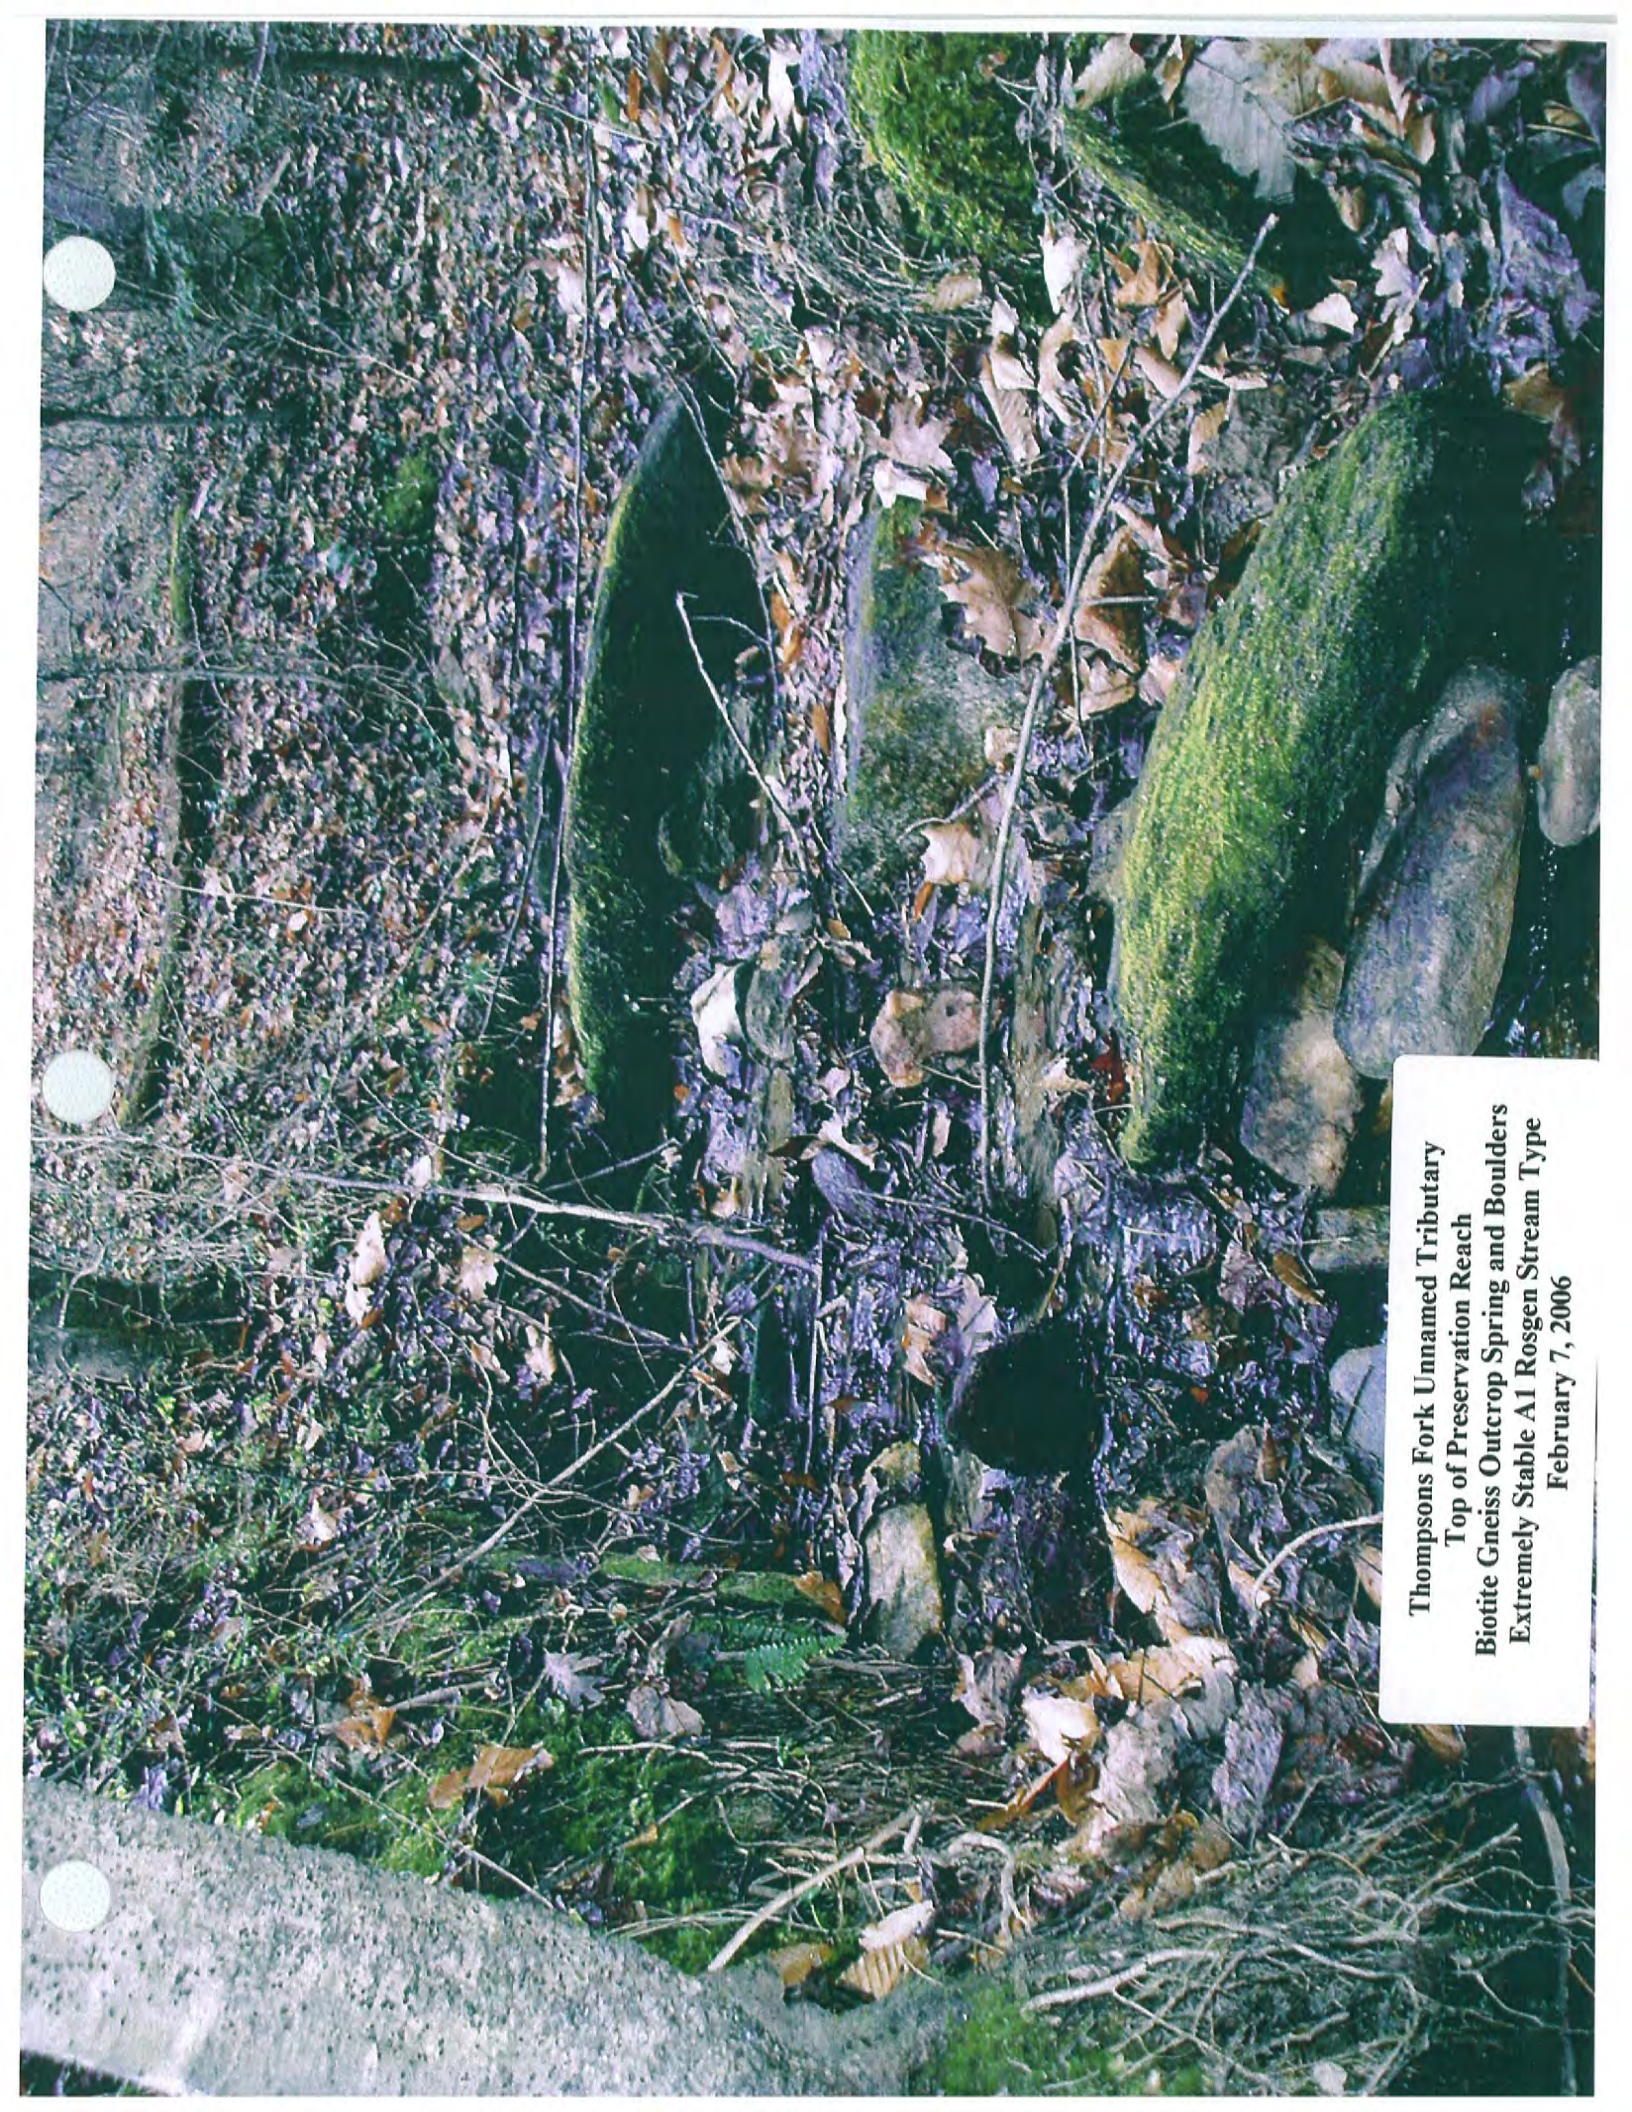
**Thompsons Fork Unnamed Tributary  
Top of Preservation Reach  
Biotite Gneiss Outcrop Spring and Boulders  
Extremely Stable A1 Rosgen Stream Type  
February 7, 2006**

A very narrow forested corridor is present along the majority of the right bank of the Unnamed Tributary. Typical species observed along this bank include *Cornus amomum*, *Bignonia capreolata* (crossvine), *Ilex opaca* (American holly), *Aeschynomene* species (jointed vetch), and the invasive species *Ligustrum sinense* (Chinese privet) and *Lonicera japonica* (Japanese honeysuckle). Cattle pastureland is present outside of the riparian corridor along the right bank of the tributary. The left bank of the tributary consists of a fully vegetated hill slope, consisting predominately of the following species: *Abies* species (fir), *Pinus taeda* (loblolly pine), *Pinus elliotii* (slash pine), *Ostrya virginiana* (Eastern hophornbeam), *Diospyros virginiana* (persimmon), *Kalmia latifolia* (mountain laurel), and *Platanus occidentalis*. Along the upper limits of the Unnamed Tributary (where the forest has not been cleared for pastureland), the right bank also remains fully vegetated. **Appendix 5** presents photographs of the Unnamed Tributary.
