**Wetlands Resource Center**  
3970 Bowen Road  
Canal Winchester, Ohio 43110  
Project Manager: Cal Miller  
P: (614) 864-7511  
F: (614) 866-3691

**EMH&T, Inc.**  
5500 New Albany Road  
Columbus, Ohio 43054  
Project Manager: Miles F. Hebert, PE  
P: (614) 775-4205  
F: (614) 775-4802  
Main: (614) 775-4500

## THOMPSONS FORK RESTORATION

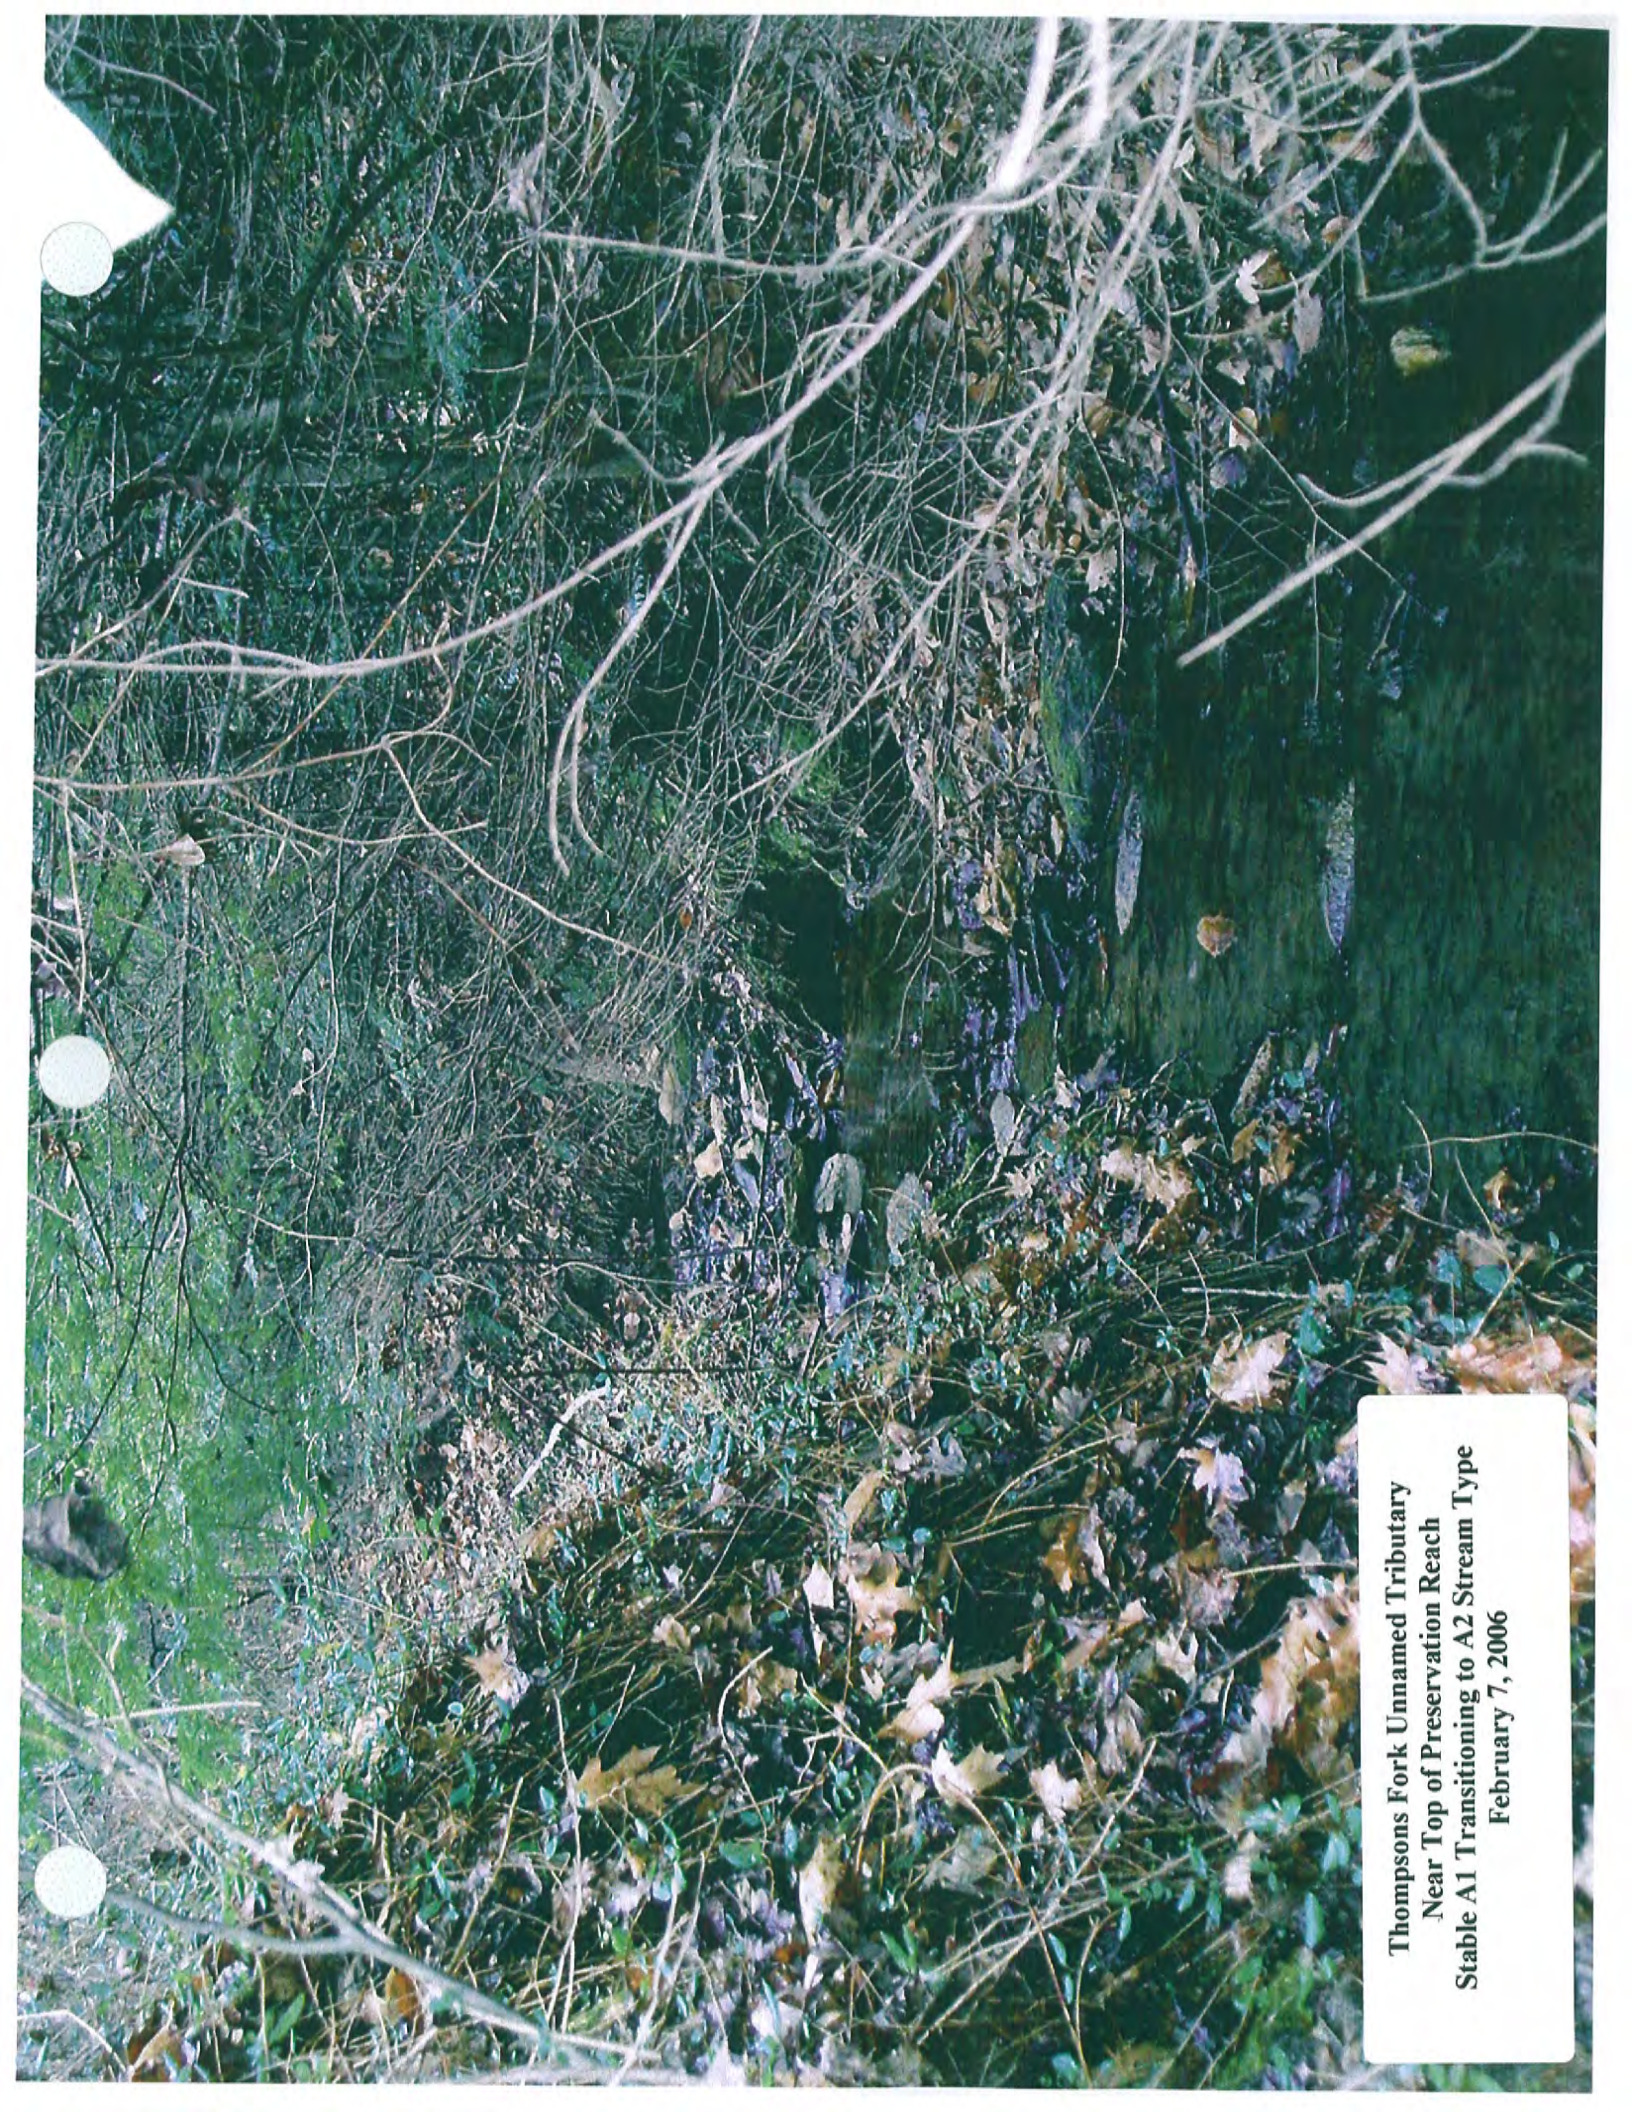
Thompsons Fork Unnamed Tributary  
Near Top of Preservation Reach  
Stable A1 Transitioning to A2 Stream Type  
February 7, 2006

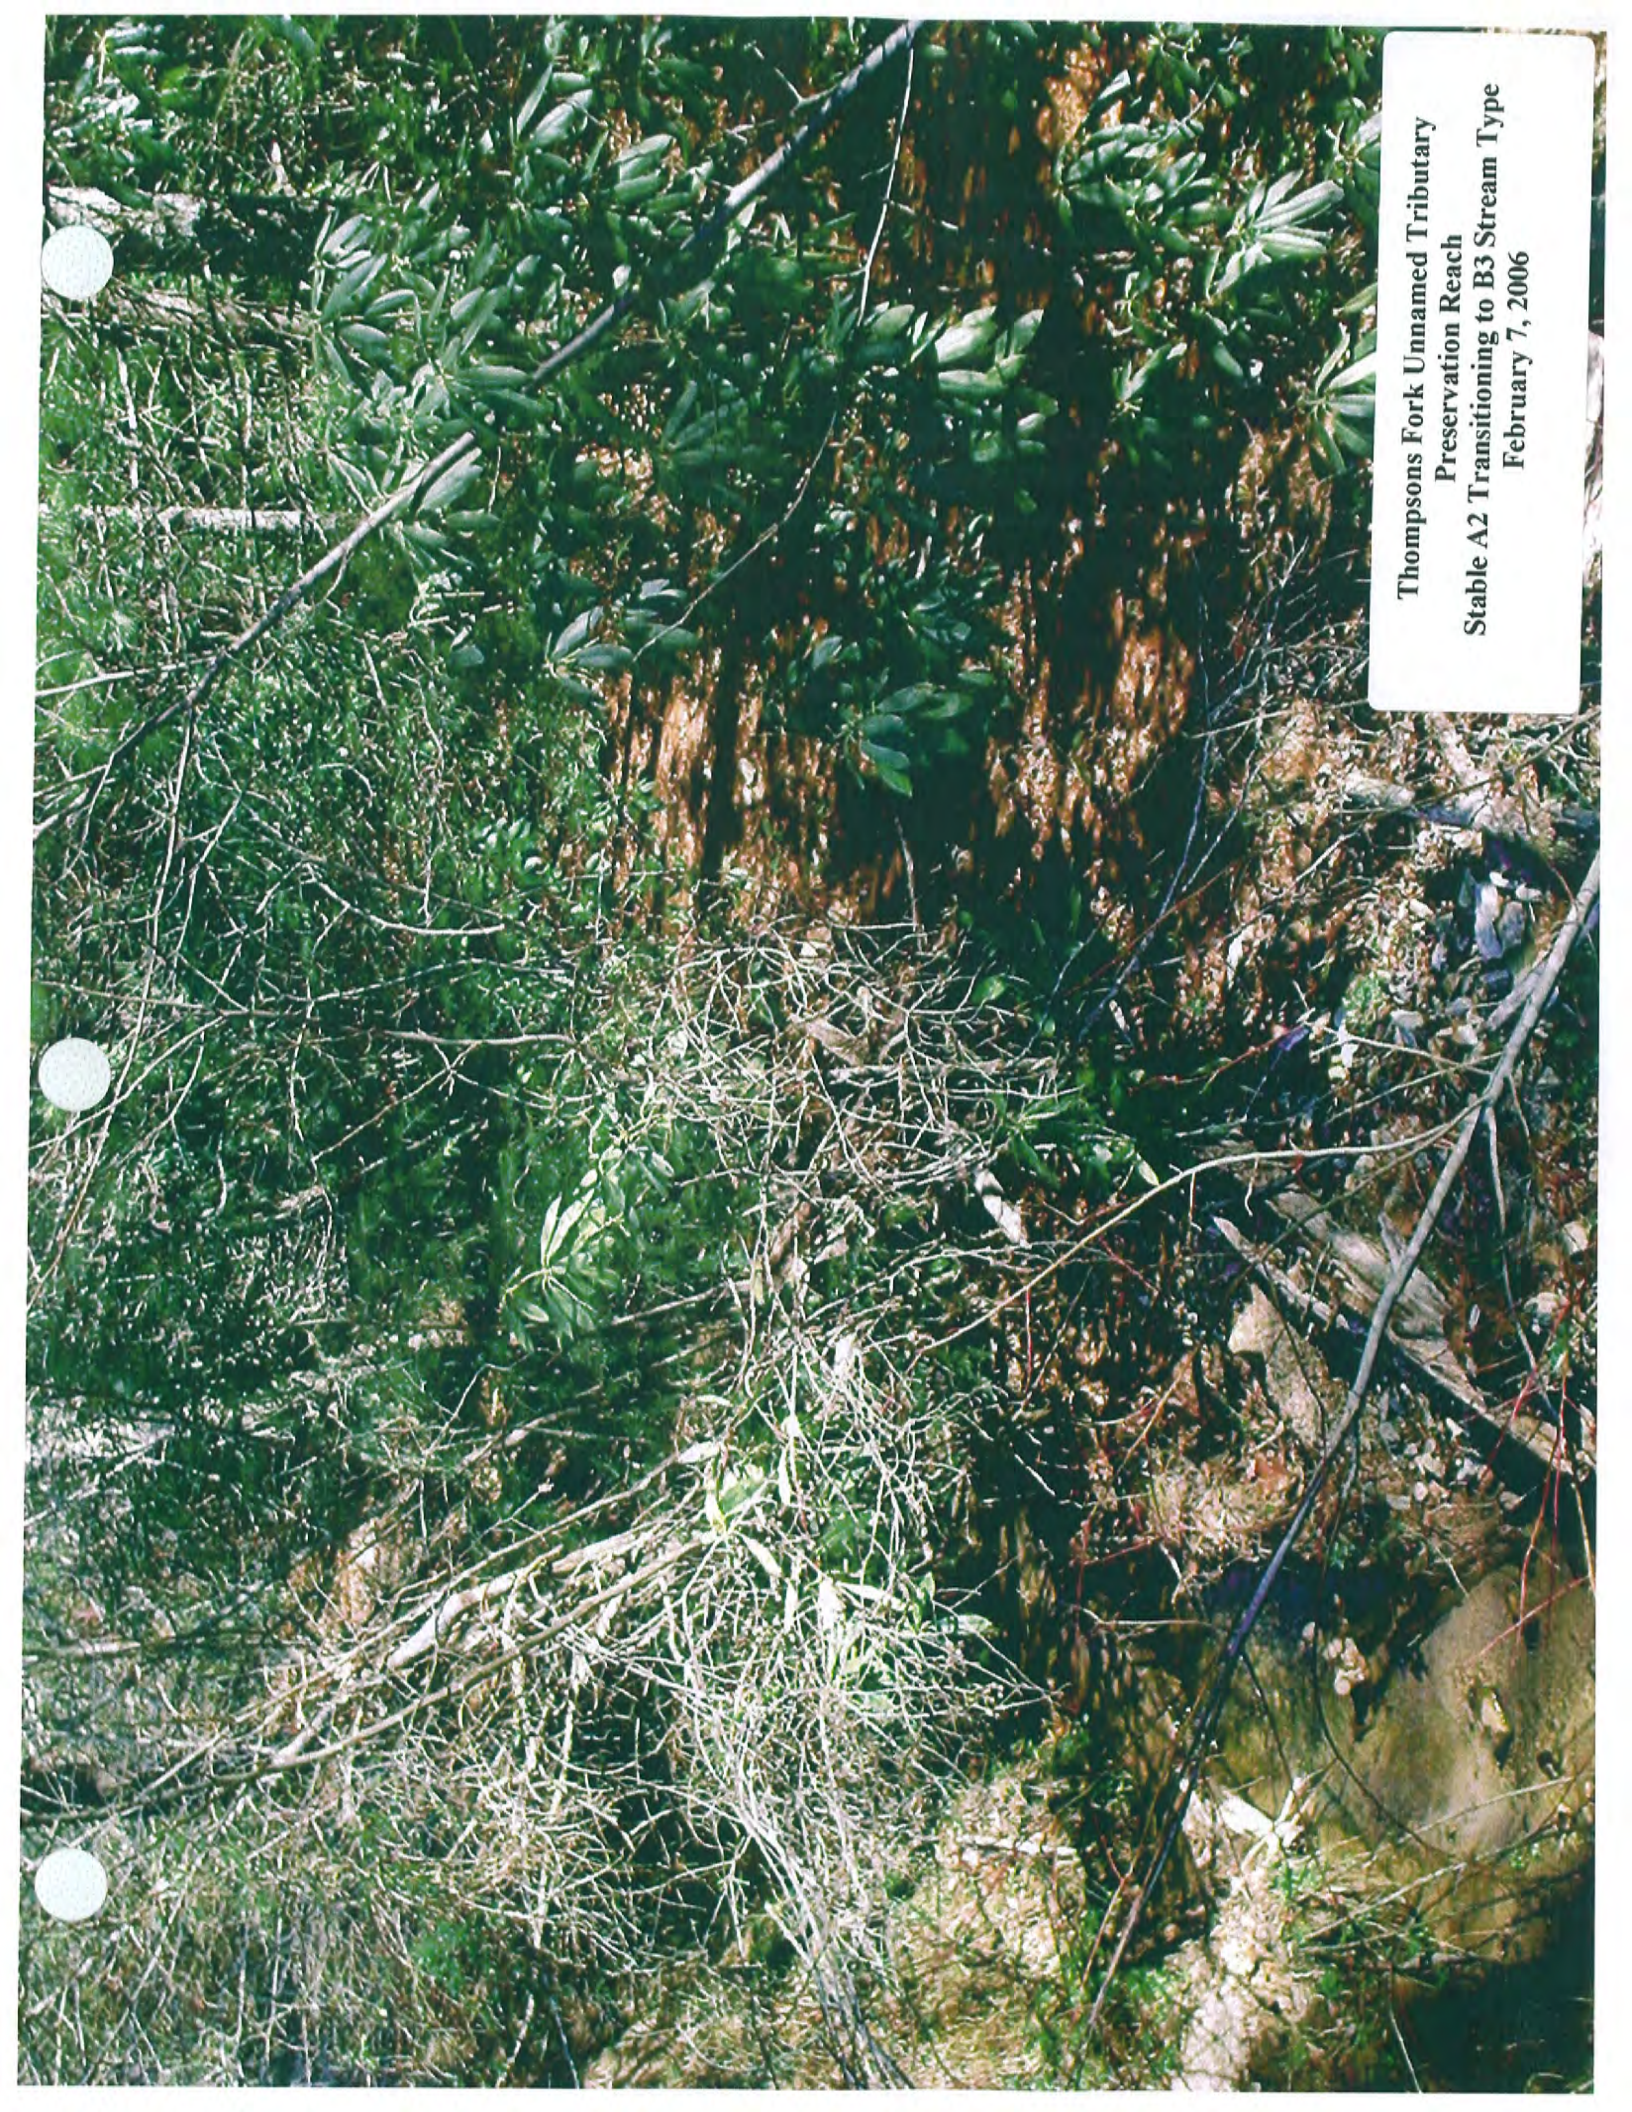
Thompsons Fork Unnamed Tributary  
Preservation Reach  
Stable A2 Transitioning to B3 Stream Type  
February 7, 2006

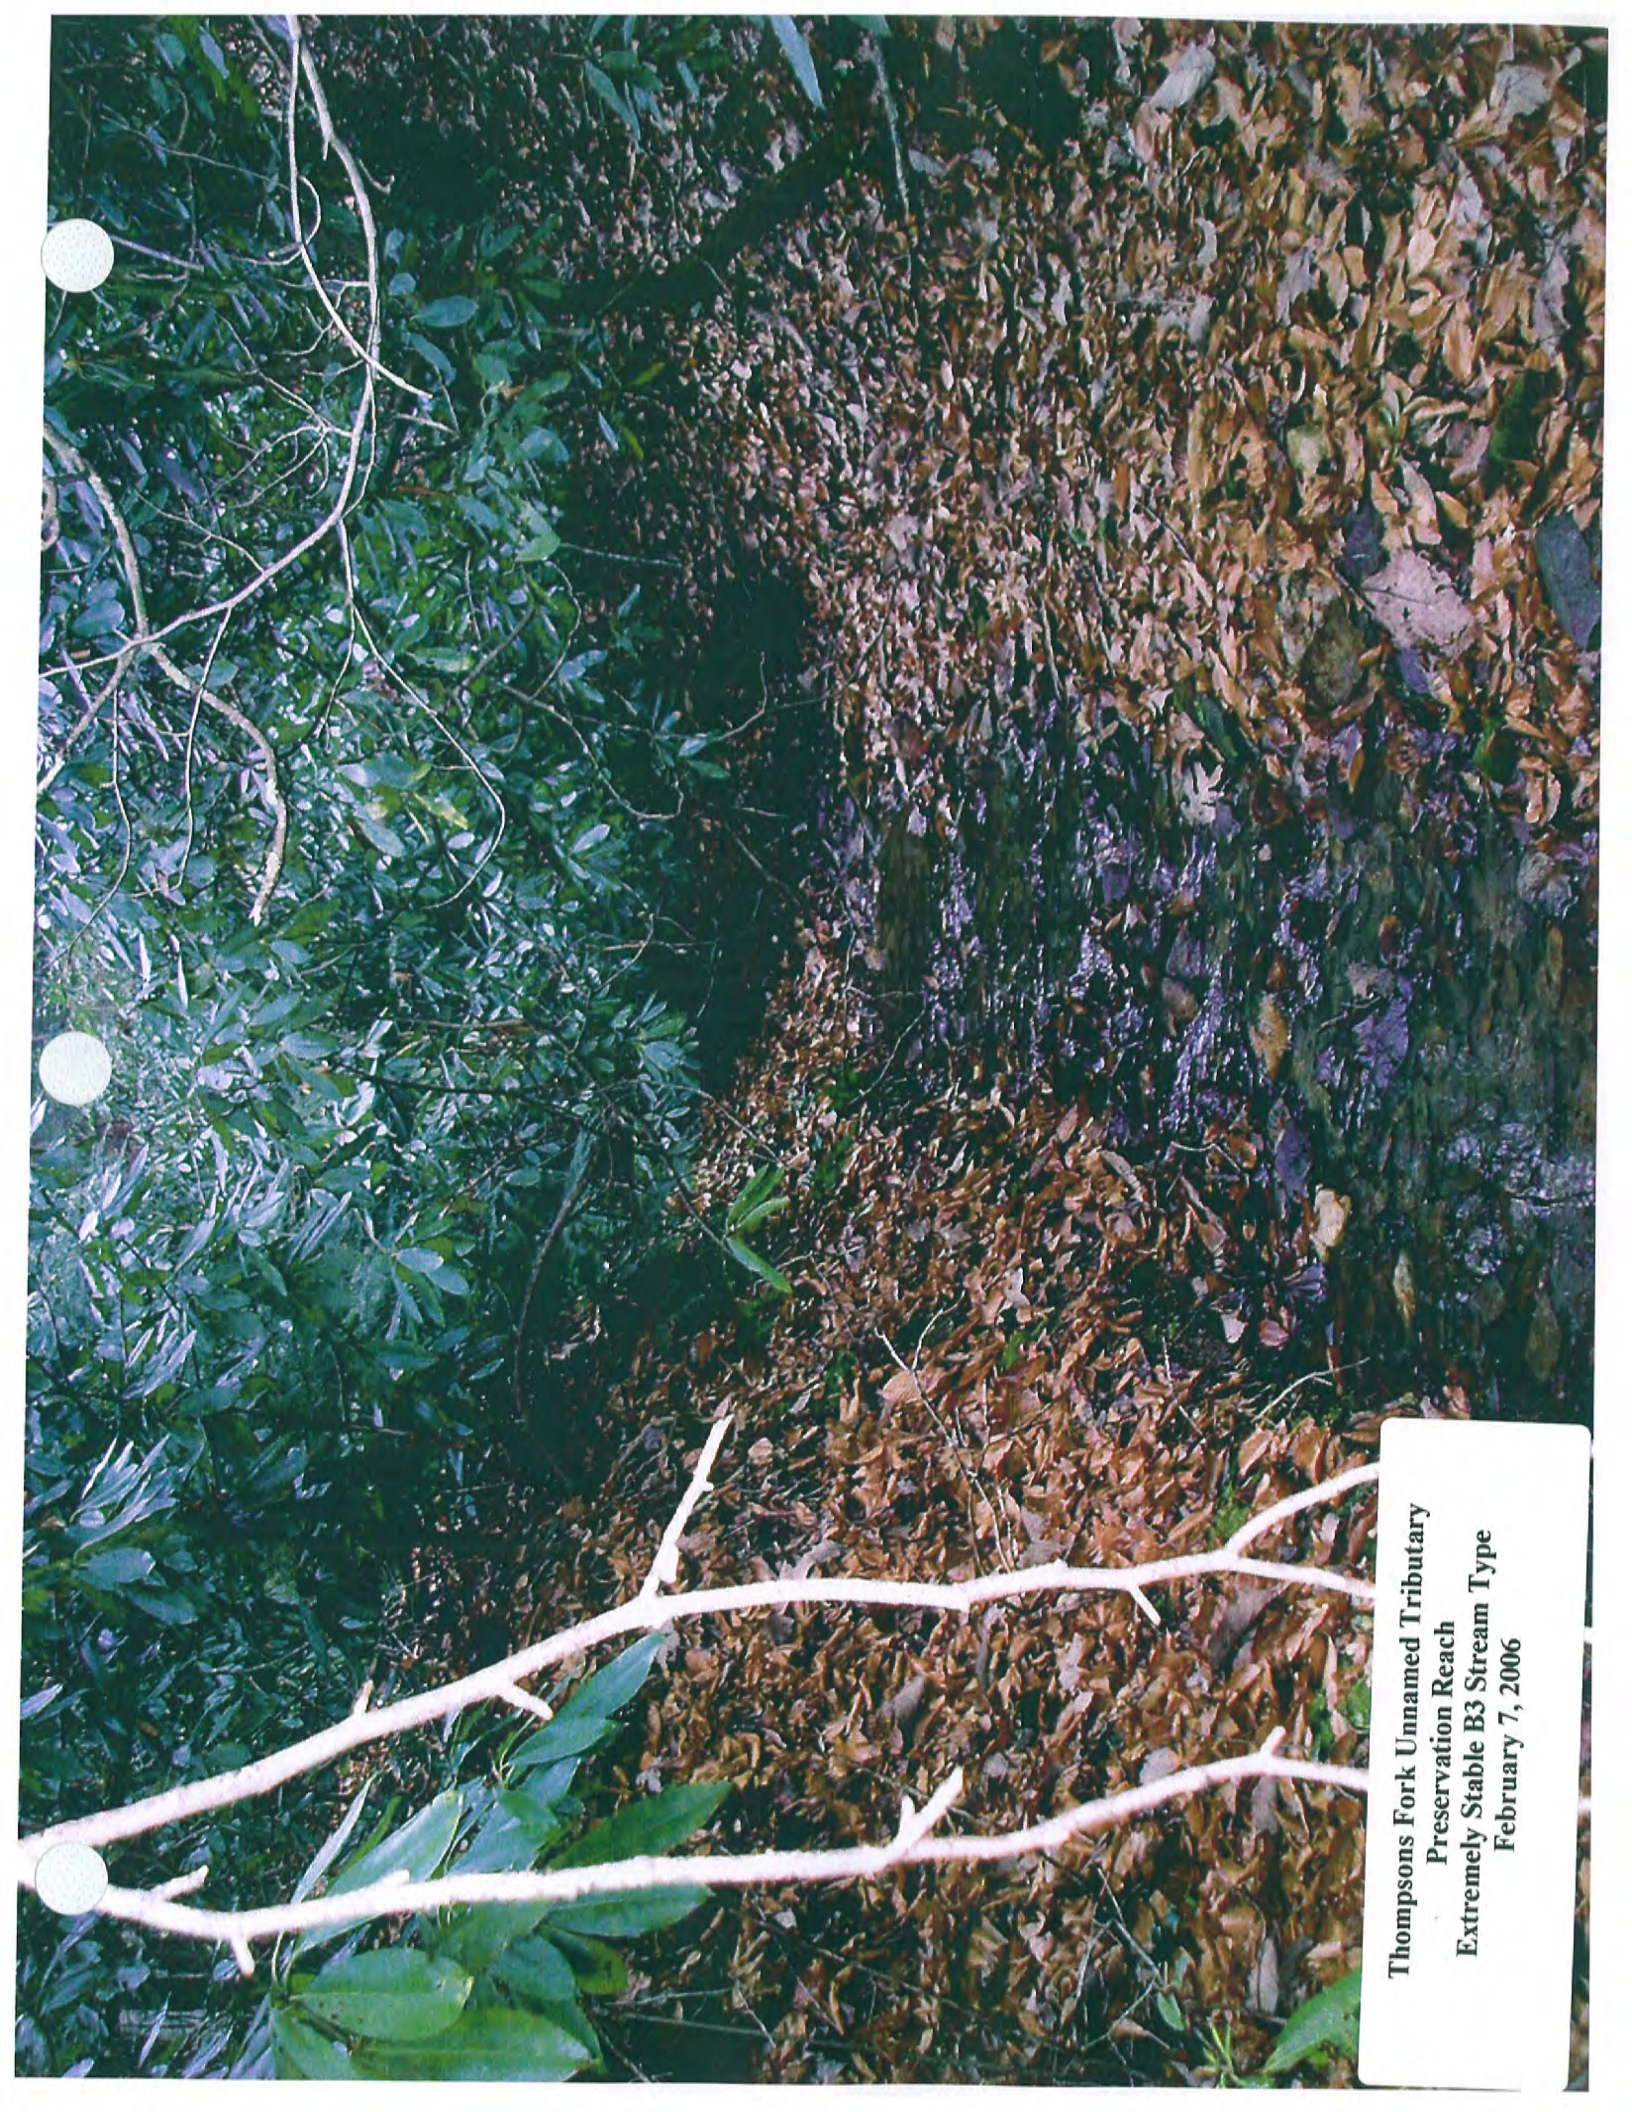
Thompsons Fork Unnamed Tributary  
Preservation Reach  
Extremely Stable B3 Stream Type  
February 7, 2006

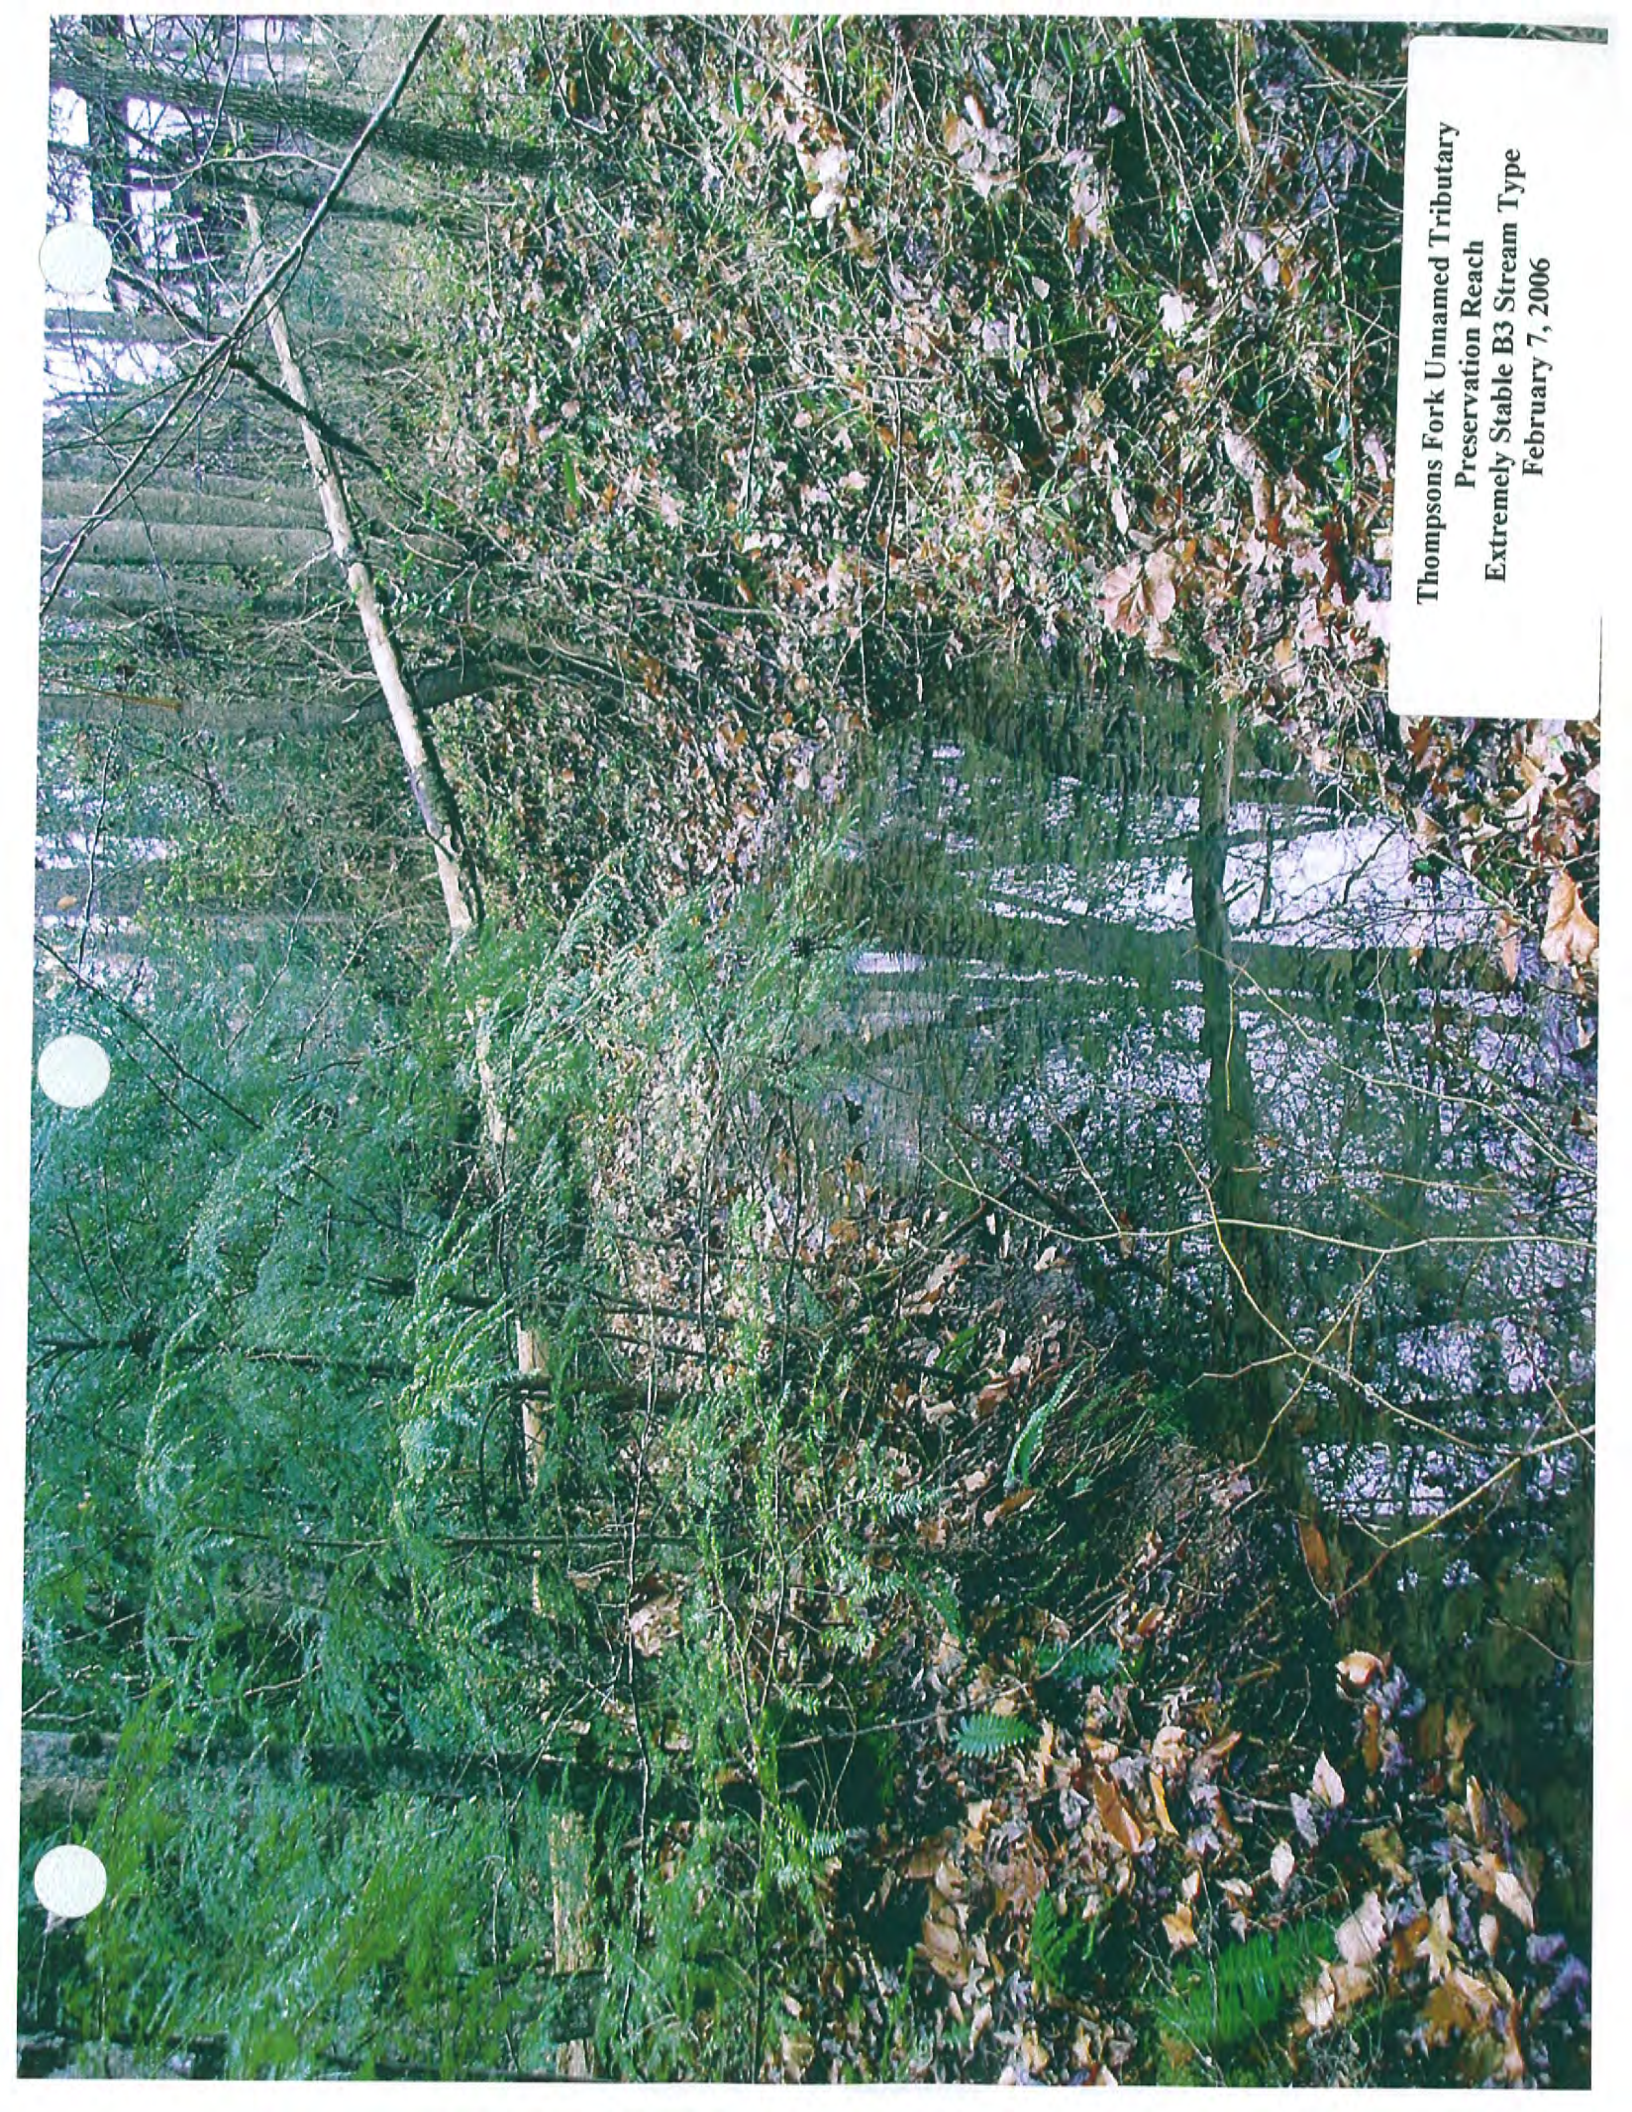
Thompsons Fork Unnamed Tributary  
Preservation Reach  
Extremely Stable B3 Stream Type  
February 7, 2006

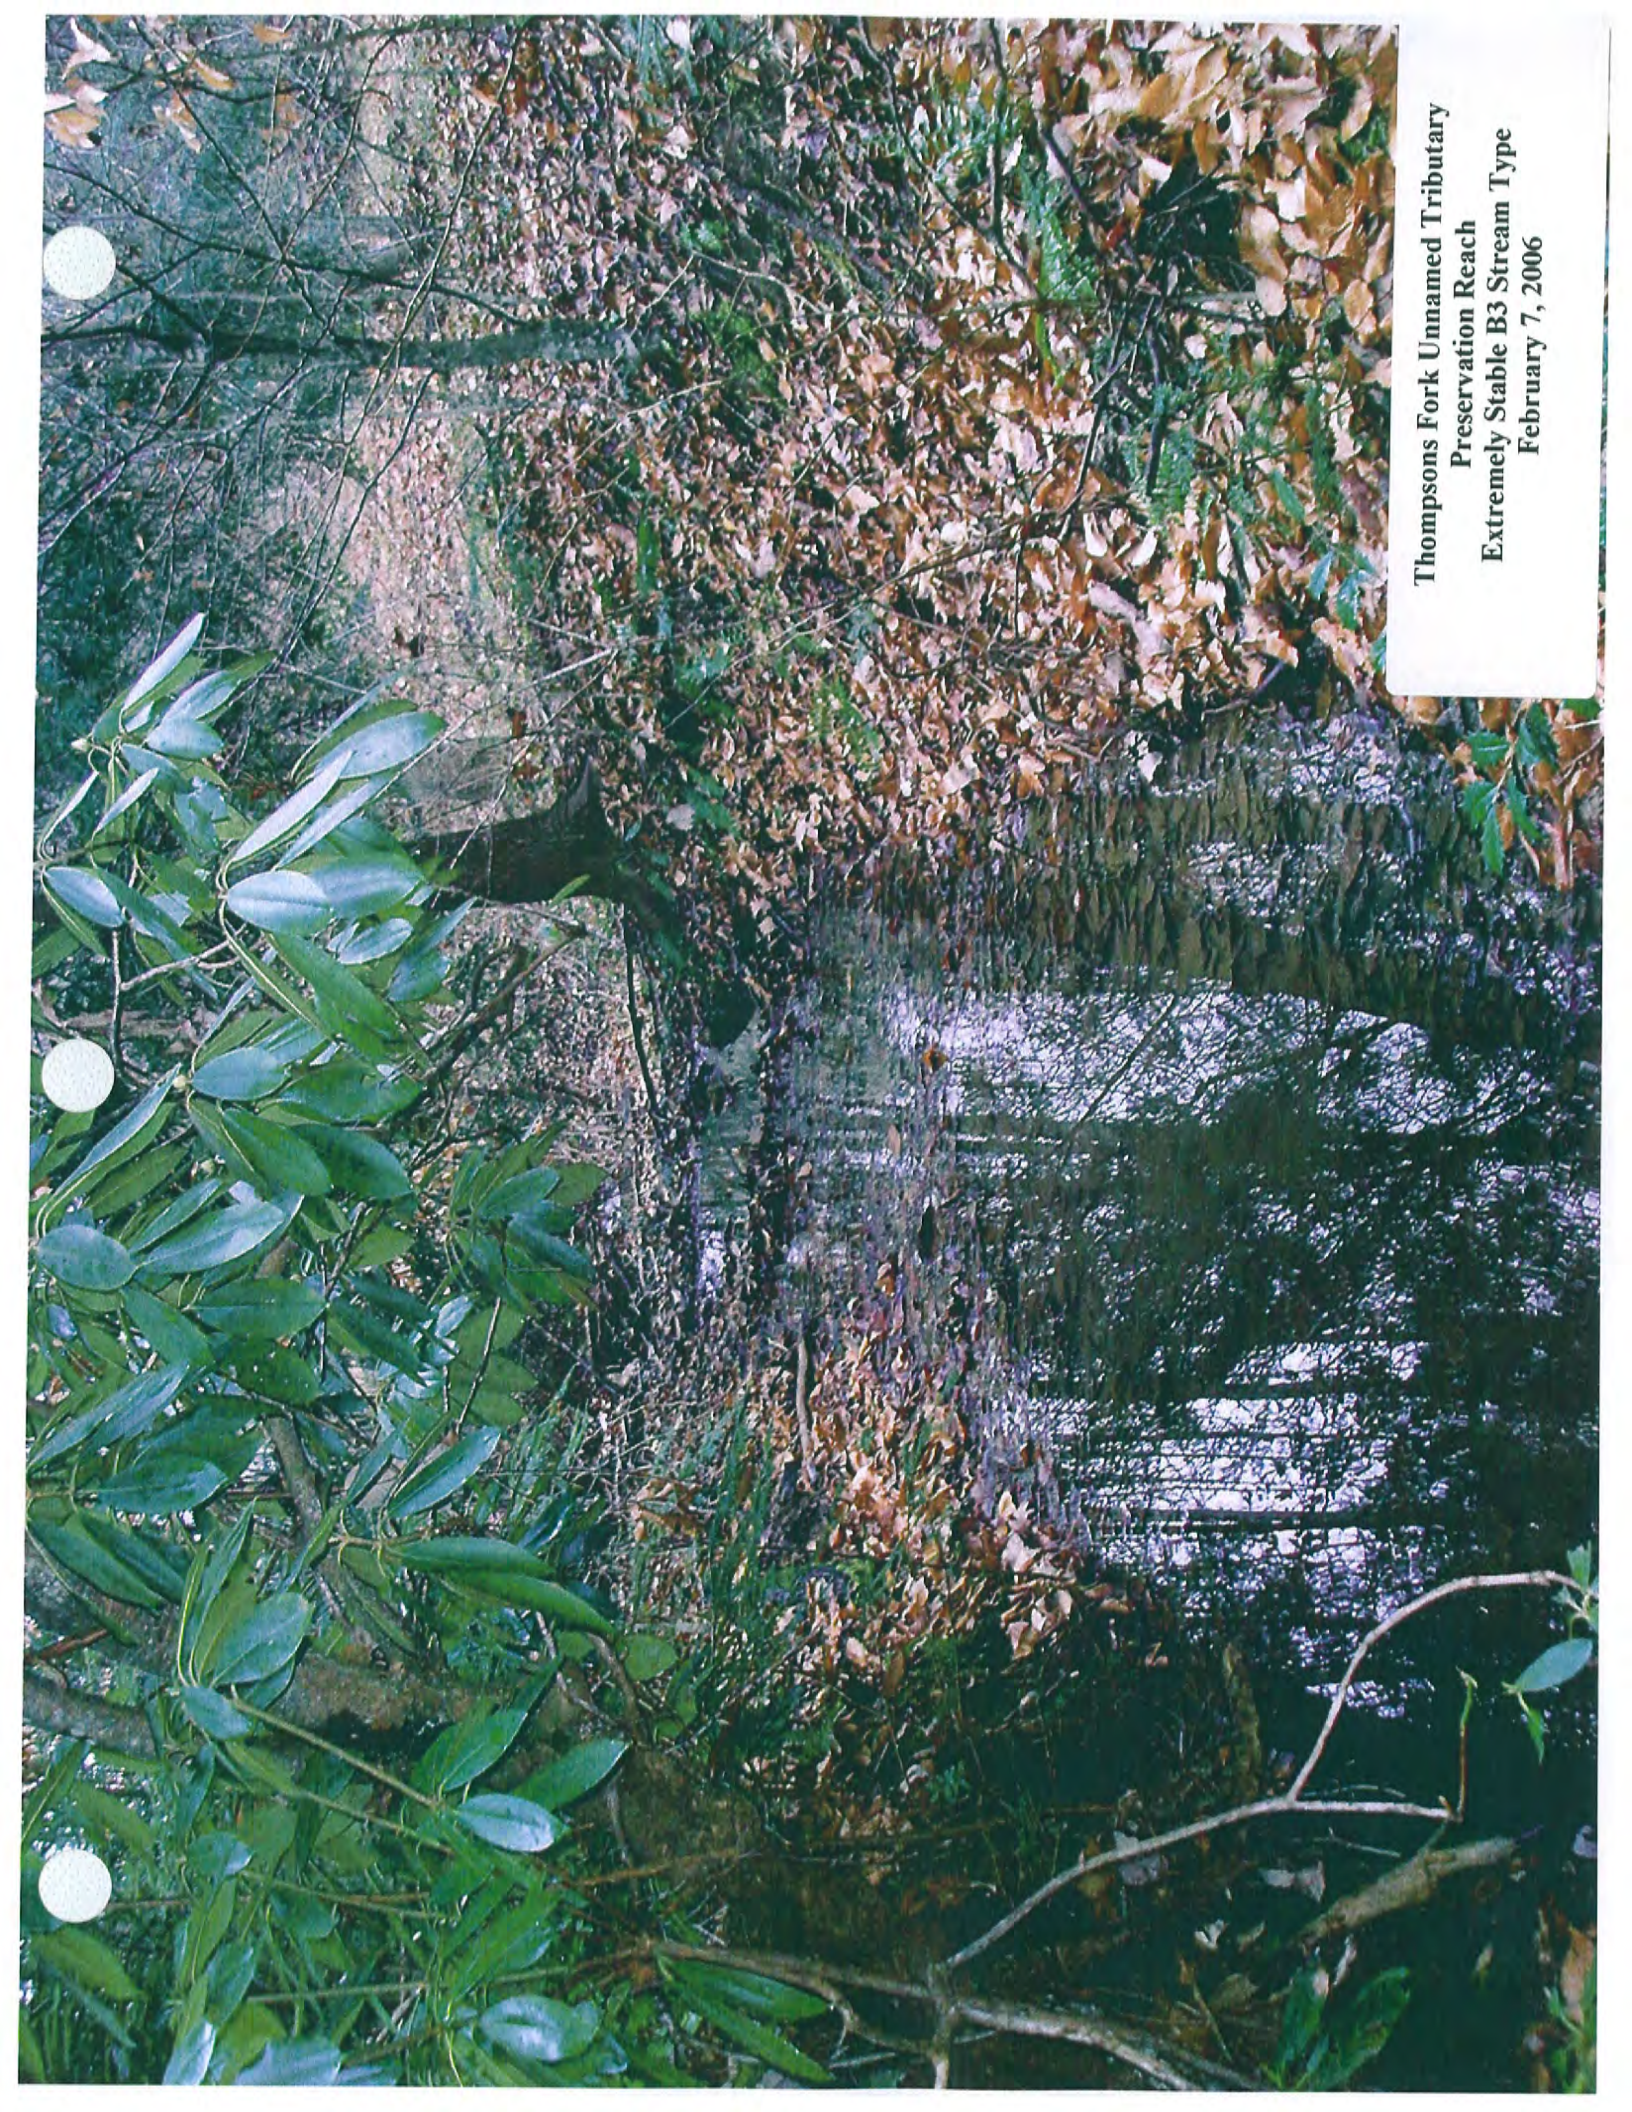
Thompsons Fork Unnamed Tributary  
Preservation Reach  
Extremely Stable B3 Stream Type  
February 7, 2006

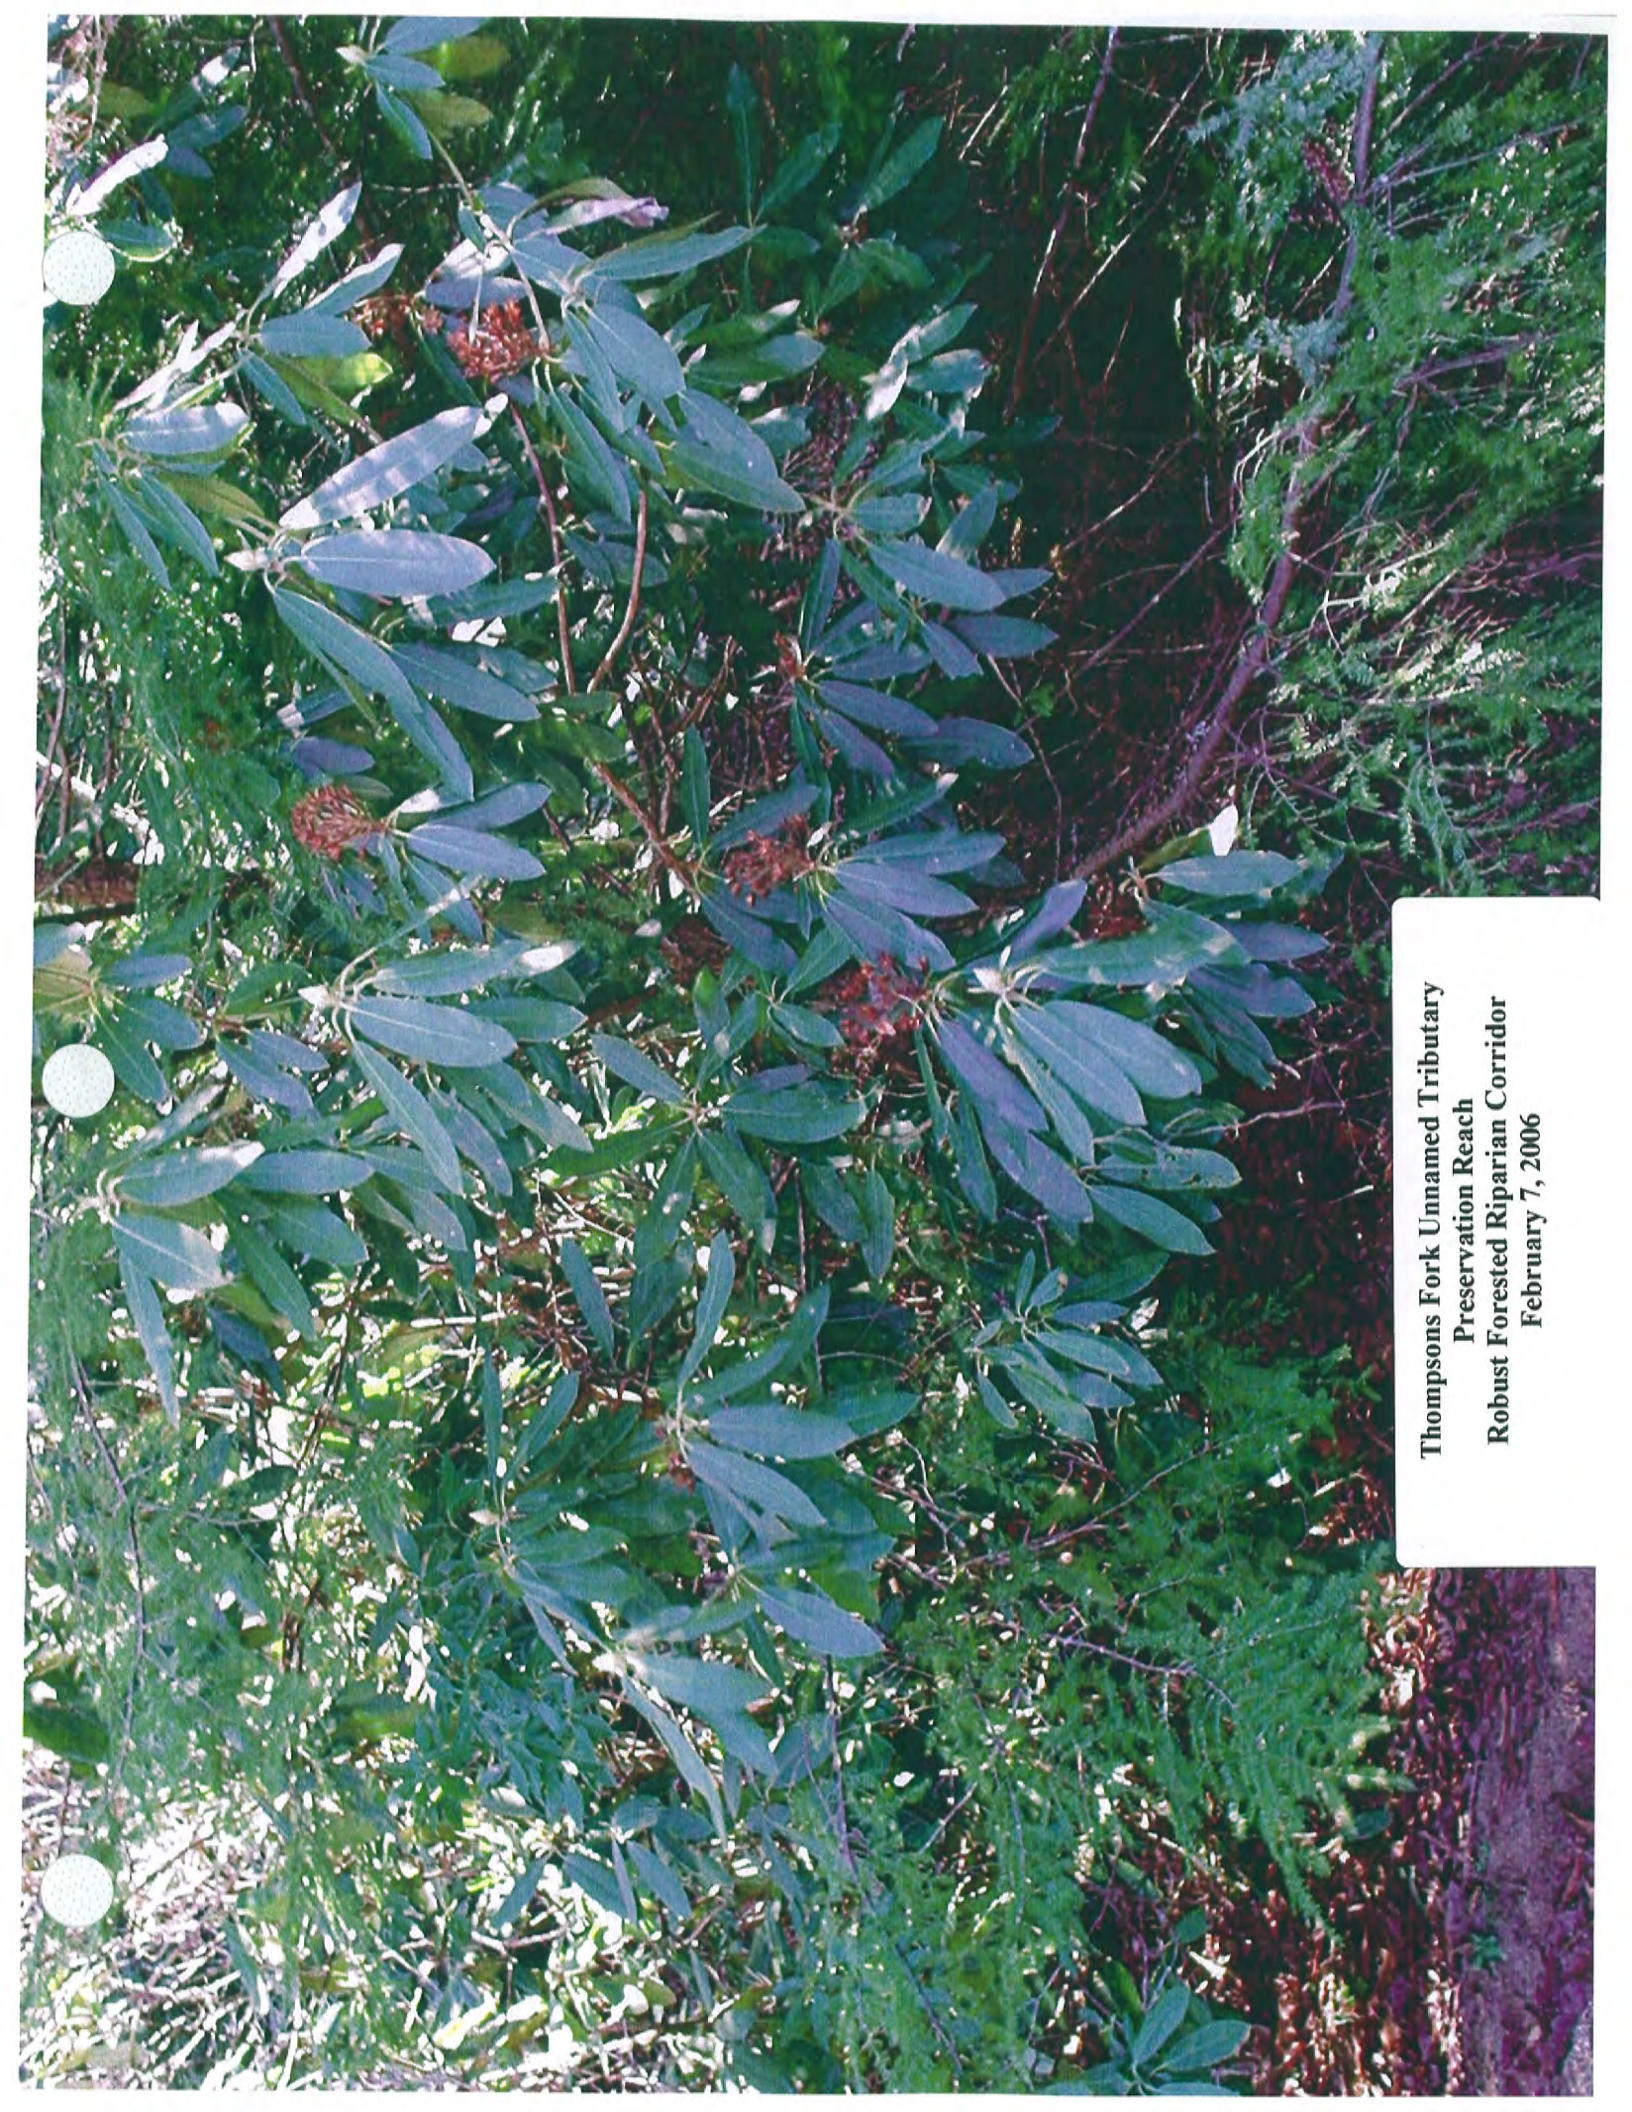
Thompsons Fork Unnamed Tributary  
Preservation Reach  
Robust Forested Riparian Corridor  
February 7, 2006
