**Wetlands Resource Center**  
3970 Bowen Road  
Canal Winchester, Ohio 43110  
Project Manager: Cal Miller  
P: (614) 864-7511  
F: (614) 866-3691

**EMH&T, Inc.**  
5500 New Albany Road  
Columbus, Ohio 43054  
Project Manager: Miles F. Hebert, PE  
P: (614) 775-4205  
F: (614) 775-4802  
Main: (614) 775-4500

## THOMPSONS FORK RESTORATION

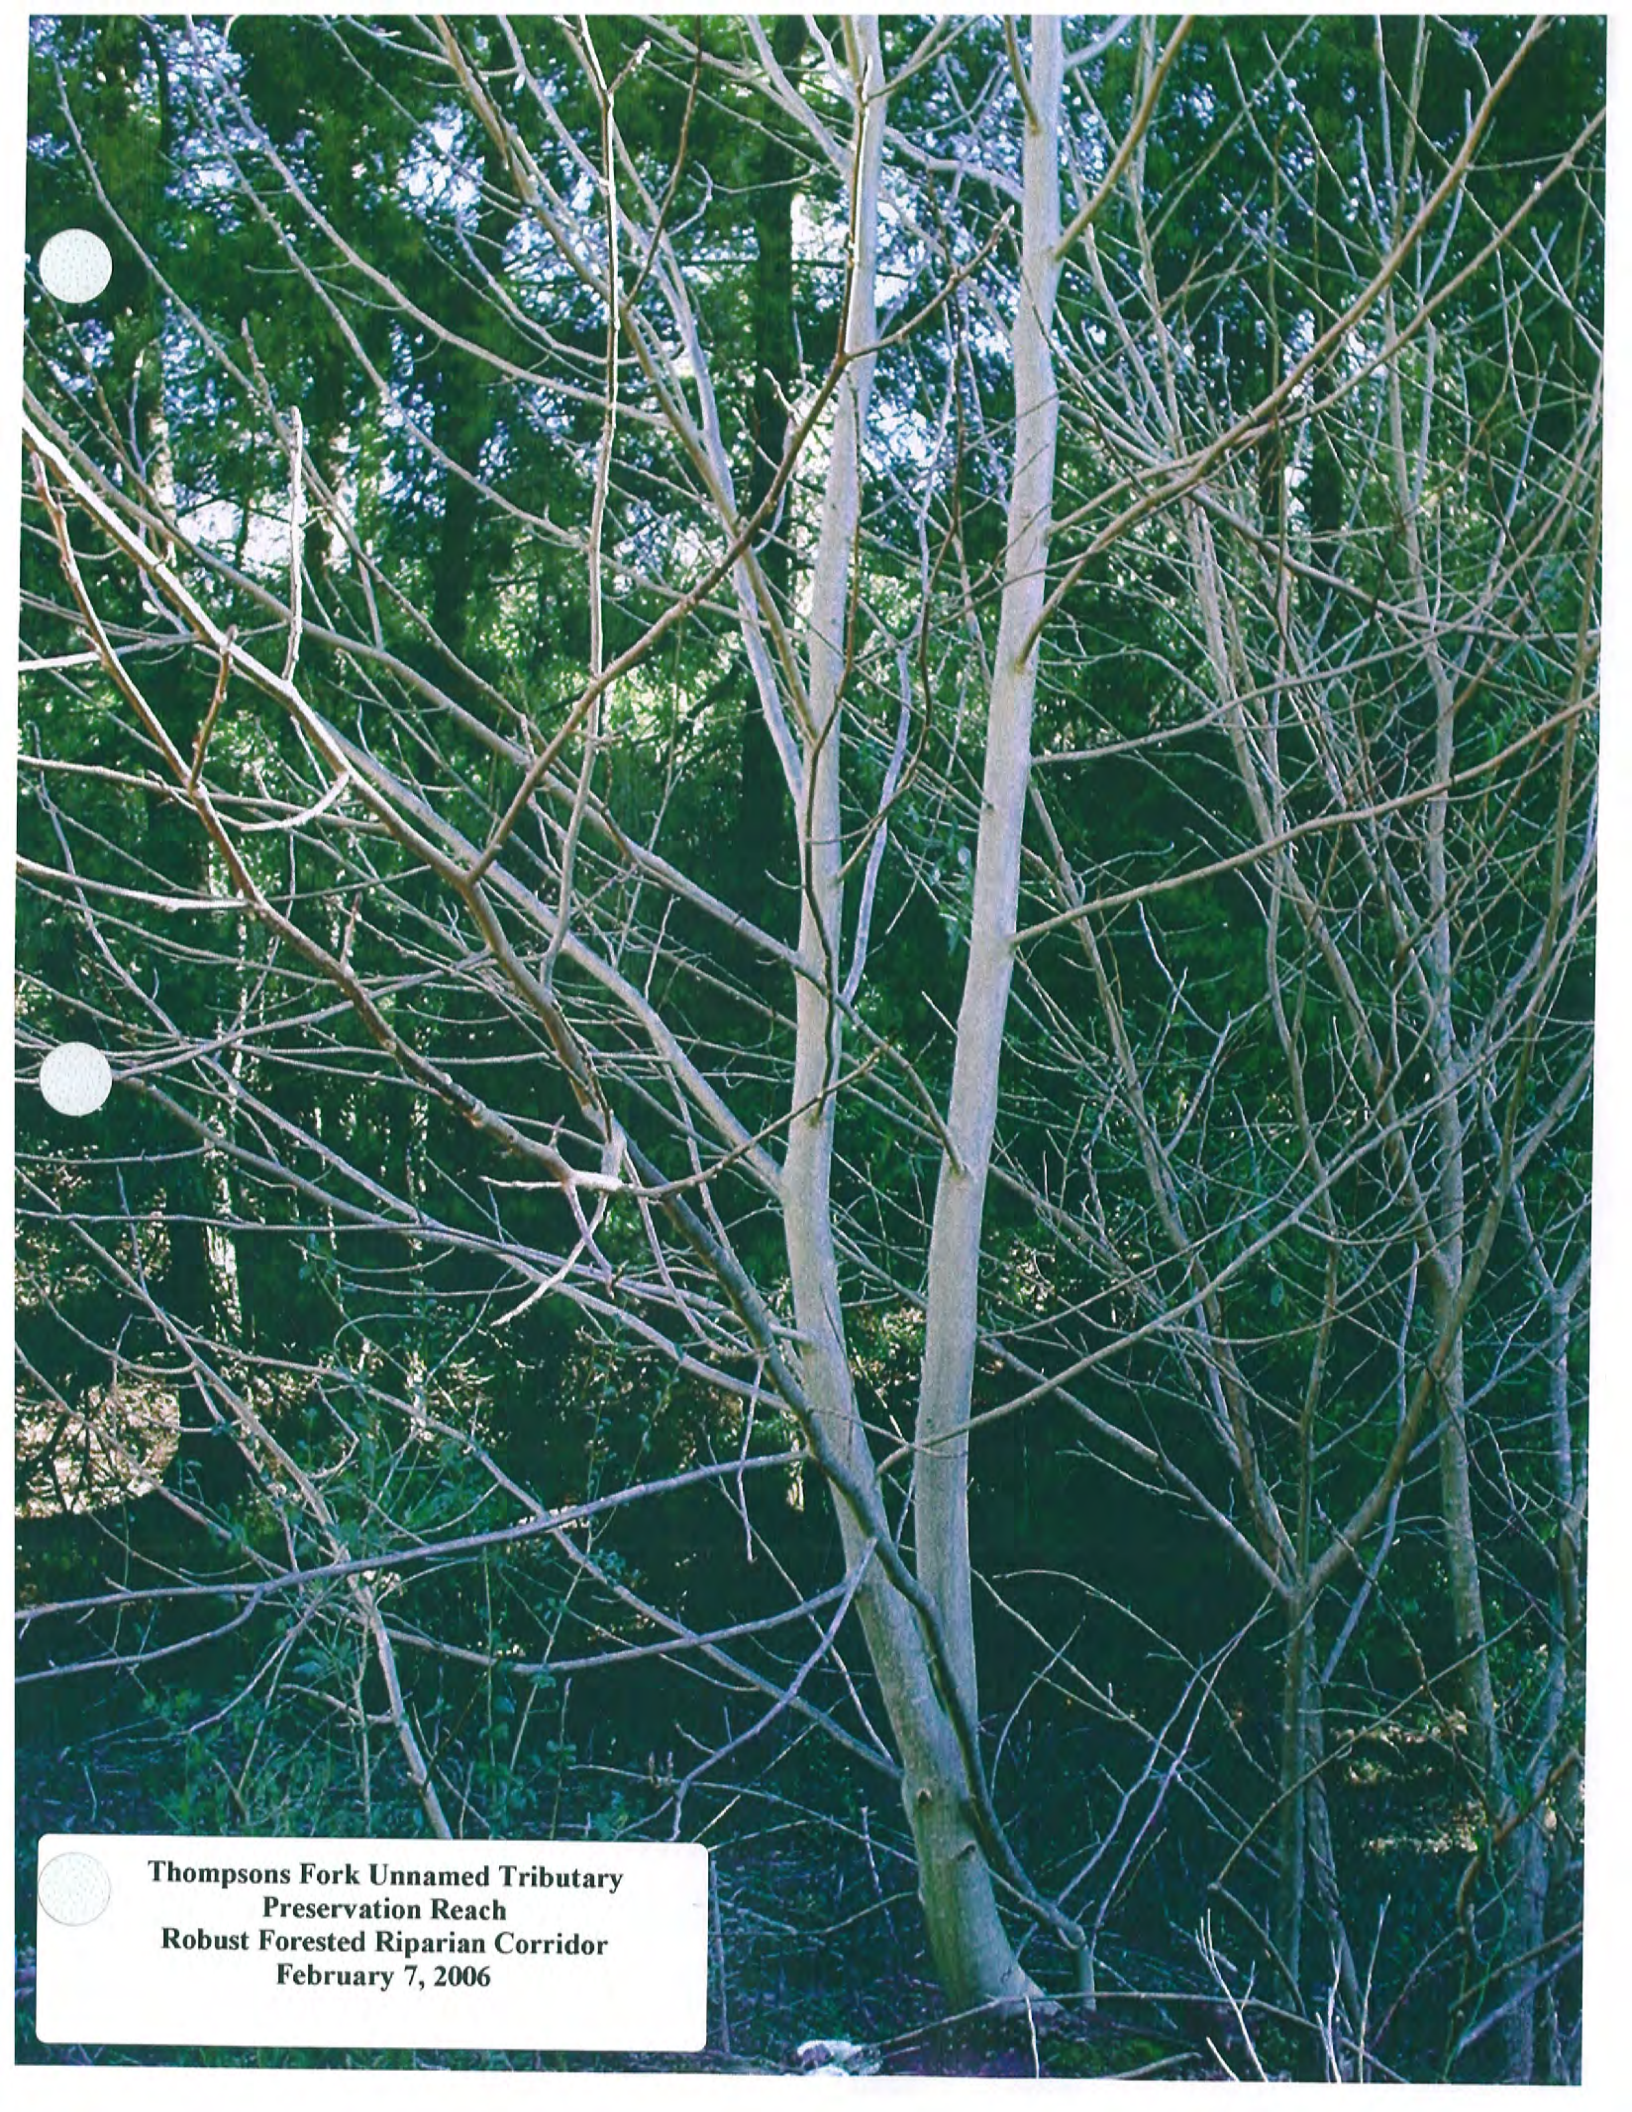
**Thompsons Fork Unnamed Tributary  
Preservation Reach  
Robust Forested Riparian Corridor  
February 7, 2006**

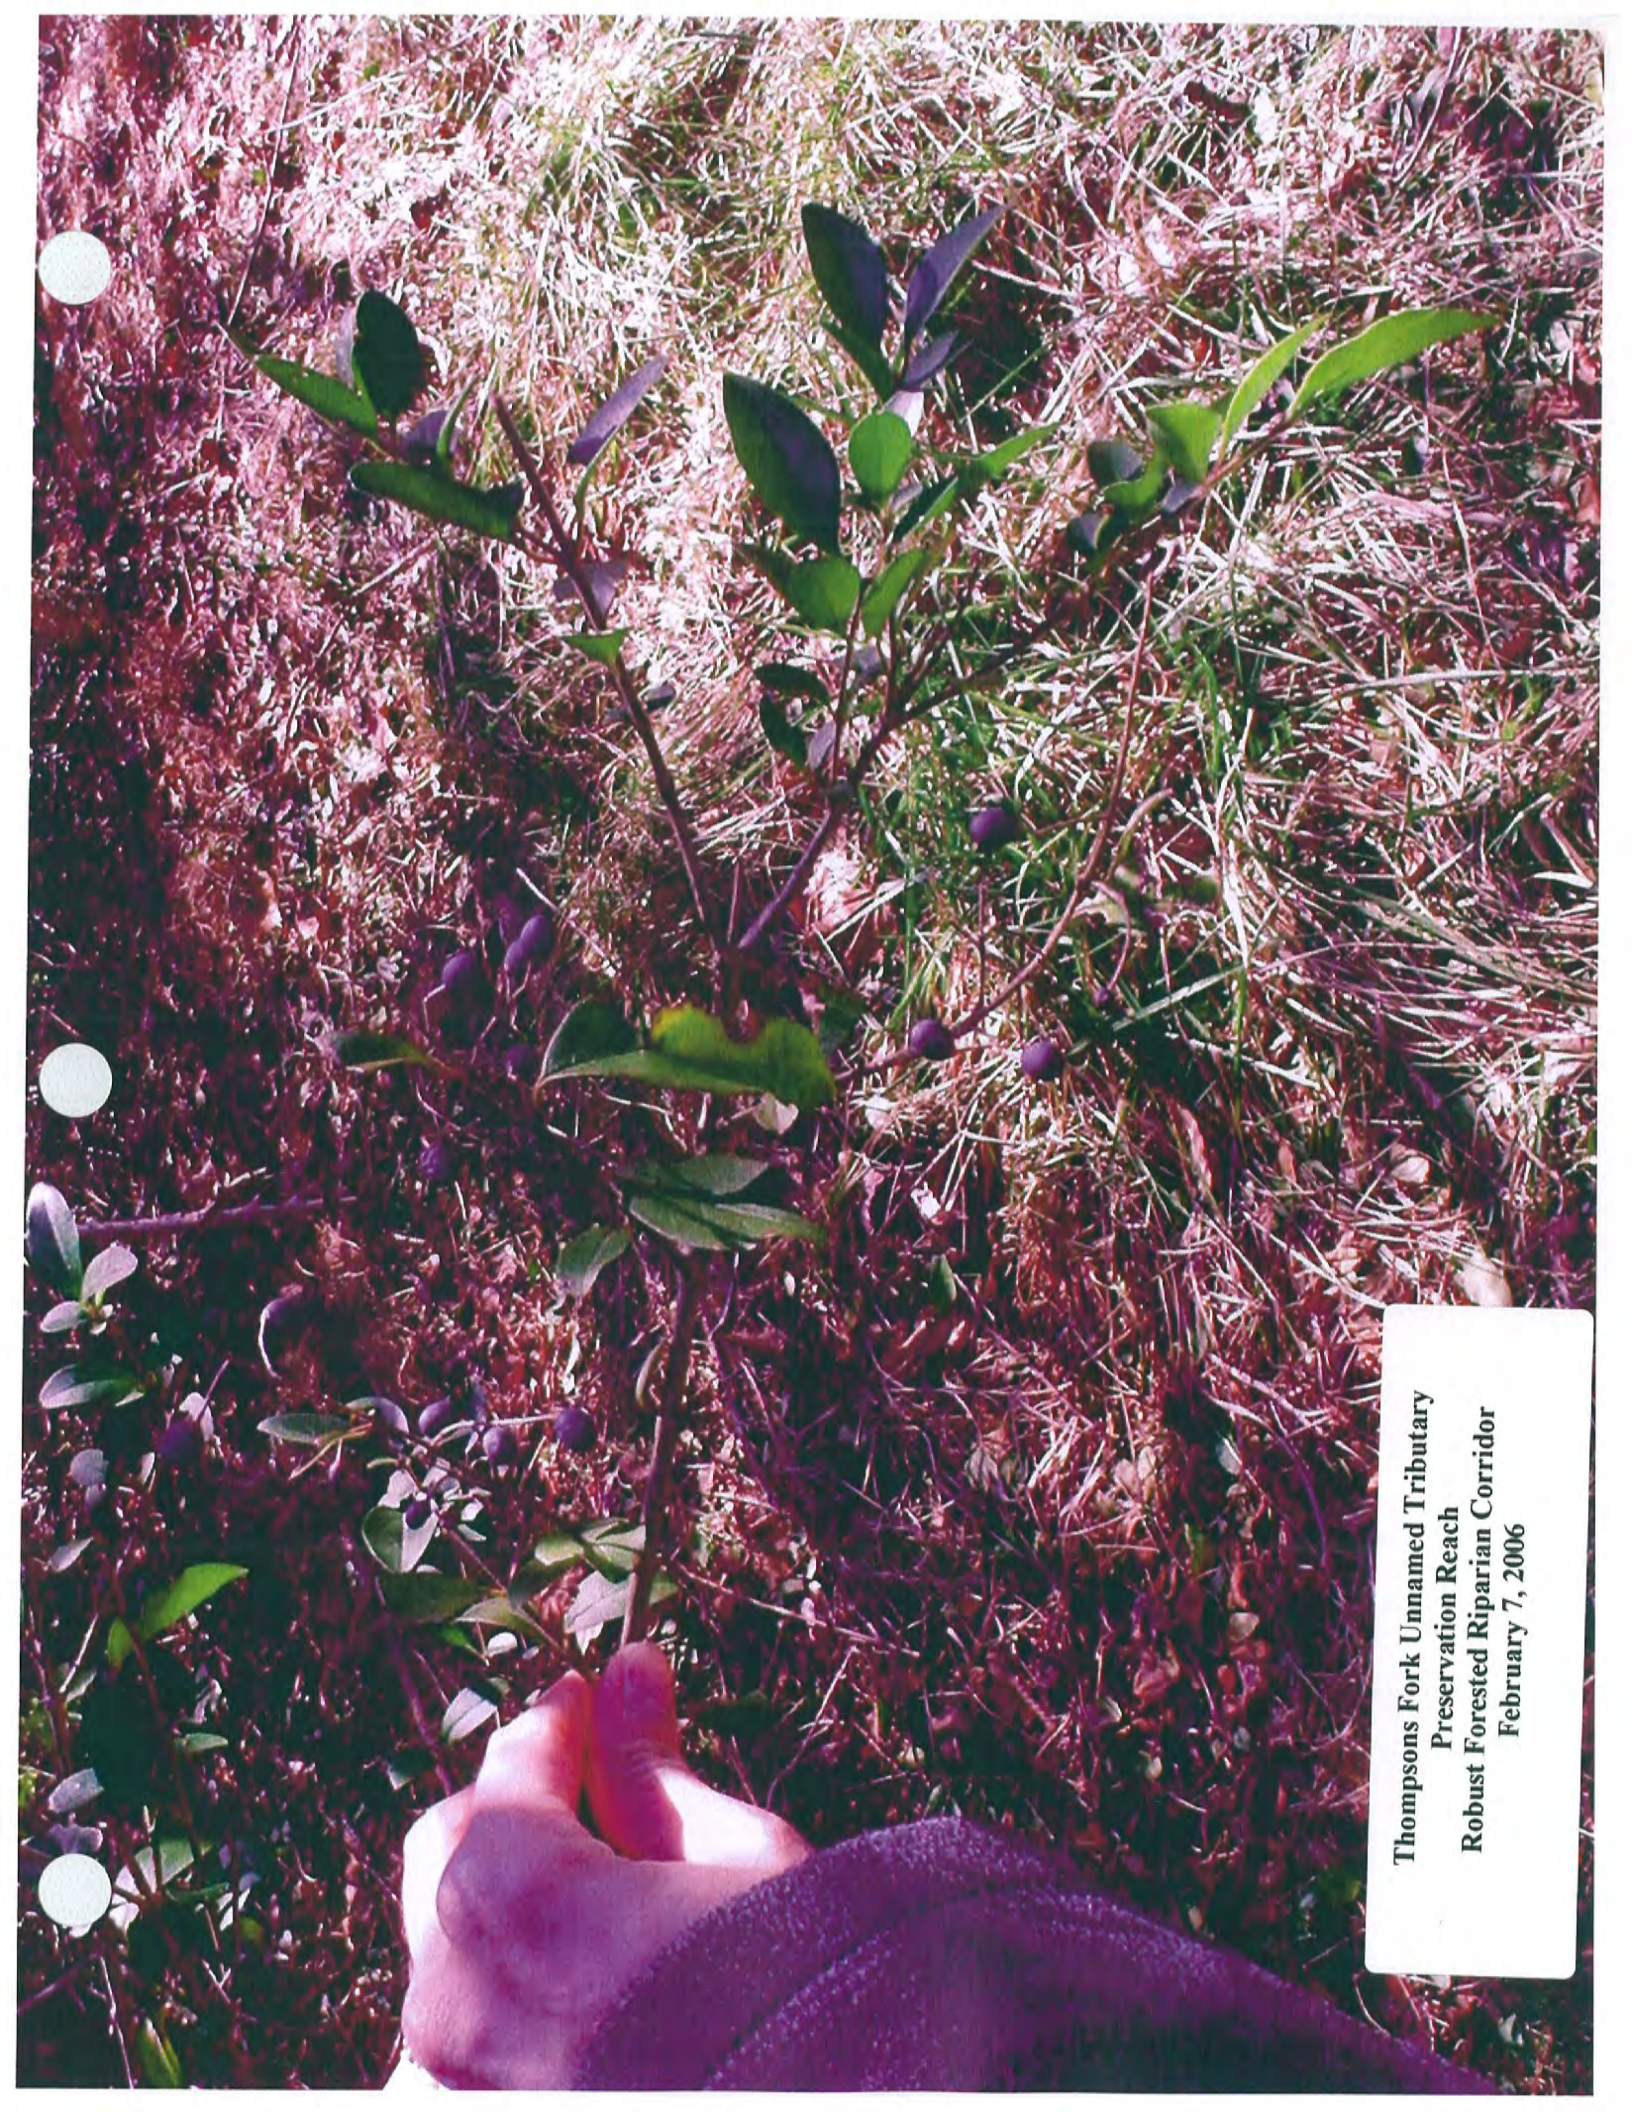
Thompsons Fork Unnamed Tributary  
Preservation Reach  
Robust Forested Riparian Corridor  
February 7, 2006

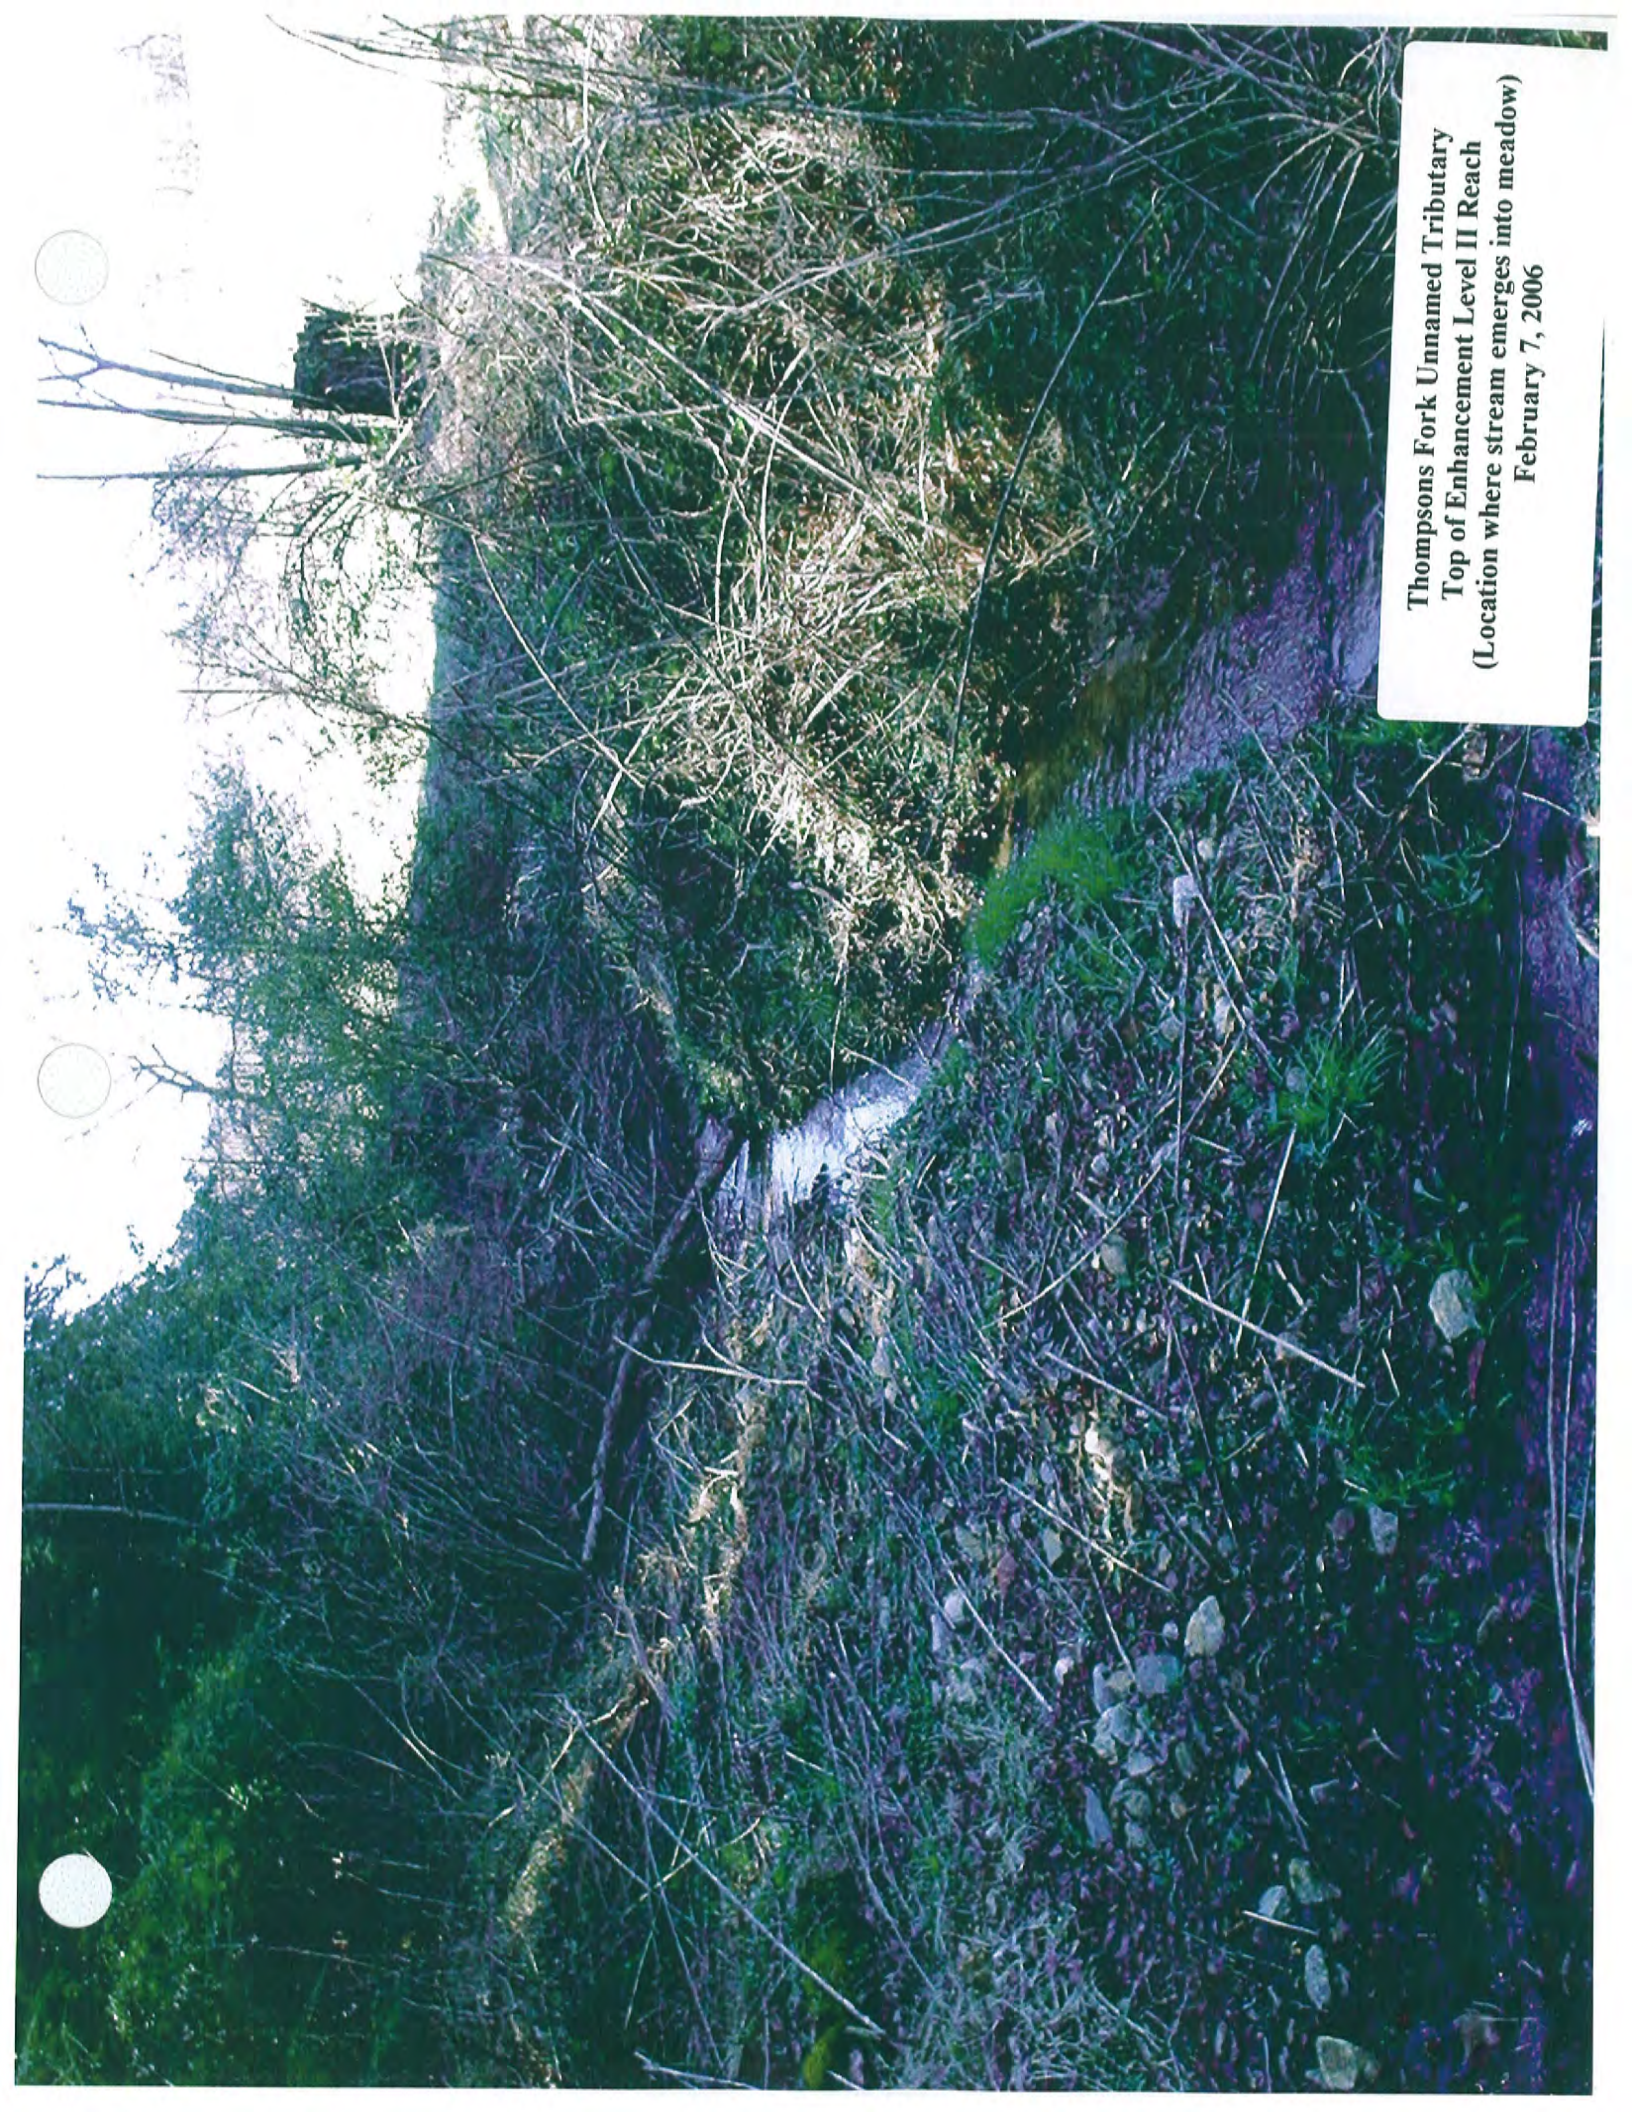
Thompsons Fork Unnamed Tributary  
Top of Enhancement Level II Reach  
(Location where stream emerges into meadow)  
February 7, 2006

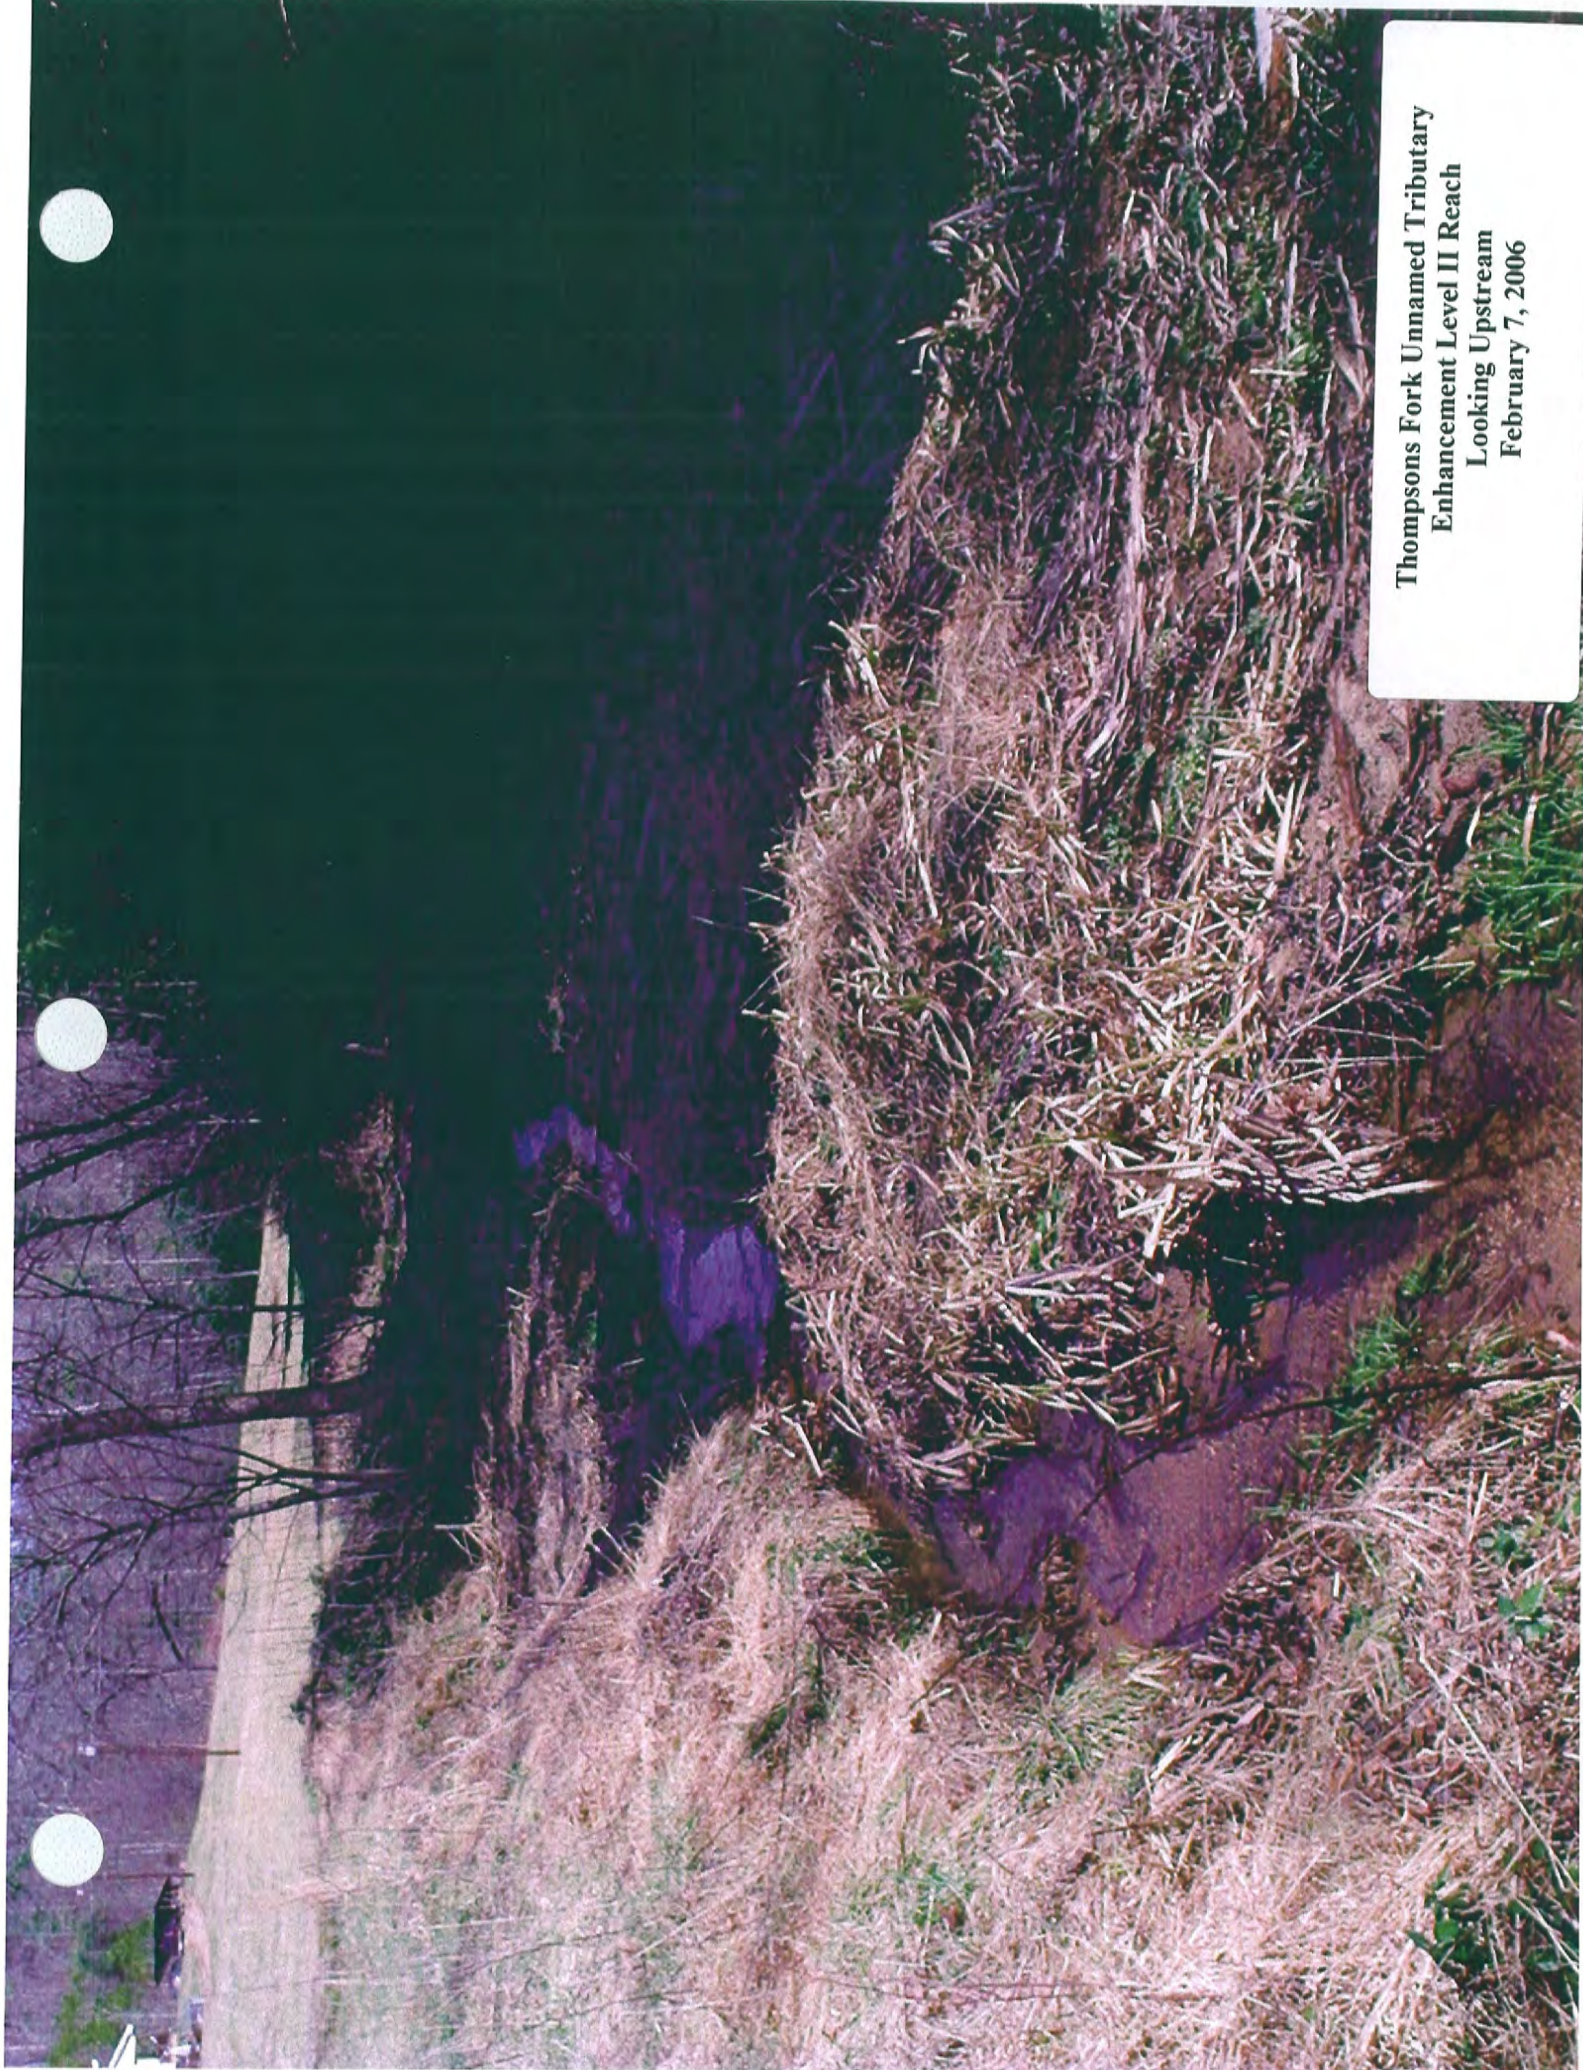
Thompsons Fork Unnamed Tributary  
Enhancement Level II Reach  
Miniature Step-Pools Looking Upstream  
February 7, 2006

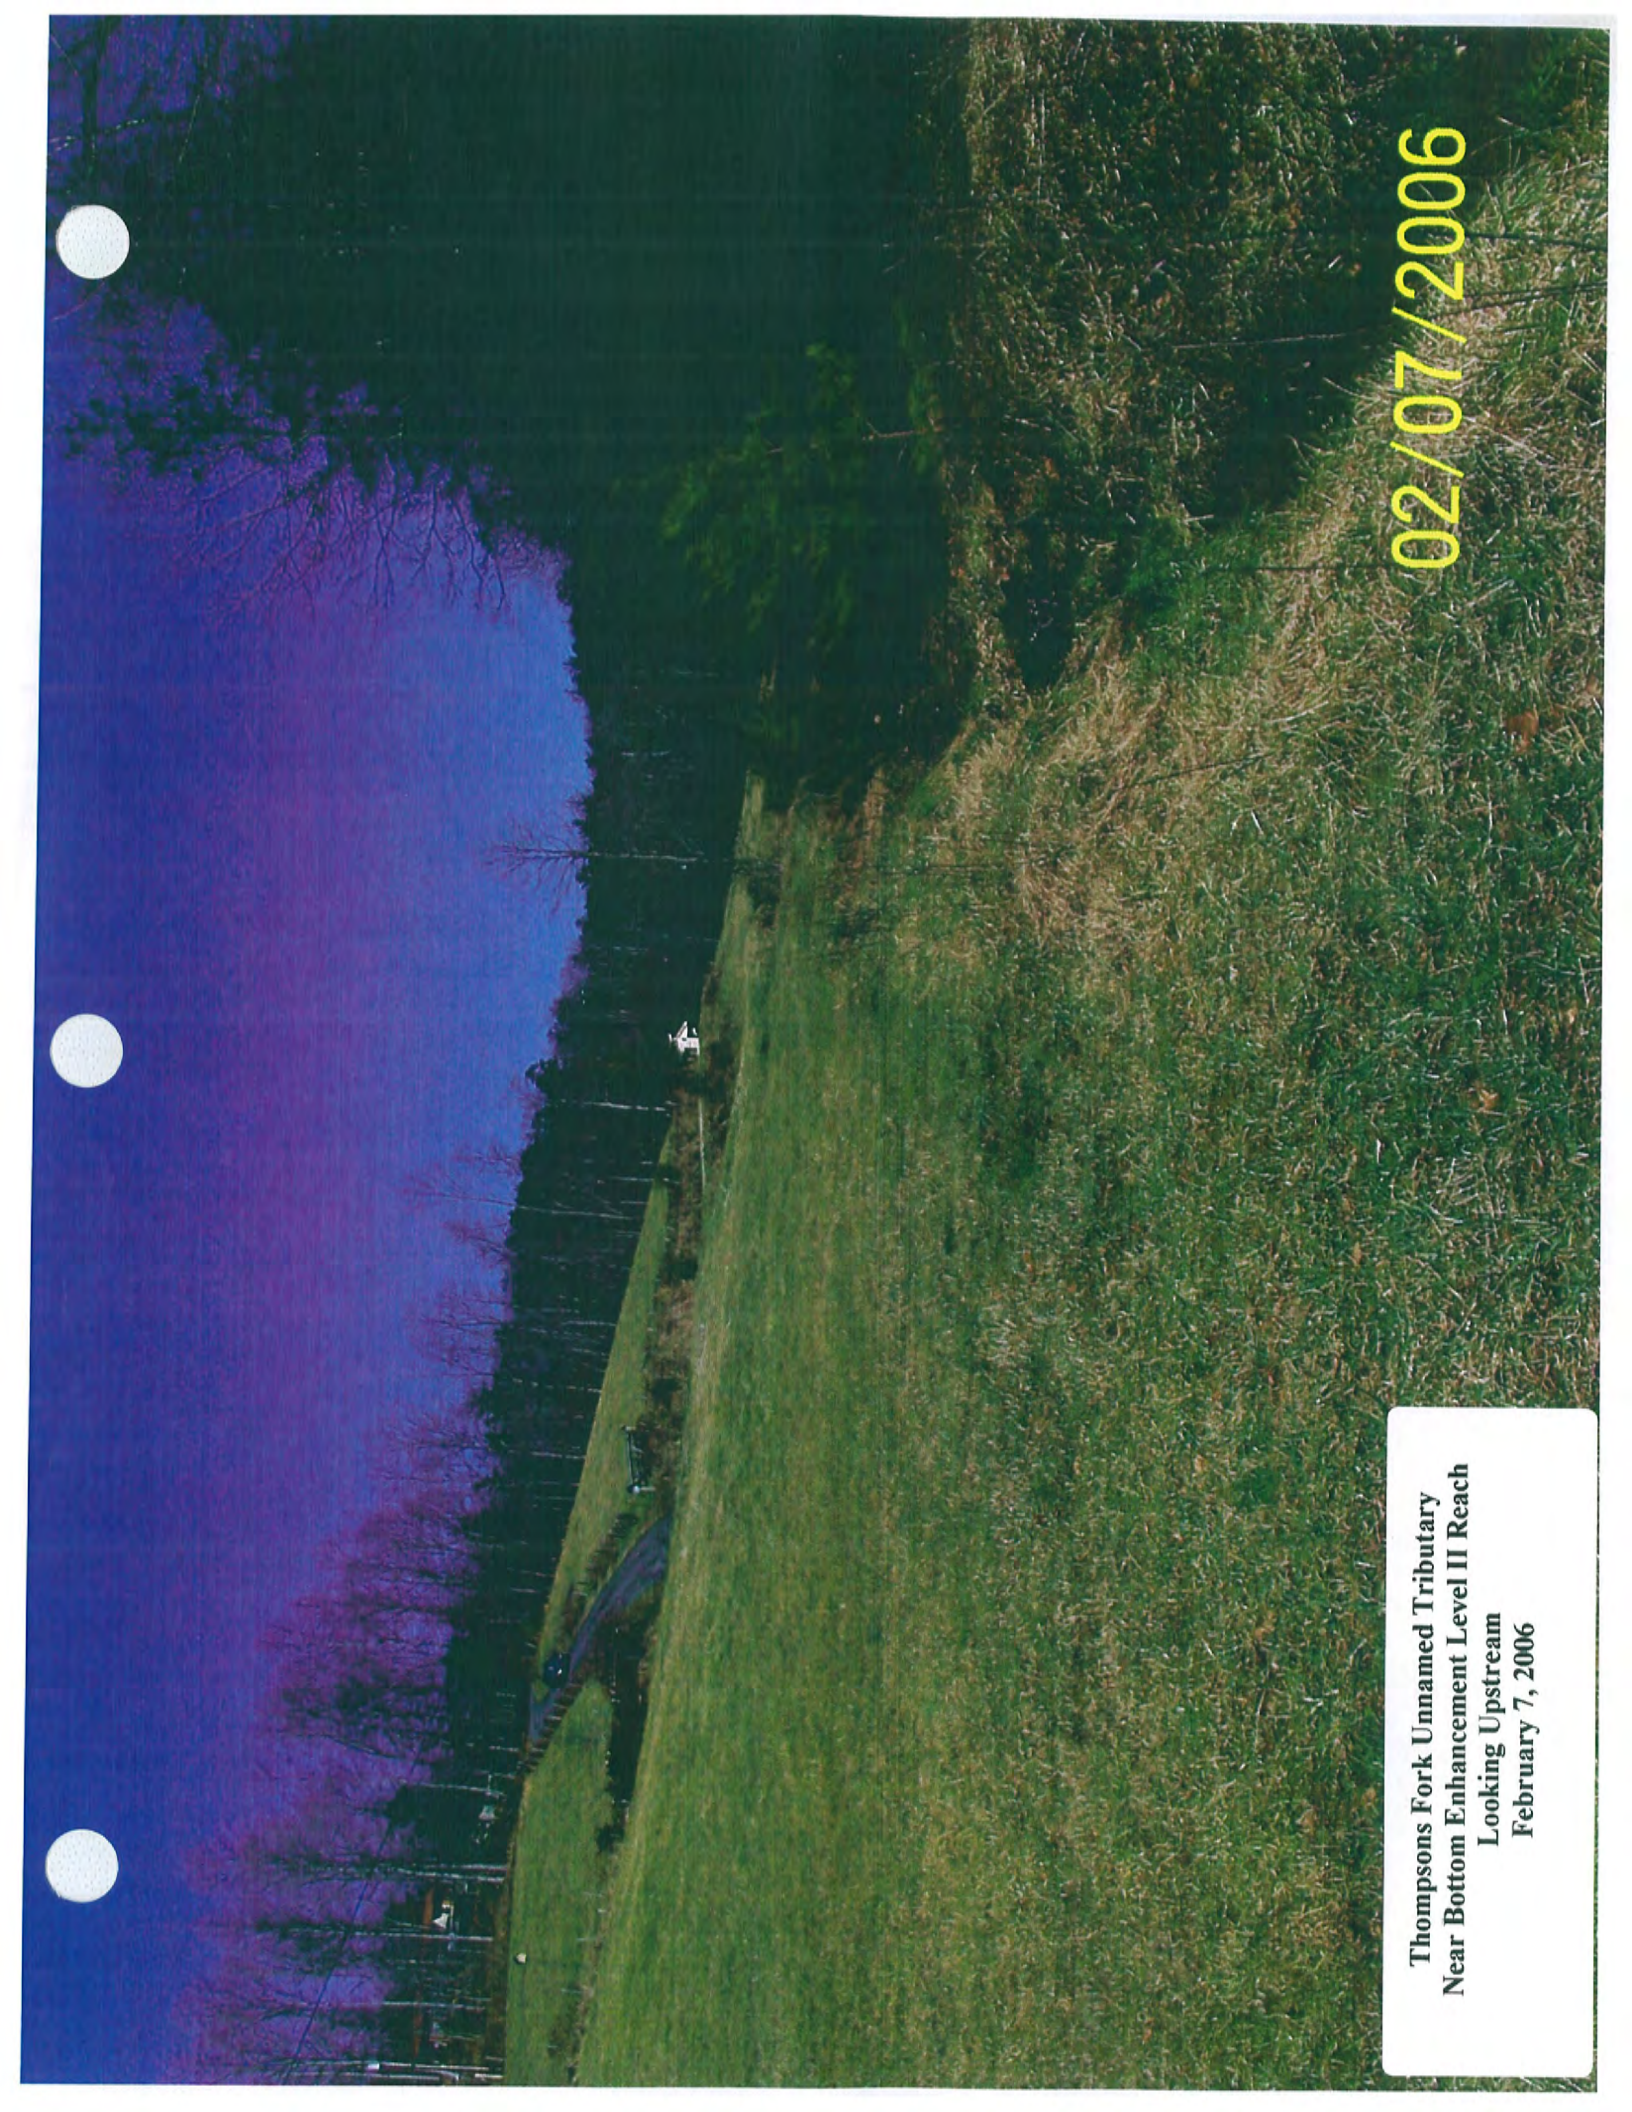
Thompsons Fork Unnamed Tributary  
Near Bottom Enhancement Level II Reach  
Looking Upstream  
February 7, 2006

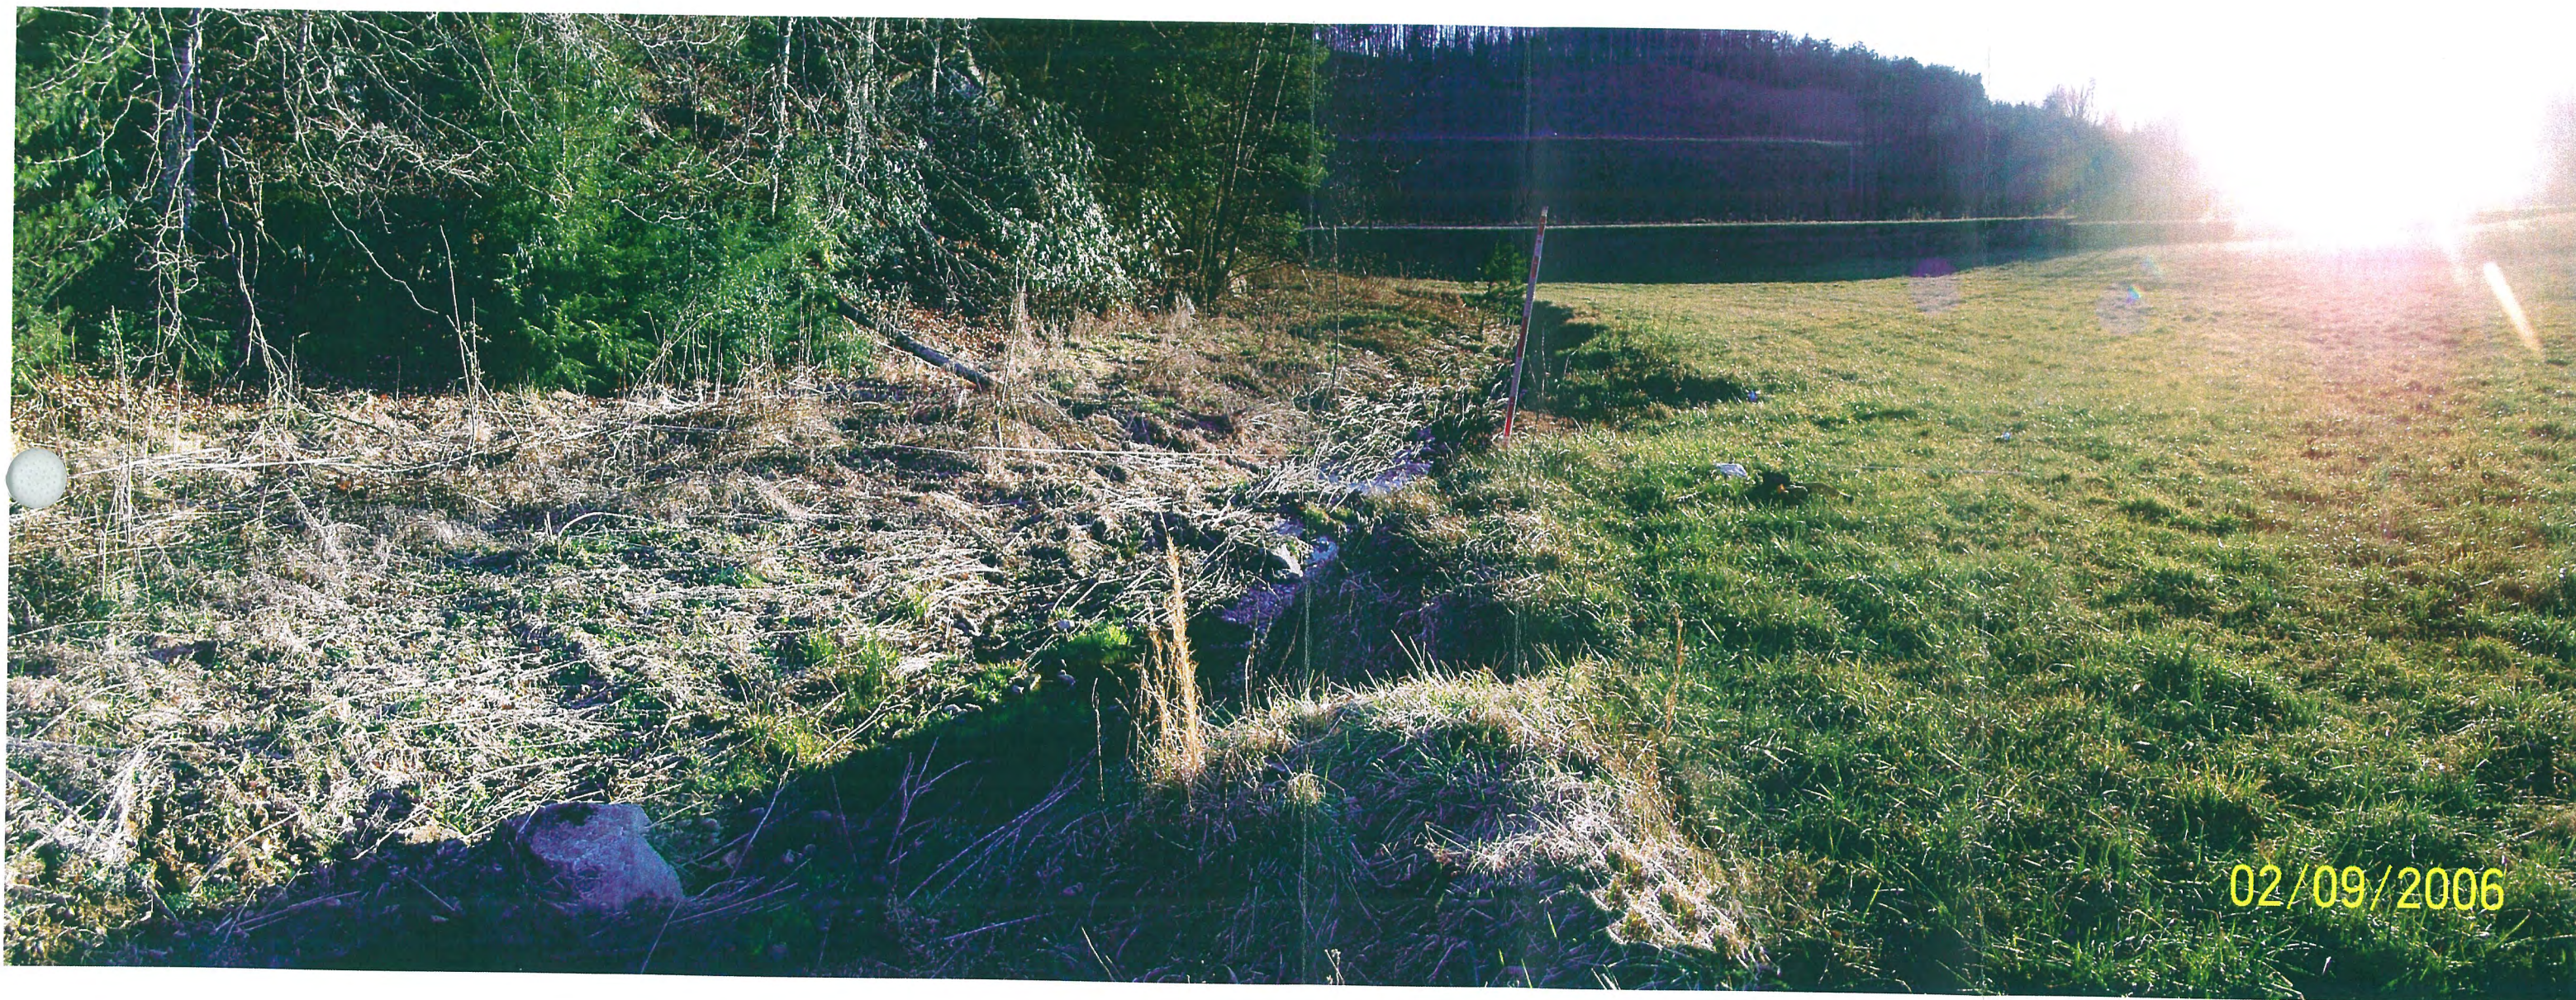
Thompsons Fork Unnamed Tributary  
Priority Level I Restoration Reach  
Looking Downstream  
Existing Conditions Riffle Cross-Section  
February 9, 2006

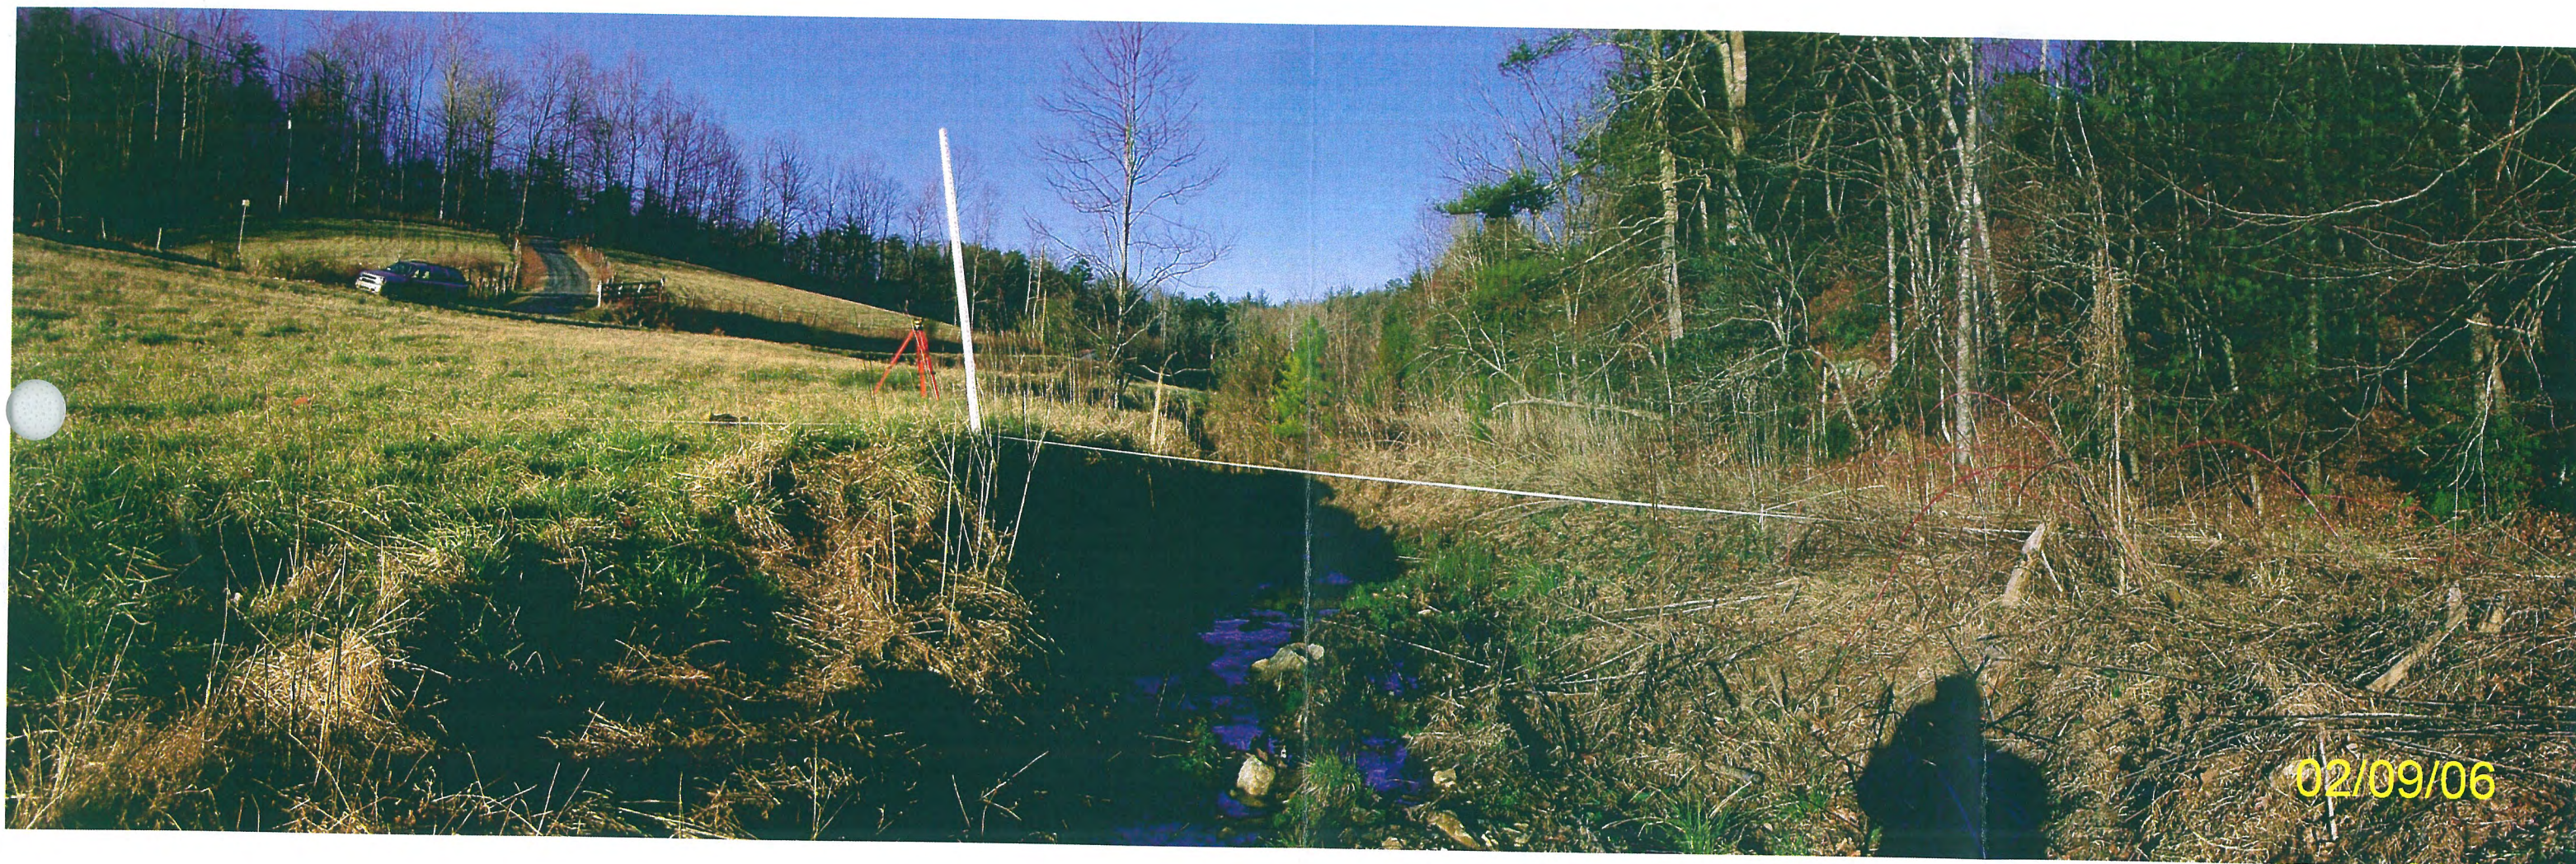
Thompsons Fork Unnamed Tributary  
Priority Level I Restoration Reach  
Looking Upstream  
Existing Conditions Riffle Cross-Section  
February 9, 2006
