**Wetlands Resource Center**  
3970 Bowen Road  
Canal Winchester, Ohio 43110  
Project Manager: Cal Miller  
P: (614) 864-7511  
F: (614) 866-3691

**EMH&T, Inc.**  
5500 New Albany Road  
Columbus, Ohio 43054  
Project Manager: Miles F. Hebert, PE  
P: (614) 775-4205  
F: (614) 775-4802  
Main: (614) 775-4500

## THOMPSONS FORK RESTORATION

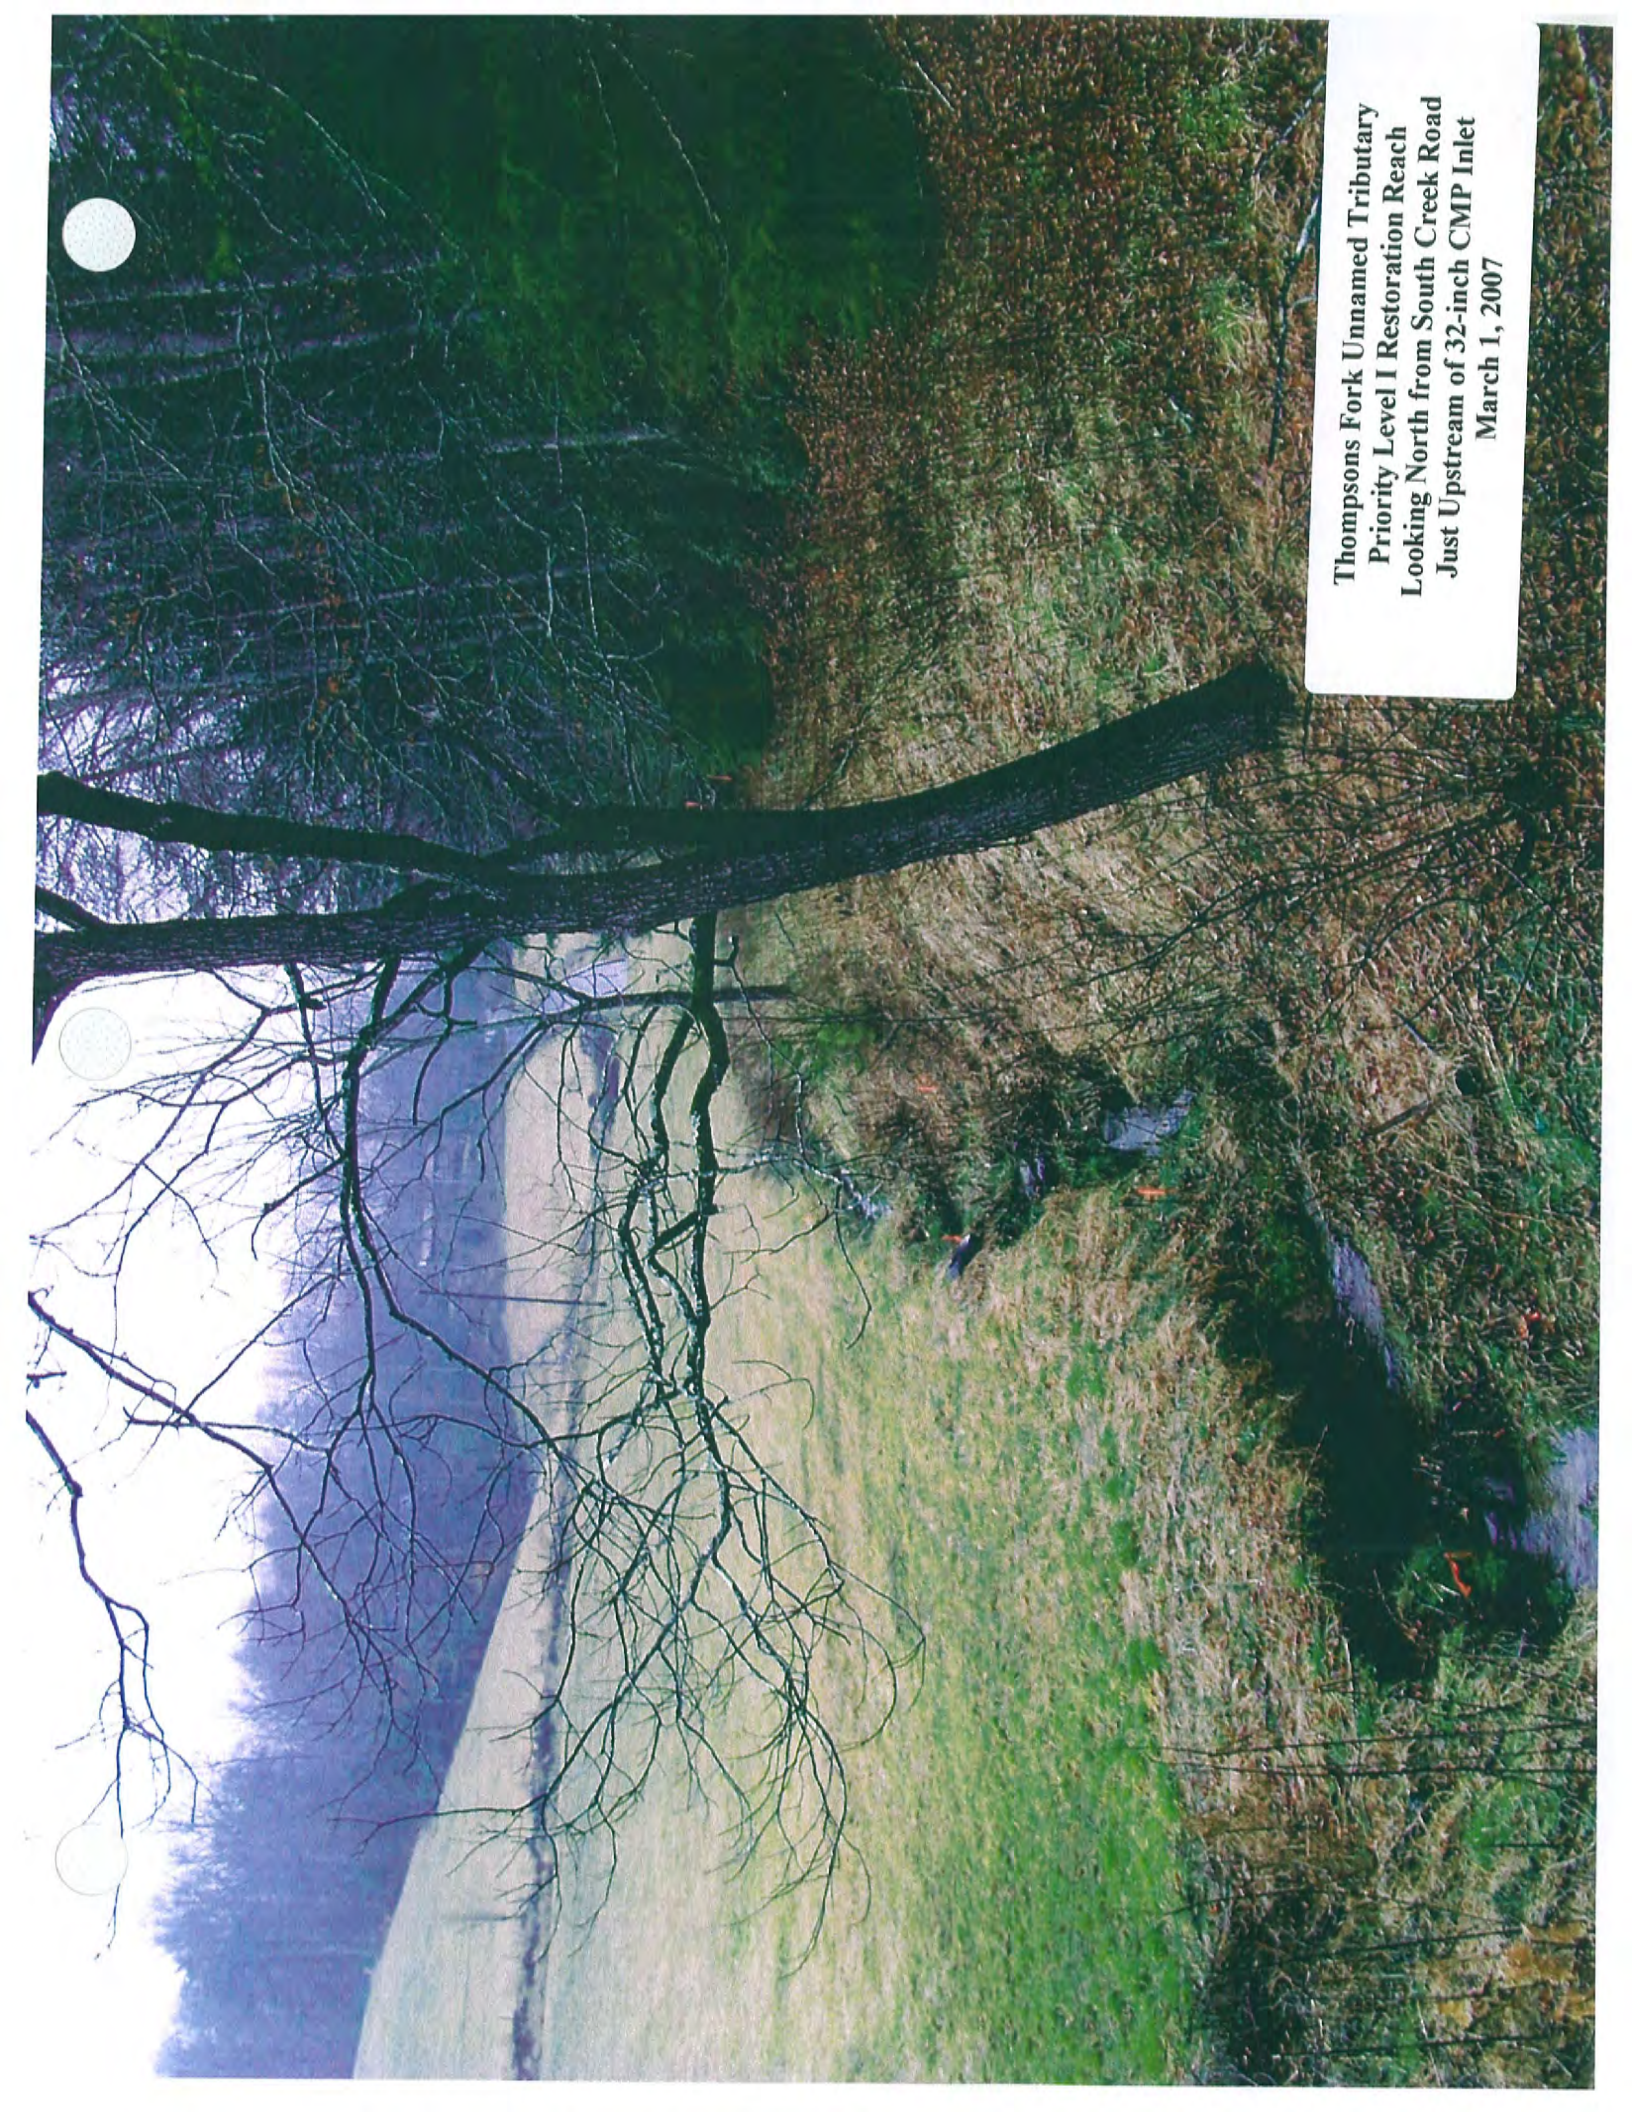
Thompsons Fork Unnamed Tributary  
Priority Level I Restoration Reach  
Looking North from South Creek Road  
Just Upstream of 32-inch CMP Inlet  
March 1, 2007

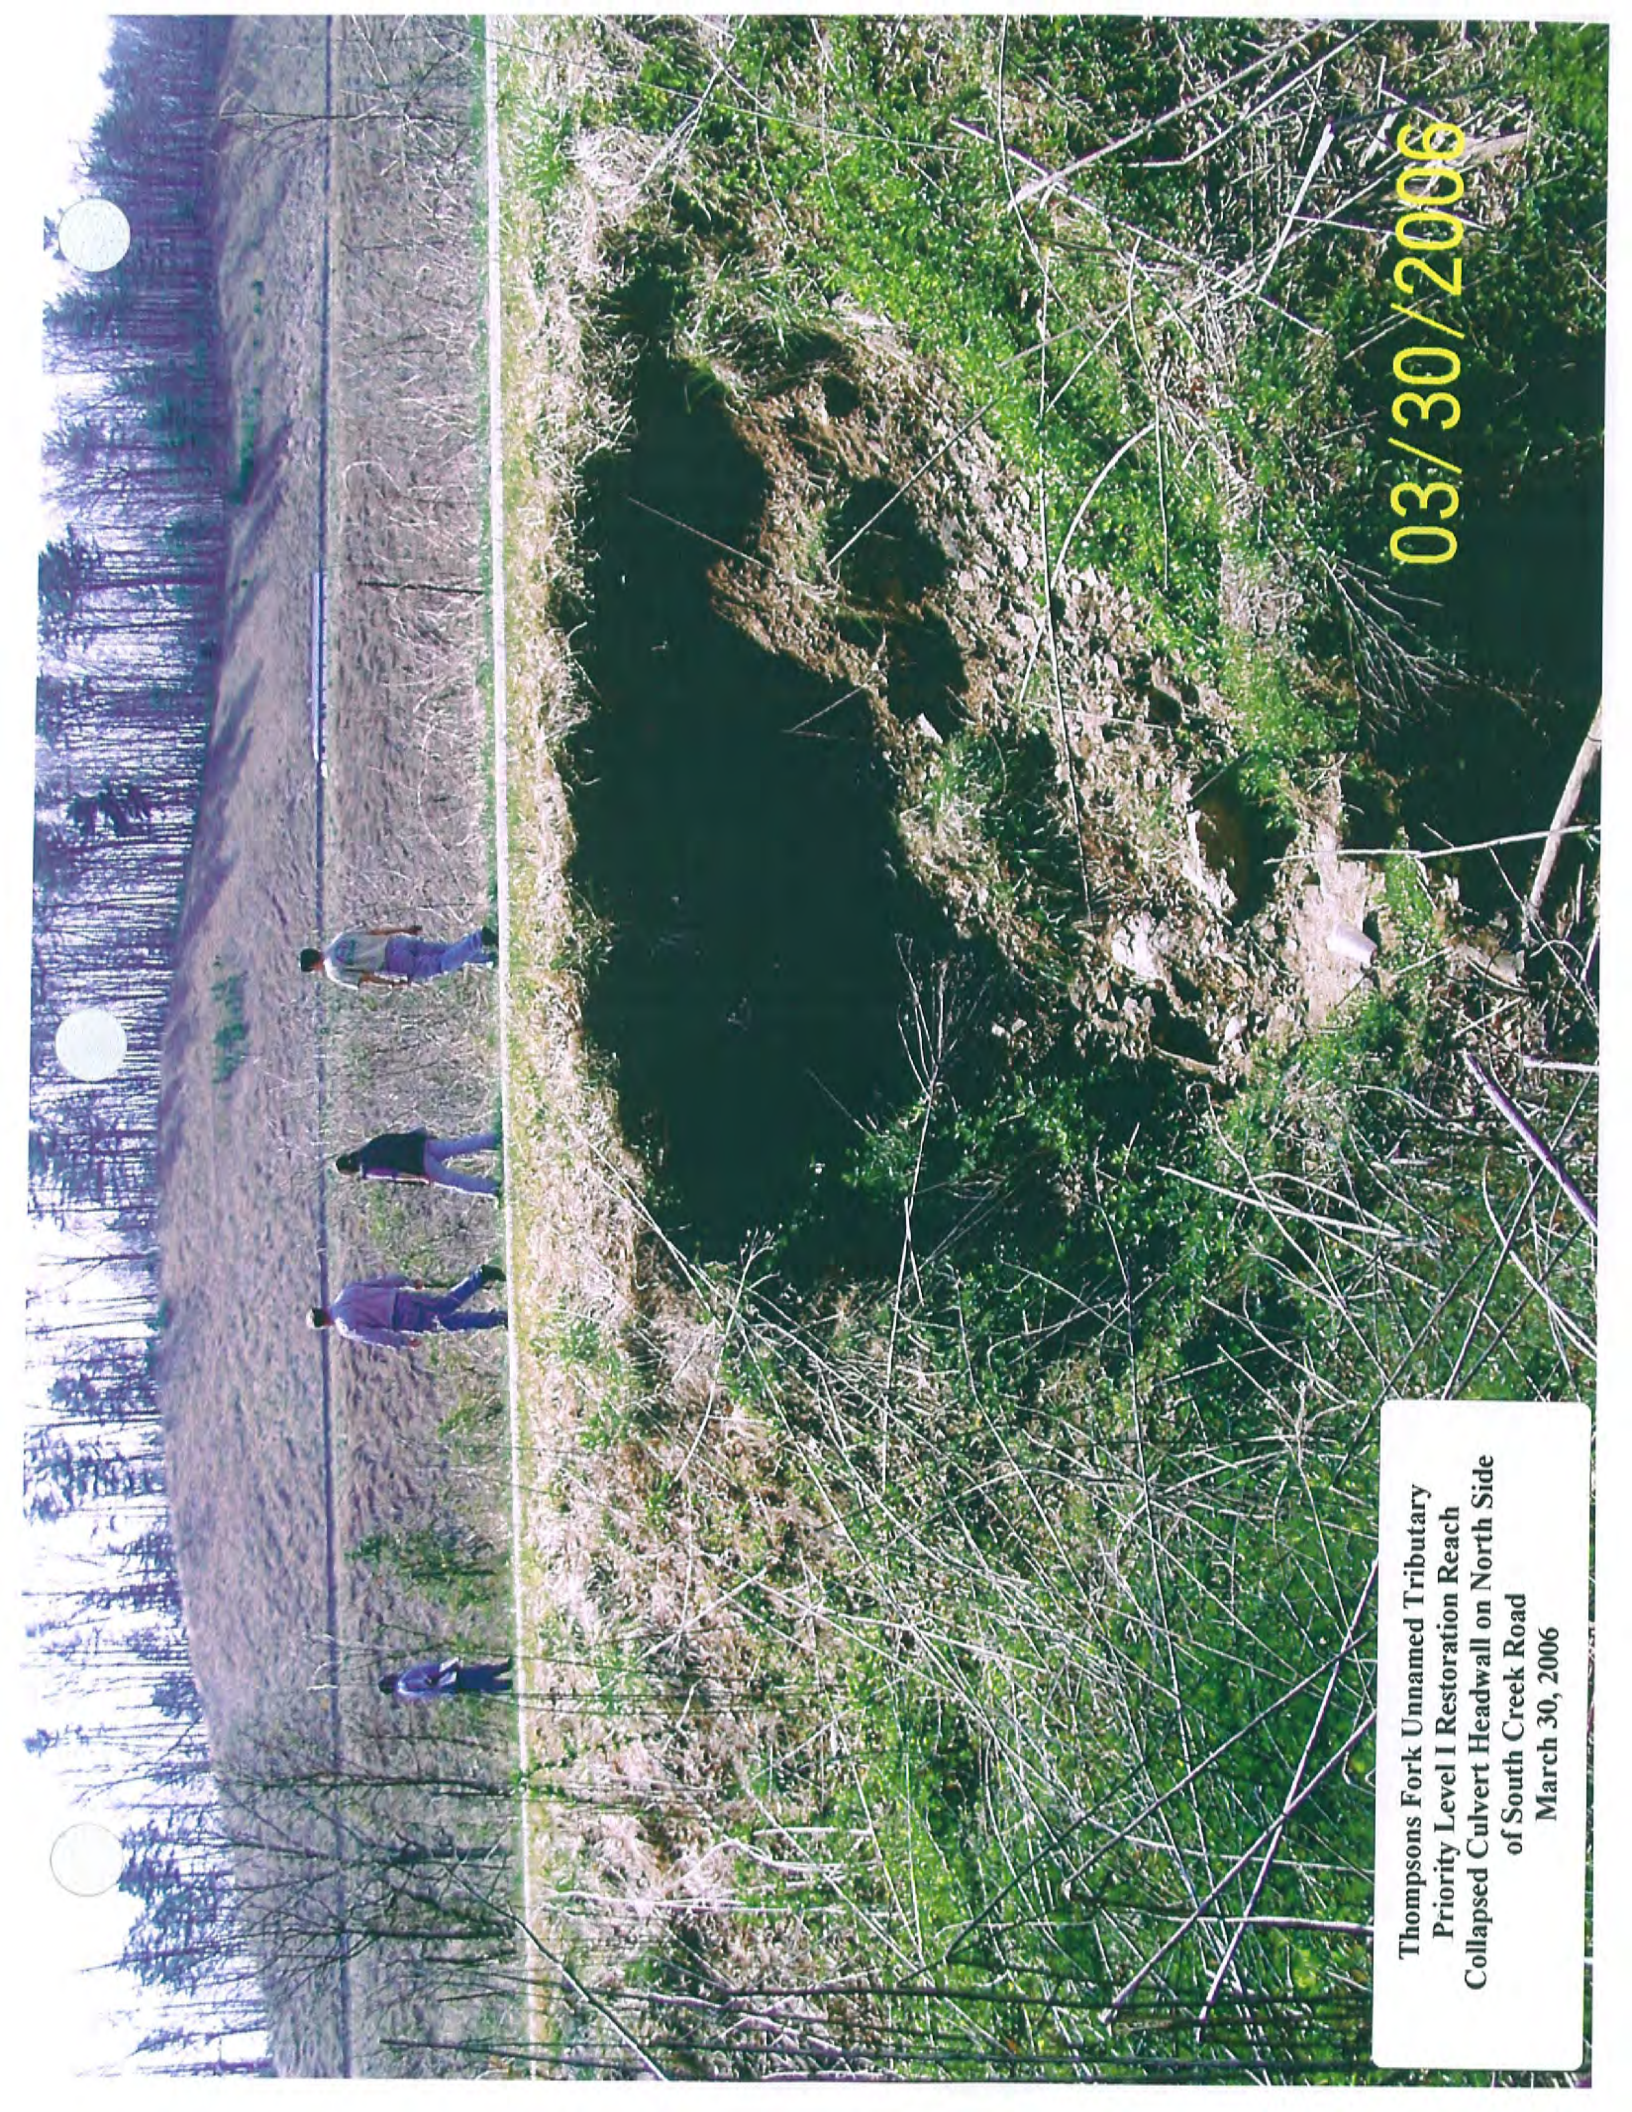
03/30/2006

Thompsons Fork Unnamed Tributary  
Priority Level I Restoration Reach  
Collapsed Culvert Headwall on North Side  
of South Creek Road  
March 30, 2006

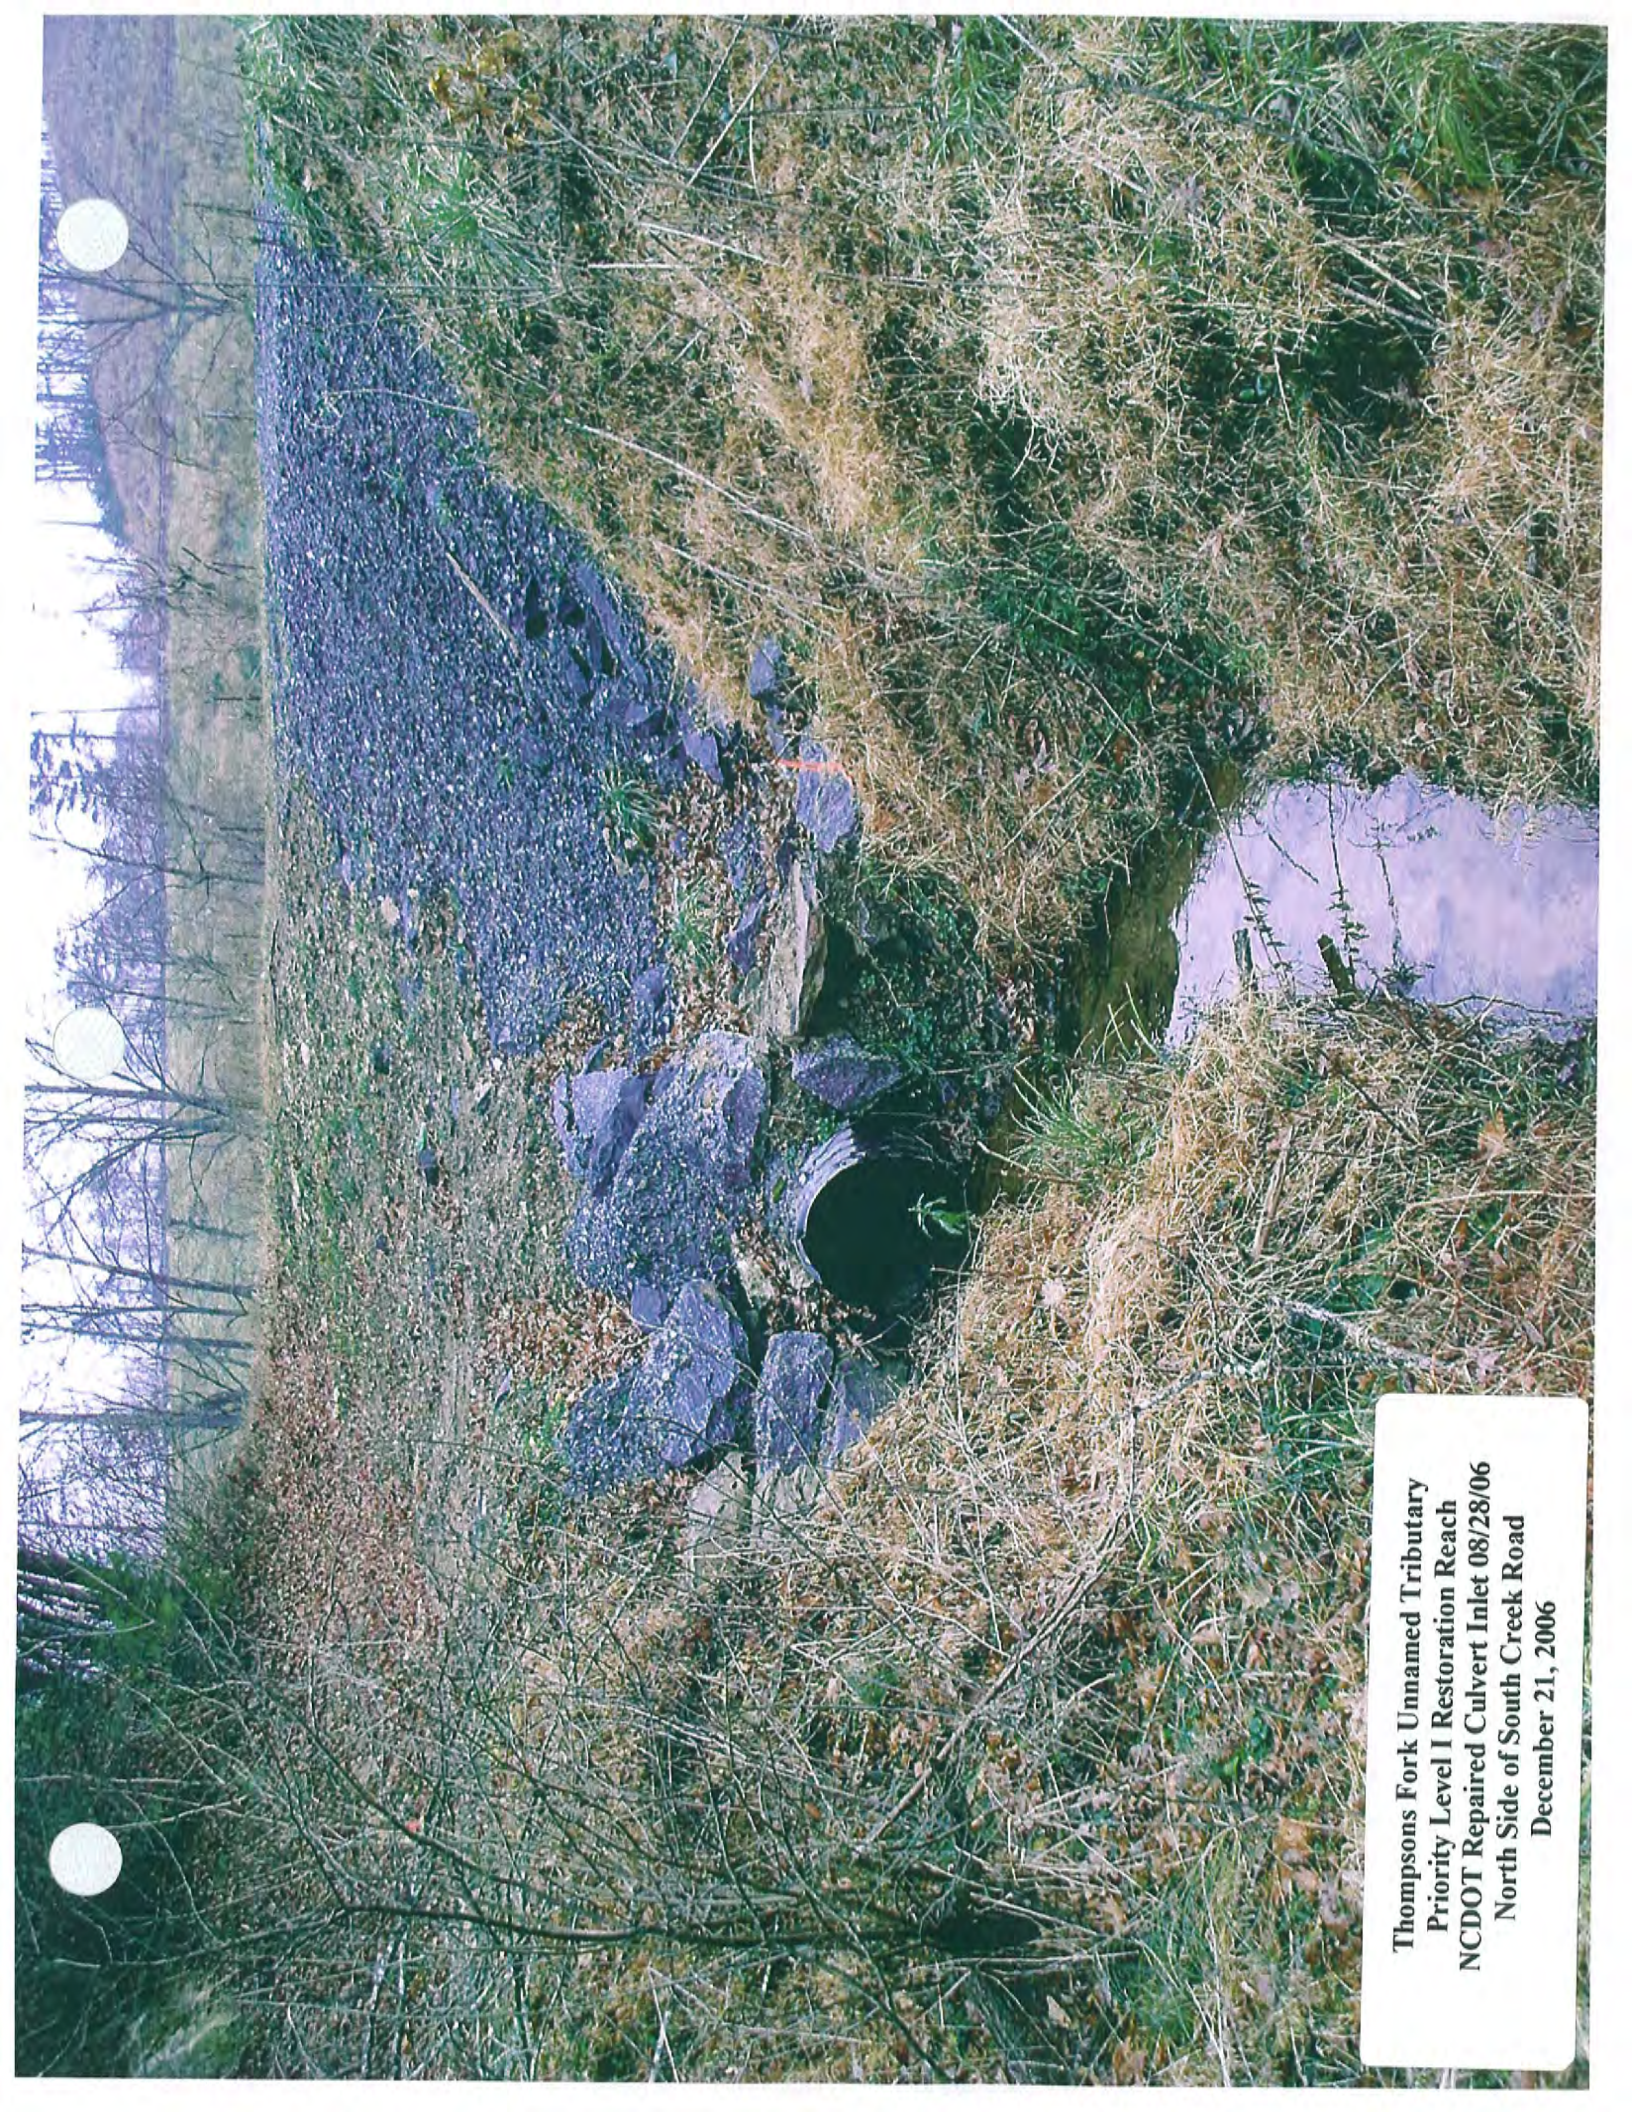
Thompsons Fork Unnamed Tributary  
Priority Level I Restoration Reach  
NCDOT Repaired Culvert Inlet 08/28/06  
North Side of South Creek Road  
December 21, 2006

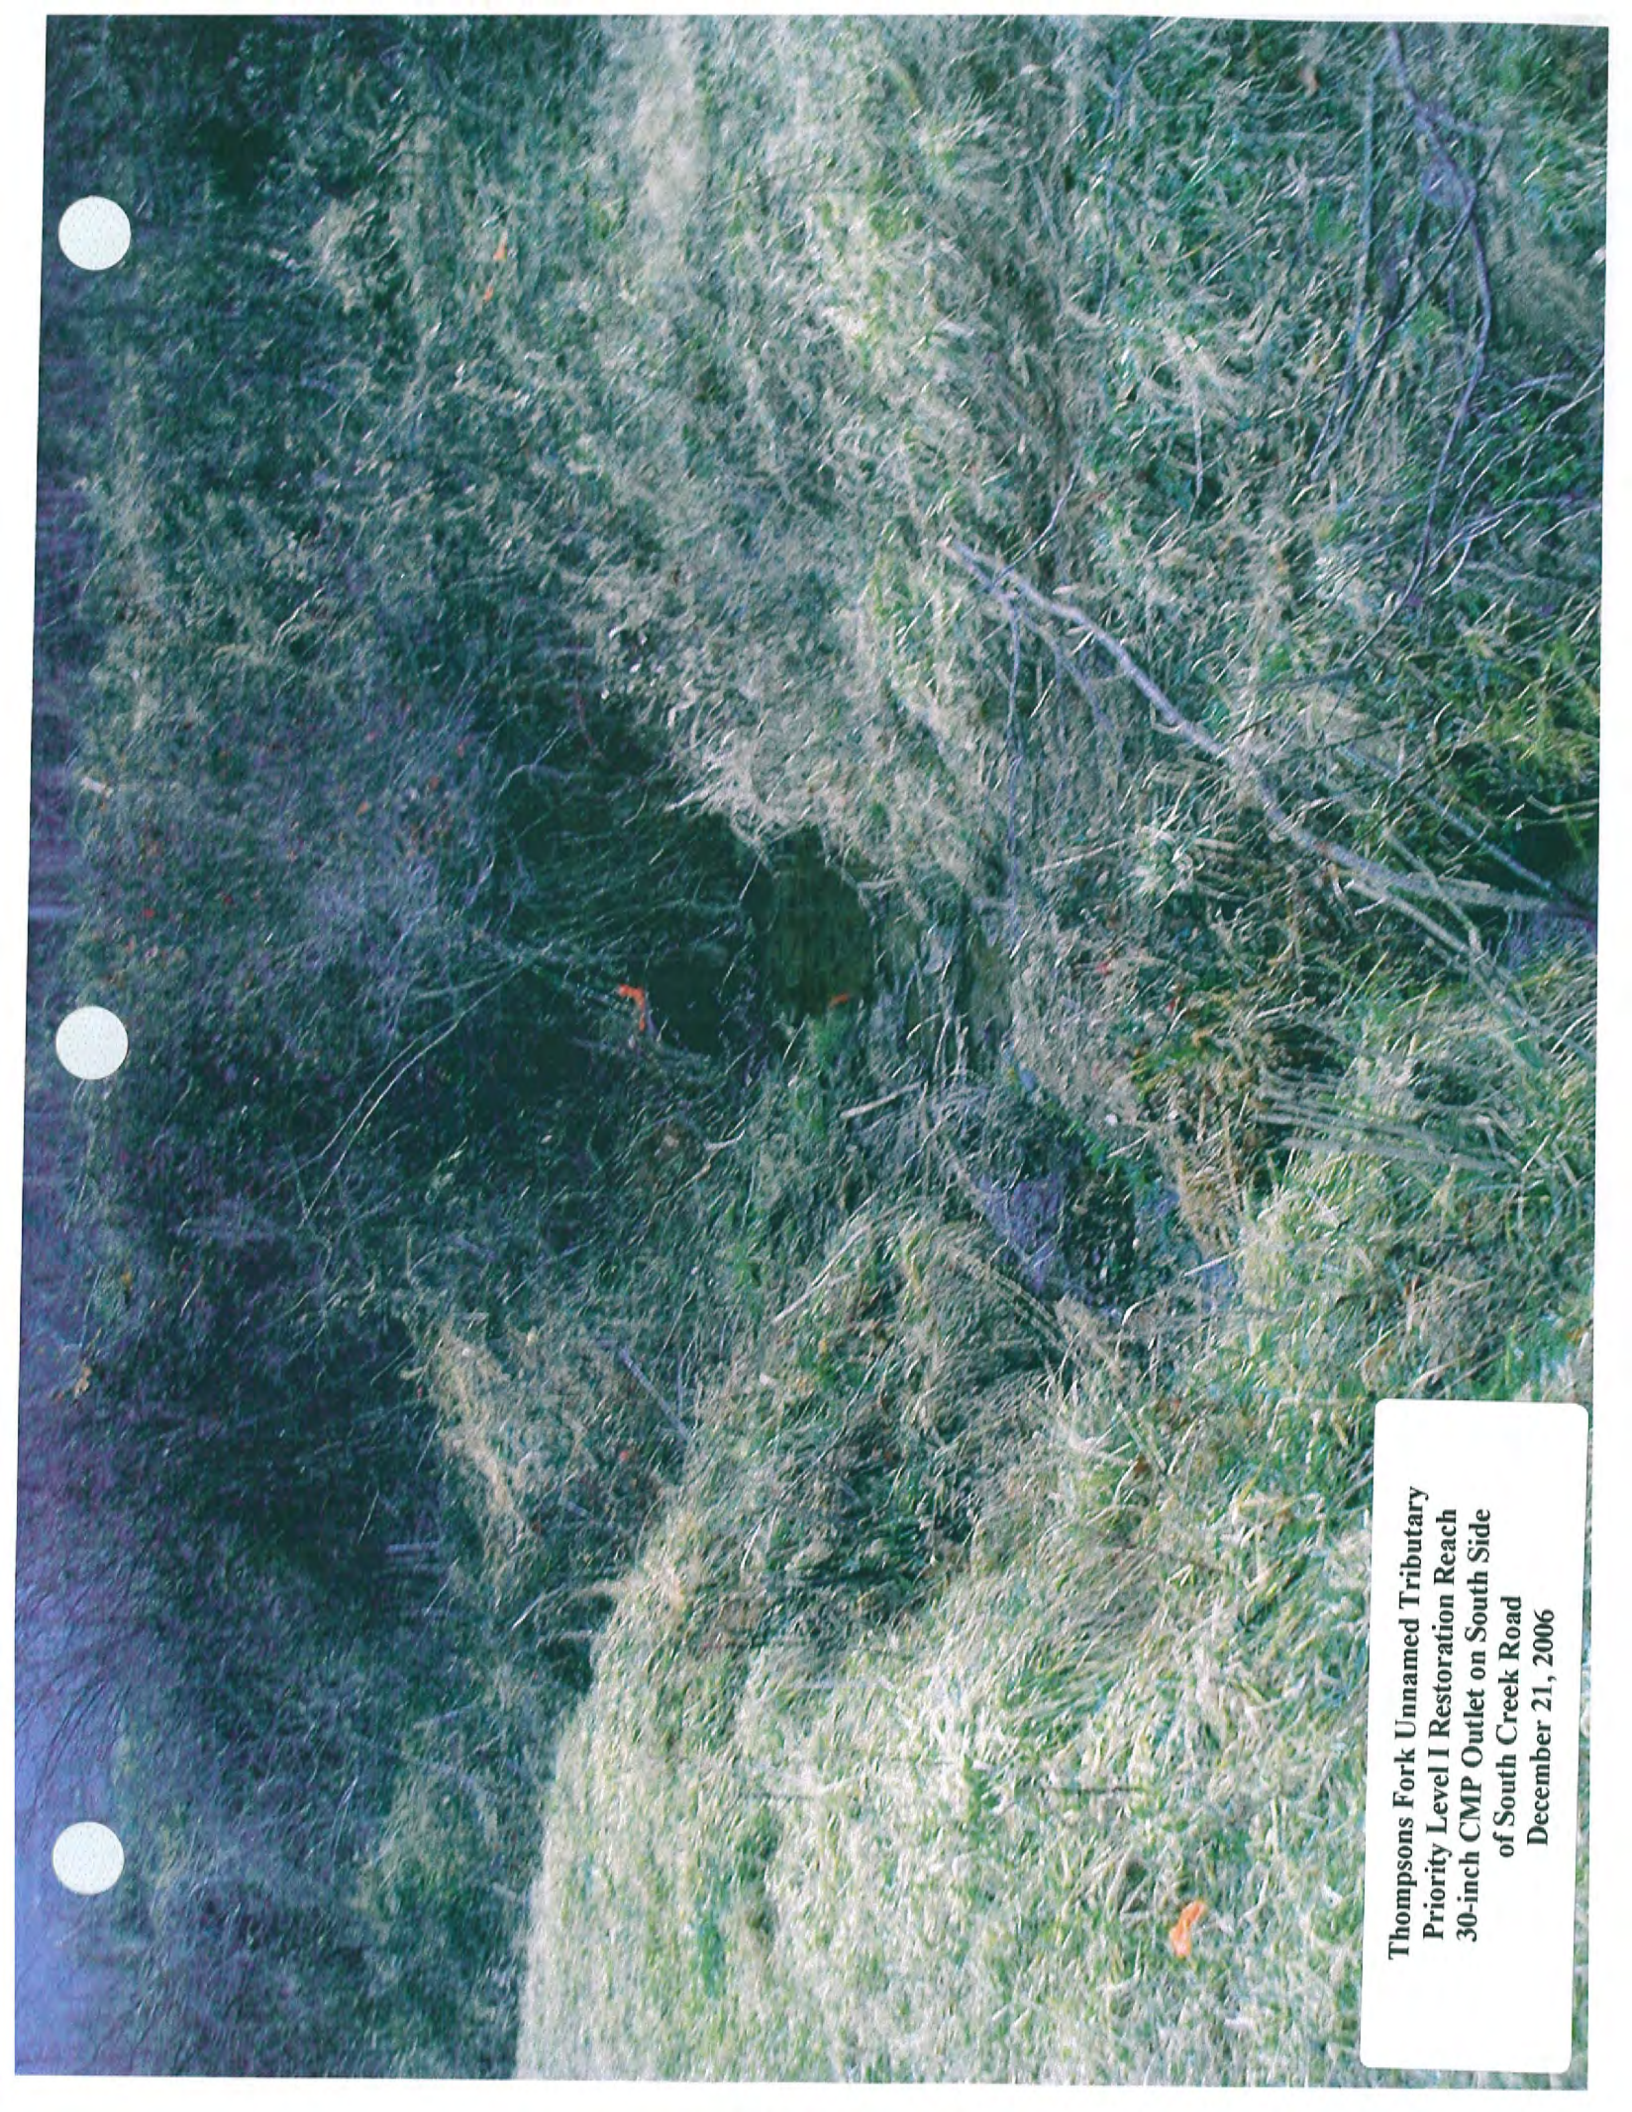
Thompsons Fork Unnamed Tributary  
Priority Level I Restoration Reach  
30-inch CMP Outlet on South Side  
of South Creek Road  
December 21, 2006

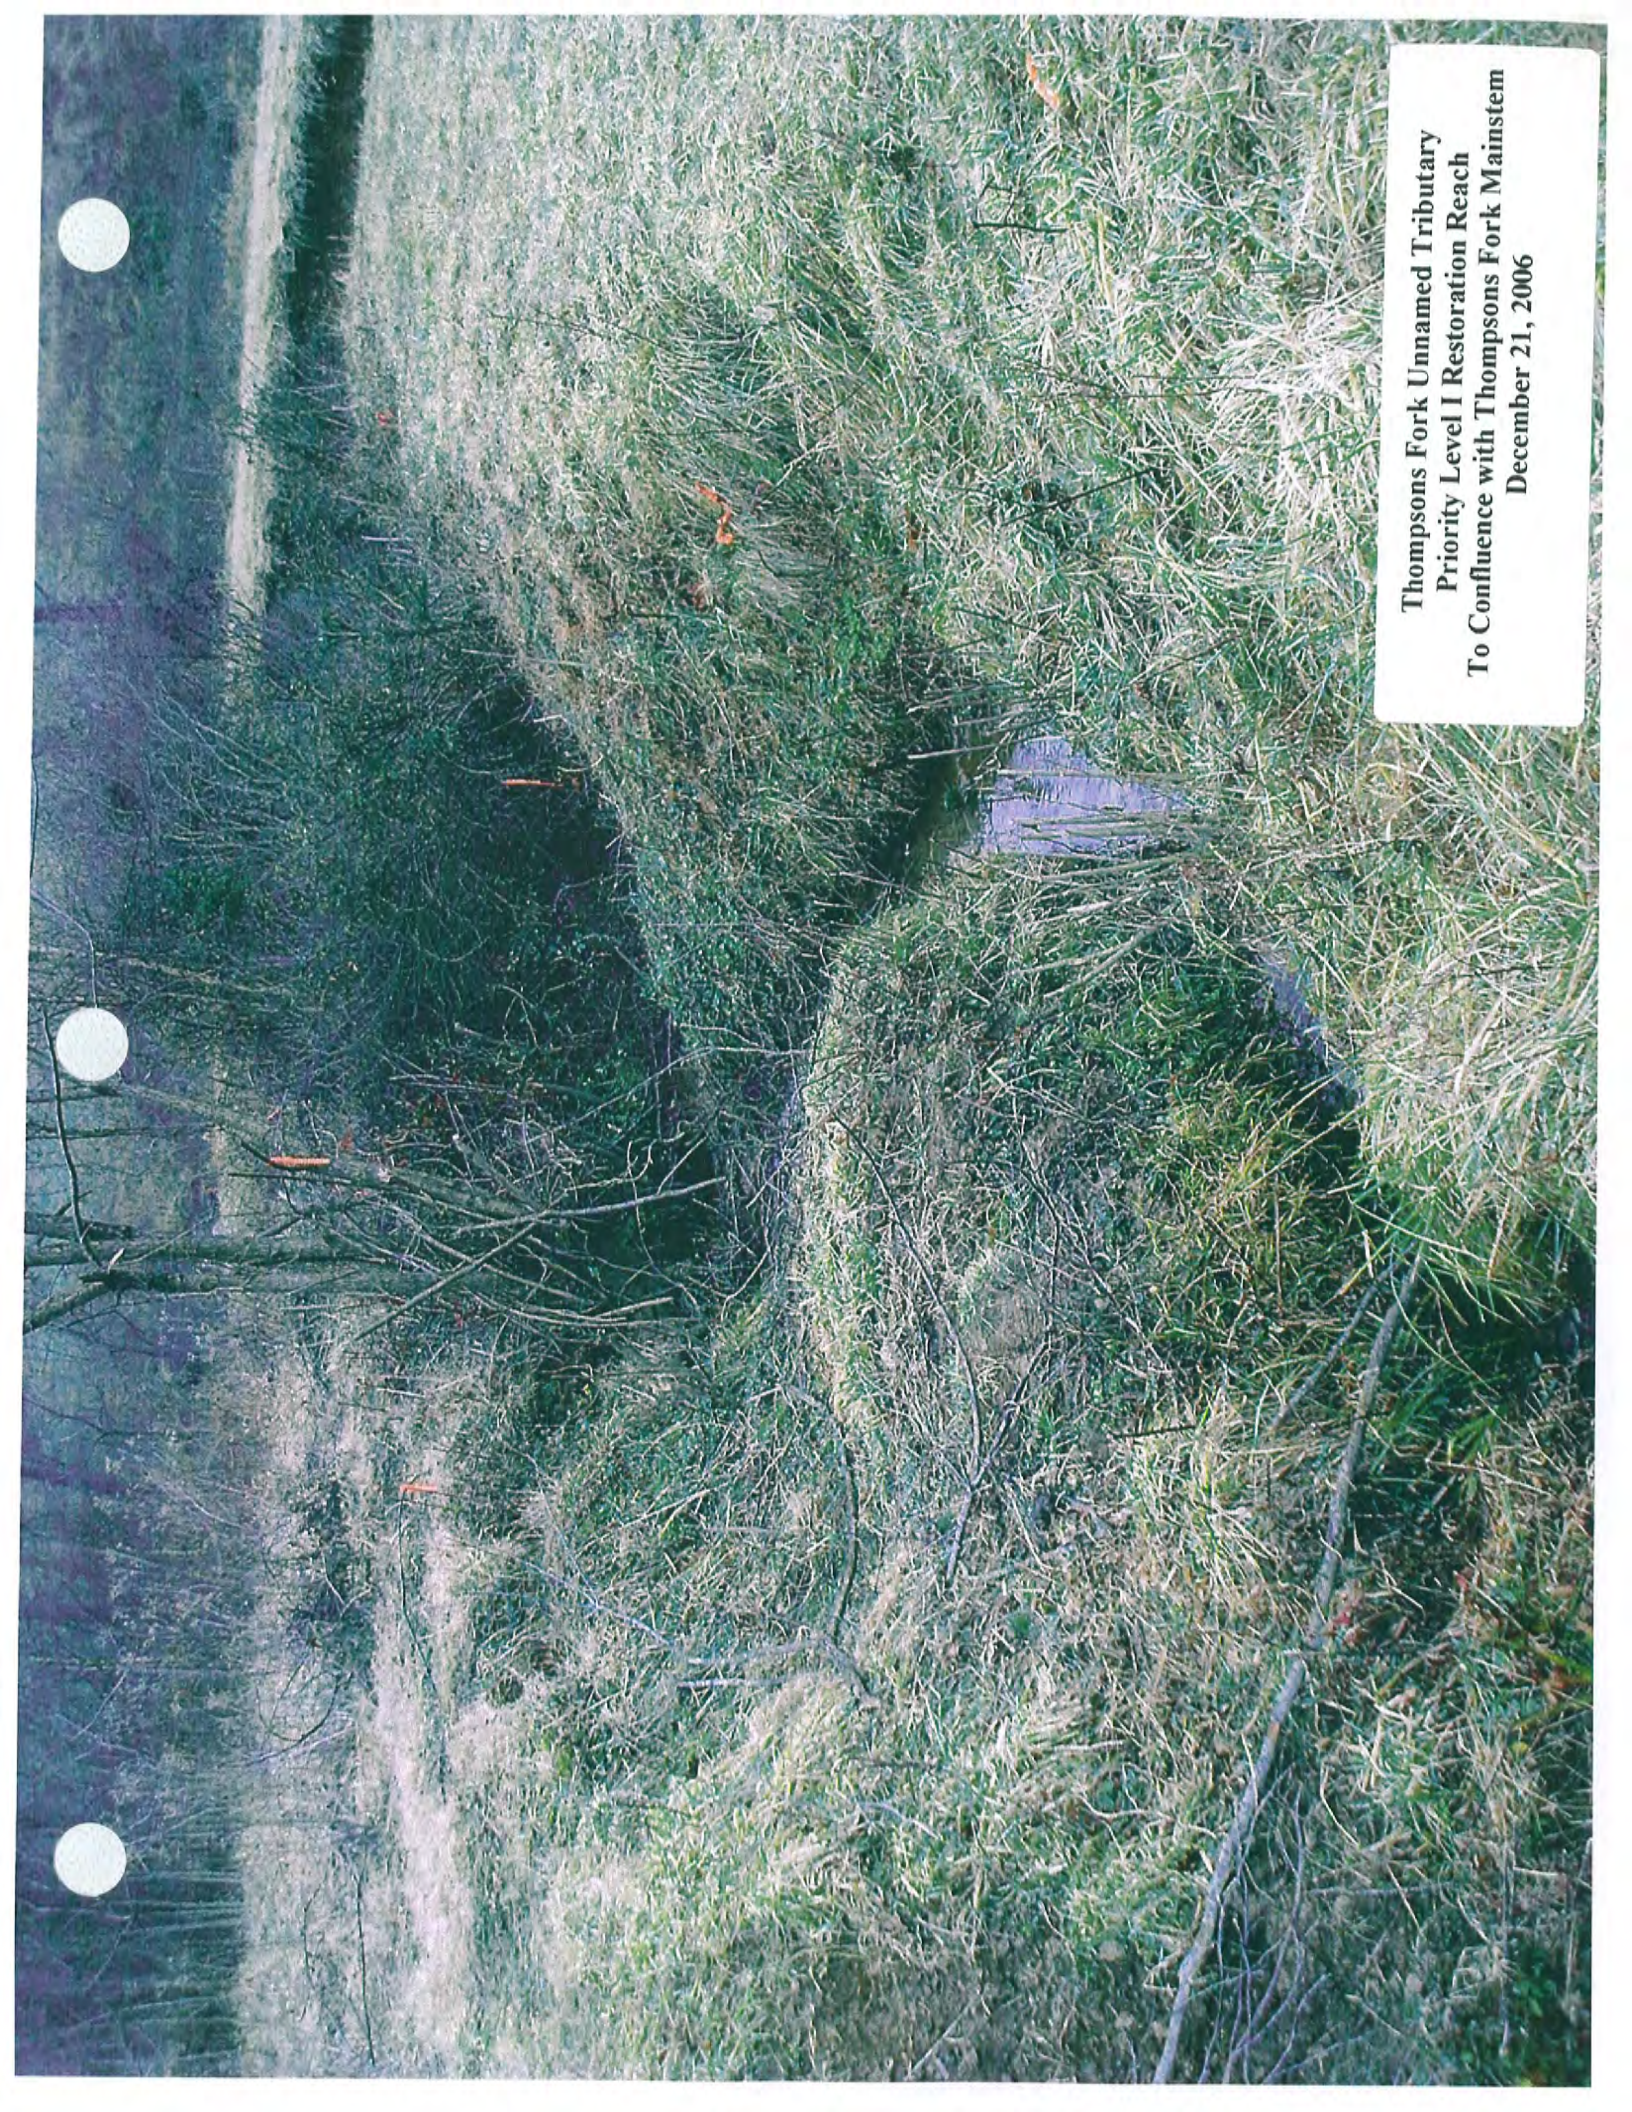
Thompsons Fork Unnamed Tributary  
Priority Level I Restoration Reach  
To Confluence with Thompsons Fork Mainstem  
December 21, 2006

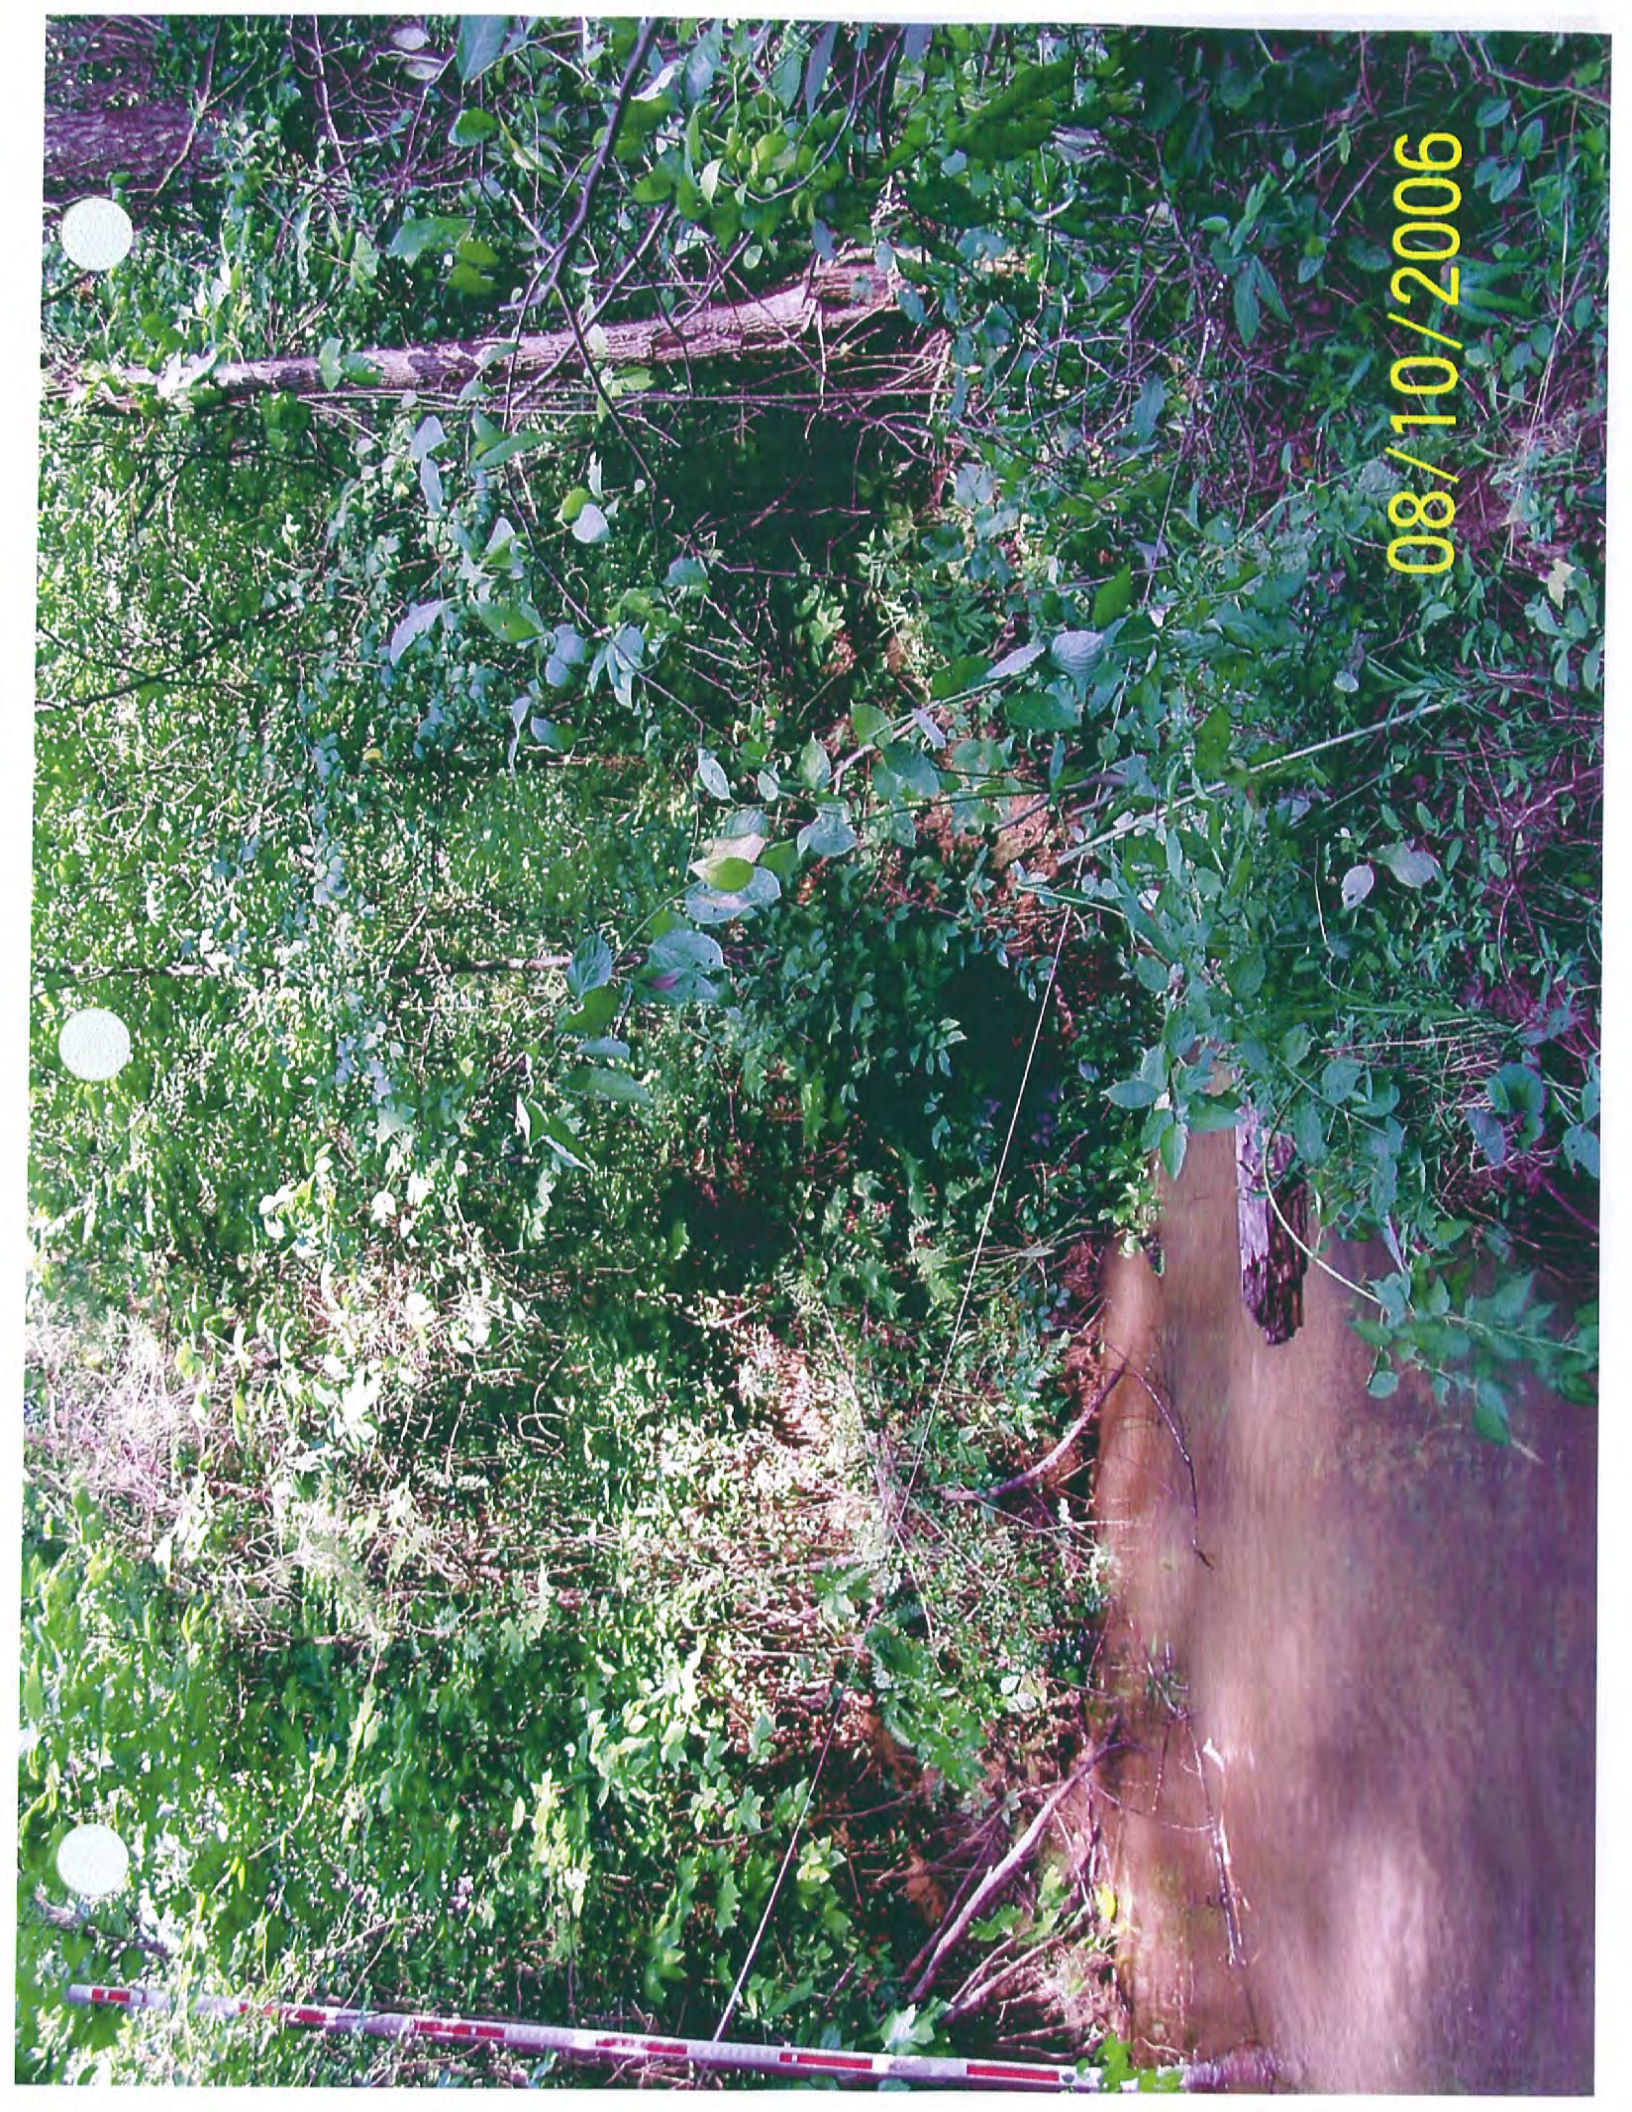
# Thompsons Fork Reference Reach Particle Distributions

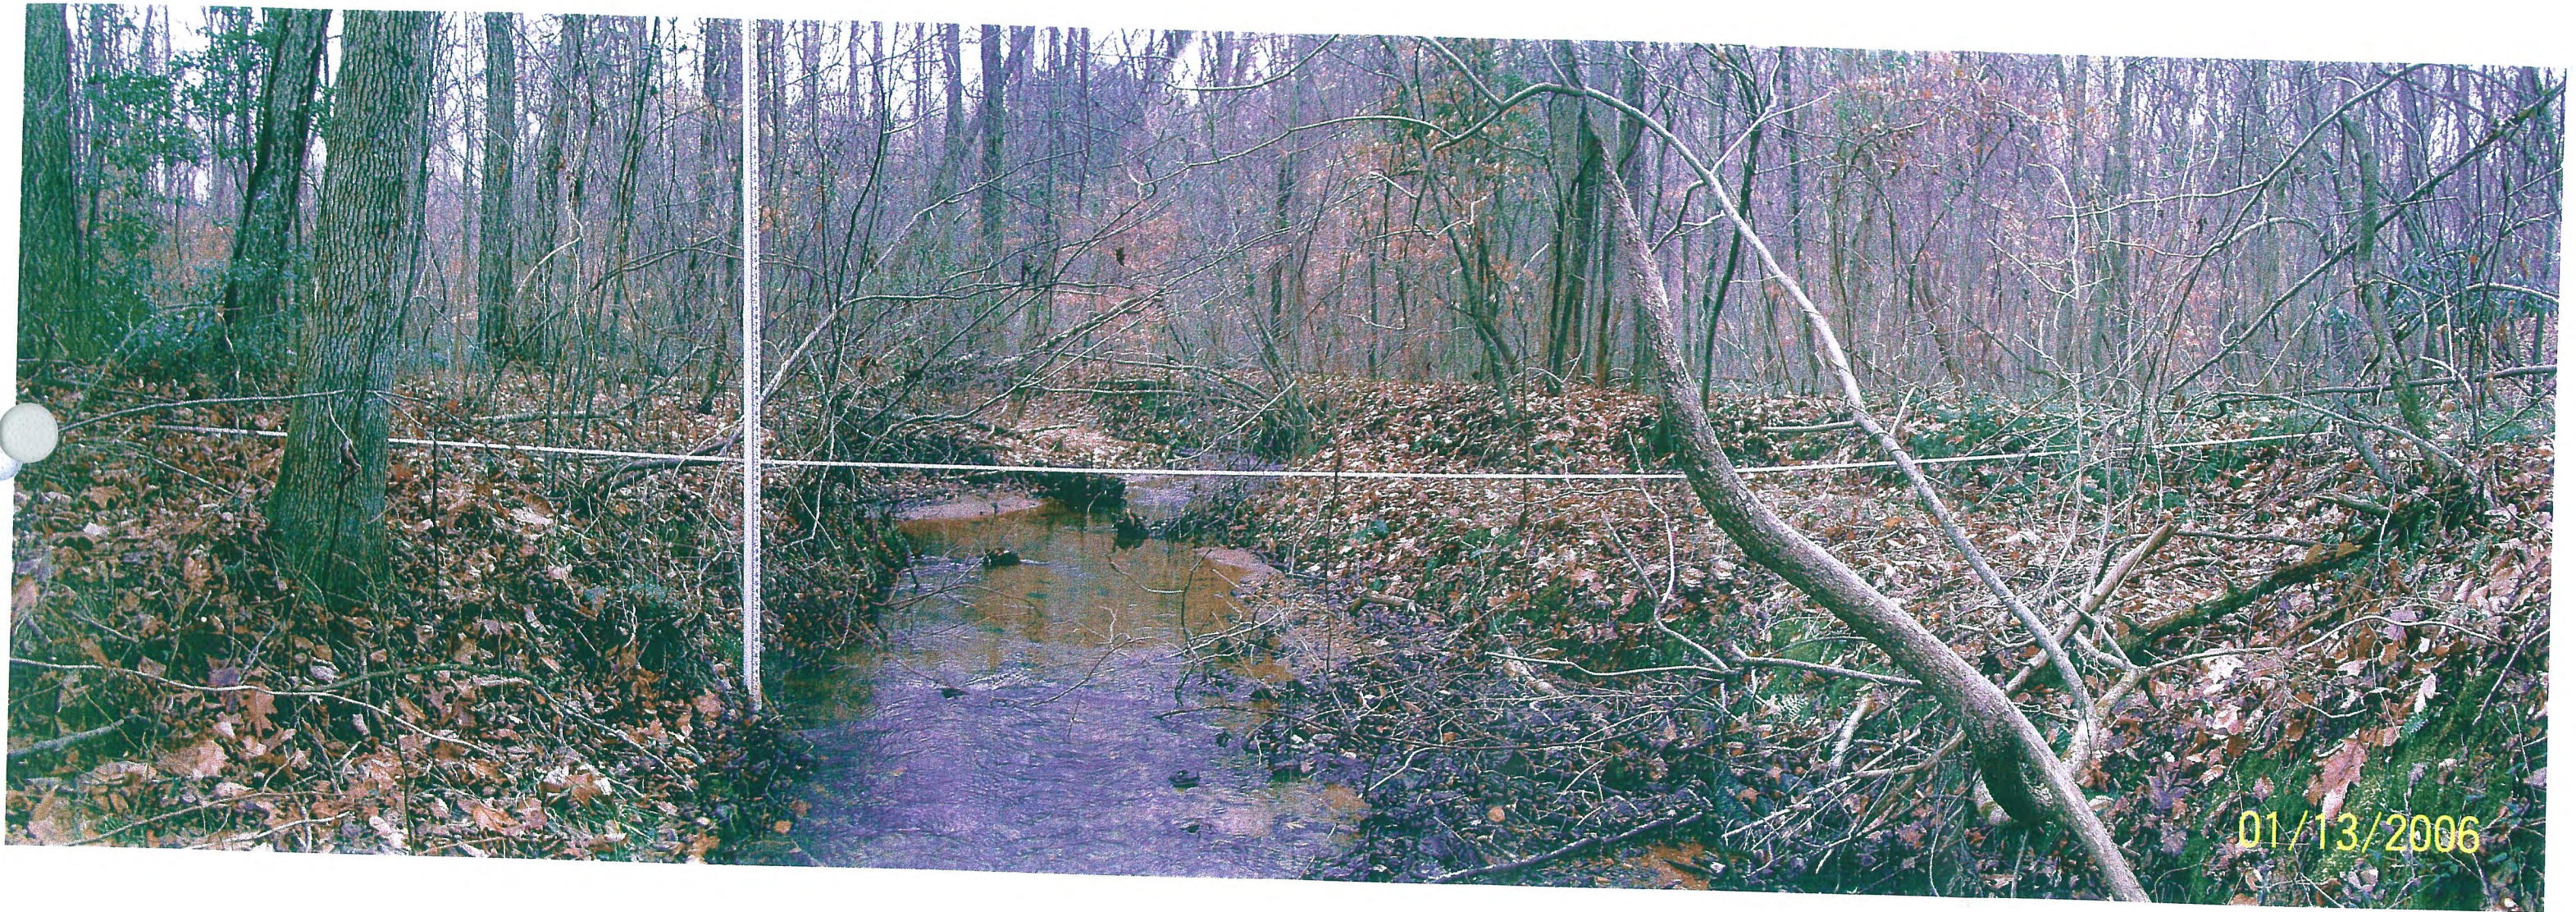
Reference Reach Riffle Cross-Section  
Profile Station 0+22  
January 13, 2006
