**Wetlands Resource Center**  
3970 Bowen Road  
Canal Winchester, Ohio 43110  
Project Manager: Cal Miller  
P: (614) 864-7511  
F: (614) 866-3691

**EMH&T, Inc.**  
5500 New Albany Road  
Columbus, Ohio 43054  
Project Manager: Miles F. Hebert, PE  
P: (614) 775-4205  
F: (614) 775-4802  
Main: (614) 775-4500

## THOMPSONS FORK RESTORATION

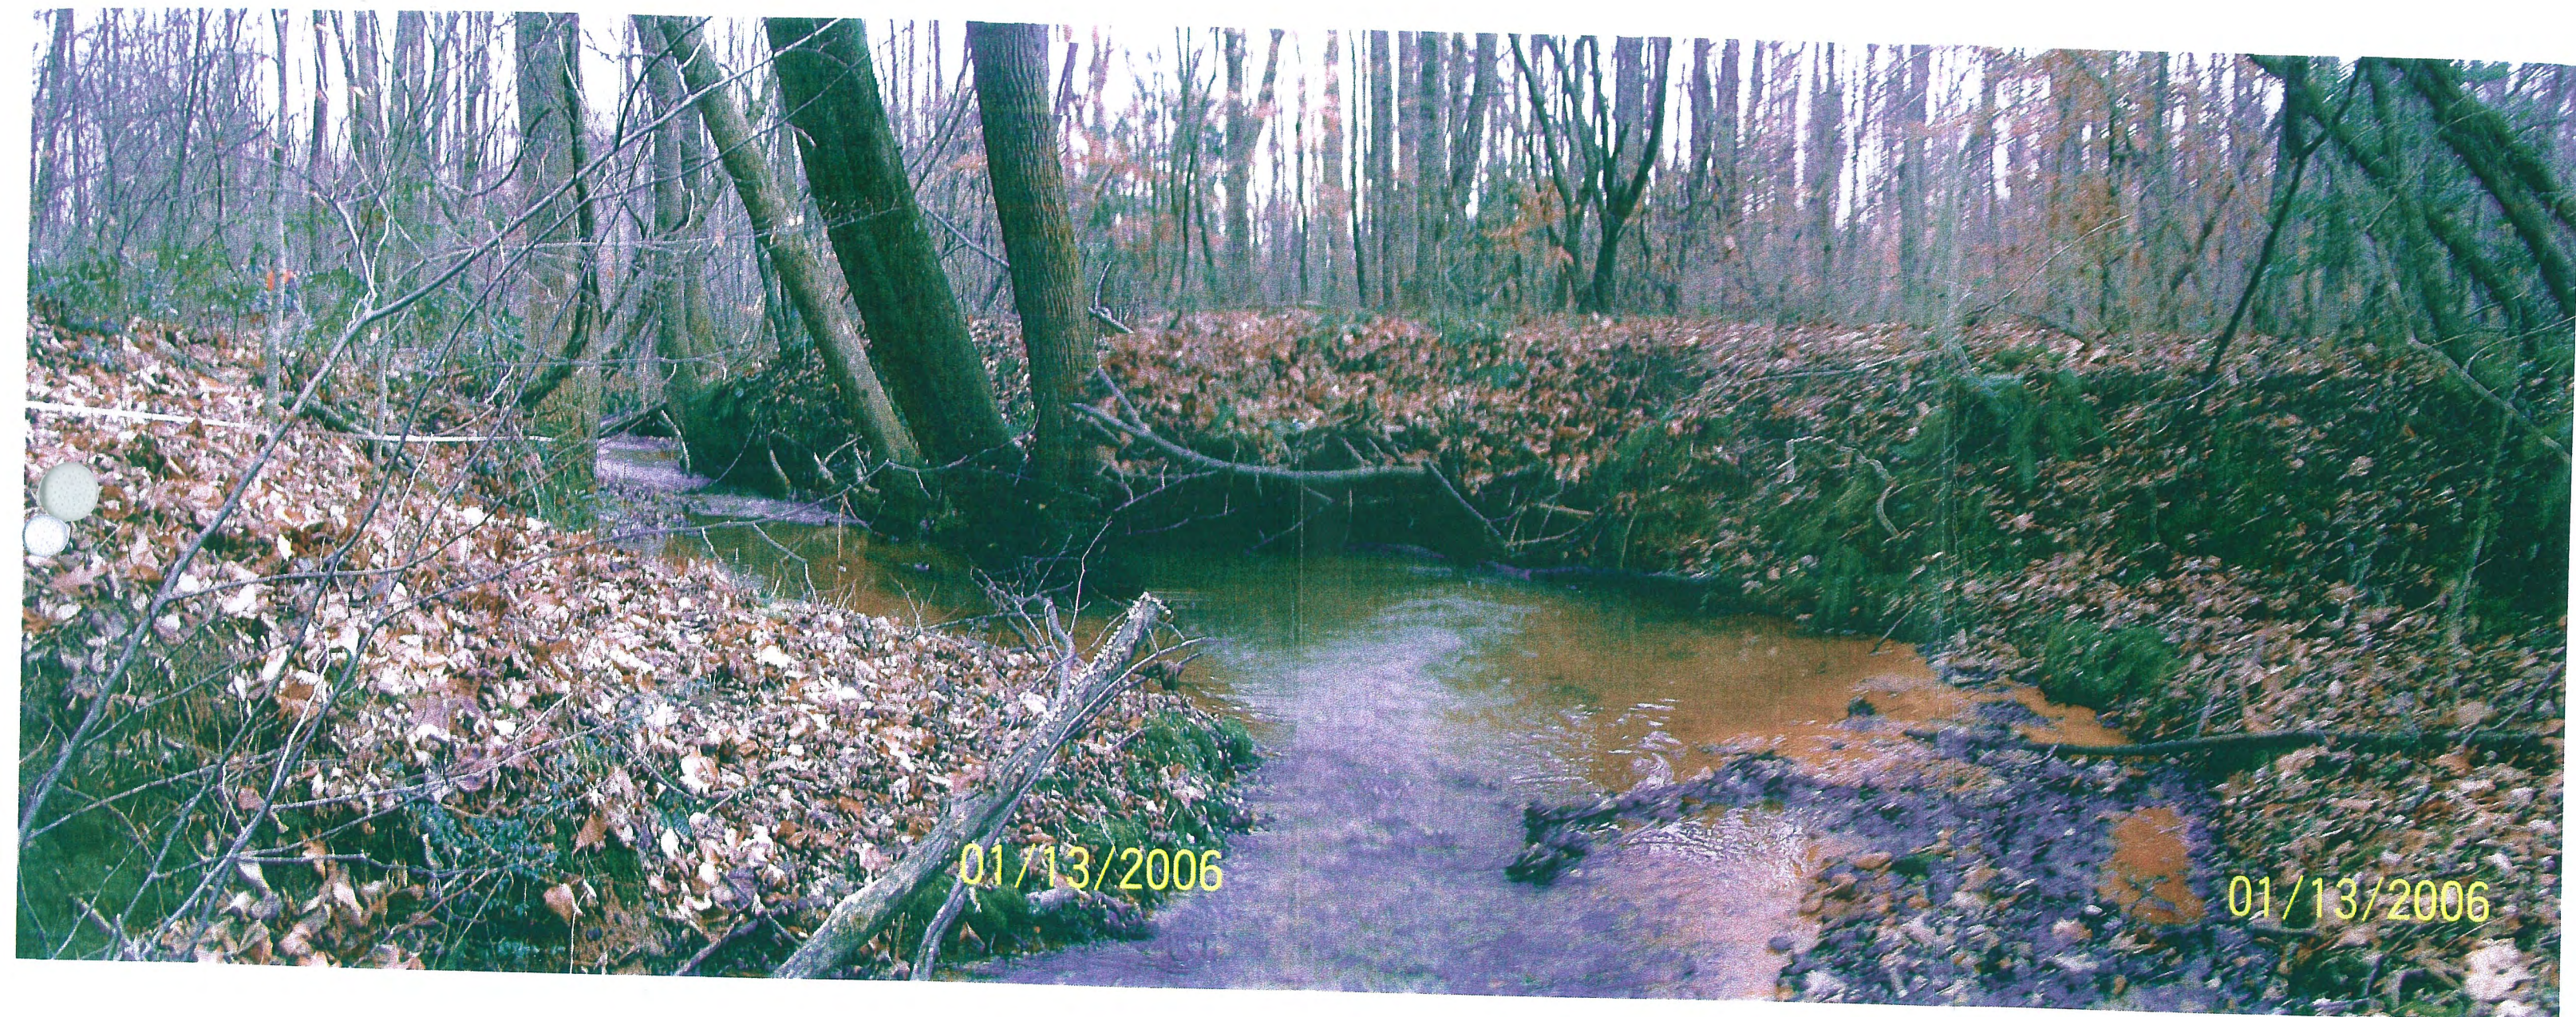
Reference Reach Pool Cross-Section  
Profile Station 3+20  
January 13, 2006

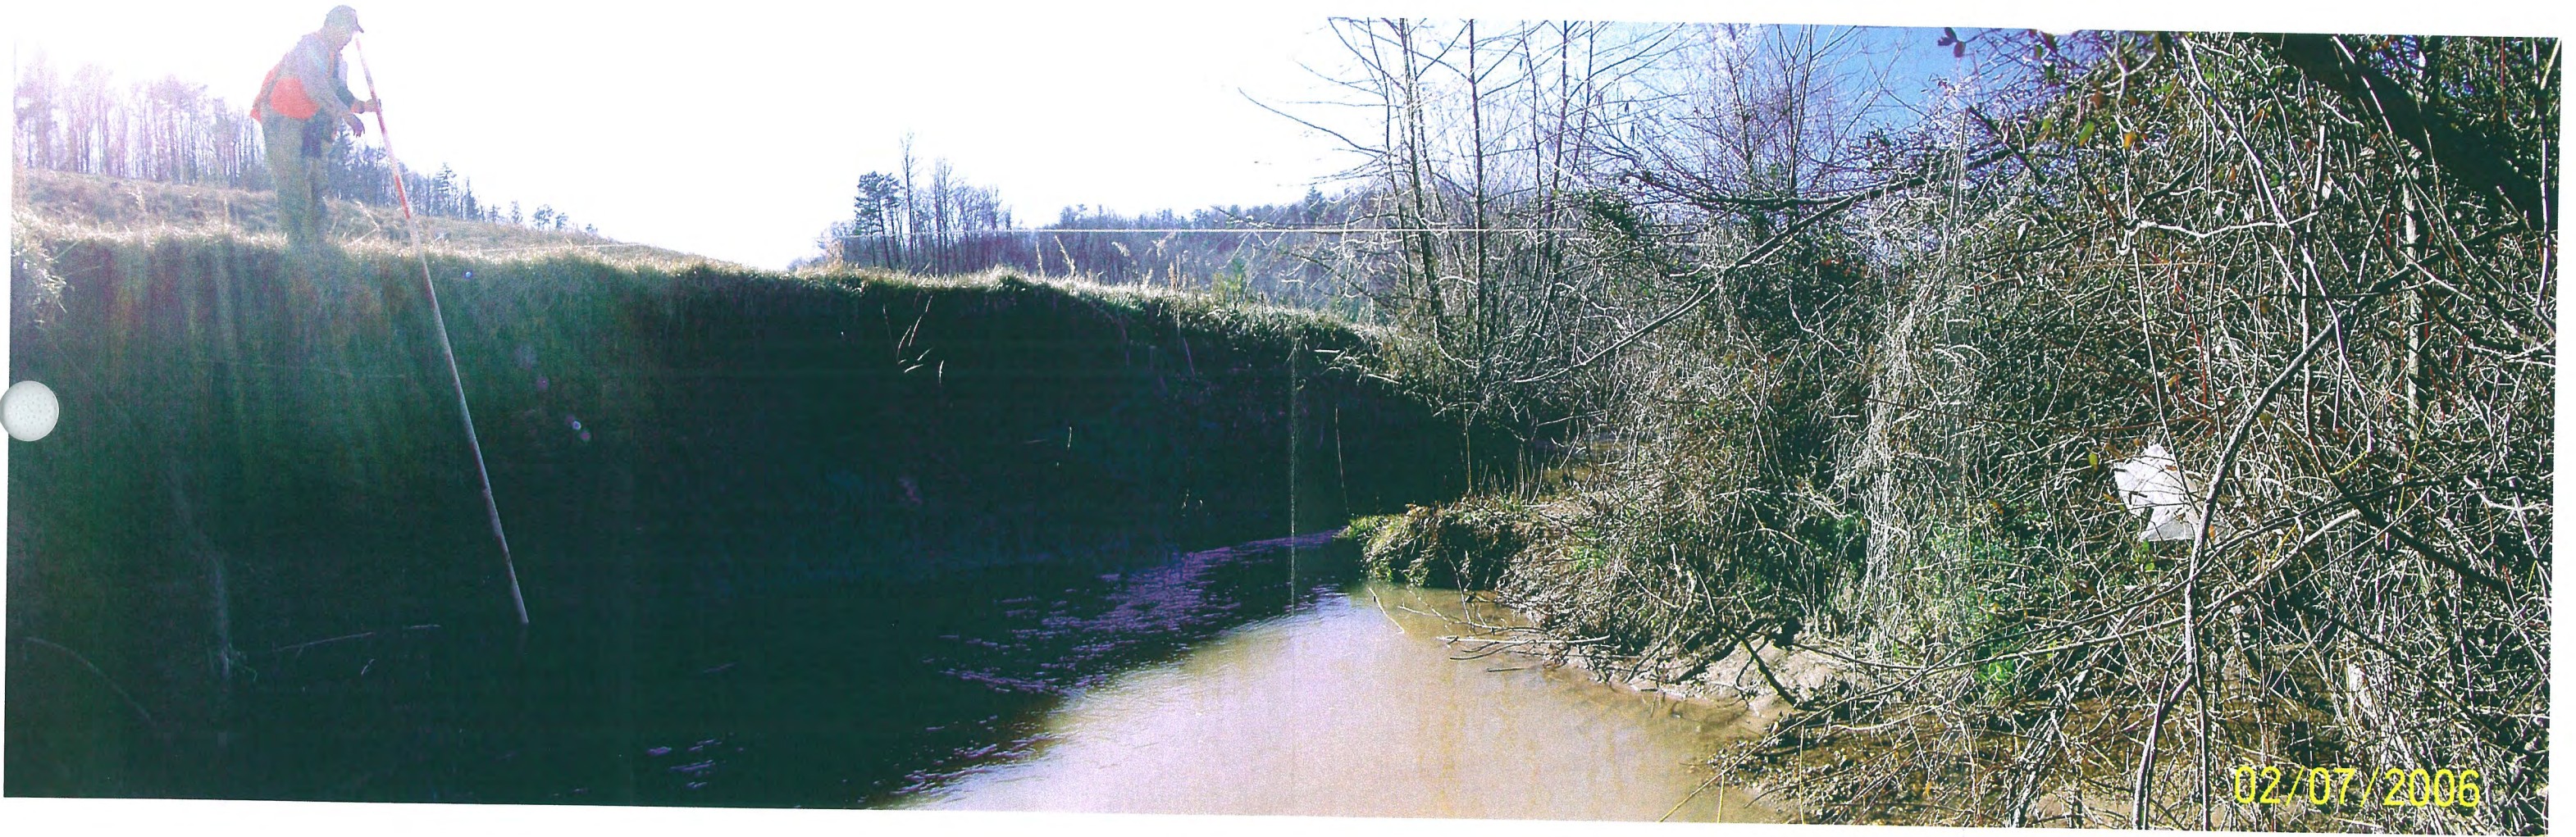
Thompsons Fork Mainstem  
Existing Conditions Pool Cross-Section  
Looking Upstream near  
Confluence of Unnamed Tributary  
February 7, 2006

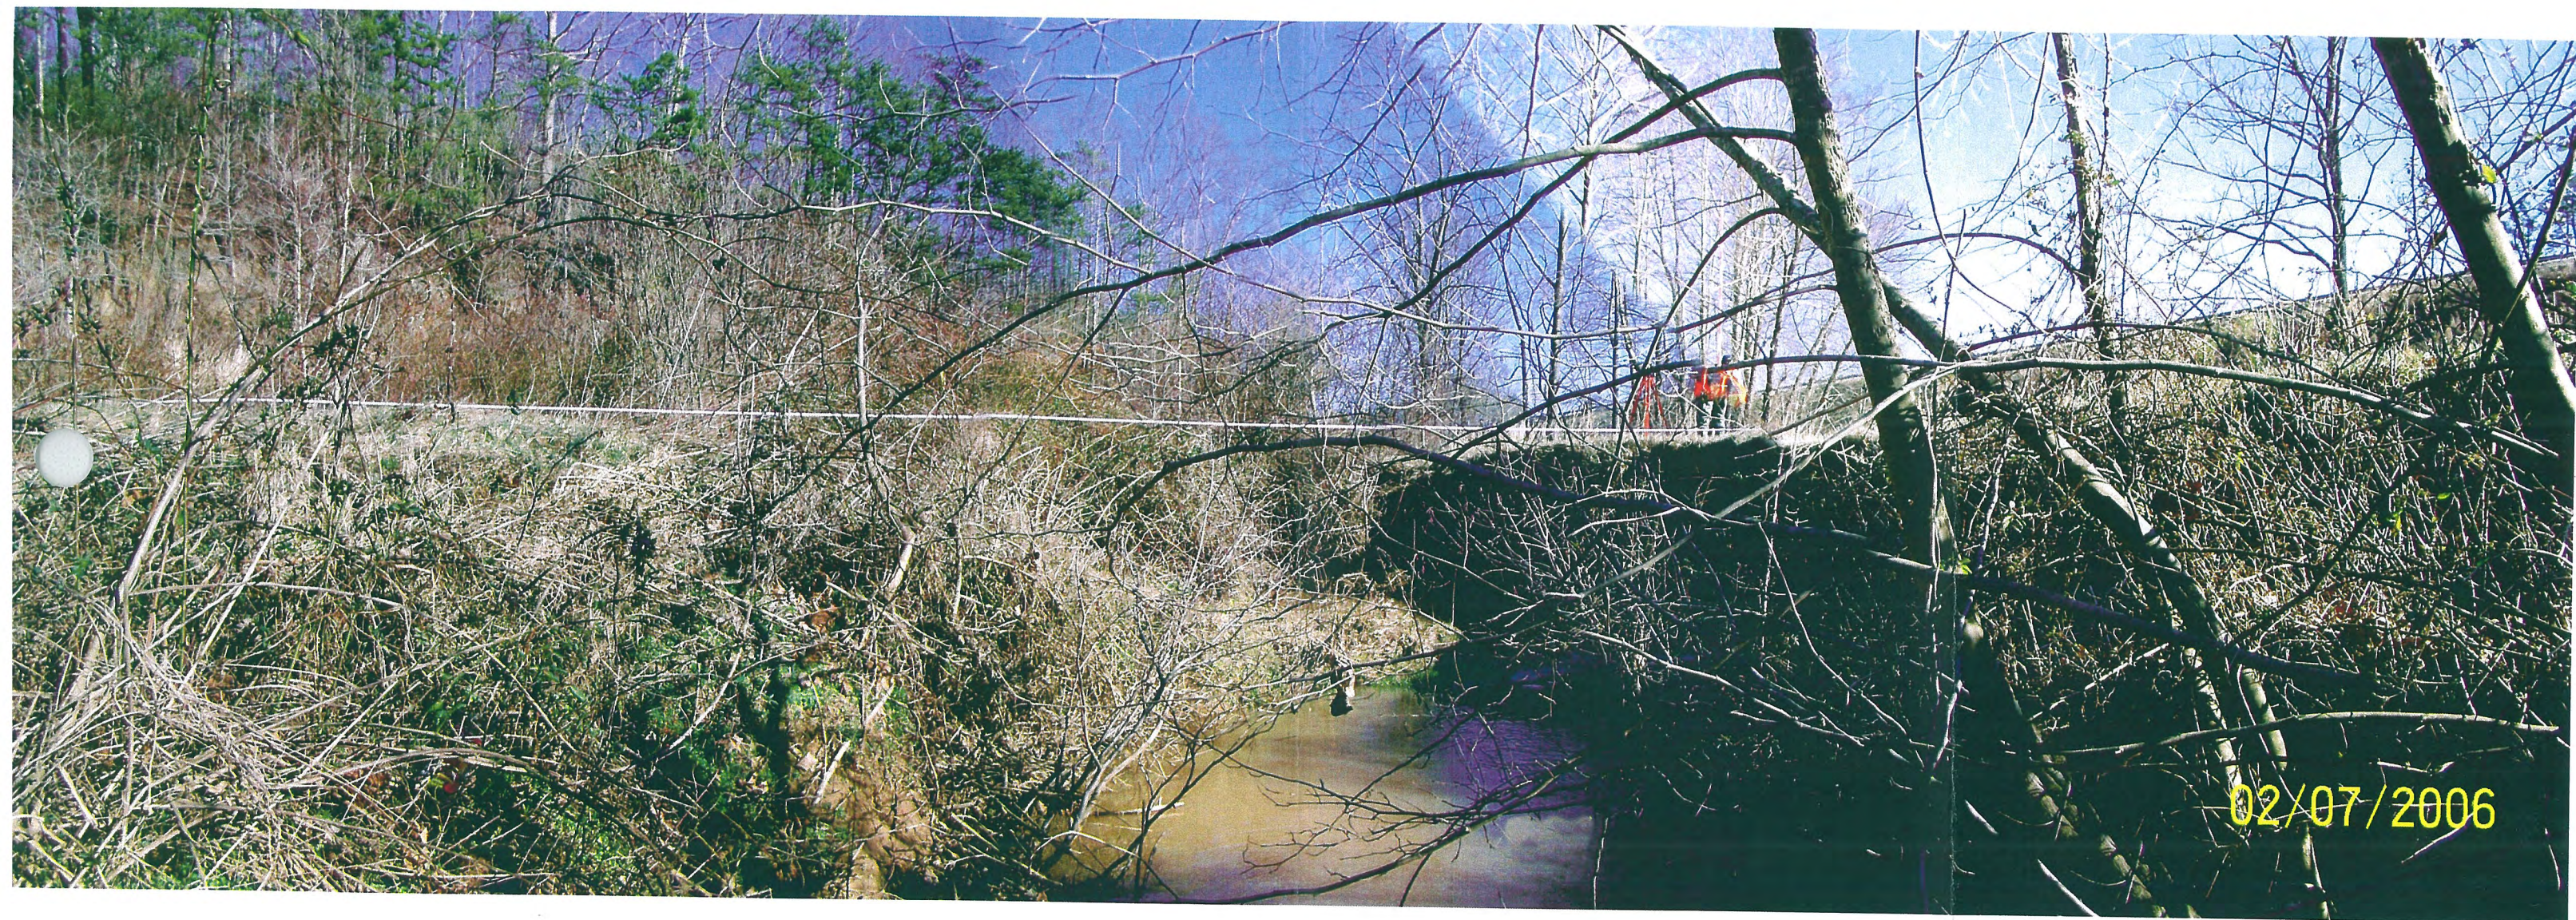
Thompsons Fork Mainstem  
Existing Conditions Pool Cross-Section  
Looking Down Stream near  
Confluence of Unnamed Tributary  
February 7, 2006

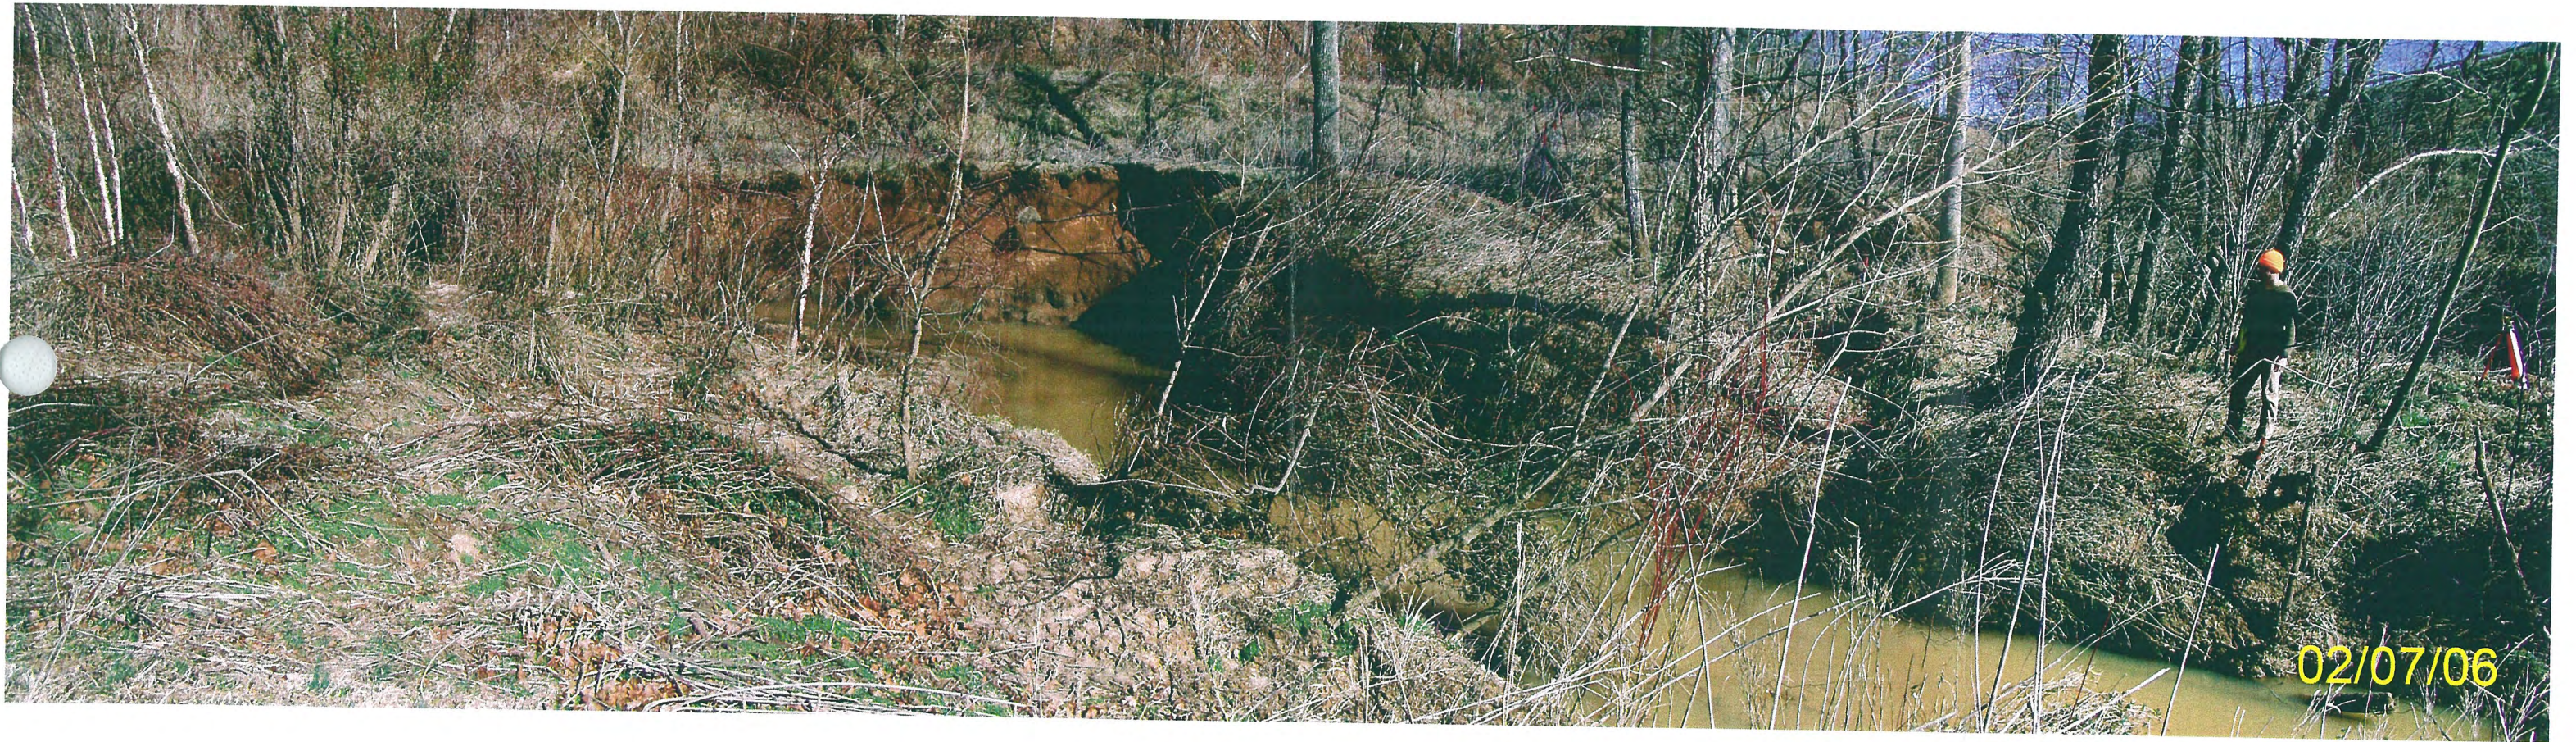
Down Stream Limits of Project  
Thompsons Fork Mainstem  
15-ft Vertical to Undercut Streambank  
February 7, 2006

Thompsons Fork is a vertically incised stream that has abandoned its floodplain due to a lowering of stream base level and is characterized by up to 15 feet high, near vertical to undercut streambanks. The consequence of channelization, cattle intrusion, confinement (lateral containment), major floods, changes in sediment regime, loss of riparian vegetation and shift in stream base level at the invert of the 3-chamber box culvert carrying Thompsons Fork under I-40, constructed in the 1960's, are attributed causes and effects for existing conditions along the altered mainstem reach. The effects of these anthropogenic changes are accelerated streambank erosion, channel incision, land loss, aquatic habitat loss, lowering of the water table, land productivity reduction and in-stream and downstream sedimentation.

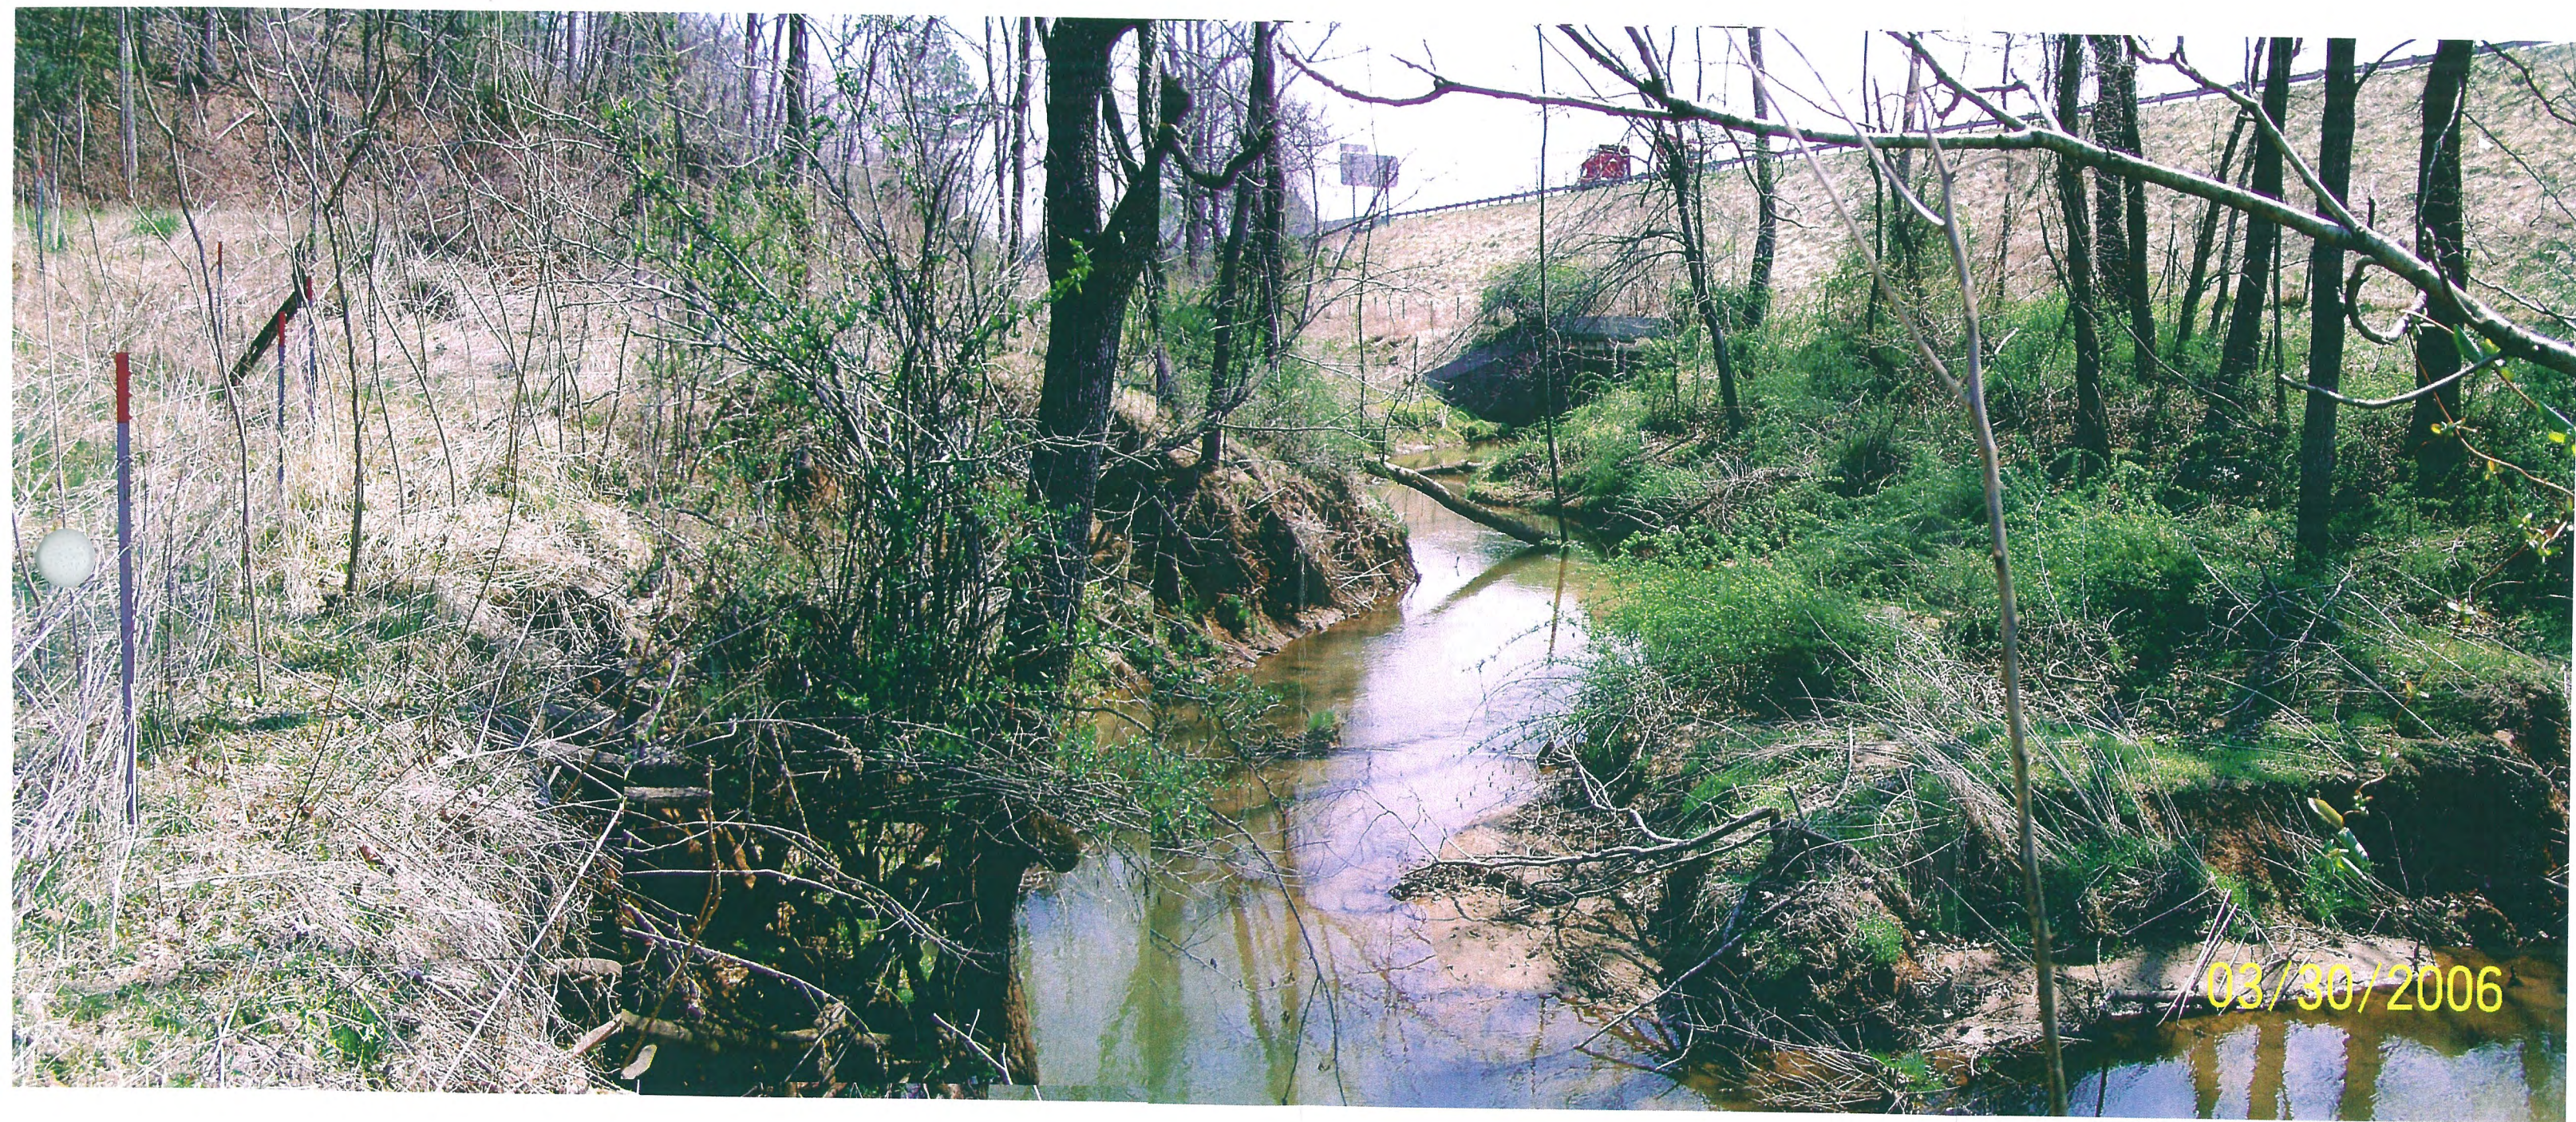
Thompsons Fork Mainstem  
End of Priority Level I Project  
Confined by South Creek Road & I-40  
Inlet 3-Chamber Box Culvert Under I-40  
March 30, 2006
