MITIGATION PLAN (FINAL)

Upper South Hominy Mitigation Site, South Hominy Creek, French Broad River Basin, Buncombe County, North Carolina

EEP Project Number: 92632
Contract Number: D06082; Task Order: 08 FB05-1b-d

Submitted: 15 December 2010

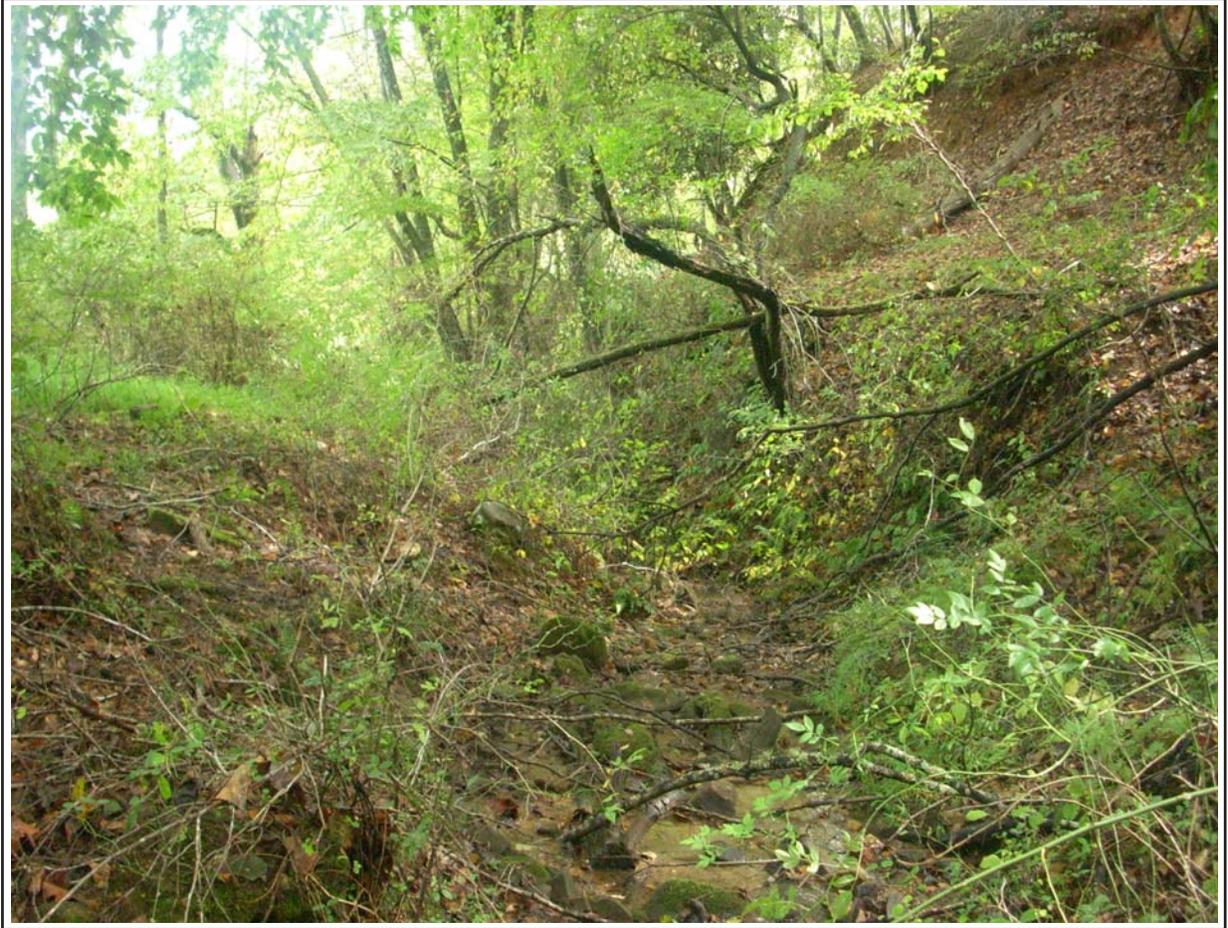
Figure 8. Tributary 4 showing steep side slopes and eroded soils, view to northwest.

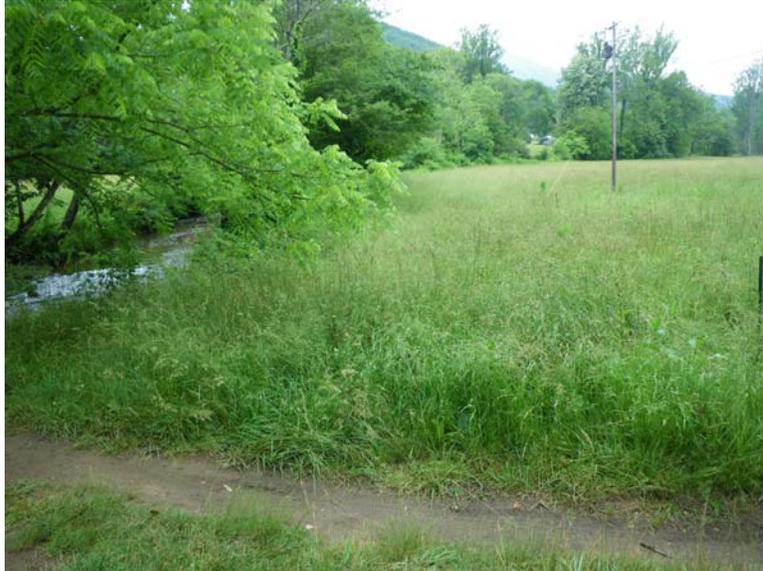
Bank Erosion on South Hominy Creek

Right Floodplain, Looking Downstream

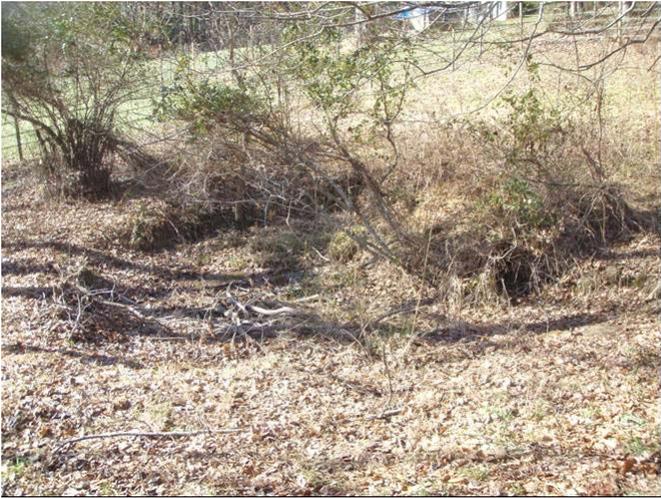
Origin of UT1 on Bianculli property.

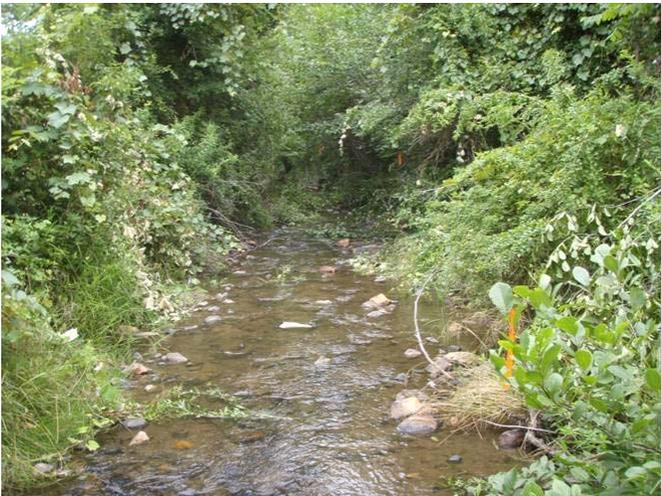
Channel incision and invasive vegetation observed, sta. 6+00 to 7+00, facing downstream.

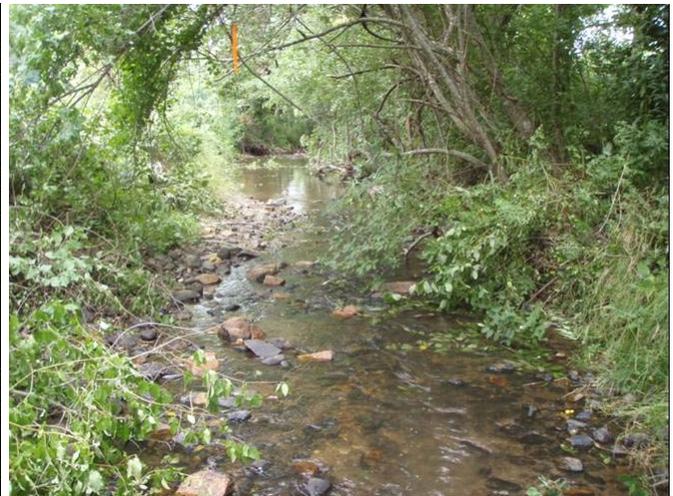
Lower end of Davis property, sta. 7+50, end of project next riffle.
