# **UT to Clarke Creek Annual Final Monitoring Report**

DMS # 92500  
DENR Contract # 005363  
USACE Action ID # SAW-2010-00471  
DWR Project # 11-0409  
SCO # 09-07763-01  
DLR (Land Quality) Project # MECK-2012-034

Monitoring Report Year 2 of 5  
Mecklenburg County, North Carolina

UT to Clarke Creek Stream and Wetland Restoration  
DMS Project #92500

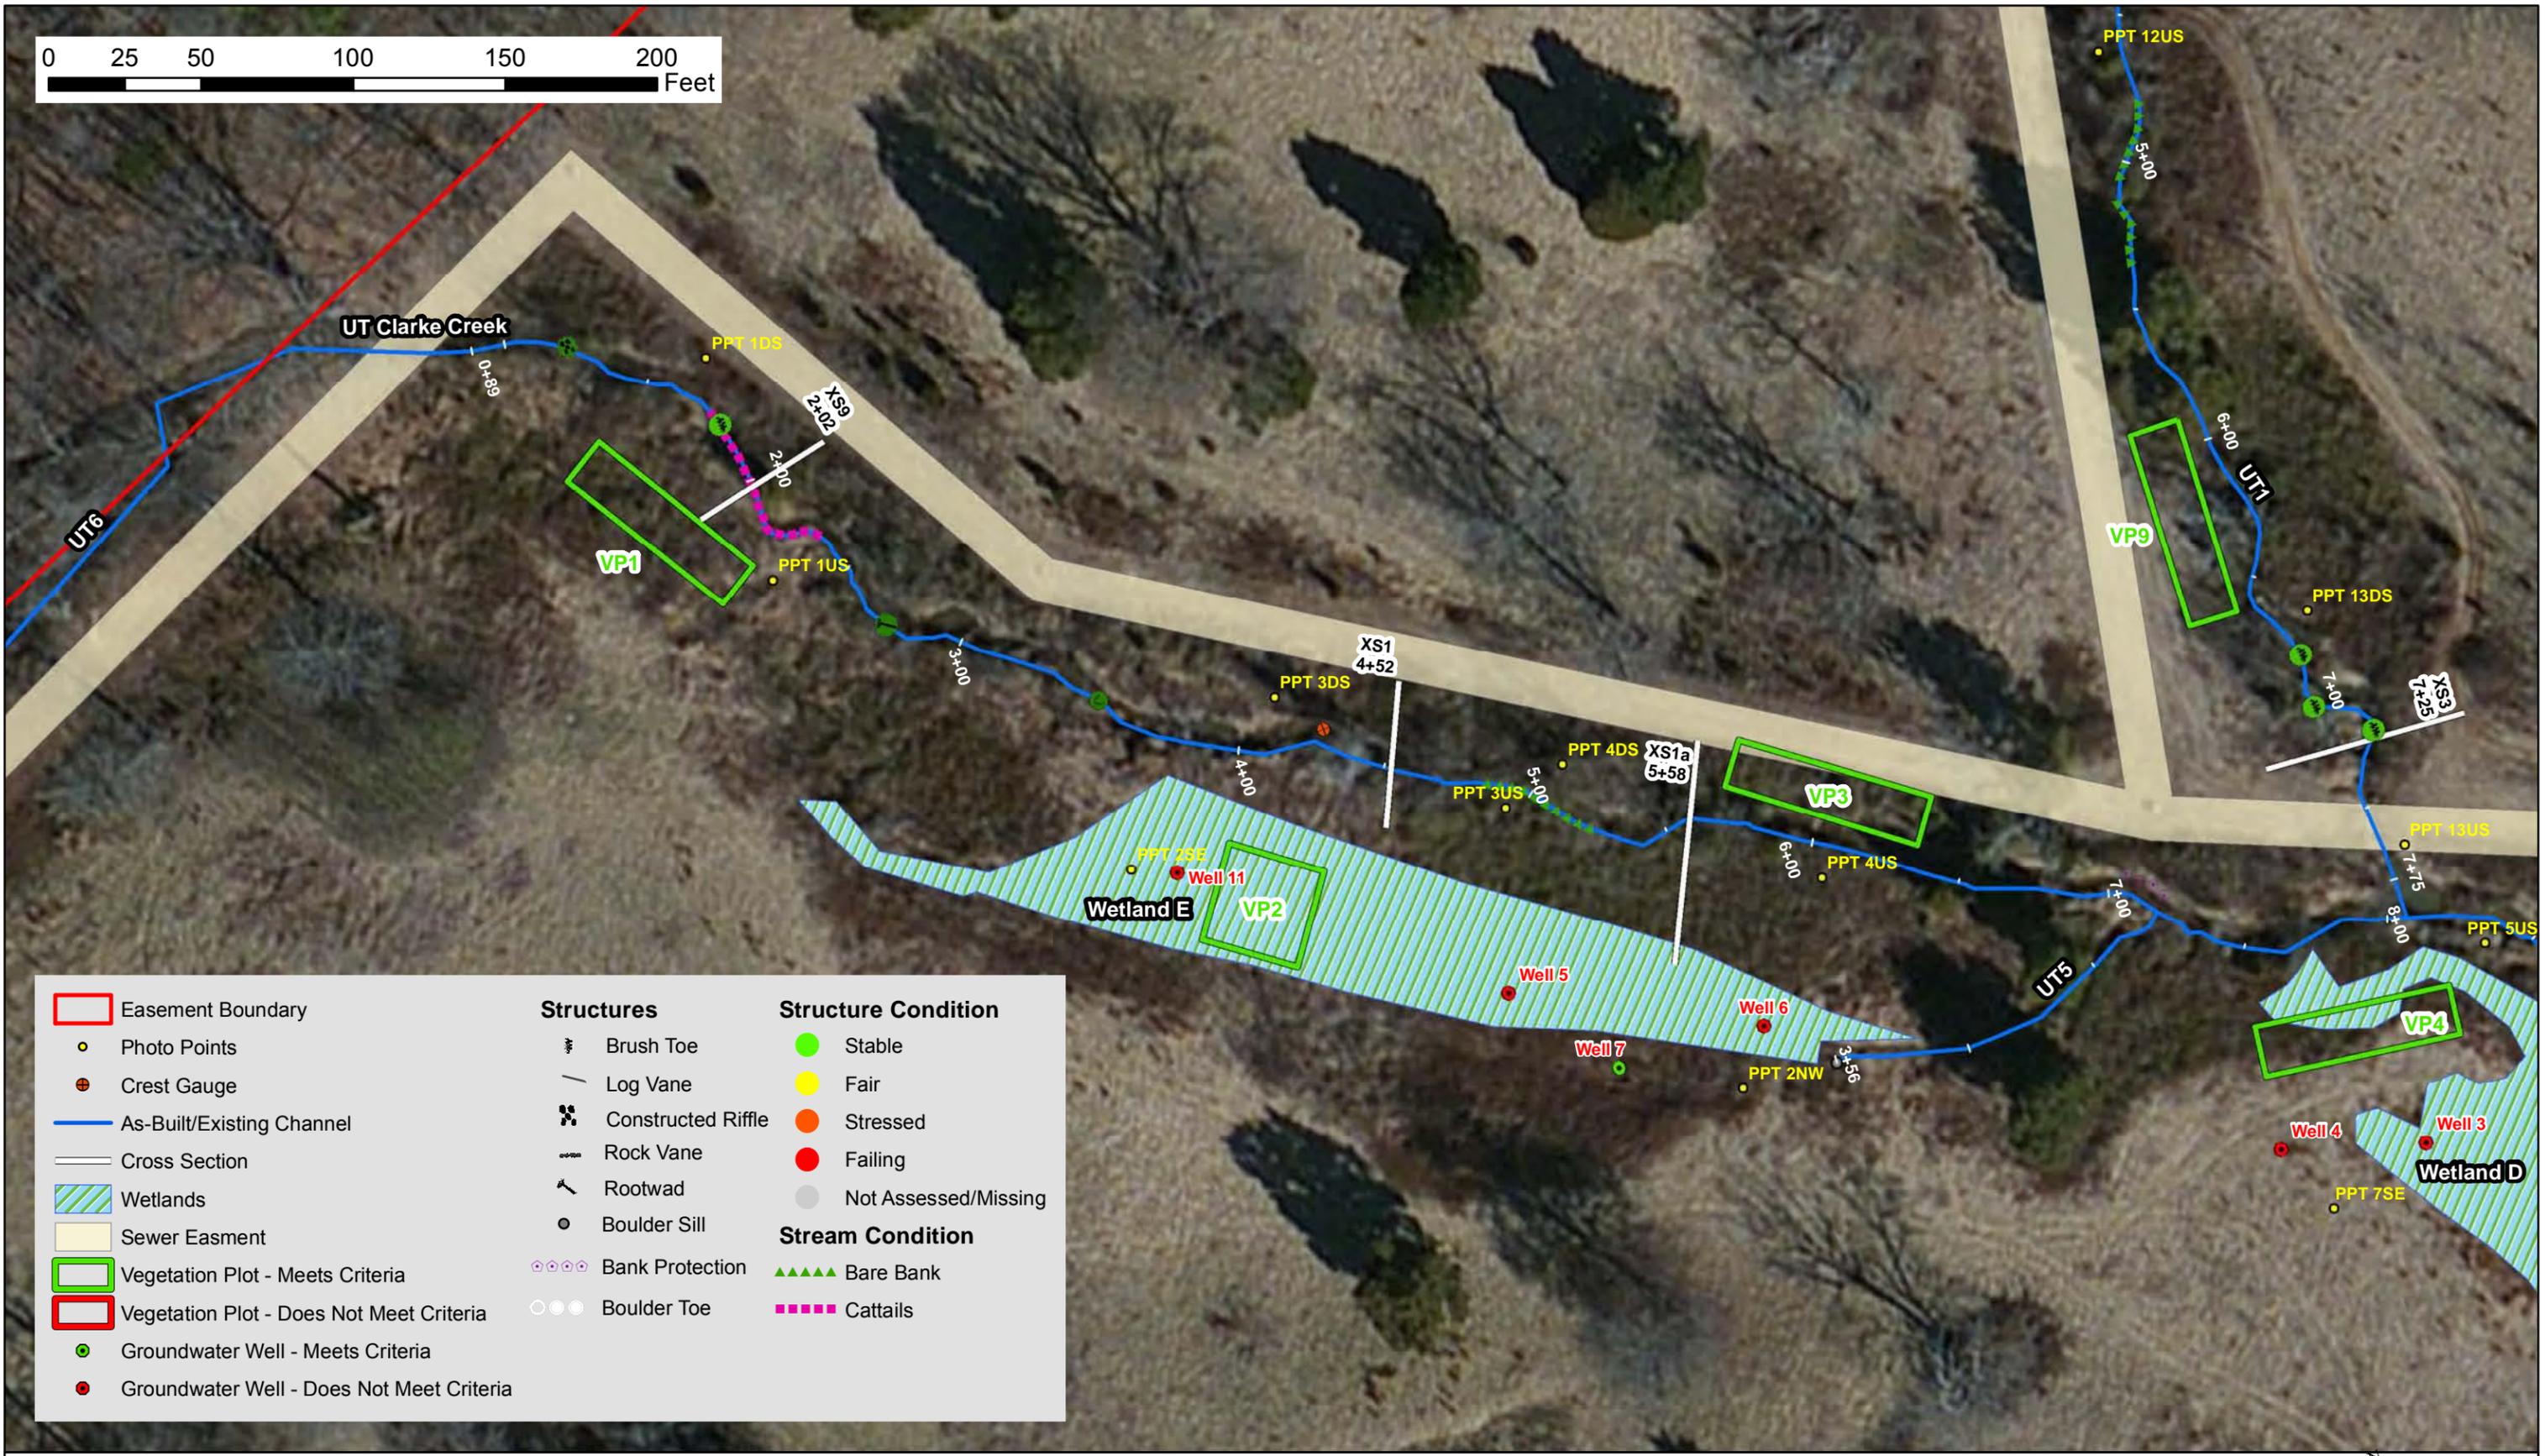
## Current Conditions Plan View - UT Clarke Creek above Confluence

On UT to Clarke Creek, one area of notable bare bank was noted between Stations 4+90 and 5+29. This area was lacking significant woody vegetation along the stream bank. Vegetation was also found growing in the channel between Station 1+78 and 2+41. Particle size increased in cross section 9, while cross section 1A saw a decrease in particle size compared to monitoring year 1 data.

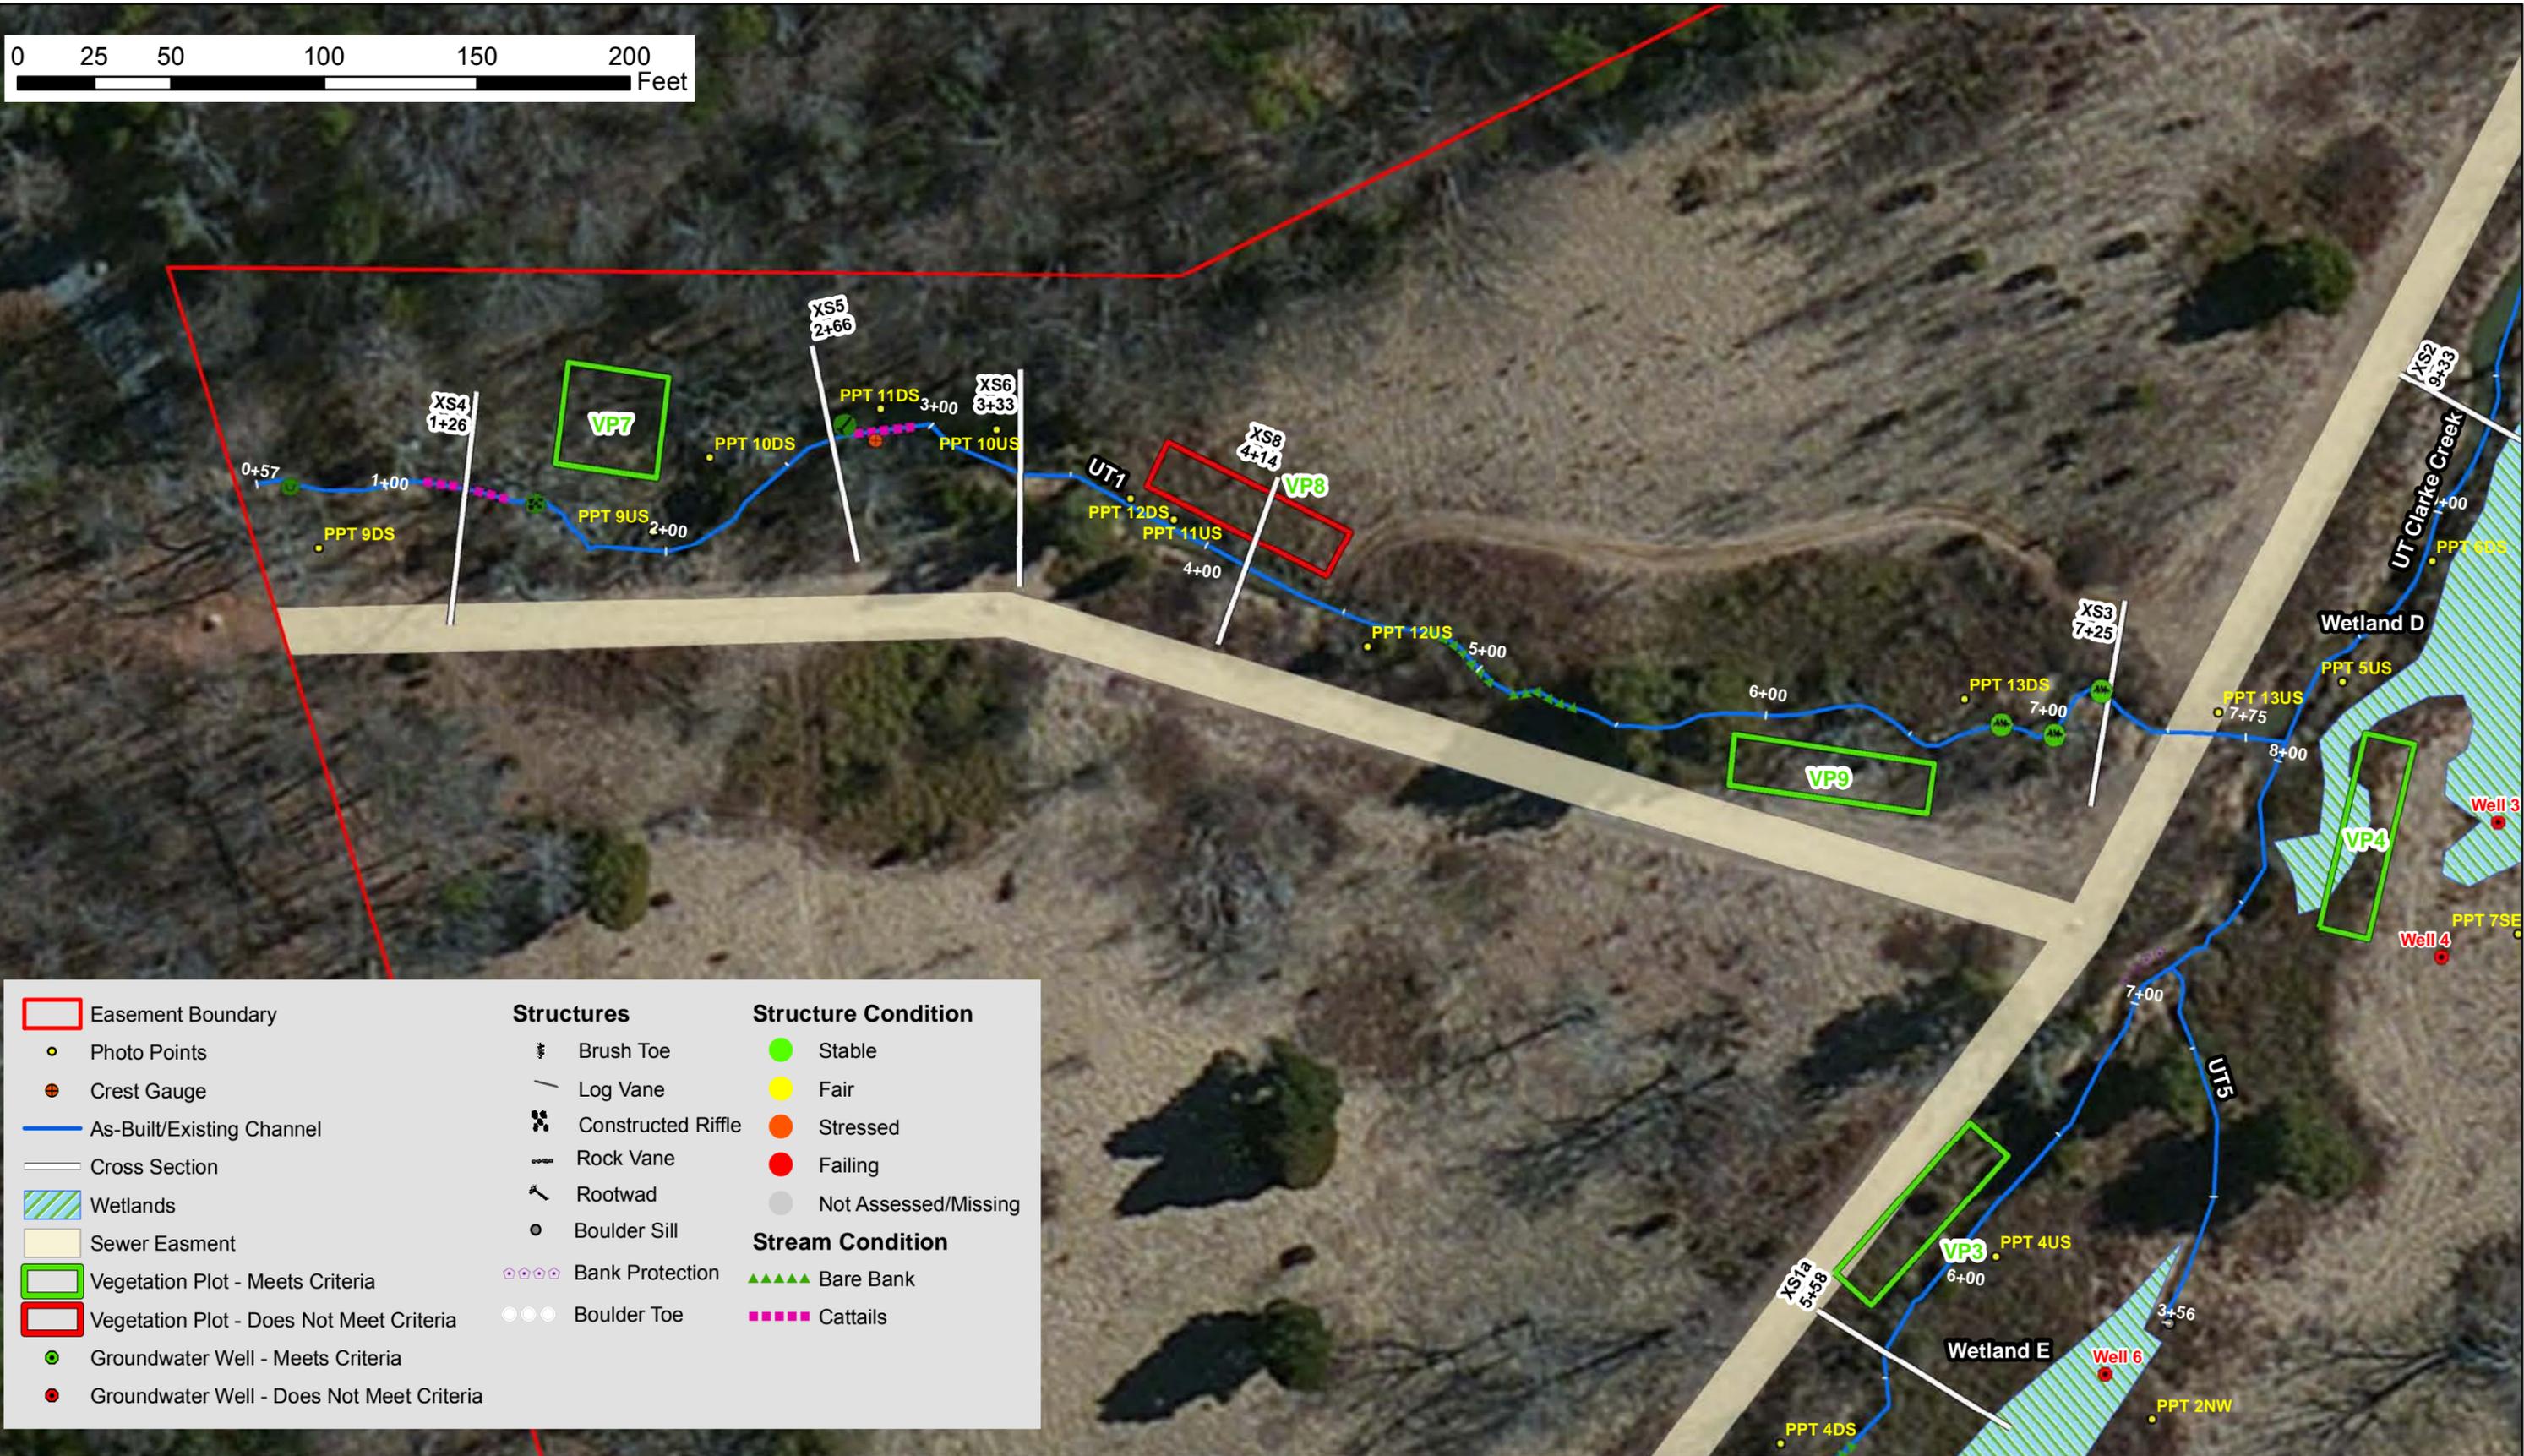
## Current Conditions Plan View - UT 1

Reach UT1 had one area of bare bank between Stations 4+78 to 5+37. This area was lacking significant woody and herbaceous vegetation. Two instances of vegetation in the channel were noted between Stations 1+12 to 1+41 and 2+74 to 2+92. This vegetation trapped smaller particles in cross sections 4 and 5 leading to smaller particle sizes collected for the pebble counts. Particle size in cross section 8 increased from baseline data, while cross section 6 had a decrease in particle size.

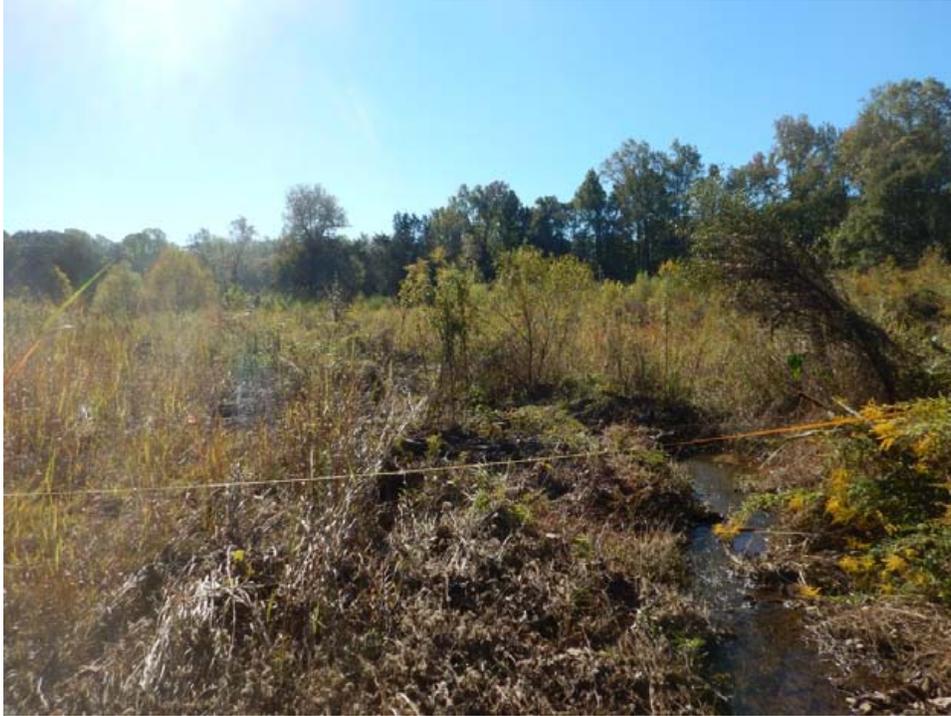
Photo Station 1 Downstream-XS9 (MY2 – 10/22/2015)

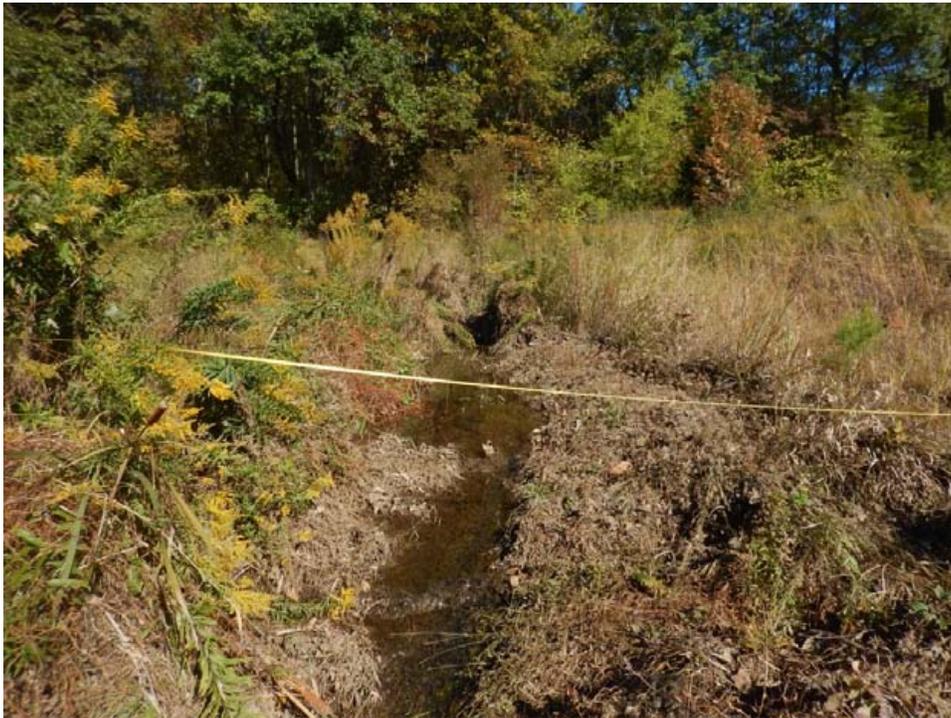
Photo Station 1 Upstream-XS 9 (MY2 – 10/22/2015)

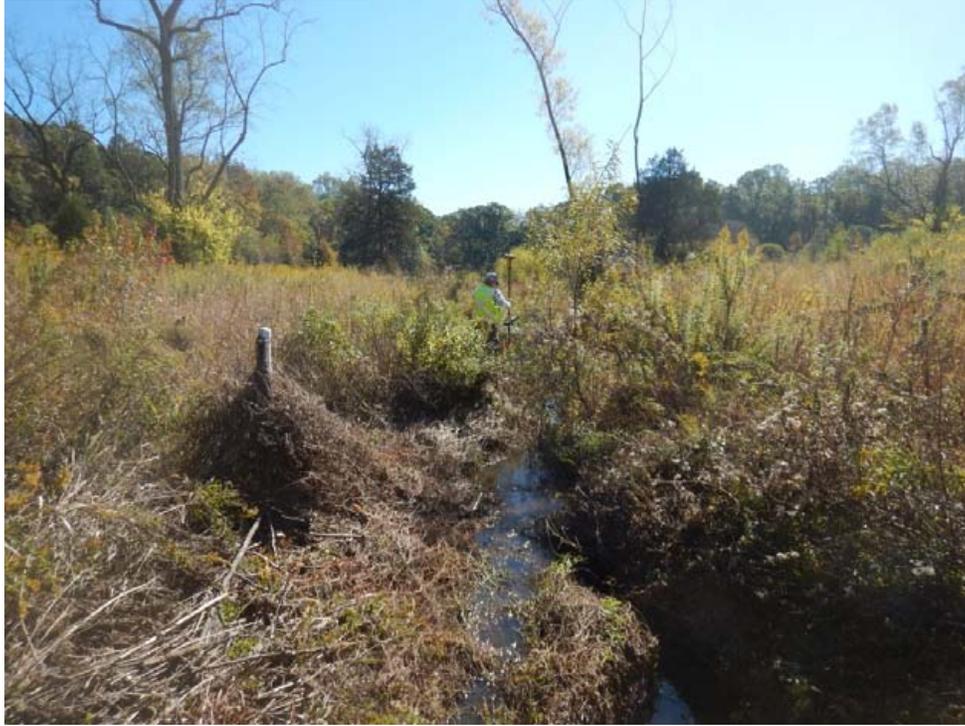
Photo Station 4 Downstream-XS1A (MY2 – 10/22/2015)

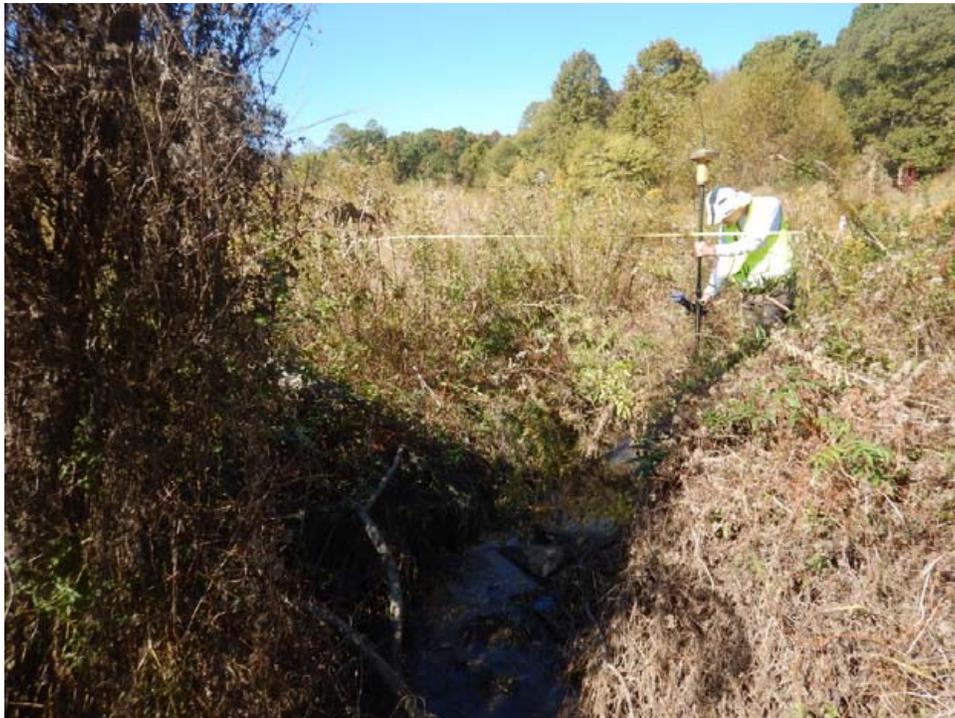
Photo Station 4 Upstream-XS1A (MY2 – 10/22/2015)

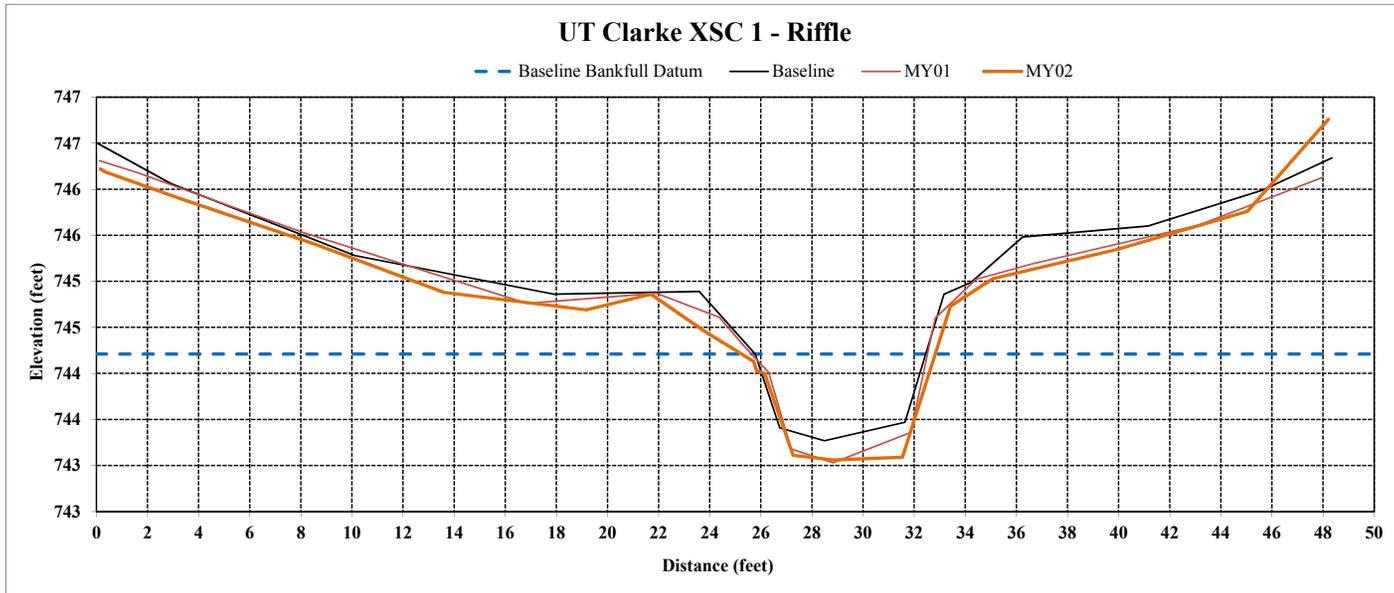
Sta. 4+52 Looking Downstream

Reach	UT to Clarke Creek
River Basin	Yadkin/Pee Dee
Cross Section ID	XSC-1, Riffle, 4+52
Drainage Area (Sq Mi)	1.08
Date	10/22/2015
Observers	P. Beach, K. Hamlin, C. Flowers

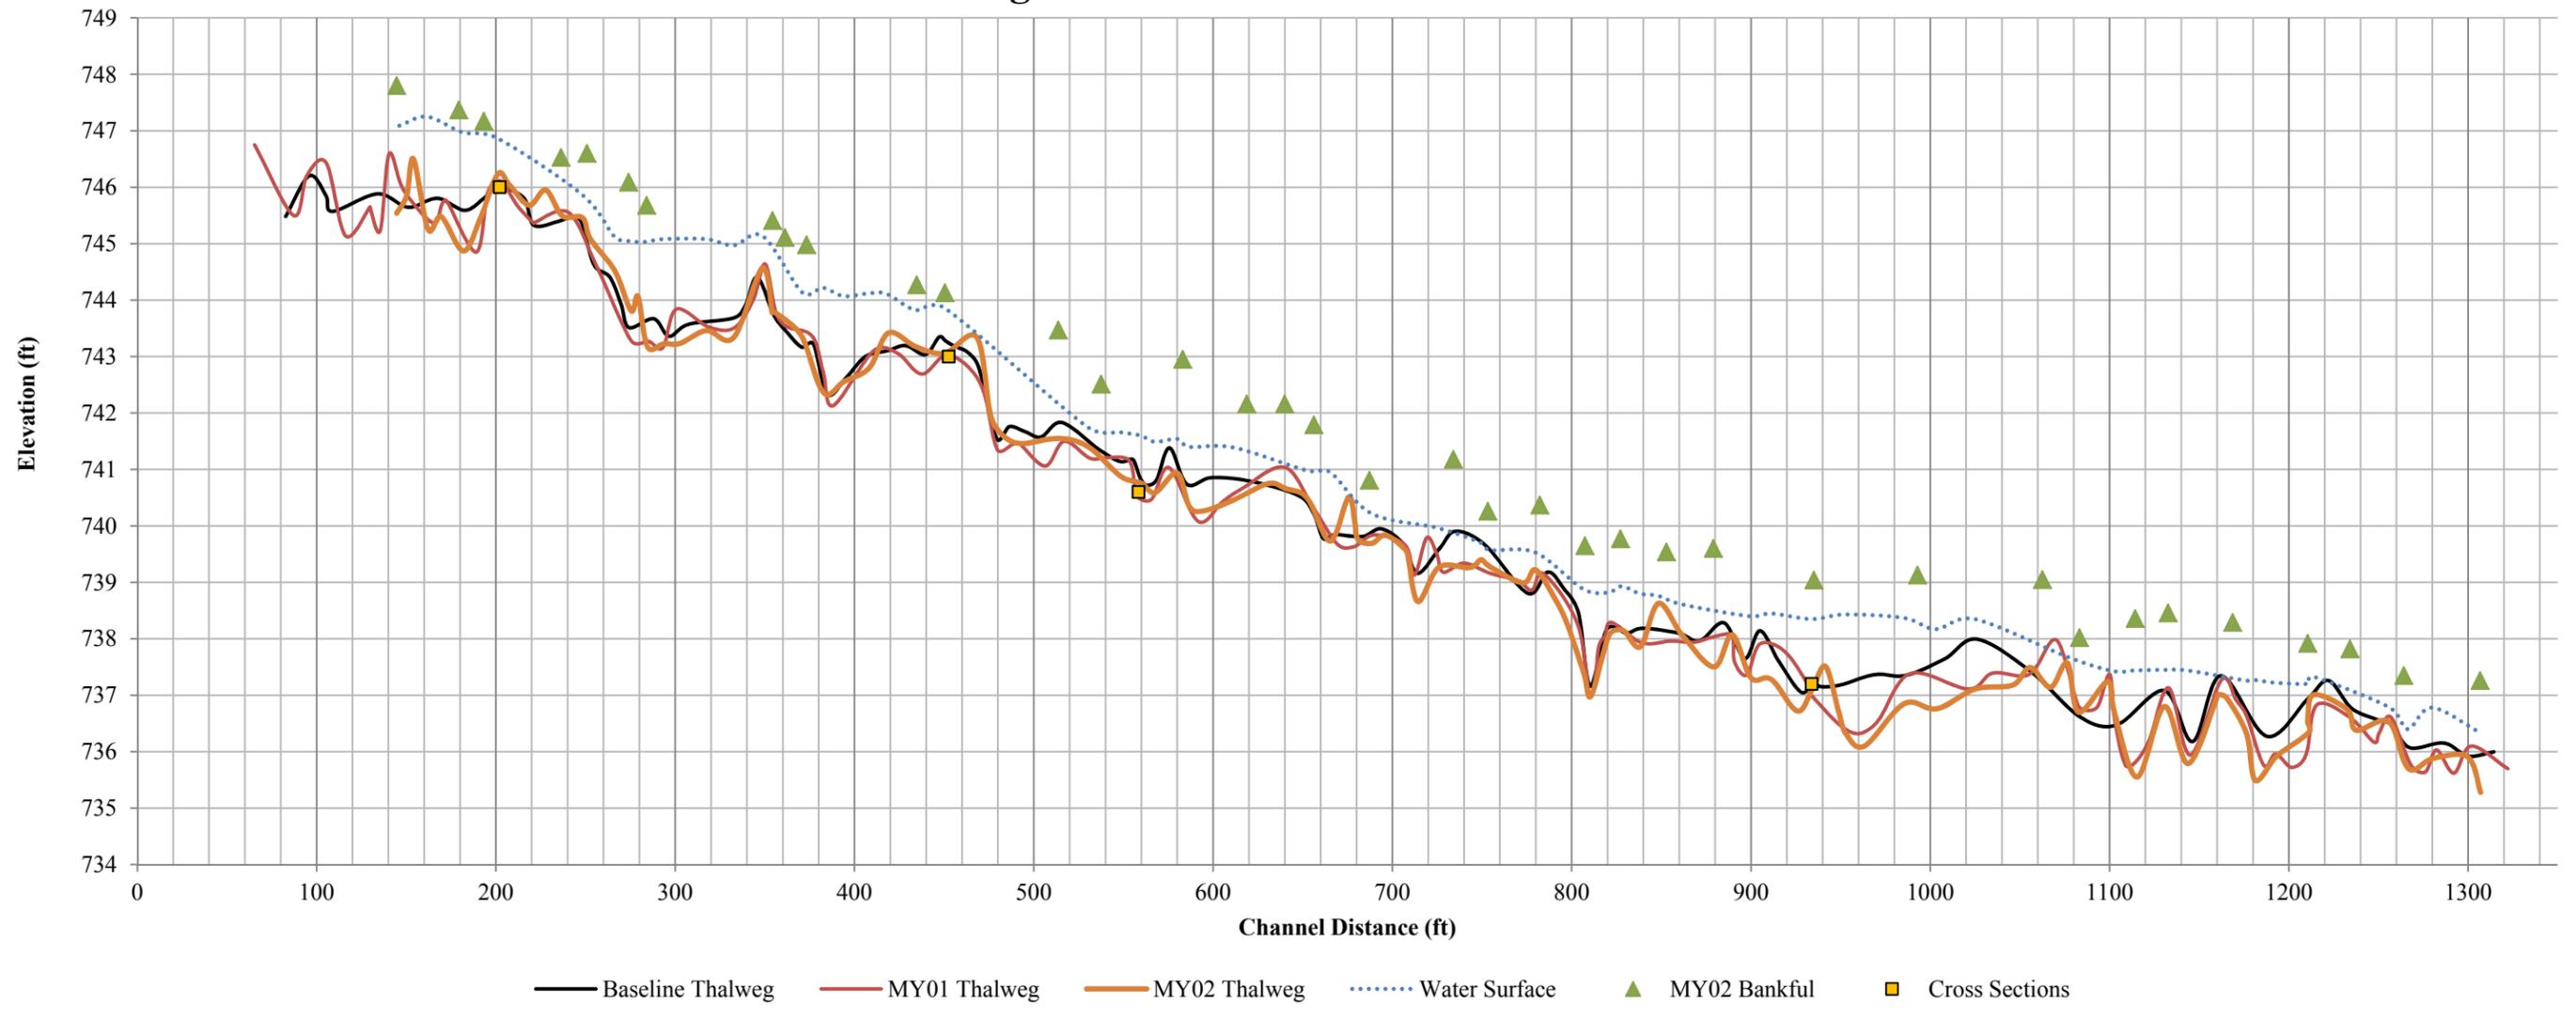
### Longitudinal Profile - UT to Clarke Creek

Both reaches' profiles and cross sections adjusted minimally from the monitoring year 1 conditions. The channels access the floodplain and evidence of bankfull events were observed during Year 2 monitoring. This evidence includes the presence of wracklines, sediment deposits, a field visit during a bankfull event, and a crest gauge reading of 20" above bankfull on UT1 and 19" above bankfull on UT to Clarke Creek.

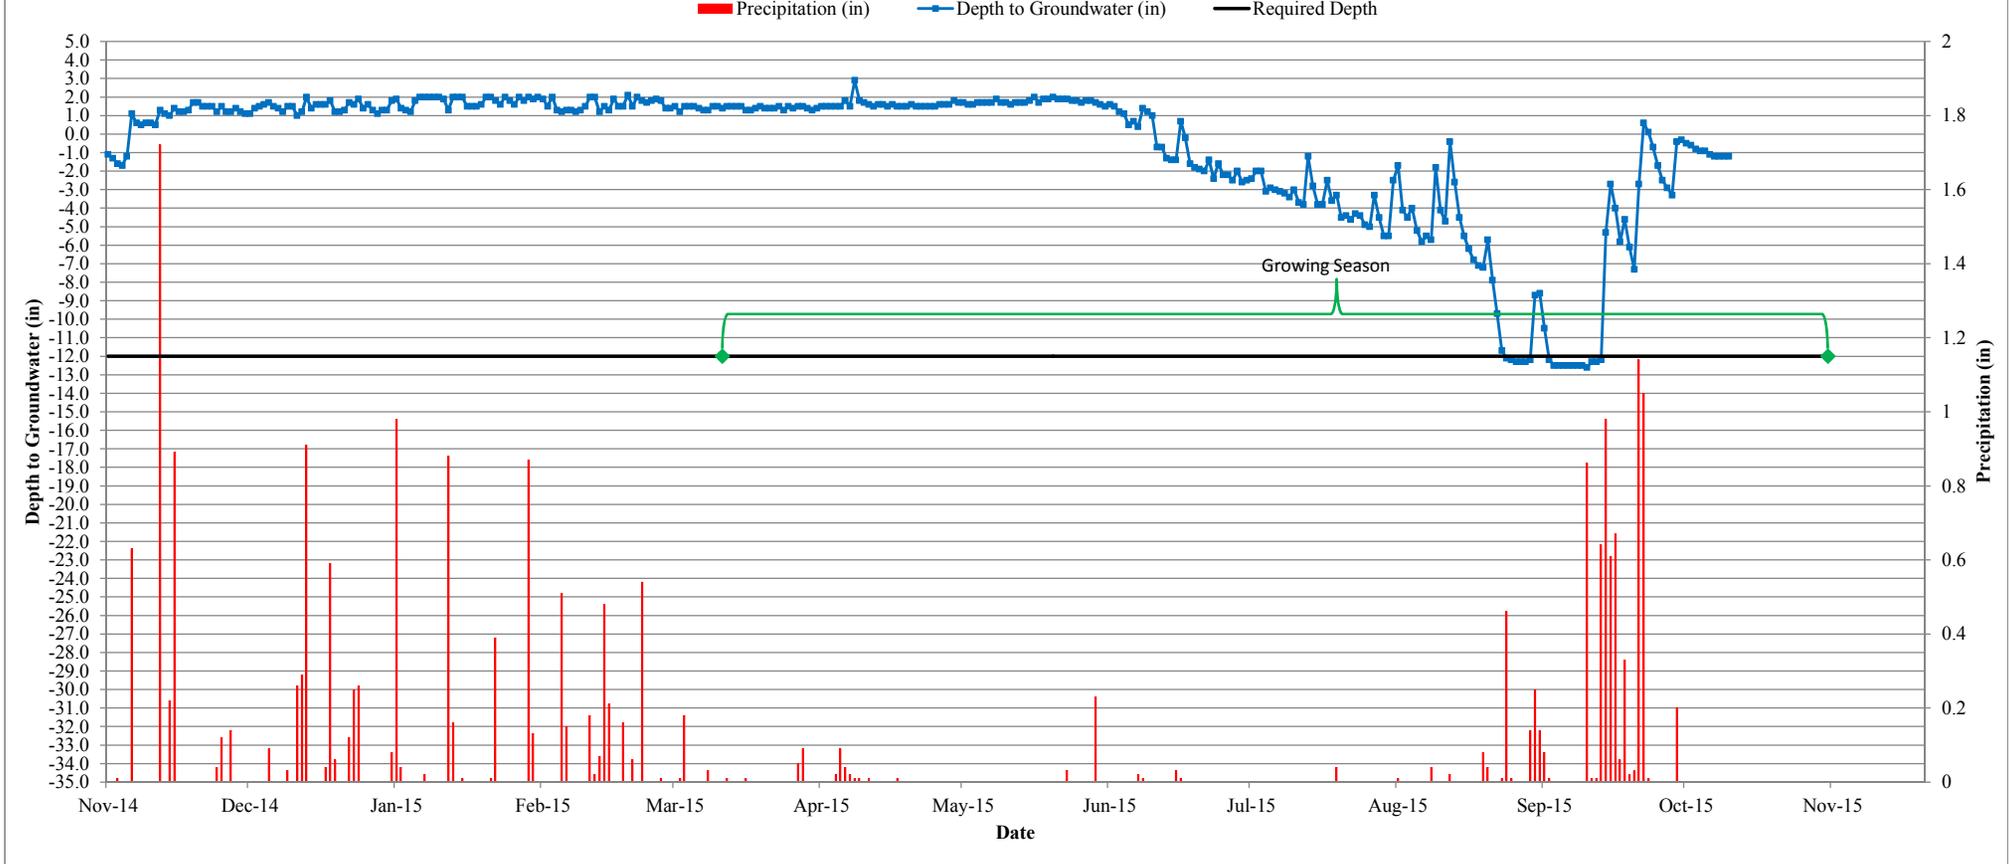
**Figure 5**  
**UT to Clarke Creek Hydrology Monitoring**  
**Groundwater Gauge 1 - 2015**  
**WM0000136A5C22**

Wells 1 and 7 met the hydrology success criteria for monitoring year 2. Wells 2, 3, and 4 did not meet the success criteria. Wells 5, 6, and 8 malfunctioned and do not have data during the growing season. According to rainfall data for the area, less than 1 inch of rain fell for each month from March to August. This could explain why the majority of the wells placed in wetland areas did not meet the success criteria.
