# FINAL MONITORING BASELINE DOCUMENT UT TO HAW BECKOM RESTORTION SITE ALAMANCE COUNTY, NORTH CAROLINA (EEP Project No. 92694)

March 2011

### UT to Haw (Beckom) Site (92694) Post Construction Photographs January 3, 2011

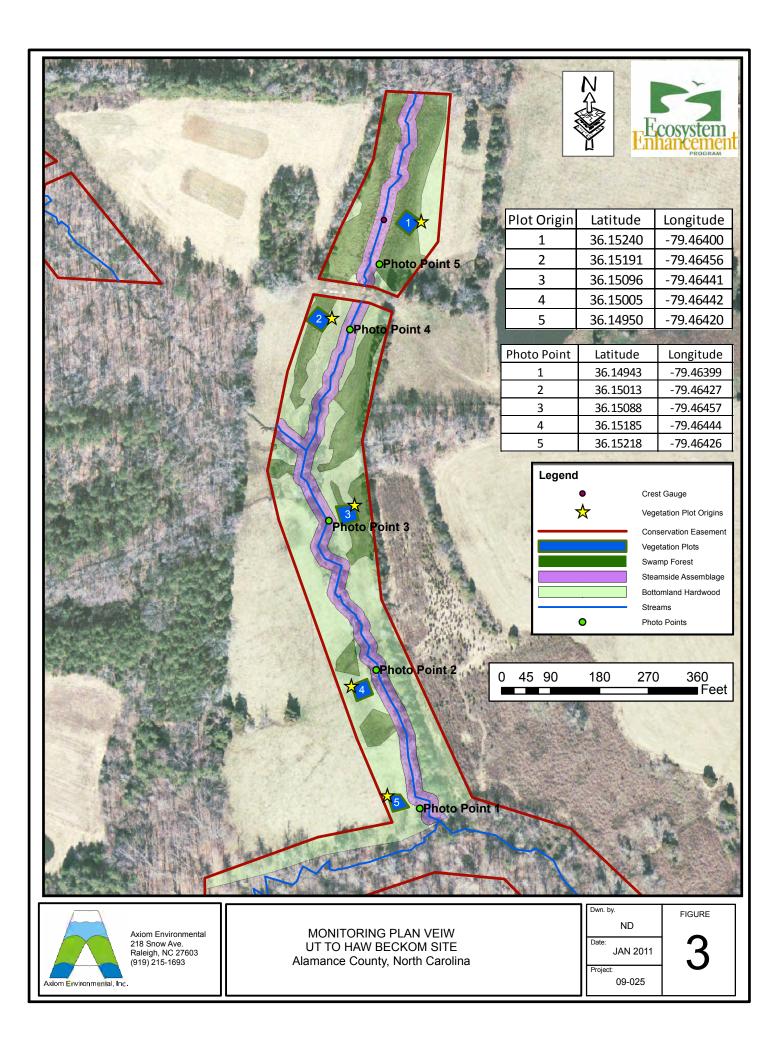
After planting was completed, an initial evaluation was performed to verify planting methods and to determine initial species composition and density. Five sample plots (10-meter by 10-meter) were installed within the Site as per guidelines established in *CVS-EEP Protocol for Recording Vegetation, Version 4.0* (Lee et al. 2006); locations are depicted on Figure 3 (Appendix A).
