**FINAL
ANNUAL MONITORING REPORT
UT TO HAW BECKOM RESTORATION SITE
ALAMANCE COUNTY, NORTH CAROLINA
(EEP Project No. 92694, Contract No. 004545)**

Monitoring Year 4 of 5 (2014)

Prepared by:
Axiom Environmental, Inc.
218 Snow Ave.
Raleigh, North Carolina 27603

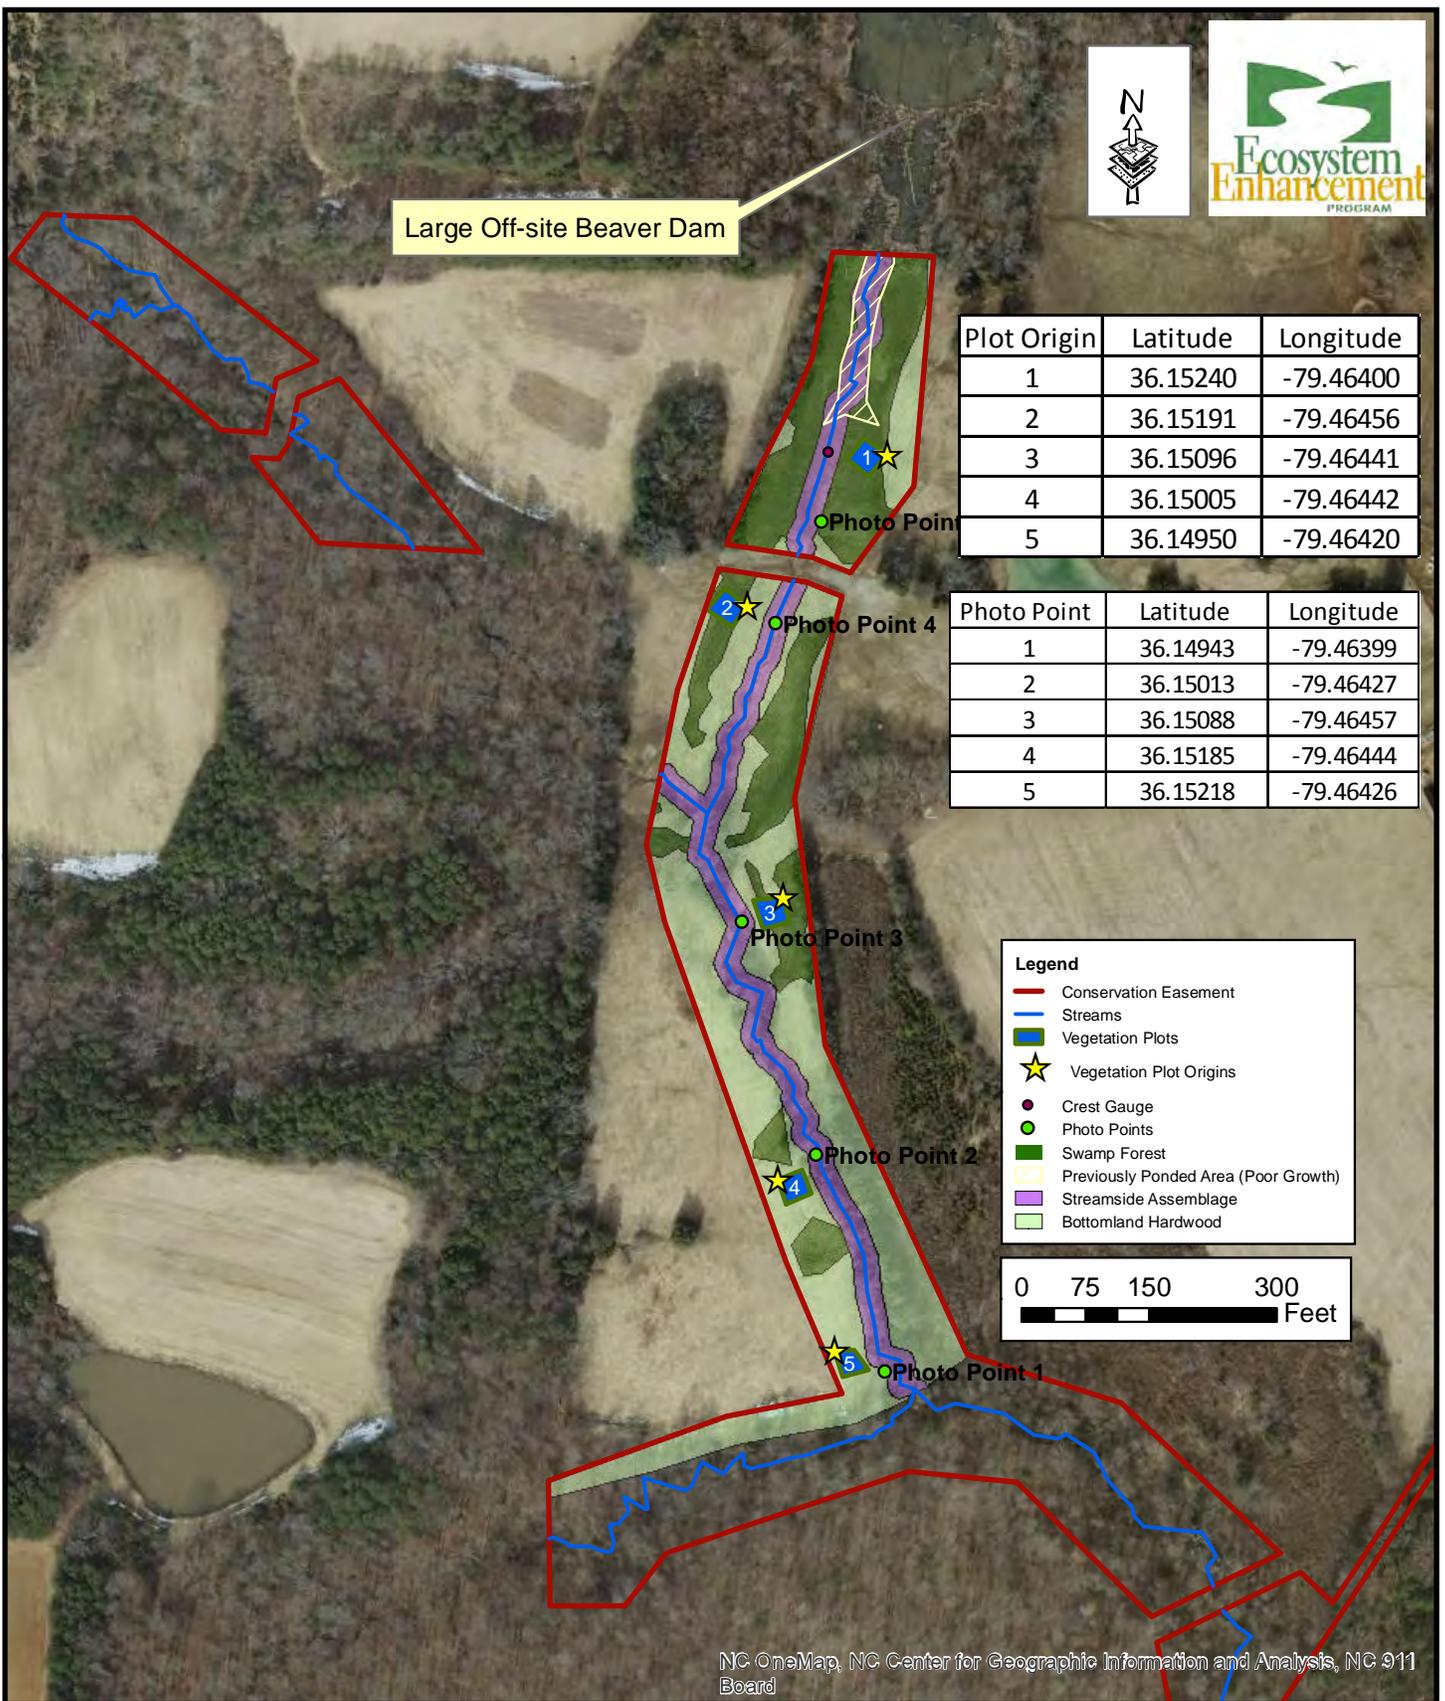
FIGURE
2

No signs of beaver activity were observed on the Site during monitoring year 4 (2014). One large, well-established dam is located just upstream of the Site, but no dams currently exist on the Site. The previously ponded area upstream of the breached dam continues to have poor vegetation. APHIS personnel are providing beaver management and will continue to trap at the Site as necessary. The beaver dam location and previously ponded area are depicted on Figure 2 (Appendix B).

**CURRENT CONDITIONS PLAN VEIW
UT TO HAW BECKOM SITE
Alamance County, North Carolina**

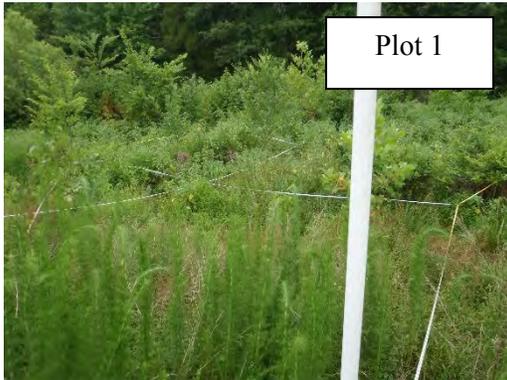
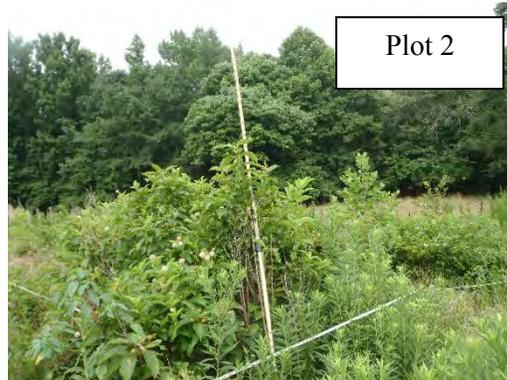
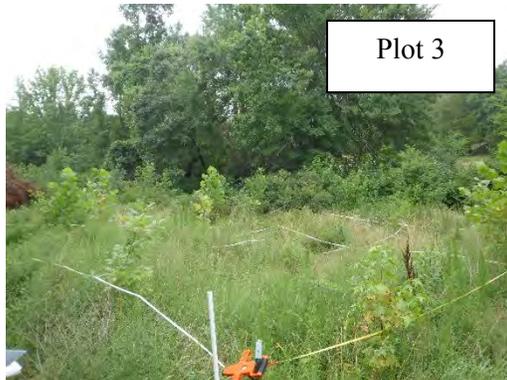
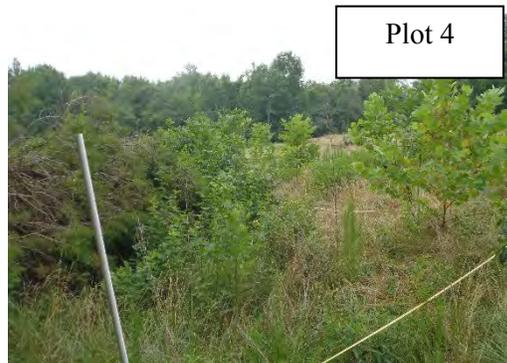
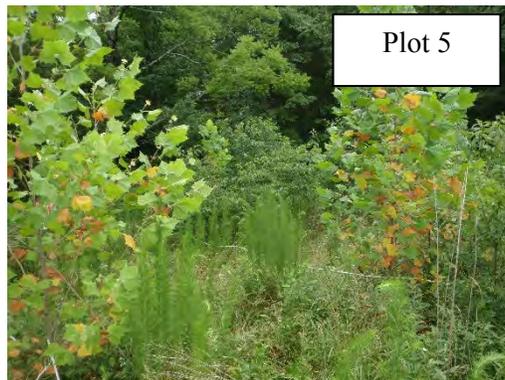
**UT Haw (Beckom) Year 4 - 2014
Vegetation Monitoring Photographs
Taken July 2014**

Planted stems in the majority of the site, including bare roots planted in 2011, appear to be vigorous in all areas except for portions of the Site previously ponded by beaver where no stems were observed. Herbaceous species in ponded areas contributed to low planted stem densities; fescue does not appear to be of concern at this time for planted stem survival.
