UT to Magness Creek Mitigation Project Mitigation Plan – Final

Cleveland County, North Carolina Broad River Basin: 03050105 DMS Project ID No. 100081, DMS RFP #16-007400 (Issued: 12/7/2017) DEQ Contract No. 7604, USACE Action ID SAW-2018-01759, DWR# 20181275

July 2021

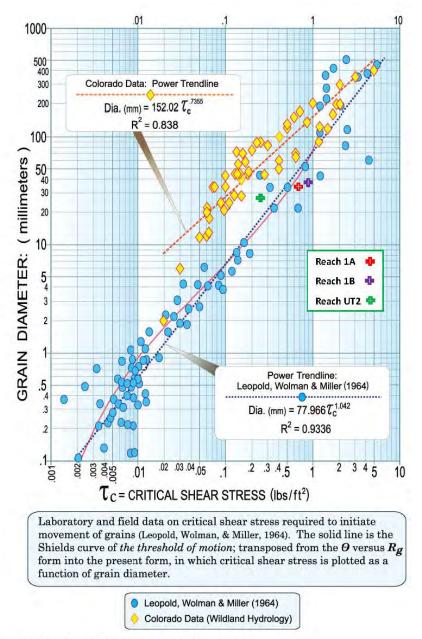
(Adapted from WARSSS, Figure 5-49, Rosgen 2009)

particularly for the Shield's curve predictions. All of this again indicates that the designed system should have no difficulty moving the existing bed load.

The post-construction channels will include constructed riffles that will contain larger sized materials; a mix of Class 1, Class B, Class A, and ABC stone, in addition to harvested native channel material (the existing bed load noted above), for a combined D50 of approximately 100 mm (though only about 15% of the stone will be larger than is expected to be actively transported and mobile). Thus, the analysis shows that the new channels should not produce enough shear stress to entrain the largest particles in the system, consequently allowing the constructed channel beds to remain stable, while still allowing for the active movement and transport of much of the bed load through the stream system.

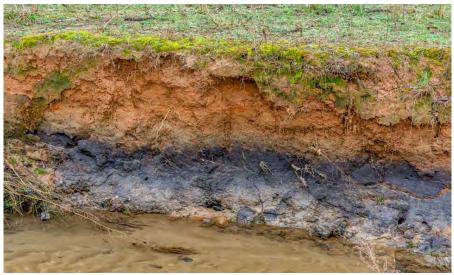
Example of the significant erosion at the upper end of this project site.
