FINAL MITIGATION PLAN VALLE CRUCIS MITIGATION SITE

Watauga County, North Carolina

DMS Project ID No. 100205 Full Delivery Contract No. 200104-01 USACE Action ID No. SAW-2021-01272 DWR Project No. 2019-0050 v2 RFP No. 16-20200104 (Issued 12/1/2020)

> Watauga River Basin Cataloging Unit 06010103

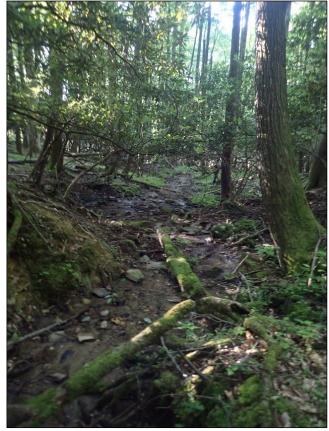
The bed is 2 to 8 feet in width, and the banks are 0.5 to 6 feet deep. The substrate composition is sand, gravel, and cobble, with some silt and boulders. Cattle actively enter the stream bed, and there is a small amount of deadfall and woody debris in the streambed.

Photo 1: UT-1 Upstream Wooded Area

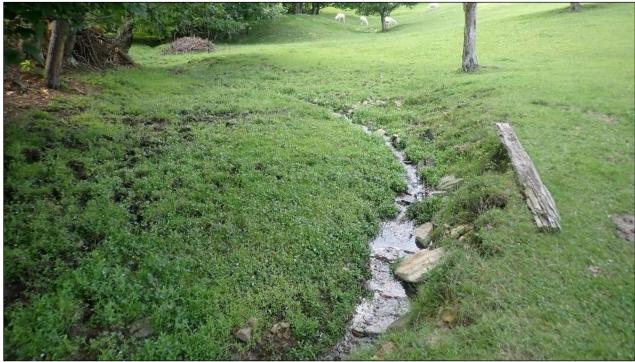
Photo 2: UT-1 Below Wooded Area

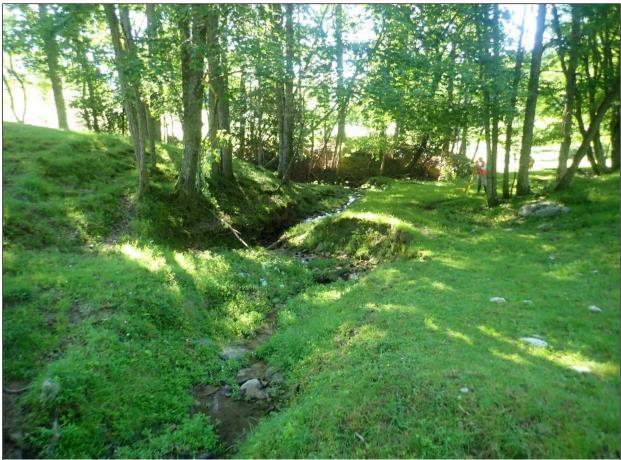
Photo 3: UT2

The bed is 4 to 8 feet wide, and the banks are incised at 0.5 to 8 feet. Substrate composition includes sand, silt, gravel, and some cobble. Active cattle access is evident, and erosion forces have exposed roots of some larger trees.

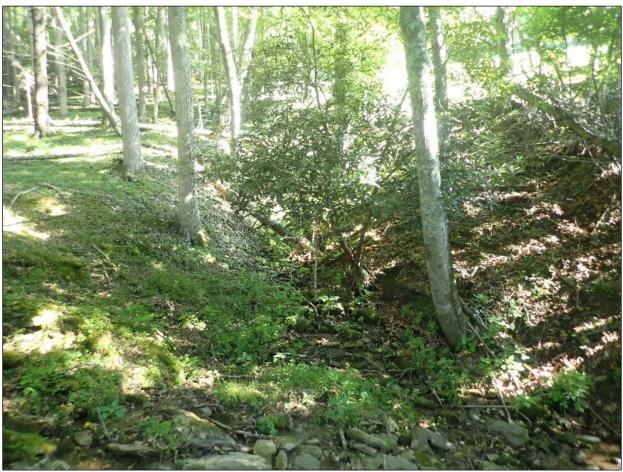
Photo 4: UT-2A

UT-2A is contained in a short, steep, and very narrow valley. Active cattle access and the creek originates at a steep headcut immediately below a cattle path above the stream. The bed is 3 to 15 feet wide, and the banks are 4 to 6 feet deep. The substrate composition is sand and gravel. Common nettle is thick at the origin, and there is significant woody debris presence in-channel covering much of the stream.

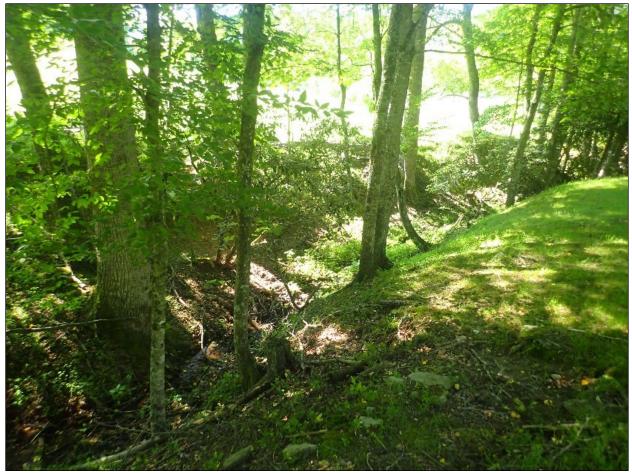
Photo 5: UT-3

UT-3 starts at a large headcut below a cattle trail, similar to UT-2A. The bed is 2 to 20 feet in width, and the banks are steep with a depth of 6 to 15 feet. The substrate is composed of sand, silt, and gravel. Seep-like wetlands border both sides of the stream within its steep banks.

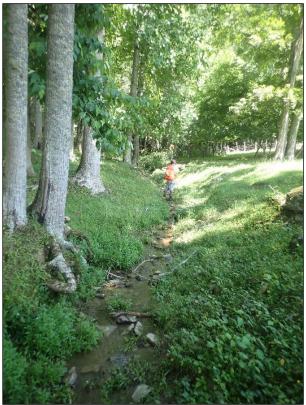
The uppermost part of UT-4 is contained within a very steep and narrow valley with slopes exceeding 20 feet in depth. The stream channel is 3 to 6 feet in widthwide, and the banks are incised 2 to 6 feet. The substrate composition is mostly sand and gravel with some cobble, silt, and boulders mixed in. Cattle have access to much of the stream channel, and further erosion from fluvial processes is evidenced by large undercuts and exposed roots of mature trees.

Photo 7: UT-4 (upstream wooded area)

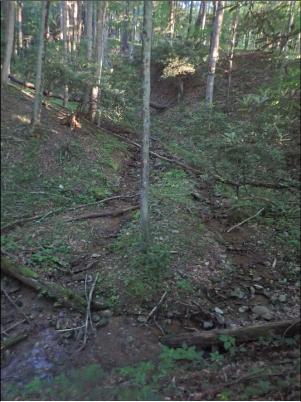
Photo 6: UT-4 (upstream wooded area)

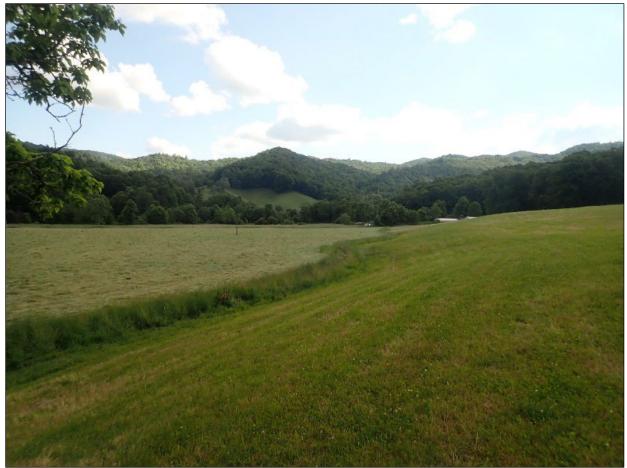
The stream has been dredged, straightened, and pushed to the toe of slope along the margins of a flat open pasture. The channel is 1 to 3 feet wide, and the banks are 0.5 to 3 feet deep.

Photo 8: UT-4 (below wooded area)

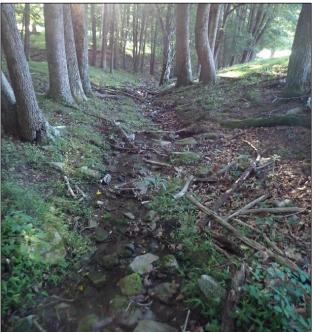
The stream originates from a depressional wetland and descends down a steep slope before dropping over a headcut and quickly joining UT-1. The bed is 3 to 6 feet wide, and the banks are 0.5 to 6 feet deep. The substrate composition is mostly sand, gravel, and cobble with some silt.

Photo 9: UT-5

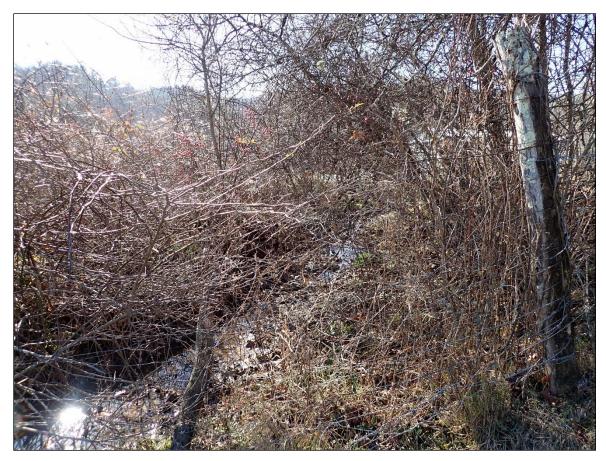
UT 6 and UT 4 have been ditched and dredged to merge upstream and off site. Therefore, the size and discharge of UT 6 are inflated. The existing stream is approximately 5 feet in width and 2 feet in depth but will be significantly smaller once UT 4 is rerouted across its proper floodplain. In addition, UT 6 is currently characterized by scrubby vegetation upstream of the pasture fence and fescue below the fence.

Photo 10: UT-6

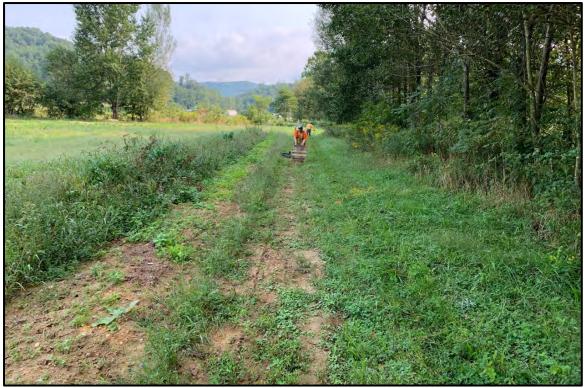
Figure 2.1. Shovel testing in agricultural field on north side of Dutch Creek, facing northeast.

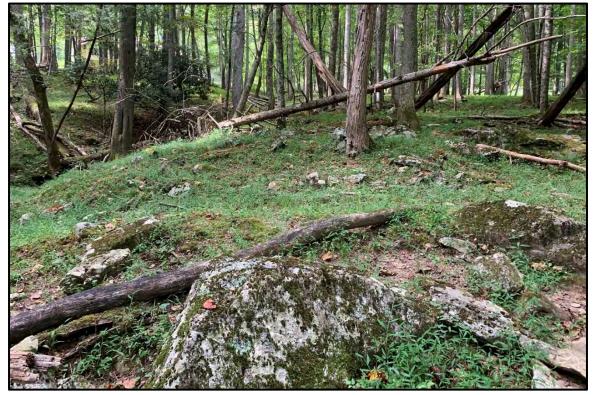
Figure 2.7. Eroded stream channel in wooded pasture, facing northwest.

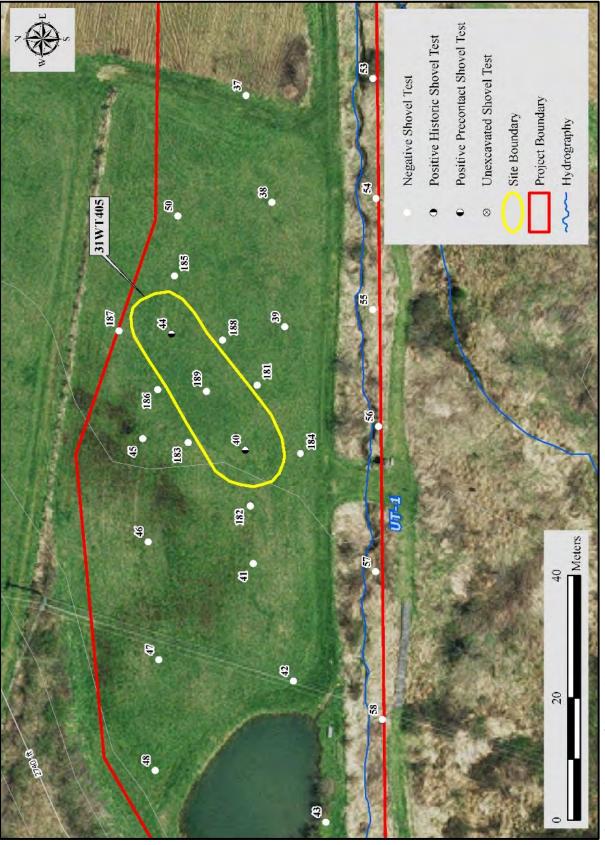
Figure 5.8. Map of 31WT405.

<u>Summary and Recommendations</u>. Site 31WT405 is a precontact period site situated on the level terrace north of a Dutch Creek tributary. Shovel tests generated a fragmentary projectile point made of Knox chert, which is not considered diagnostic of any particular component, and a piece of unmodified debitage of the same raw material. The extremely low artifact density at 31WT405 suggests that no intensive habitation or activities occurred within the LOD. Based on these data, site 31WT405, as expressed within the LOD, represents a low density, precontact period artifact deposit characteristic of many in western North Carolina and lacks evidence of meaningful artifact concentrations that would suggest the presence of associated features or any other intact aspects of site structure and integrity. The portion of the site within the LOD has little potential to provide substantial information on the prehistory of the area and is recommended not eligible for the NRHP under Criterion D; this part of the site also appears to lack the characteristics necessary for eligibility under the other NRHP criteria.

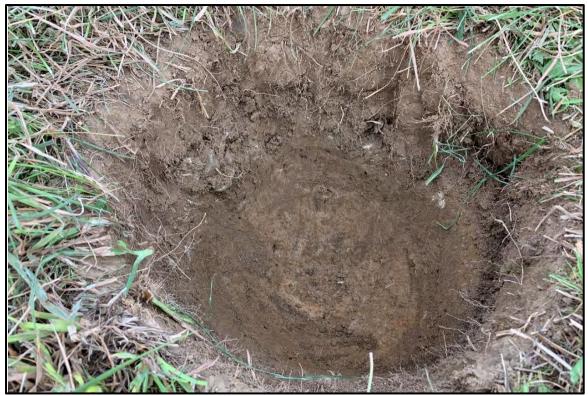
Figure 5.11. Shovel Test 40 at 31WT405.

Shovel Tests. Fifteen shovel tests were excavated at 10- and 20-m intervals across the area (including all transect and delineation tests situated within 20 m), and two of these generated a total of two lithic artifacts (Figure 5.11). The two positive shovel tests each produced one artifact from the plowzone.

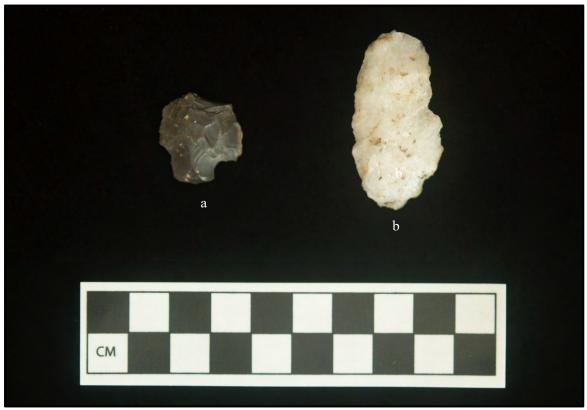
Figure 5.12. Selected precontact artifacts from 31WT405 and 31WT406. 31WT405: a) chert small stemmed PPK, ST 40; 31WT406: b) lanceolate PPK/biface, ST 125

Artifacts. The assemblage includes a fragmentary, lanceolate, late-stage biface or projectile point preform made of quartz (see Figure 5.12b), three pieces of unmodified debitage (two chert, one quartzite), and an unmodified cobble (that appears to have been transported to the site from a near-stream environment, and not part of the colluvial load). None of these is temporally diagnostic.

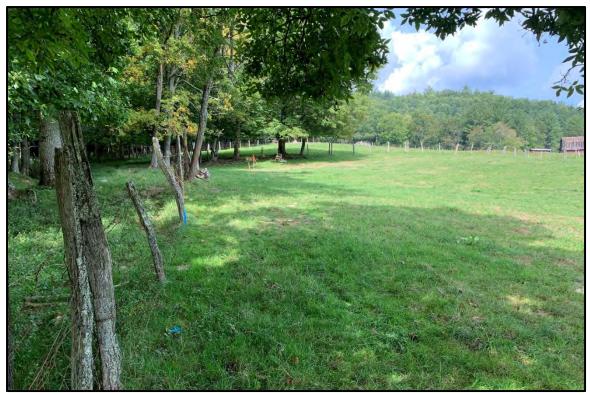
Figure 5.16. Site 31WT407, facing northeast.

<u>Summary and Recommendations</u>. Site 31WT407 is a low-density precontact period artifact scatter located on a sloped ridge toe adjacent to a first order stream (the stream separates 31WT407 from 31WT406 located to the west). Shovel tests produced no diagnostic artifacts, and the representative artifacts were dispersed, confined to the Ap horizon, and suggest ephemeral occupation. Consequently, the portion of 31WT407 within the LOD is unlikely to provide any significant or new information concerning precontact occupations in the area and is recommended not eligible for the NRHP under Criterion D; this part of the site also appears to lack the characteristics necessary for eligibility under the other NRHP criteria.

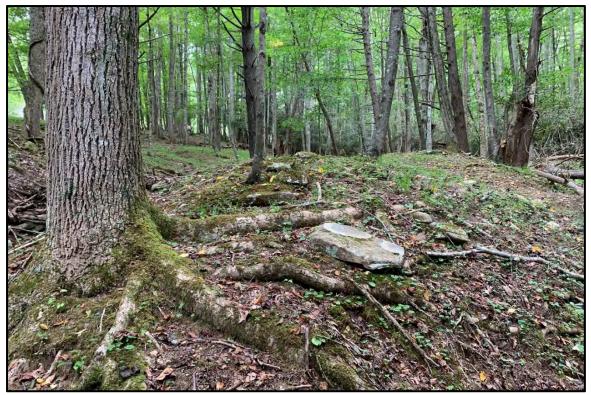
Figure 5.25. Site 31WT409, facing northwest.

The soils at 31WT409 are mapped as Dellwood cobbly sandy loam, 1-5% slopes (DeB), an alluvial-type soil (USDA NRCS 2020). The setting of the site is difficult to reconcile with the mapped soil type; the setting and soil conditions more closely resemble one of the Saunook varieties, such as Saunook cobbly loam, central mountains, 8-15% slopes (SkC), or Saunook loam (central mountains, very stony), associated with 8-15% slopes (SoC). Soils encountered in the single shovel test were excessively rocky and consisted of a 13 cm thick very dark brown (10YR 2/2) silt loam Oi to A horizon overlying yellowish brown (10YR 5/4) gravelly sandy clay loam.

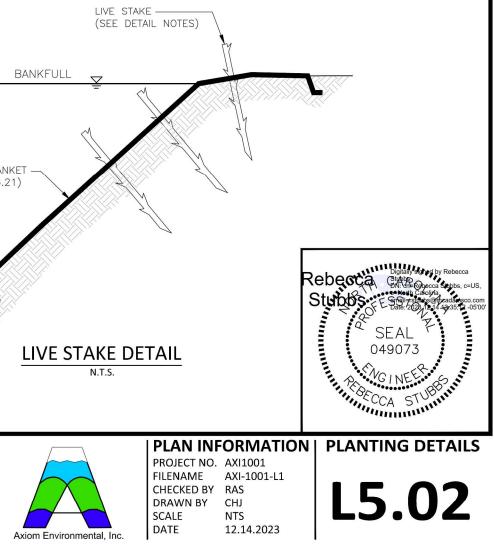
- 1. AREAS NOTED AS LIVE STAKES WITHIN THE PLANTING ZONE SHALL BE PLANTED WITH SPECIES LISTED ON SHEET L5.00.
- 2. ONE LIVE STAKE SPECIES PER LIVE STAKE AREA. ALTERNATE SPECIES PER LIVE STAKE AREA.
- 3. ALL LIVE STAKES SHALL BE DORMANT AT TIME OF ACQUISITION AND PLANTING.
- 4. LIVE STAKES SHALL BE 1/2-2" IN DIAMETER. LIVE STAKES SHALL ALSO BE 2 4 FEET IN LENGTH.
- 5. DURING PREPARATION, THE BASAL ENDS OF THE LIVE STAKES SHALL BE CLEANLY CUT AT AN ANGLE TO FACILITATE REMOVED FROM THE SIDES OF THE LIVE CUTTING PRIOR TO INSTALLATION.
- WATER TO BE SOAKED FOR 10 DAYS, AND THEN PLANTED IMMEDIATELY AFTER THE 10 DAYS ARE COMPLETED. SHADED AND PROTECTED FROM WIND AND DIRECT SUNLIGHT.
- REPLACED.
- 8. THE AREA AROUND EACH LIVE STAKE SHALL BE COMPACTED BY FOOT AFTER THE LIVE STAKE HAS BEEN INSTALLED.
- 9. APPROXIMATELY 15 DEGREES FOLLOWING INSTALLATION.
