WELLS CREEK #2
NCEEP Project #92688
2011 MONITORING REPORT – YEAR 1

CONDUCTED FOR THE NORTH CAROLINA DEPARTMENT OF ENVIRONMENT
AND NATURAL RESOURCES

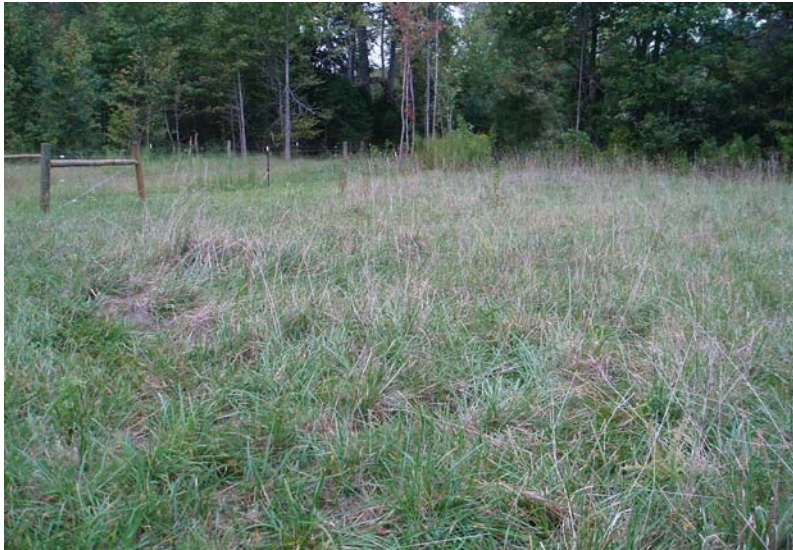
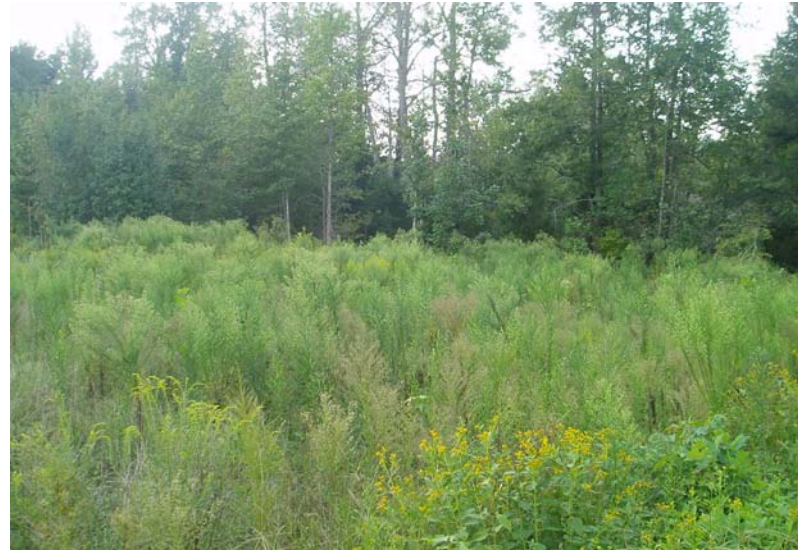
PP #1 – Looking Downstream from Easement Boundary (09/16/09)

PP #1 – Looking Downstream from Easement Boundary (09/15/11)

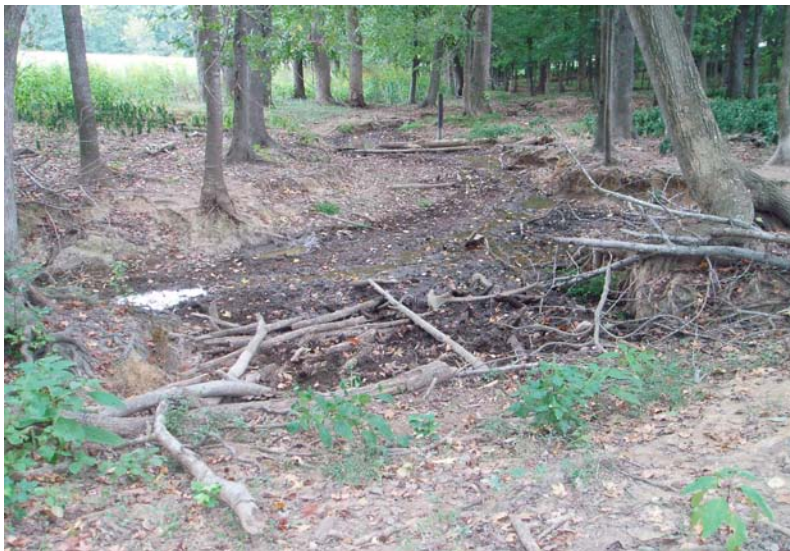
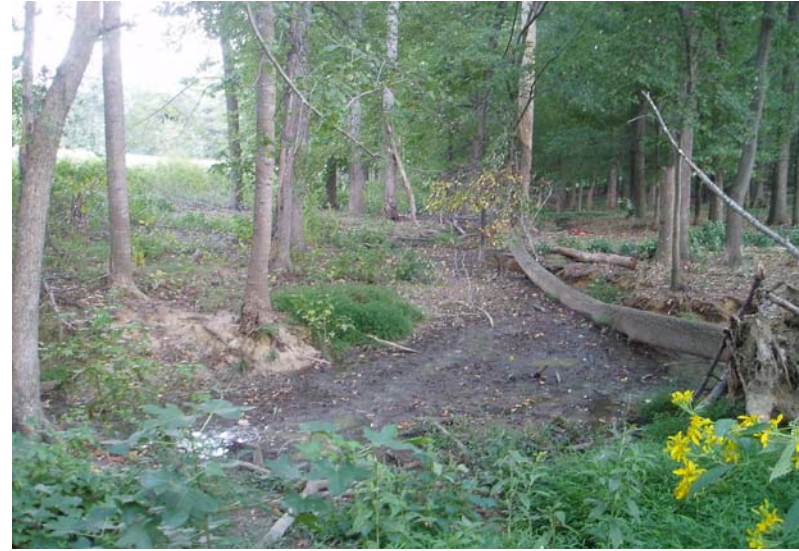
Based on the permanent photopoints and a visual assessment, there are no new areas of channel instability in the project area. Smaller hogs are able to access UT3 by going under the easement fence. Hog wallows and paths were noted in the upper portion of the reach during the September 15, 2011 visit. The presence of hogs does not appear to have affected the survival of the planted woody vegetation. The wallows are located in the same area as those that existed prior to the restoration.

PP #10 – Looking across Trampled Banks of UT3 (09/16/09)

PP #10 – Looking across Trampled Banks of UT3 (09/15/11)

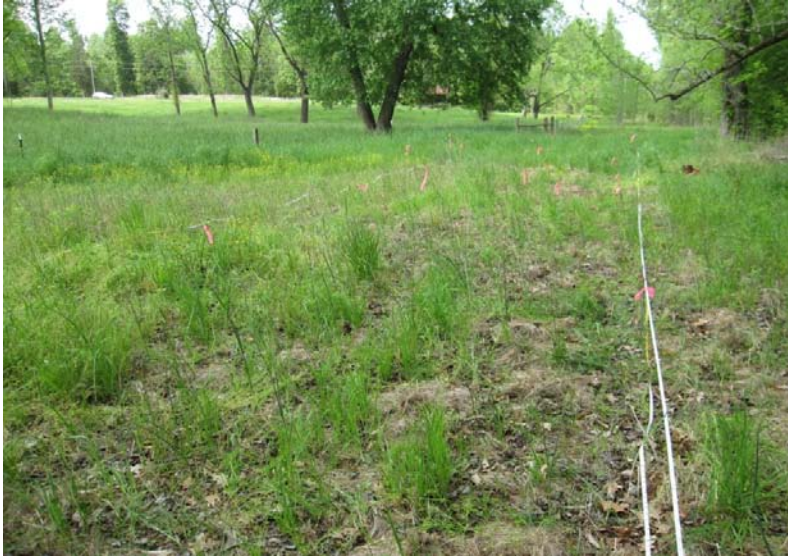
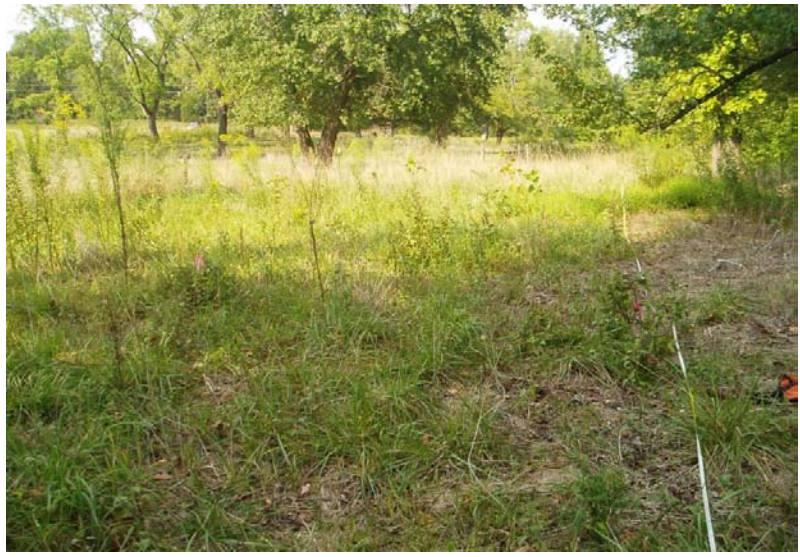
Two vegetation monitoring plots were established on April 27, 2011 and resampled on September 15, 2011. The Monitoring Year 1 live planted woody stem density is 586 stems per acre. Based on visual assessment, stem survival appears to be good throughout the restoration, despite the dry summer. Invasive species treatment in 2010 and early 2011 appears to have effectively reduced the presence of tree of heaven, multiflora rose, and other exotic species along both the enhancement and preservation reaches.

VP 1 (April 27, 2011)

VP 1 (September 15, 2011)

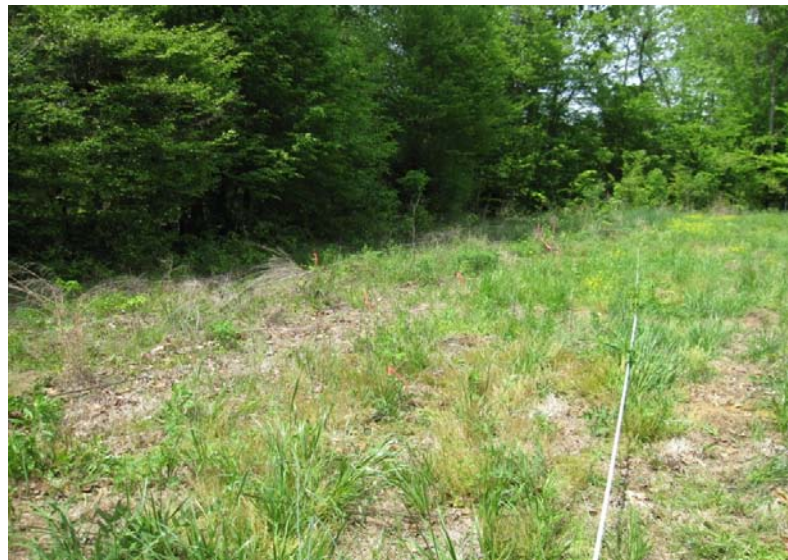
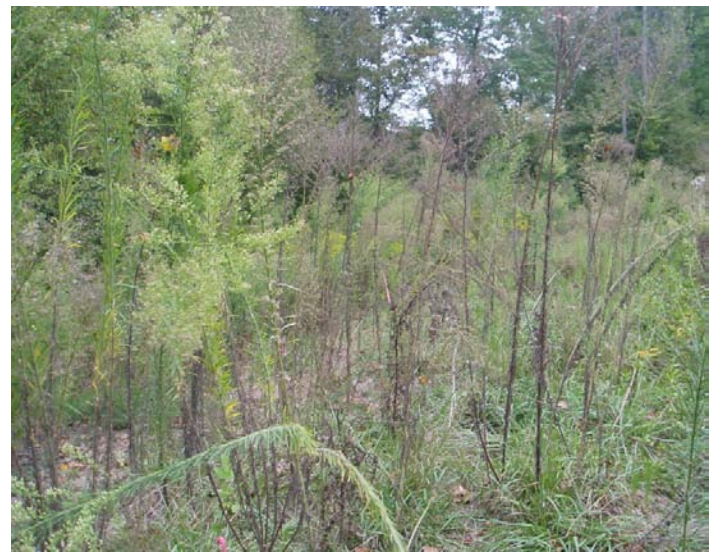
VP 2 (April 27, 2011)

VP 2 (September 15, 2011)
