Case Study – Pinehurst Hotel Cleaners

- **Laundry & dry-cleaning facility for former Pinehurst Hotel**
- **Operated 1930's through 1970's**
- **Contamination identified during due diligence assessment on adjacent property in 1990**
- **Property owner entered site into DSCA Program in 2001**

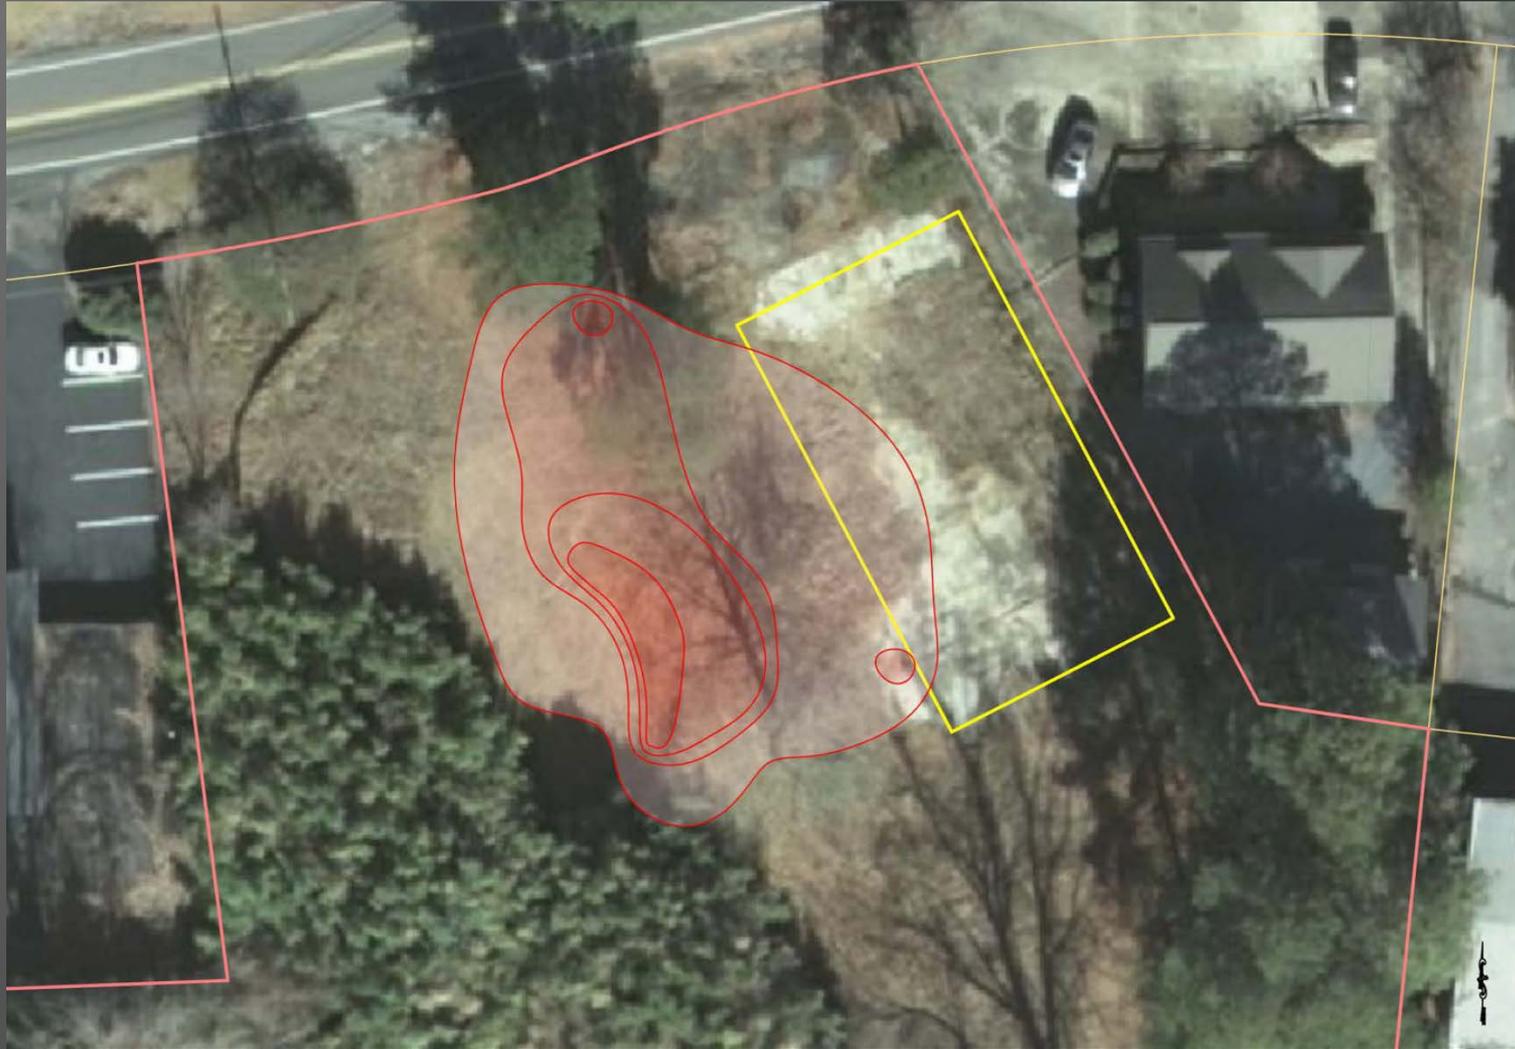
PCE Plume in Soil

- Maximum PCE concentration: 180 ppm
- Impacted soil exposed at ground surface

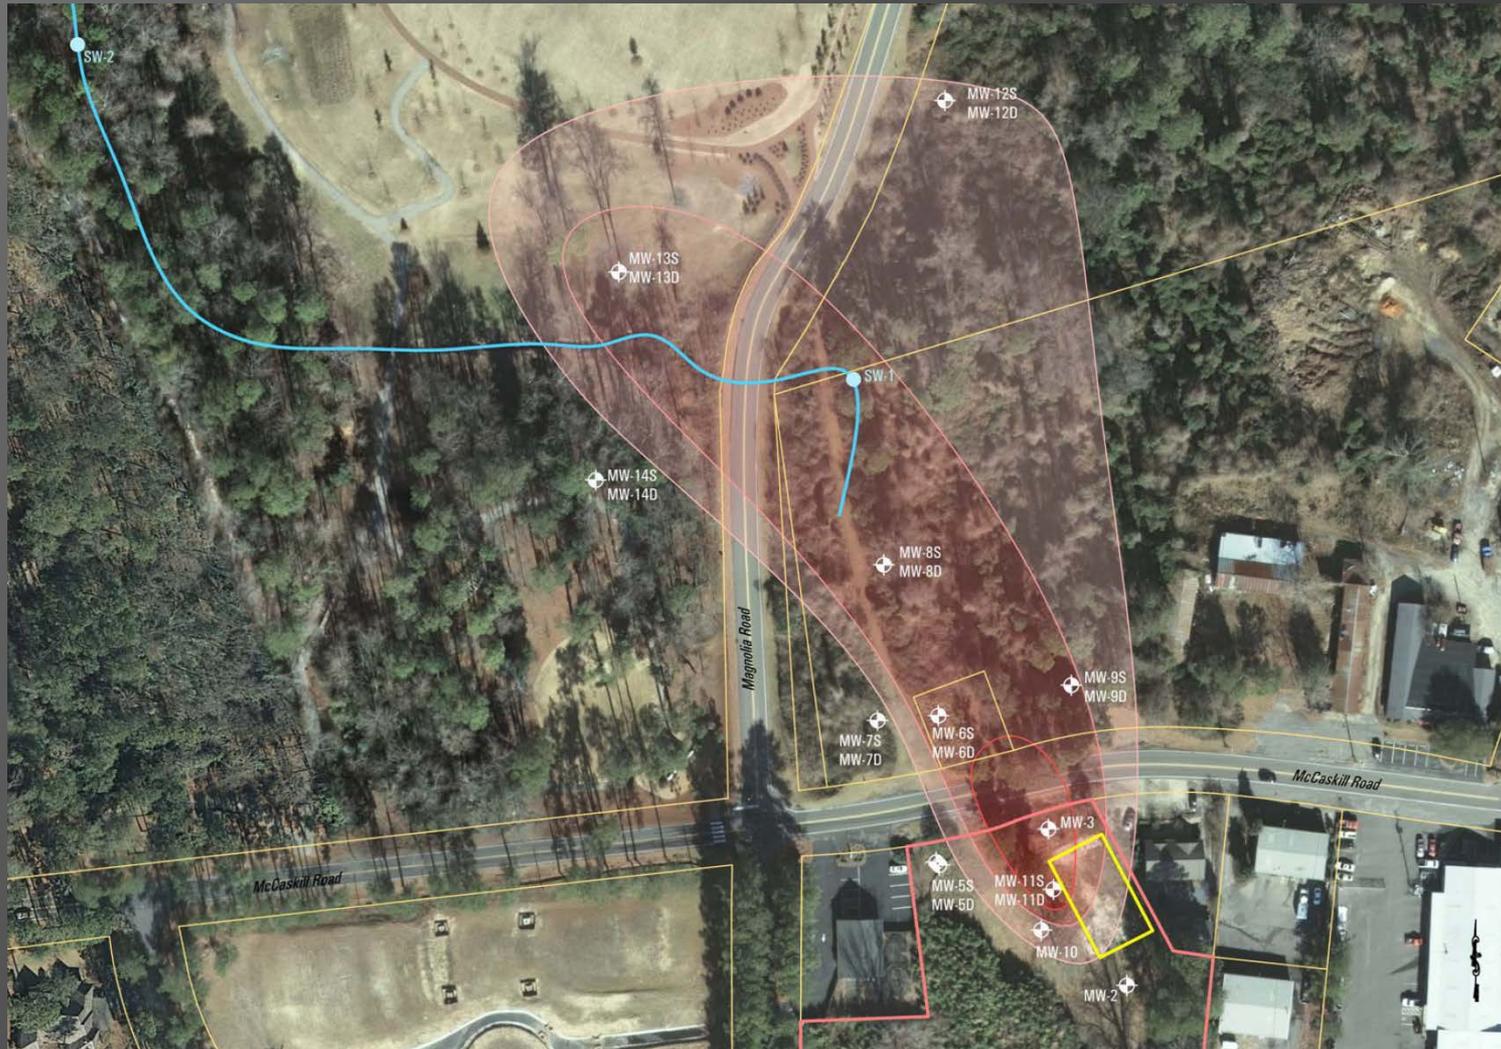
PCE Plume in Groundwater

- Maximum PCE concentration in groundwater: 340 ug/L
- Maximum PCE concentration in surface water: 14 ug/L

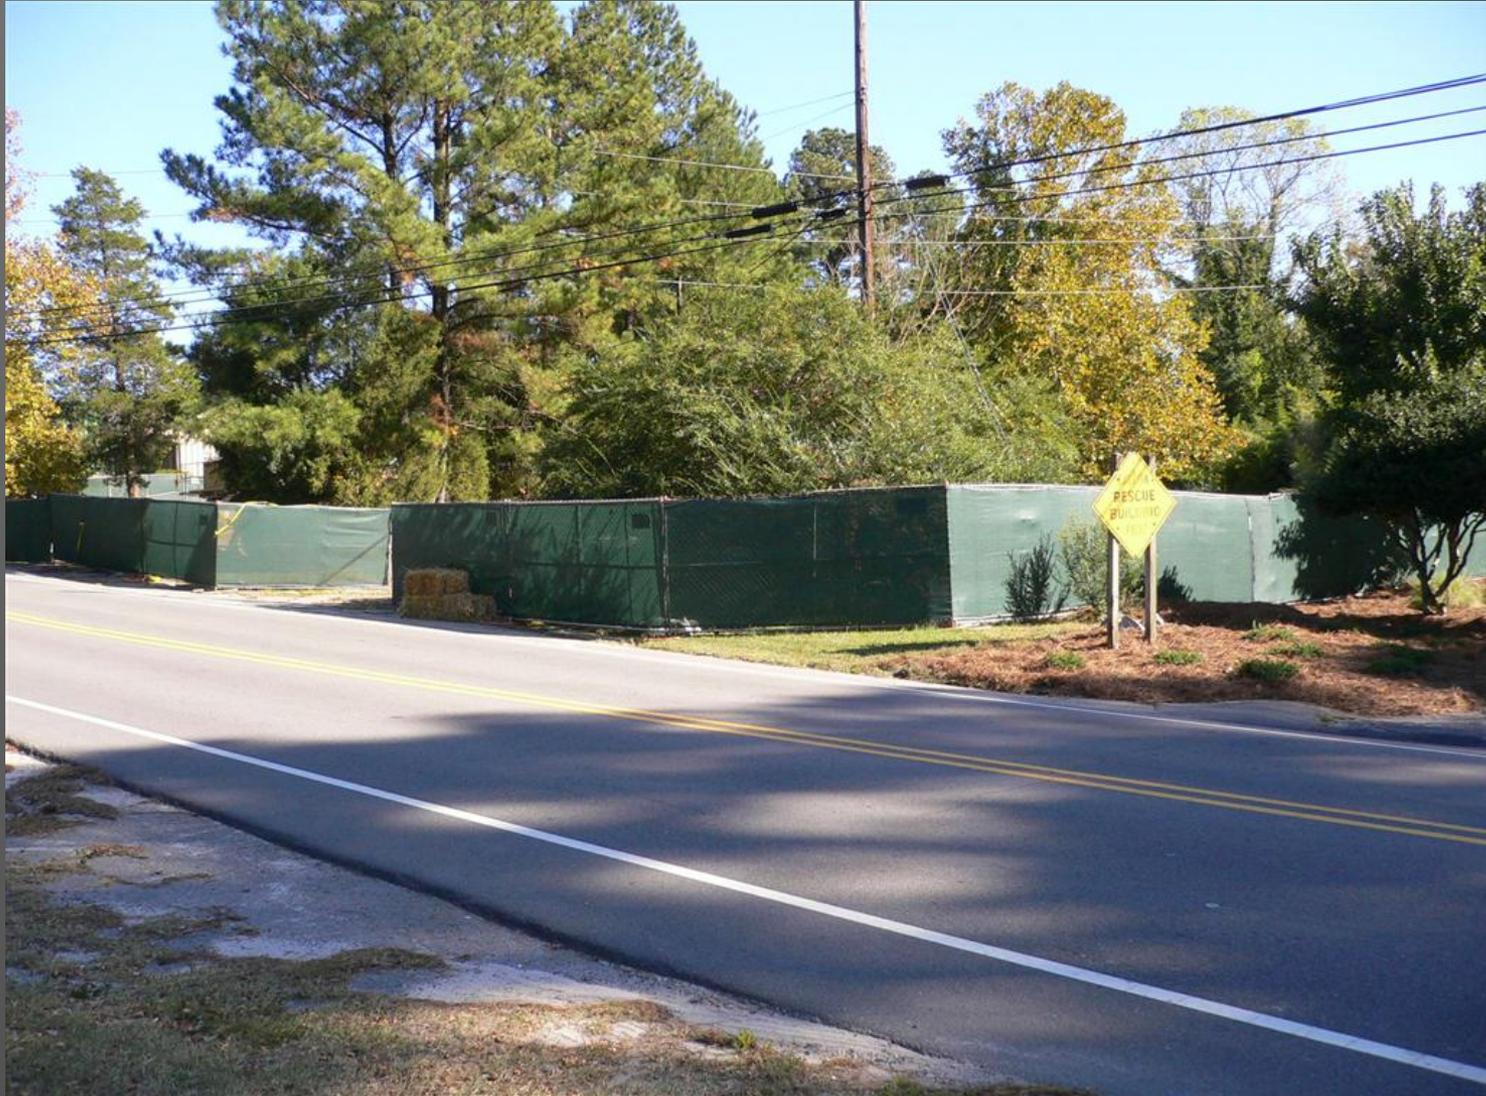
Soil Remediation

- Treated on-site using mobile steam distillation unit

- Compliance with Village of Pinehurst requests
