Draft Remedial Action Plan
East Wake County LF – Zone C
Knightdale, Wake County, NC
NCDEQ ID No. NONCD0000614
S&ME Project No. 22050404
NCDEQ Task Order 614RA-2

Reference: **Draft Remedial Action Plan**
East Wake County LF – Zone C
Knightdale, Wake County, North Carolina
NCDEQ ID NONCD0000614
Task Order 614RA-2
S&ME Project No. 22050404

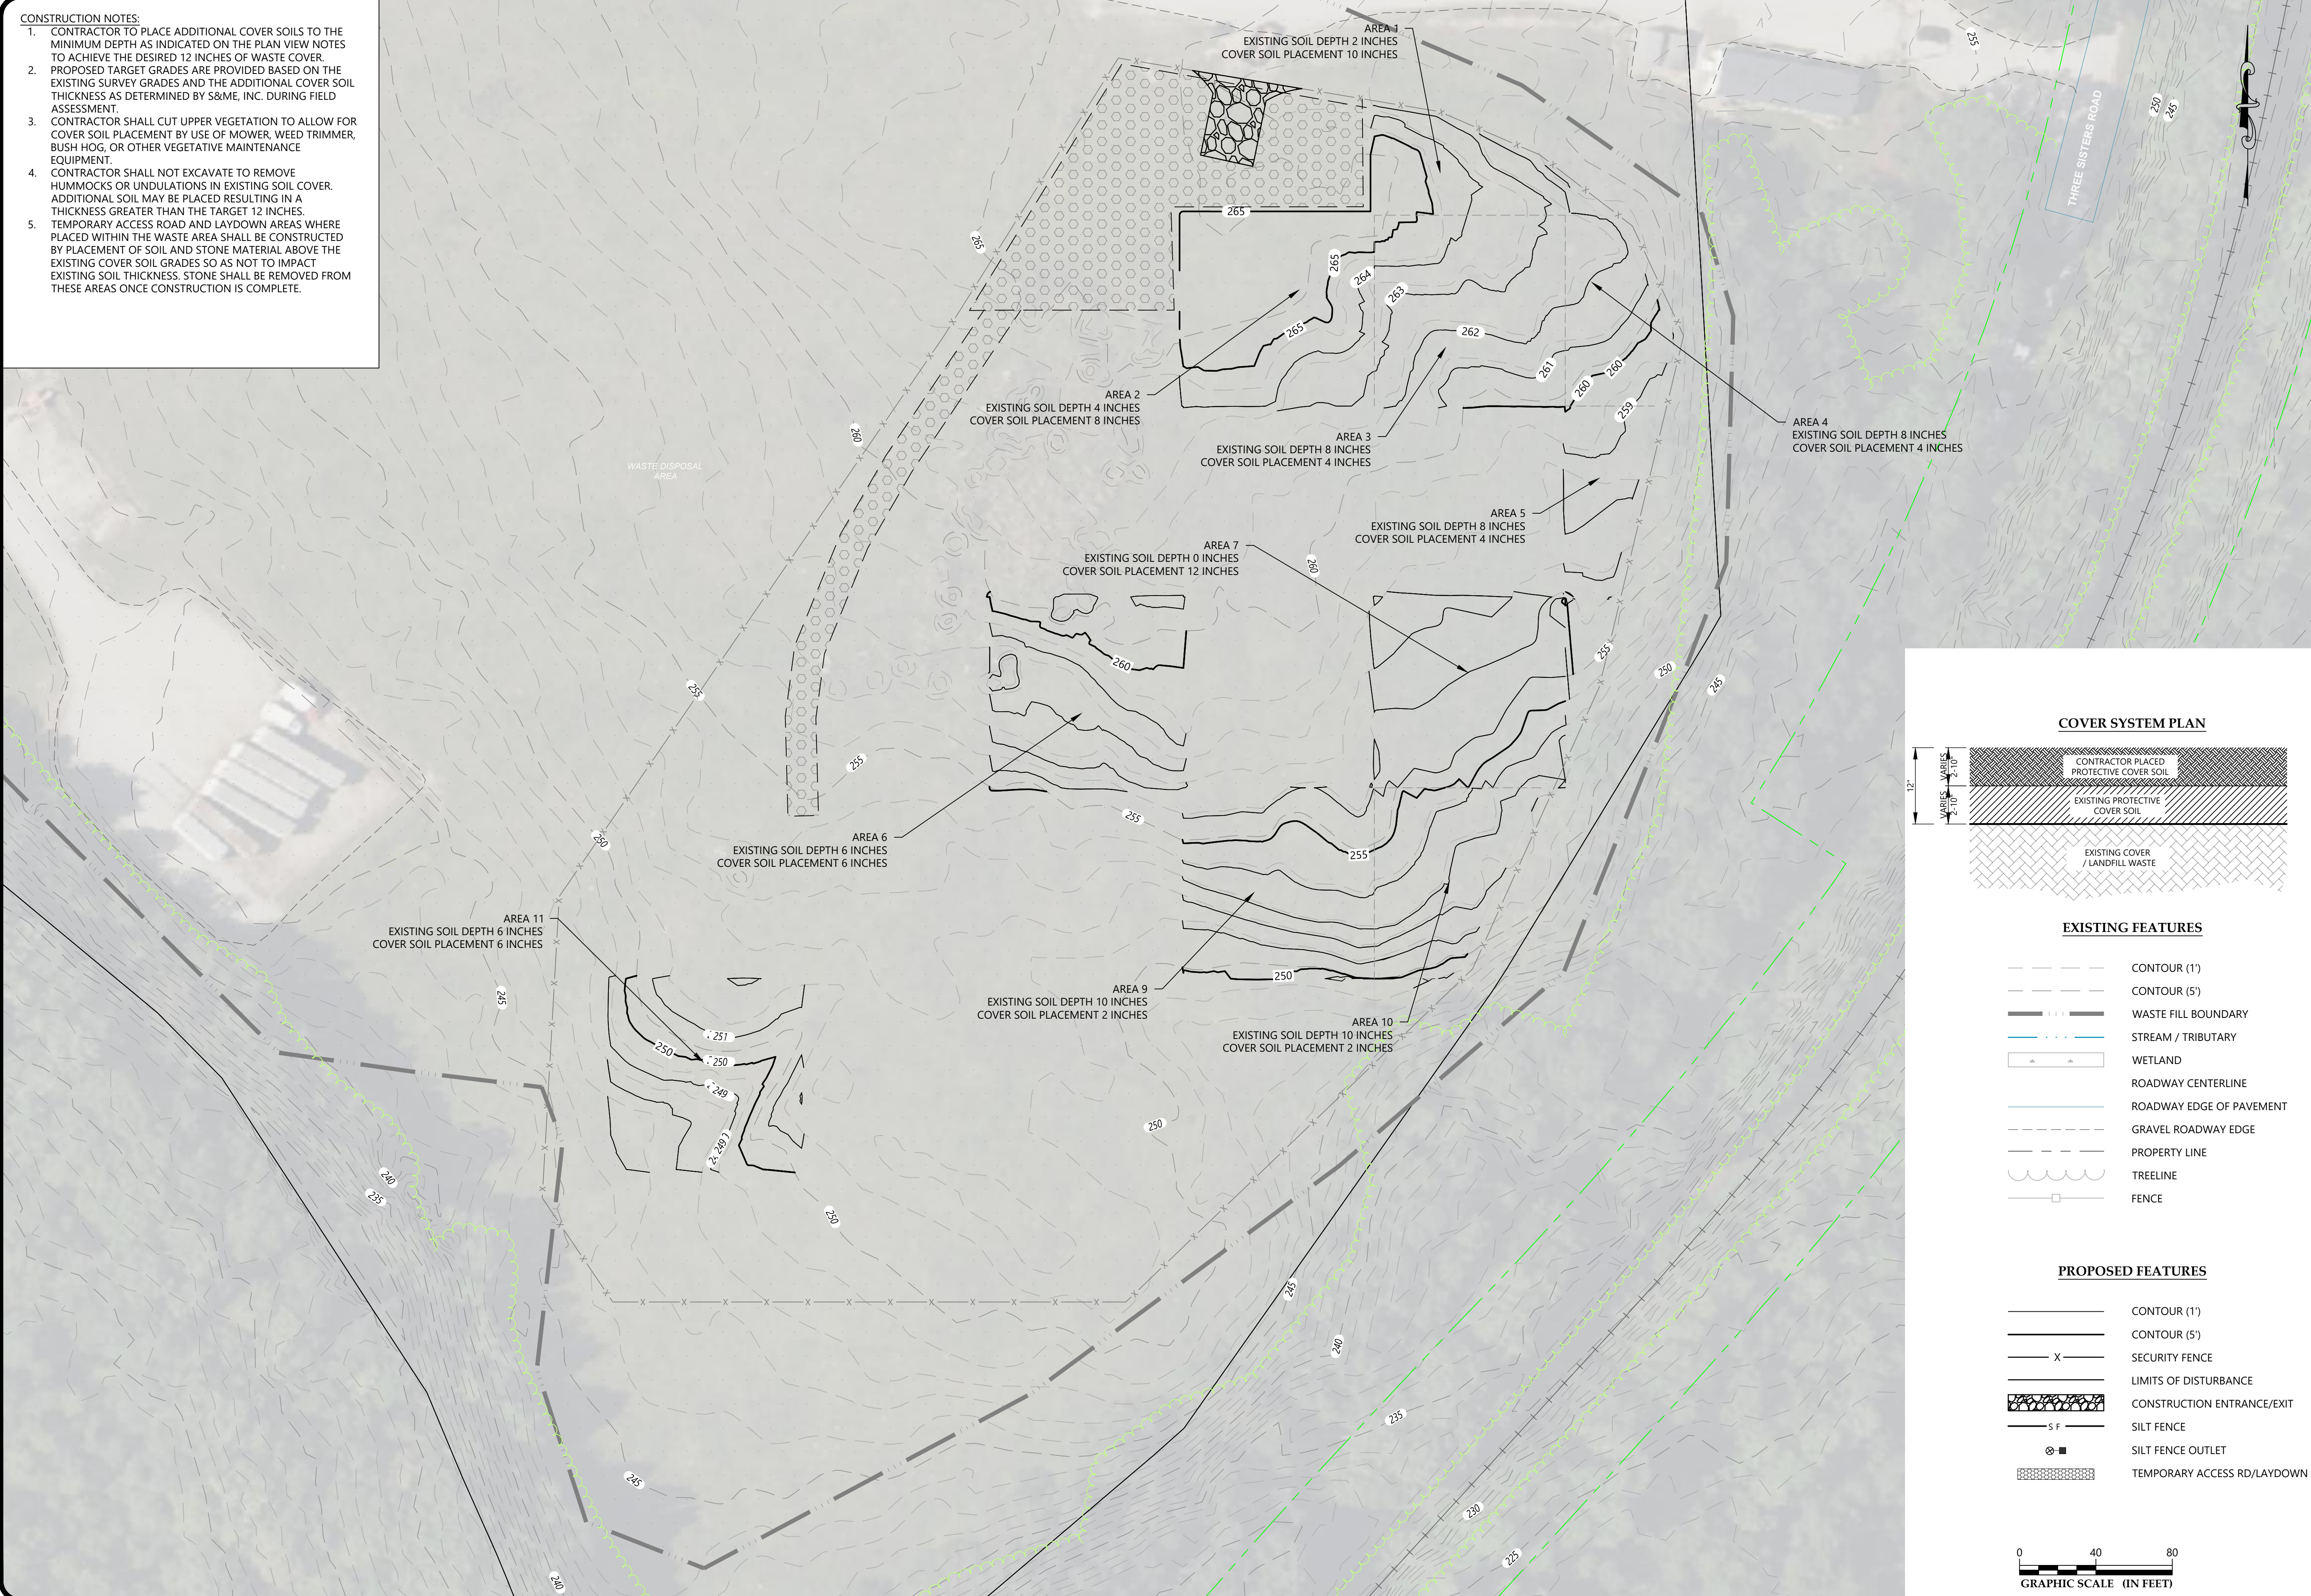
COVER SYSTEM PLAN

5. TEMPORARY ACCESS ROAD AND LAYDOWN AREAS WHERE PLACED WITHIN THE WASTE AREA SHALL BE CONSTRUCTED BY PLACEMENT OF SOIL AND STONE MATERIAL ABOVE THE EXISTING COVER SOIL GRADES SO AS NOT TO IMPACT EXISTING SOIL THICKNESS. STONE SHALL BE REMOVED FROM THESE AREAS ONCE CONSTRUCTION IS COMPLETE.

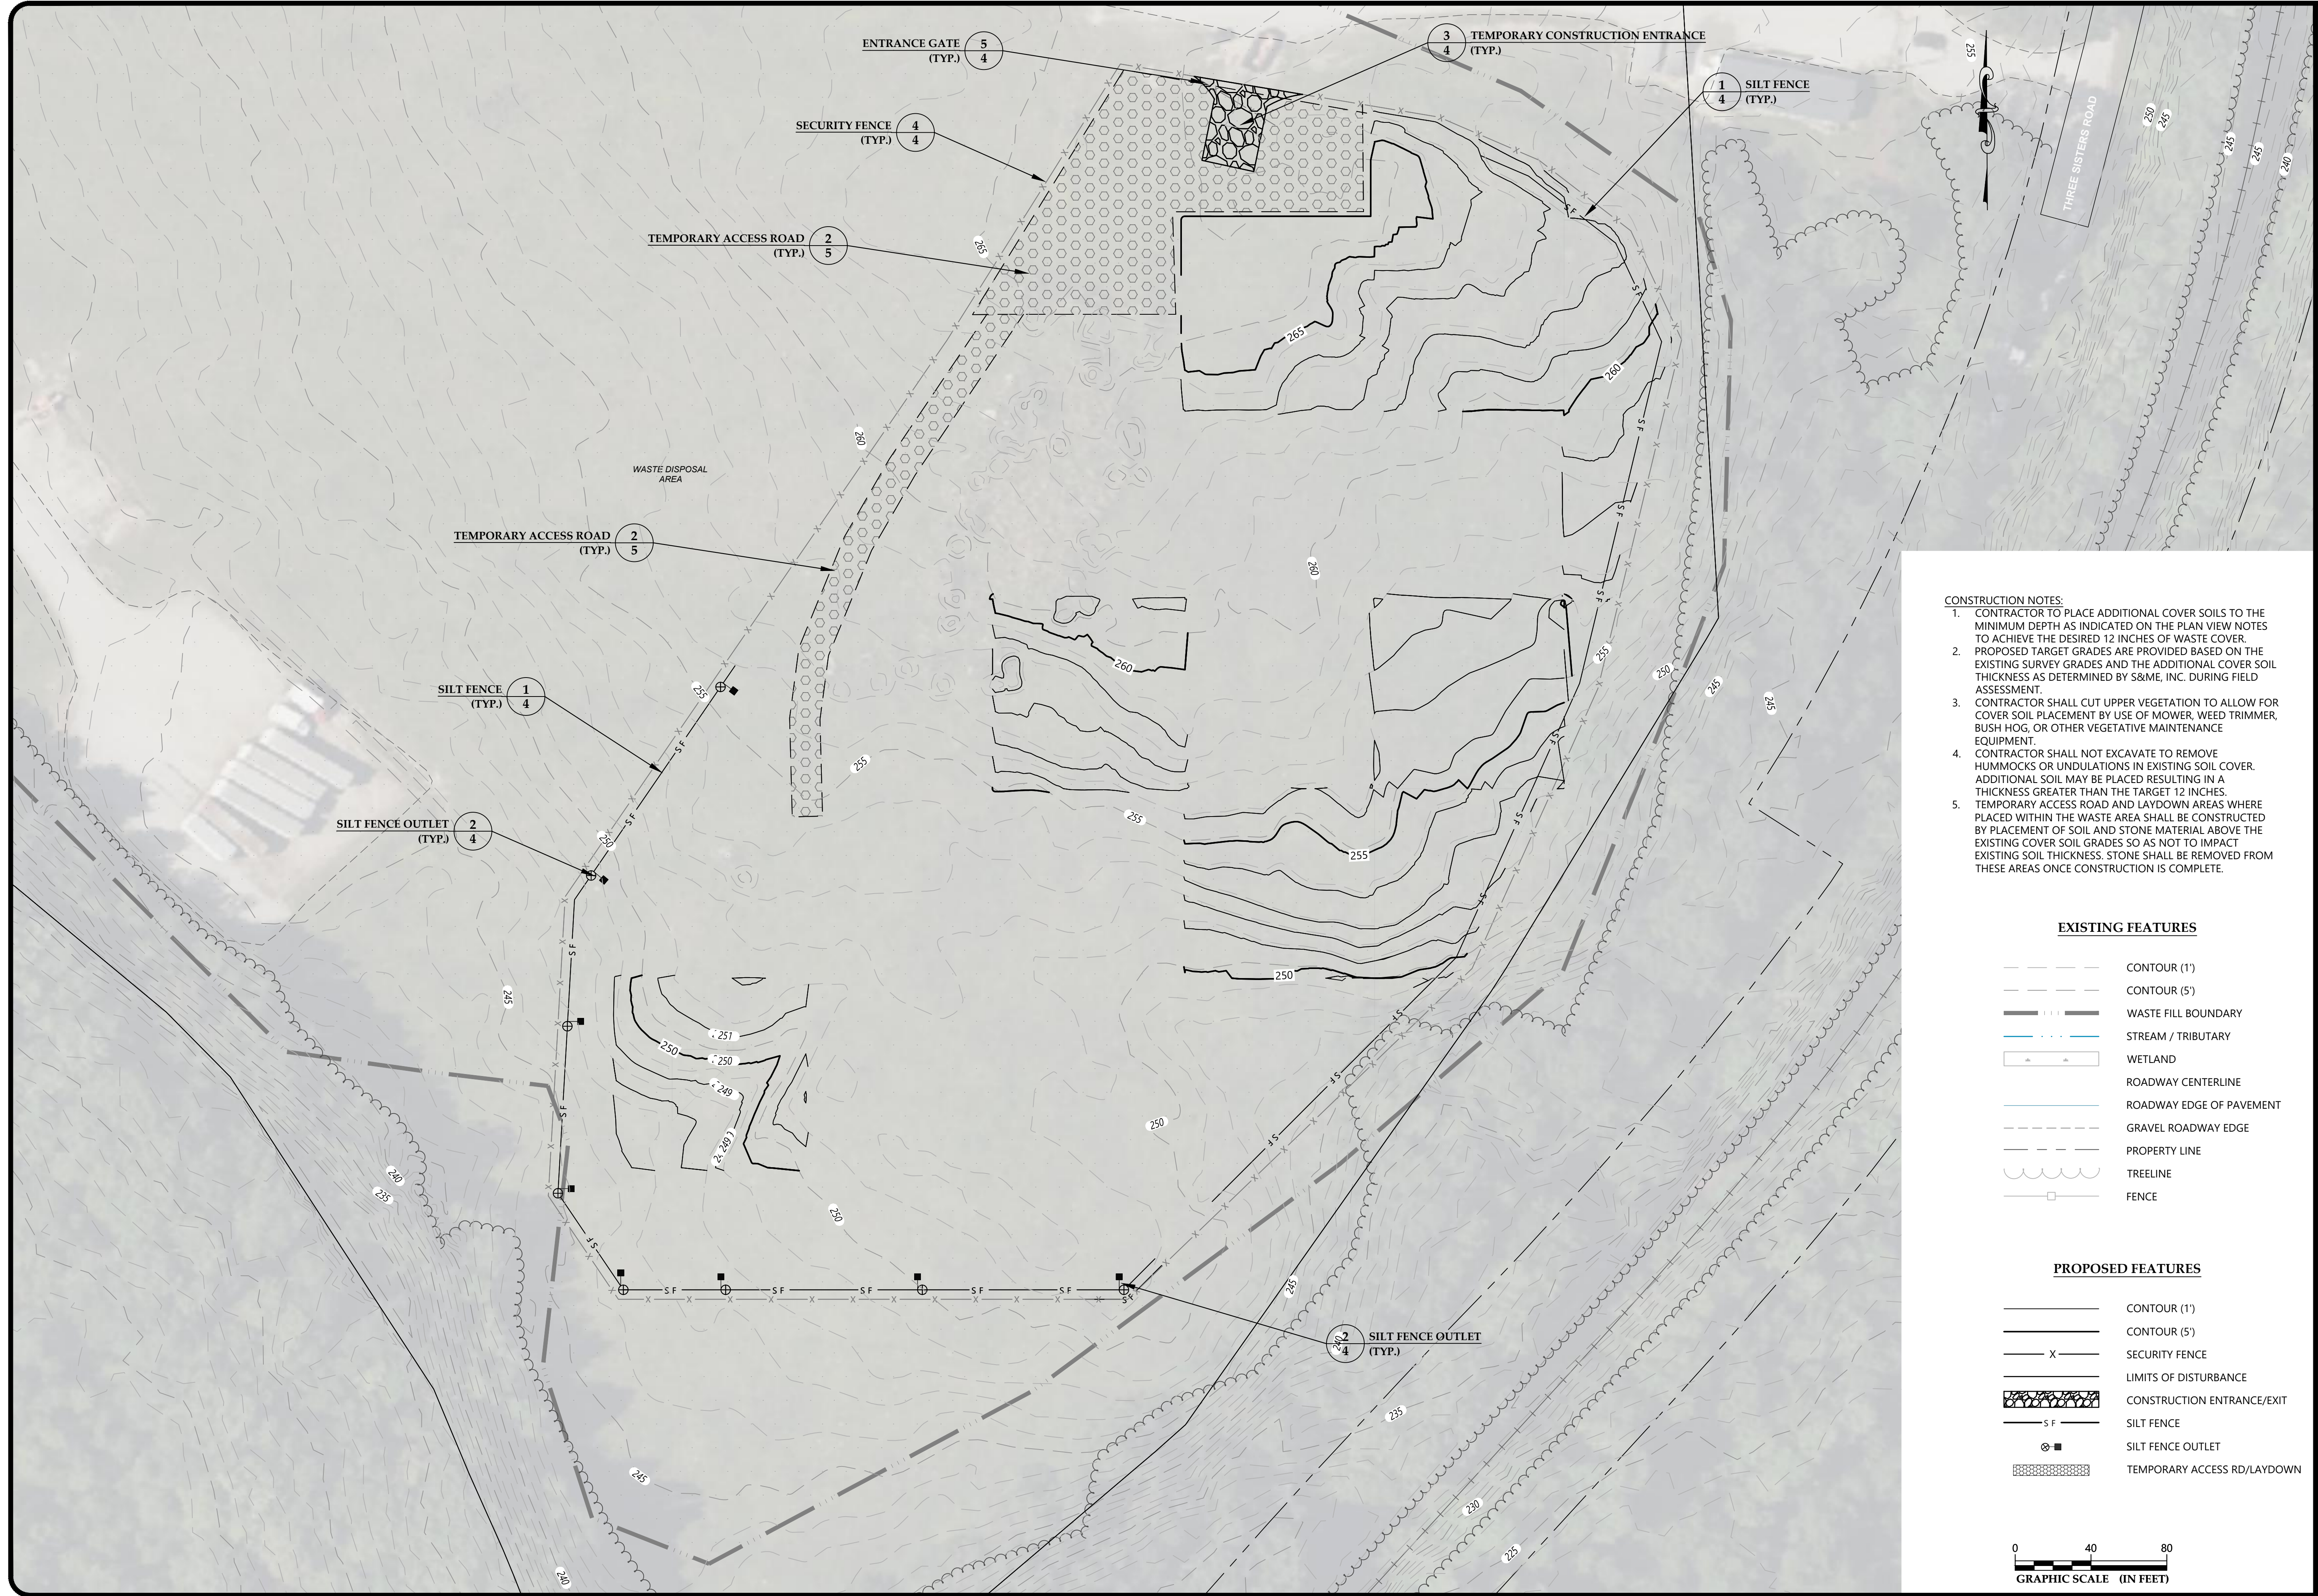
- CONSTRUCTION NOTES:**
- CONTRACTOR TO PLACE ADDITIONAL COVER SOILS TO THE MINIMUM DEPTH AS INDICATED ON THE PLAN VIEW NOTES TO ACHIEVE THE DESIRED 12 INCHES OF WASTE COVER. PROPOSED TARGET GRADES ARE PROVIDED BASED ON THE EXISTING SURVEY GRADES AND THE ADDITIONAL COVER SOIL THICKNESS AS DETERMINED BY S&ME, INC. DURING FIELD ASSESSMENT.

Following limited thin spot soil infill resulting in a consistent 12 inch cover, in-place amendment of the existing soil cover will be necessary. Following placement the resulting surface will be tracked. Amendment will likely include introduction of organic material, lime, and fertilizer in proportions directed by the Wake County extension service. Organic material (i.e., finely ground compost) will be used to increase the nutrient capacity of the topsoil. Compost has a high moisture retention and slow-release nutrients that will reduce the need for additional fertilization to establish vegetative growth. Amendments will be drilled, punched, or disked into the existing soil cover to a depth of approximately 4 inches. Seeding and mulching will be conducted; however, the extent of application will be limited to the areas of new infill, and along those equipment access paths that may require additional vegetative effort. Where necessary, the compacted access paths will be disked to an appropriate depth prior to hydro application(s). Soil placement and amendment will result in a disturbance area of greater than one acre, and will require the E&SC design and permit package. Promptly following amendment, the entirety of soil cover & disturbed areas in the vicinity of the WDA will be hydroseeded/hydr mulched to achieve vegetative stability.

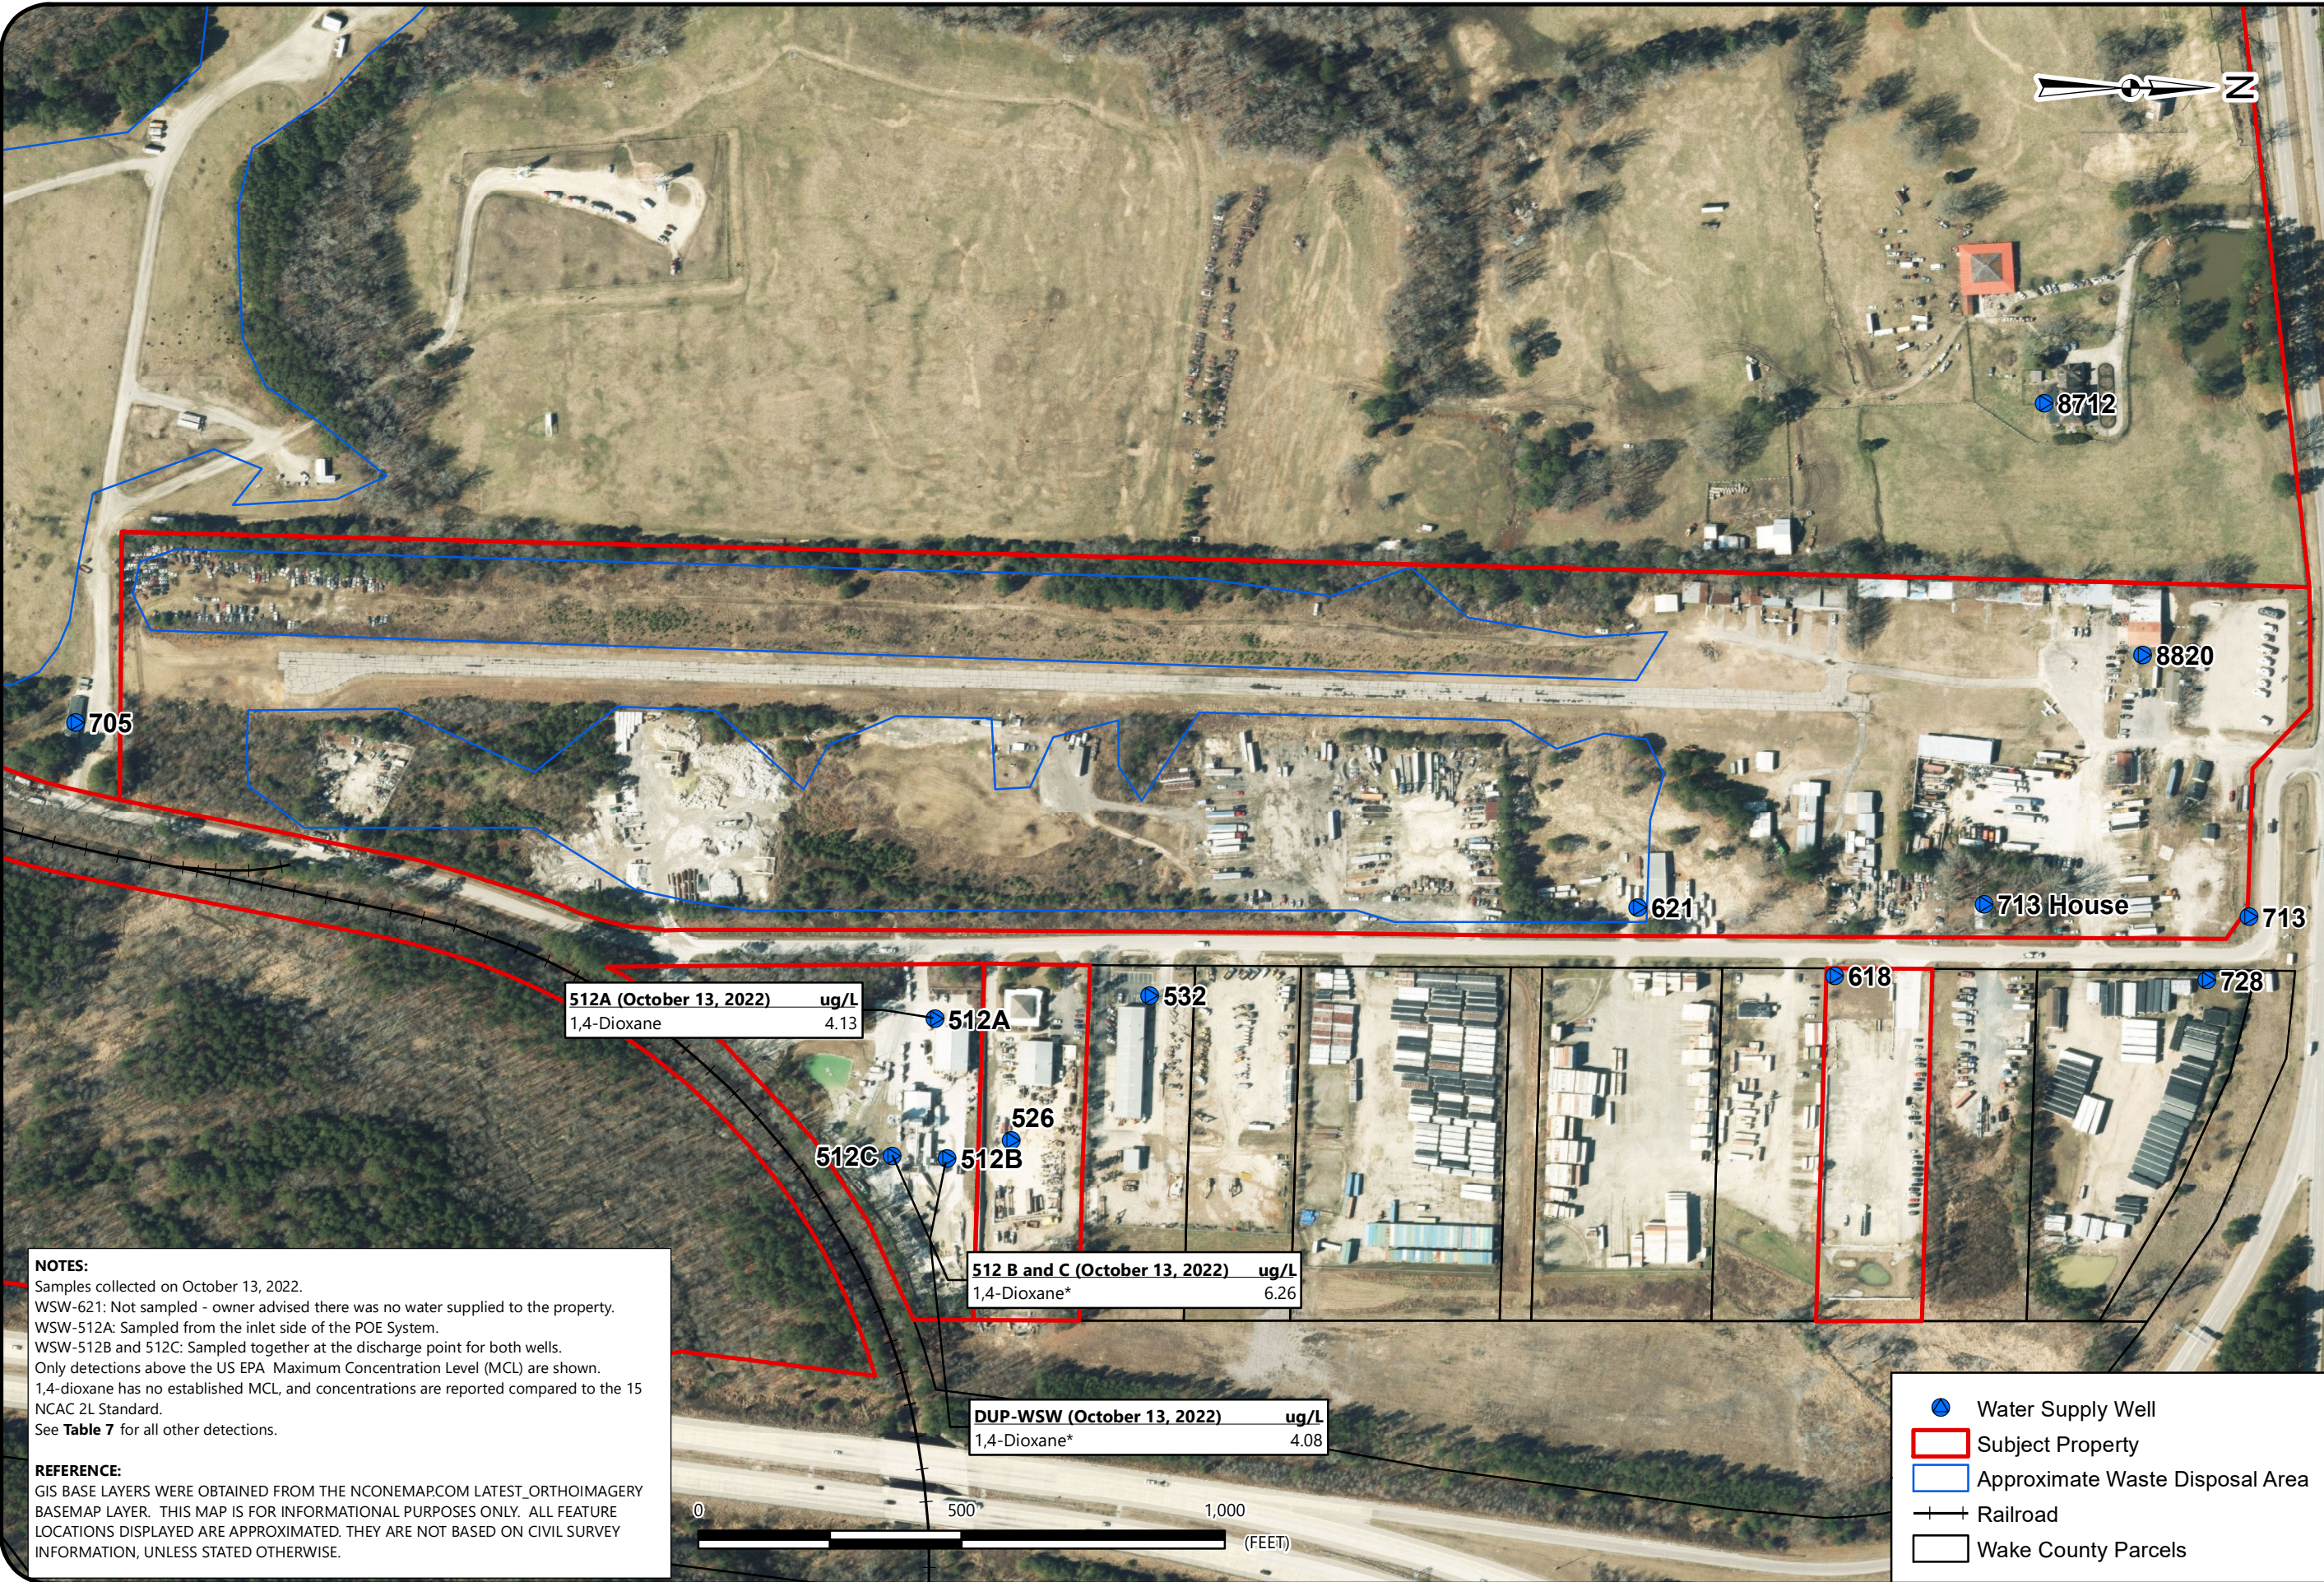
NOTES:
 Samples collected on October 13, 2022.
 WSW-621: Not sampled - owner advised there was no water supplied to the property.
 WSW-512A: Sampled from the inlet side of the POE System.
 WSW-512B and 512C: Sampled together at the discharge point for both wells.
 Only detections above the US EPA Maximum Concentration Level (MCL) are shown.
 1,4-dioxane has no established MCL, and concentrations are reported compared to the 15 NCAC 2L Standard.
 See **Table 7** for all other detections.
