Remedial Investigation  
Additional Waste Delineation Assessment Report  
Southside Park Landfill NONCD00000807  
2645 Toomey Avenue, Charlotte, Mecklenburg County North Carolina  
Task Order 807RI-17  
S&ME Project No. 215952

Reference: **Remedial Investigation-Additional Waste Delineation Assessment Report  
Southside Park Landfill**  
2645 Toomey Ave., Charlotte, Mecklenburg County, North Carolina  
NCDEQ ID No. NONCD0000807  
NCDEQ Task Orders 807RI 17  
S&ME Project No. 215952

# WASTE DELINEATION SITE MAP

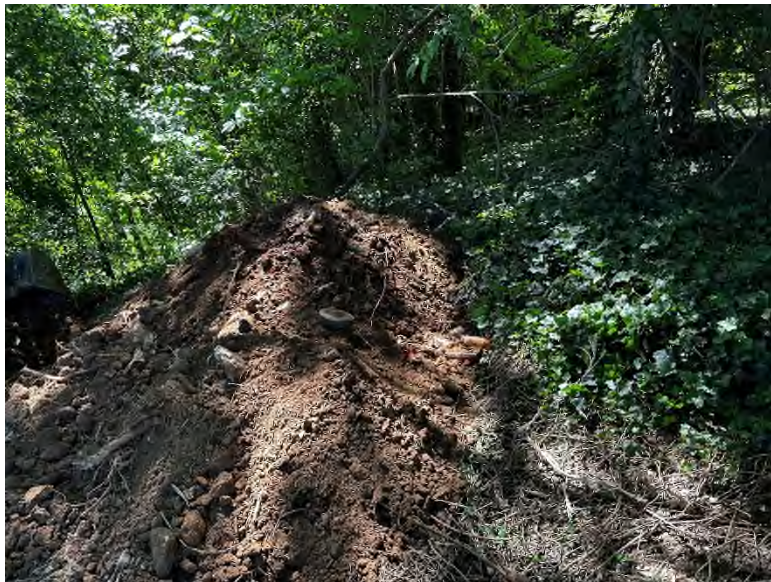
| 1 | Location / Orientation | T-2 | | |

Where waste was encountered in trenches, the waste was comprised of glass bottles, plastic, rubber, old tires, household waste and appliances, wiring, and other miscellaneous items. Trenches near the parking lot (T-1 to T-3) contained waste down to 5-7 feet bgs and extended close to the park boundary. It is interpreted that waste may be located off site and onto residential properties in these areas.

| | Remarks | Example of waste in trench, which included glass, tires, plastic, wires, and concrete. | | |

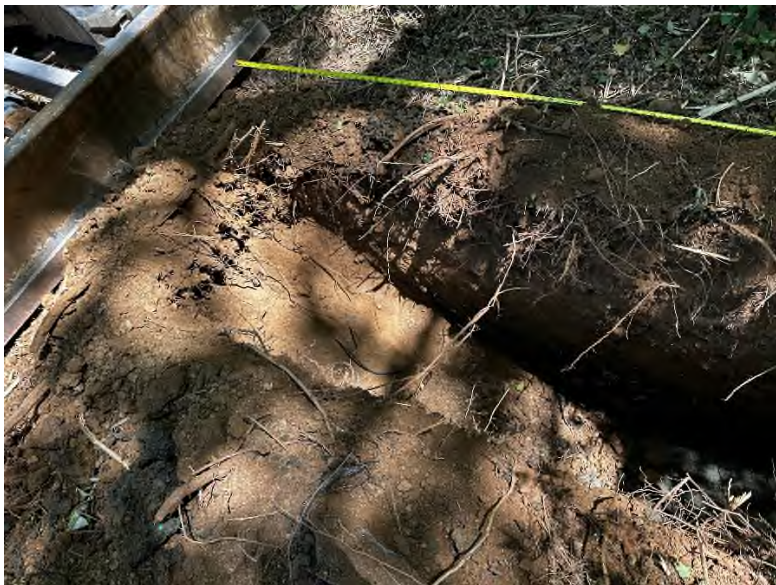
| 2 | Location / Orientation | T-3 | | |

| | Remarks | Waste at a depth of 4 to 6 feet, observed as the black layer at the bottom of the trench. | | |

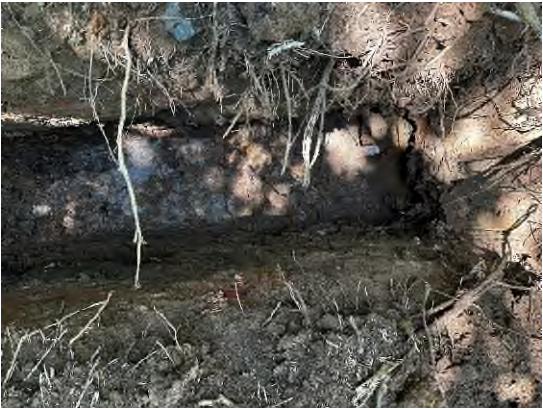
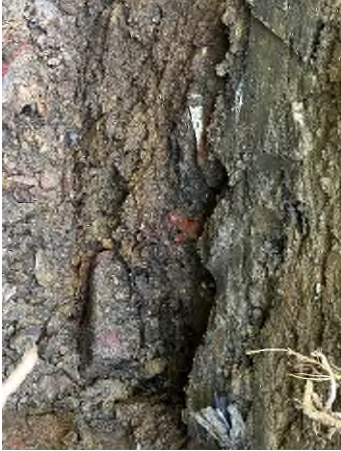
Trenches near the creek bed (T-4 to T-7) had waste leading up to and sometimes into the creek. Waste was observed at a depth of 7 feet bgs.

| | Remarks | Waste at depth of 3 feet throughout the trench near the creek bed, example of waste shown in the right photo. | | |

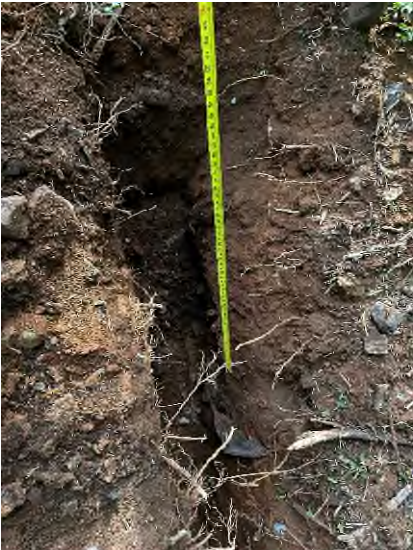
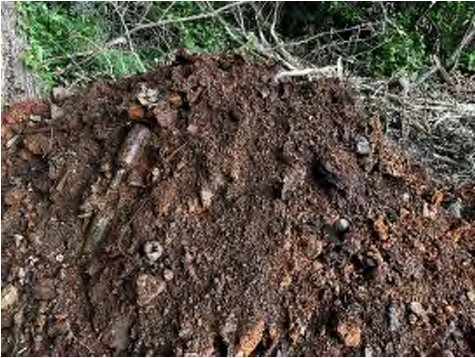
| | Remarks | Trench filled with waste. Waste is shown in the photo on the right. | | |

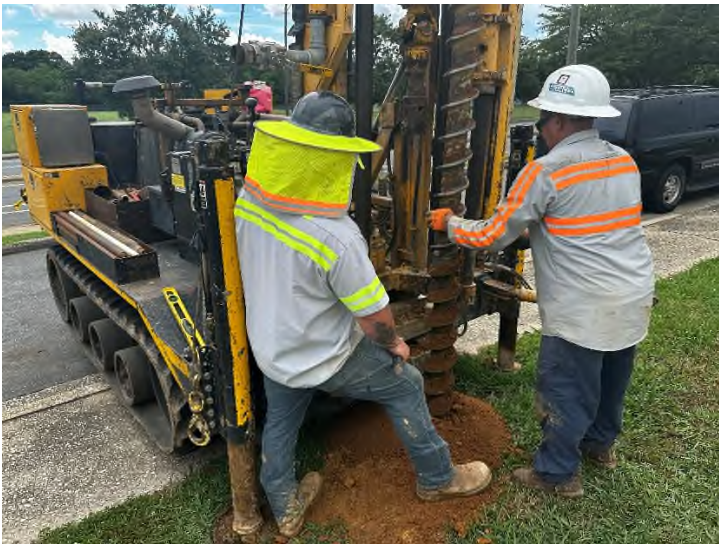
Waste was located near the eastern property line along Remount Road during the first WDA delineation work. During this additional assessment, waste was confirmed to not cross Remount Road. Borings (SB-157-174) did not contain waste on parcels 11905202, 11905301, and 11905406.

| | Remarks | Orange silty sand at boring across Remount Road which contained no waste. | | |

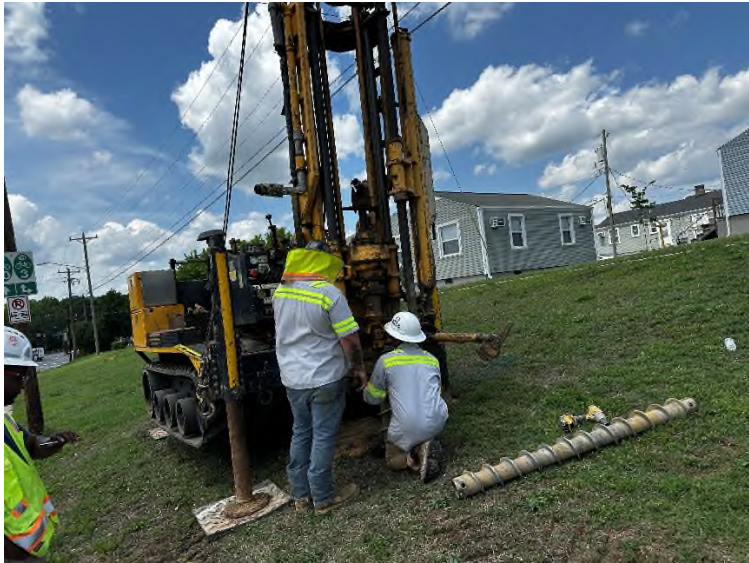
| | Remarks | Orange silty sand at boring across Remount Road which contained no waste near residential buildings. | | |

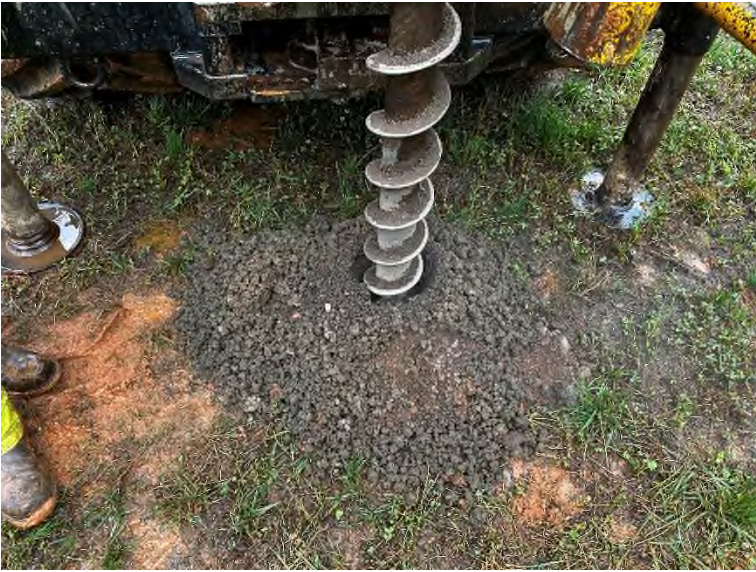
| | Remarks | Soil boring contains no waste with hard tan native silty sand. | | |

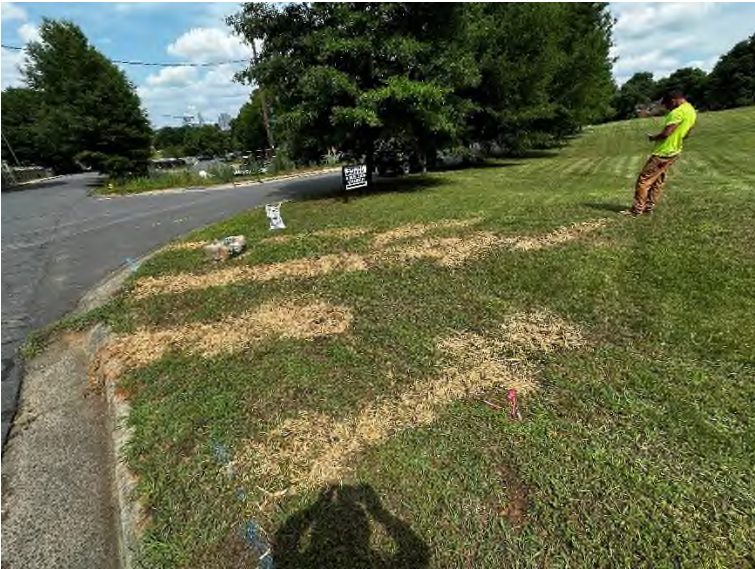
| | Remarks | SAEDACCO crew cleaning up and repairing track ruts from rig and excavator. | | |

Investigative derived waste (IDW) extracted from the soil borings and test pits were placed back into the ground and covered with soil, seed, and straw.
